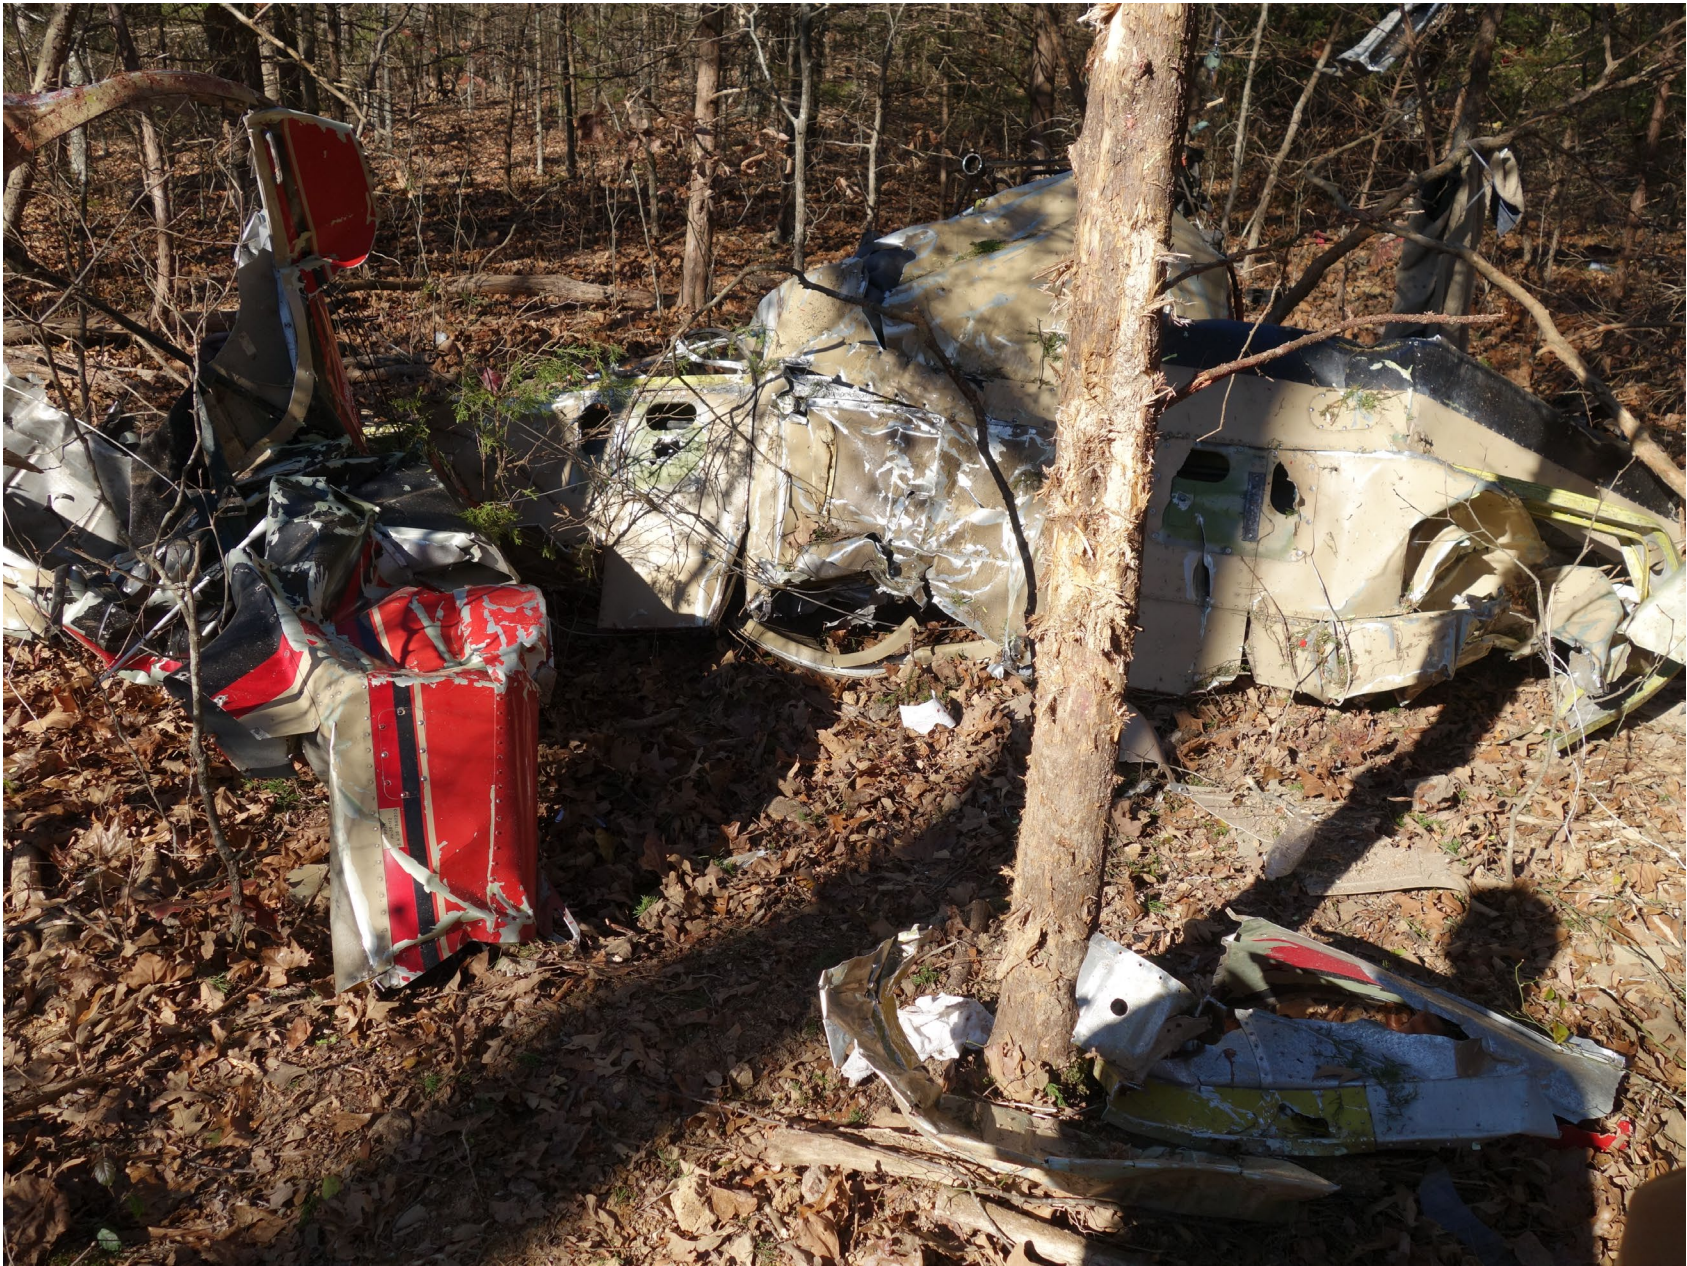
**Photo 1 – Main wreckage at accident site (Piper Photo)**

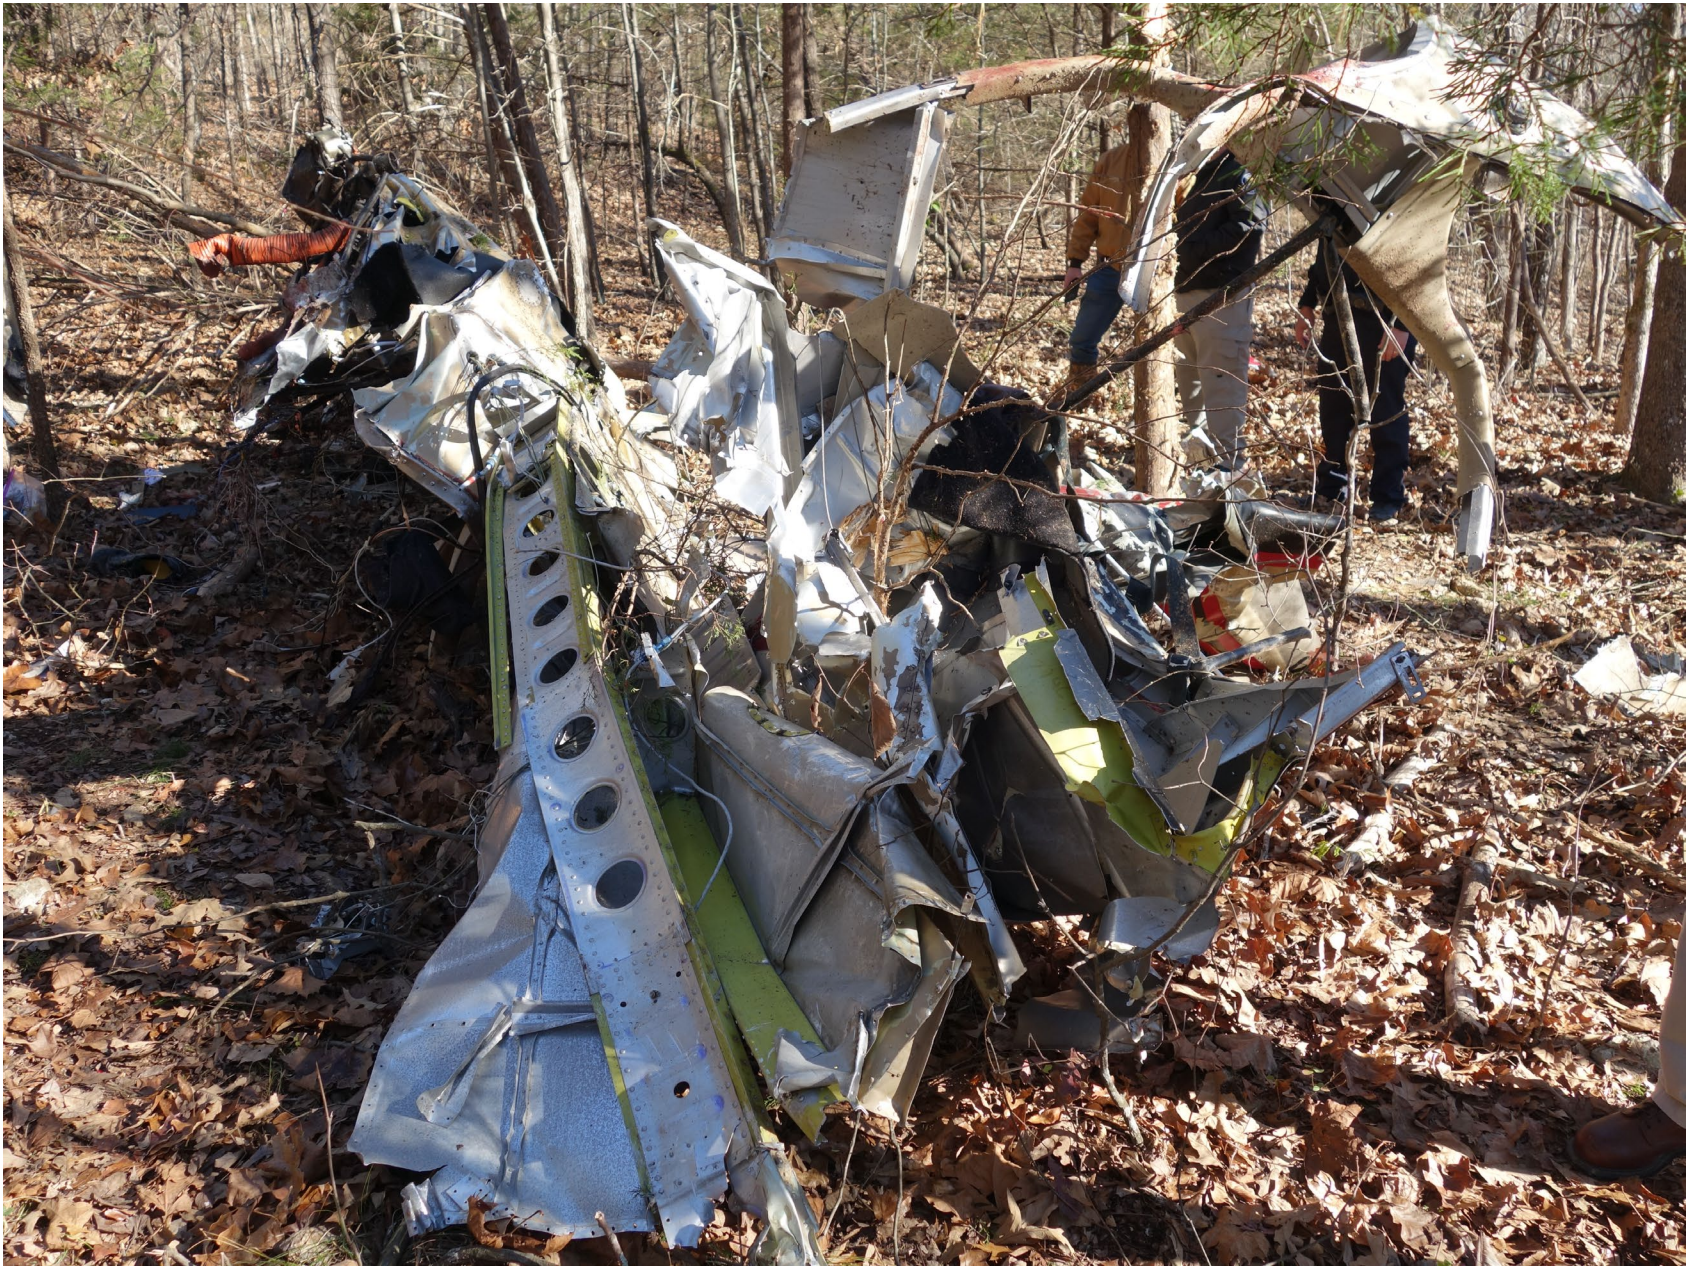
**Photo 2 – Main wreckage at accident site (Piper photo)**

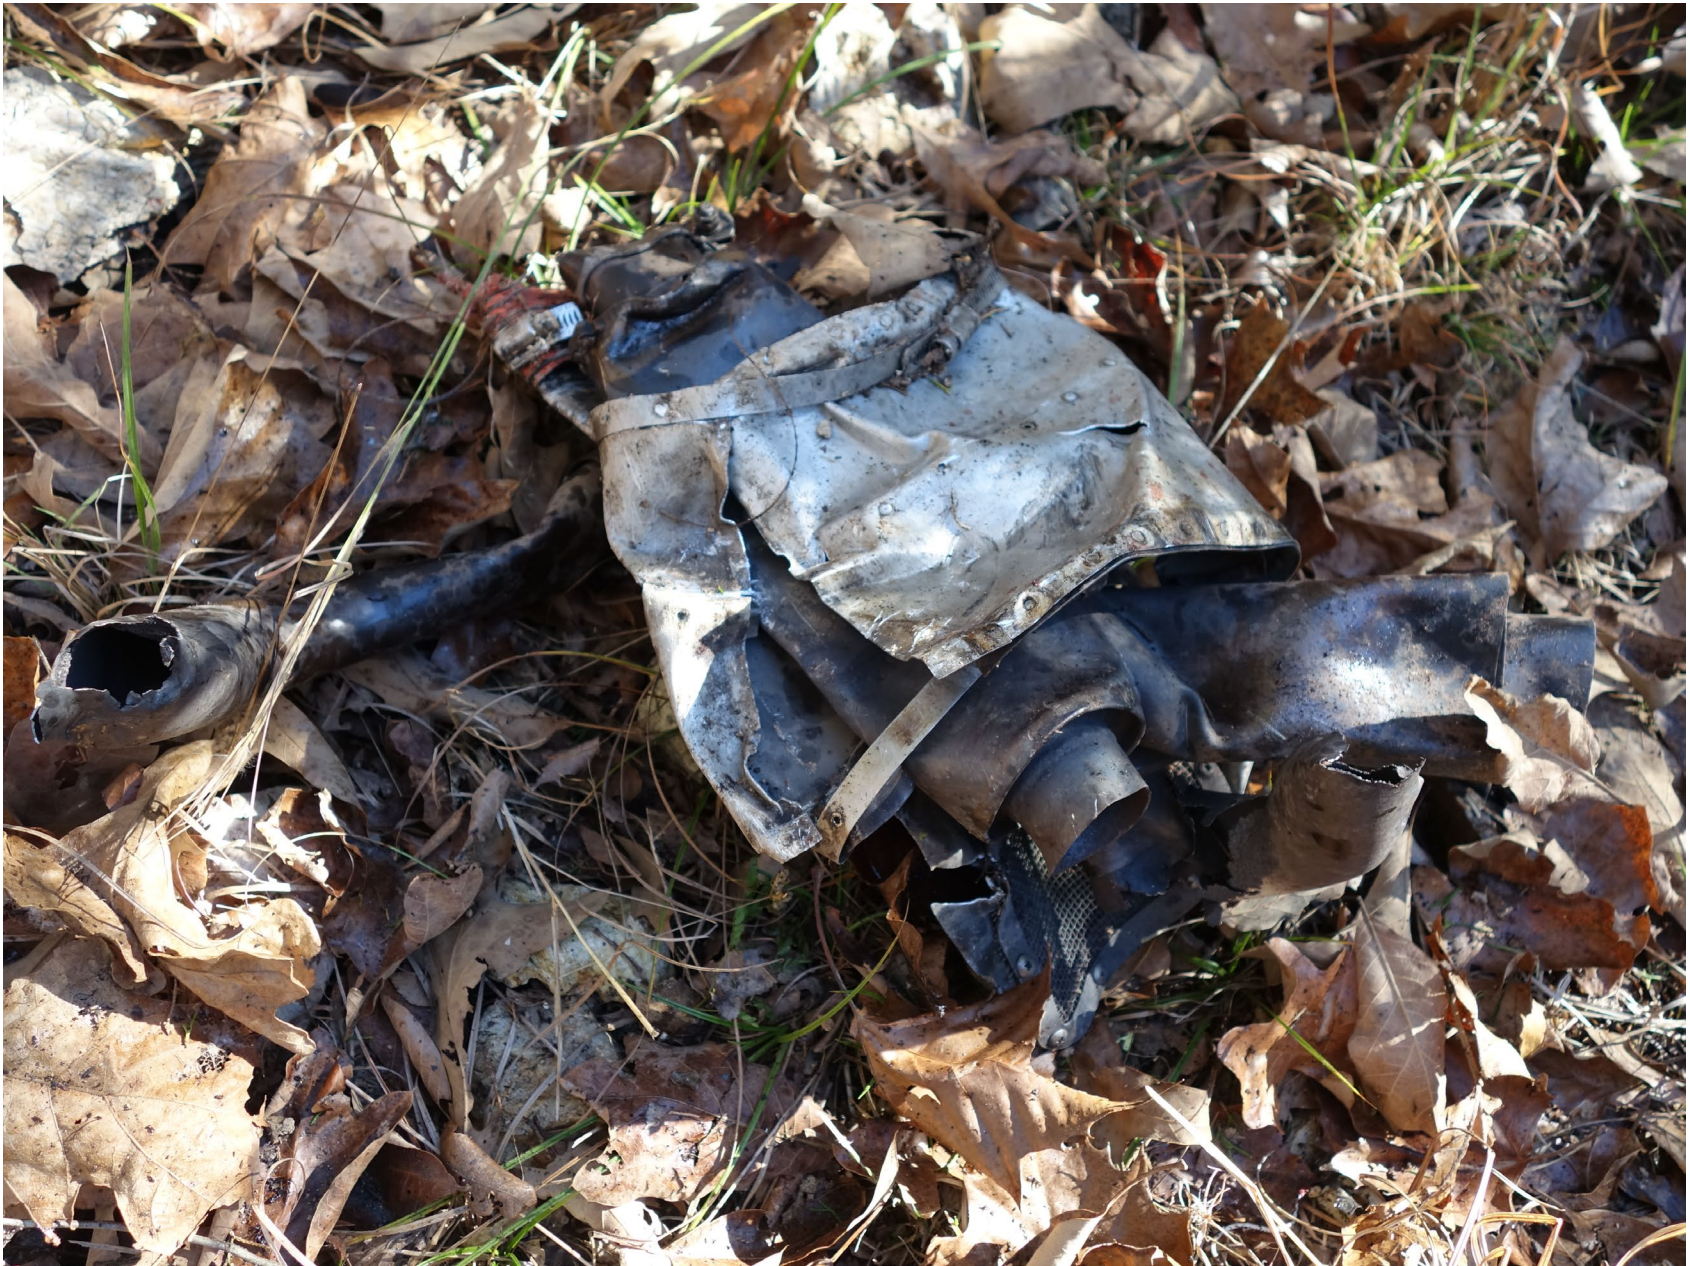
**Photo 3 – Mufflers as found at accident site (Piper photo)**

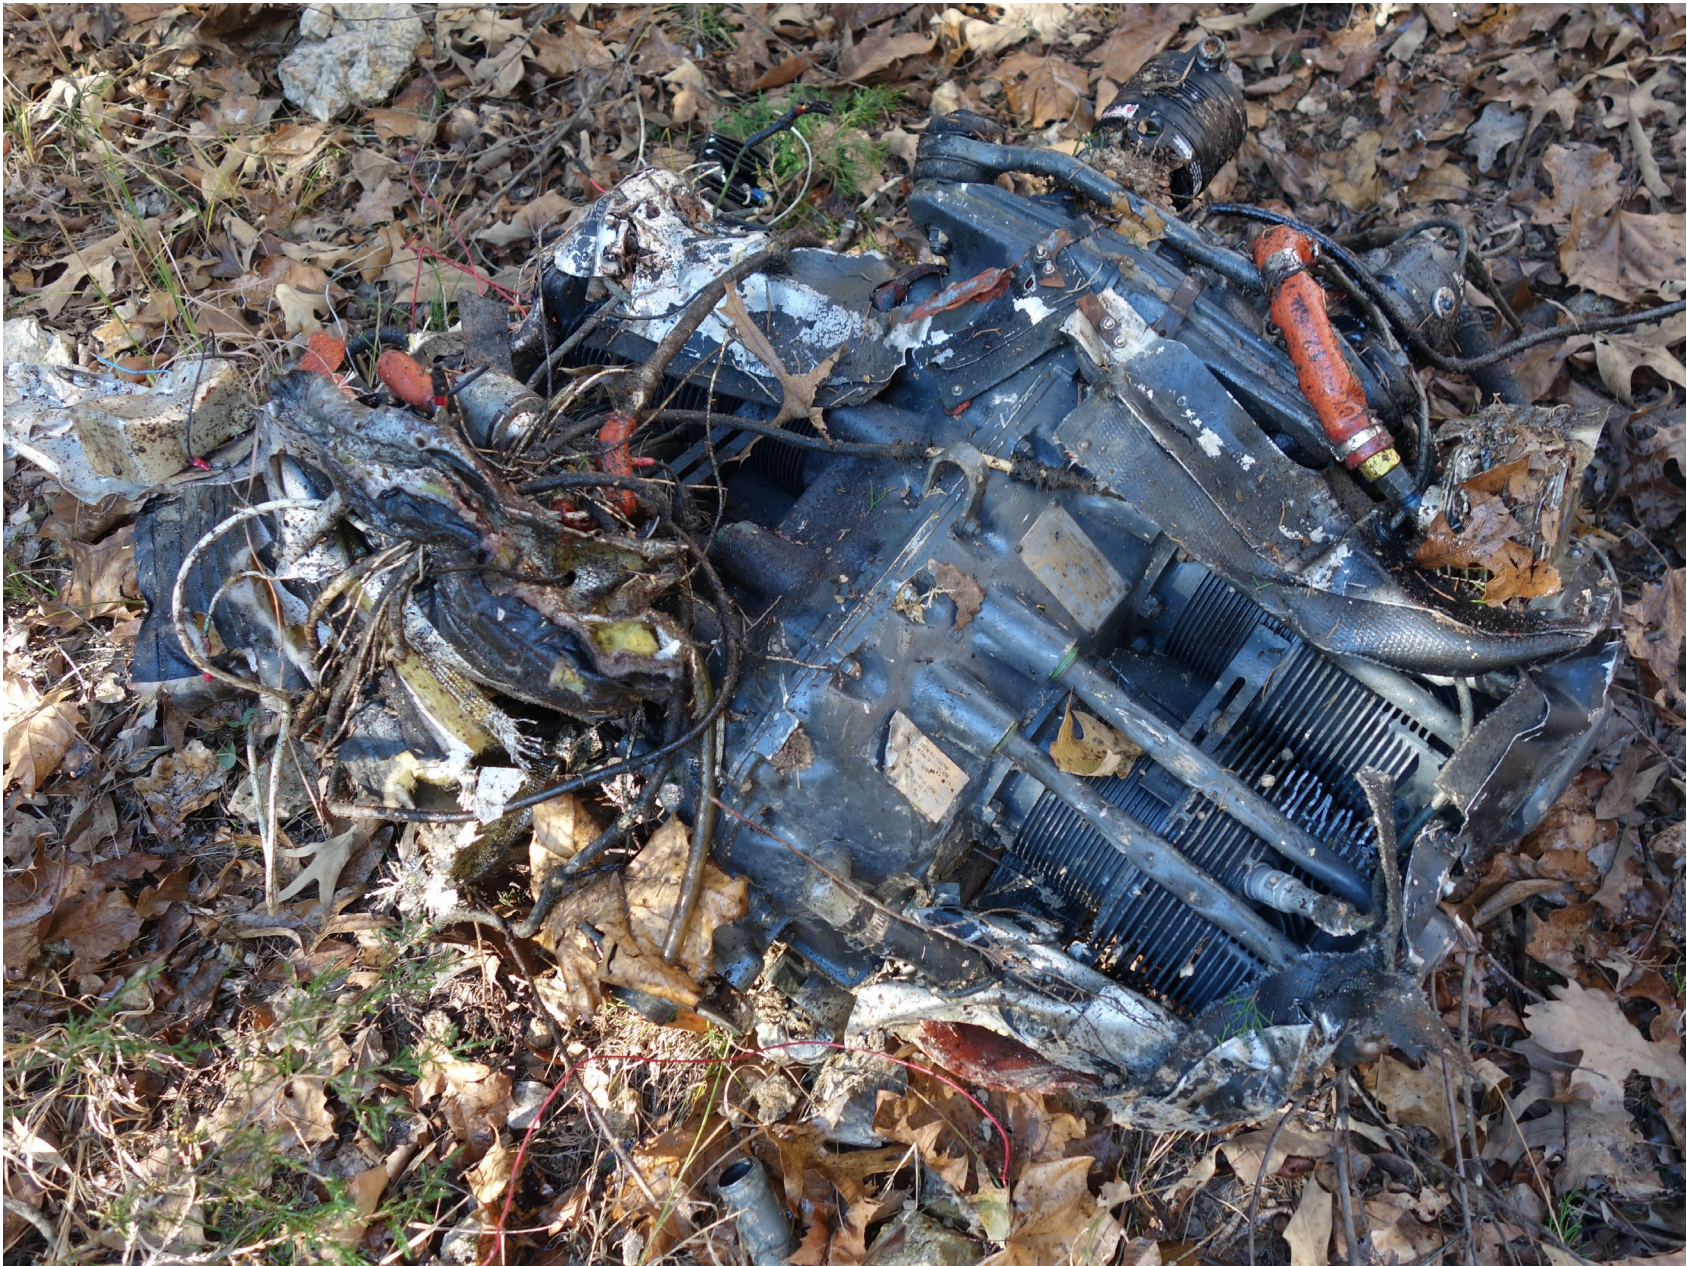
**Photo 4 – Top view of engine at accident site (Piper photo)**

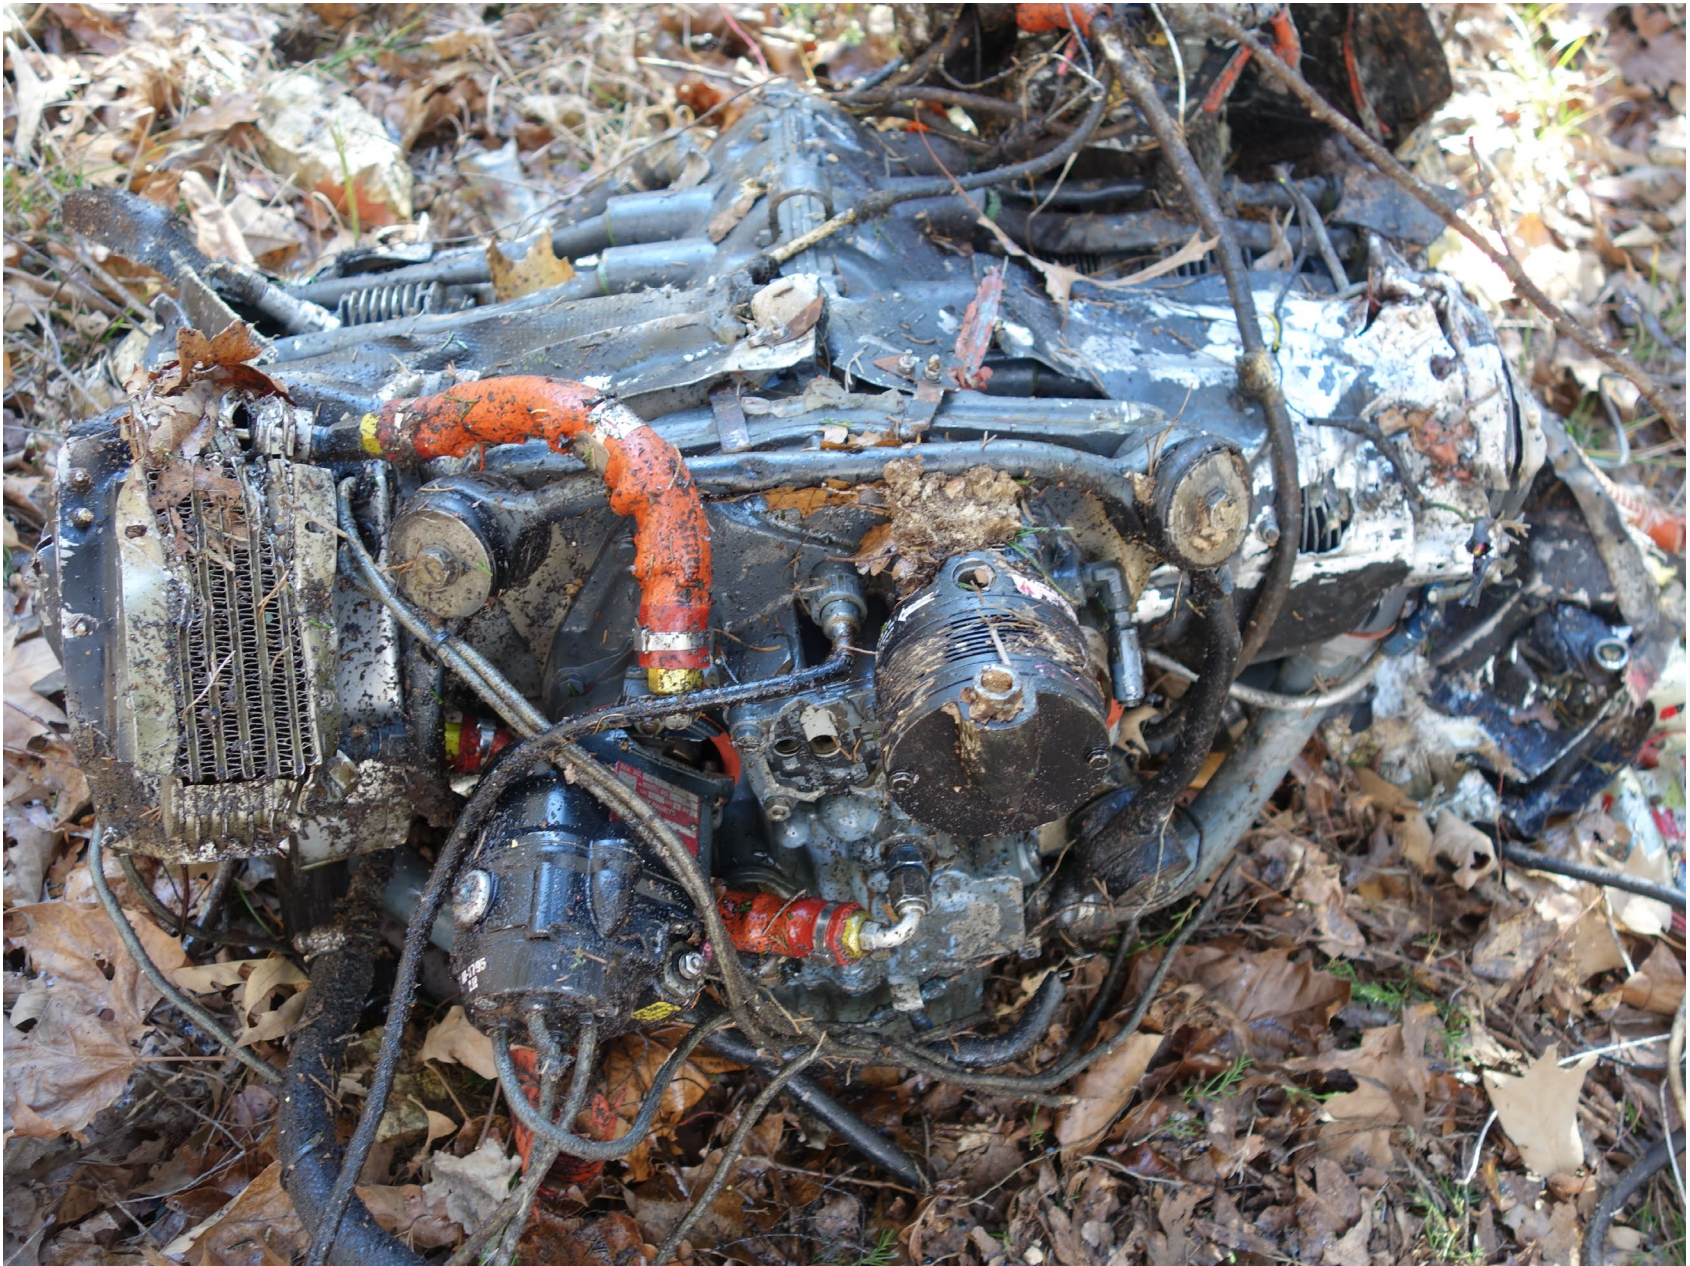
**Photo 5 – Accessory end of engine at accident site (Piper photo)**

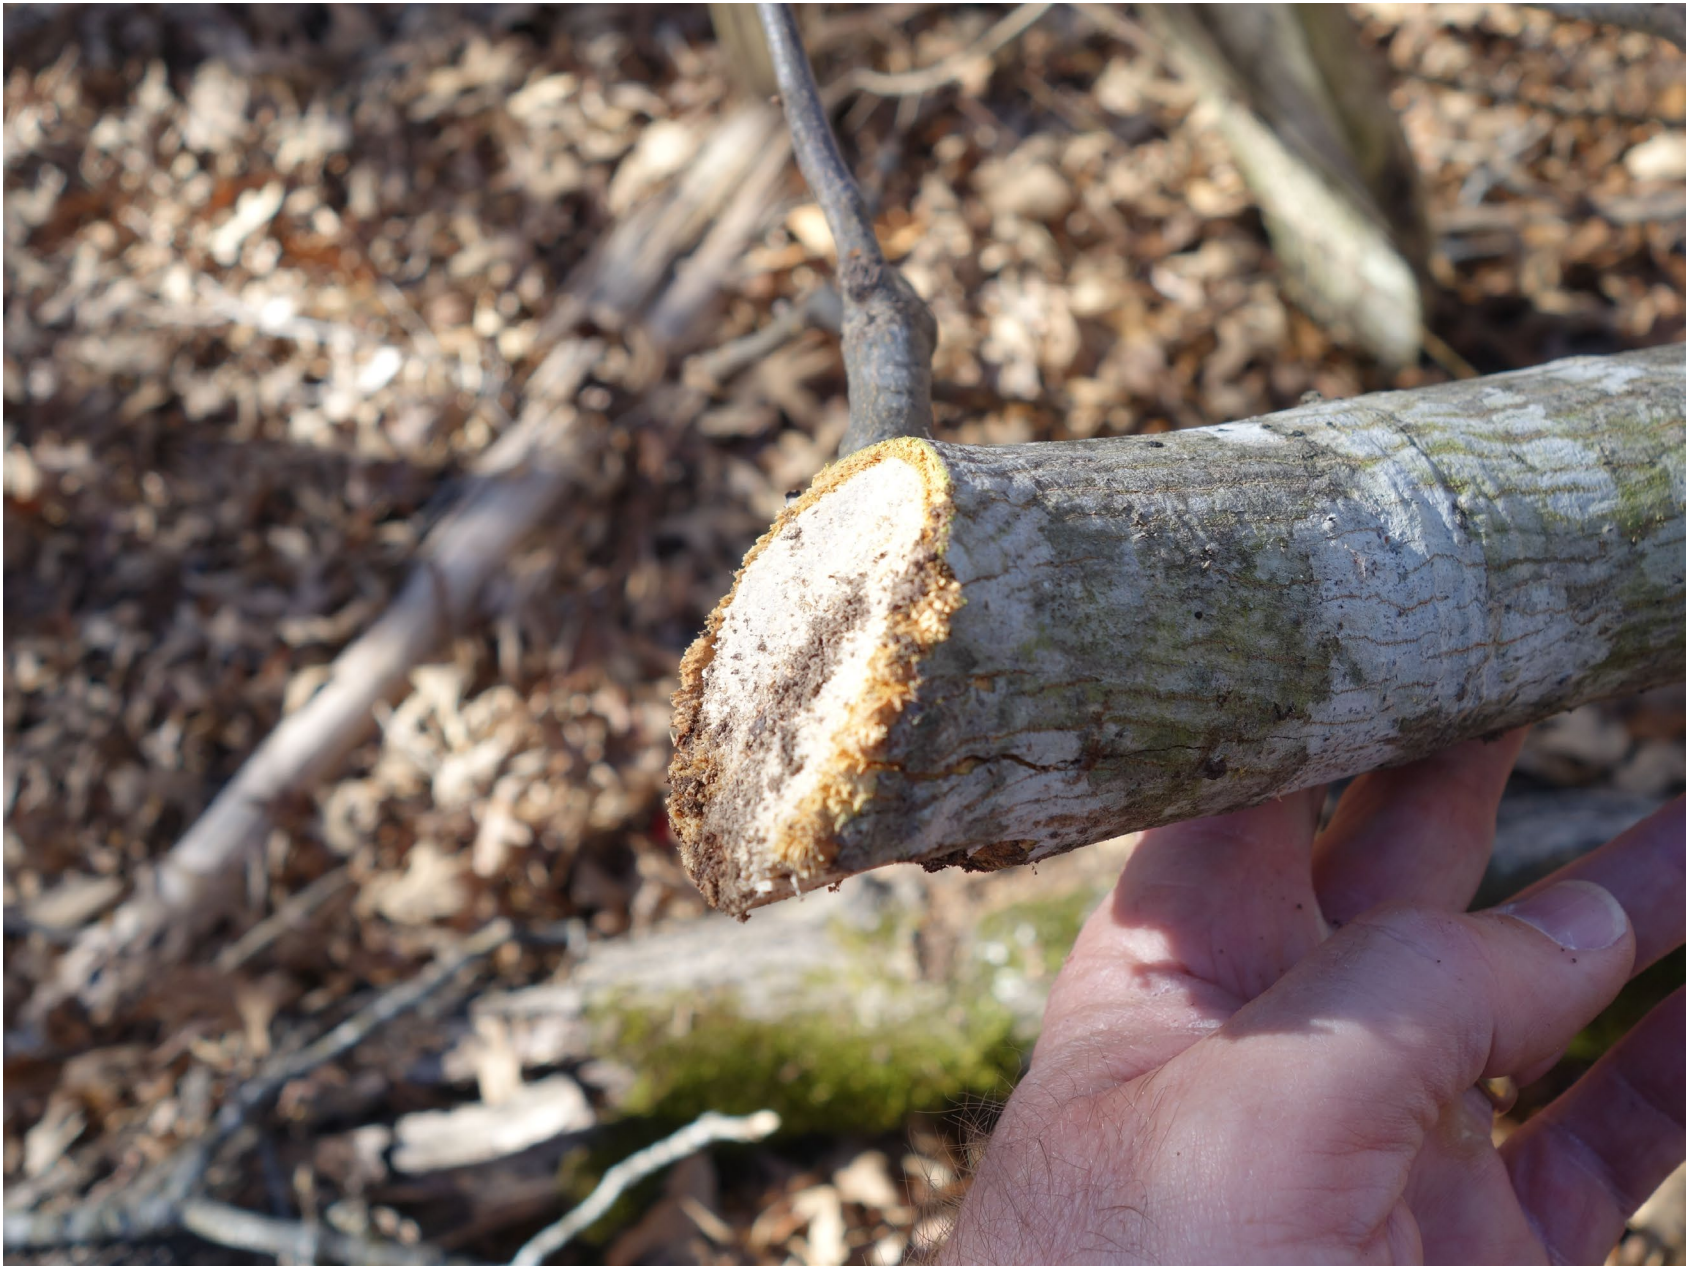
**Photo 8 – Propeller tree strike (Piper photo)**
