**NATIONAL TRANSPORTATION SAFETY BOARD**  
**Office of Aviation Safety**  
**Washington, DC 20594**

**SUMMARY OF AIRCRAFT EXAMINATIONS**

**-- CEN21A075 --**

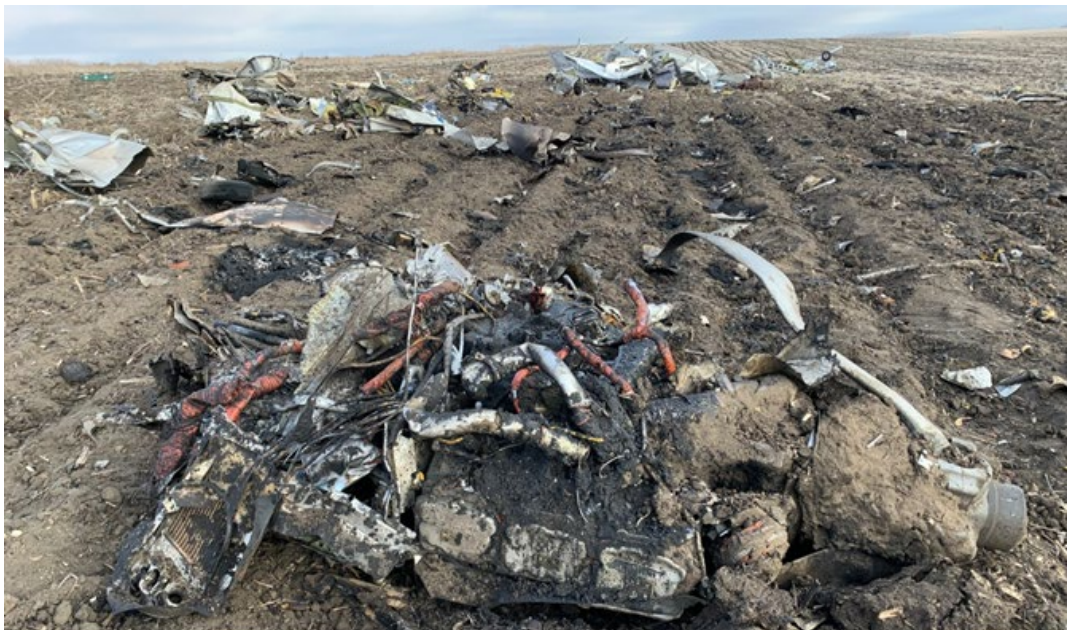
The airplane impacted a plowed field on an easterly heading about 2.5 miles from the end of Runway 35 and slightly west of the extended runway centerline. The initial impact point included portions of the right-wing position light and the debris path was about 220 ft long. The airplane was highly fragmented.

Figure 1. Wreckage at Accident Site
