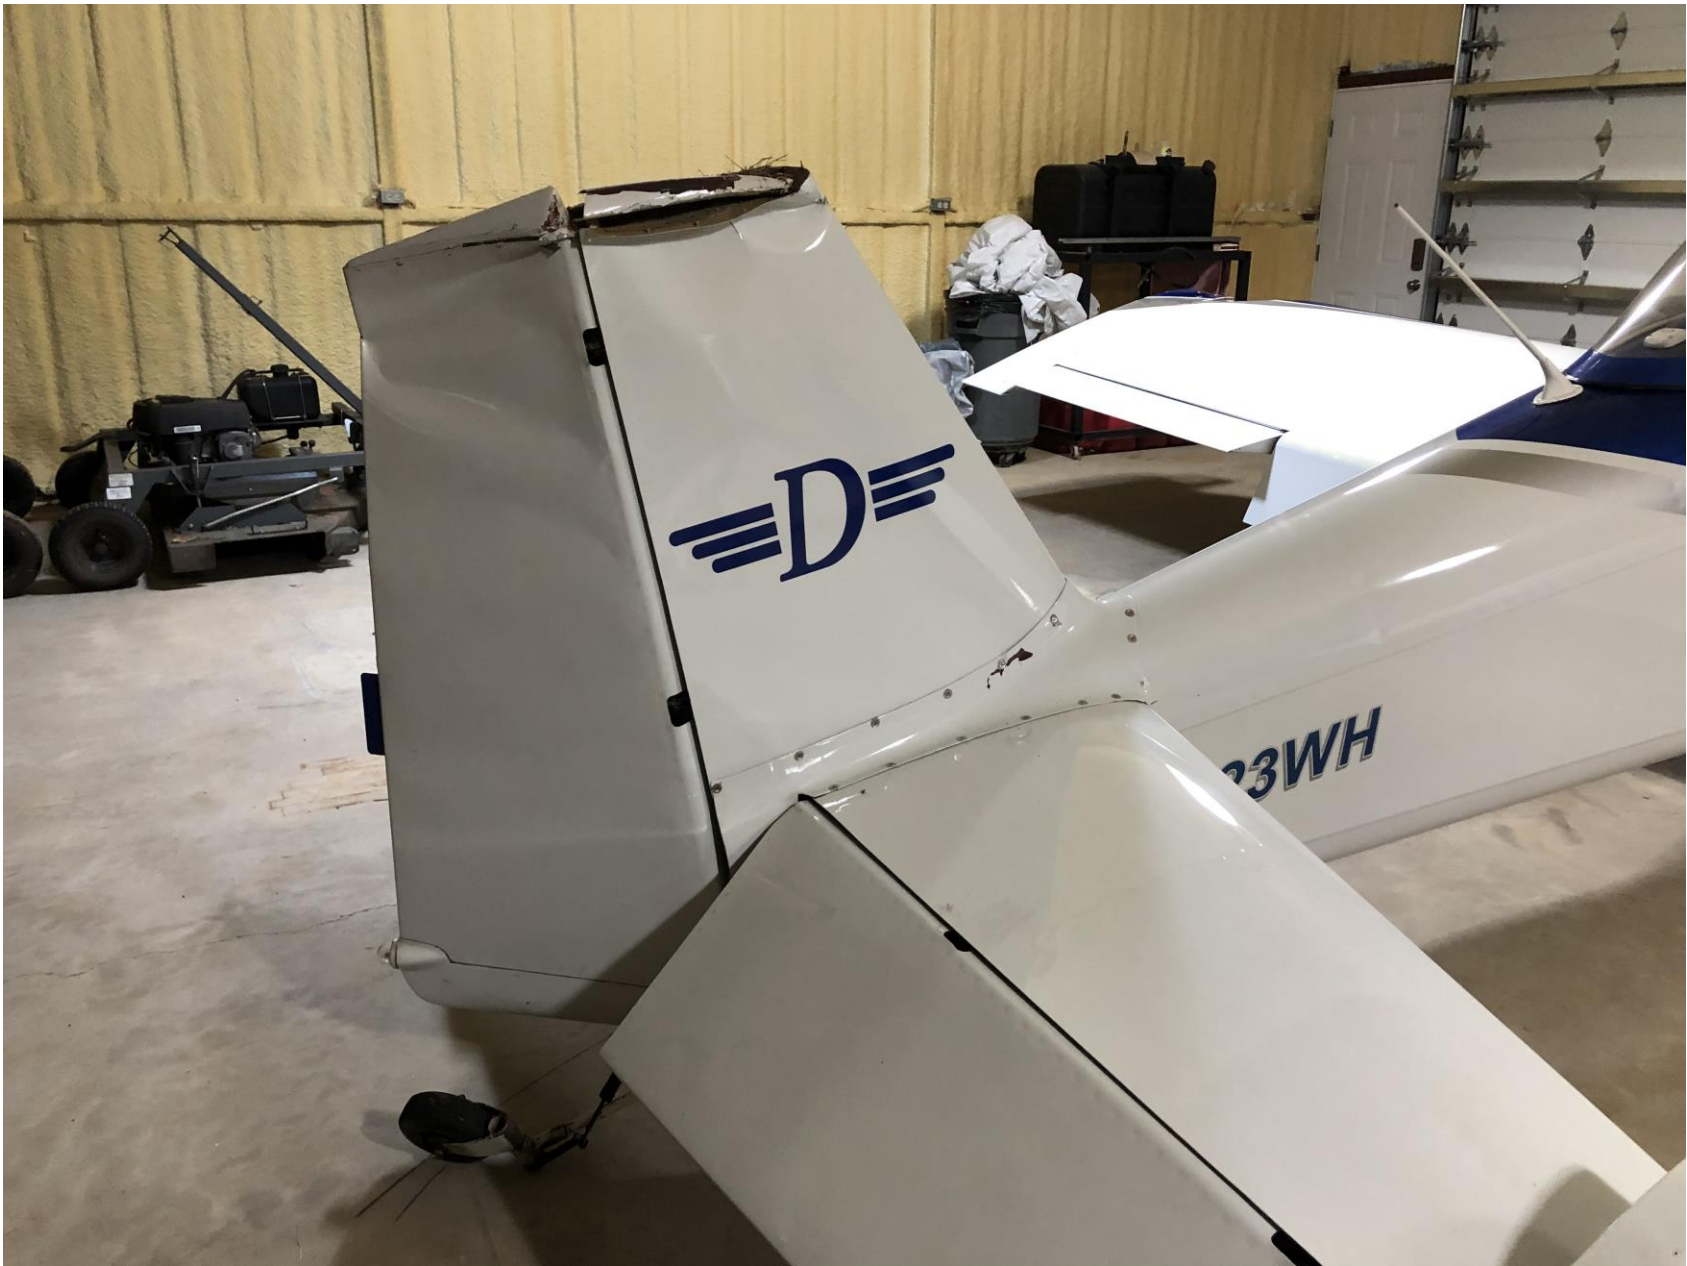
**Photo 1 – Vertical Stabilizer and Rudder Damage (Owner Photo)**

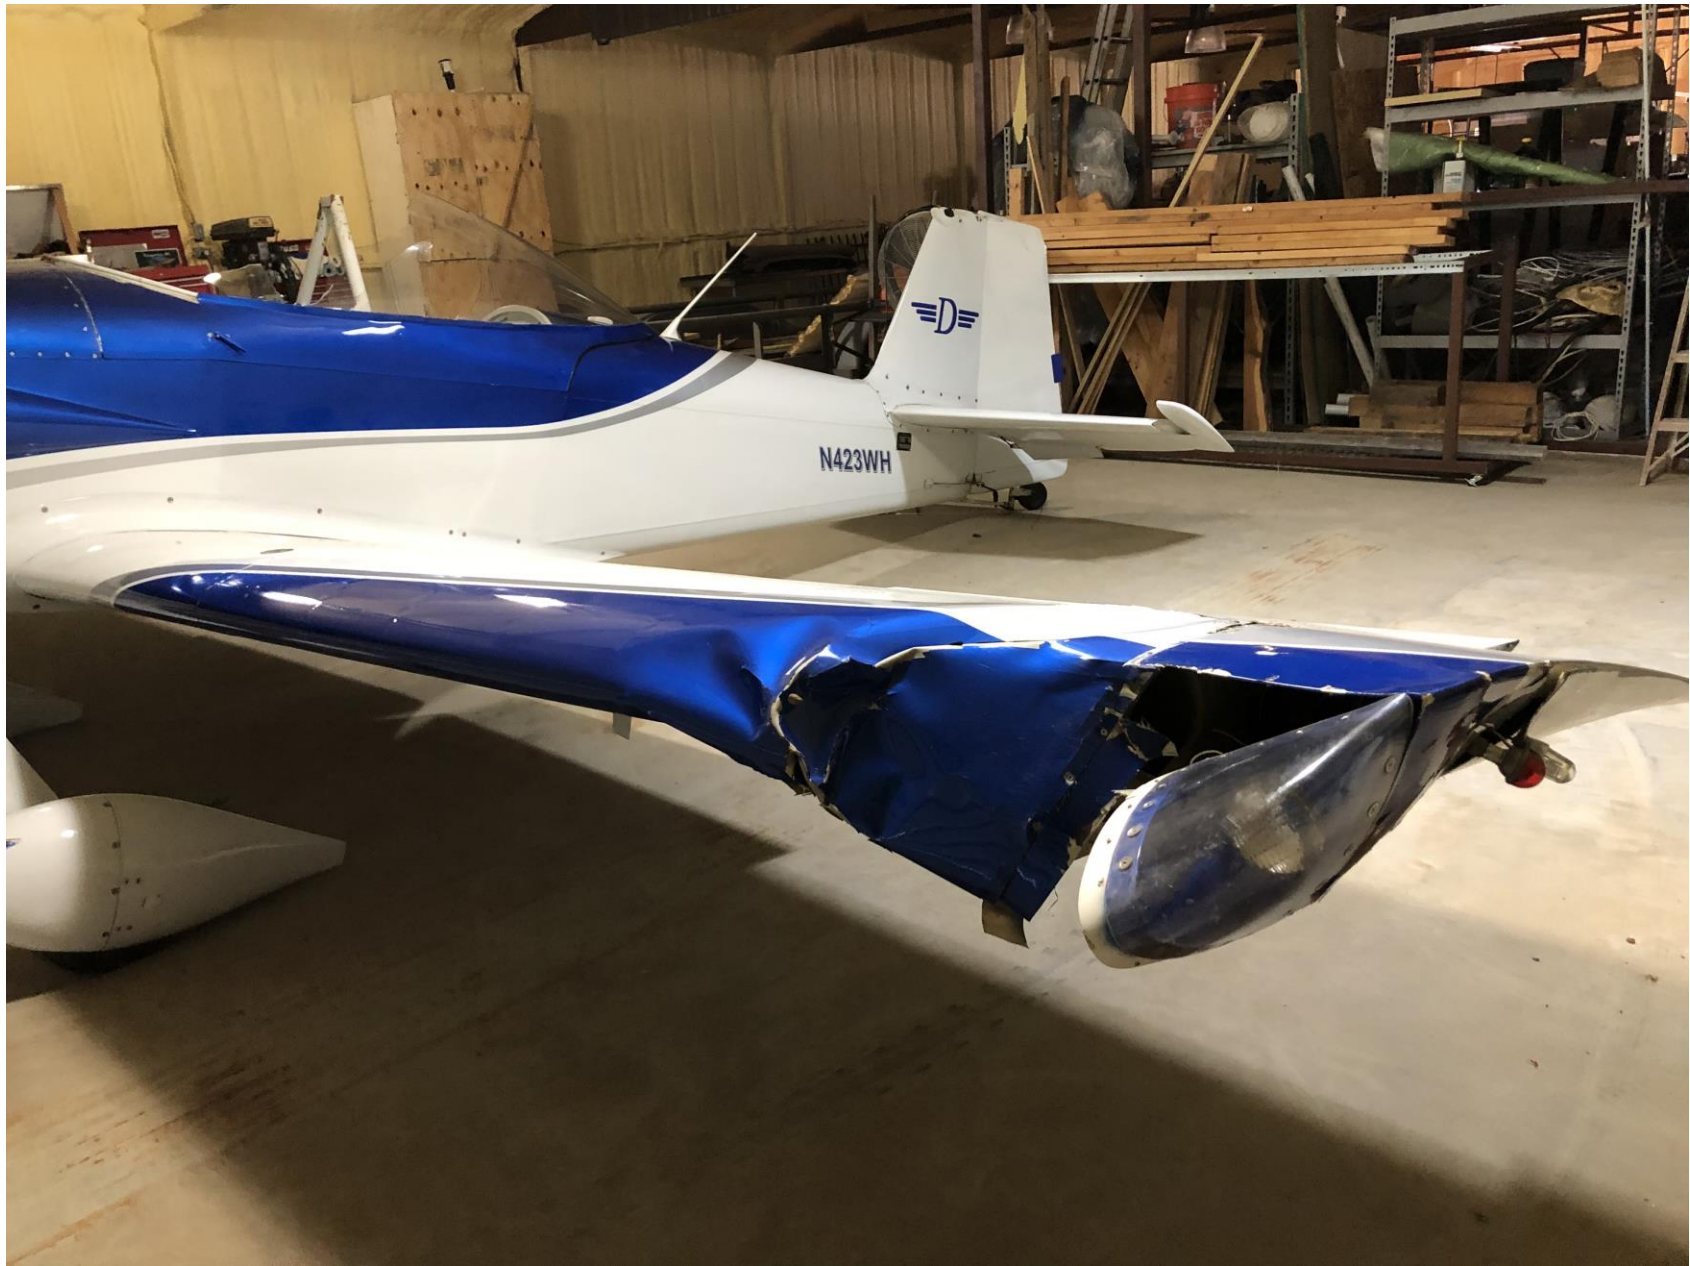
**Photo 2 – Left Wing Damage (Owner Photo)**
