# Lake County / Leadville Airport

## Eclipse Aircraft accident – Landing on RW 16 Overshooting

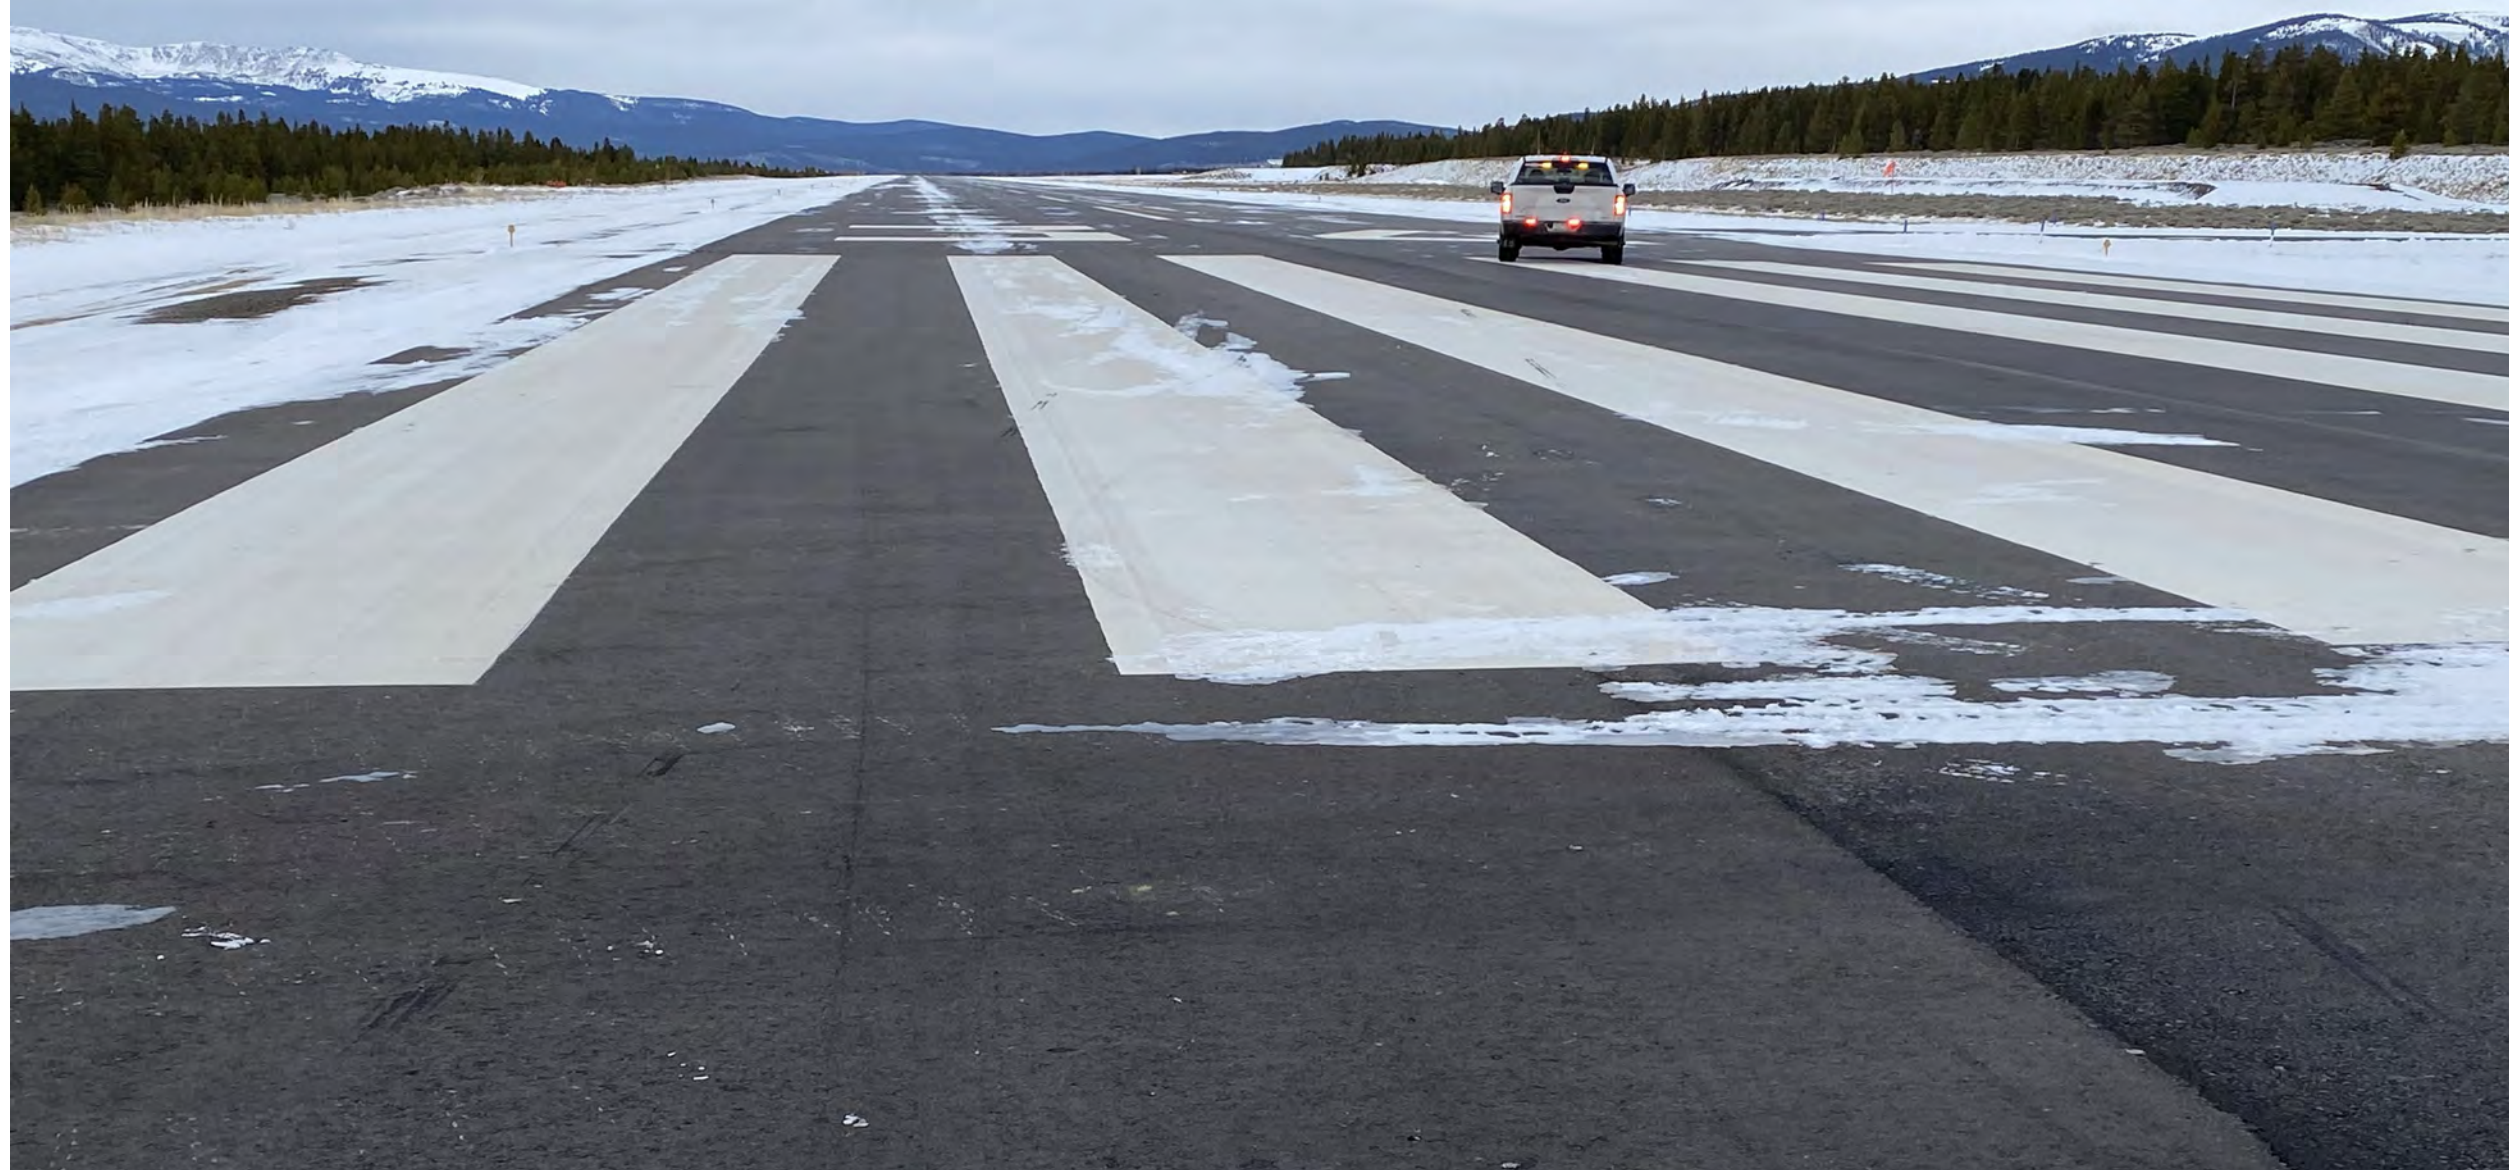
Looking down RW 34 from the point where the aircraft went off the end of RW 16: Note skid marks veering across center line tracking to the West

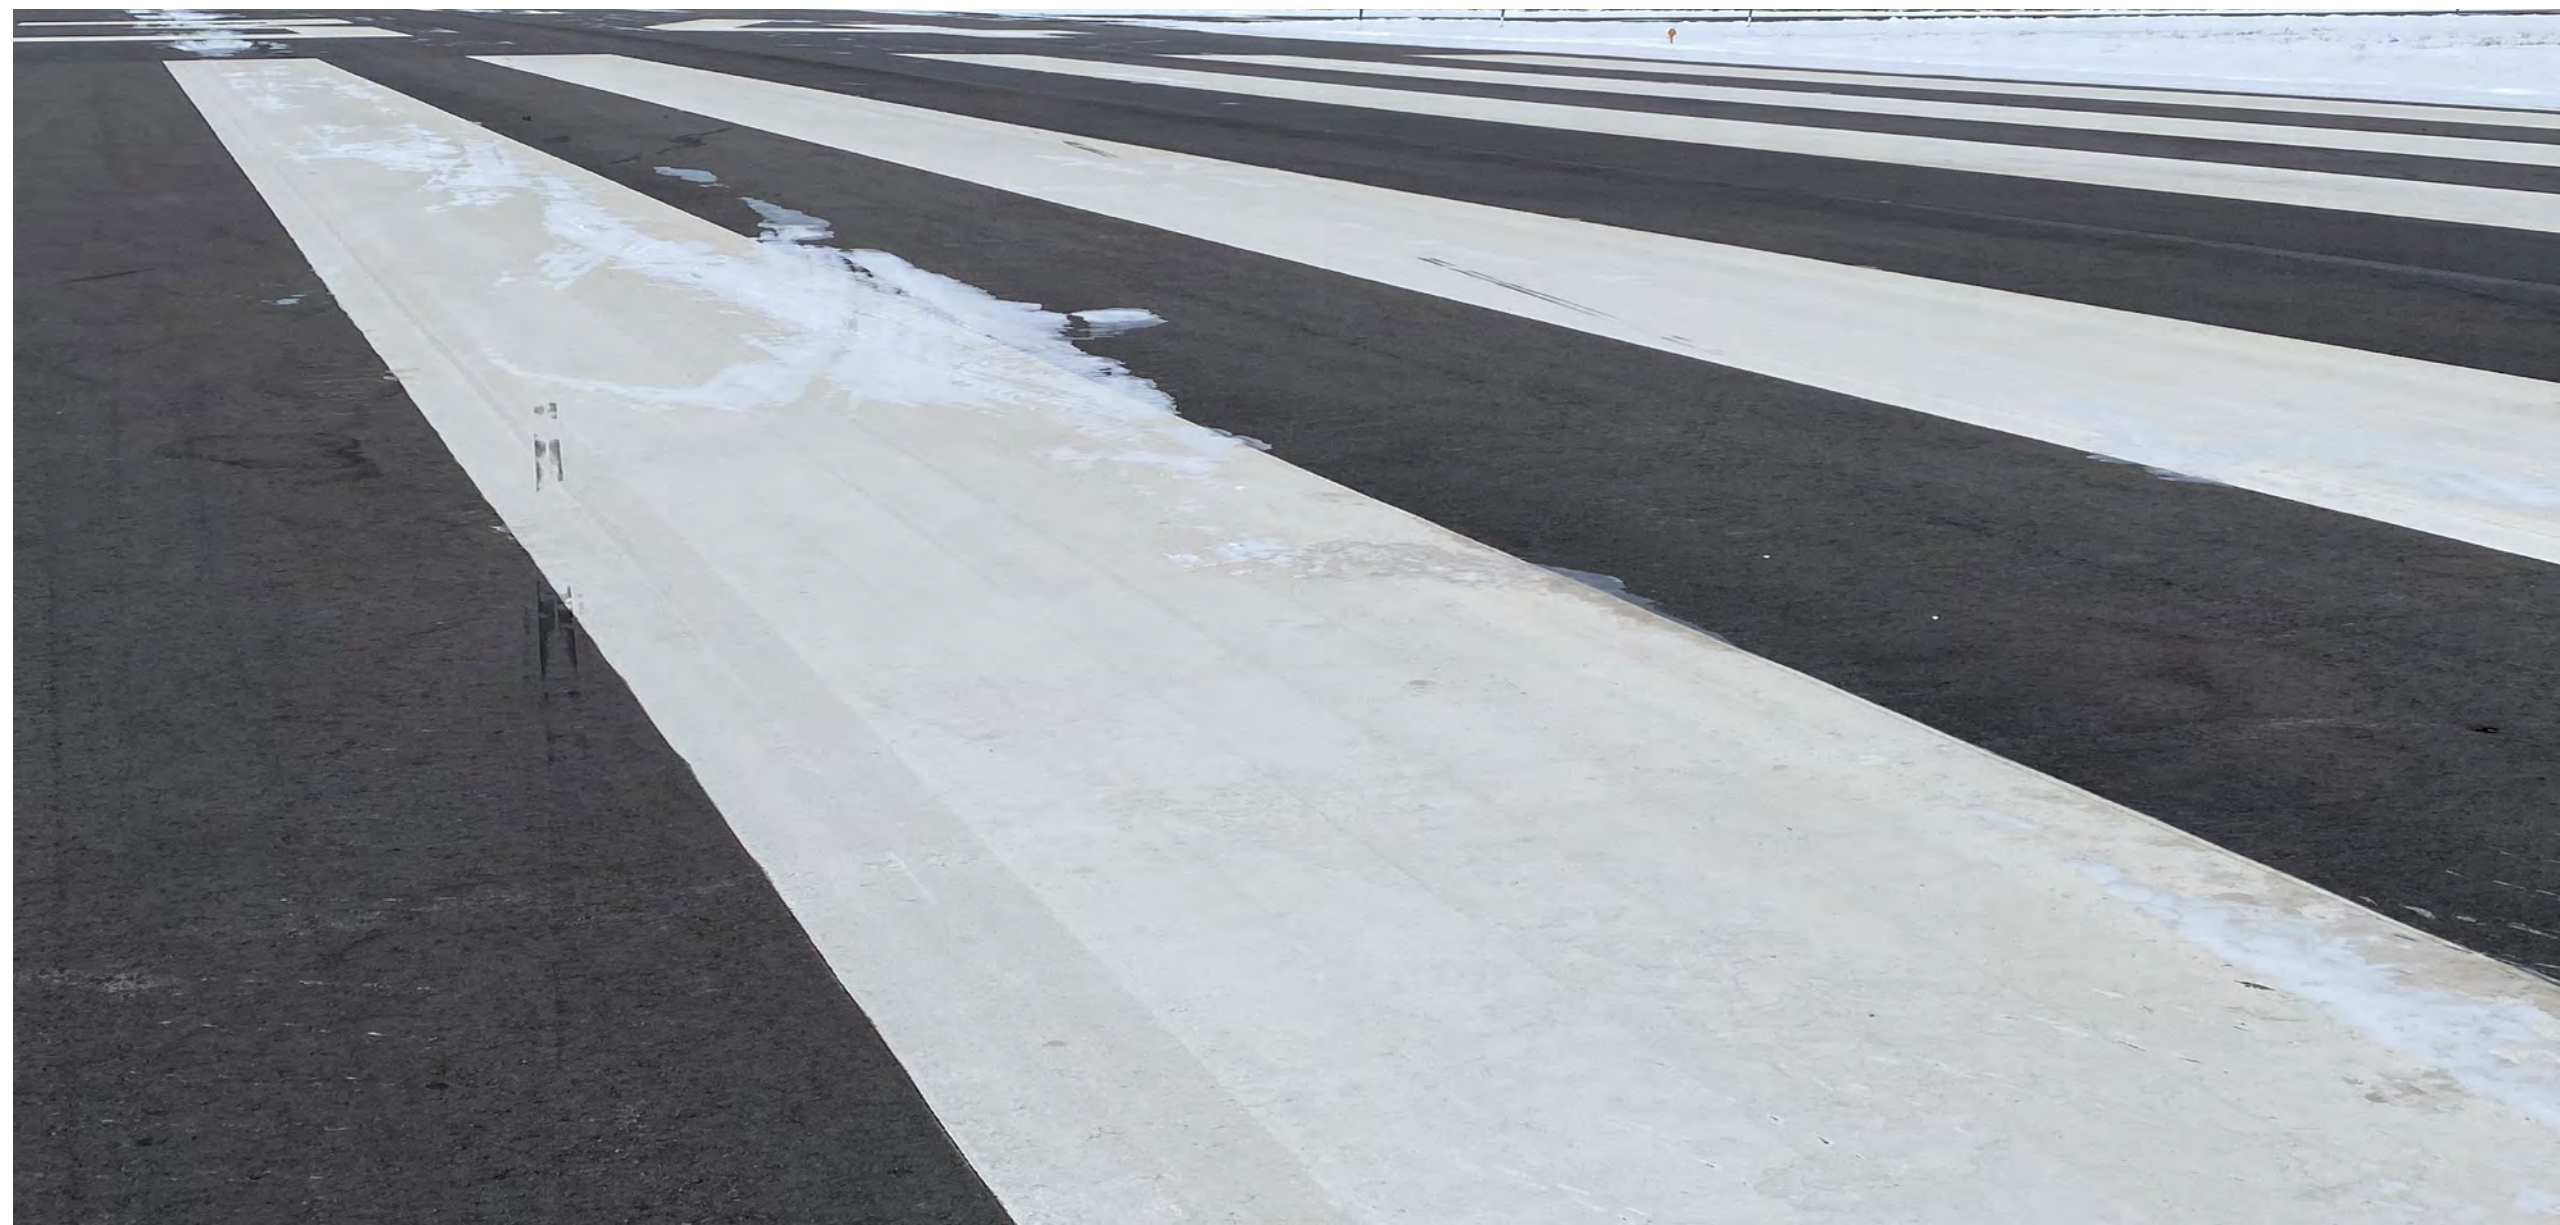
Looking further down RW 16 @ AC skid marks – both wheels skidding towards the West or Right of RW CL

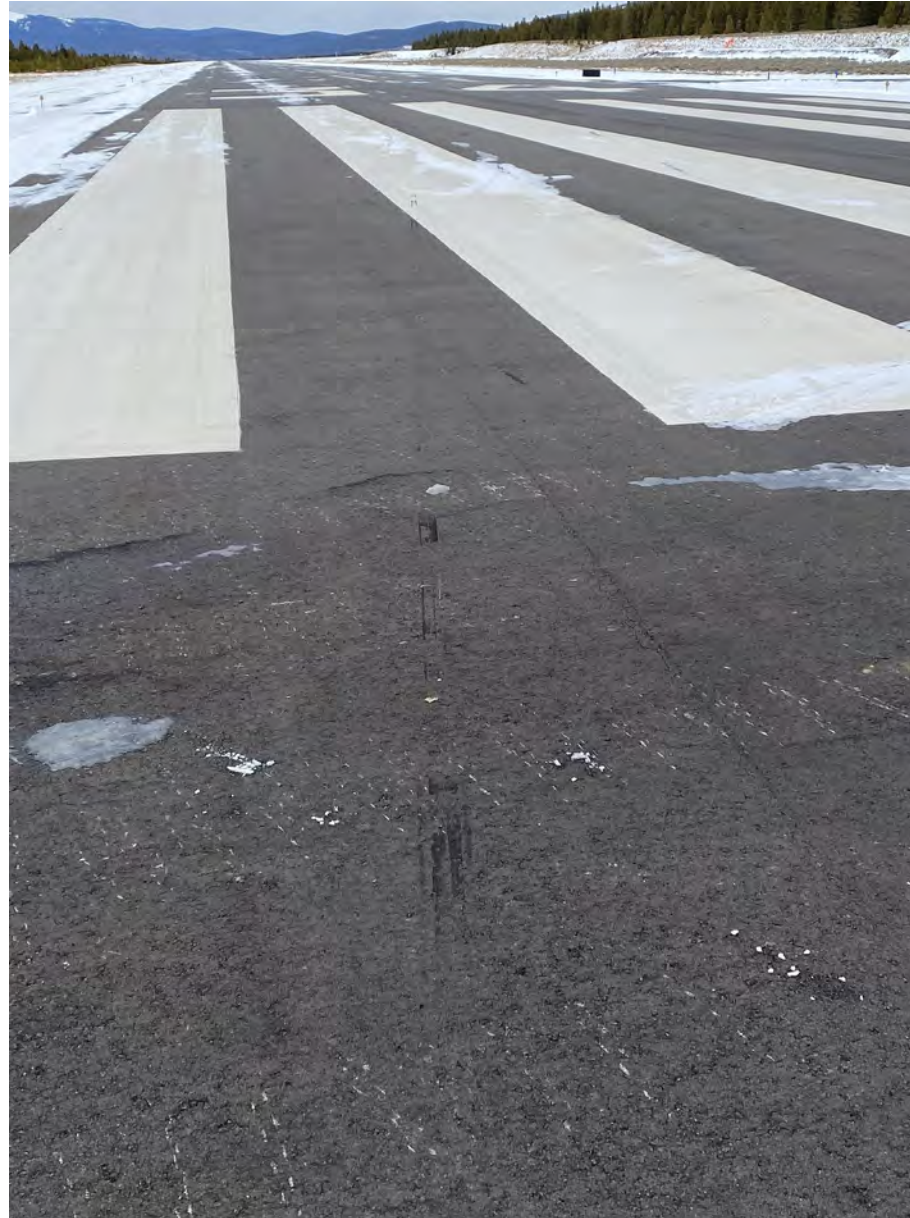
# Right main landing gear tire skid marks

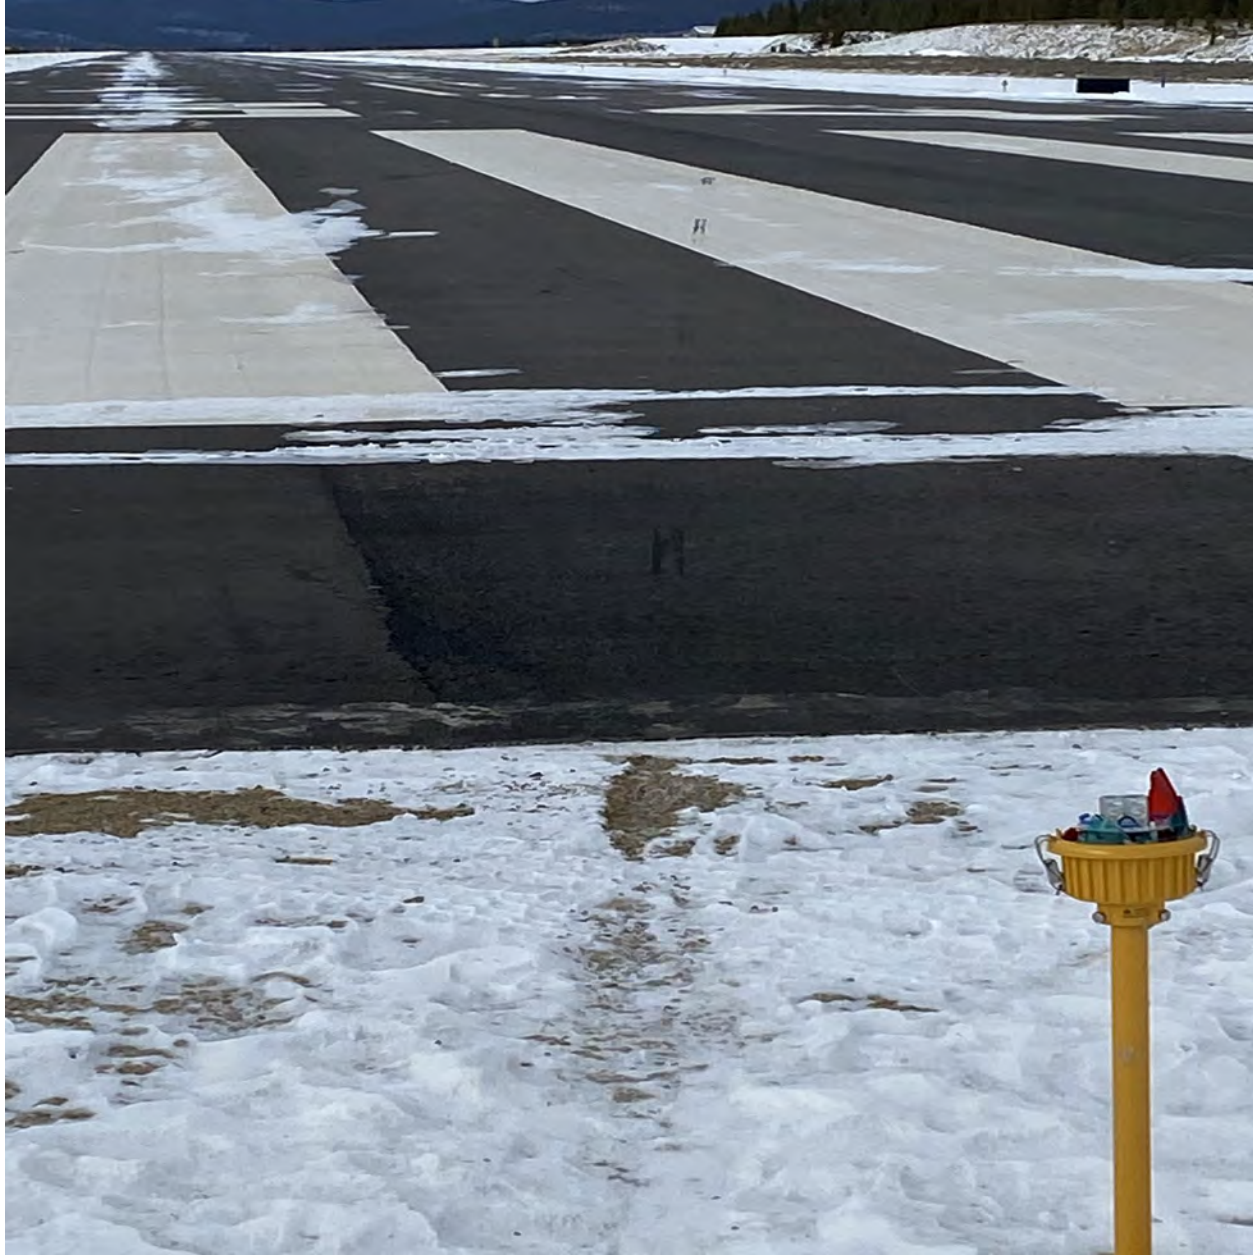
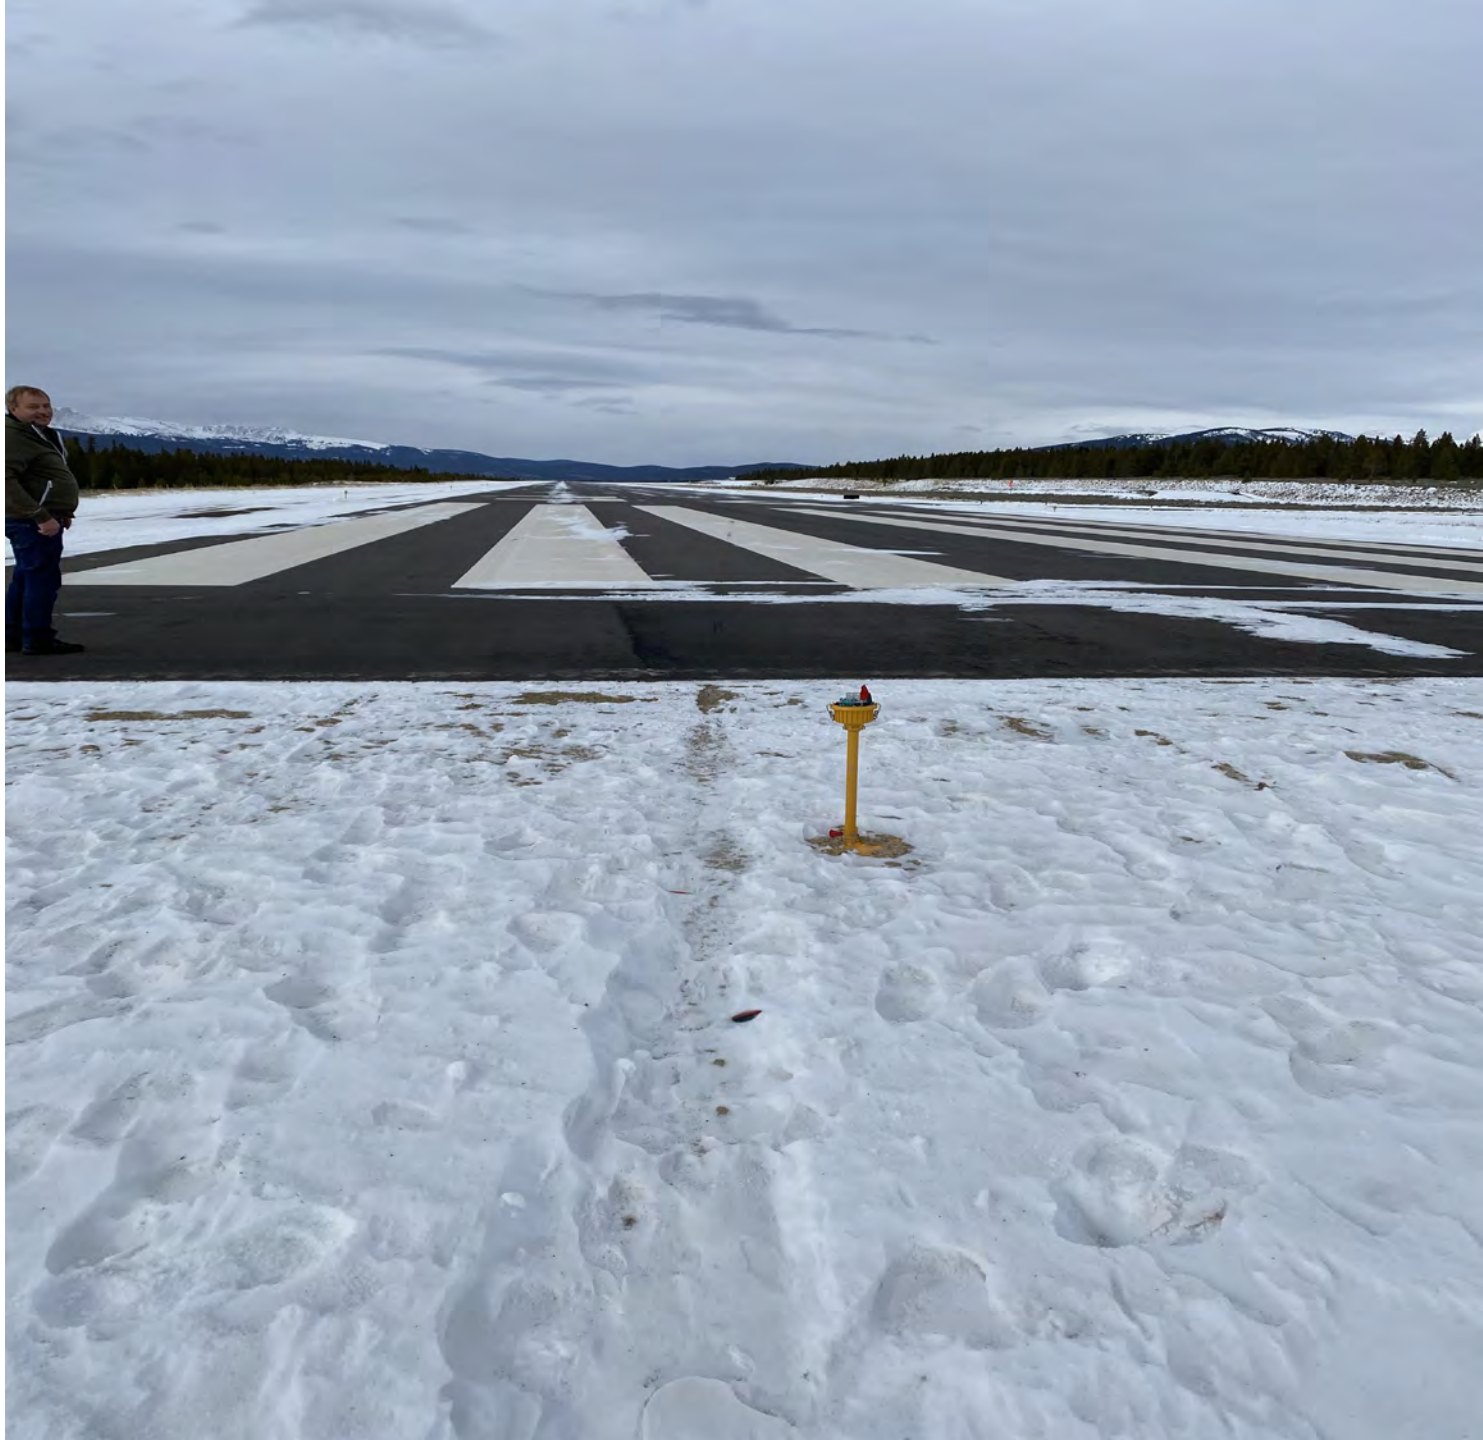
Looking down RW 34 at AC skid marks & REILs; AC Tracks begin in snow (1 of 2)  
The REIL to the left of this photos was broken off at the base – subsequent photo

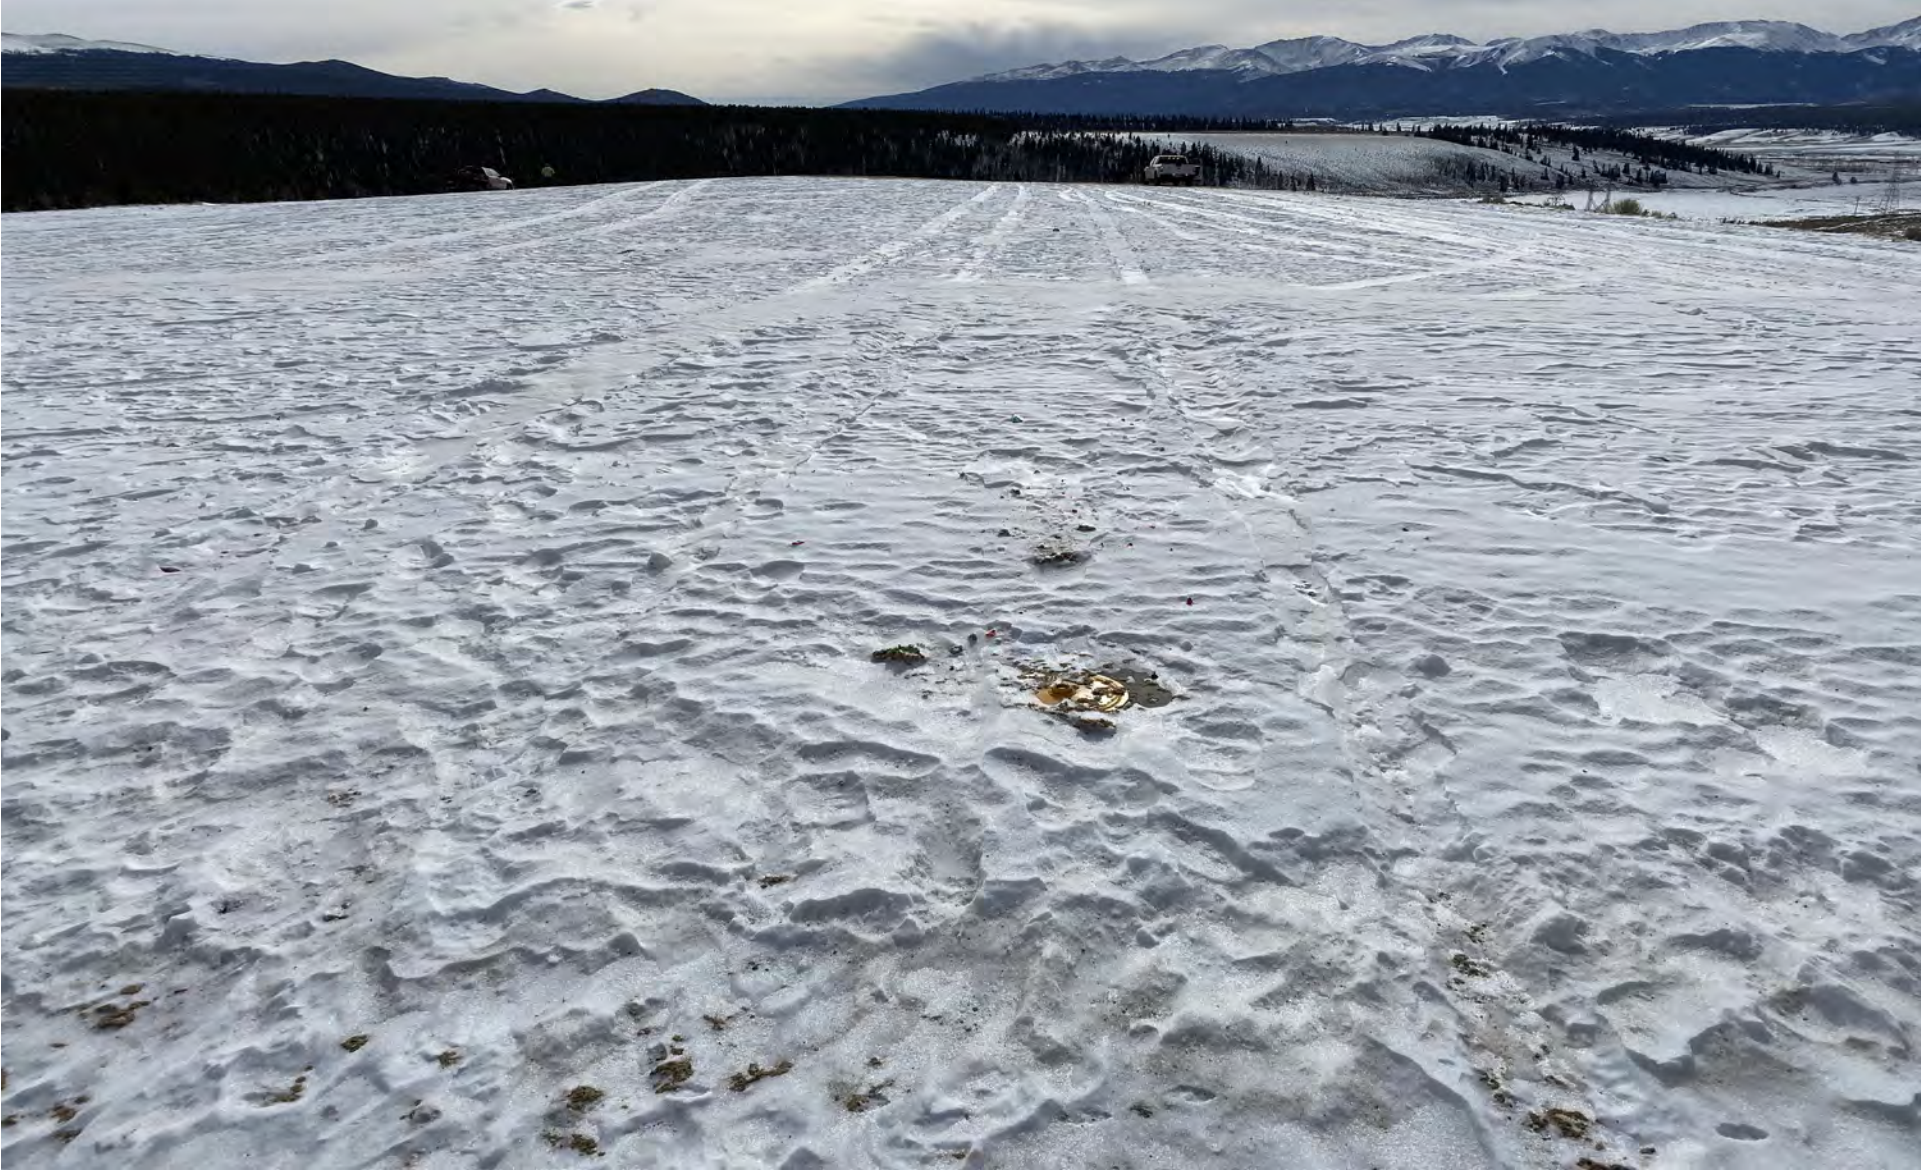
Looking off the end of RW 16 @ AC tracks and 1 of 2 RELIS damaged.

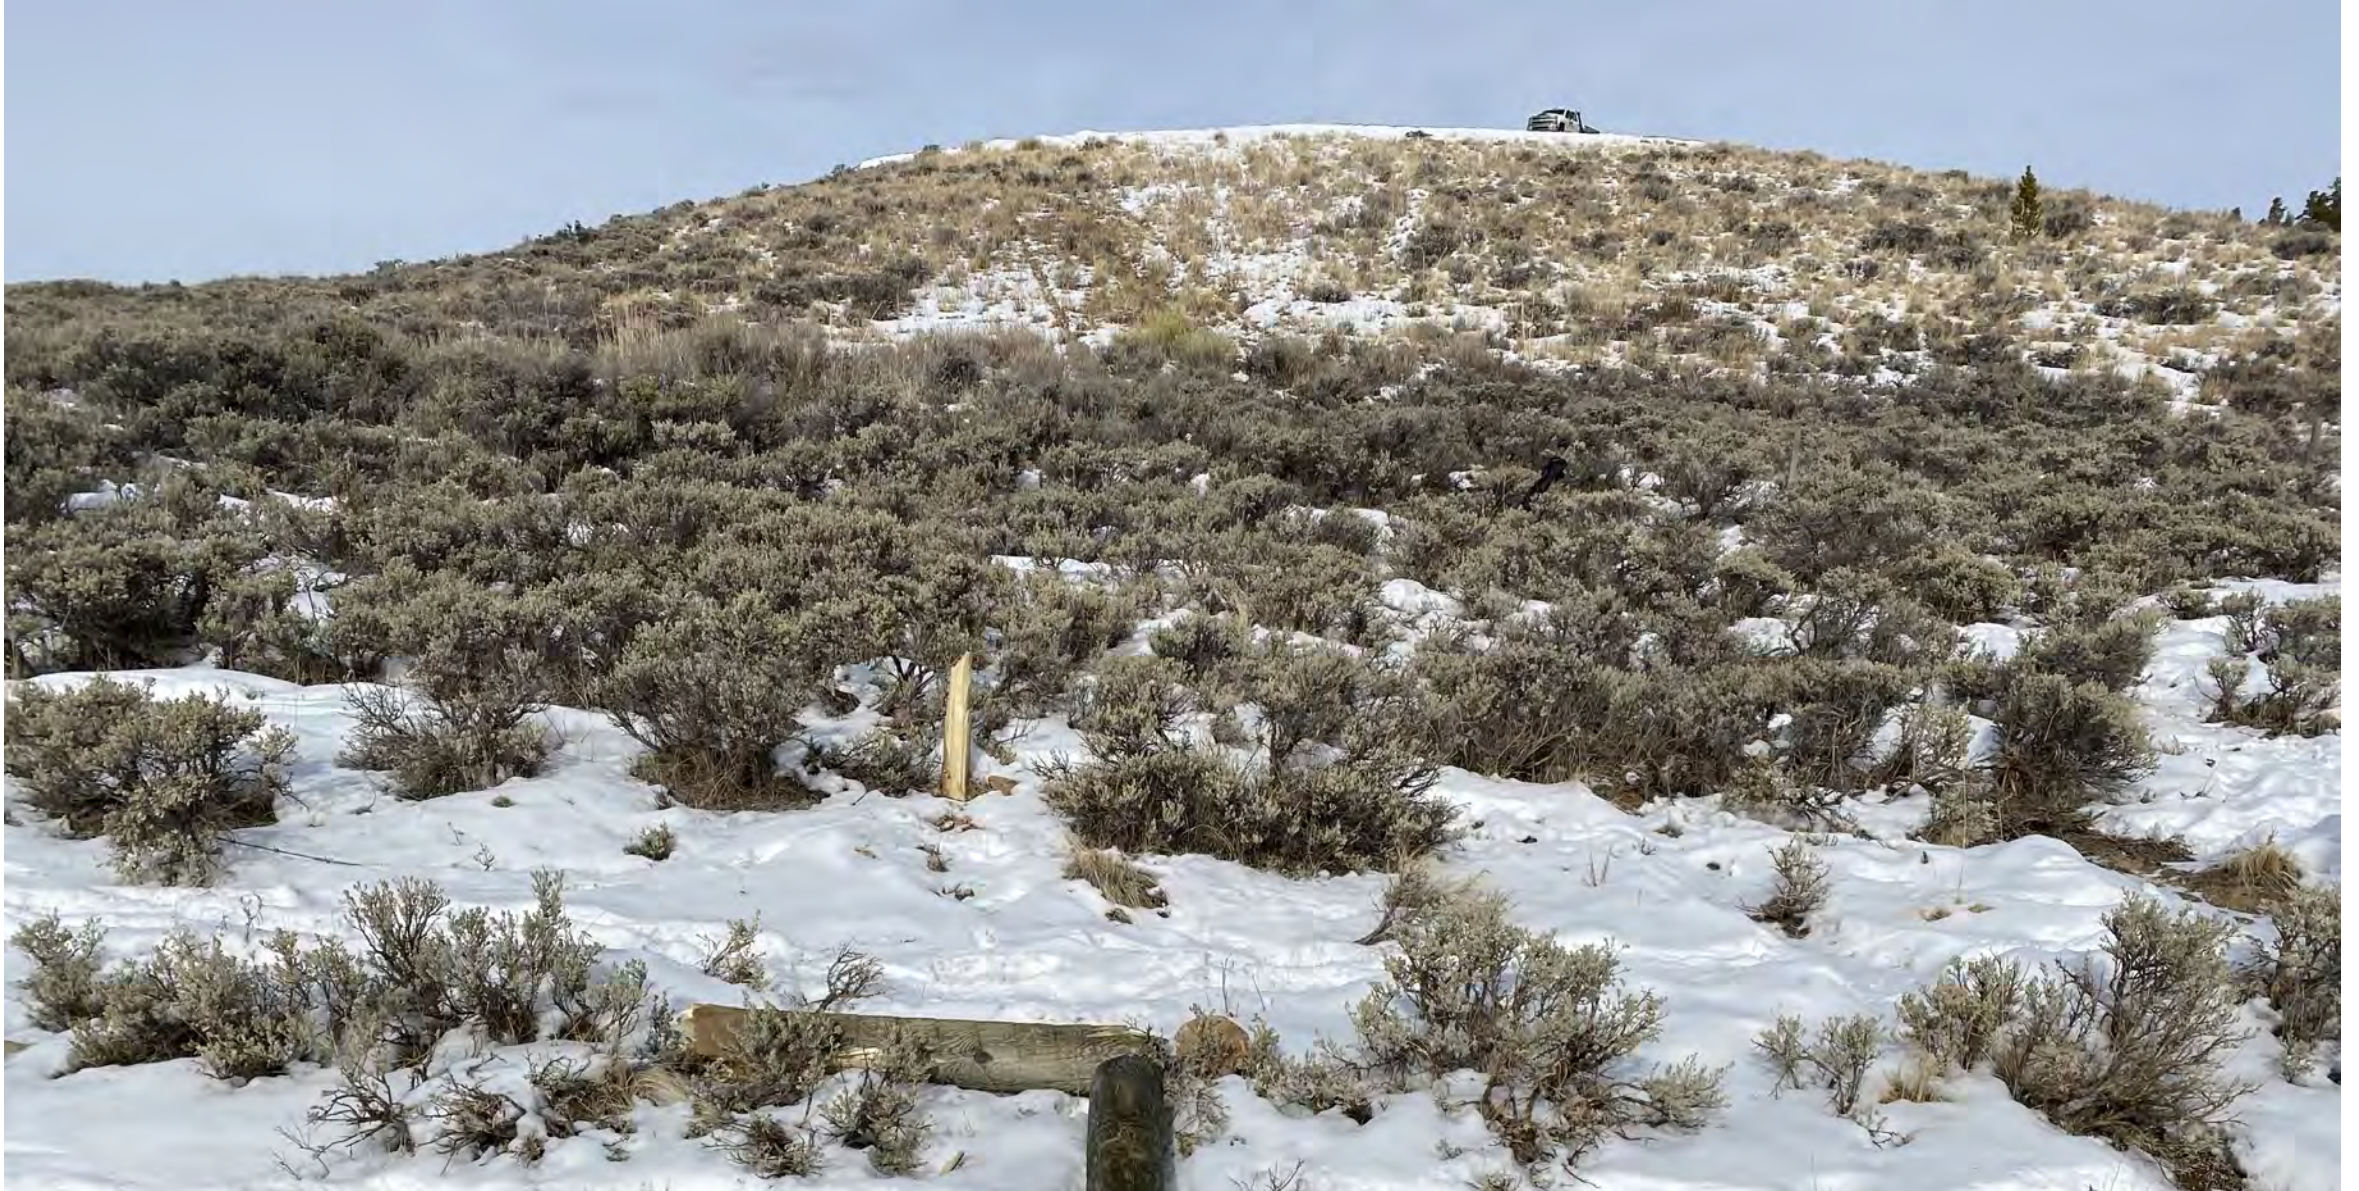
Looking up @ RW 16 end/overrun. Truck is on extended RW CL. Aircraft tire tracks show West of CL – left side of the hill as you look at the picture.

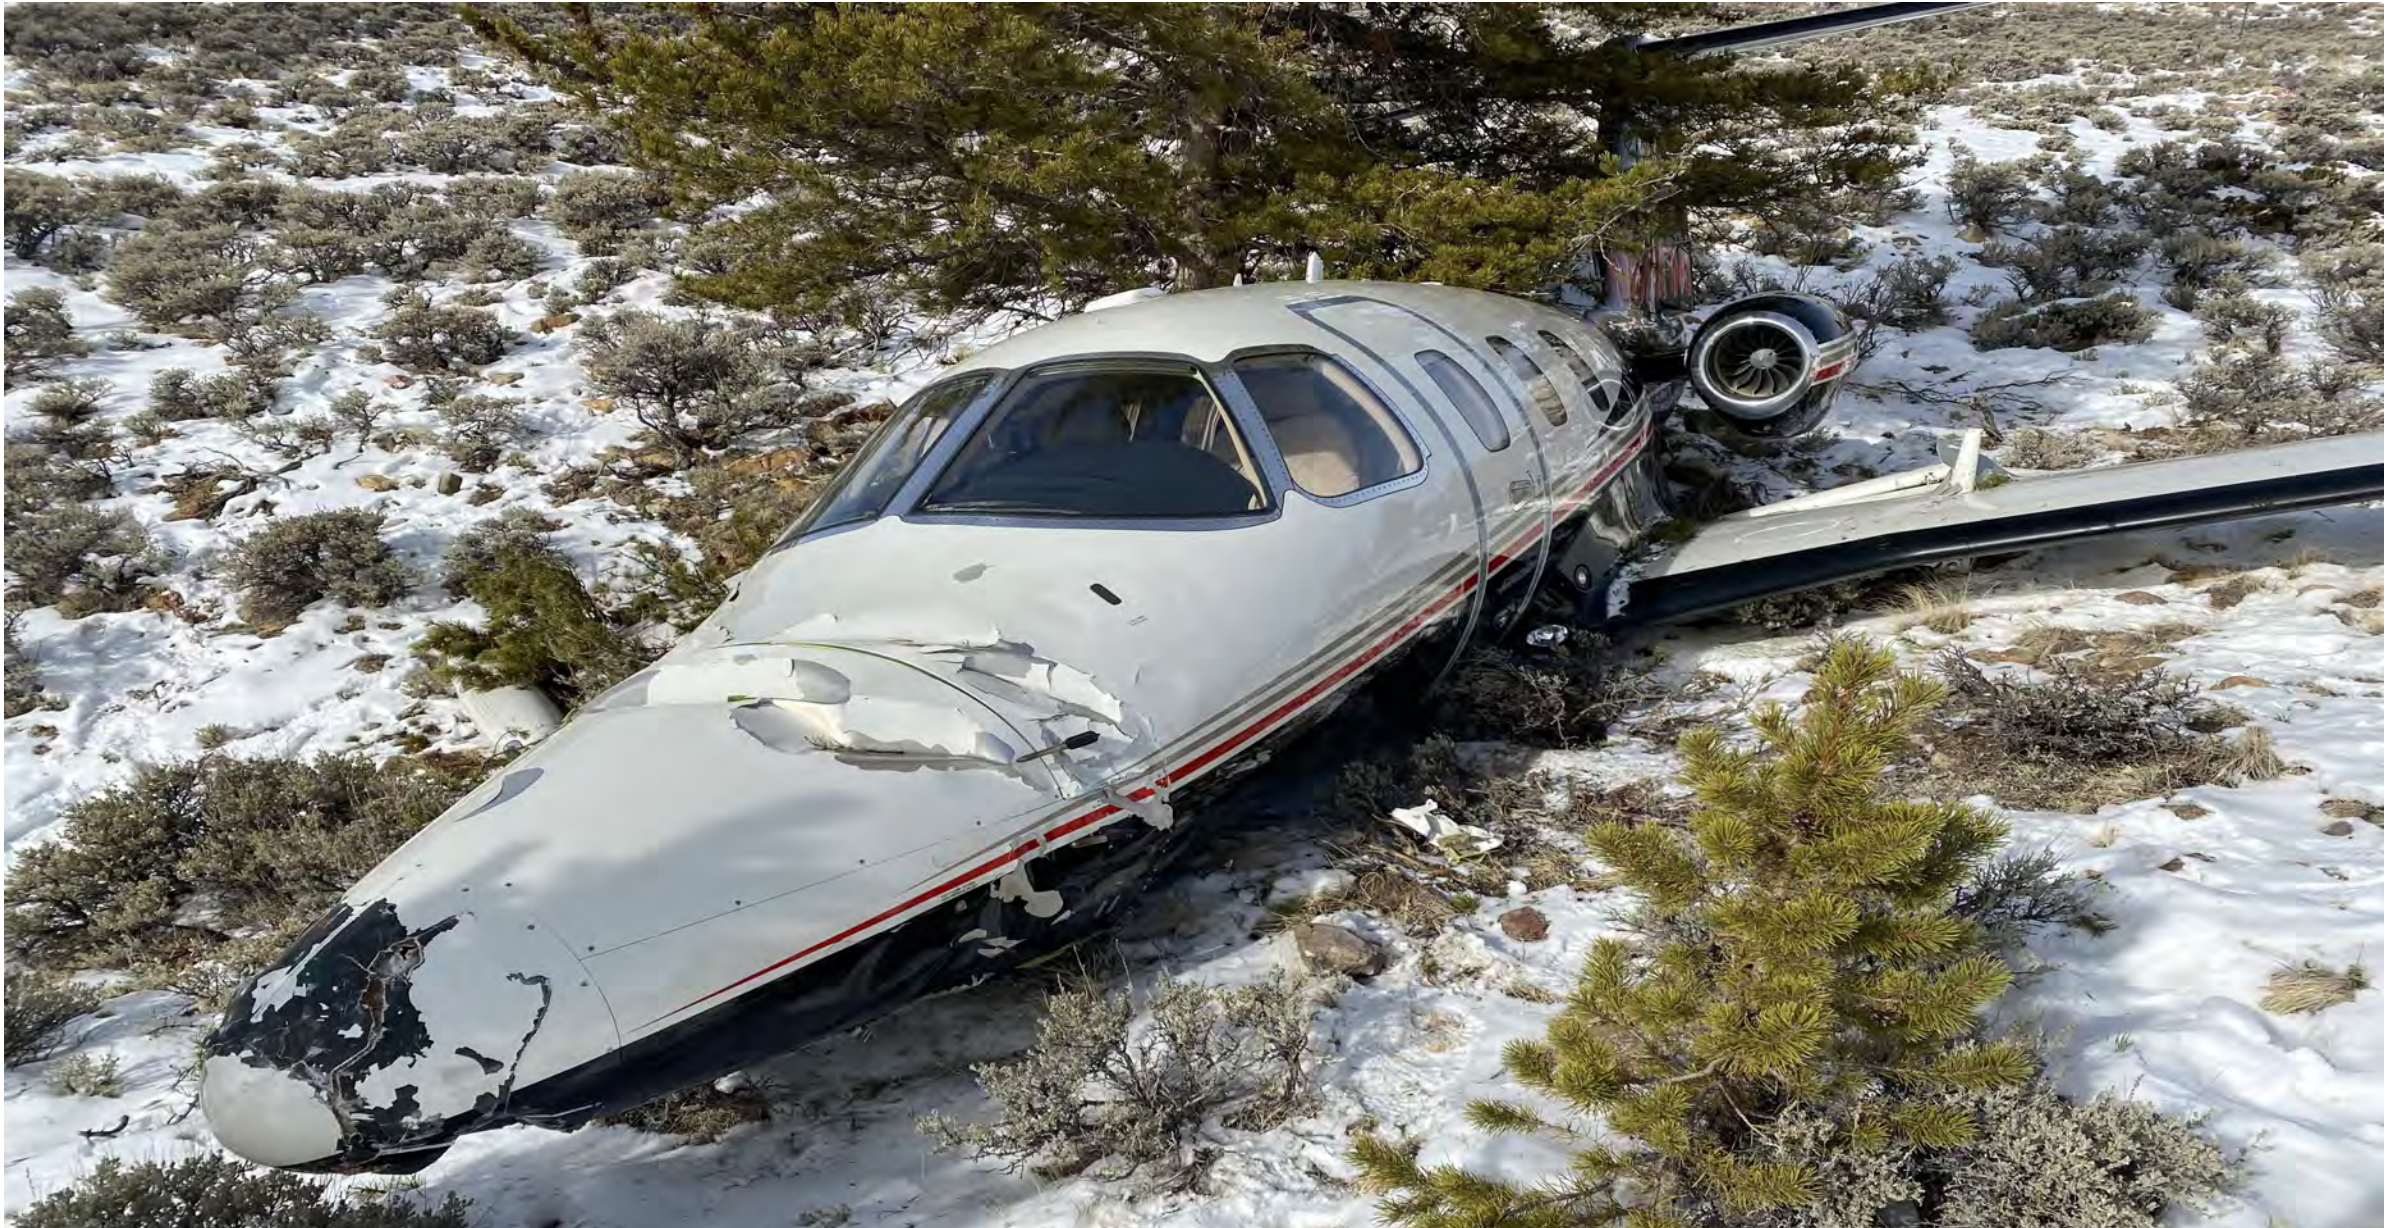
Gear punched up and through left wing.

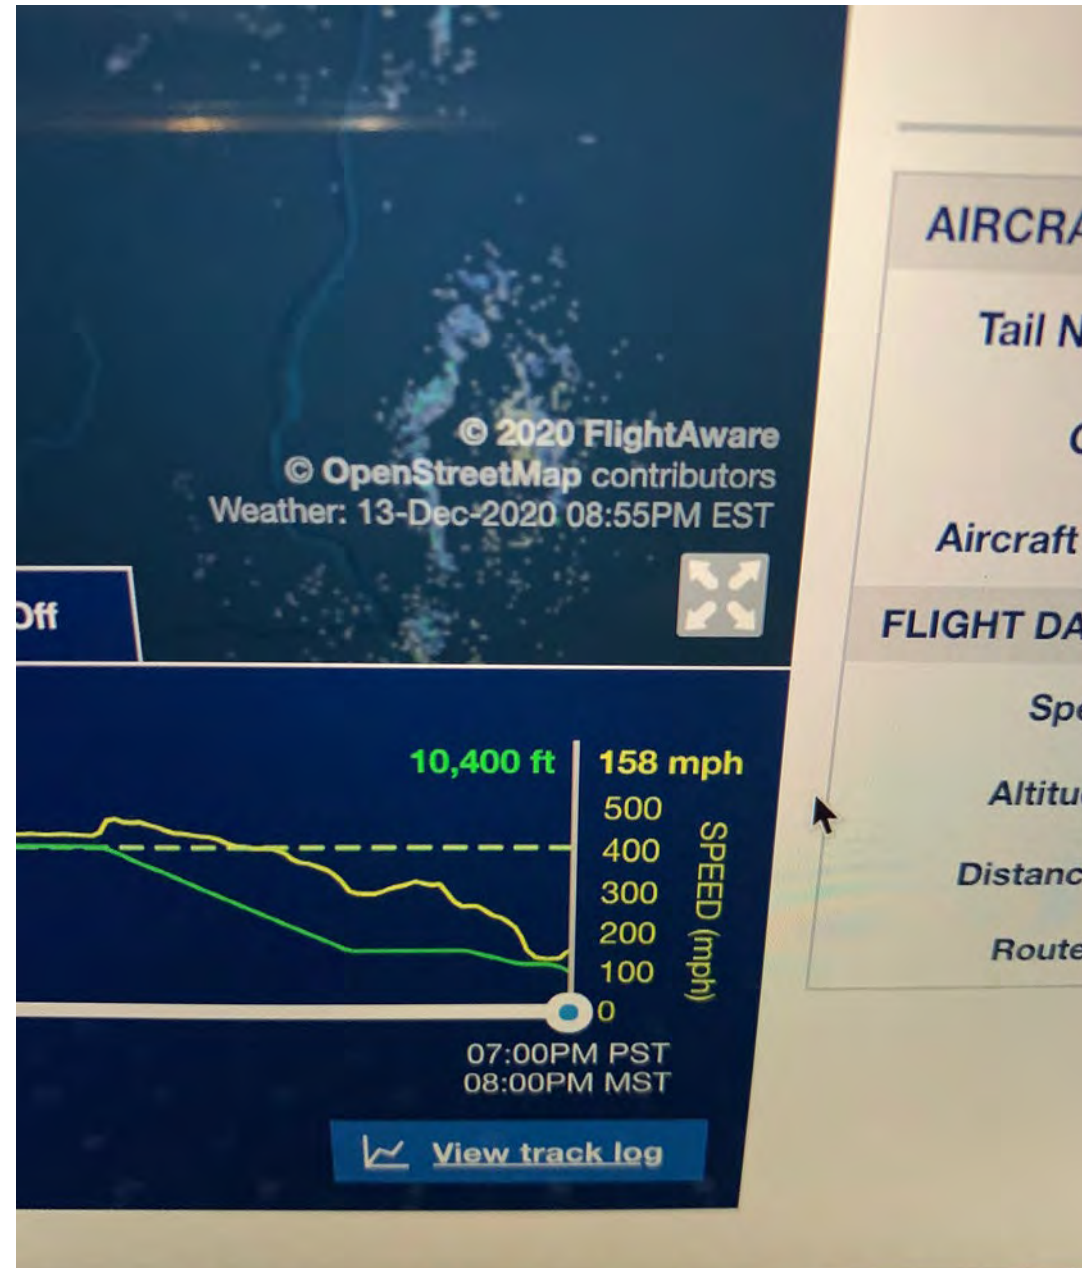
Data from Flight Aware: N686TM @158 mph approach to LXV

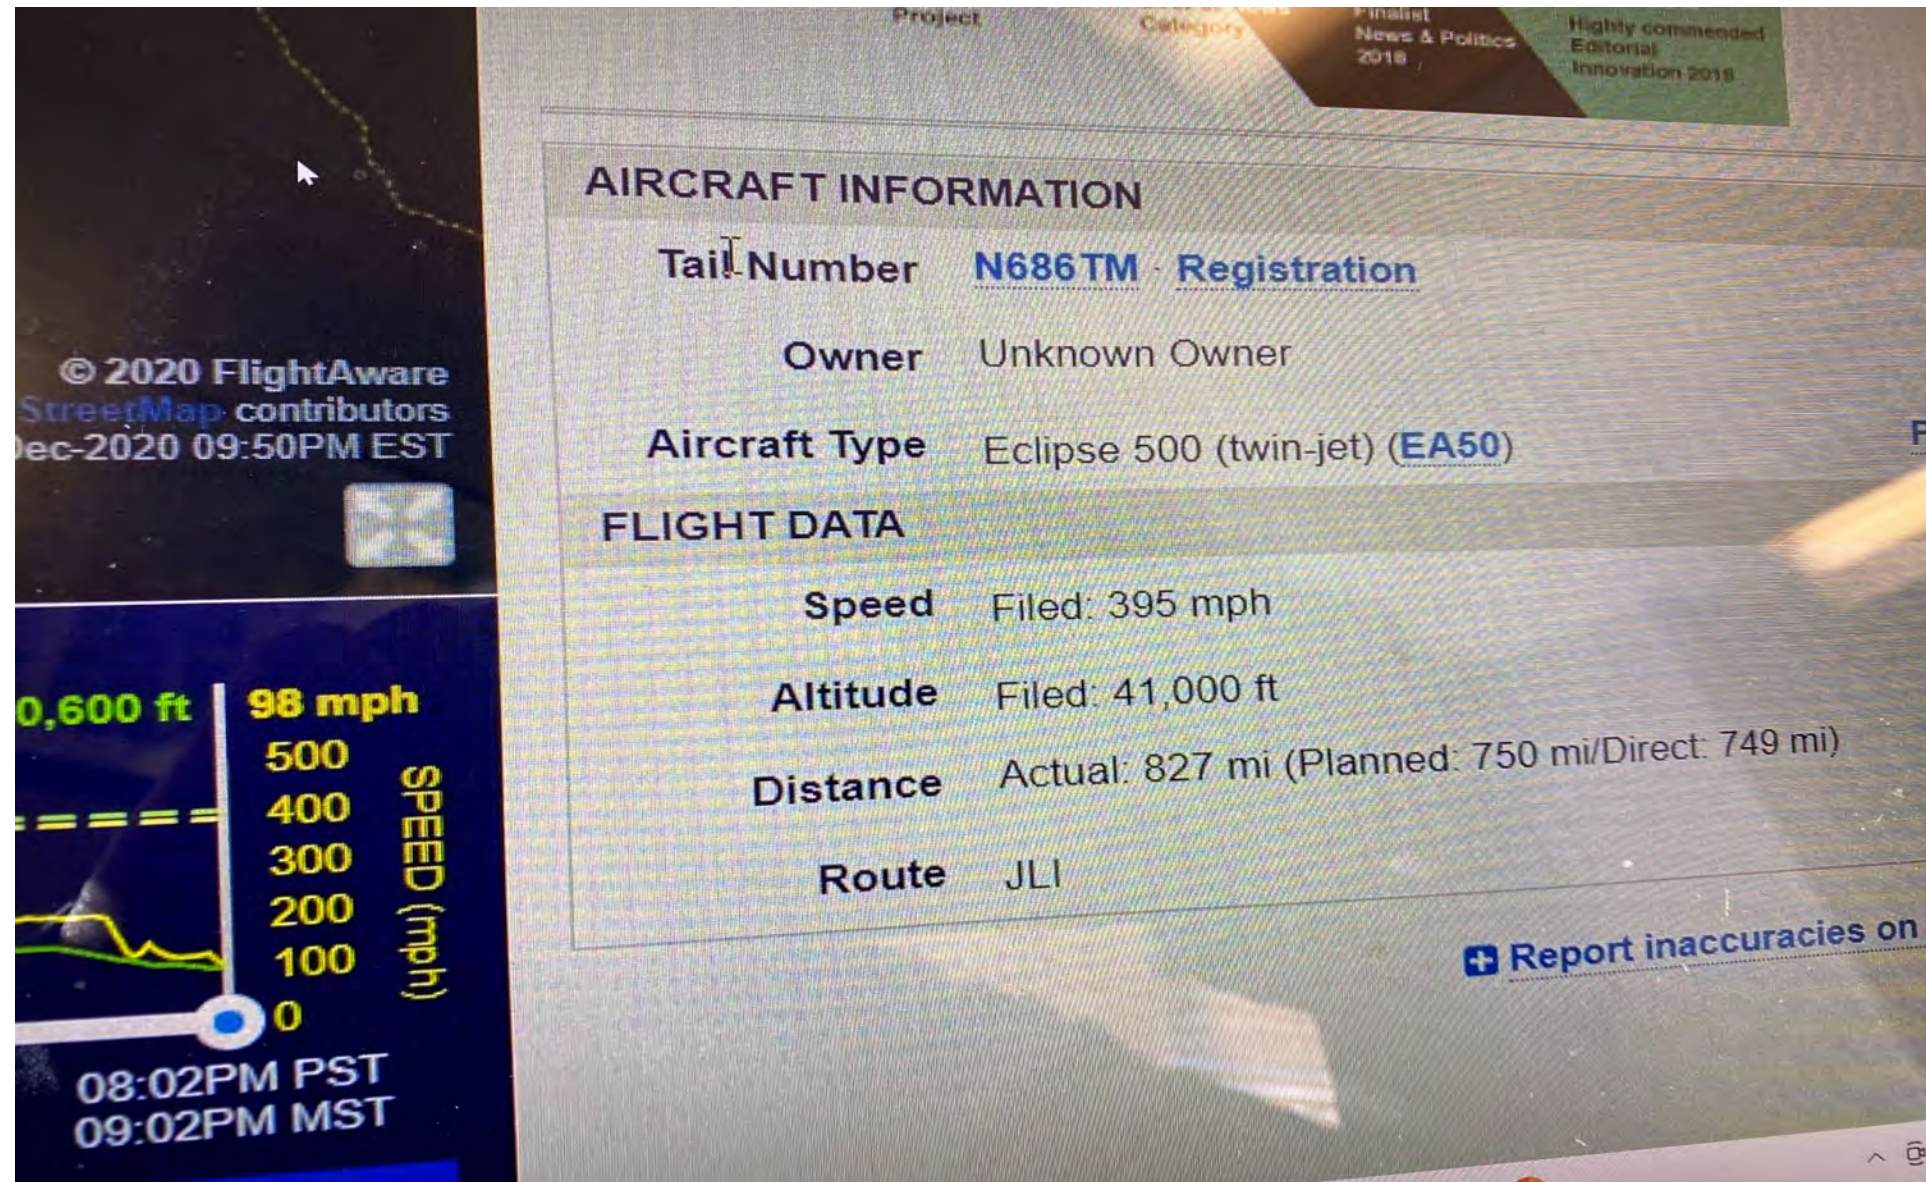
Data from FlightAware: N686TM @ 98 mph

This is the data from his landing on the Friday before the accident
