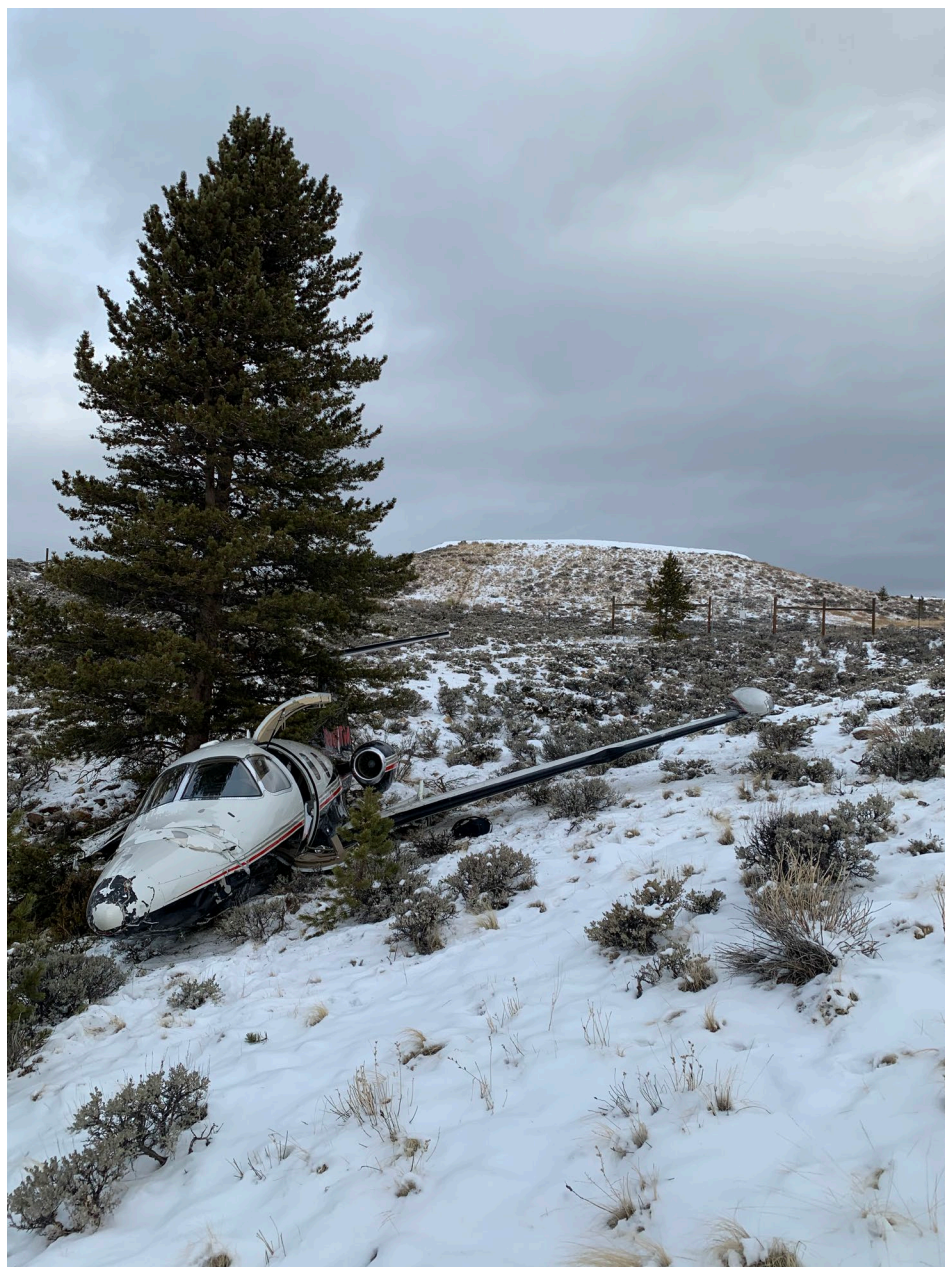
**Photo 1 – N686TM at the accident site. The departure end of runway 16, LXV, is at the top of the mesa in background (Robert Held photo)**

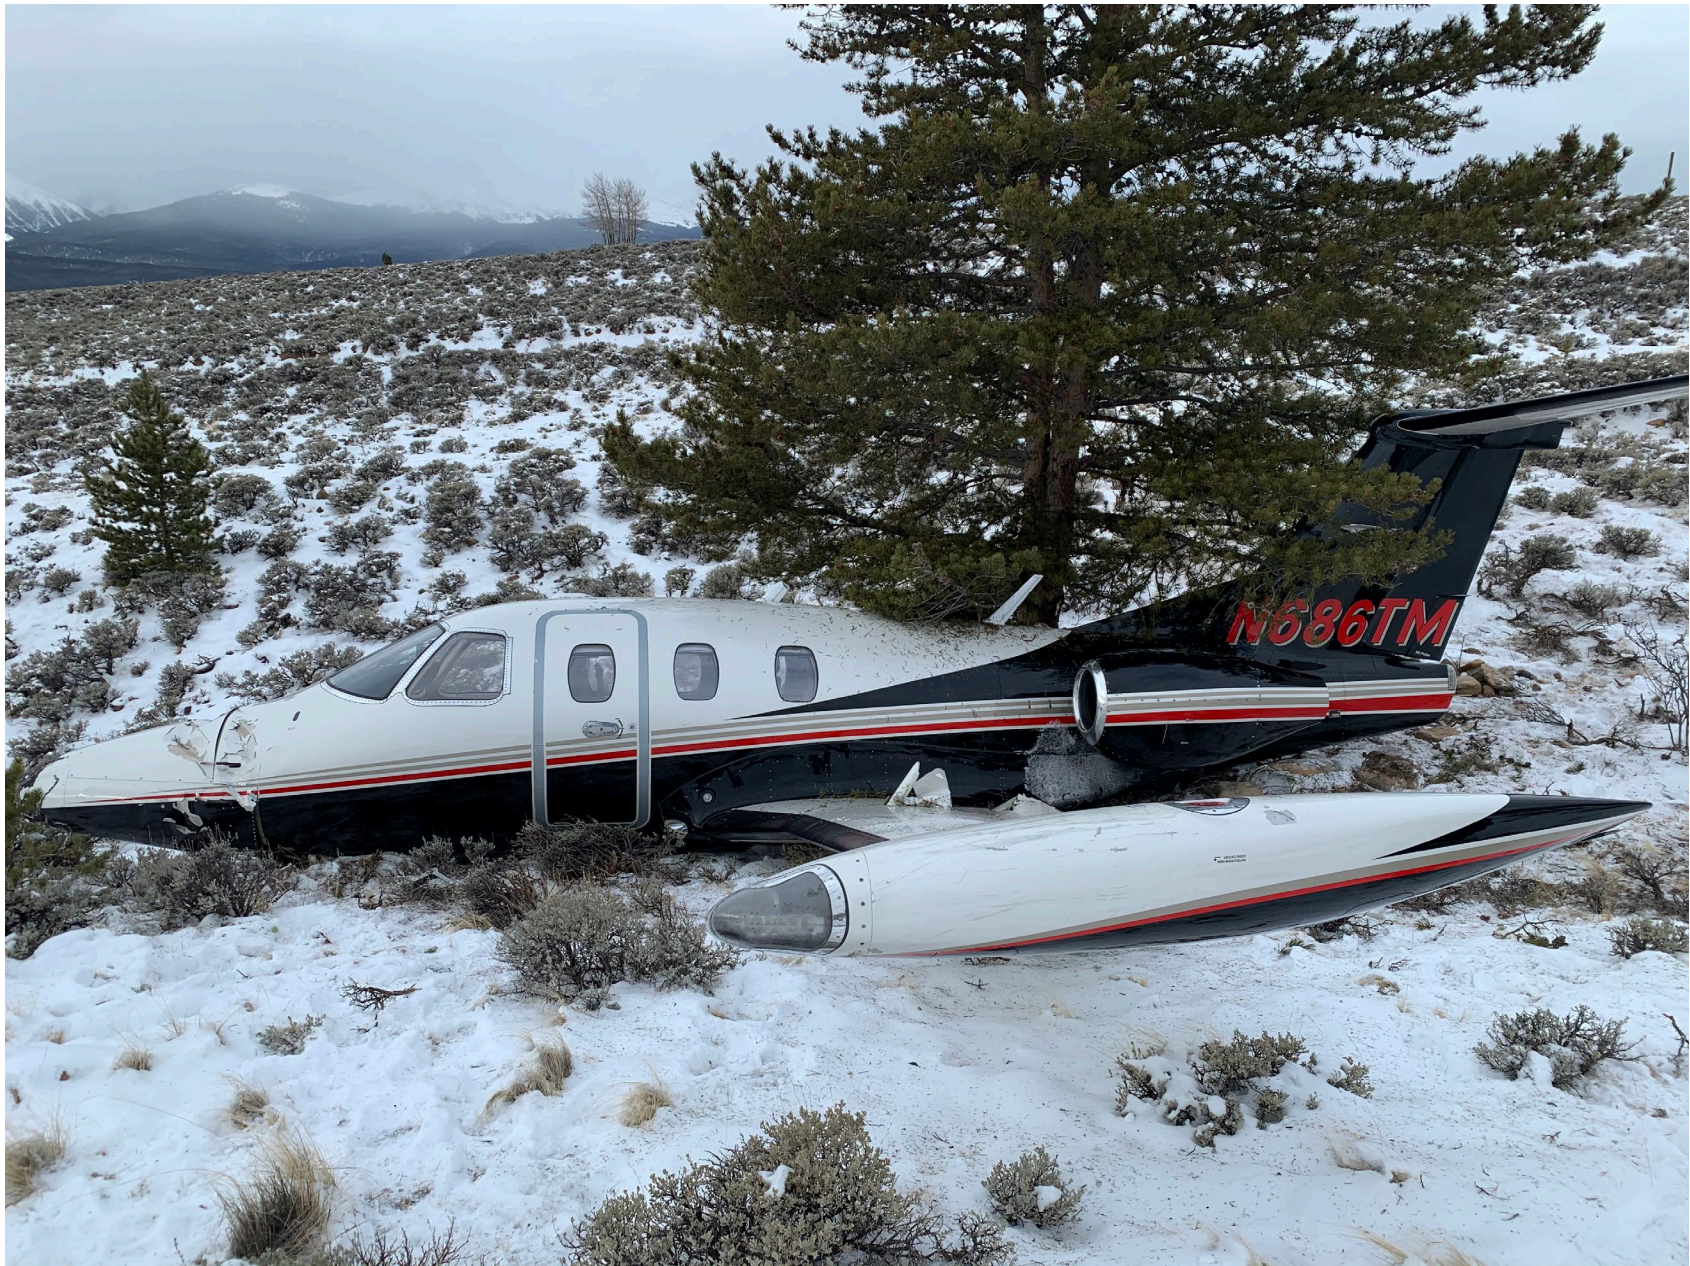
**Photo 2 – N686TM at the accident. Nose landing gear collapsed, left main landing gear strut pushed up through left wing, and right wing severed by tree (Robert Held photo)**
