## **NATIONAL TRANSPORTATION SAFETY BOARD**

### **Specialist's Factual Report**

# **METEOROLOGY**

CEN21LA089

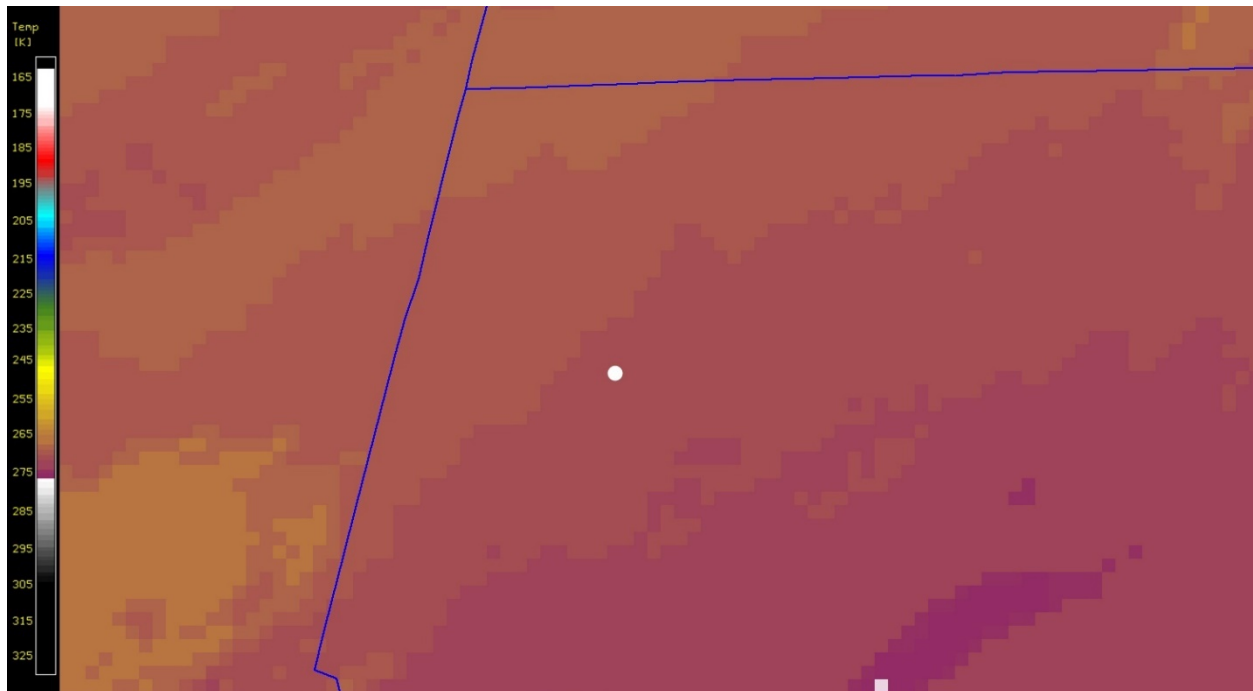
Geostationary Operational Environmental Satellite (GOES)-16 satellite data were obtained from an archive at the Space Science Engineering Center at the University of Wisconsin-Madison. Figure 2 presents the GOES-16 infrared cloud-top temperatures over the accident site, which were about  $-2^{\circ}\text{C}$ , which, when considering the 0500 CST HRRR sounding, corresponded to cloud top heights of about 3,400 feet. Figure 3 presents a red-green-blue ( $12.3\mu\text{m}$ - $10.3\mu\text{m}$  –  $10.3\mu\text{m}$ - $3.9\mu\text{m}$  –  $10.3\mu\text{m}$ ; RGB) nighttime microphysics GOES-16 band combination product for 0441 CST. This product assists in visually identifying cloud level and type at night. Figure 4 presents a guide on interpreting these types of images.

**Figure 2** – GOES-16 infrared imagery from 0441 CST. Accident location denoted by the white dot. Image is not corrected for parallax error.

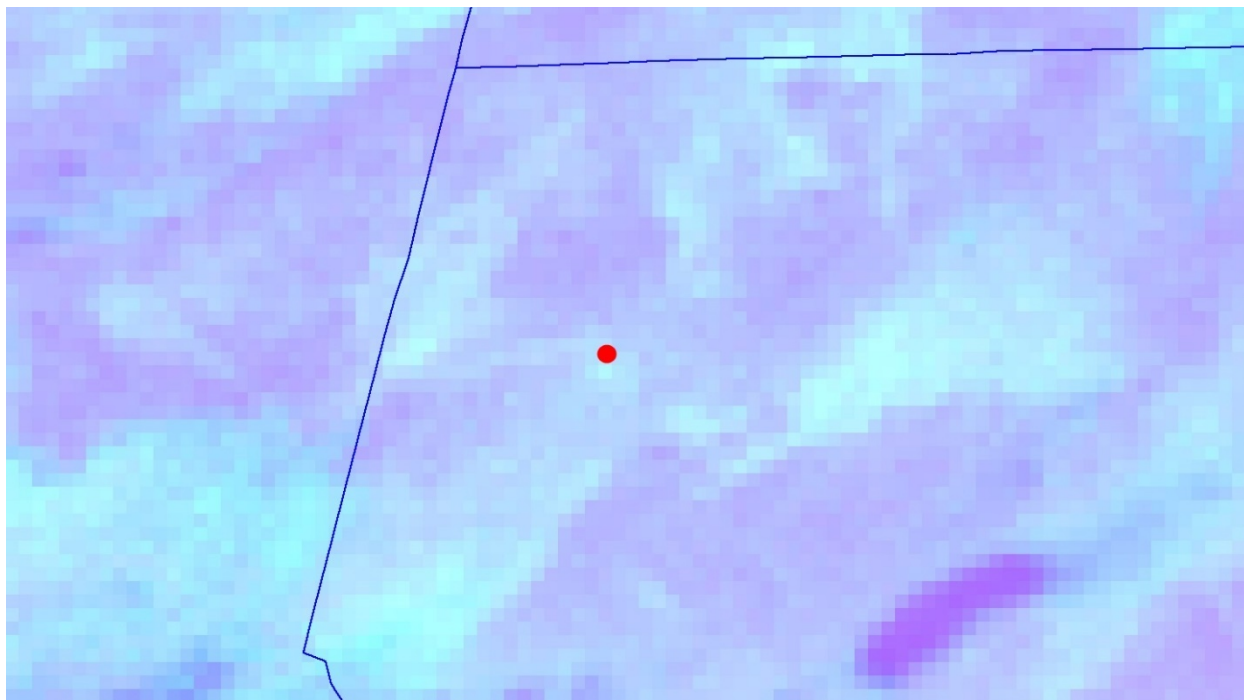
**Figure 3** – GOES-16 RGB nighttime microphysics image for 0441 CST. Accident location denoted by the red circle. This image has not been corrected for any parallax error.

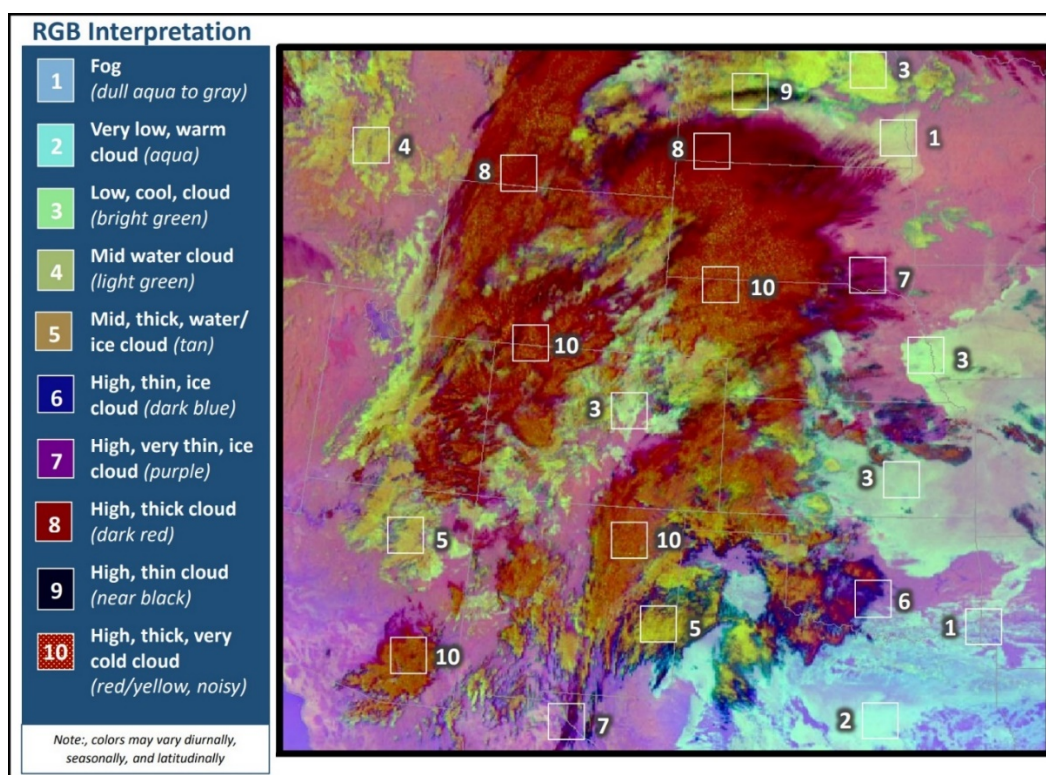
**Figure 4** – Interpretation aid for the GOES-16 RGB nighttime microphysics image found in Figure 3. Taken from:
