# Engine Investigation

Allison  
M250-C20B  
Engine CAE 835942

MD 369D  
Registration : N103SU

**Accident date: December 29, 2020  
Investigation date Arkansas: February 10, 2021  
Disassembly Arrow Aviation: July 21, 2021  
Report date: May 5, 2022**

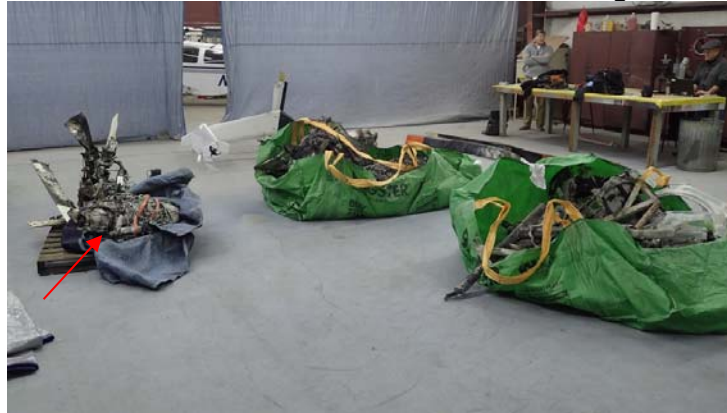
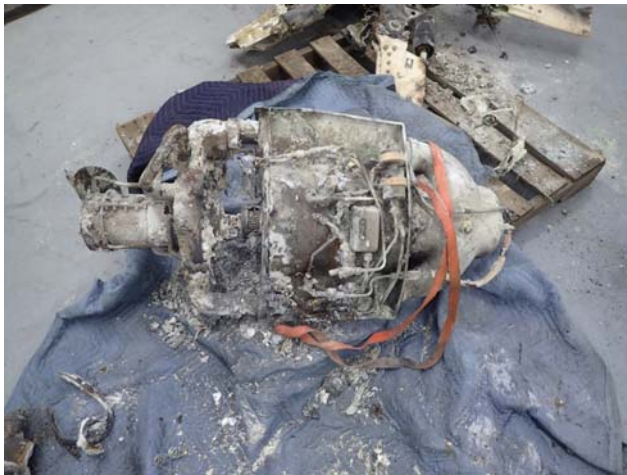
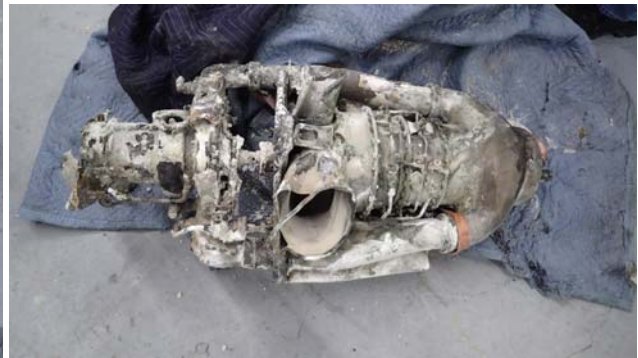
Fig 1

The engine was removed from the recovered wreckage where it exhibited overall thermal damage resultant from the post-crash fire. The accessory gear box had been completely consumed by post-crash fire leaving the compressor attached to the engine by the left and right compressor air discharge tubes and the spur adapter gear shaft. Several drive gears including the power take off gear and torque meter gear normally resident within the accessory gear box were located. Other than thermal damage no other anomalies were noted.

The main drive shafts of both the fuel control unit and power turbine governor were located however the cases of both units as well as internal components were consumed by fire. Neither the upper nor lower engine chip detectors were located. (Fig 1)

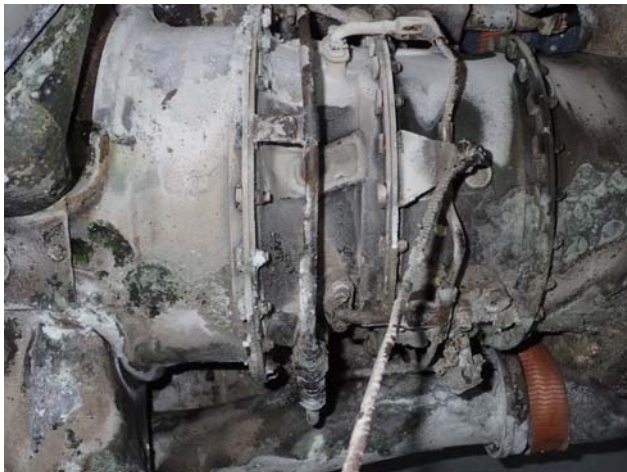
Turbine Module

The turbine module and exhaust collector support remained in position. The turbine displayed overall thermal damage but was otherwise normal in appearance. Both left and right-side exhaust stacks displayed impact damage and minor tearing but were otherwise normal. The stage four turbine wheel as viewed through the exhaust collector revealed it to be in position with no evidence of damage.

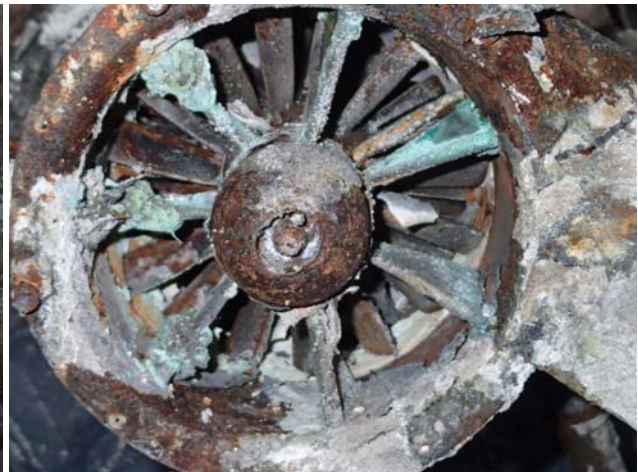
Compressor Inlet

The compressor displayed overall thermal damage with the bleed valve having been consumed by the fire. The scroll displayed heavy burn damage with an approximate 6-inch section burned through on the top of the scroll. Visual examination of the compressor inlet and visible blades and vanes revealed no evidence of FOD type damage. Both compressor air discharge tubes remained in position. The right tube displayed areas of burn through on the forward end. The left side air tube remained intact however the snap ring on the aft end at the outer combustion case was dislodged. The spur adapter gear shaft remained in position and other than thermal damage was visually normal.

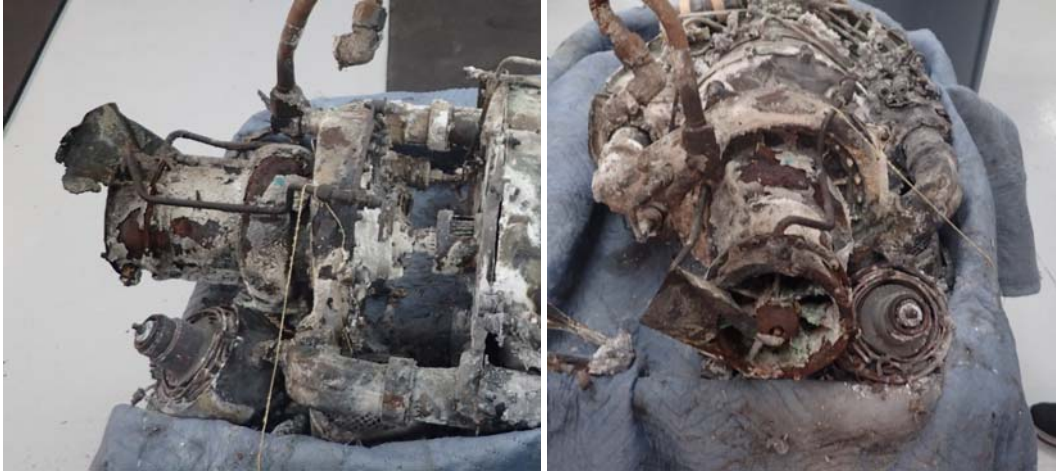
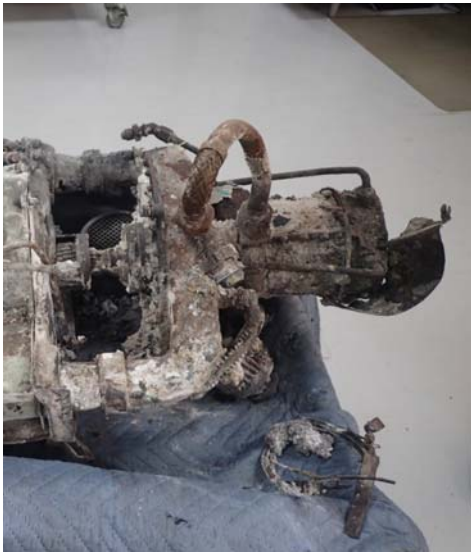
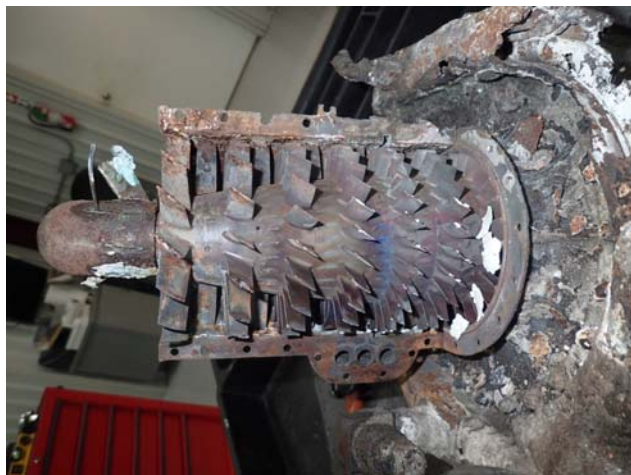
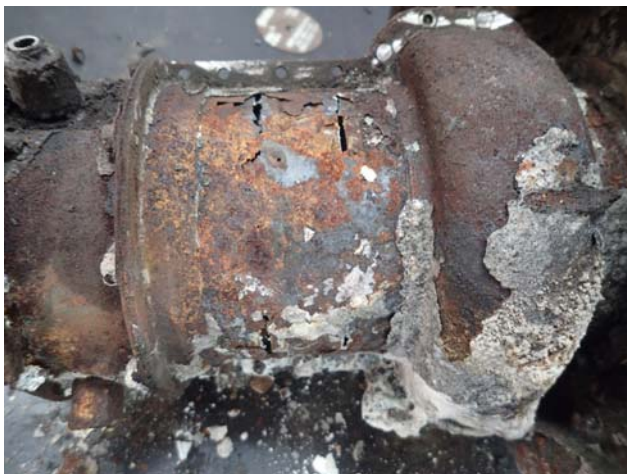
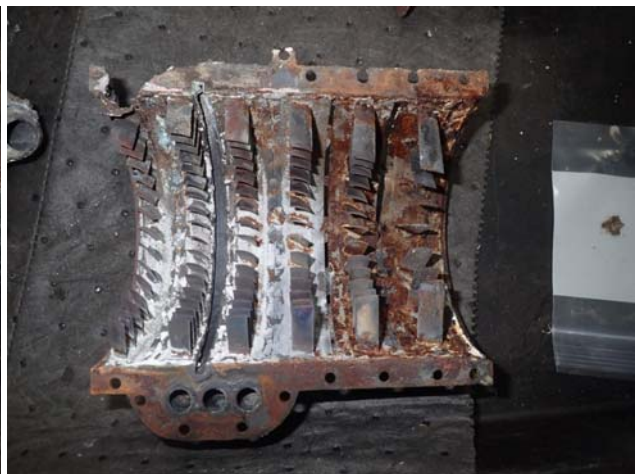
Fig 2

The compressor front support and inlet guide vanes exhibited no visible damage other than post-crash fire signatures. Separation of the compressor case halves revealed the stage 1-6 compressor blades and stage 1-6 stator vanes to exhibit no damage and other than thermal damage and rust coating from post-crash fire exposure. Areas of burn through from post-crash fire were noted in several blade tracks of the compressor case halves. The compressor scroll exhibited areas of burn through from post-crash fire but were otherwise undamaged. (Fig 2)

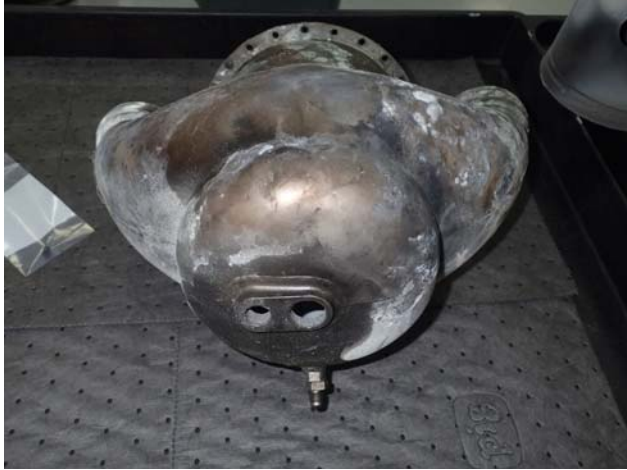
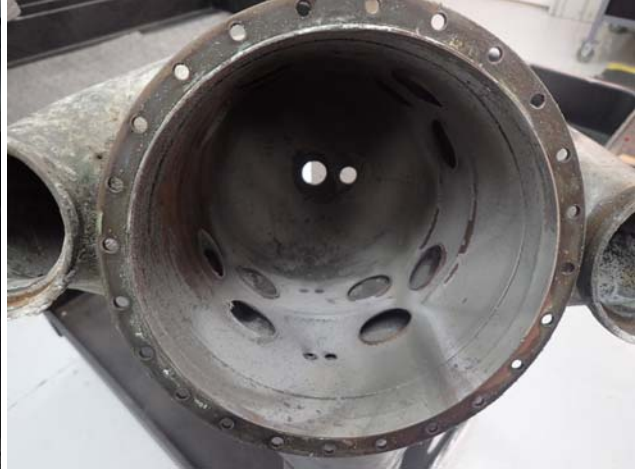
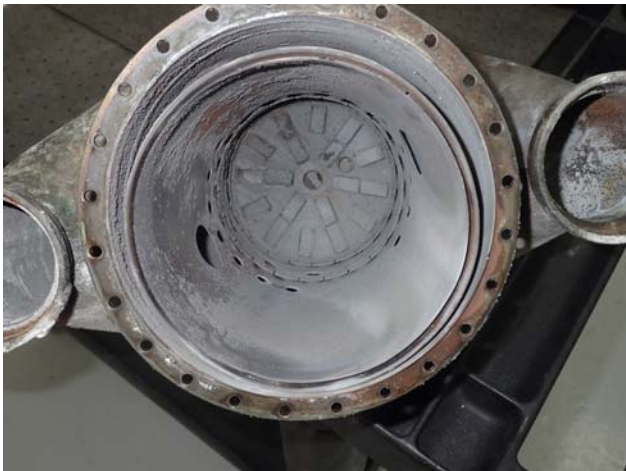
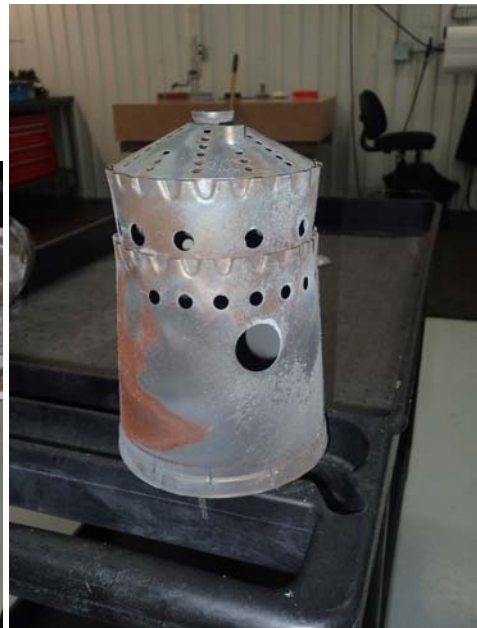
Fig 3

The outer combustion case exhibited discoloring and heavy thermal damage from post-crash fire exposure but was otherwise normal. Removal of the outer combustion case and examination of the combustor liner revealed an ash coating on the interior of the liner but was otherwise visually normal in appearance with no evidence of unusual streaking or burn patterns. The right side air tube displayed areas of burn through on the forward end. The left side air tube remained intact however the snap ring on the aft end at the outer combustion case was dislodged. (Fig 3)

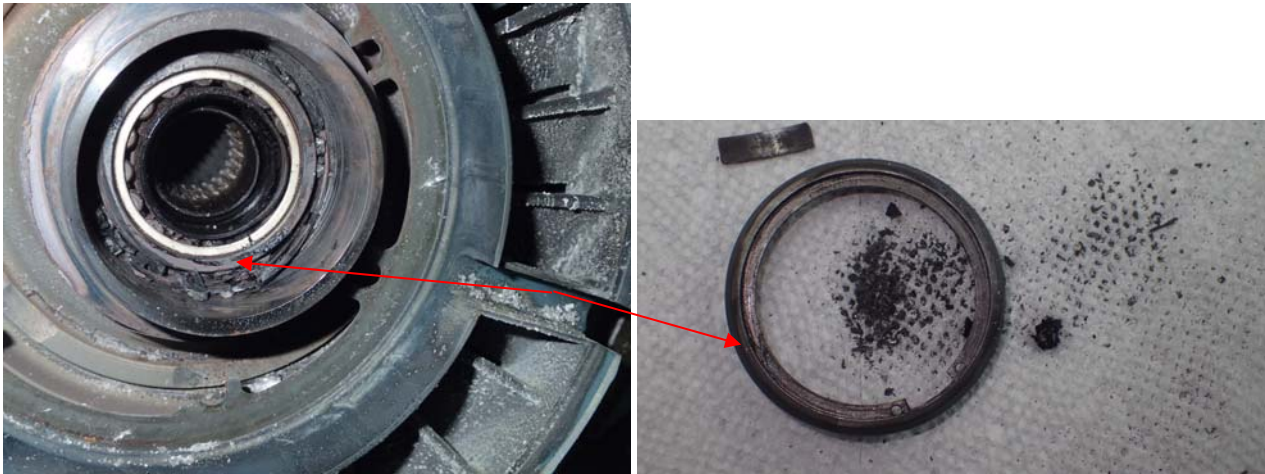
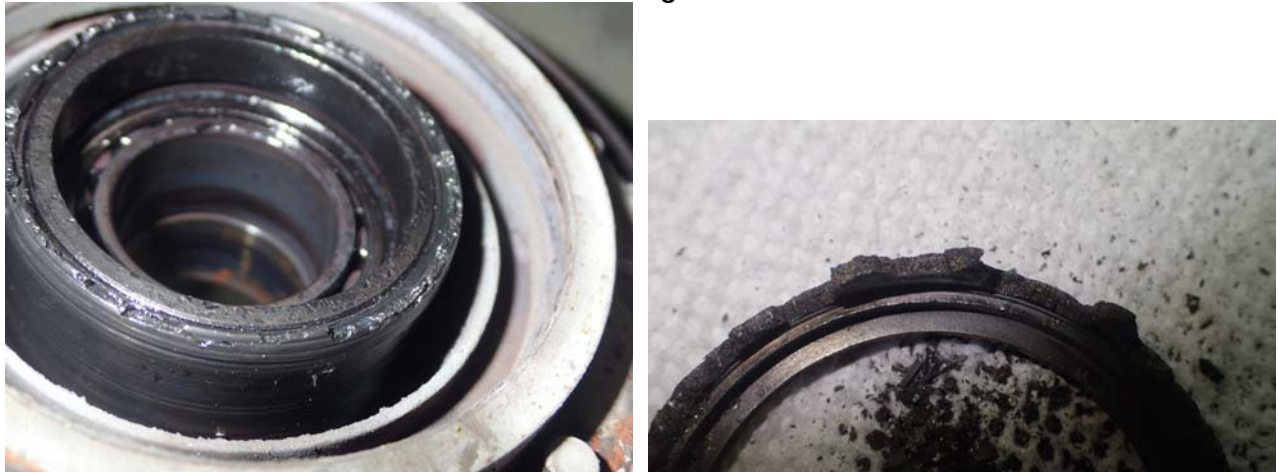
Fractured Bearing Bore

The gas producer support remained in position and other than post-crash fire exposure exhibited no visible damage. The power turbine support remained in position and displayed thermal damage from post-crash fire exposure. The forward power turbine support bearing bore had fractured approximately ¼ inch from the forward end and retained the #6 bearing retaining ring. Both the # 6 and 7 bearings remained in position. (Fig 4)

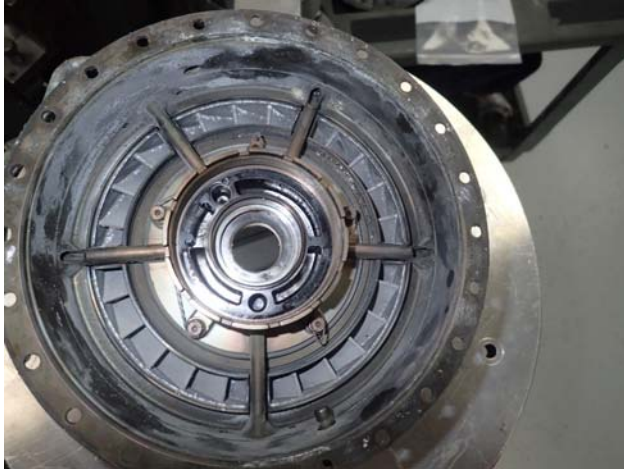
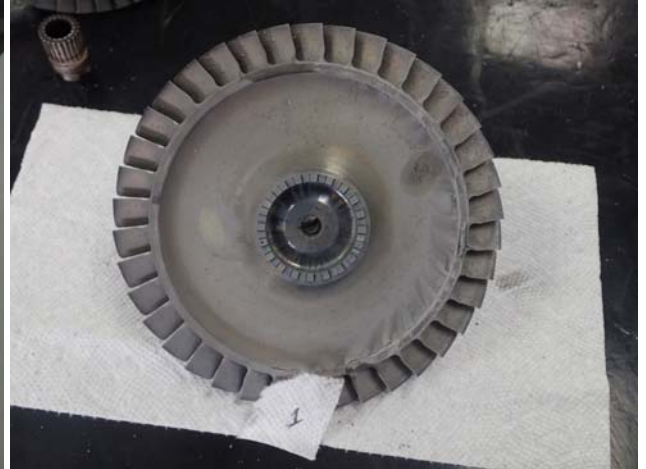
Fig 5

The stage one nozzle and stage one nozzle shield both exhibited light spatter and ash coating over the shield and across vane surfaces with areas of oil staining and coking on the nozzle diaphragm area and several vane surfaces. The stage one turbine wheel exhibited no visible damage however light spatter and light tip rub was noted.

The first and second stage turbine airfoils exhibited tip rub.

The first stage turbine blades exhibited coarsened gamma prime and rafting of the gamma prime at midspan.

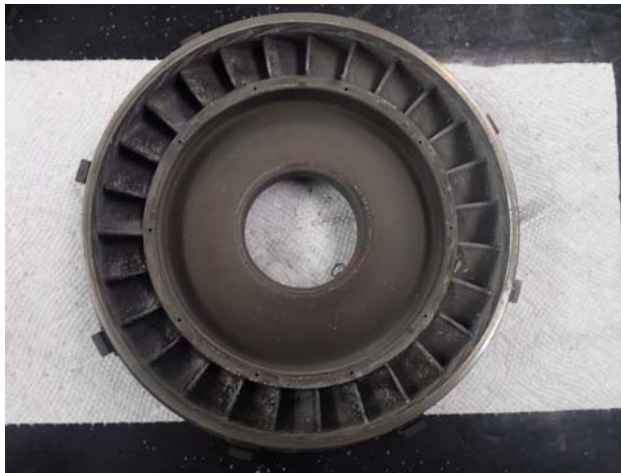
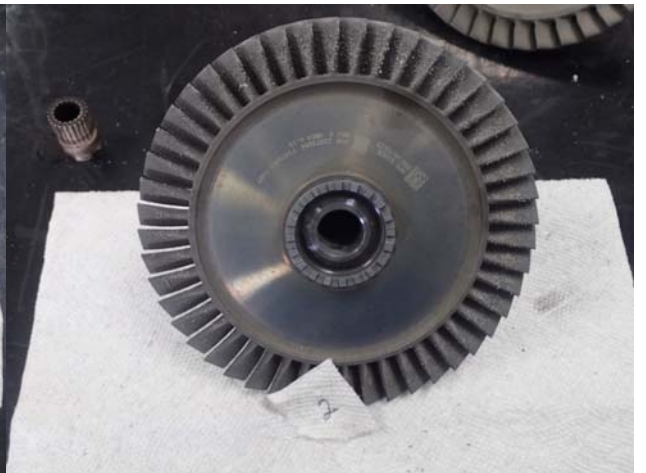
Stage Two Nozzle

The stage two nozzle, other than light spatter and white ashen coating across vane surfaces was visually normal in appearance and exhibited no damage. The stage two wheel was visually normal and other than very light spatter and light tip rub, exhibited no damage. (Fig 5)

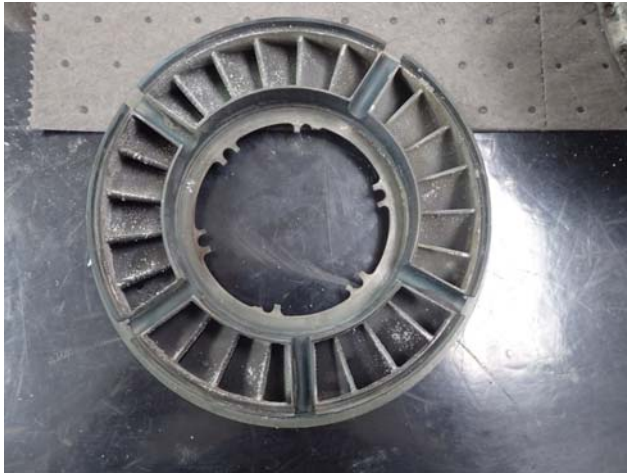
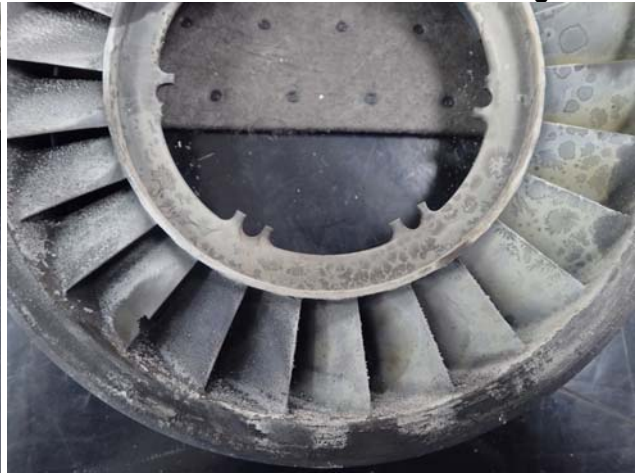
Stage Three Nozzle W/Fractured Positioning Tangs

The stage three nozzle exhibited thermal discoloring from fire exposure. Two inner ring alignment tangs had fractured 180 degrees apart. Impact damage was noted to a single trailing edge vane.

Two of the mounting tabs on the third stage turbine nozzle diaphragm were fractured and missing. Two fourth stage nozzle airfoils were fractured in overload. The hub castellations on the fourth stage nozzle assembly were partially fractured.

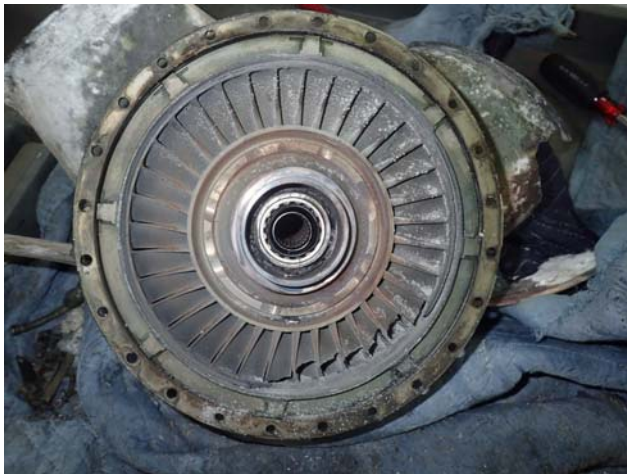
Stage Three Wheel

The stage three wheel exhibited seven blades having fractured at or about mid span with the outer shroud above the blades absent. The stage four wheel exhibited a fracture in the outer rim with all blades present. Due to damage the power turbine rotor could not be separated at disassembly for a detailed examination of the stage three wheel and the stage four nozzle and wheel. (Fig 6)

Seven airfoils comprising a single packet of third stage turbine wheel airfoils between shroud slots were fractured in overload near the shroud. The outboard portions of the airfoils and the shroud segment were not recovered. All the airfoil fractures were consistent with overload. There was no evidence of progressive fracture on any of the third stage turbine blades.

The intact portion of the shroud on the third stage turbine wheel exhibited asymmetric rub damage, with the most severe rub damage located approximately 90° in the direction of engine rotation from the center of the packet of missing airfoils.

The third stage turbine blades exhibited re-solutioned gamma prime near midspan consistent with thermal distress. The thermally distressed area spanned approximately 60% of the airfoil span, centered around midspan on a longitudinal cross-section through an unfractured blade.

The third stage turbine blades exhibited a re-crystallization layer on the airfoil surfaces in the thermally distressed area.

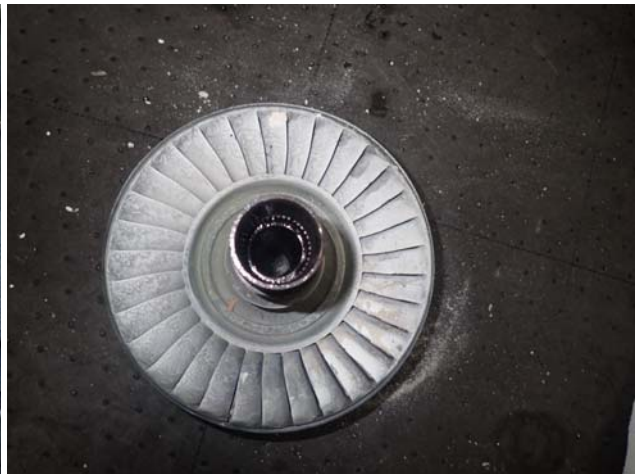
Stage Four Wheel

The fourth stage turbine blades did not exhibit any impact damage. Deposited material was found on the fourth stage blades.

The fourth stage turbine blades exhibited coarsened gamma prime and rafting of the gamma prime at midspan.

The shroud on the fourth stage turbine wheel exhibited asymmetric rub damage and was cracked, with at least one through crack. The most severe rub damage was located approximately 90° in the direction of engine rotation from the center of the packet of missing third stage airfoils.

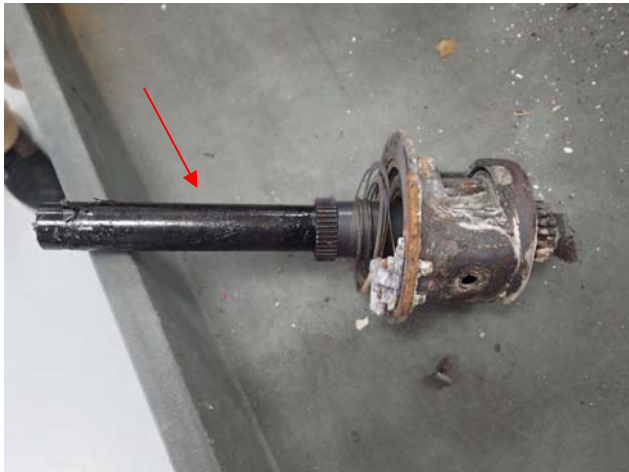
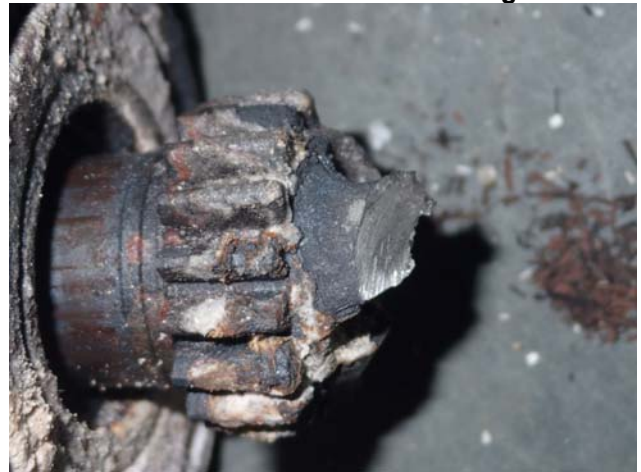
Fig 7

N1 shafting consisting of the spur adapter gear shaft, and turbine to compressor coupling were both found in proper position. The spur adapter gear shaft could not be removed from the #3/4 bearing housing due to molten gear box material however the forward end of the shaft displayed no visible damage. The spur adapter gear shaft was mechanically cut to allow of compressor for removal. The turbine to compressor coupling and was discolored with surface flaking due to post crash fire exposure but was otherwise undamaged. (Fig 7)

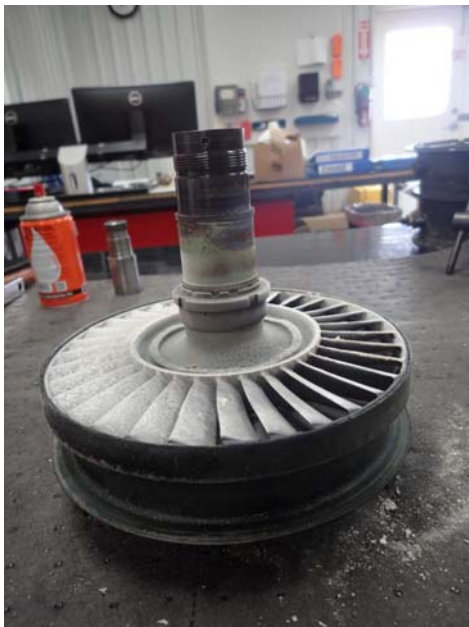
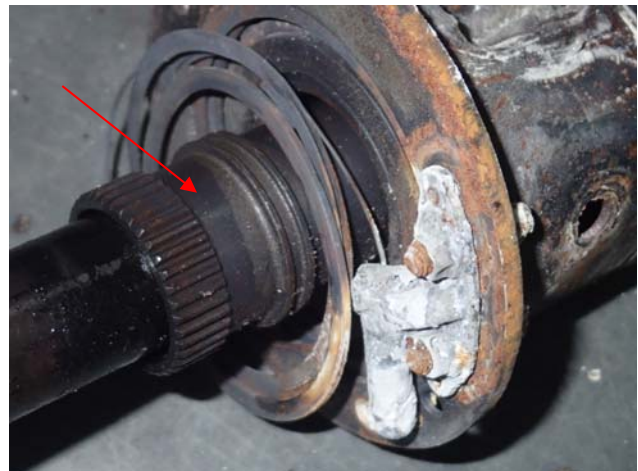
Fig 8

N2 shafting consisting of the power turbine outer shaft and the power turbine to pinion gear coupling were generally dry in appearance and thermally blackened. The power turbine to pinion gear coupling remained in position and was visually undamaged however the Teflon rings had melted away. Rotational scoring was observed on the power turbine out shaft however a detailed examination of the power turbine inner and outer shafts could not be conducted as the power turbine rotor could not be separated at disassembly. (Fig 8)

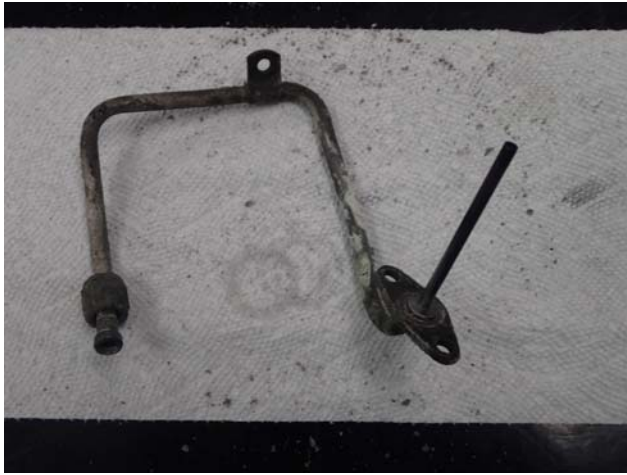
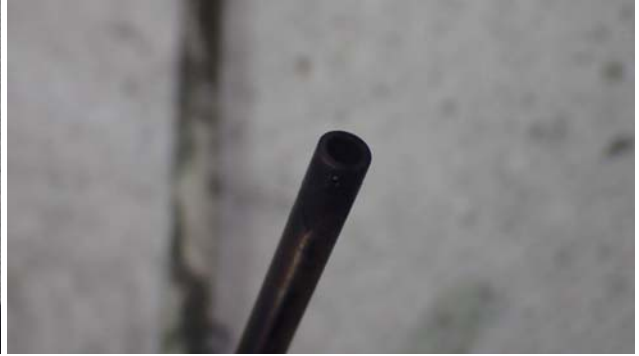
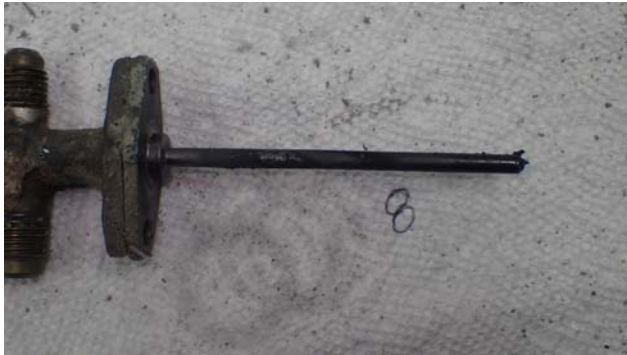
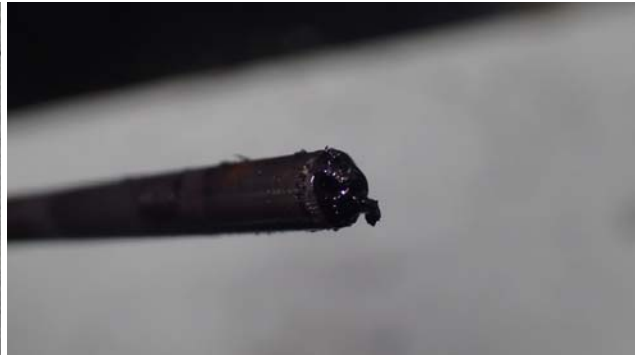
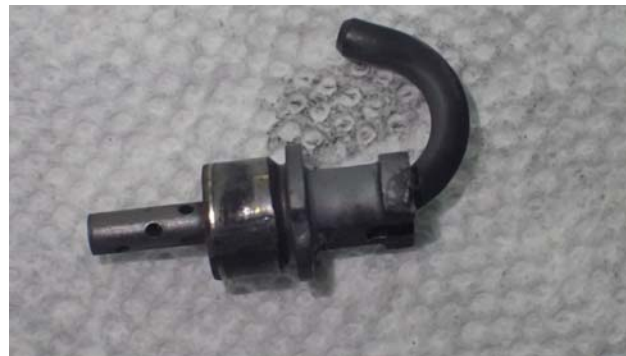
Fig 9

Removal and visual examination of the #6/7 bearing oil delivery tube, revealed the tube to be visually open; and other than minor coking was normal in appearance. The inline oil screen at the #6/7 bearing pressure line "T" fitting was open and void of material. The #8 bearing oil delivery tube was normal in appearance and open to air flow. The #8 bearing oil nozzle was in position and visually open. The #8 bearing sump area was visually dry and exhibited oil coking. (Fig 9)

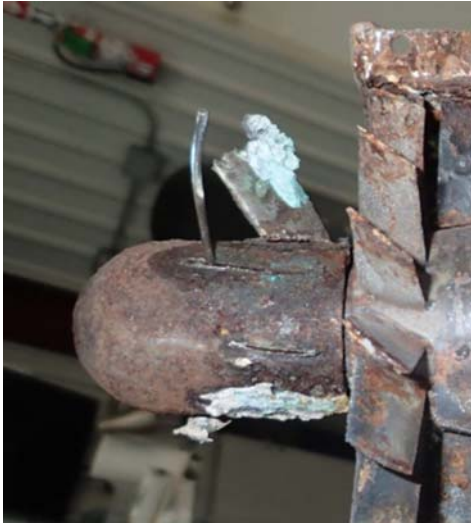
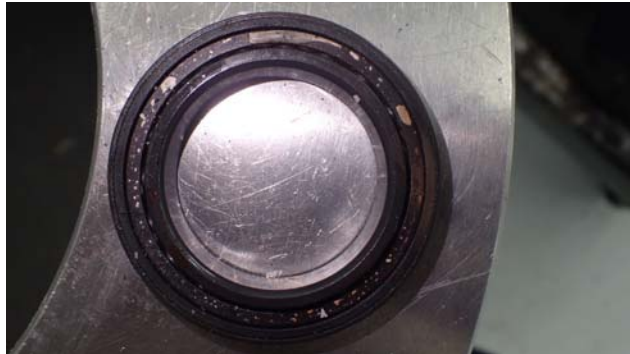
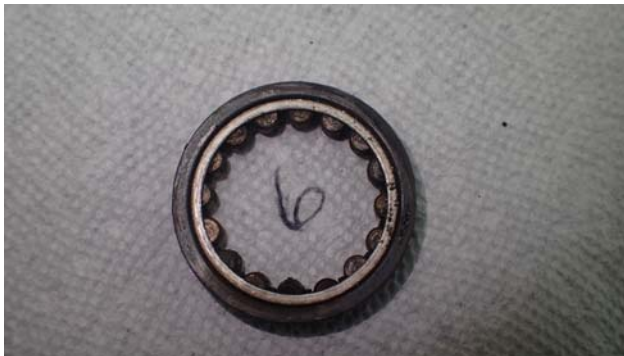
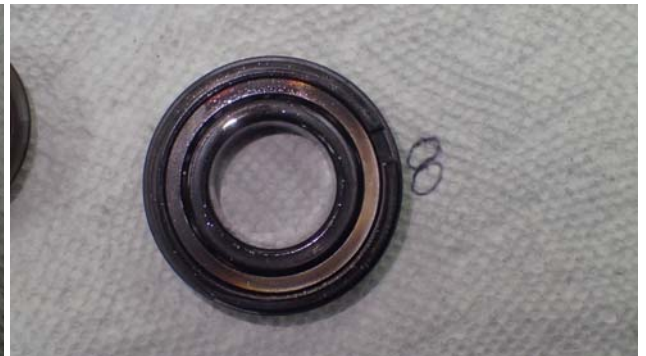
Fig 10

Engine bearings consisting of # 2, 3, 4, 5, 6, 7 and 8 were all visually examined. The #1 bearing residing in the compressor front support could not be removed due to fire exposure. The front support could however be rotated allowing for rotation of the bearing resulting relatively smooth bearing rotation. The #2 bearing exhibited heavy external fire damage however both the inner and outer races were in position and the balls exhibited no sign of spalling or wear. The # 3 and 4 bearings normally resident within the bearing housing and inside accessory gear box cover could not be removed from the bearing housing due to post crash fire exposure and molten gear box material, however visual examination of the bearings revealed all rollers to be in position and no visible evidence of failure. The #5 bearing was blacked due to fire exposure however all balls were in position and displayed no evidence of damage or failure. Both the #6 and #7 bearings were dry but visually normal with all rollers displaying no evidence of damage. The #8 bearing was slightly discolored but was rotationally free with no evidence of damage. (Fig 10)

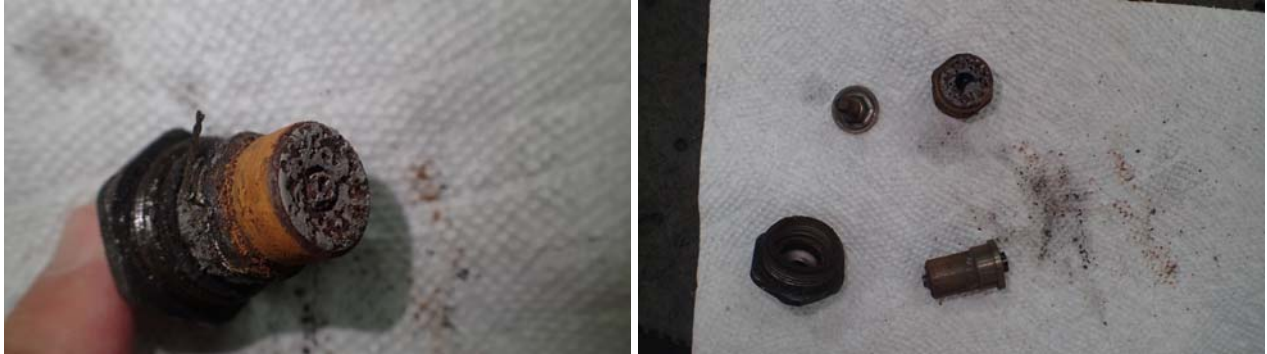
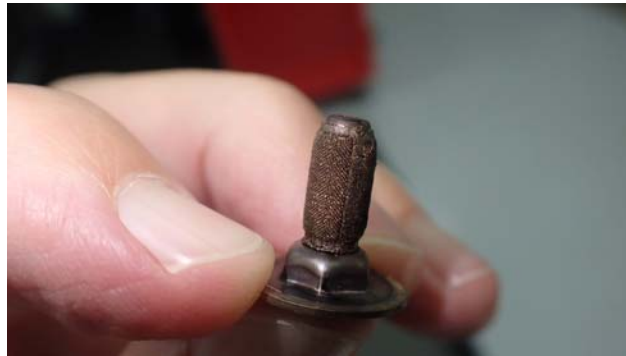
Fig 11

The fuel nozzle remained in position. Upon removal and disassembly, other than rust and discoloration from fire exposure the nozzle was visually normal and the fuel screen clear. (Fig 11)
