| <b>Rolls-Royce</b> | Rolls-Royce Corporation<br>450 S. Meridian Street<br>Indianapolis, Indiana<br>46225-1103, USA | <b>REPORT NO.</b><br>21FAE-055 | <b>REV.</b><br>Initial | <b>PAGES</b><br>1 of 108 |
| <b>TITLE</b><br><b>METALLURGICAL INVESTIGATION OF A THIRD STAGE TURBINE WHEEL, P/N 23065818, REMOVED FROM AN M250, ENGINE S/N CAE835942, OPERATED BY SIGNATURE UTILITY SERVICES</b> | | <b>PREPARED</b><br>Digitally signed by Alexander Sheridan_9782(Bldentity)<br>Date: 2022.05.03 10:26:22 -04'00' | | |

| Part Name: | Third Stage Turbine Wheel |
| Engine Model: | M250-C20B |

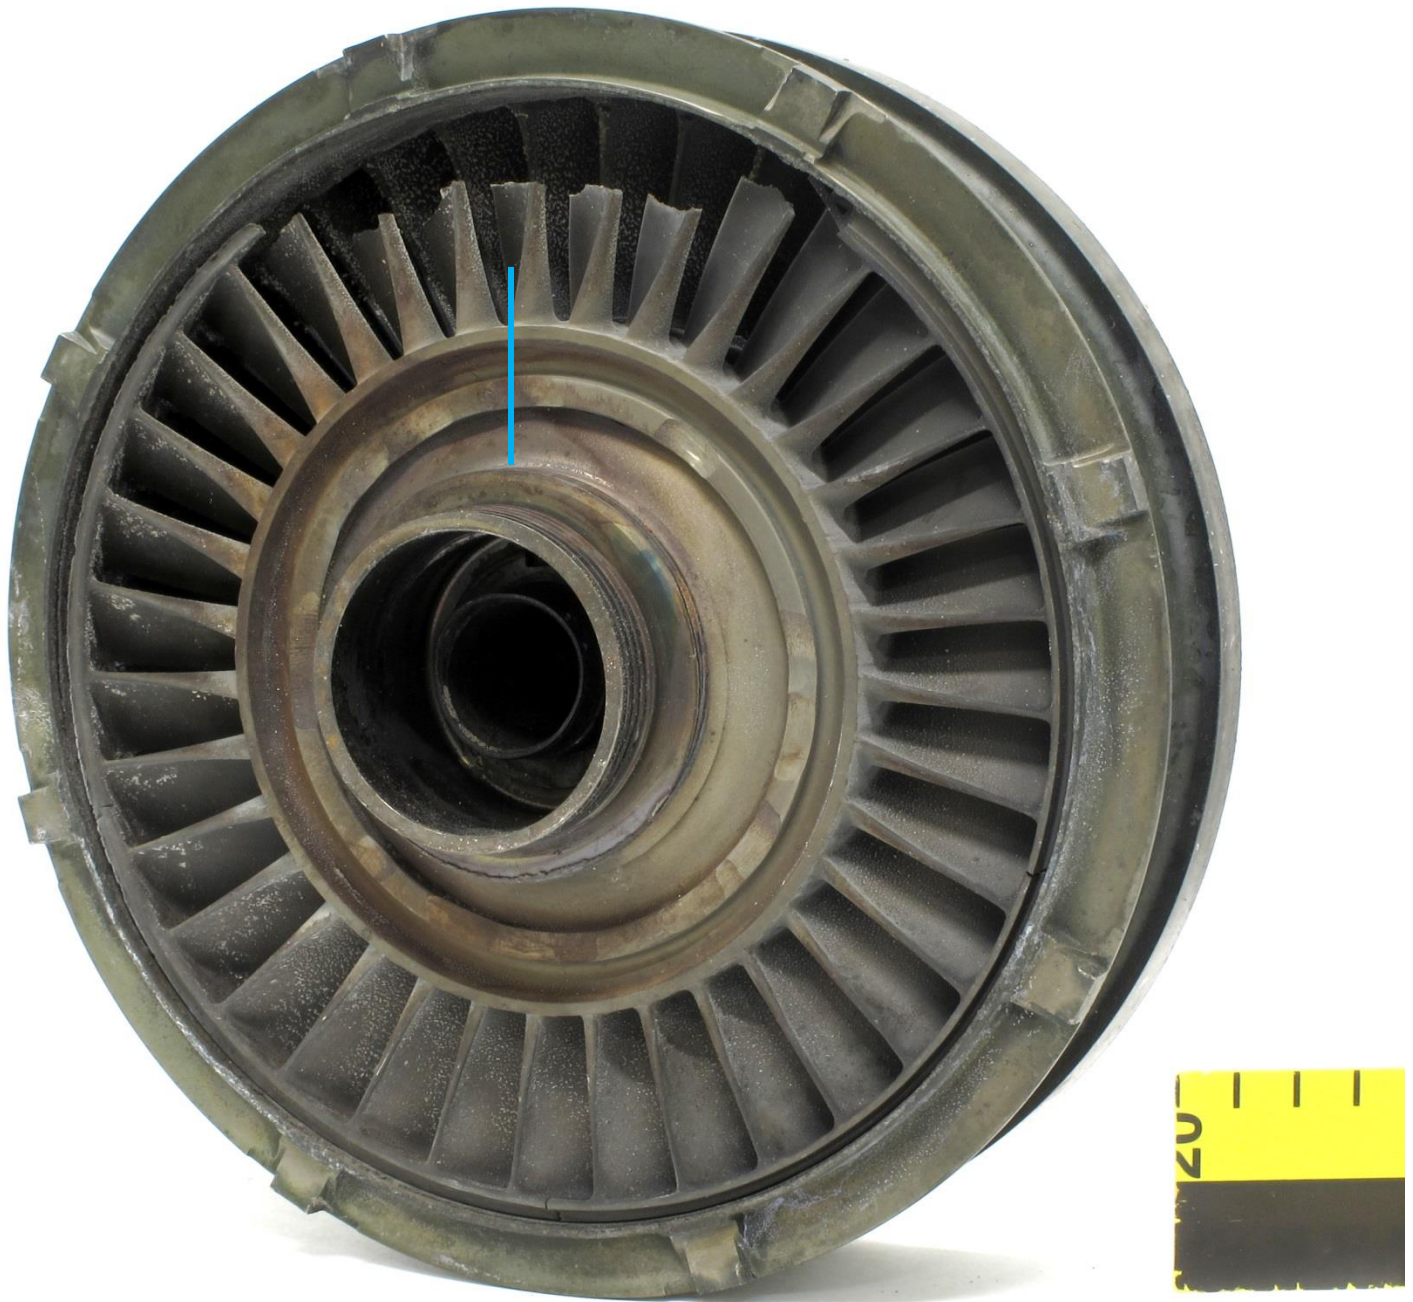
Figure 1 and Figure 2 show the as-received condition of the power turbine (PT) module, which had the third and fourth stage wheels assembled with the power turbine outer and inner shafts and the fourth stage turbine nozzle. Seven consecutive airfoils in a single shroud packet on the third stage turbine wheel were fractured near the tip, liberating the shroud outboard of all the airfoils as shown in Figure 3. The missing portion of the shroud spanned the entire packet between two consecutive as-manufactured slots on the third stage turbine wheel. For reference, the third stage turbine wheel airfoils were numbered starting with #1 for the preceding blade in the packet and increasing opposite the direction of engine rotation.

**Figure 1.** Leading edge side view showing the as-received condition of the power turbine rotor and T4 nozzle. The blue line shows the location of the match mark applied to the rotor in the laboratory. Divisions =cm.

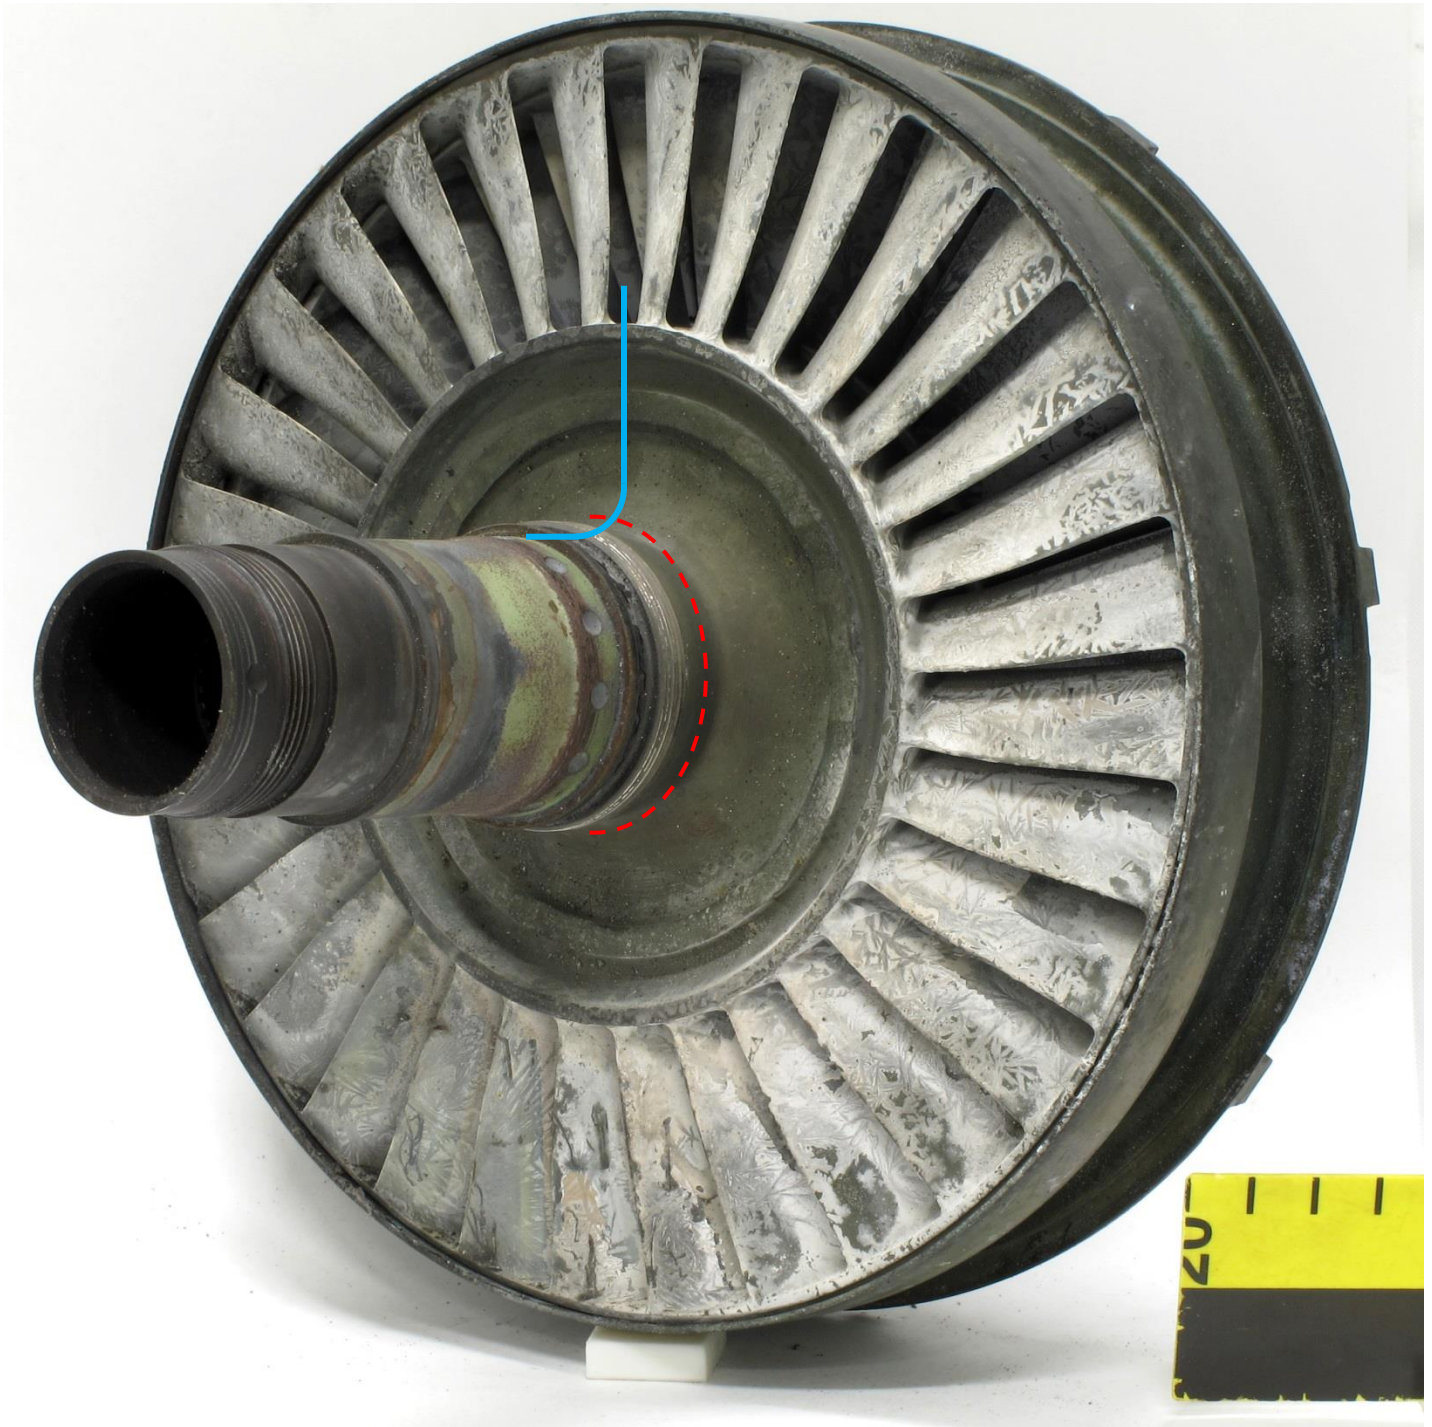
**Figure 2.** Trailing edge side view showing the as-received condition of the PT rotor and T4 nozzle. The blue line shows the location of the match mark applied to the rotor in the laboratory. The red dashed line shows the approximate location of the band saw cut made to disassemble the PT rotor and shafting. Divisions = cm.

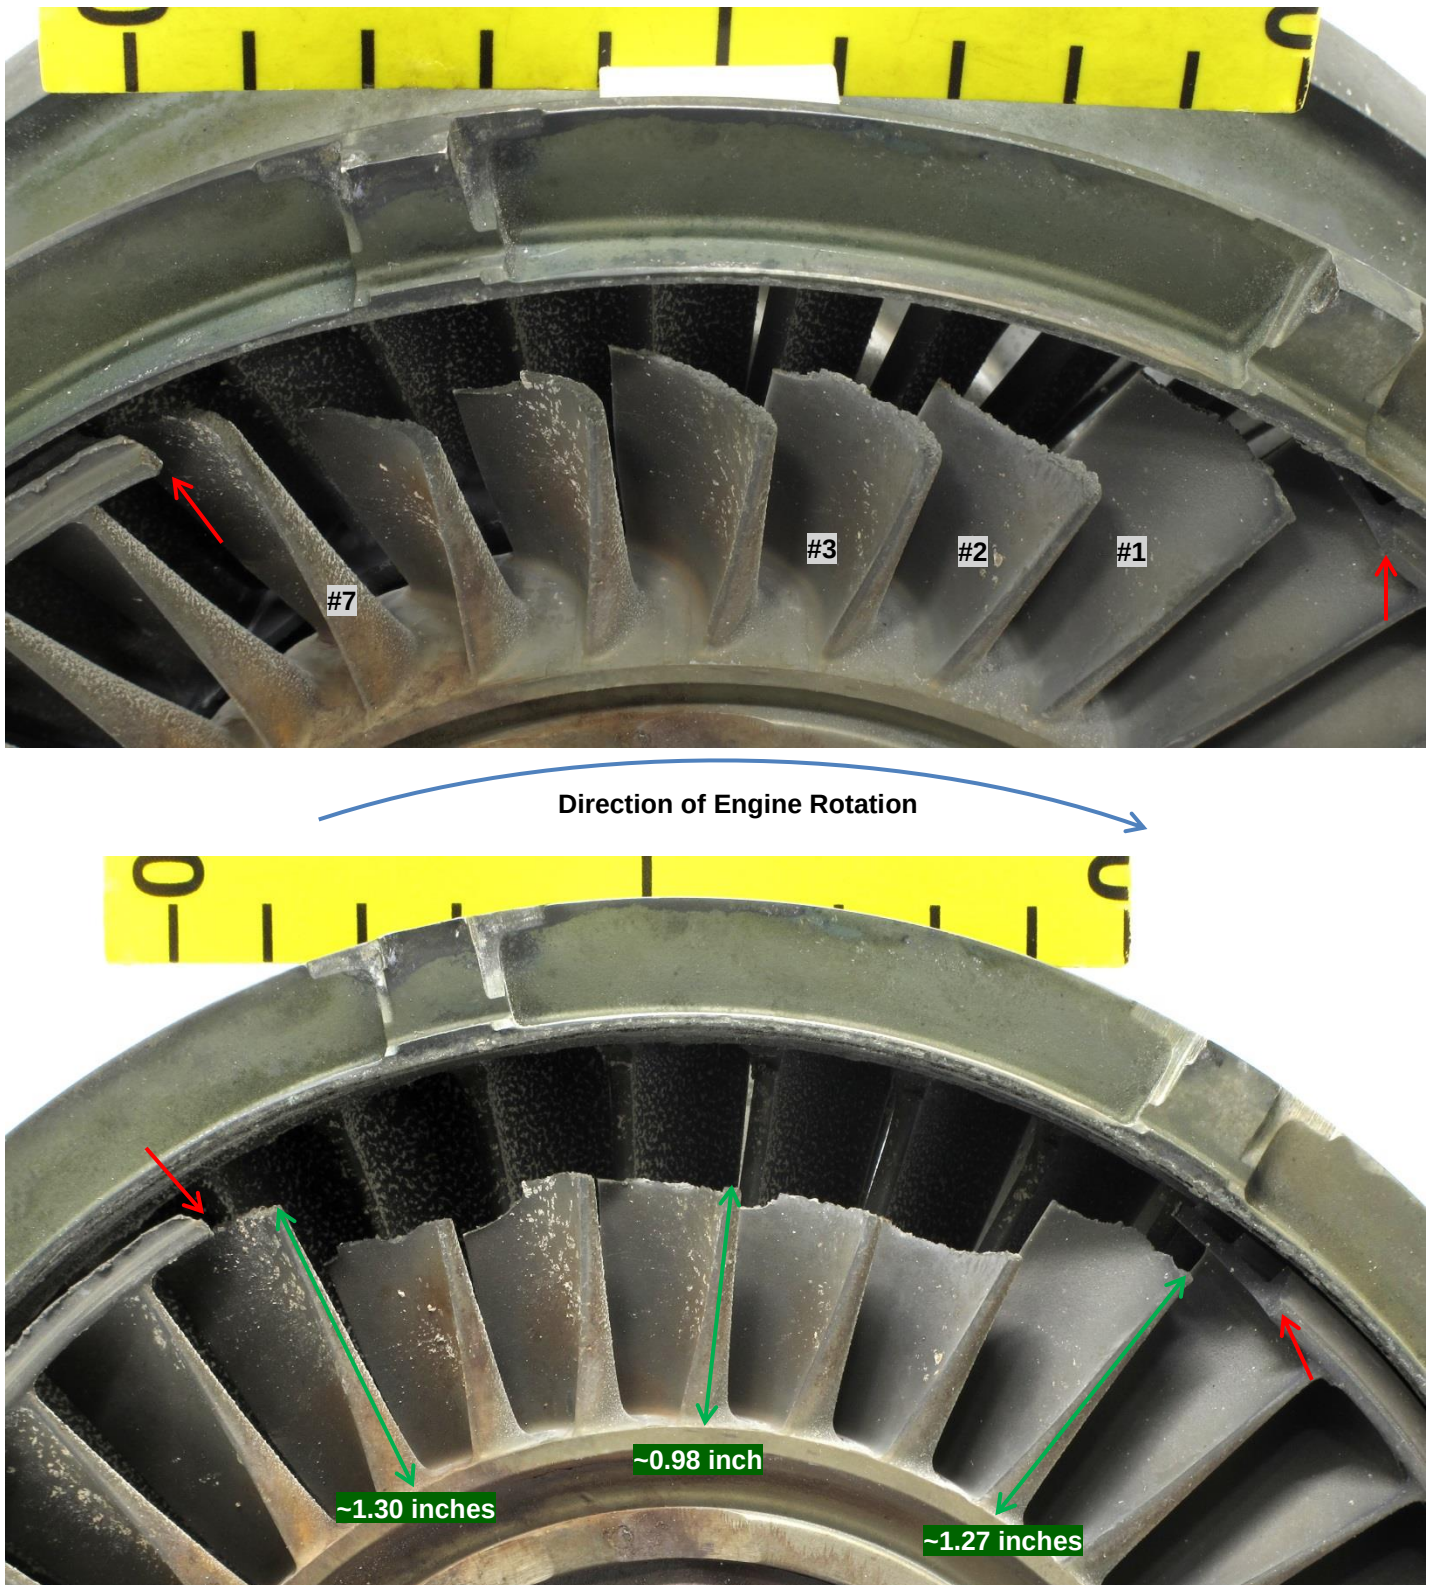
- 2.1 Seven airfoils comprising a single packet of third stage turbine wheel airfoils between shroud slots were fractured in overload near the shroud. The outboard portions of the airfoils and the shroud segment were not recovered. All of the airfoil fractures were consistent with overload. There was no evidence of progressive fracture on any of the third stage turbine blades.

**Figure 3.** Detailed leading edge side views showing the seven (7) fractured third stage turbine blades. All of the fractured blades were in the same packet of seven blades between slots in the shroud (red arrows). The blades were numbered starting with #1 for the leading fractured blade and increasing opposite the direction of engine rotation (blue arrow) as shown at top. Divisions = cm.

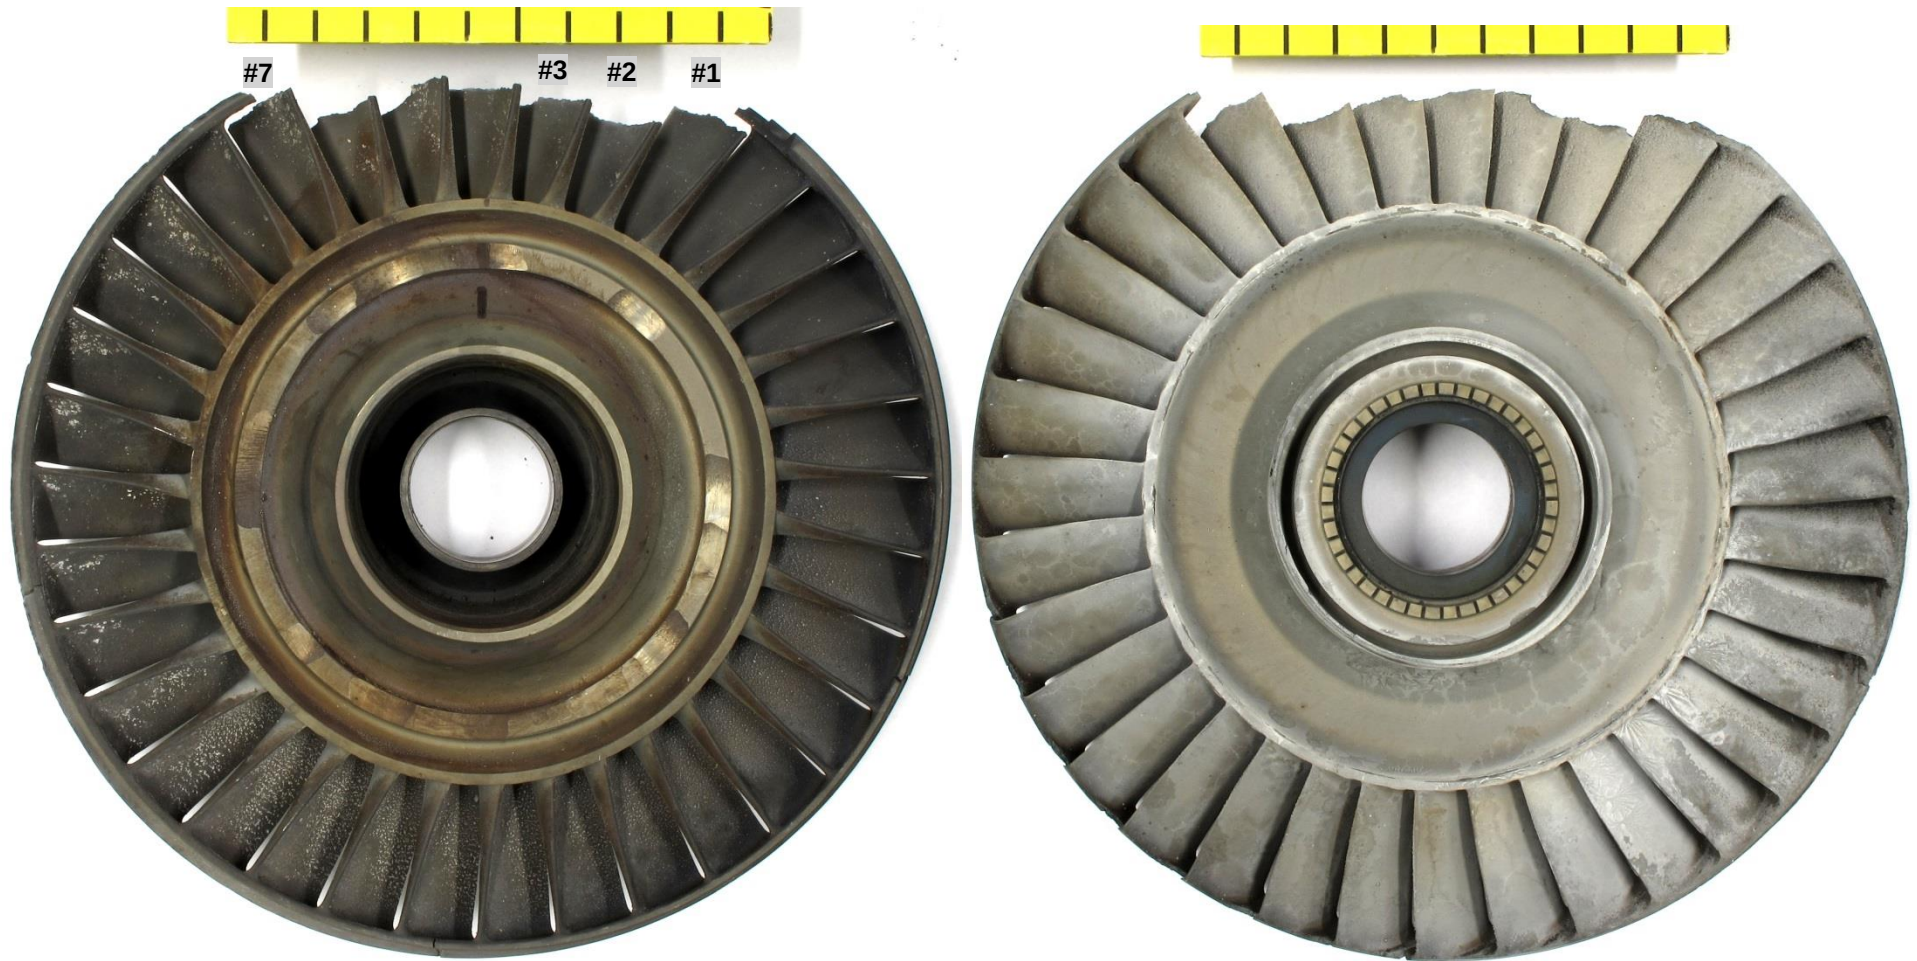
Figure 4 shows the condition of the third stage turbine wheel on the leading and trailing edge sides after the PT rotor was disassembled. Detailed examination of the wheel revealed asymmetric rub damage to the shroud and trailing edge side knife seals as shown in Figure 5. The most severe rub damage to both seals spanned between blades #22 and #30, which was centered on a location approximately 90° in the direction of engine rotation from

**Figure 4.** Leading edge (left) and trailing edge (right) side views showing the third stage turbine wheel after rotor disassembly. The black temporary match markings on the leading edge side hub and rim (left) were applied in the laboratory before the PT rotor was sectioned and separated. Divisions = cm.

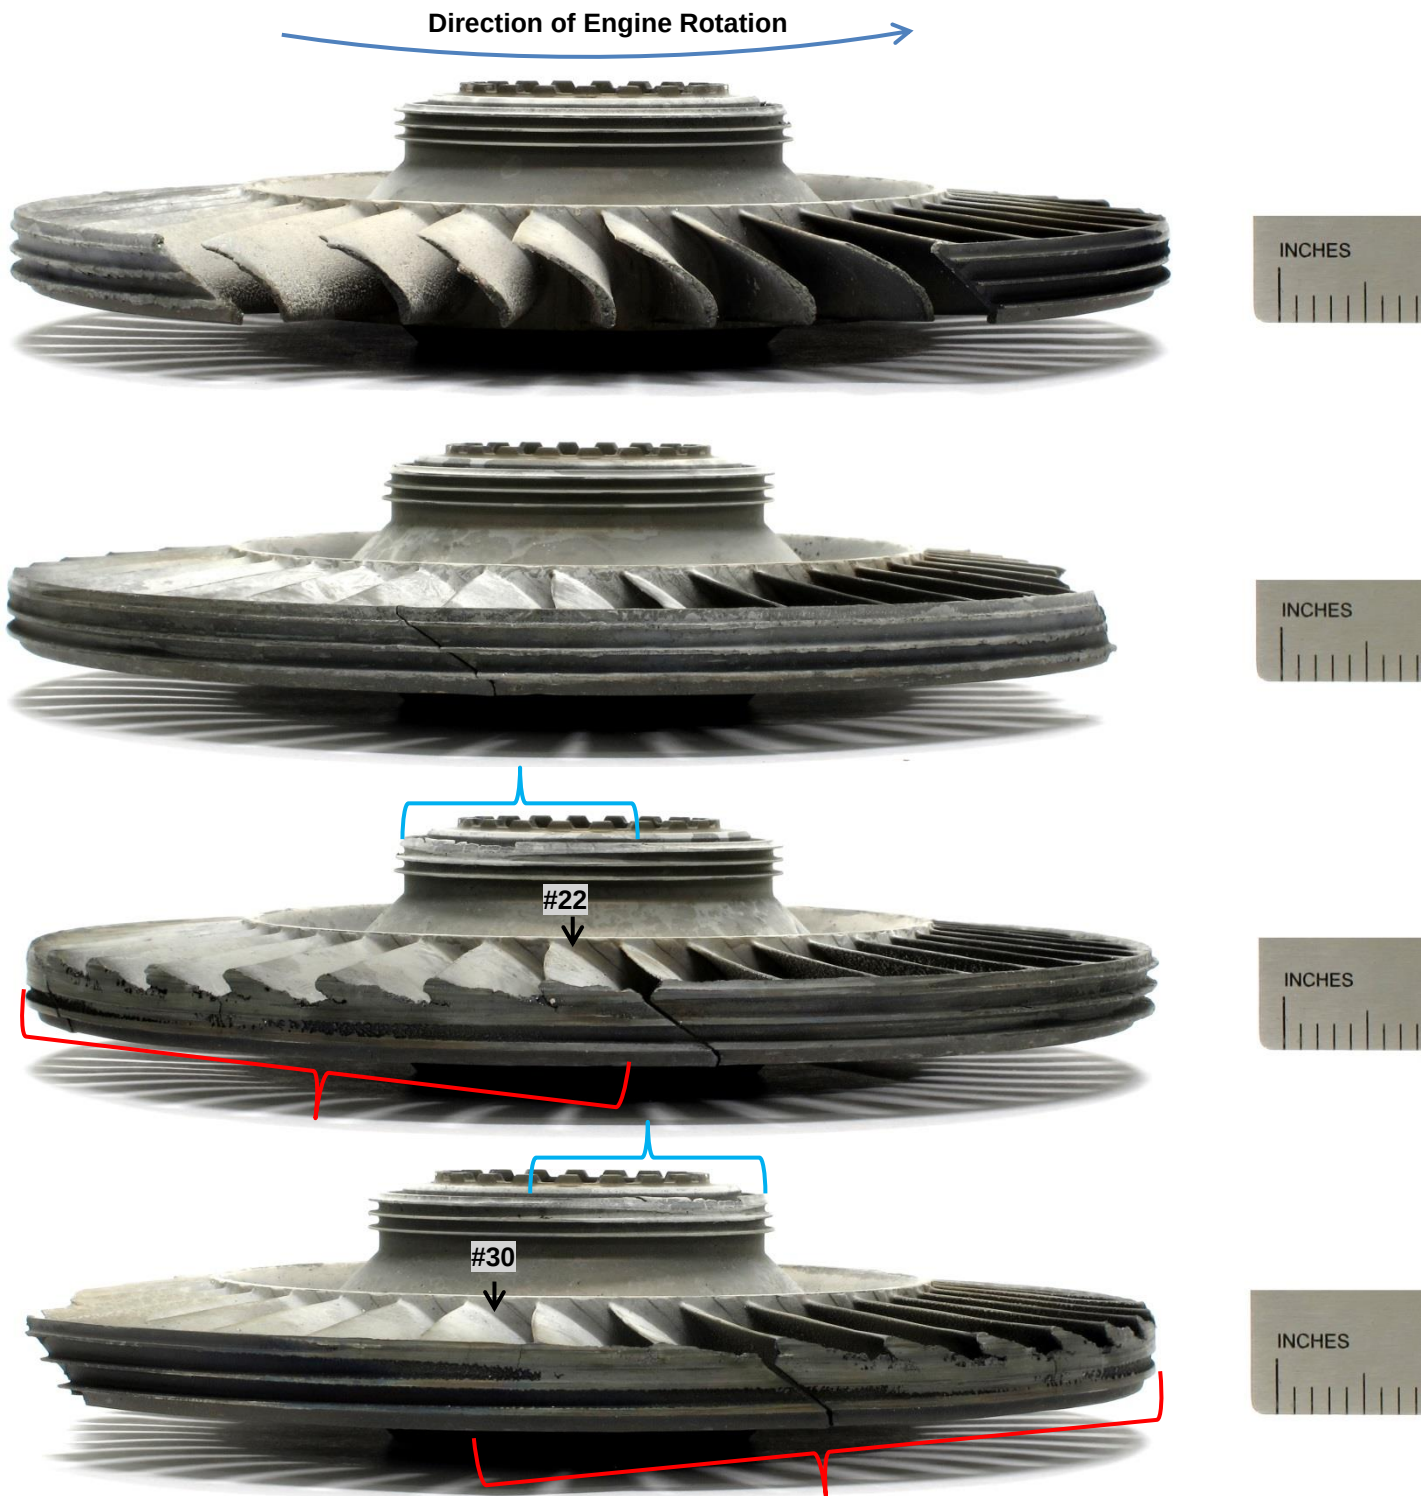
- 2.2 The intact portion of the shroud on the third stage turbine wheel exhibited asymmetric rub damage, with the most severe rub damage located approximately 90° in the direction of engine rotation from the center of the packet of missing airfoils.

**Figure 5.** Radial views showing the third stage turbine wheel fractured airfoils (top) and shroud. The wheel was rotated 90° in the direction of engine rotation for this succession of images. The most severe rub damage to the shroud (red braces) and trailing edge side knife seals (blue braces) spanned between blades #22 and #30, centered on a location approximately 90° in the direction of engine rotation from the center of the packet of missing airfoils. Divisions = 0.1 inch.

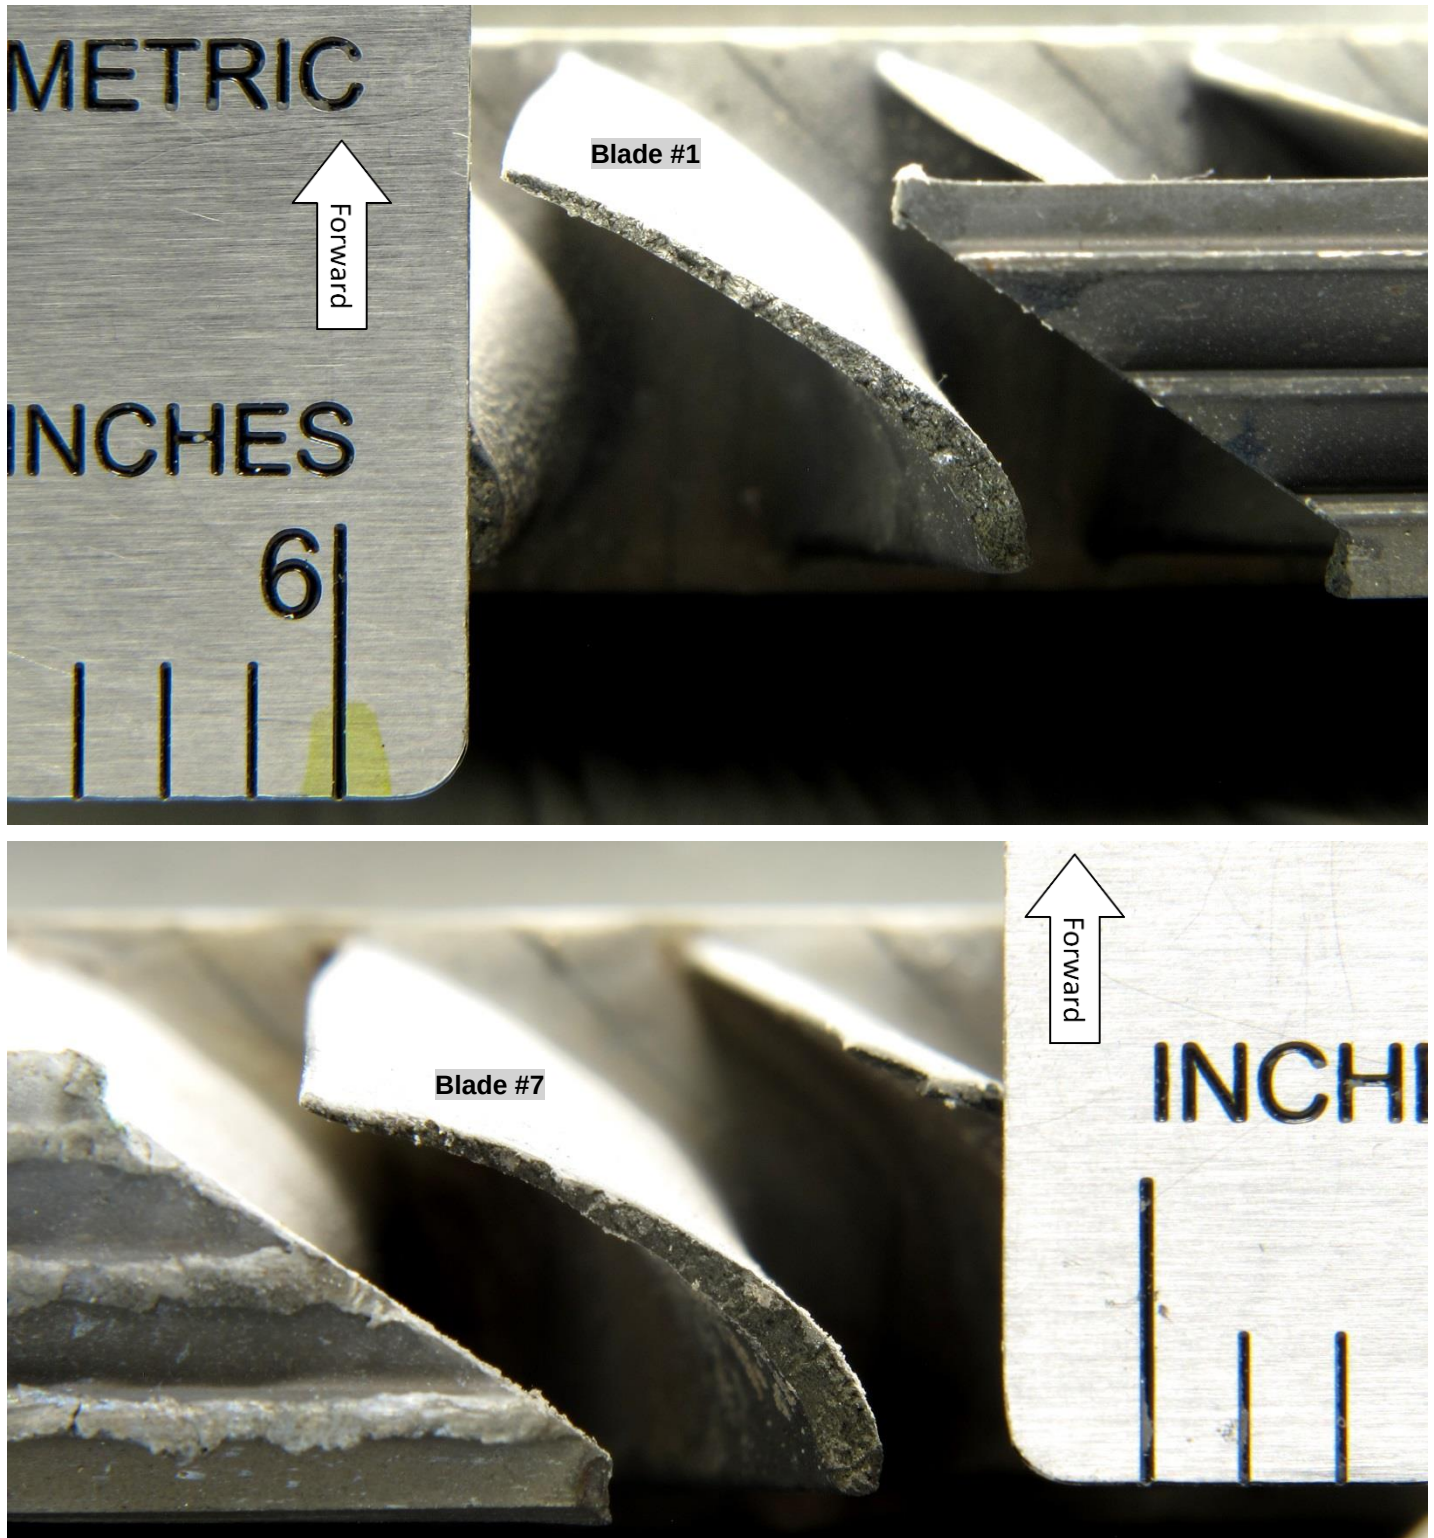
the center of the packet of missing airfoils. However, the shroud also exhibited rub damage that was not continuous with the gradient of rub damage surrounding blades #22 and #30. Immediately adjacent to the EDM slot on the trailing side of the missing shroud segment (between blades #7 and #8), the knife seals exhibited rub damage that flattened the knife tips as shown in Figure 6. The knife seals immediately adjacent to the EDM slot on the leading side of the missing shroud segment were relatively undamaged.

**Figure 6.** Detailed views of the shroud knife seals adjacent to the leading (top) and trailing (bottom) EDM slots surrounding the liberated portion of the shroud. The knife seals adjacent to the trailing EDM slot exhibited rub damage that flattened the knife edges, while the knife seals adjacent to the leading EDM slot were relatively undamaged. Divisions = 0.1 inch.

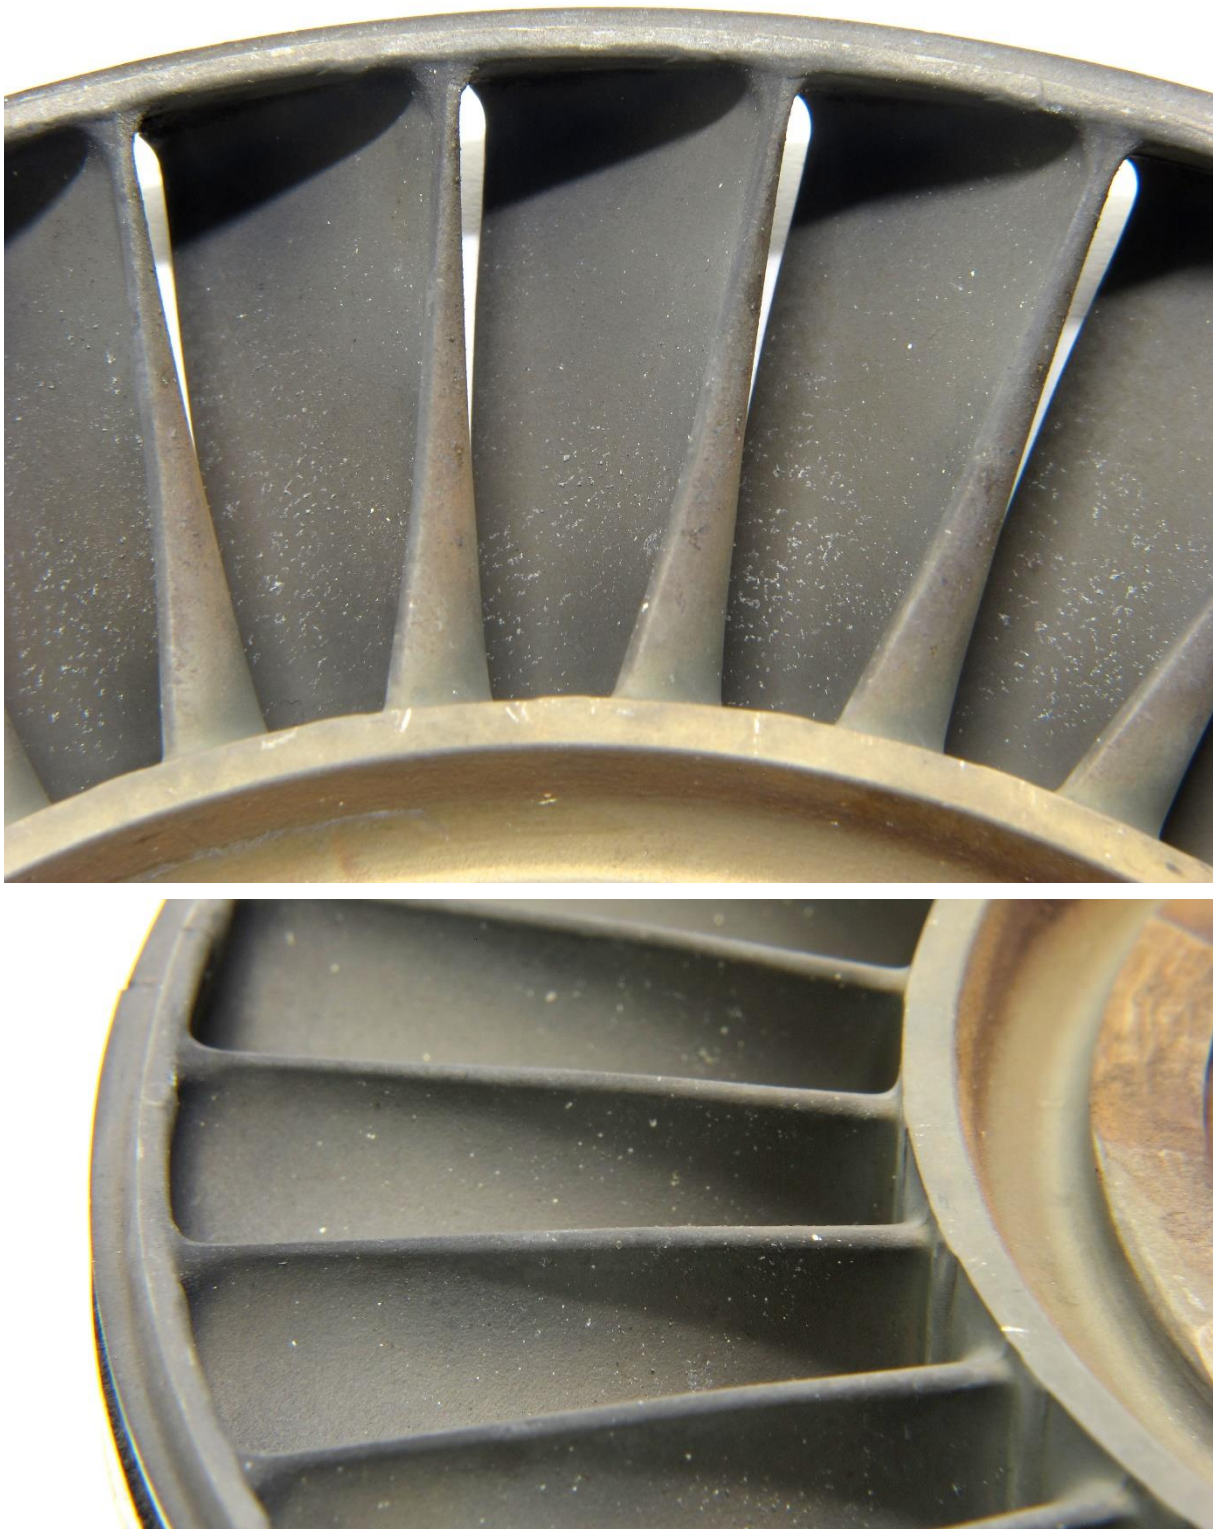
The wheel was cleaned with soapy water prior to fluorescent penetrant inspection (FPI, discussed later), and the cleaned condition of several representative unfractured third stage turbine airfoils is shown in Figure 7 and Figure 8. The leading and trailing edges of the airfoils did not exhibit any deformation or impact damage. The pressure side surfaces exhibited intermittent deposited material consistent with re-deposited material from the rub damage to the shrouds and blade tracks in the power turbine.

**Figure 7.** Detailed views showing the leading edges and pressure side surfaces of several representative unfractured third stage turbine airfoils. There was no impact damage to the leading edges and the pressure side surfaces exhibited intermittent deposited material consistent with re-deposited material from the rub damage to the shrouds and blade tracks in the power turbine. No scale provided.

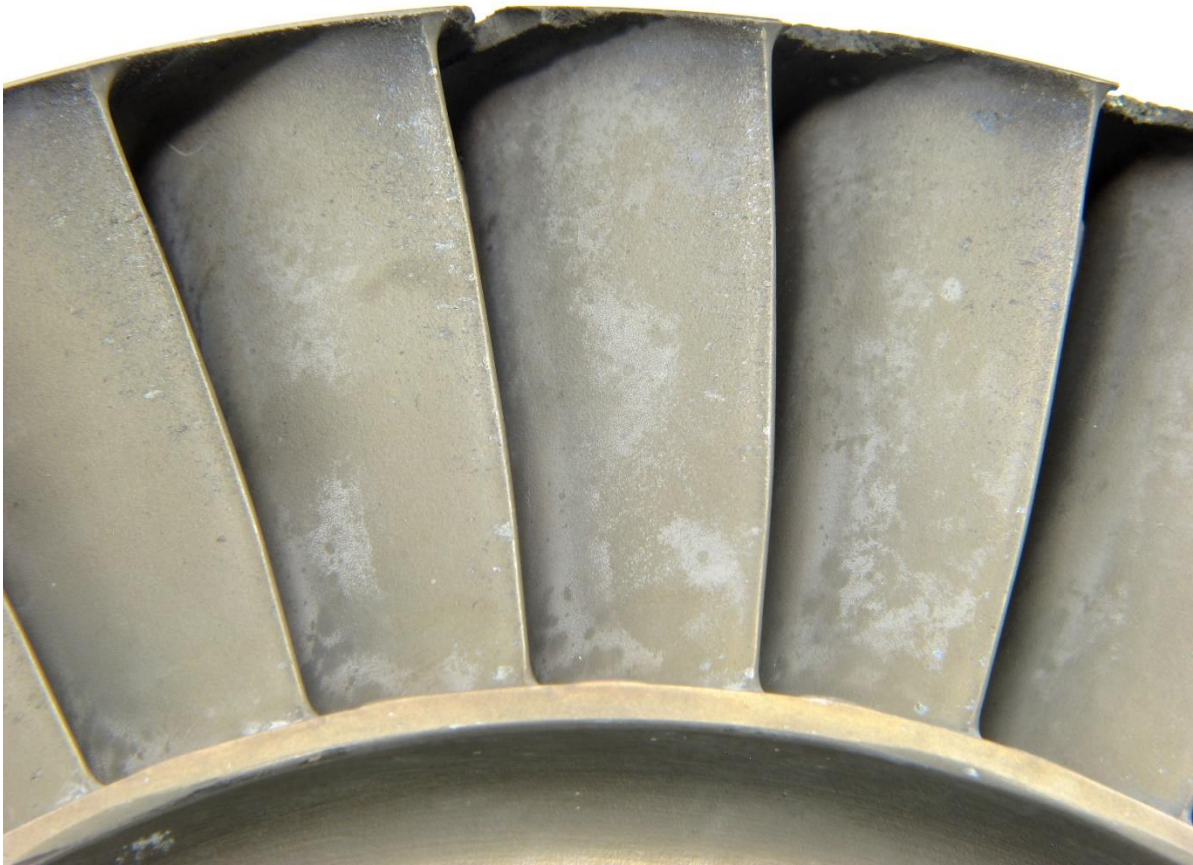
**Figure 8.** Detailed view showing the trailing edges and suction side surfaces of several representative third stage turbine airfoils. The trailing edges did not exhibit any impact damage. No scale provided.

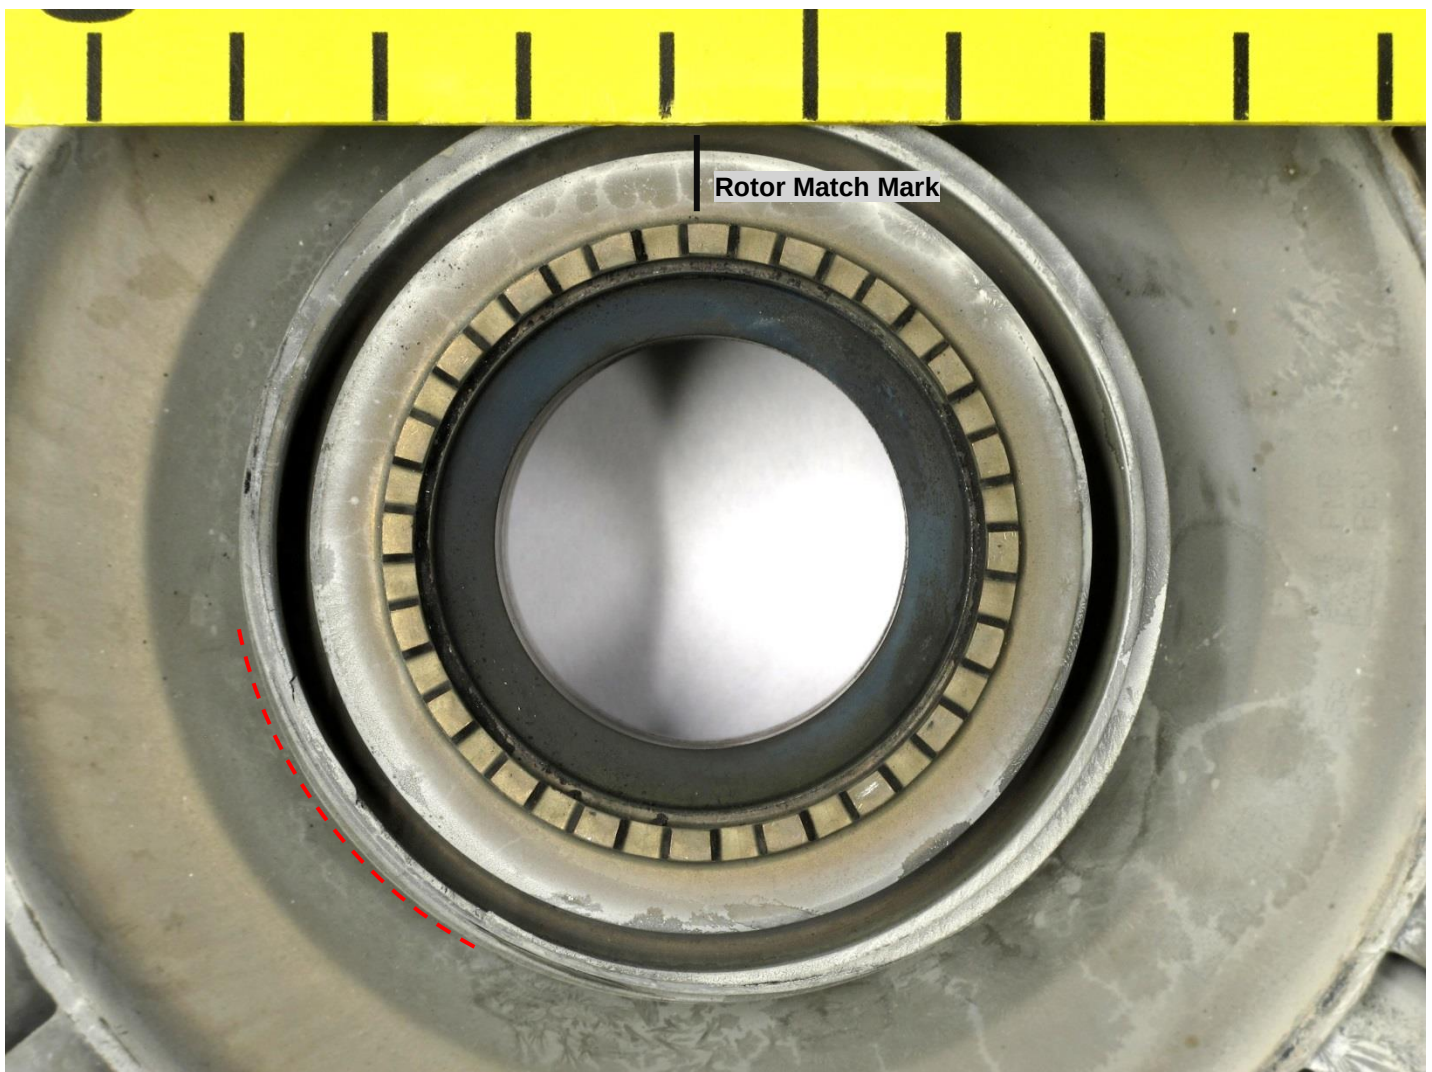
The trailing edge side curvic teeth, shown in Figure 9, did not exhibit any damage. The trailing edge side interstage knife seals, however, exhibited asymmetric rub damage similar to that found on the intact portion of the shroud as shown in Figure 10. Part of the seal was missing in the middle of the rub damage, centered approximately 90° in the direction of engine rotation from the center of the packet of missing airfoils.

**Figure 9.** Detailed view showing the trailing edge side curvic teeth. The red dashed line indicates the arc where a part of the knife seals was missing. The black line shows the approximate location of the rotor match mark. Divisions = cm.

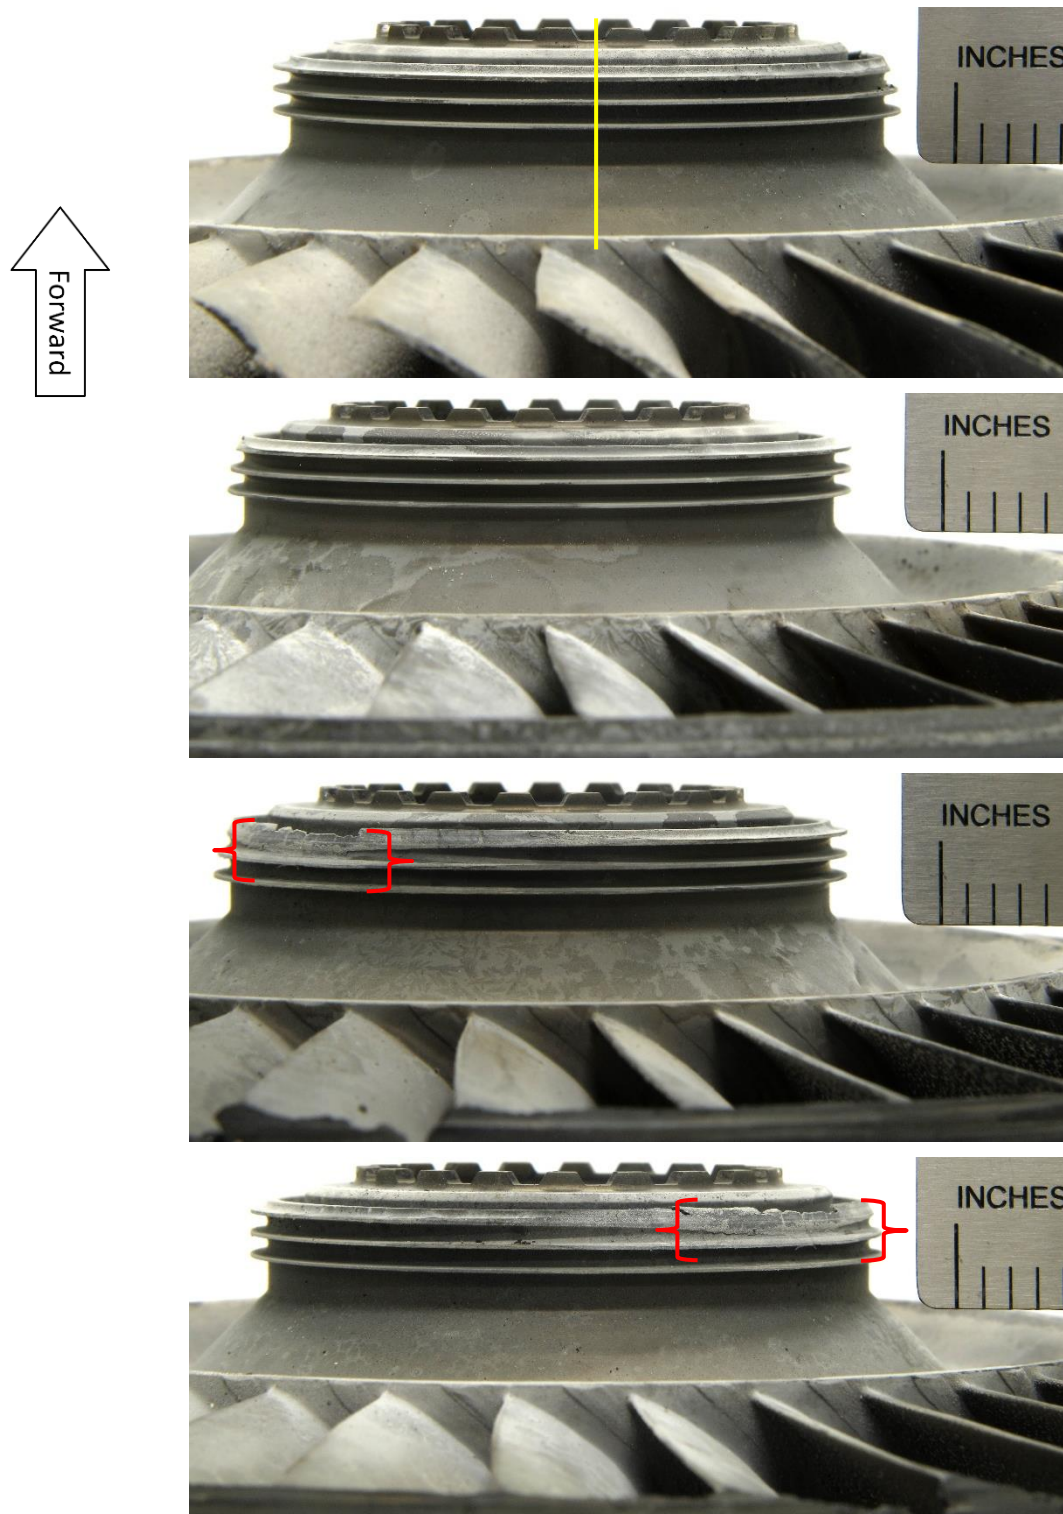
**Figure 10.** Radial views showing the trailing edge side knife seals on the third stage turbine wheel. The wheel was rotated 90° in the direction of engine rotation for this succession of images. The most severe rub damage to the shroud (red braces) was centered on a location approximately 90° in the direction of engine rotation from the center of the packet of missing airfoils. The yellow line shows the location of the PT rotor match mark. Divisions = 0.1 inch.

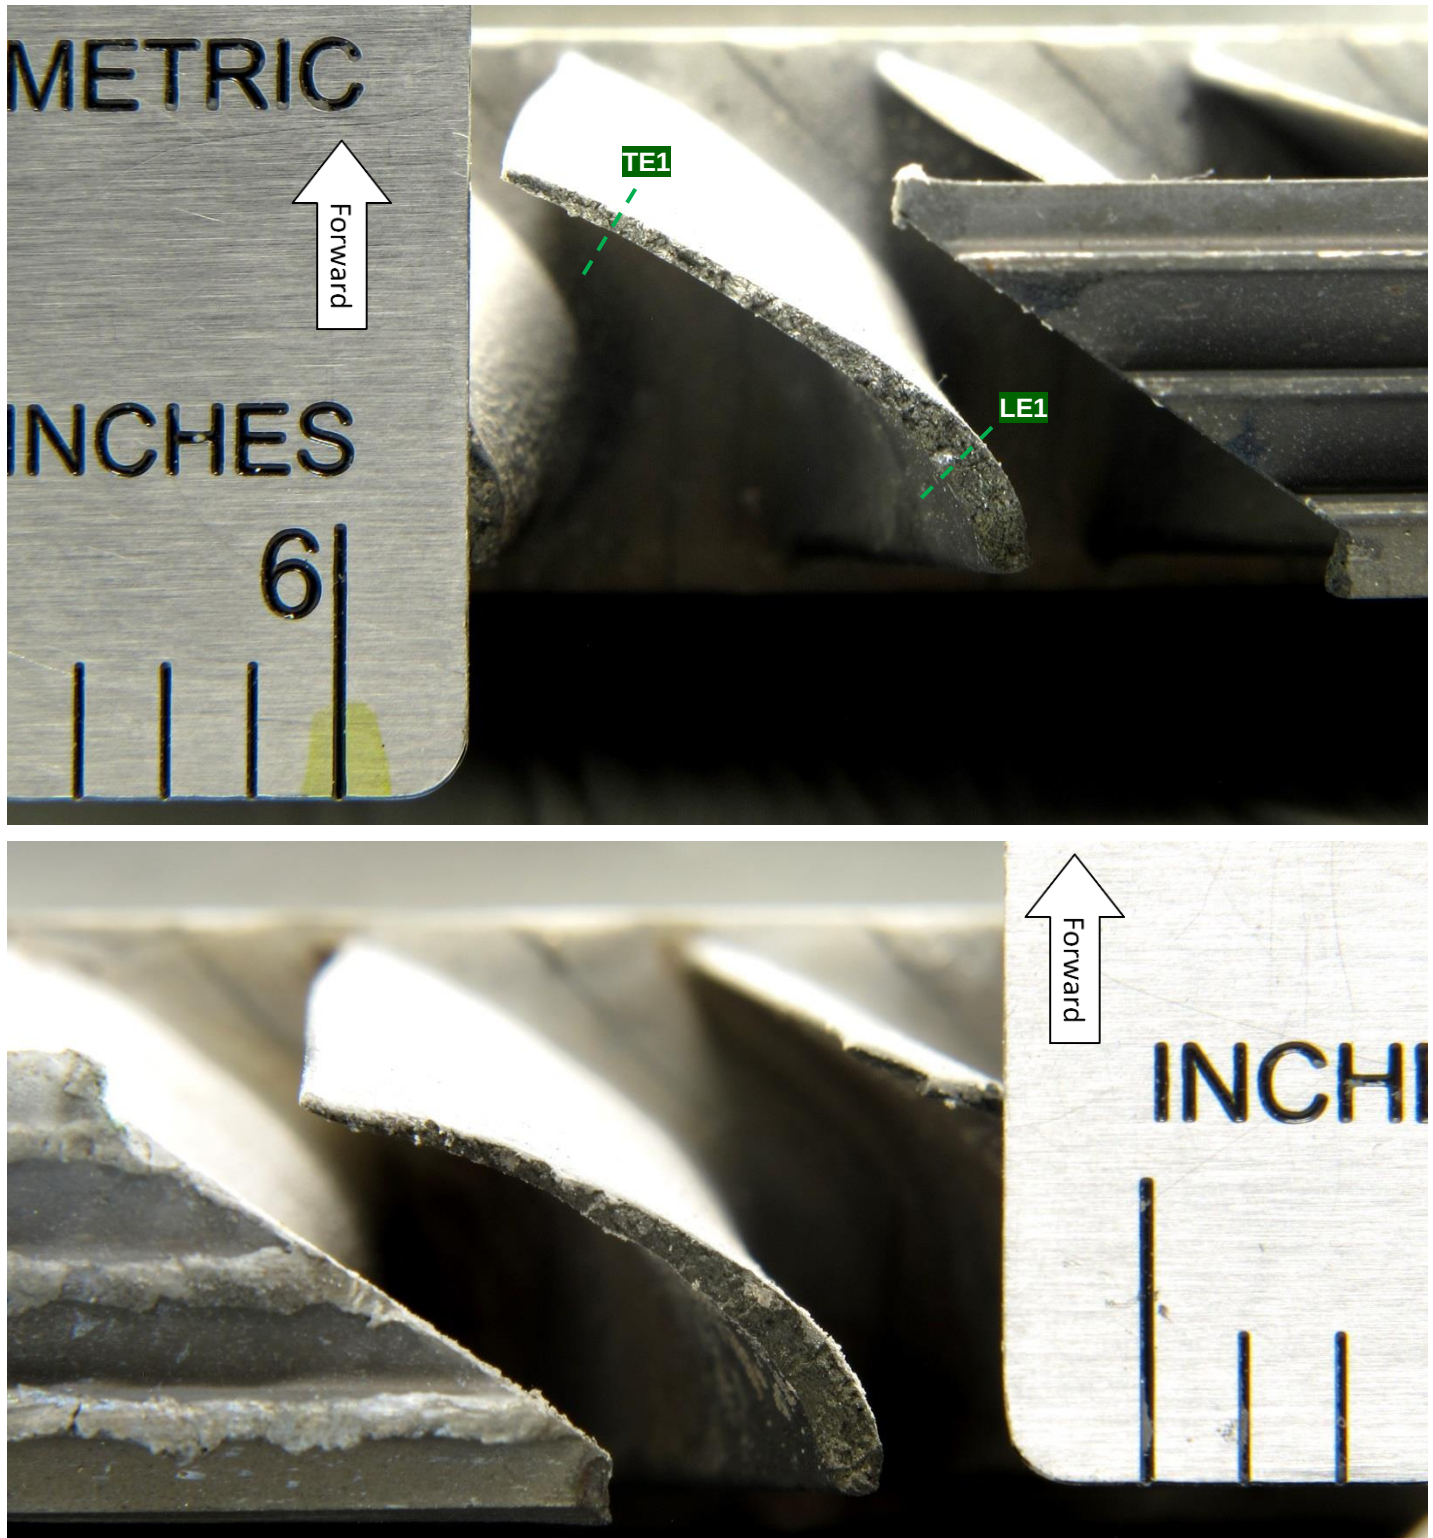
Detailed optical examination of the airfoil fracture surfaces (prior to cleaning for FPI) revealed interdendritic features consistent with overload fracture intermixed with smearing damage. Figure 11 shows detailed views of the fracture surfaces on the first (#1) and last (#7) airfoils in the packet before cleaning, both of which exhibited interdendritic fracture features consistent with overload. The fracture surfaces on the other airfoils, shown after ultrasonic cleaning in Figure 12 through Figure 14, also exhibited interdendritic features consistent with overload.

Figure 11. Detailed views showing the fracture surfaces on the blade #1 (top) and blade #7 (bottom) airfoils in the packet where the shroud was liberated. The green dashed lines at top show the approximate locations of the radial-longitudinal sections through blade #1 near the leading edge (LE1) and trailing edge (TE1). The remaining fracture surfaces are shown in the following figures. Divisions = 0.1 inch.
