| <b>Rolls-Royce</b> | Rolls-Royce Corporation<br>450 S. Meridian Street<br>Indianapolis, Indiana<br>46225-1103, USA | <b>REPORT NO.</b><br>21FAE-055 | <b>REV.</b><br>Initial | <b>PAGES</b><br>1 of 108 |
| <b>TITLE</b><br><b>METALLURGICAL INVESTIGATION OF A THIRD STAGE TURBINE WHEEL, P/N 23065818, REMOVED FROM AN M250, ENGINE S/N CAE835942, OPERATED BY SIGNATURE UTILITY SERVICES</b> | | <b>PREPARED</b><br>Digitally signed by Alexander Sheridan_9782(Bldentity)<br>Date: 2022.05.03 10:26:22 -04'00' | | |

| Part Name: | Third Stage Turbine Wheel |
| Engine Model: | M250-C20B |

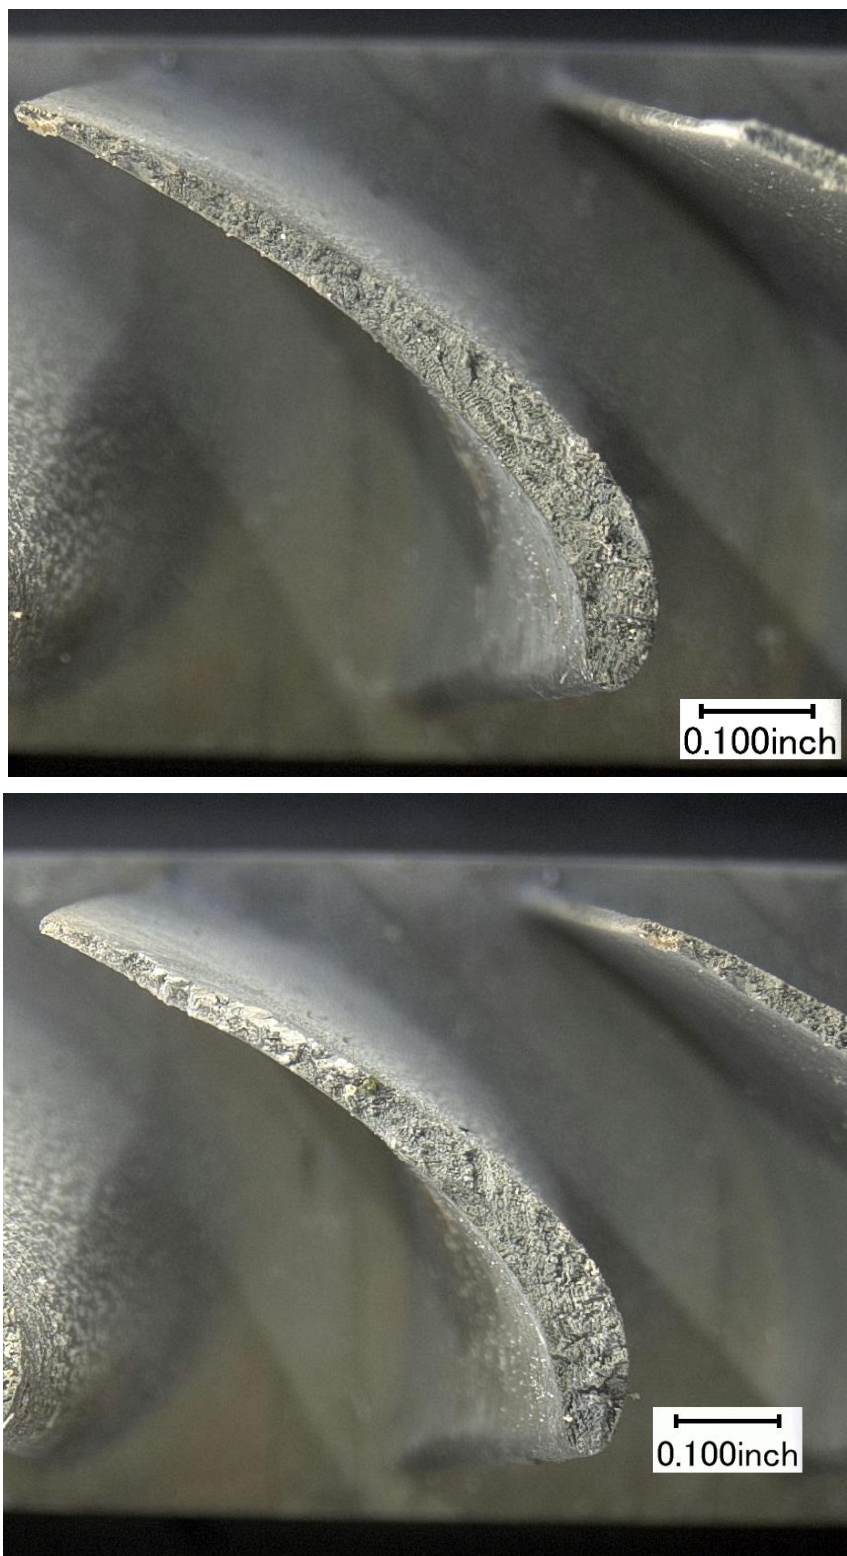
**Figure 12. Fracture surfaces on blades #2 (top) and #3 (bottom) prior to cleaning.**

Detailed optical examination of the airfoil fracture surfaces (prior to cleaning for FPI) revealed interdendritic features consistent with overload fracture intermixed with smearing damage. Figure 11 shows detailed views of the fracture surfaces on the first (#1) and last (#7) airfoils in the packet before cleaning, both of which exhibited interdendritic fracture features consistent with overload. The fracture surfaces on the other airfoils, shown after ultrasonic cleaning in Figure 12 through Figure 14, also exhibited interdendritic features consistent with overload.

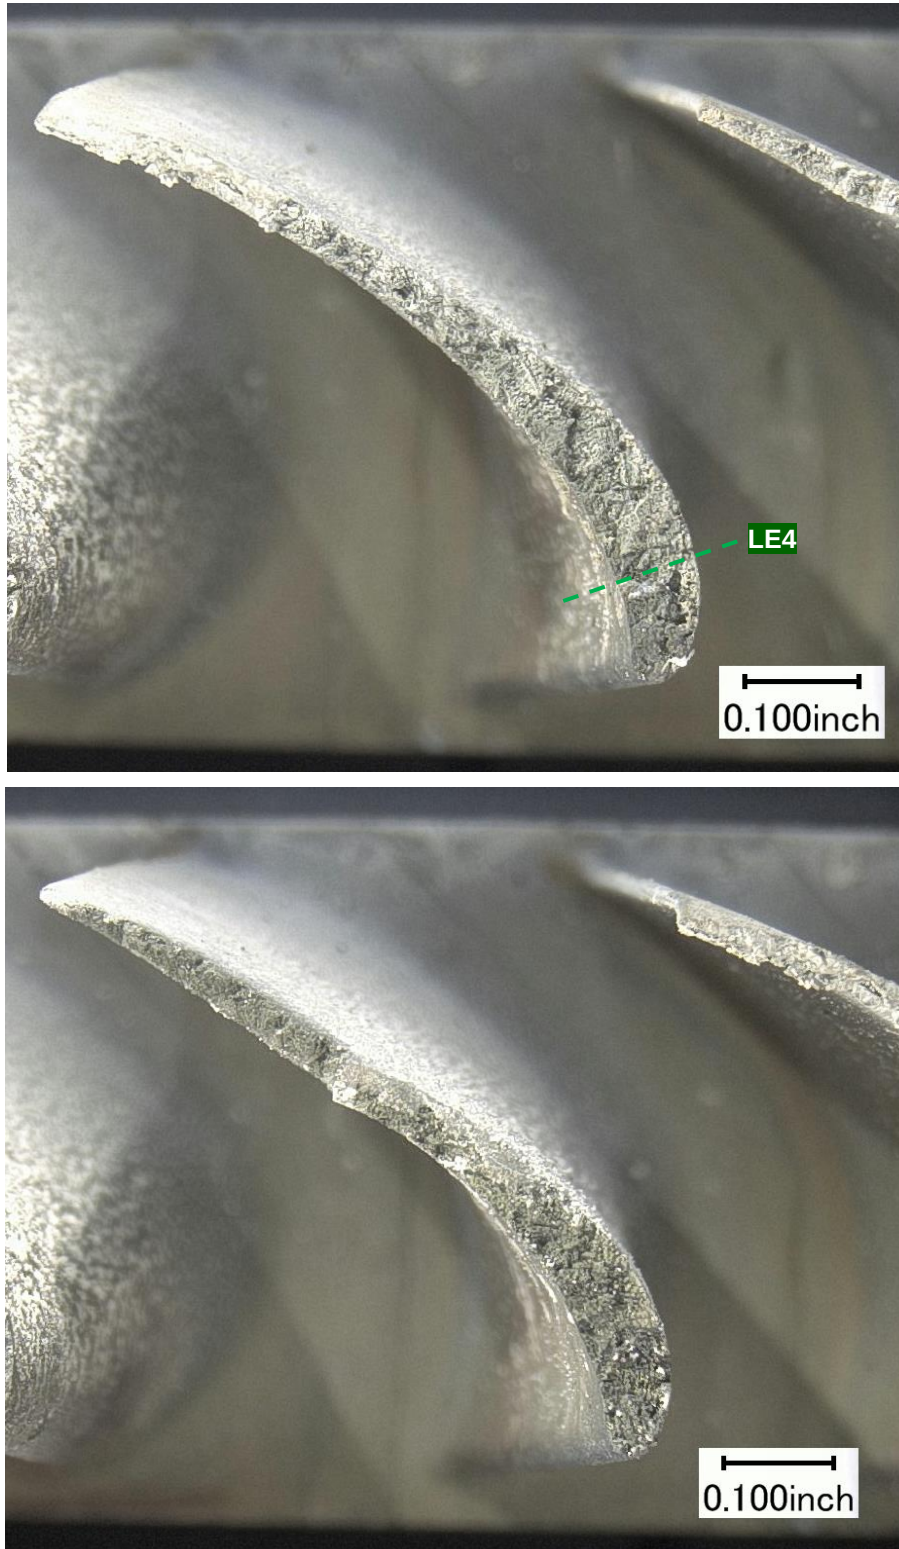
**Figure 13.** Fracture surfaces on blades #4 (top) and #5 (bottom) prior to cleaning. The green dashed line shows the approximate location of the radial-longitudinal section near the leading edge of blade #4 (LE4).

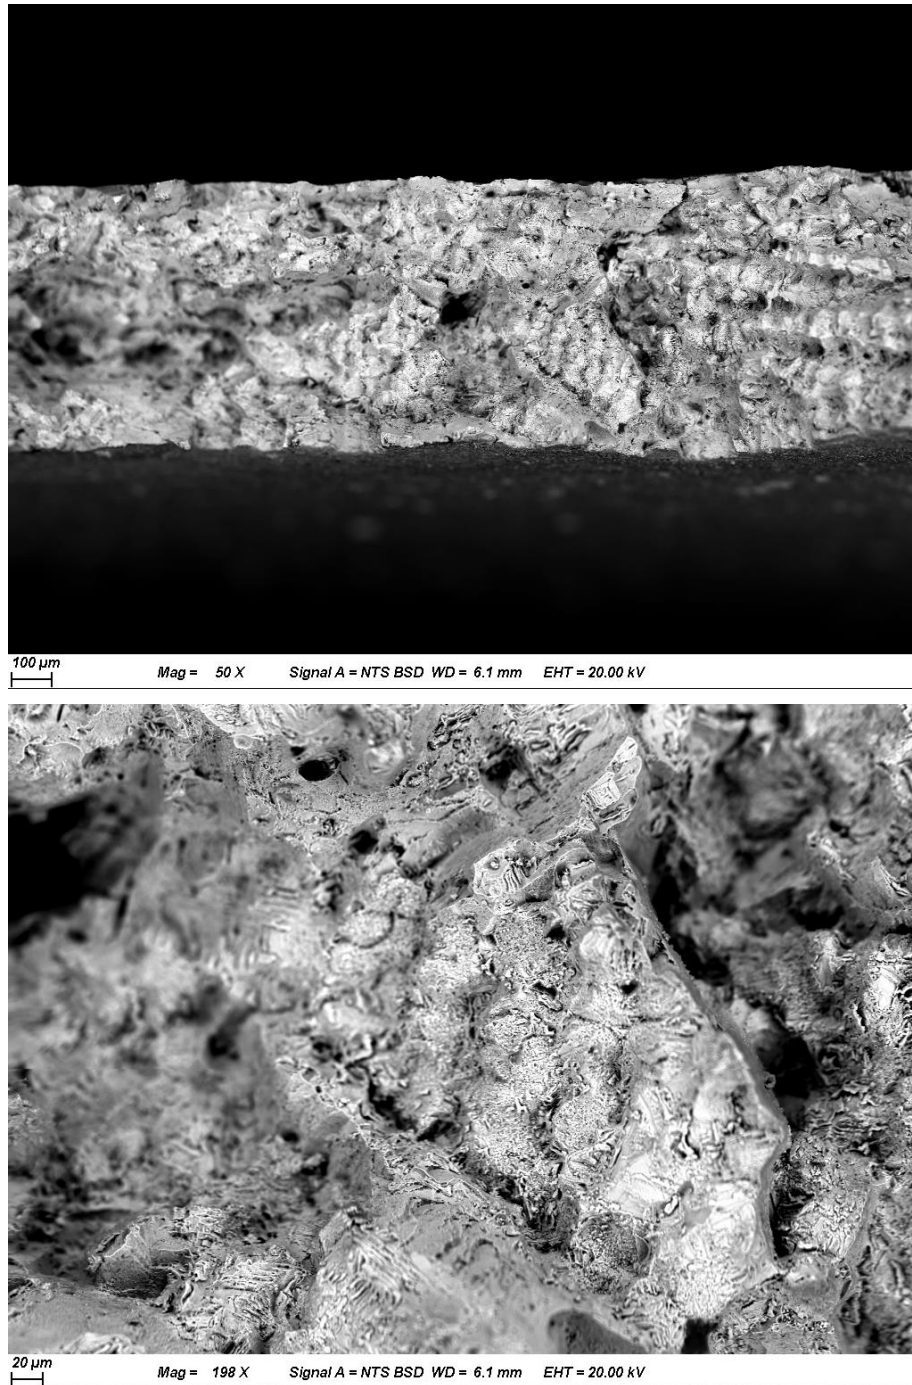
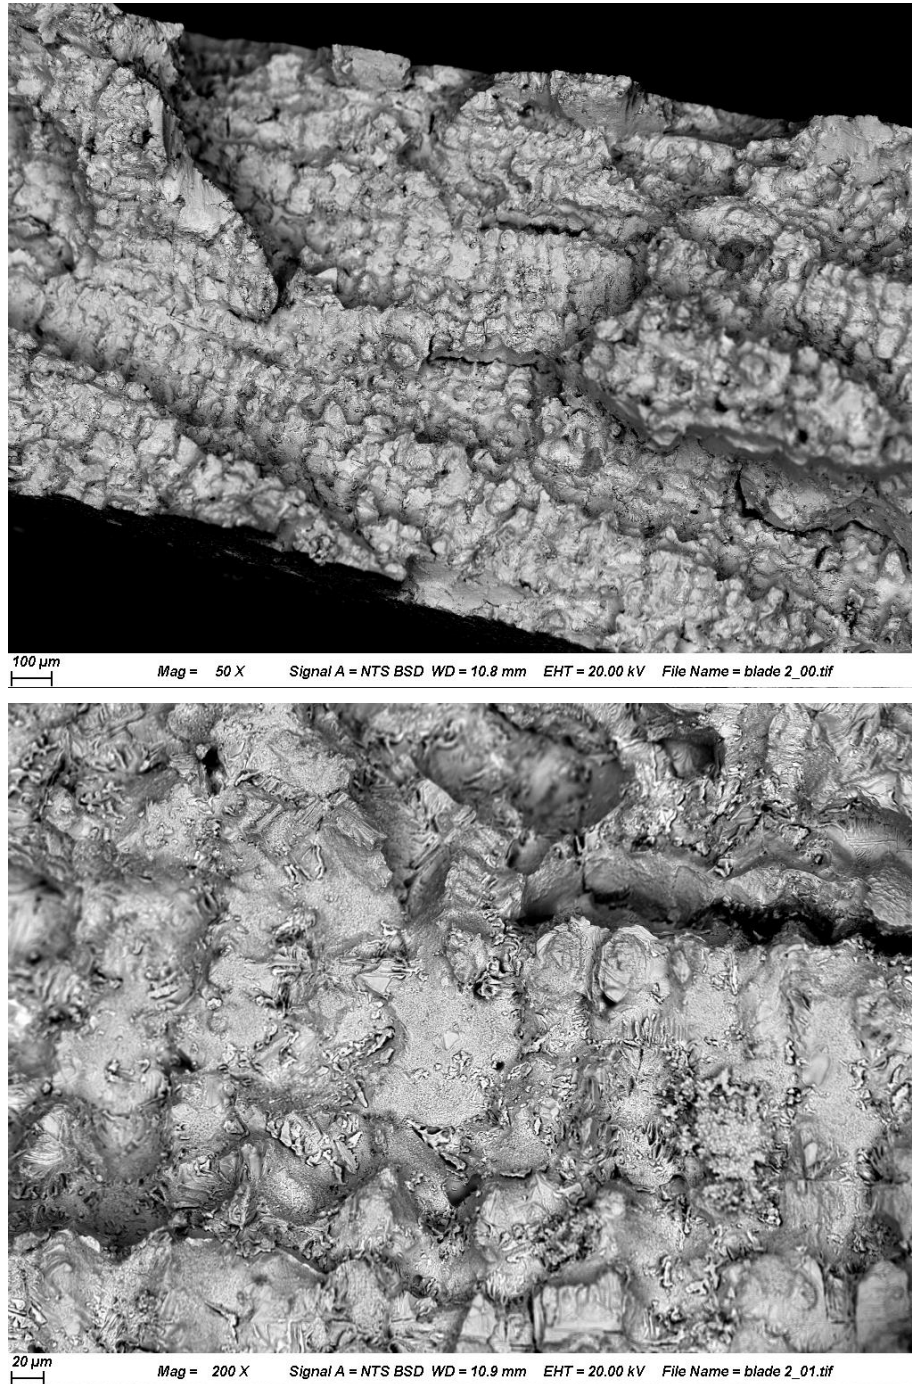
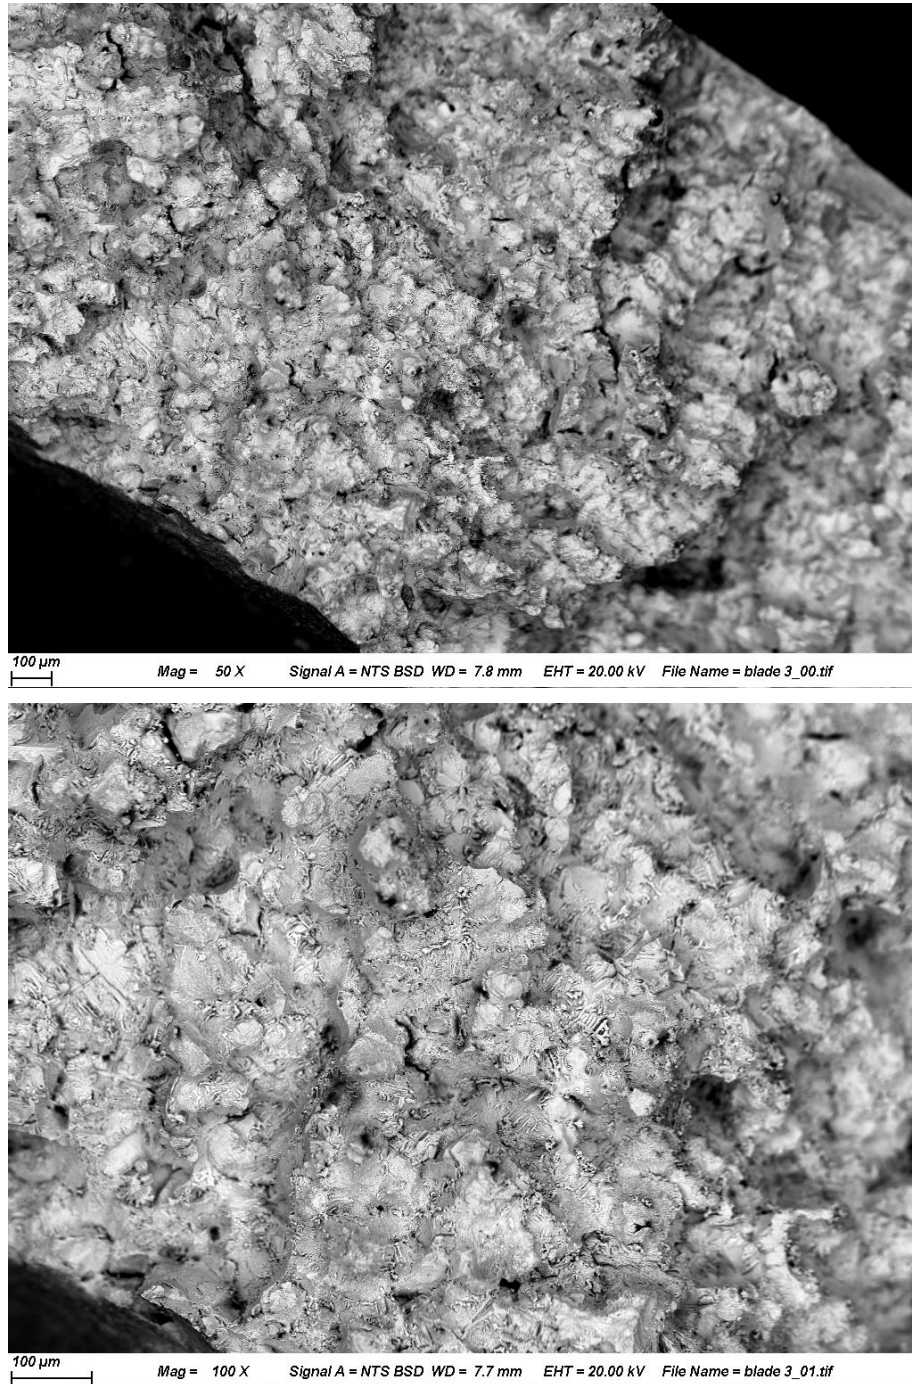
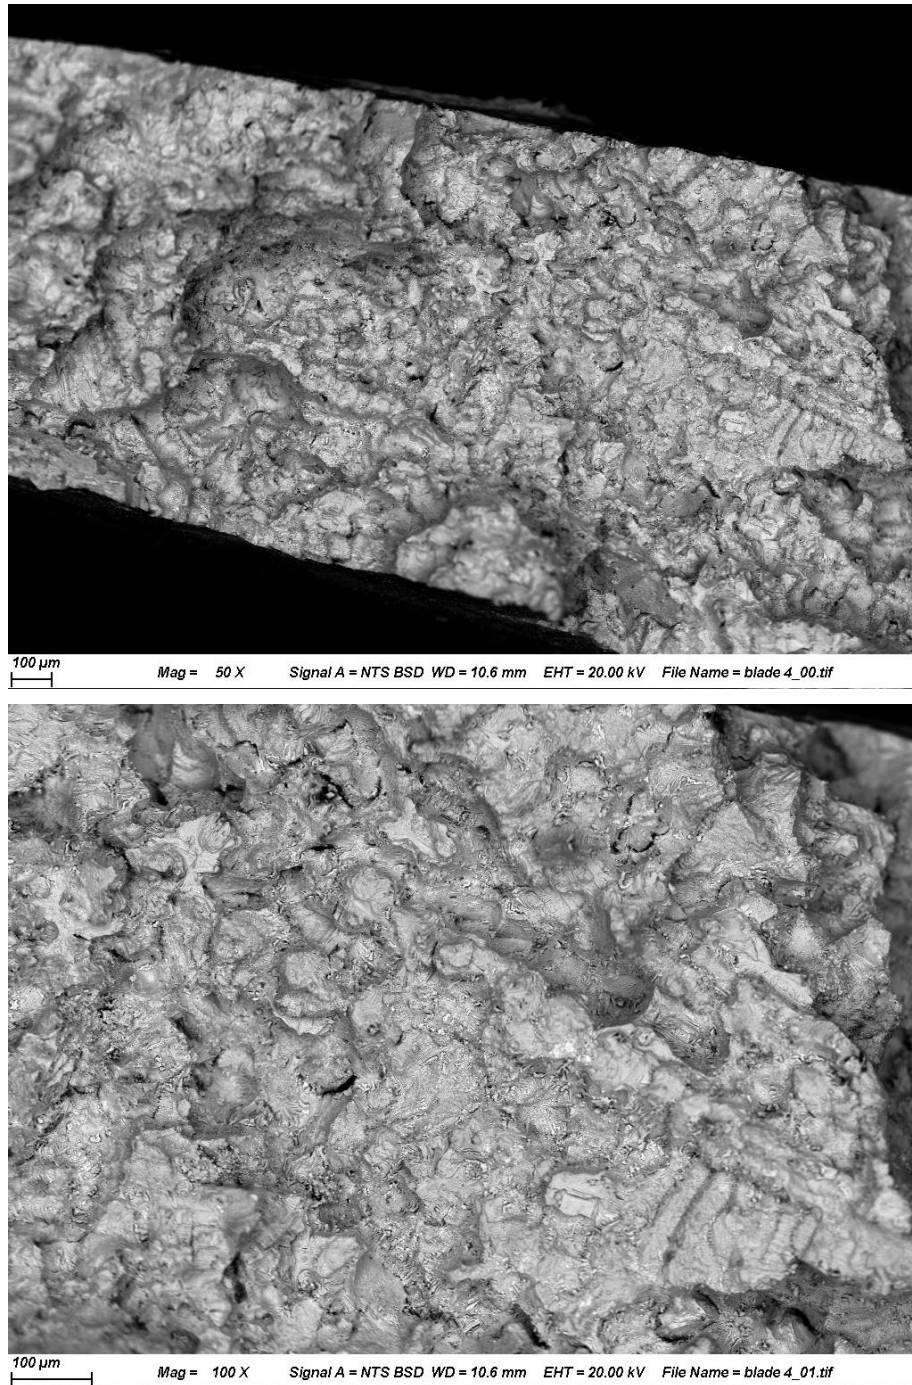
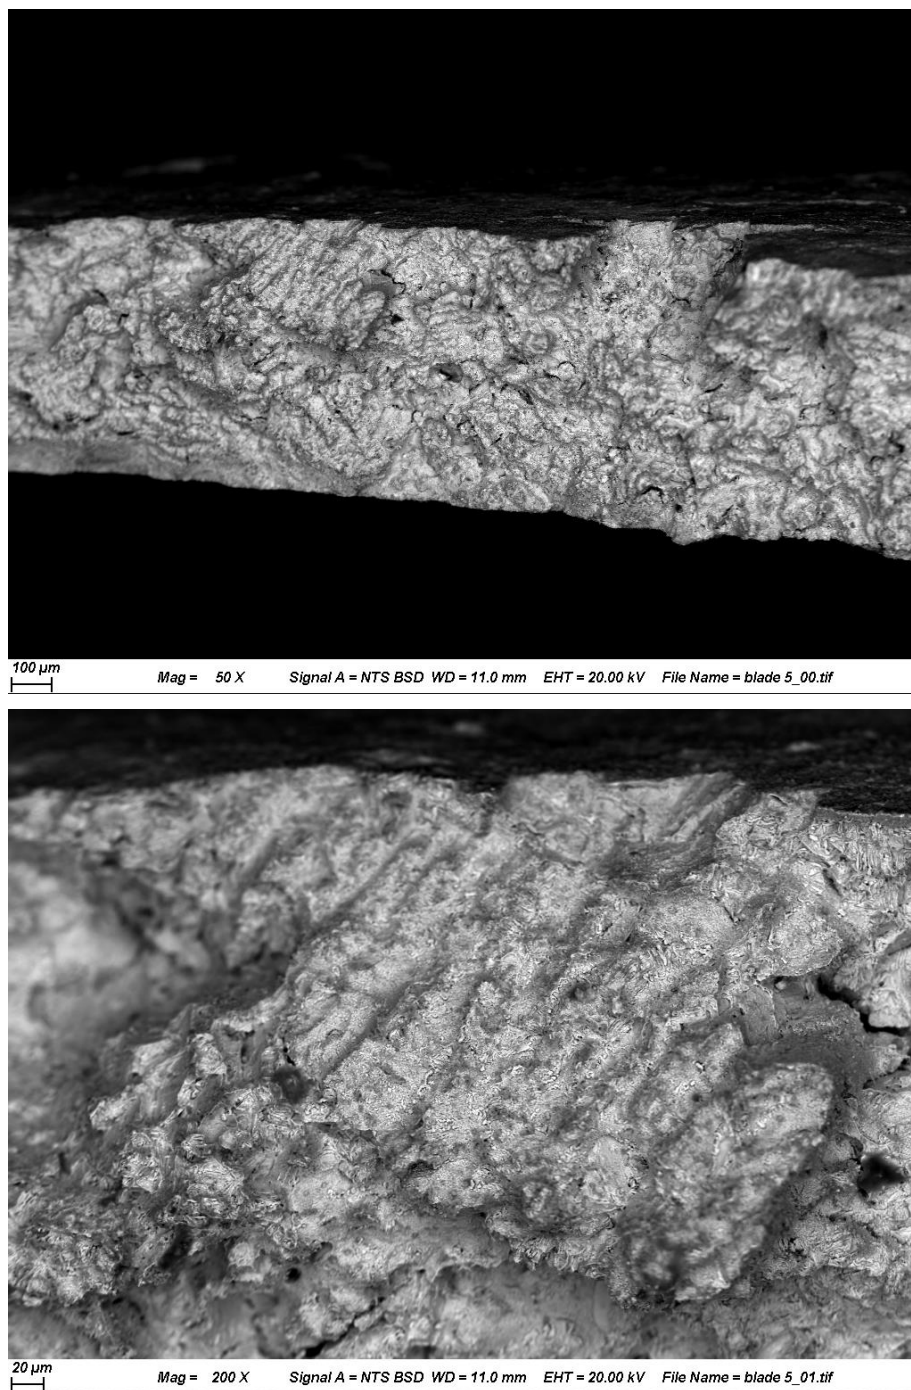
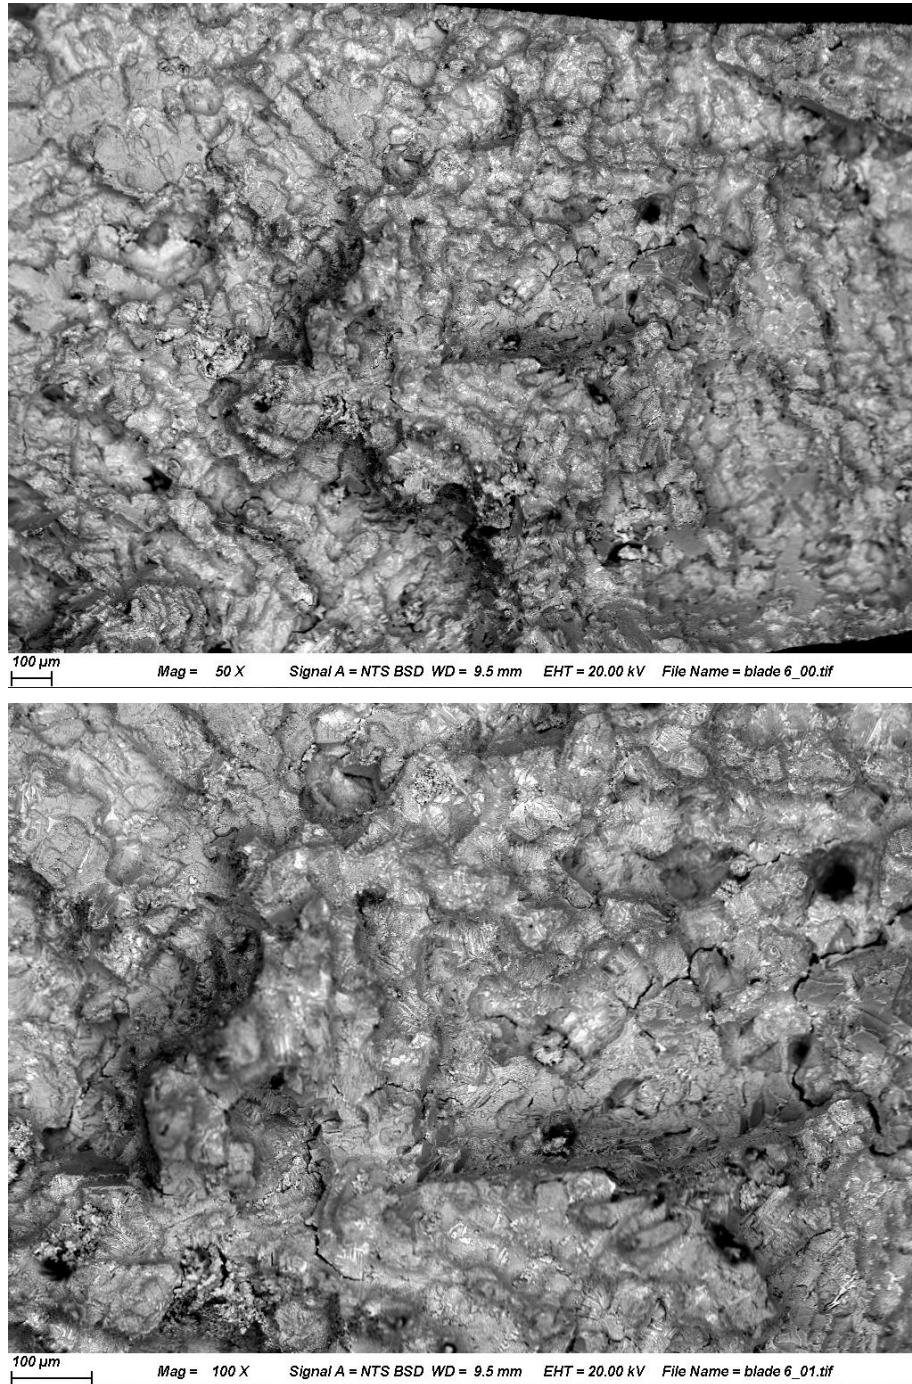
Representative fracture features from each blade are shown in Figure 15 through Figure 21. All the fracture surfaces exhibited interdendritic features consistent with overload, and some also exhibited intermittent smearing damage. There was no evidence of progressive fracture on any of the fracture surfaces.

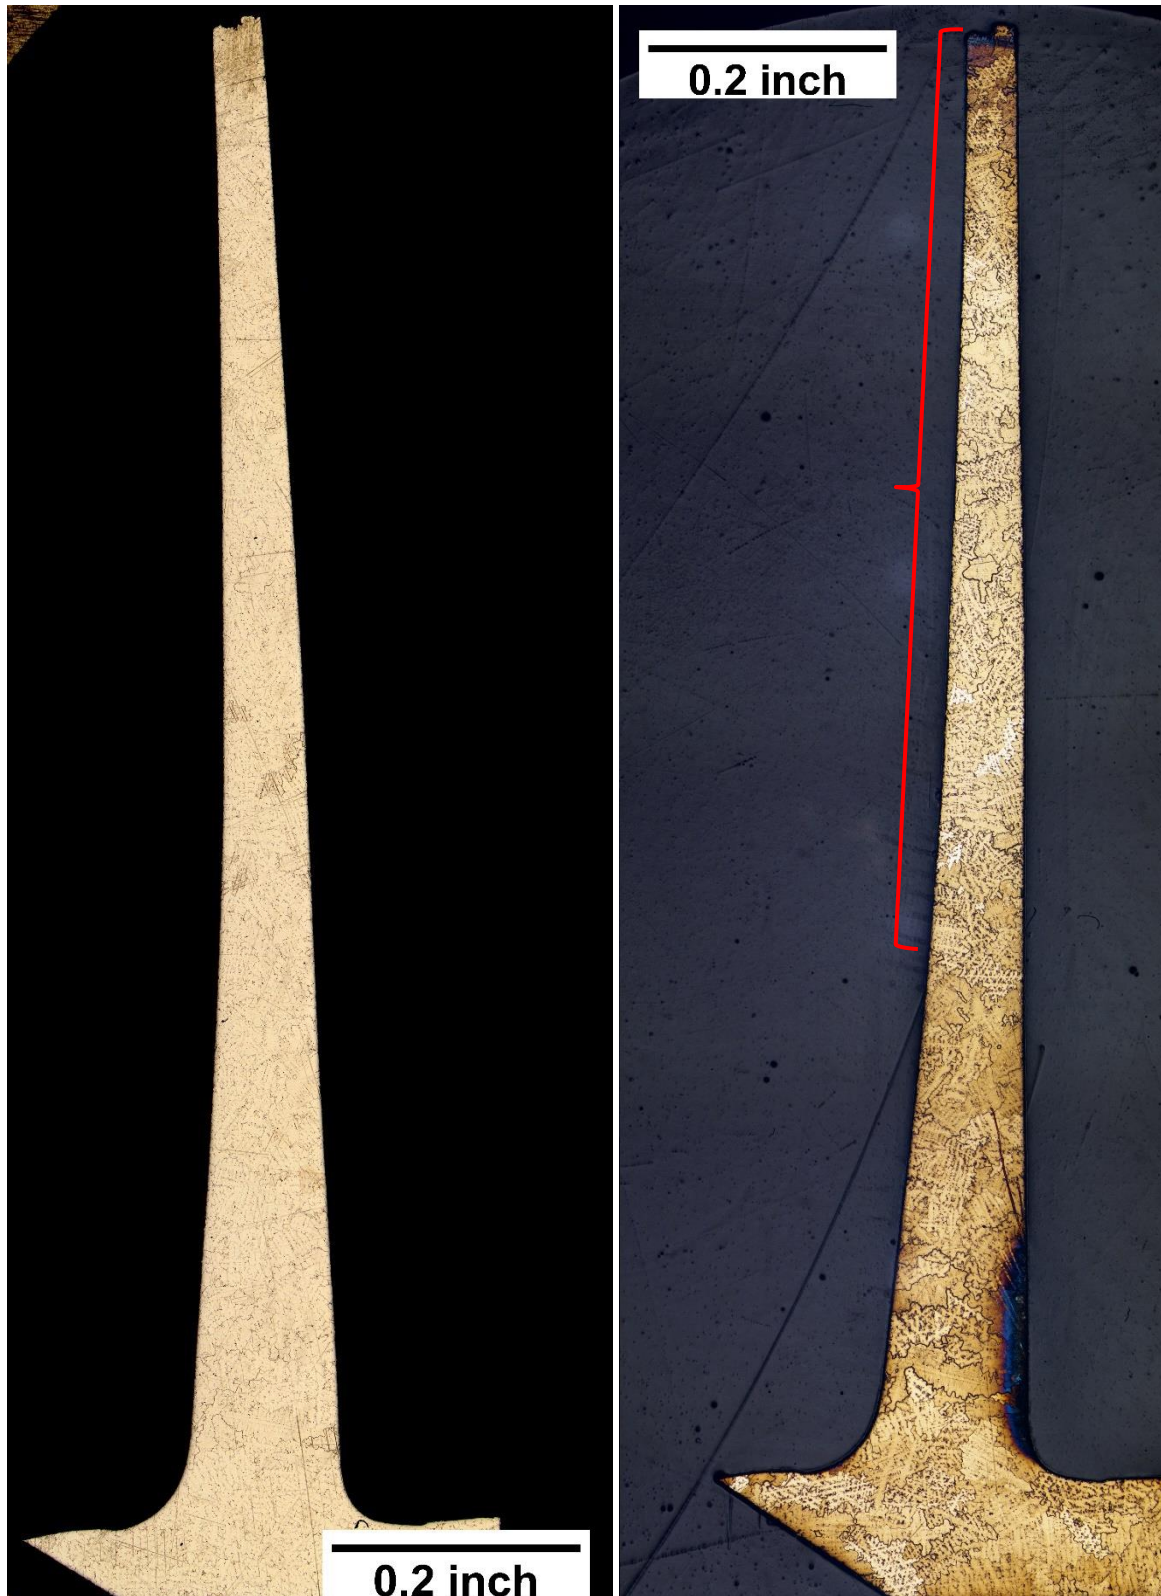
Figure 22 shows overall views of cross-section LE1 near the leading edge of blade #1. The outboard portion of the blade etched lighter than the inboard span. There was no evidence of stress rupture void formation on the cross-section as shown in Figure 23. Detailed views of the microstructure in the rim of the wheel, the root of the blade, the lighter etching area, and near the fracture surface are shown in Figure 24 through Figure 27. In the lighter etching area, the gamma prime structure appeared finer than in the rest of the blade consistent with re-solutioned and re-precipitated gamma prime from elevated temperature exposure. SEM examination of other third stage turbine blade cross-sections with similar lighter etching areas where the gamma prime appeared finer, including the trailing edge section of the same airfoil, revealed refined gamma prime, discussed later. SEM examination was not conducted on cross-section LE1.

**Figure 22.** Overall views of longitudinal cross-section LE1 near the leading edge of fractured blade #1. There was no evidence of stress rupture void formation on the cross-section. The red brace indicates the lighter-etching microstructure consistent with thermal distress. Left: Unetched; Right etchant: MT.

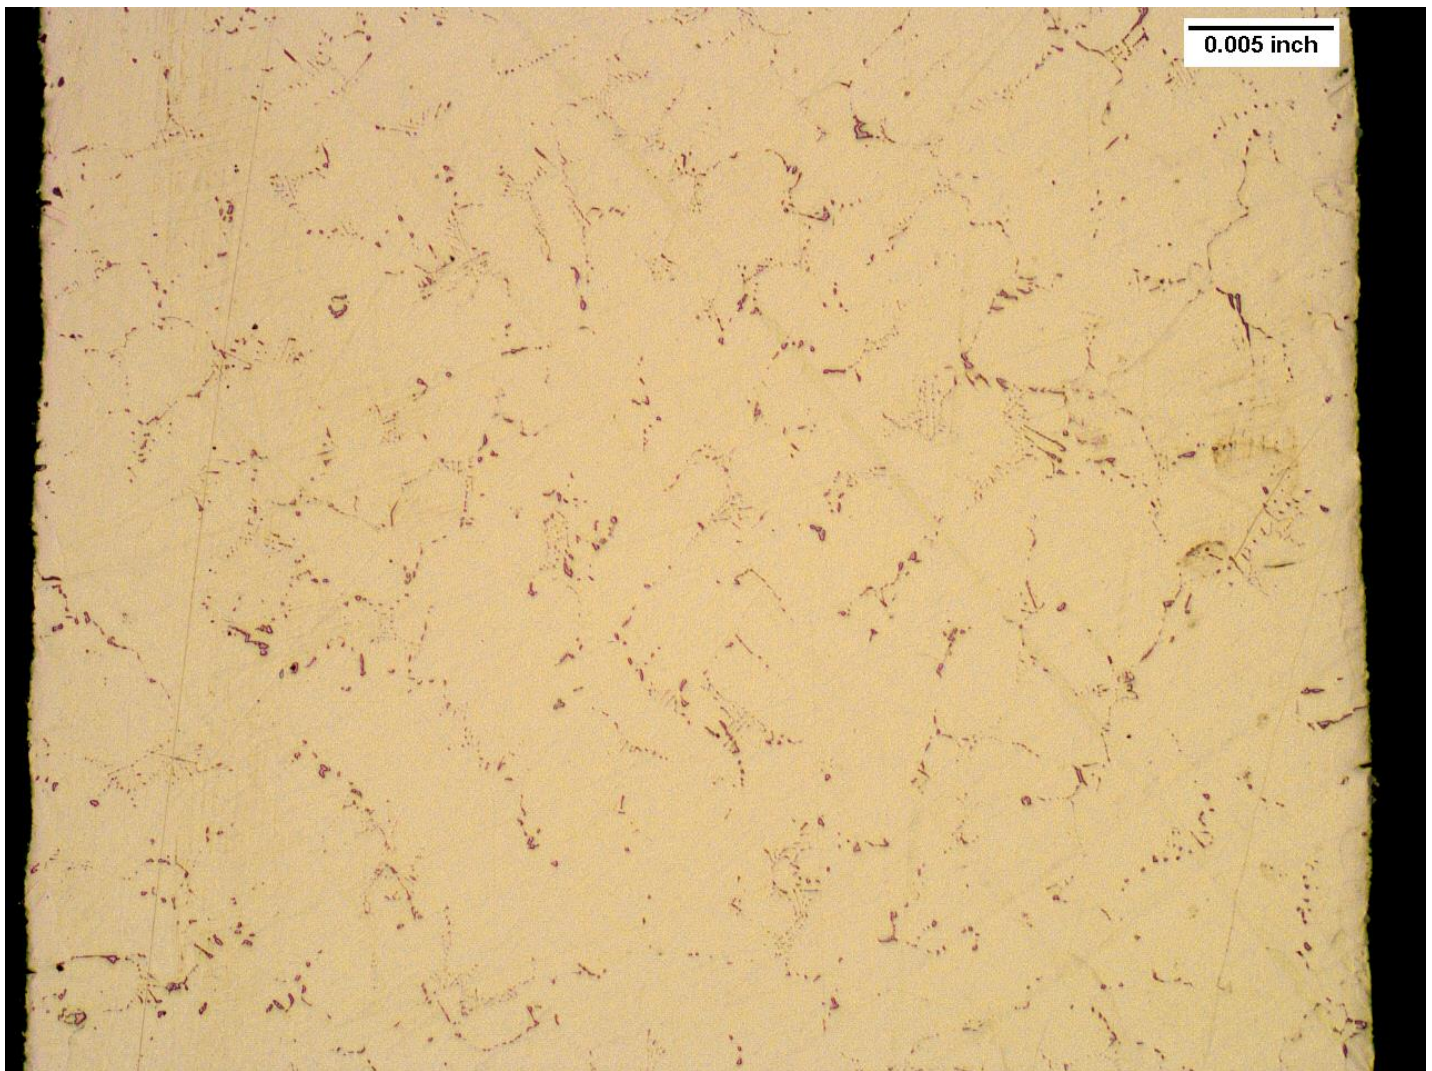
**Figure 23. Representative unetched view of cross-section LE1 near the middle of the intact span of the airfoil showing no evidence of stress-rupture void formation.**

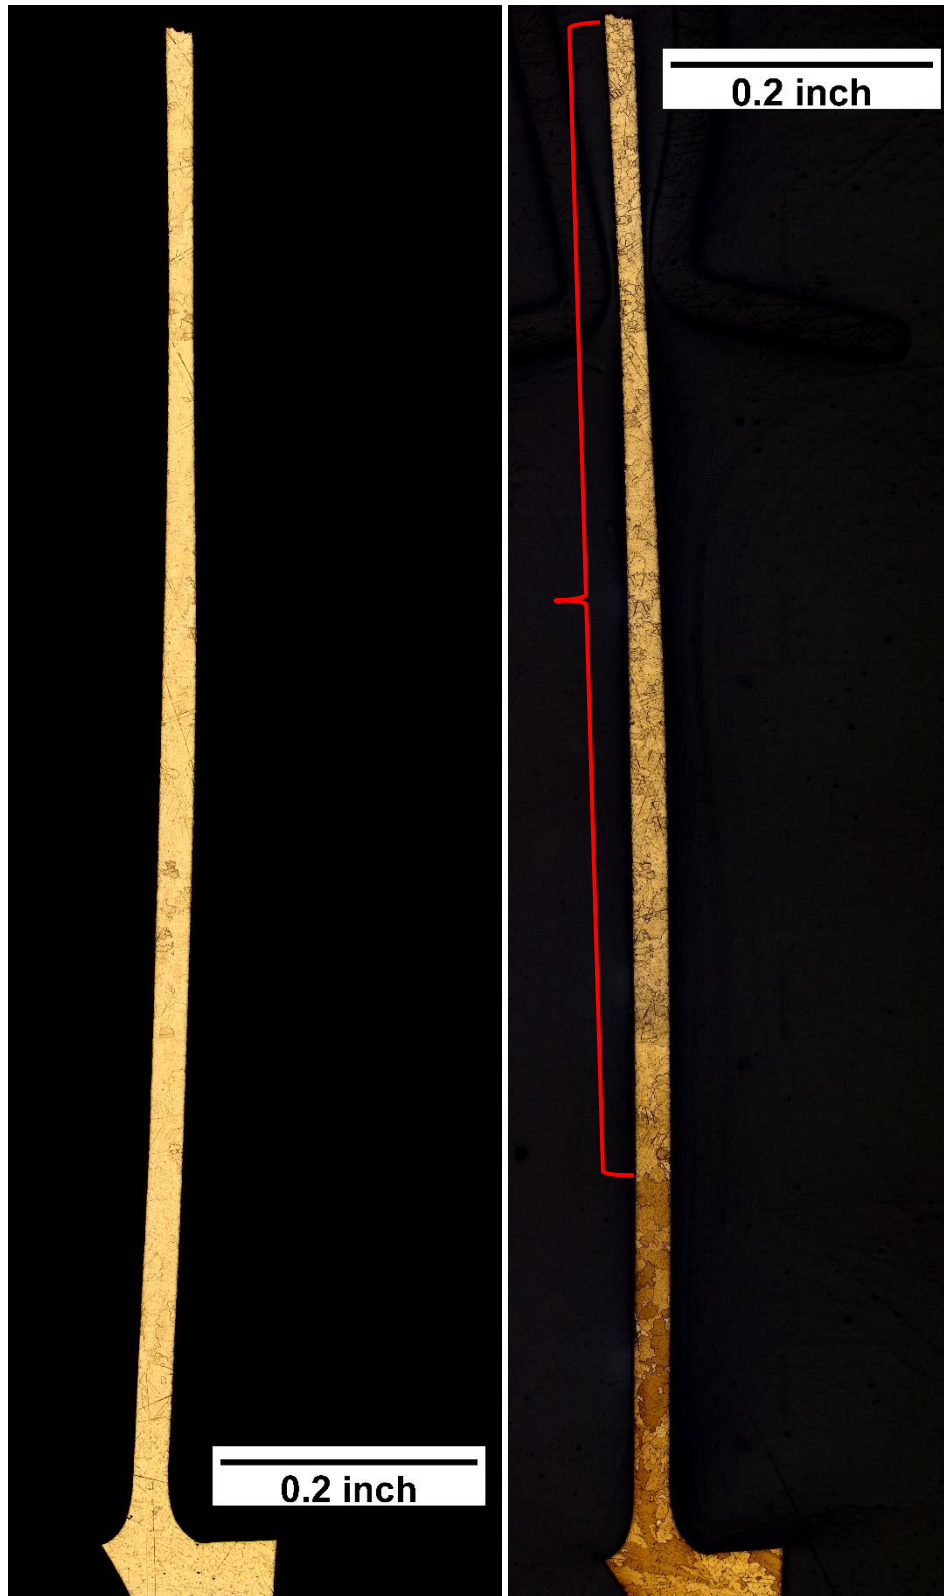
Figure 28 shows overall views of cross-section TE1 near the trailing edge of blade #1. The outboard portion of the blade etched lighter than the inboard span. There was no evidence of stress rupture void formation on the cross-section as shown in Figure 29. The cross-section was examined in the etched condition with an optical metallograph and in the SEM under backscattered electron imaging, and representative images showing the microstructure and gamma prime structure in the rim of the wheel, in the root of the blade inboard of the thermal

**Figure 28.** Overall views of longitudinal cross-section TE1 near the trailing edge of fractured blade #1. There was no evidence of stress rupture void formation on the cross-section. The red brace indicates the lighter-etching microstructure consistent with thermal distress. Left: Unetched; Right etchant: MT.

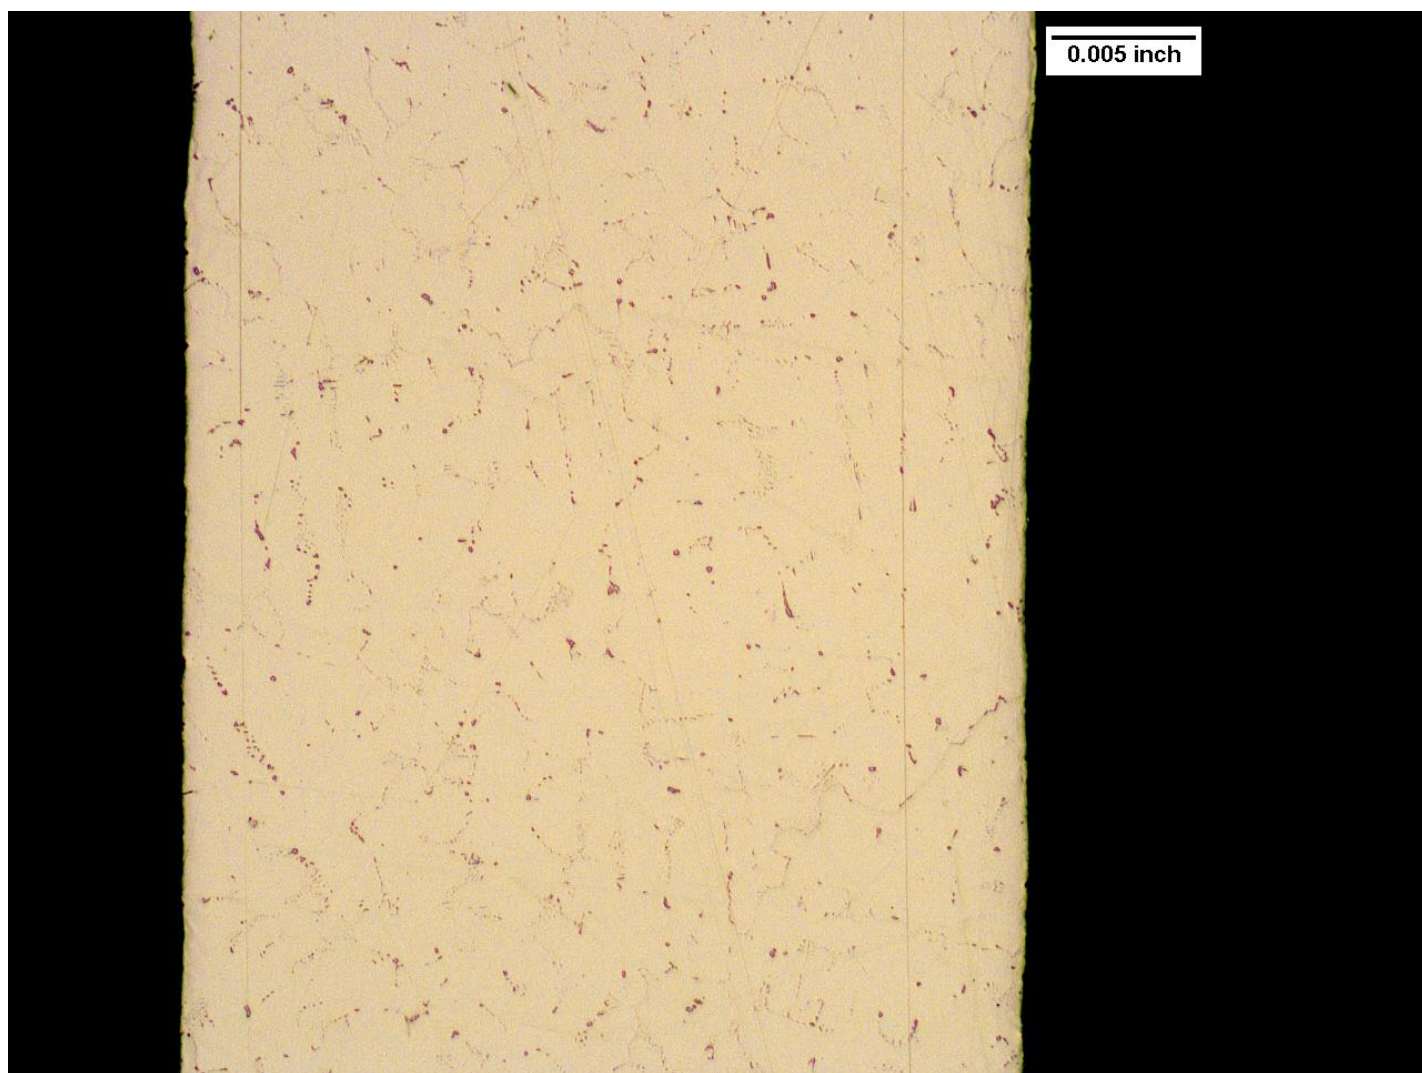
**Figure 29. Representative unetched view of cross-section TE1 showing no evidence of stress-rupture void formation.**

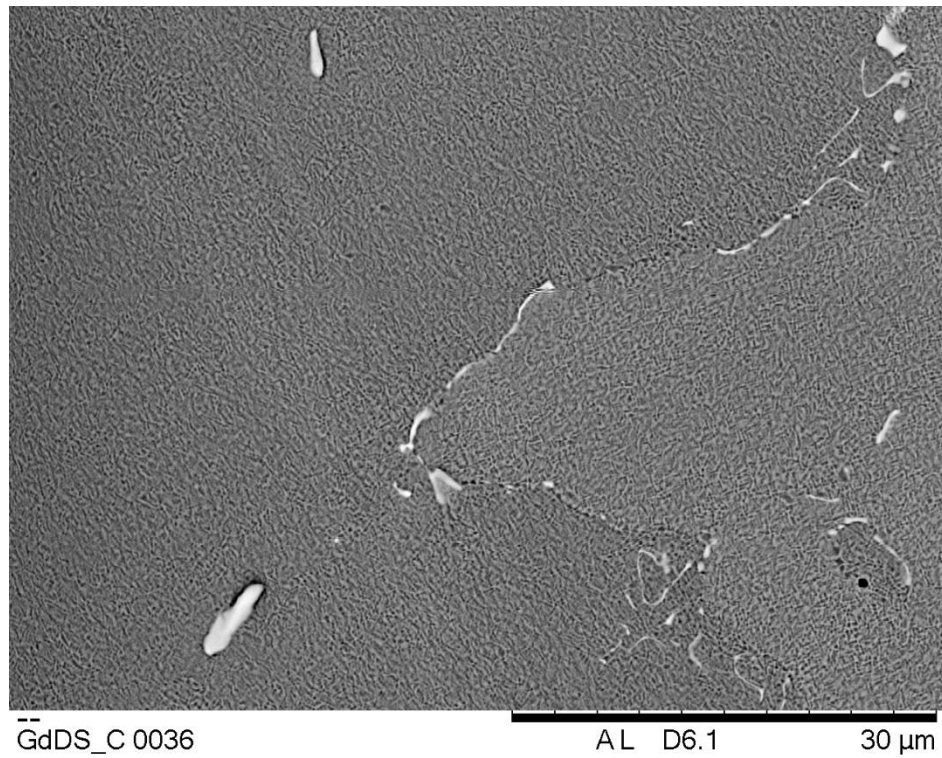
distress, and in the thermally distressed region are shown in Figure 30 through Figure 35. In the lighter etching area, the gamma prime was finer than in the root and platform, consistent with re-precipitated gamma prime formed after exposure above the re-solutioning temperature of approximately 2150°F for an EMS73648-3 (IN-713) type material. A re-crystallization layer was found on the airfoil surfaces in the thermally distressed area that was not present away from the thermal distress.

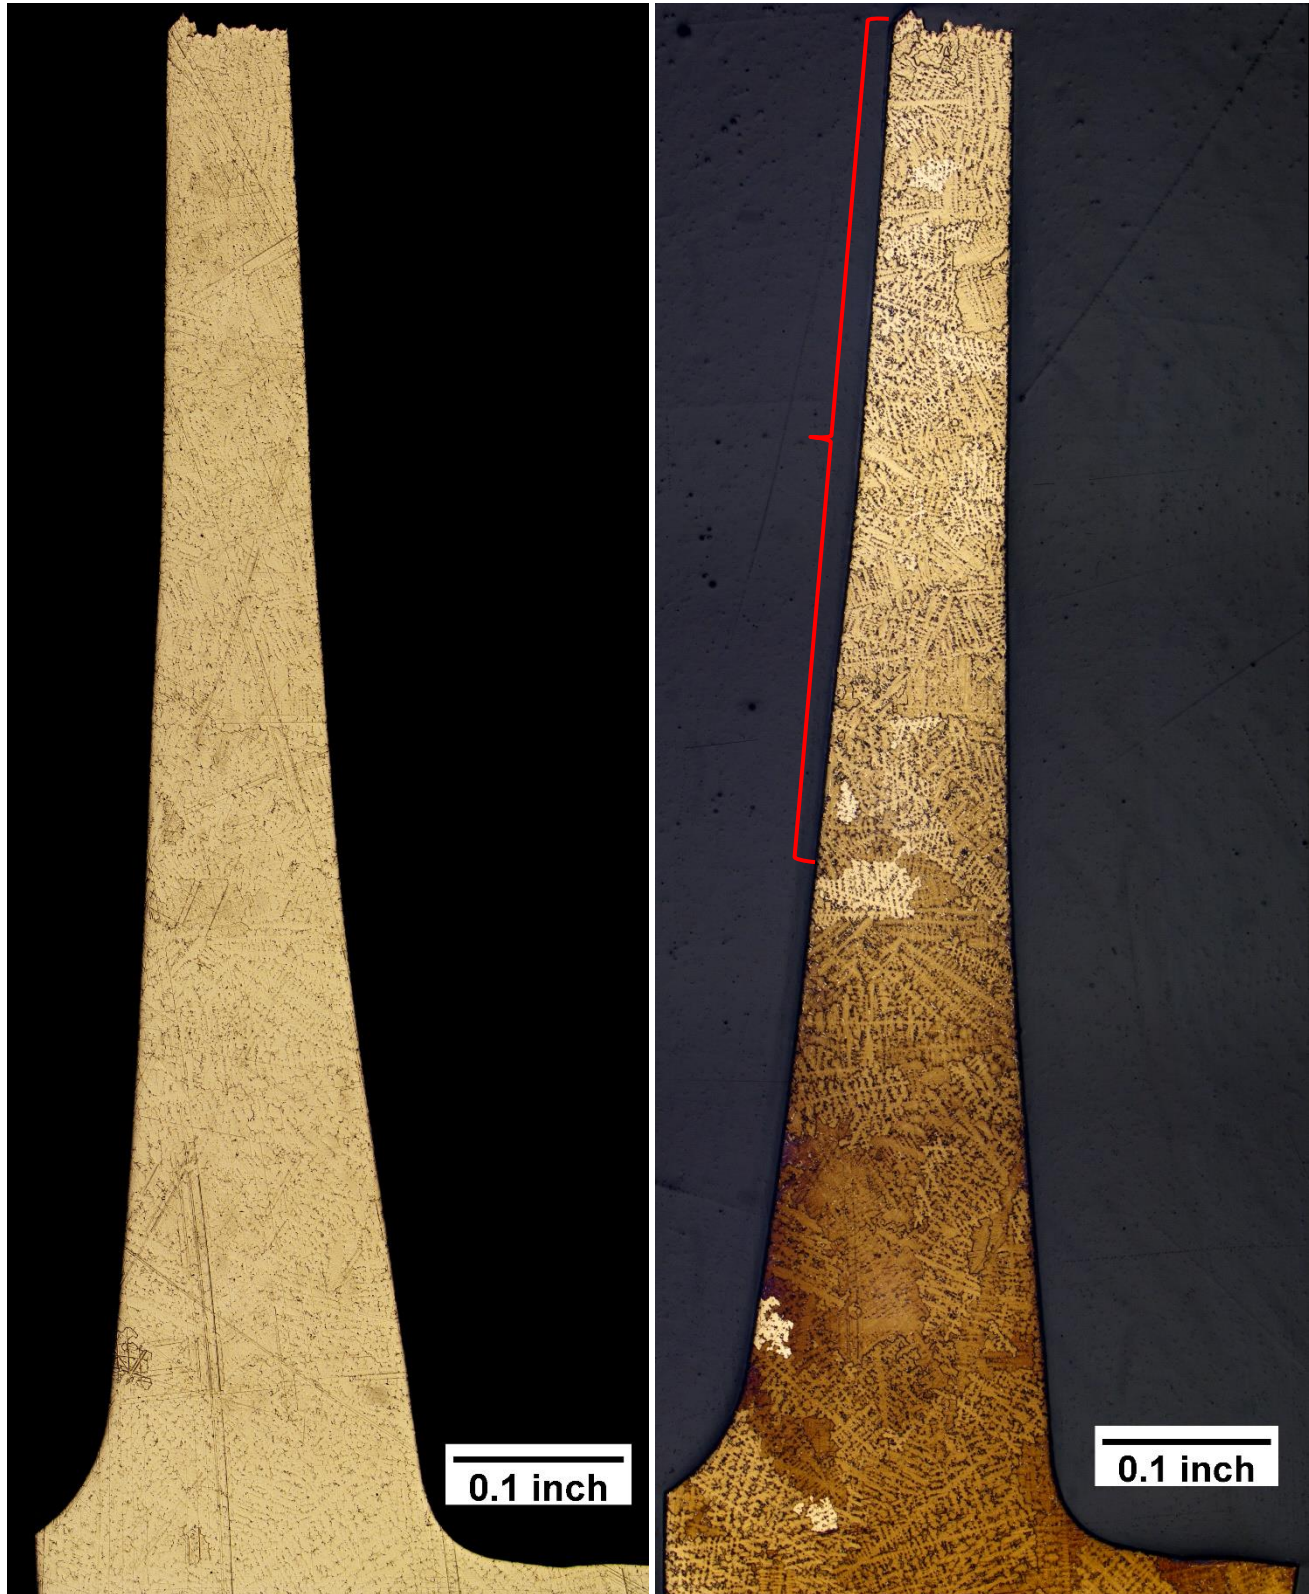
Figure 36 shows overall views of cross-section LE4 near the leading edge of blade #4. The outboard portion of the blade etched lighter than the inboard span. There was no evidence of stress rupture void formation on the cross-section as shown in Figure 37. The cross-section was examined in the etched condition with an optical metallograph, and representative images showing the microstructure in the rim of the wheel, in the root of the blade inboard of the thermal distress, in the thermally distressed region, and at the fracture surface are shown in Figure 38 through Figure 41. In the lighter etching area, which extended to the fracture surface, the gamma prime was finer than in the root and platform consistent with re-precipitated gamma prime.

**Figure 36.** Overall views of longitudinal cross-section LE4 near the leading edge of fractured blade #4. There was no evidence of stress rupture void formation on the cross-section. The red brace indicates the lighter-etching microstructure consistent with thermal distress. Left: Unetched; Right etchant: MT.

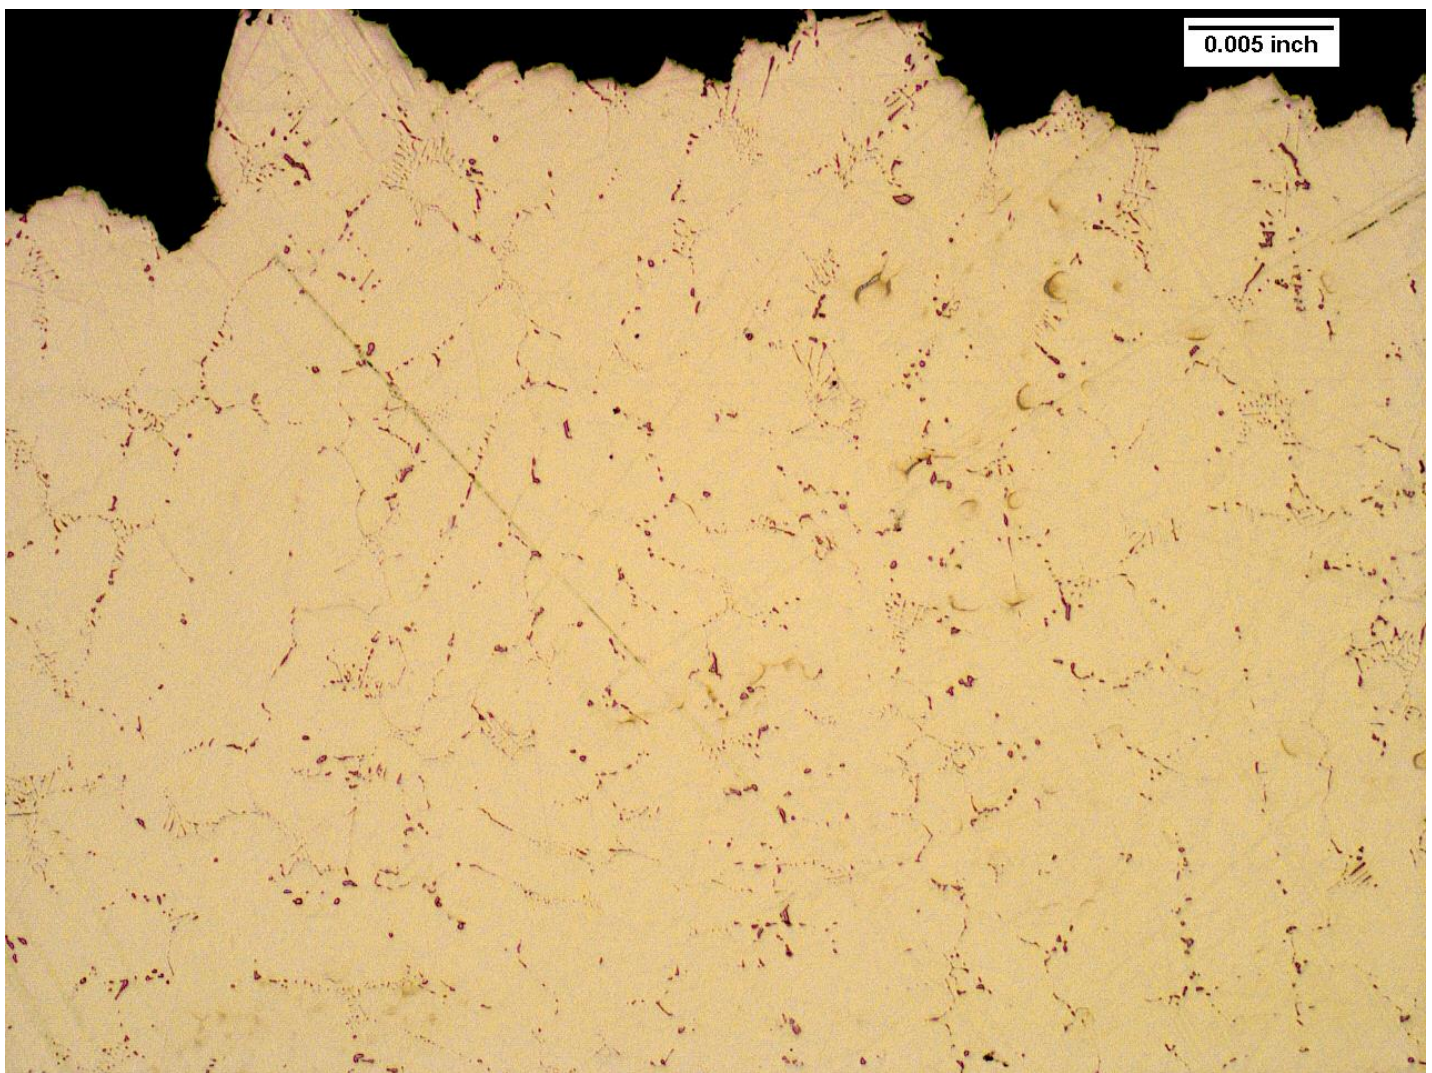
**Figure 37. Representative unetched view of cross-section LE4 near the fracture surface. There was no evidence of stress rupture void formation.**
