| <b>Rolls-Royce</b> | Rolls-Royce Corporation<br>450 S. Meridian Street<br>Indianapolis, Indiana<br>46225-1103, USA | <b>REPORT NO.</b><br>21FAE-055 | <b>REV.</b><br>Initial | <b>PAGES</b><br>1 of 108 |
| <b>TITLE</b><br><b>METALLURGICAL INVESTIGATION OF A THIRD STAGE TURBINE WHEEL, P/N 23065818, REMOVED FROM AN M250, ENGINE S/N CAE835942, OPERATED BY SIGNATURE UTILITY SERVICES</b> | | <b>PREPARED</b><br>Digitally signed by Alexander Sheridan_9782(Bldentity)<br>Date: 2022.05.03 10:26:22 -04'00' | | |

| Part Name: | Third Stage Turbine Wheel |
| Engine Model: | M250-C20B |

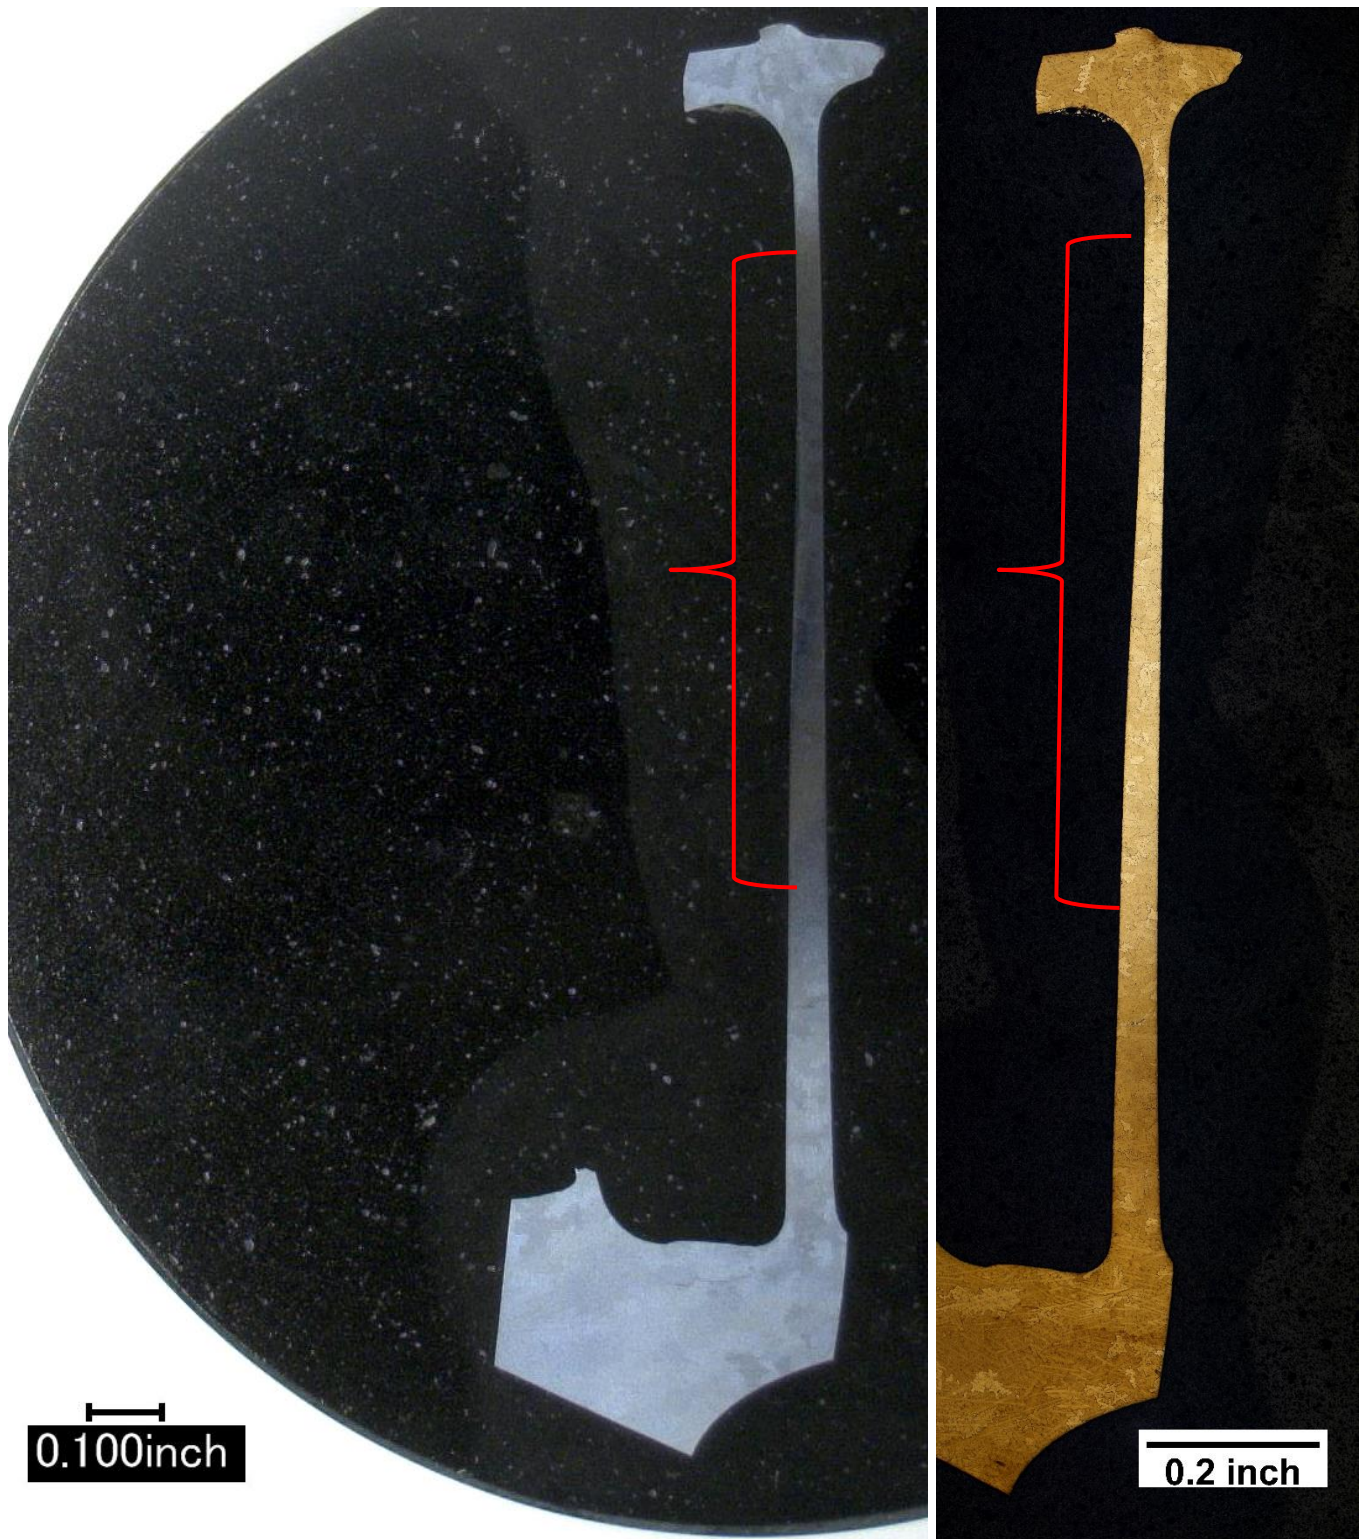
Figure 42 and Figure 43 show overall views of cross-section TE8 near the trailing edge of blade #8, which was unfractured. The microstructure etched lighter in an area measuring approximately 60% of the total airfoil span centered slightly outboard of midspan, consistent with thermal distress. There was no evidence of stress rupture void formation on the cross-section. The cross-section was examined in the etched condition with an optical metallograph and in the SEM under backscattered electron imaging, and representative images showing the microstructure and gamma prime structure in the rim of the wheel, in the root of the blade inboard of the thermal distress, in the thermally distressed region, and in the shroud are shown in Figure 45 through Figure 51. In the thermally distressed region, the gamma prime was finer than in the root and platform, consistent with re-precipitated gamma prime formed after exposure above the re-solutioning temperature of approximately 2150°F for an EMS73648-3 (IN-713) type material. There was also a re-crystallization layer present on the airfoil surfaces in the thermally distressed area that measured up to 0.002 inch deep that was not present away from the thermal distress.

**Figure 43.** Optical (left) and metallographic (right) images showing cross-section TE8 in the etched condition. The red brace indicates the span exhibiting thermal distress to the microstructure. Etchant: MT.

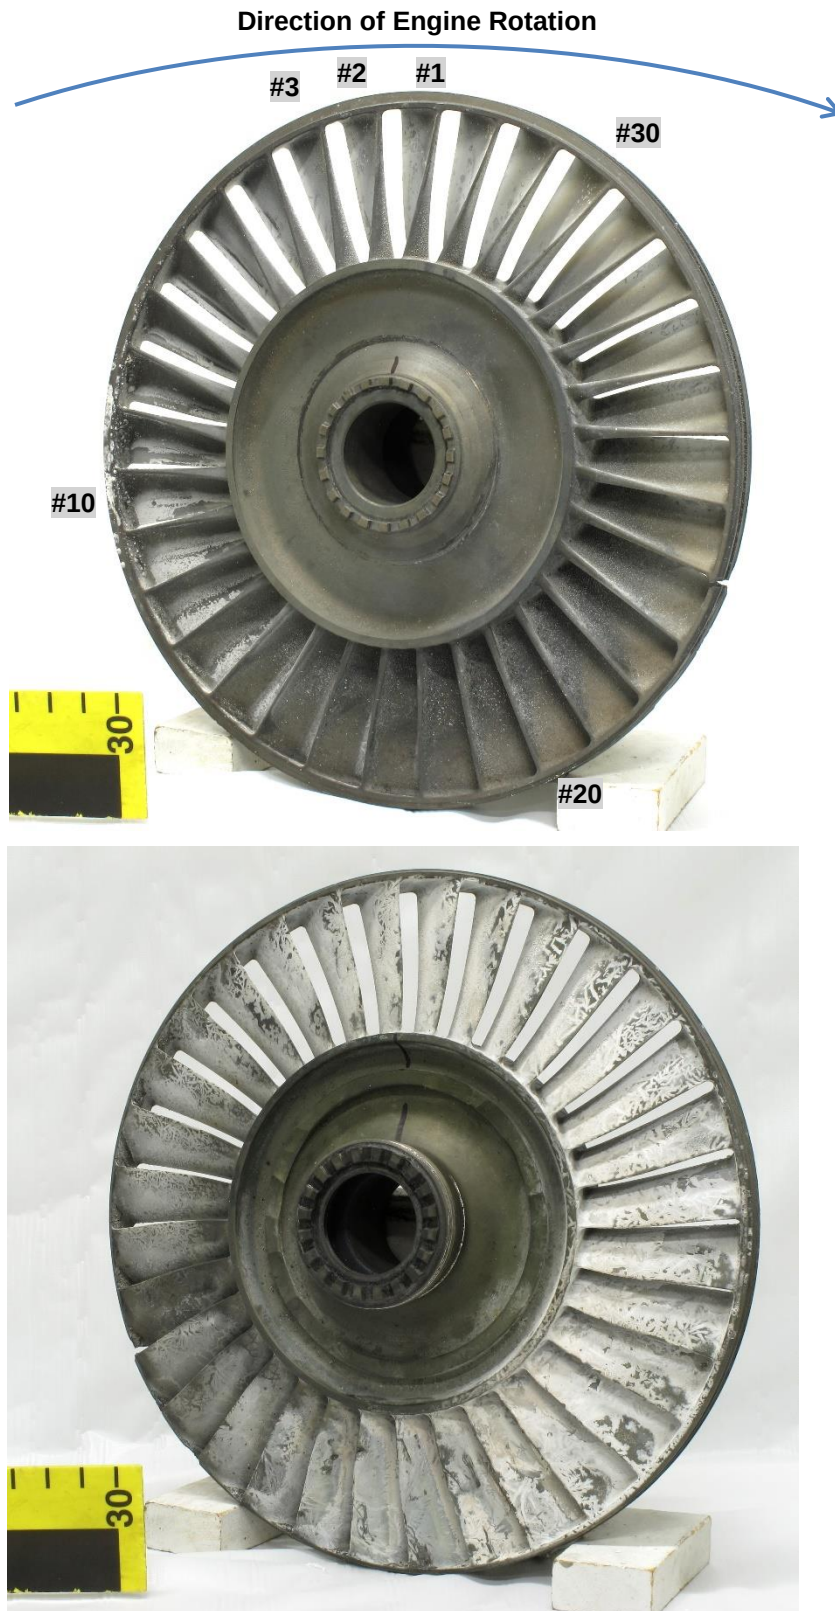
Figure 52 shows the condition of the fourth stage turbine wheel after it was cut during disassembly of the PT rotor. The wheel was covered in airframe fire retardant on the gas path surfaces. Detailed examination of the wheel revealed asymmetric rub damage to the shroud knife seals as shown in Figure 53. The circumferential location of the most severe rub damage to the shroud matched the location of the most severe rub damage found on the third stage turbine wheel. Cracking was found on the shroud near the location of the heaviest rub shown in Figure 54, including one location where the shroud was fractured through. Figure 55 shows detailed views showing the representative condition of the airfoil leading edges and pressure side surfaces. The leading edges did not exhibit any impact damage and the pressure side surfaces of the airfoils exhibited intermittent deposited material. The deposited material was consistent with re-deposited material from the rub damage to the shrouds and blade tracks in the power turbine. The leading edge side web of the wheel exhibited a circumferential band of rub damage located near the transition from the sloped surface of the bore to the flat surface of the web, shown in Figure 56. Corresponding rub was found on the interstage seal in the fourth stage turbine nozzle diaphragm as discussed later.

**Figure 52. Leading edge (top) and trailing edge (bottom) side views showing the condition of the fourth stage turbine wheel after the PT rotor was disassembled. The blades were numbered starting with #1 for the blade immediately in line with the rotor match mark (black lines) and increasing opposite the direction of engine rotation. Divisions = cm.**

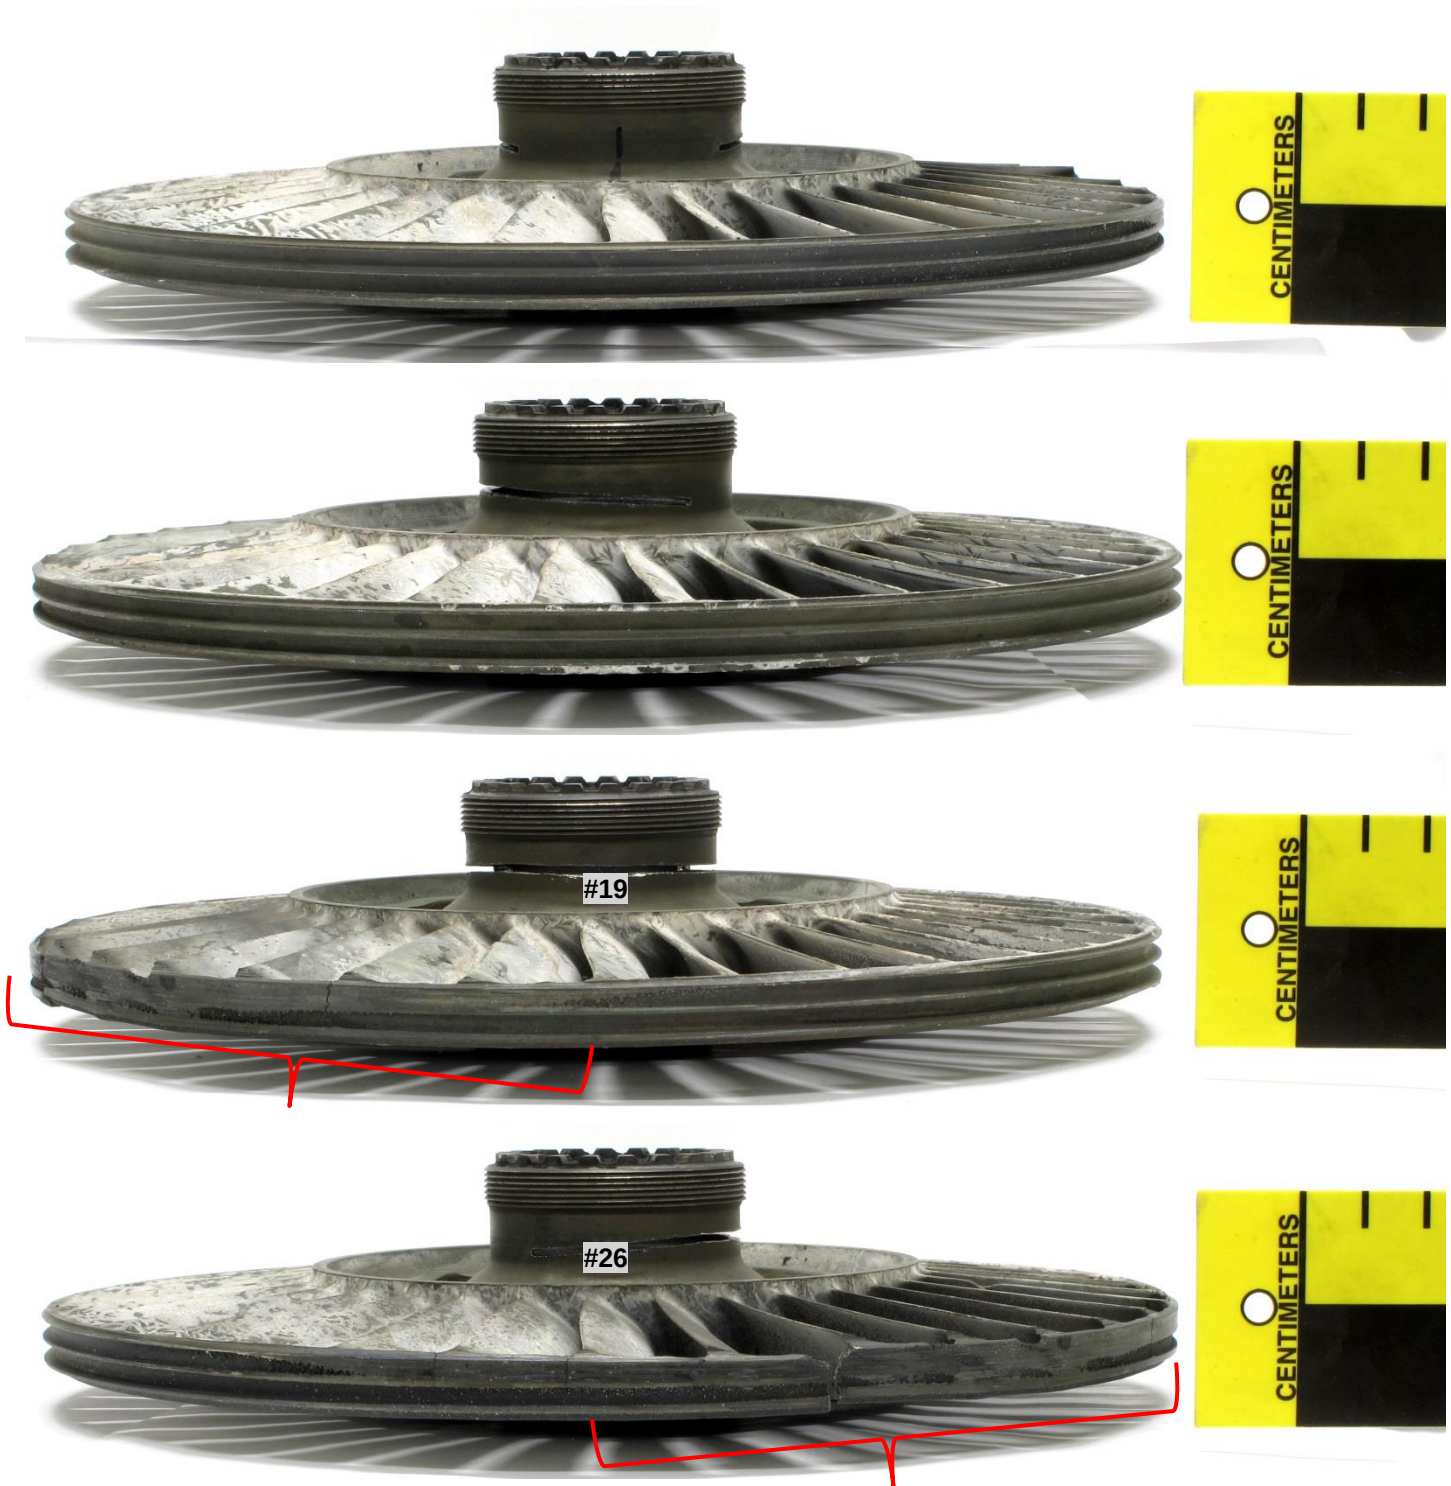
- 2.8 The fourth stage turbine blades exhibited coarsened gamma prime and rafting of the gamma prime at midspan.
- 2.9 The shroud on the fourth stage turbine wheel exhibited asymmetric rub damage and was cracked, with at least one through crack. The most severe rub damage was located approximately 90° in the direction of engine rotation from the center of the packet of missing third stage airfoils.

Figure 53. Radial views showing the fourth stage turbine wheel shroud. The component was rotated 90° in the direction of engine rotation for this succession of images. The most severe rub damage to the shroud (red braces) spanned between blades #19 and #26, centered on a location approximately 90° in the direction of engine rotation from the center of the packet of missing airfoils. Divisions = cm.

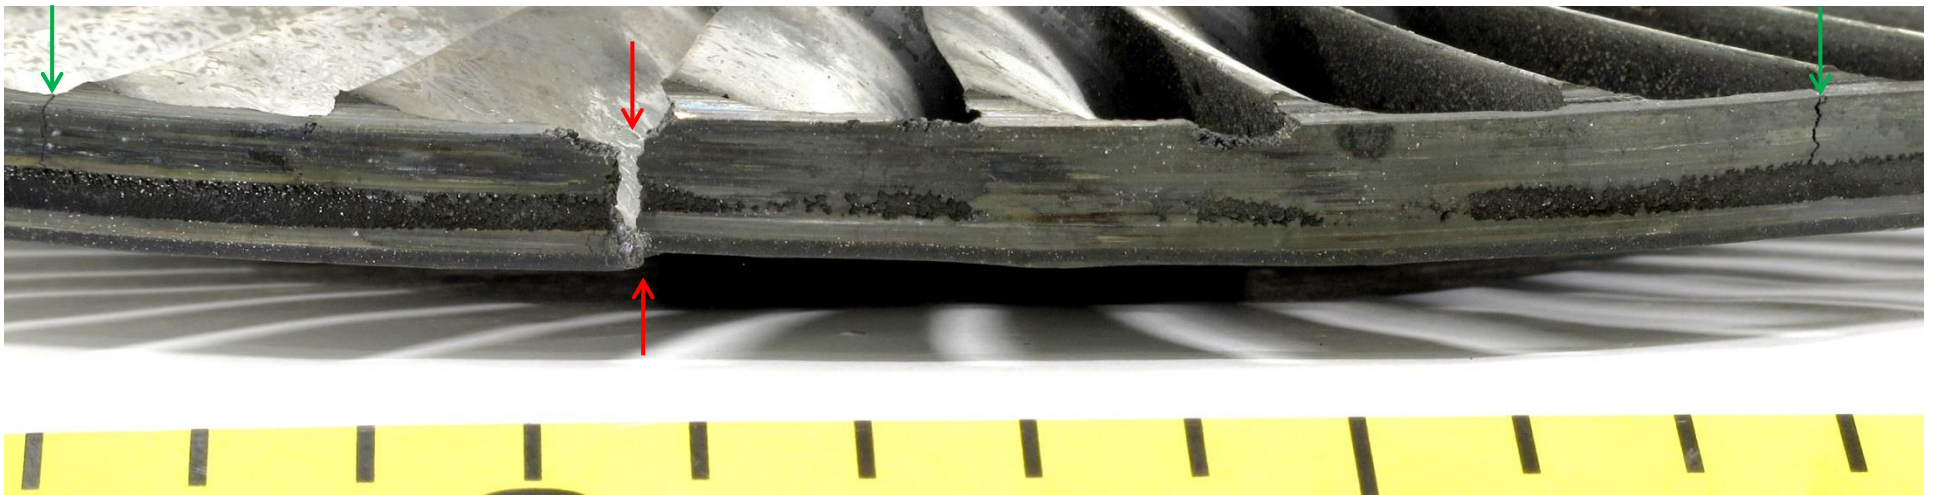
**Figure 54.** Detailed view showing the shroud where it was fractured between airfoils. The red arrows indicate a crack through the shroud and the green arrows indicate cracks that did not extend through the thickness of the shroud from the trailing edge side. Divisions = cm.

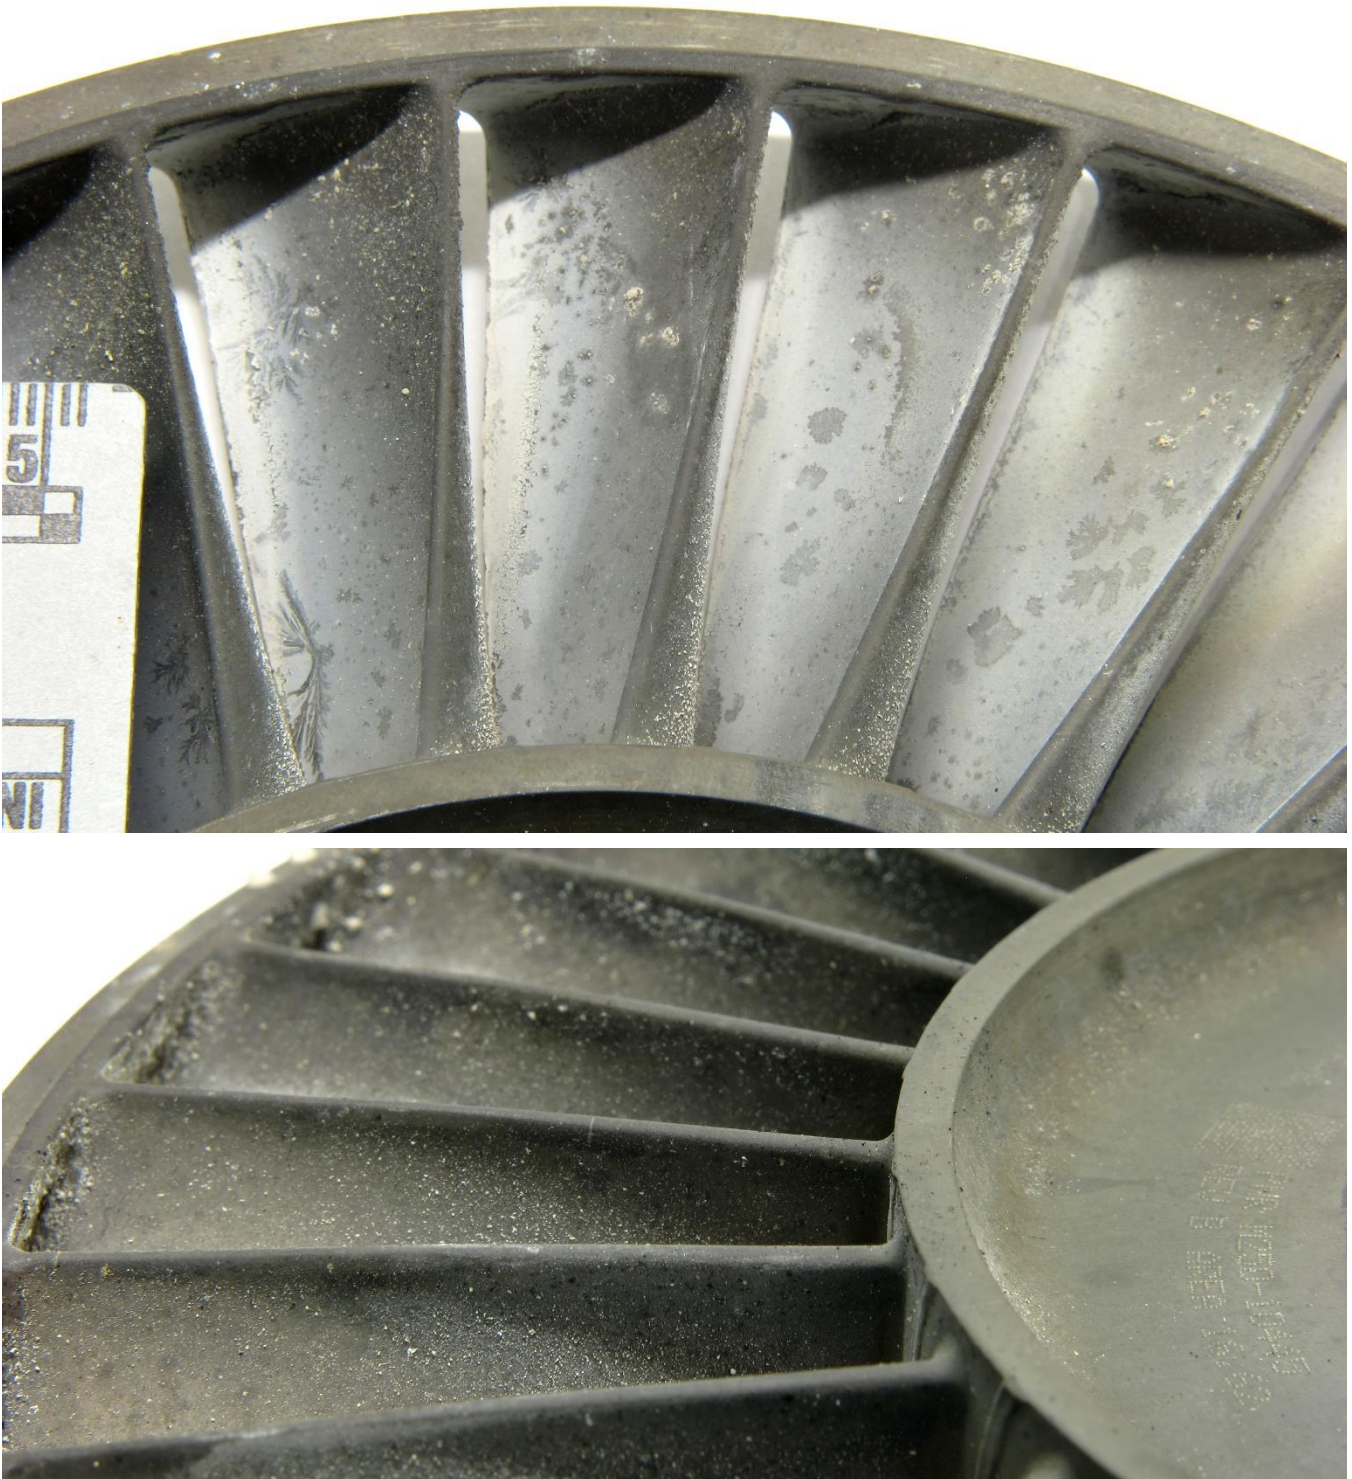
**Figure 55.** Detailed views showing the leading edges and pressure side surfaces of several representative fourth stage turbine airfoils. There was no impact damage to the leading edges and the pressure side surfaces exhibited intermittent deposited material consistent with re-deposited material from the rub damage to the shrouds and blade tracks in the power turbine. Top: Divisions = mm. Bottom: No scale provided.

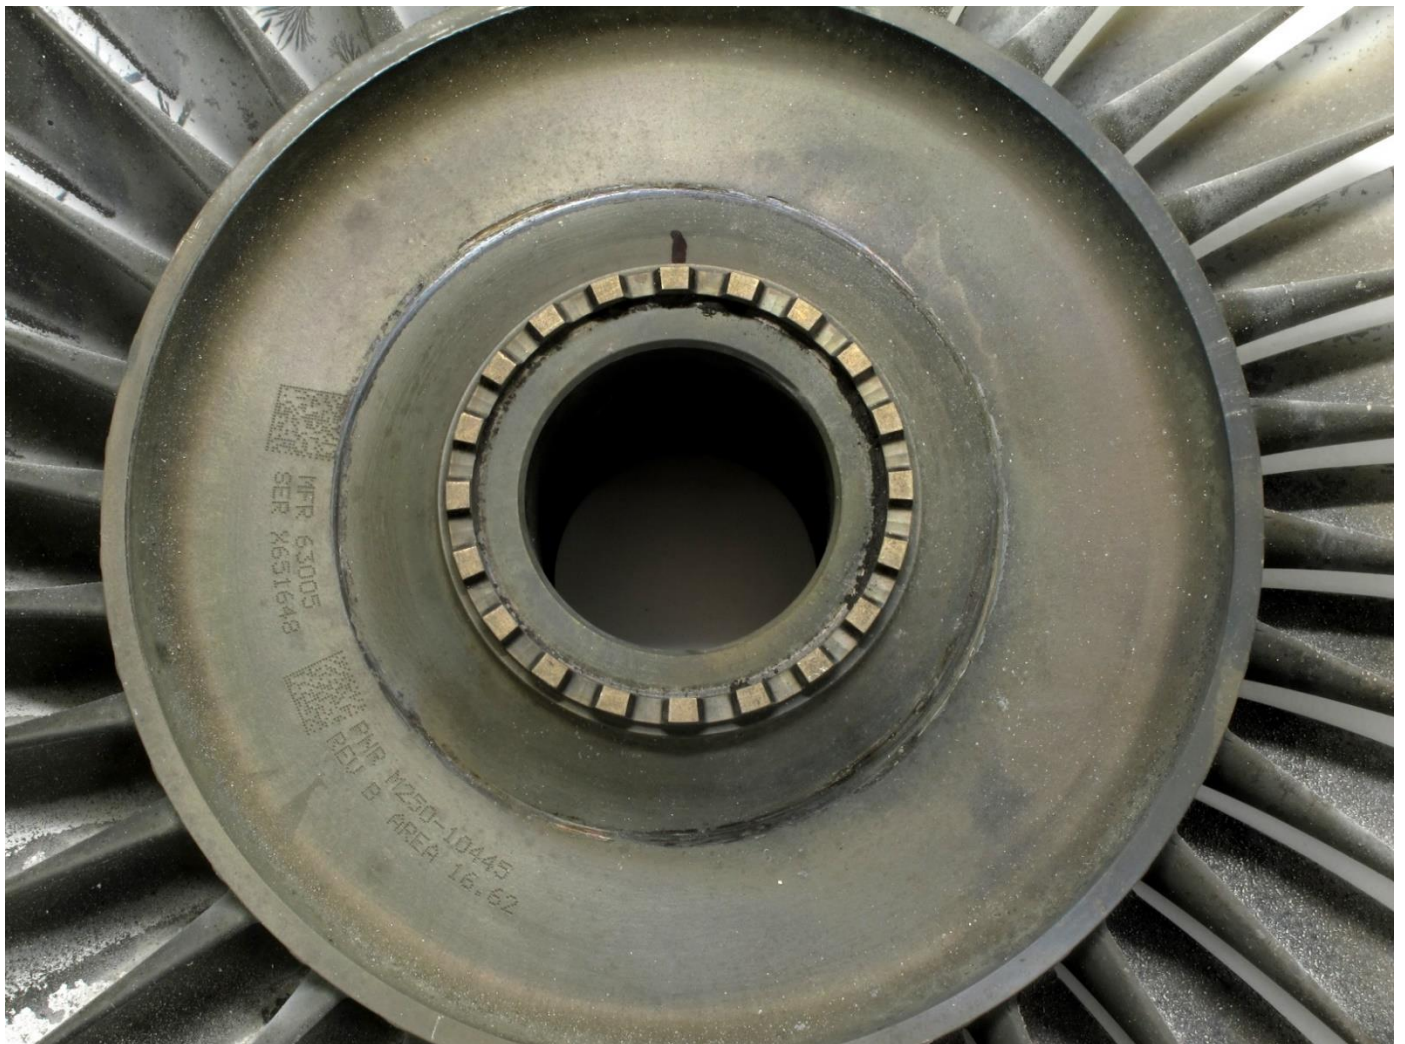
**Figure 56.** Detailed leading edge side view showing circumferential rub damage to the web near the transition to the thicker portion of the bore. The black temporary part mark above the curvic teeth was applied in the laboratory as a match mark after separating the PT rotor to reveal the leading edge side. The part markings are also shown. The inset image at top shows the corresponding rub locations on the fourth stage wheel and nozzle (red arrow; schematic for illustration purposes only). No scale provided.

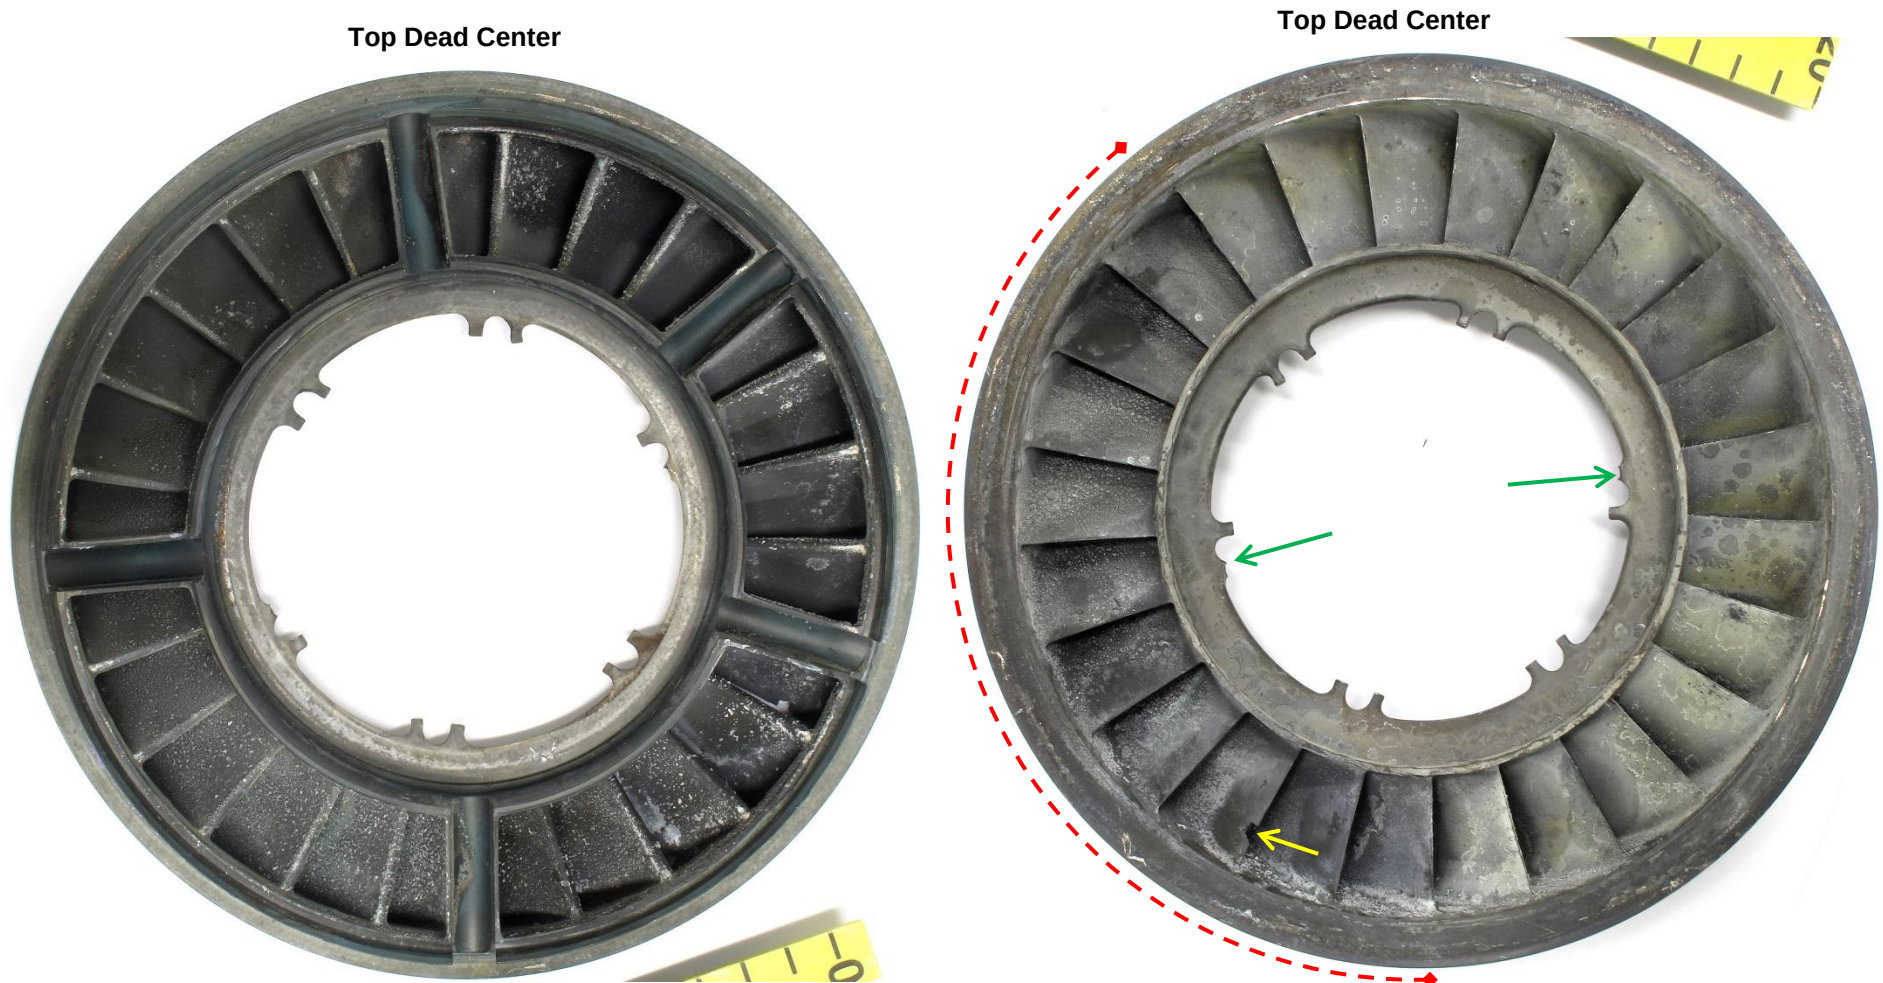
Figure 64 shows the as-received condition of the third stage turbine nozzle assembly. A span of 10 airfoils exhibited dark gray discoloration on the suction side surface consistent with oil staining. One airfoil exhibited impact damage to the trailing edge, and two of the mounting tabs on the diaphragm were fractured. There was no evidence of impact damage to the leading edges of any of the vane airfoils.

**Figure 64.** Leading edge side (left) and trailing edge side (right) views of the third stage turbine nozzle assembly. On the trailing edge side a span of approximately 10 vane airfoils exhibited darker discoloration on the suction side than the rest of the airfoils (along red dashed line) consistent with oil staining. One airfoil was missing material from the trailing edge consistent with impact damage (yellow arrow). Two of the diaphragm tabs were fractured (green arrows). Divisions = cm.

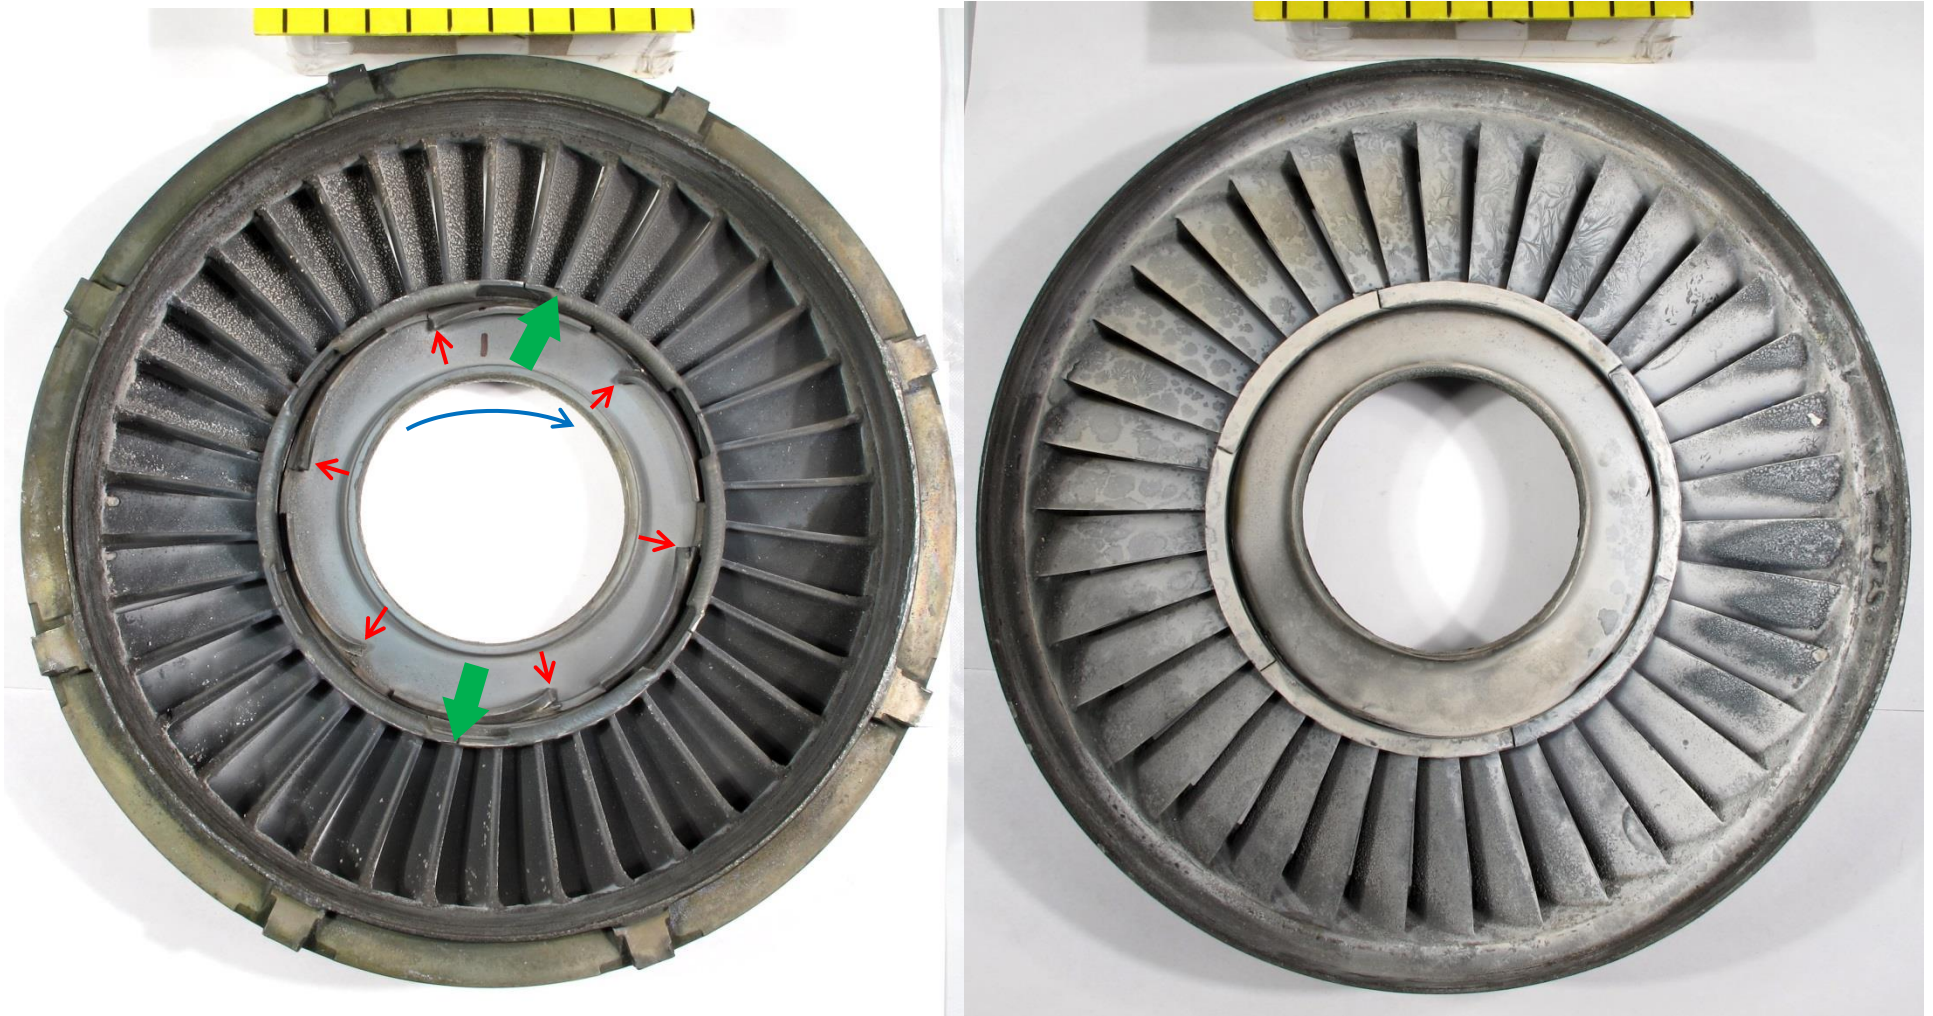
The leading and trailing edge sides of the fourth stage turbine nozzle are shown in Figure 65. The airfoils were covered intermittently in a powdery white residue consistent with airframe fire retardant. There was no evidence of impact damage to the leading edges of the vane airfoils. All the hub castellations on the trailing edge side between the vane inner band and the diaphragm were fractured and deformed inboard.

**Figure 65.** Leading edge side (left) and trailing edge side (right) views of the fourth stage turbine nozzle assembly. The airfoils were covered in a powdery white material consistent with fire retardant. Two airfoils were fractured at the trailing edge near the inner band (green arrows). The following side (relative to the direction of engine rotation, blue arrow) of the hub castellations were fractured and deformed inboard (red arrows). The black temporary part mark was applied in the laboratory for reference to the rotor match mark location at the time of disassembly. Divisions = cm.

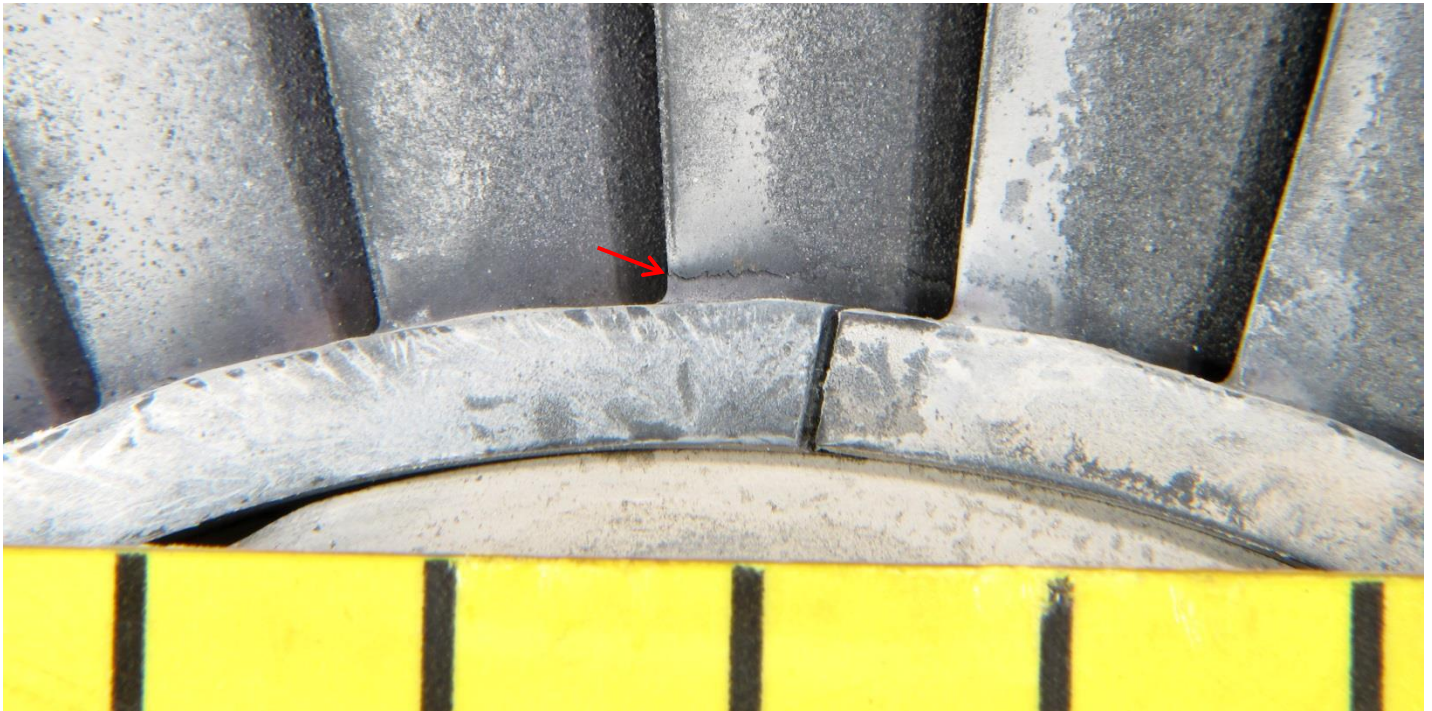
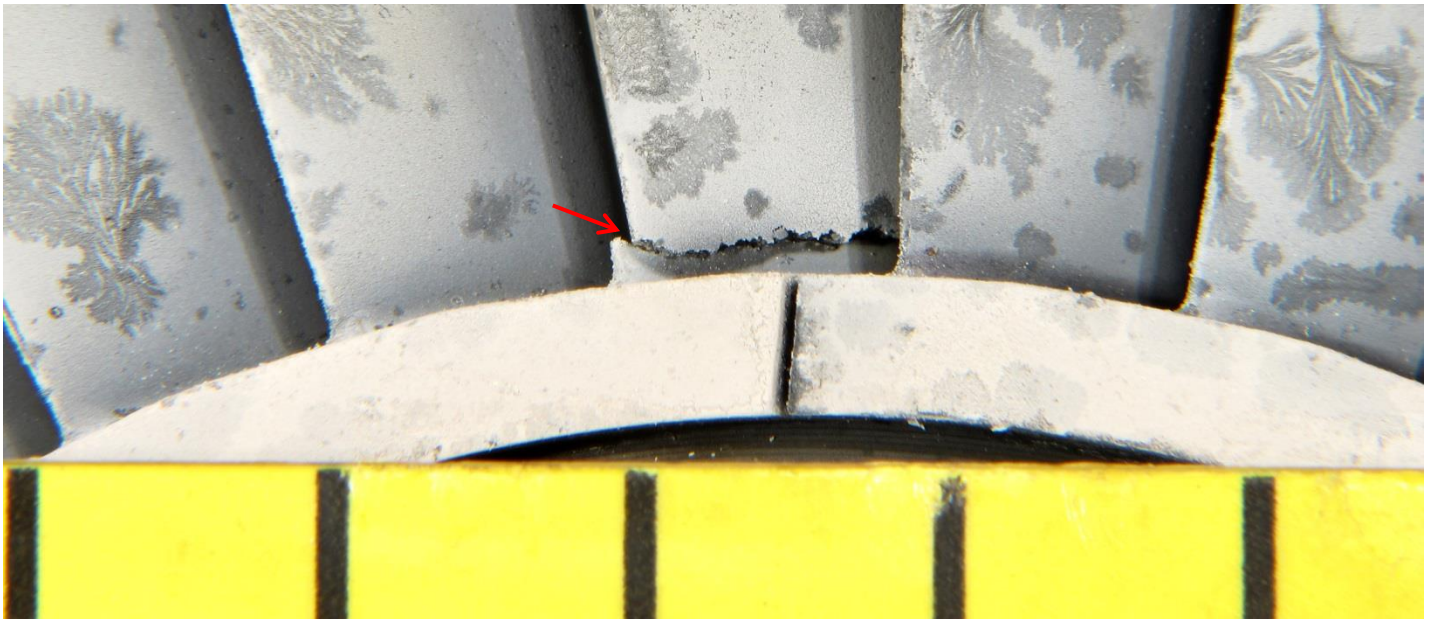
Detailed inspection of the vane airfoils revealed two of them, each the first in its respective packet, were fractured at the trailing edge root as shown in Figure 66. The fractures were jagged and rough in appearance, consistent with overload. One of the vanes was fractured along the entire chord length and was cut from the nozzle. The fracture surface was examined in the SEM. The fracture exhibited interdendritic features consistent with overload as shown in Figure 67 and Figure 68. The fracture also exhibited smearing damage.

**Figure 66.** Two airfoils, each the first in its respective packet relative to the direction of engine rotation (blue arrow), exhibiting fractures at the trailing edge near the inner band (red arrows). The airfoil in the bottom image was fractured along the entire chord length and was revealed in the laboratory by cutting the airfoil from the outer band. Divisions = cm.

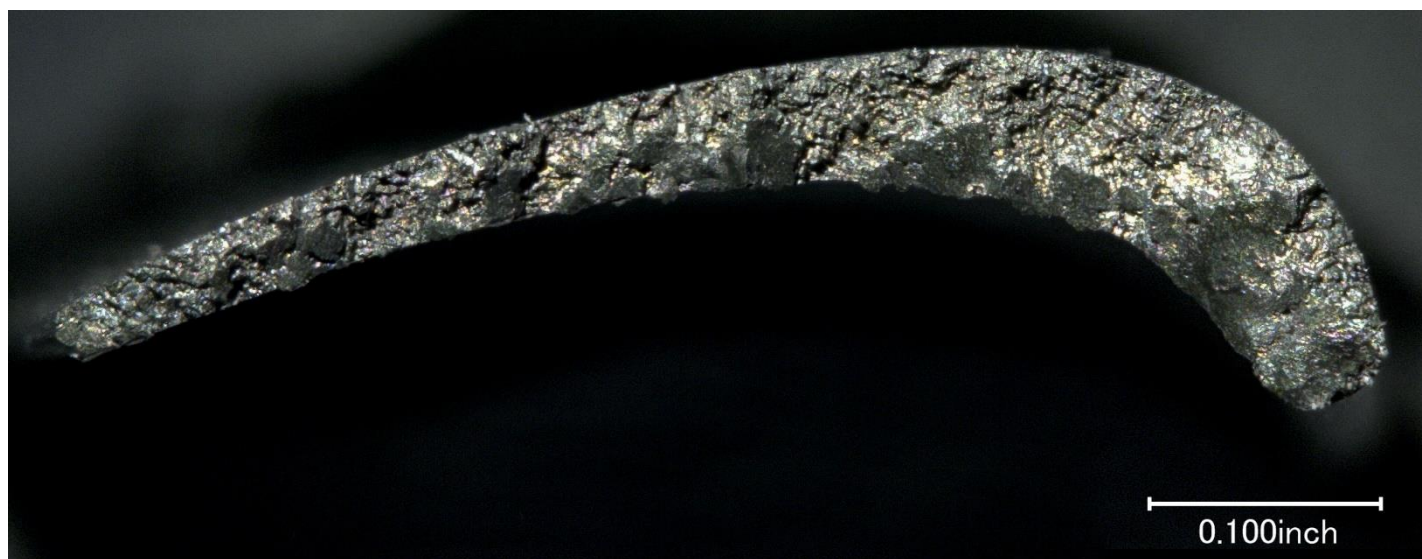
**Figure 67. Detailed view showing the revealed fracture surface on the stage 4 vane airfoil that was fractured along the entire chord length.**

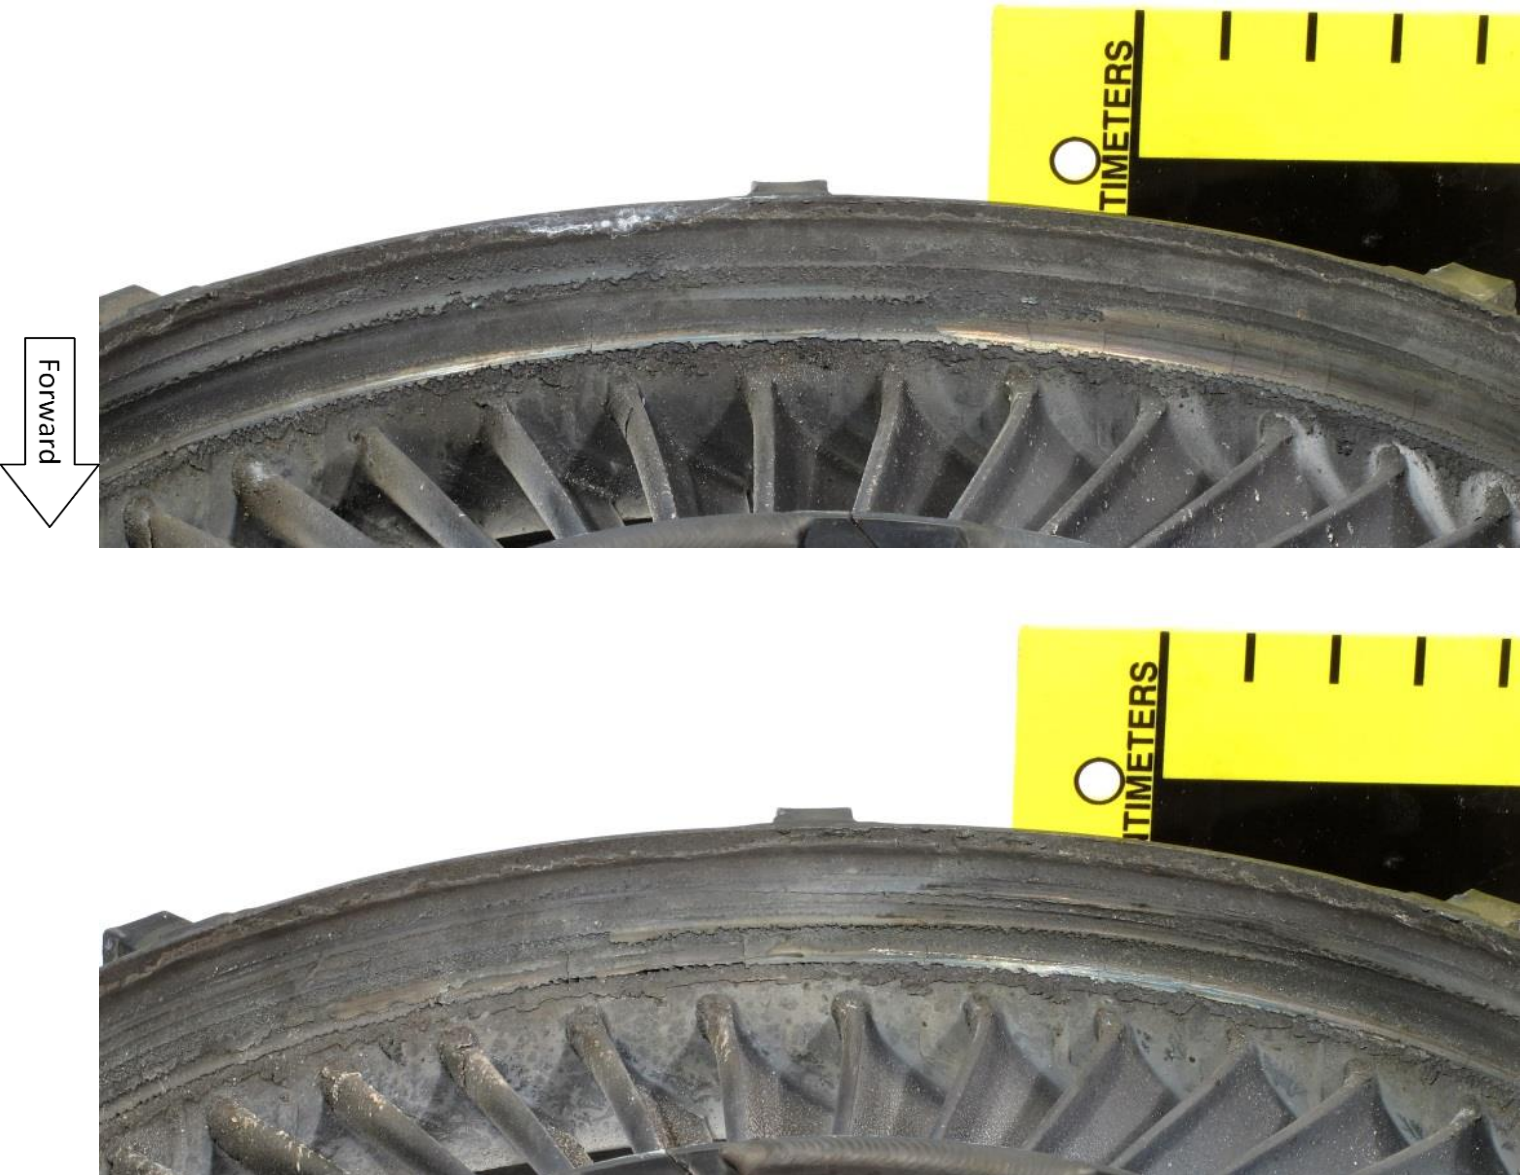
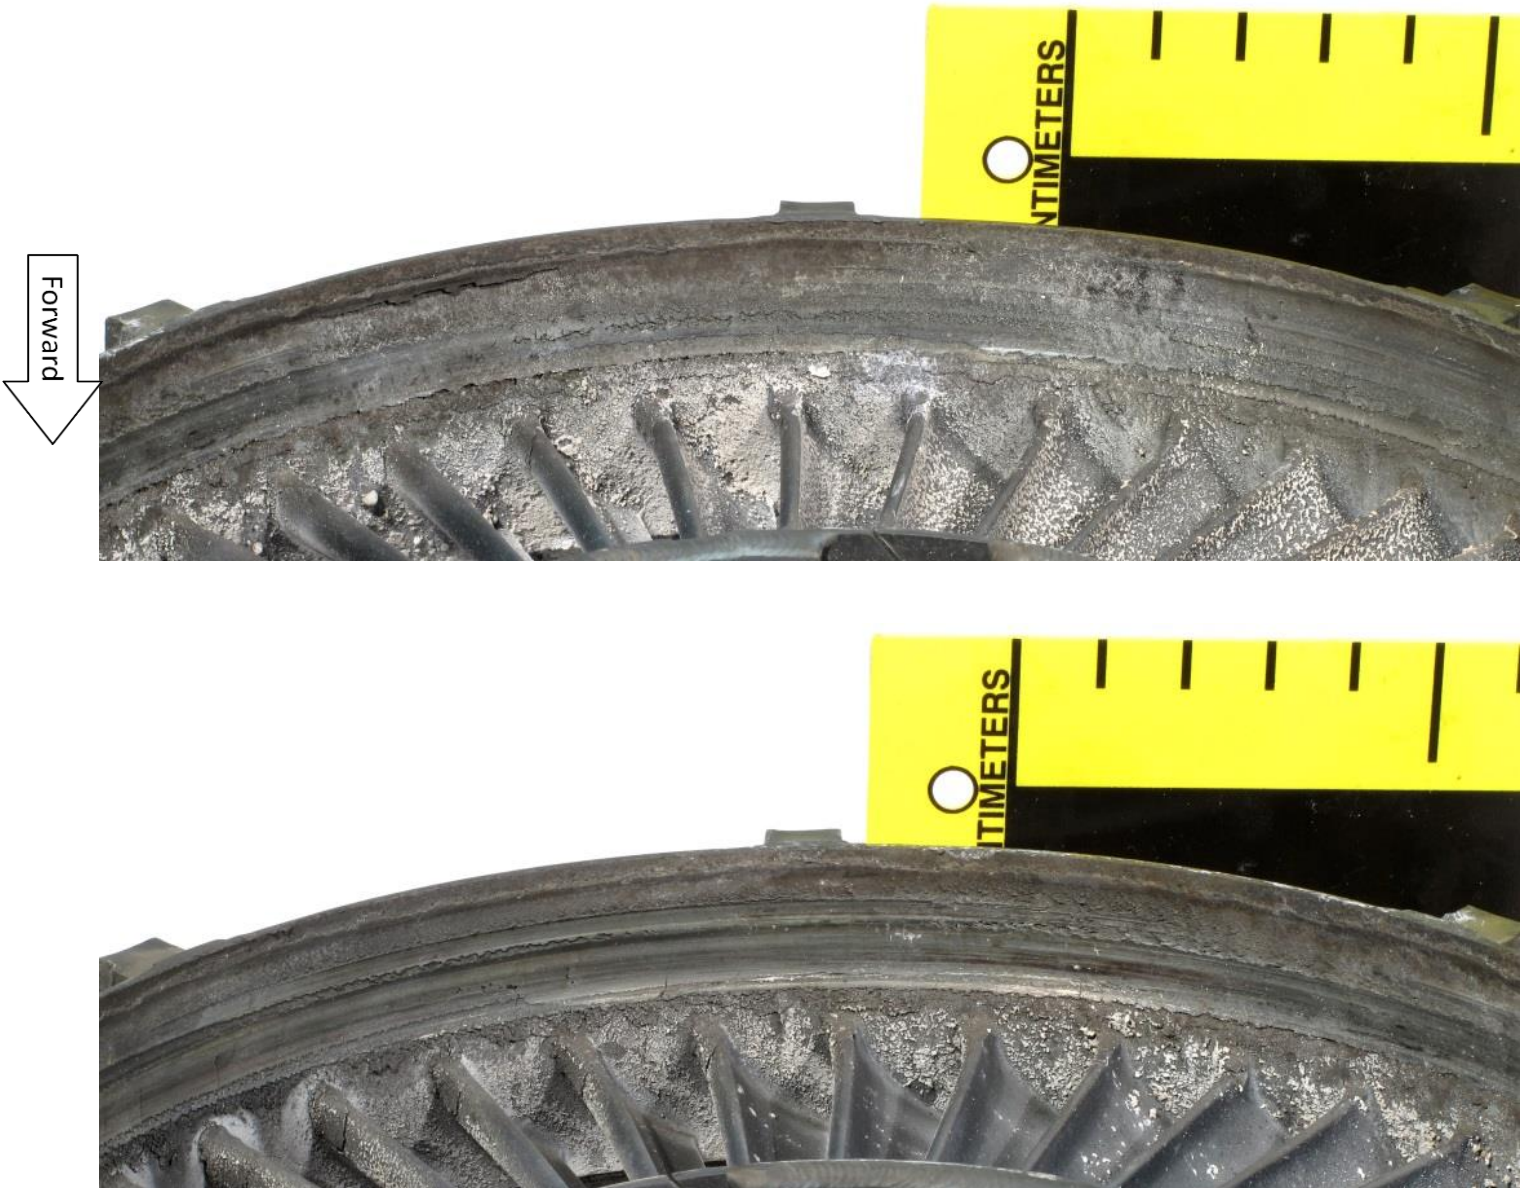
The third stage blade track, shown in Figure 69 and Figure 70, exhibited rub damage around the entire circumference. The rub damage obliterated any evidence of the knife seals cutting into the blade track. There were no apparent embedded fragments from the liberated portion of the third stage turbine wheel. The fourth stage blade track, shown in Figure 71 and Figure 72, exhibited similar rub damage around the entire circumference. The interstage abrasion seal in the bore of the fourth stage nozzle is shown in Figure 73. The seal exhibited rub damage on both the leading and trailing edge sides; the trailing edge side rub damage corresponded to the circumferential rub damage to the hub of the fourth stage turbine wheel, and the leading edge side damage corresponded to the damage on the interstage knife seals on the third stage turbine wheel.

**Figure 69.** Detailed views showing the third stage turbine blade track in the fourth stage turbine nozzle. The nozzle was rotated 90° clockwise (ALF) for this succession of images. The blade track exhibited rub damage and intermittent transferred material around the entire circumference. Divisions = cm.

**Figure 70. Detailed views showing the third stage turbine blade track in the fourth stage turbine nozzle. The nozzle was rotated 90° clockwise (ALF) for this succession of images. The blade track exhibited rub damage and intermittent transferred material around the entire circumference. Divisions = cm.**
