| <b>Rolls-Royce</b> | Rolls-Royce Corporation<br>450 S. Meridian Street<br>Indianapolis, Indiana<br>46225-1103, USA | <b>REPORT NO.</b><br>21FAE-055 | <b>REV.</b><br>Initial | <b>PAGES</b><br>1 of 108 |
| <b>TITLE</b><br><b>METALLURGICAL INVESTIGATION OF A THIRD STAGE TURBINE WHEEL, P/N 23065818, REMOVED FROM AN M250, ENGINE S/N CAE835942, OPERATED BY SIGNATURE UTILITY SERVICES</b> | | <b>PREPARED</b><br>Digitally signed by Alexander Sheridan_9782(Bldentity)<br>Date: 2022.05.03 10:26:22 -04'00' | | |

| Part Name: | Third Stage Turbine Wheel |
| Engine Model: | M250-C20B |

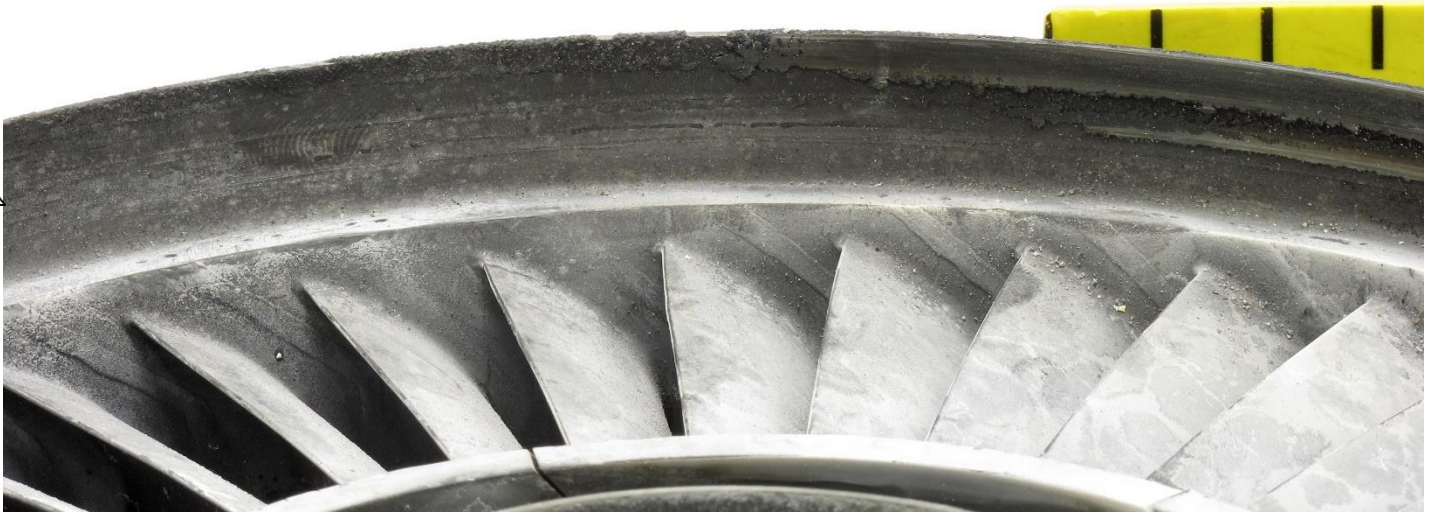
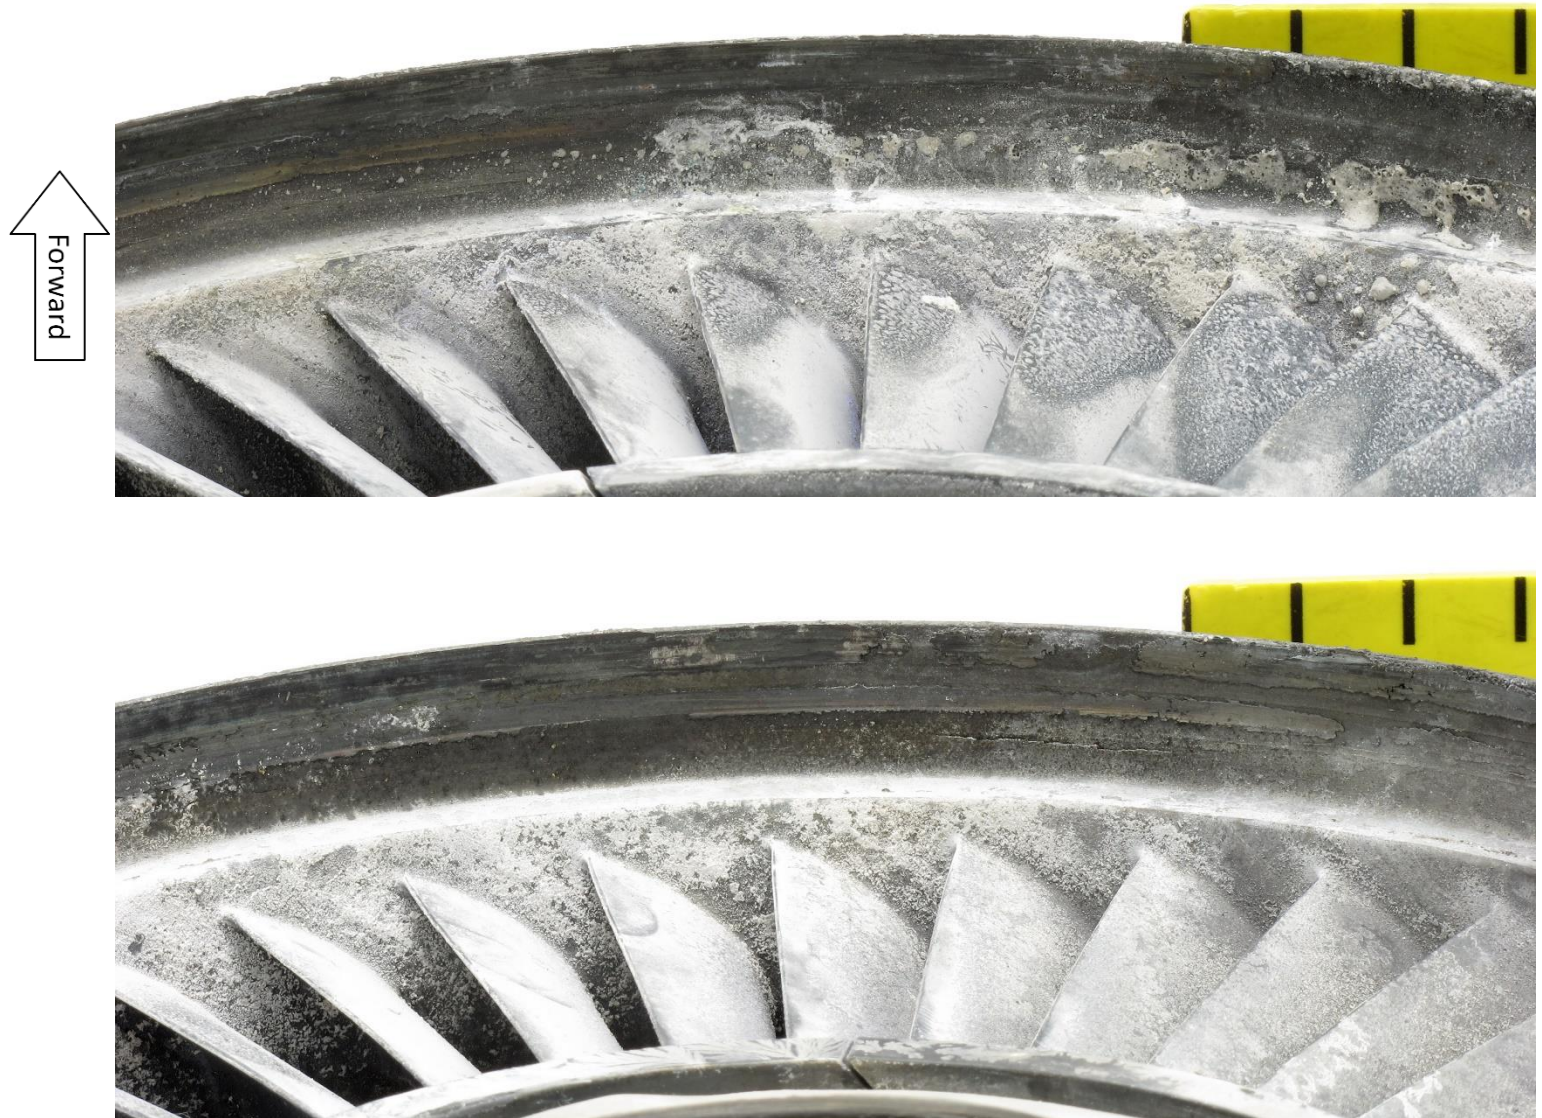
**Figure 71.** Detailed views showing the fourth stage turbine blade track in the fourth stage turbine nozzle. The nozzle was rotated 90° counterclockwise (FLA) for this succession of images. The blade track exhibited rub damage around the entire circumference. Divisions = cm.

**Figure 72. Detailed views showing the fourth stage turbine blade track in the fourth stage turbine nozzle. The nozzle was rotated 90° counterclockwise (FLA) for this succession of images. The blade track exhibited rub damage and intermittent transferred material around the entire circumference. Divisions = cm.**

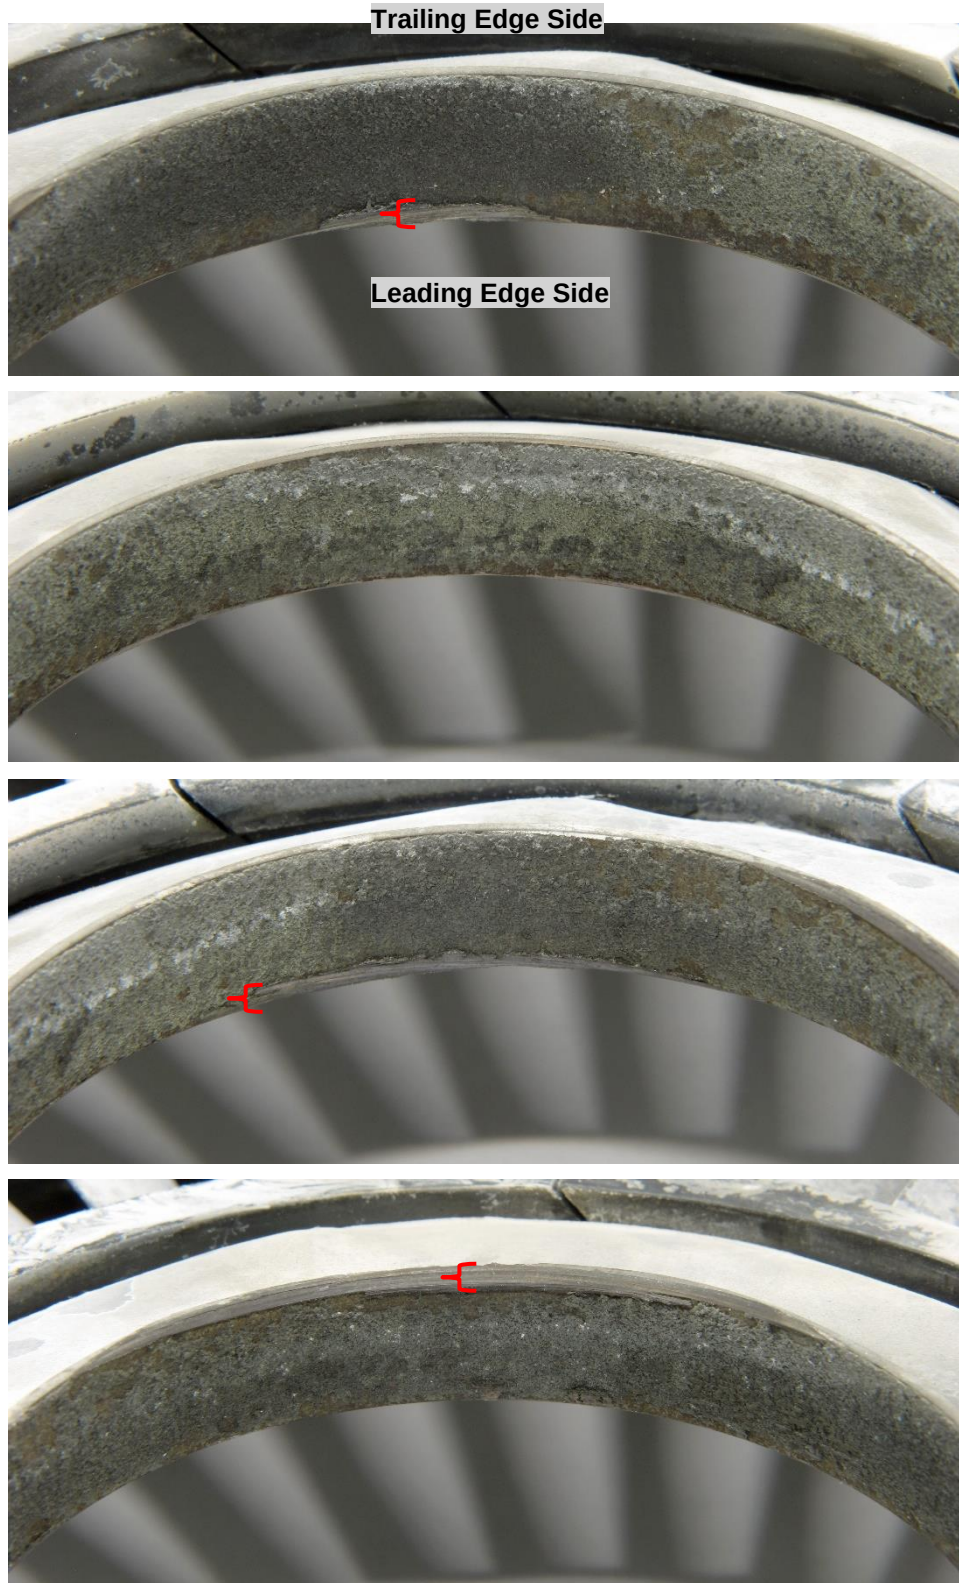
**Figure 73.** Detailed views showing the inner diameter abradsable seal surface in the fourth stage turbine nozzle. The seal exhibited smearing damage on both the leading and trailing edge sides (red braces). The nozzle was rotated 90° counterclockwise (FLA) for this succession of images. No scale provided.

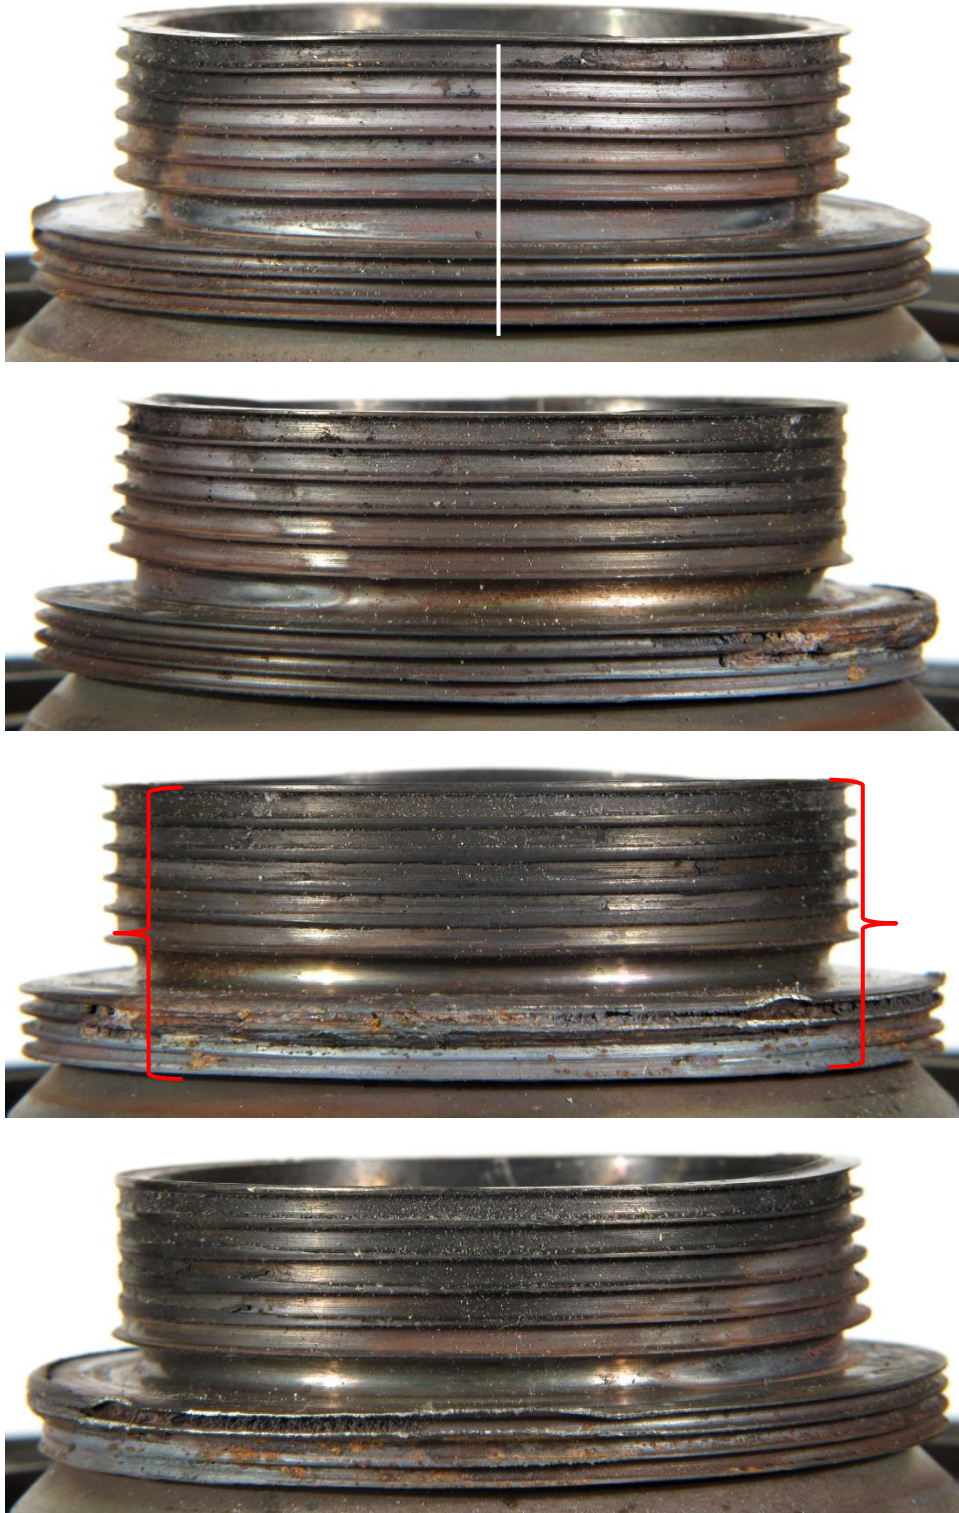
**Figure 74.** Radial views showing the power turbine labyrinth seal before the PT rotor was disassembled. The white line at top indicates the location of the match mark for the rotor. The rotor was rotated 90° in the direction of engine rotation for this succession of images. The most severe rub damage to the labyrinth knife seals (red braces) was located approximately 180° from the match mark. No scale provided.

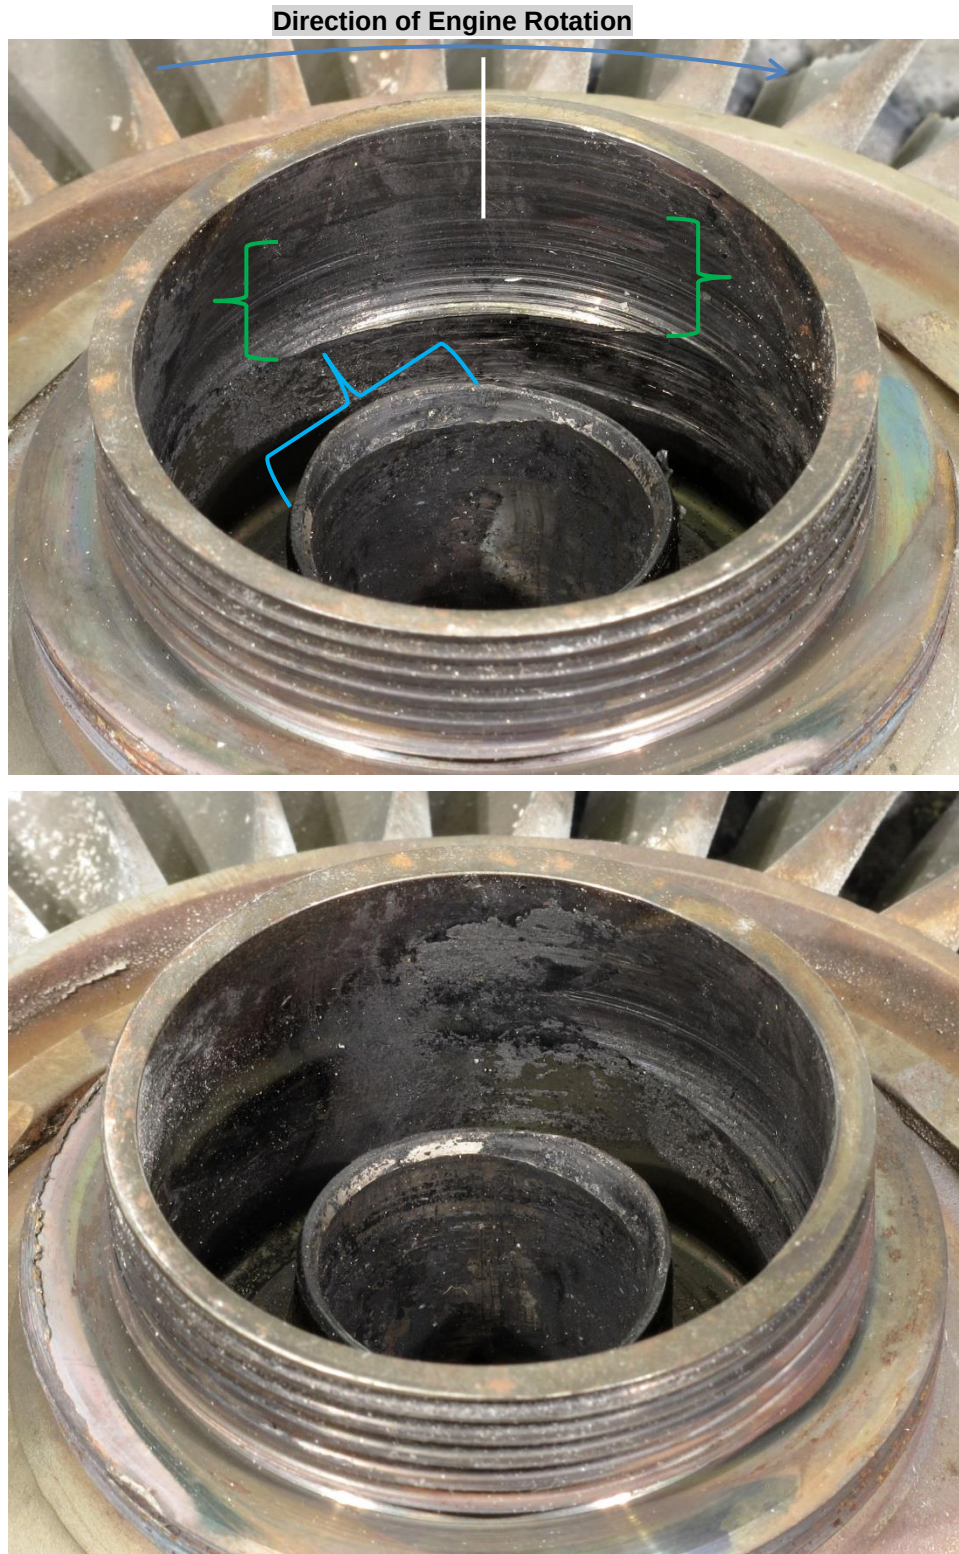
**Figure 76.** Detailed views showing the aft end of the power turbine inner shaft inside the power turbine labyrinth seal before the PT rotor was disassembled. The white line at top indicates the location of the match mark for the rotor. The rotor was rotated 90° in the direction of engine rotation for this succession of images. The PTIS was distorted outboard (blue brace) and the inner diameter of the labyrinth seal exhibited rub damage (green braces) near the location of the match mark. No scale provided.

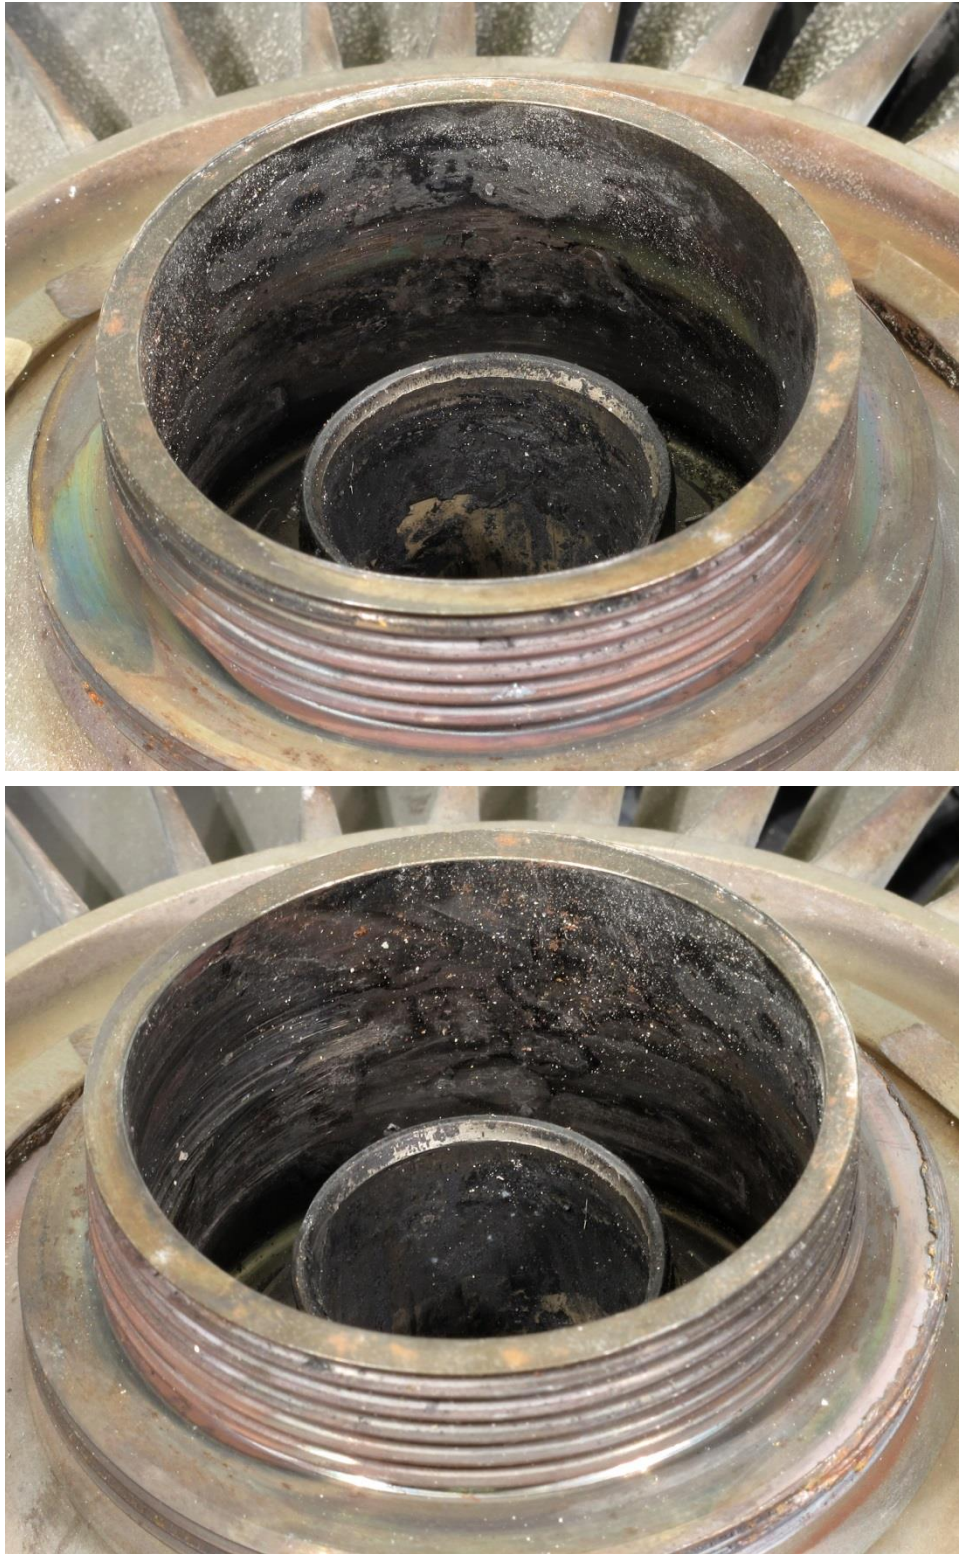
**Figure 77.** Detailed views showing the aft end of the power turbine inner shaft inside the power turbine labyrinth seal before the PT rotor was disassembled. The rotor was rotated 90° in the direction of engine rotation for this succession of images. No scale provided.

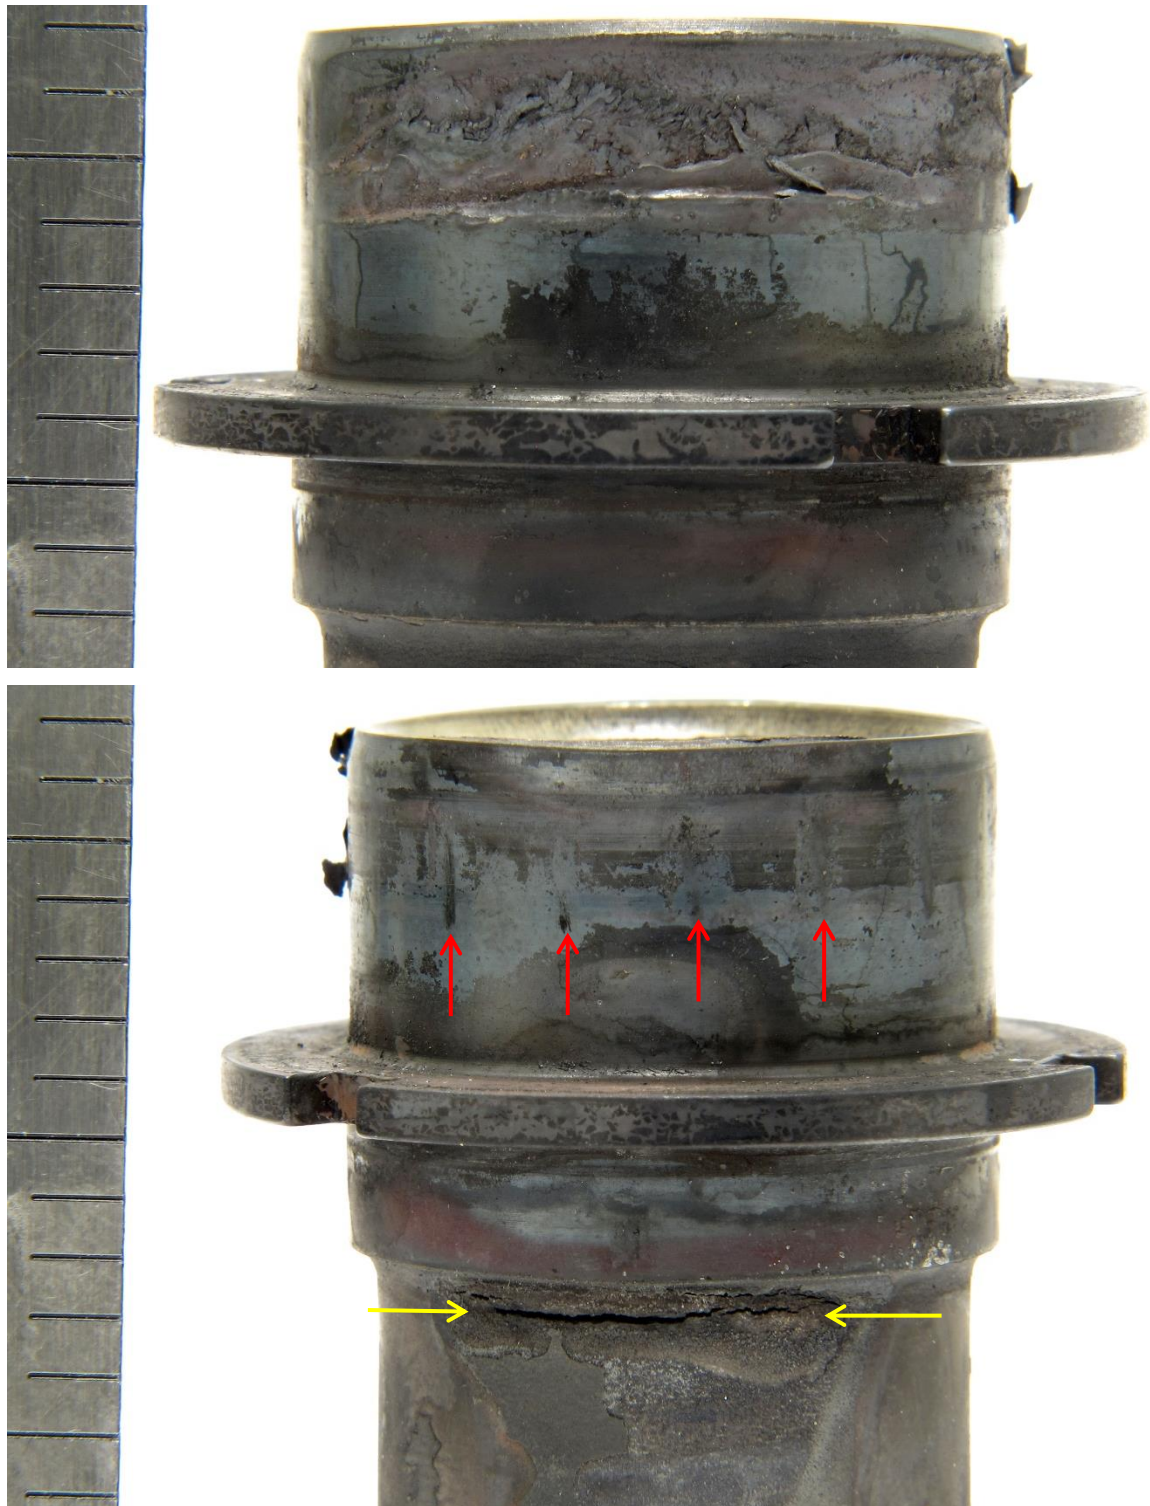
**Figure 80.** Detailed views showing the No. 6 bearing raceway surface in the groove (top) and opposite the groove (bottom). Roller-spaced black axial stains were present on the raceway away from the groove (red arrows), and the shaft was fractured (between yellow arrows) forward of the raceway located approximately in-line with the outboard deformation of the aft end of the shaft. Divisions = 0.1 inch.

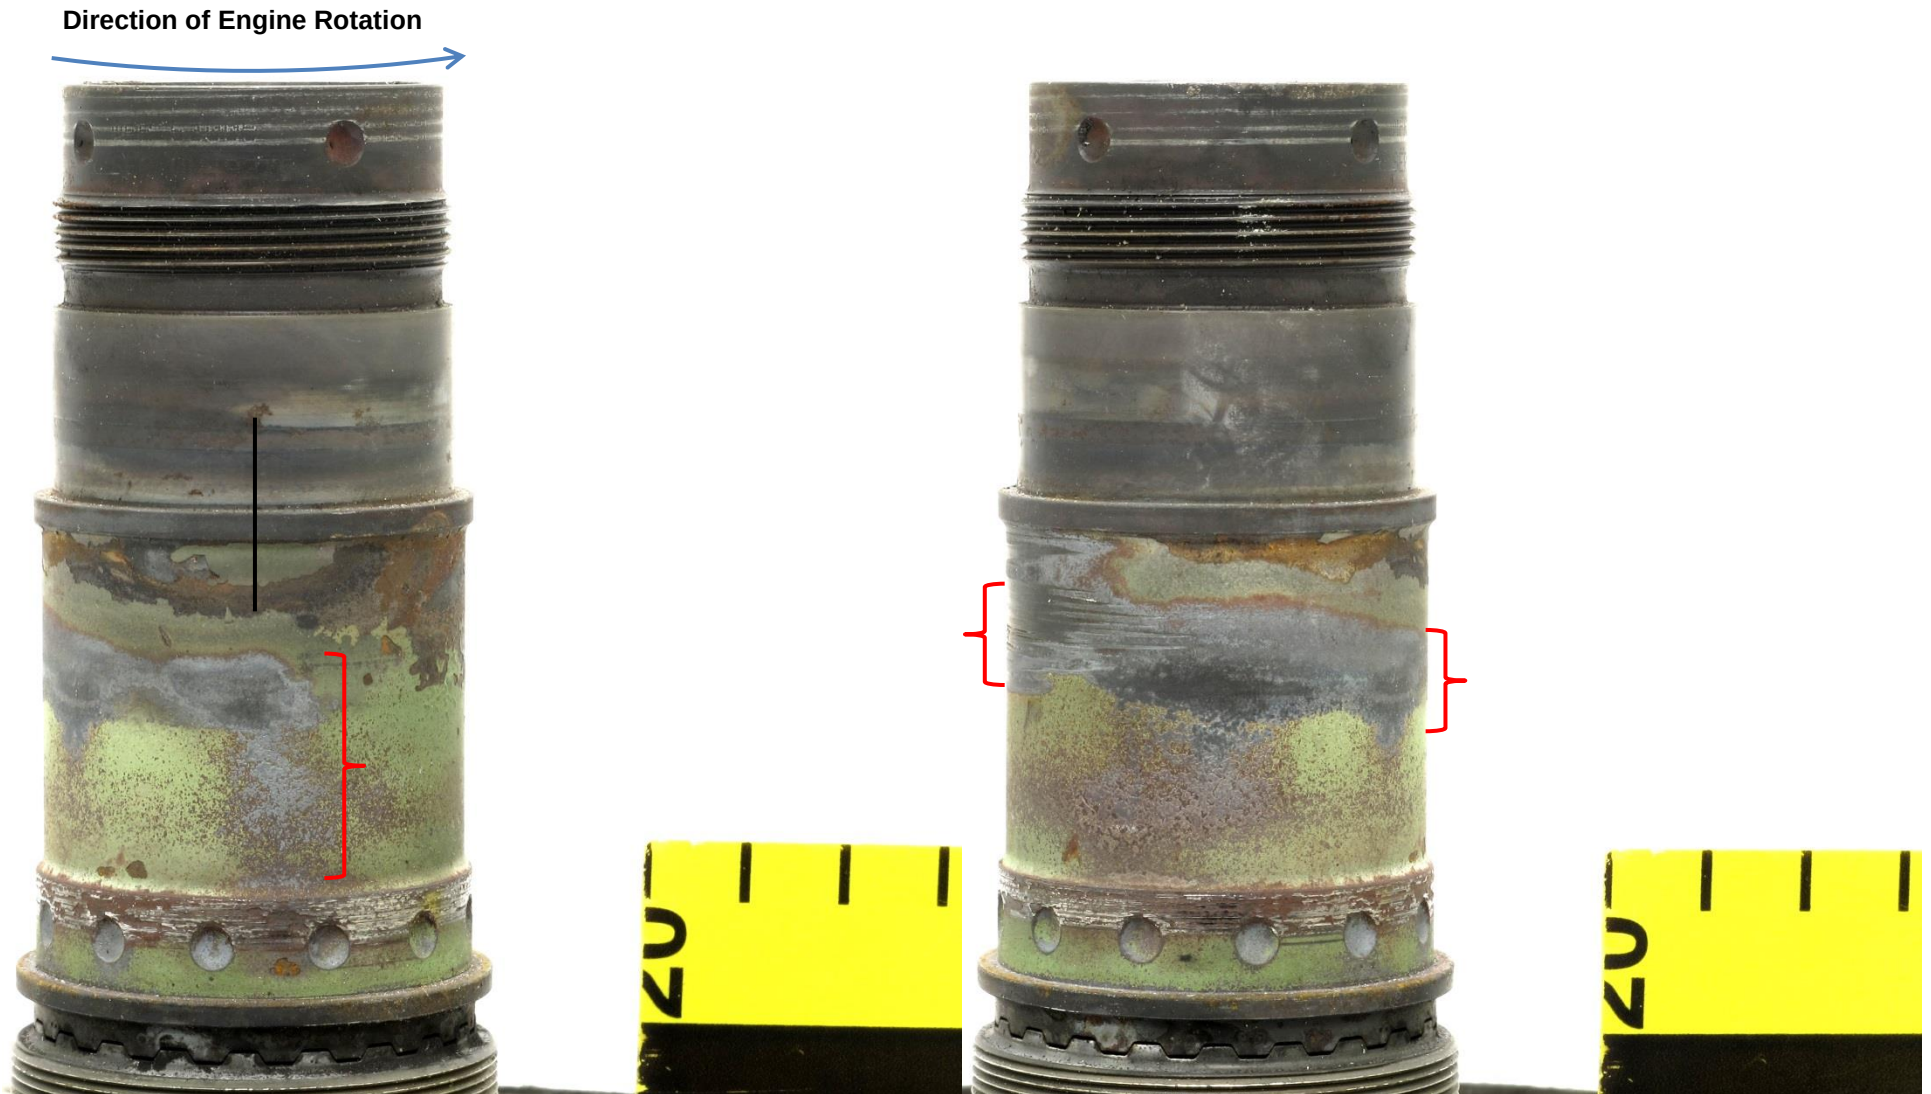
**Figure 81.** Detailed views showing the power turbine outer shaft before the PT rotor was separated. The black line shows the location of the match mark for the PT rotor. The rotor was rotated 90° in the direction of engine rotation for this succession of images. Rub damage on the outer diameter of the shaft (red braces) spanned approximately 300° around the circumference, opposite the direction of engine rotation.

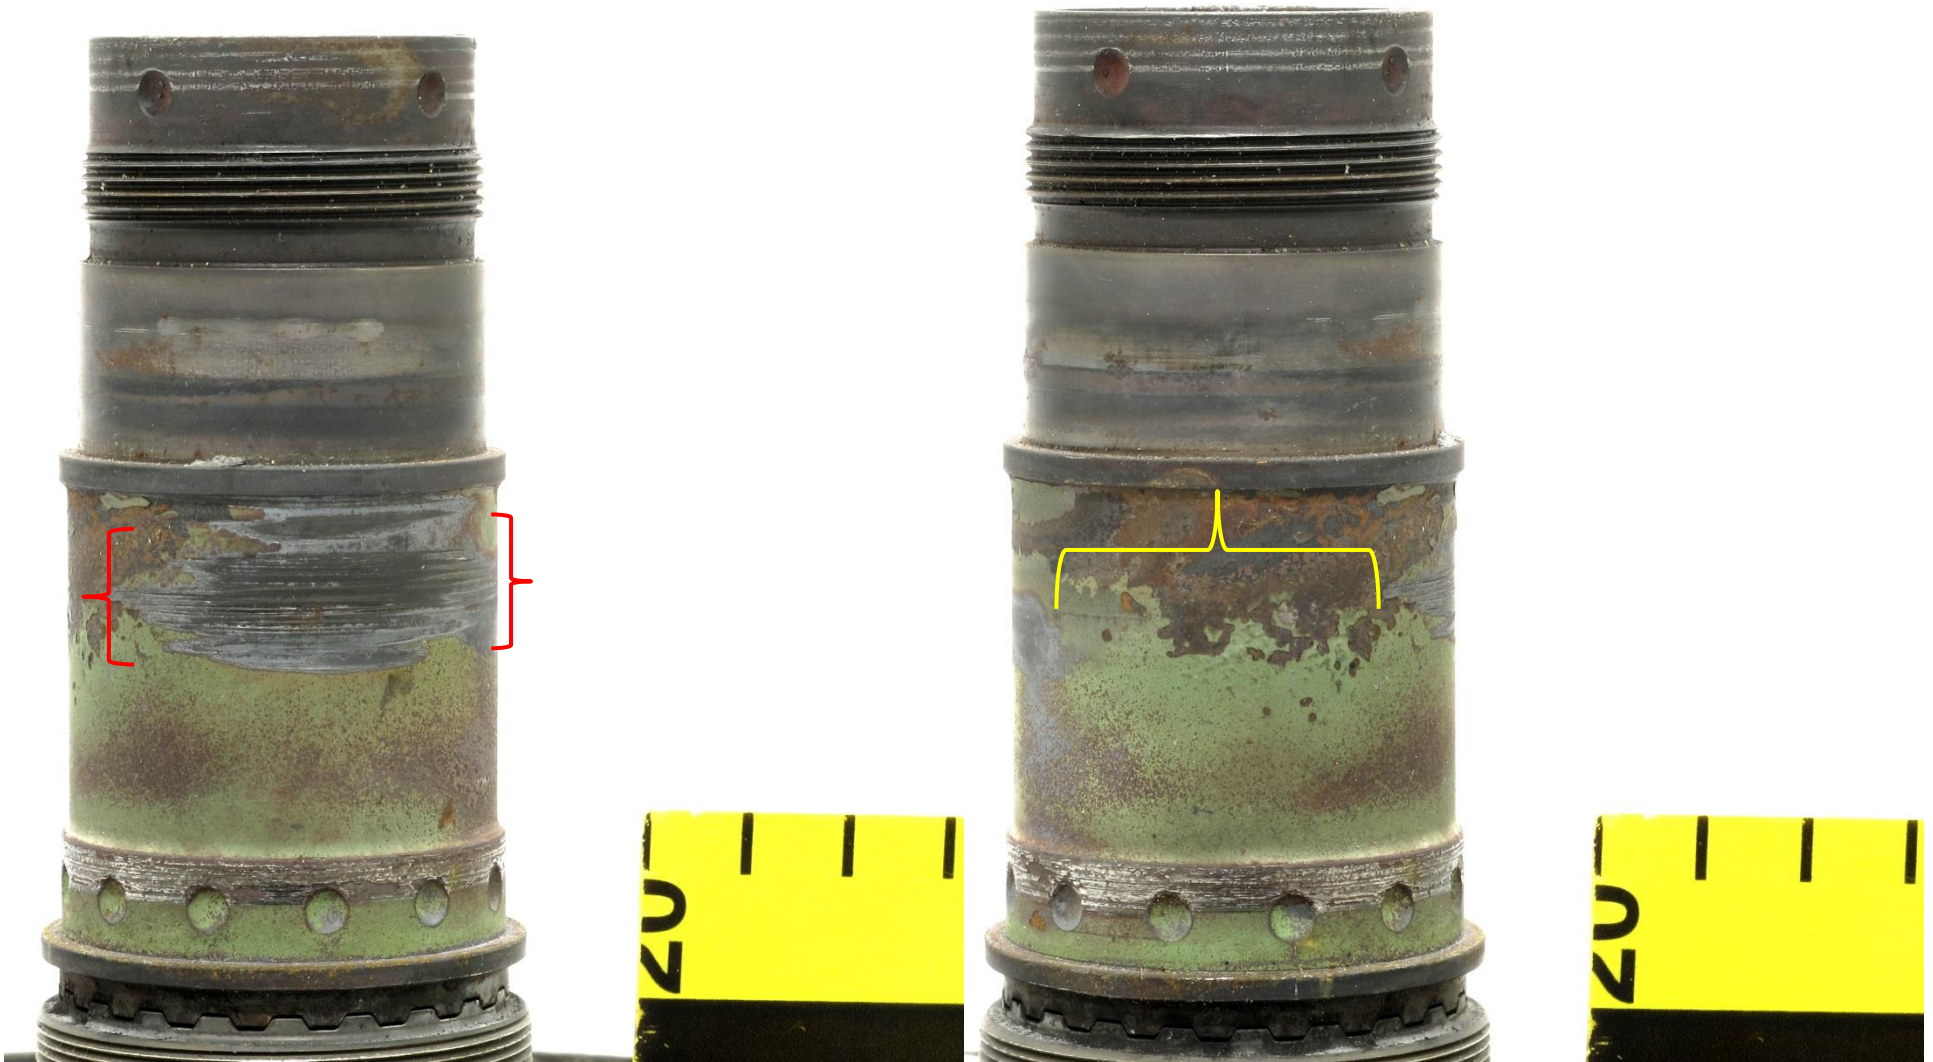
**Figure 82.** Detailed views showing the power turbine outer shaft before the PT rotor was separated. The rotor was rotated 90° in the direction of engine rotation for this succession of images. Rub damage on the outer diameter of the shaft (red braces) spanned approximately 300° around the circumference, opposite the direction of engine rotation. The yellow brace marks the span of the shaft that did not exhibit rub damage through the coating thickness. Divisions = cm.

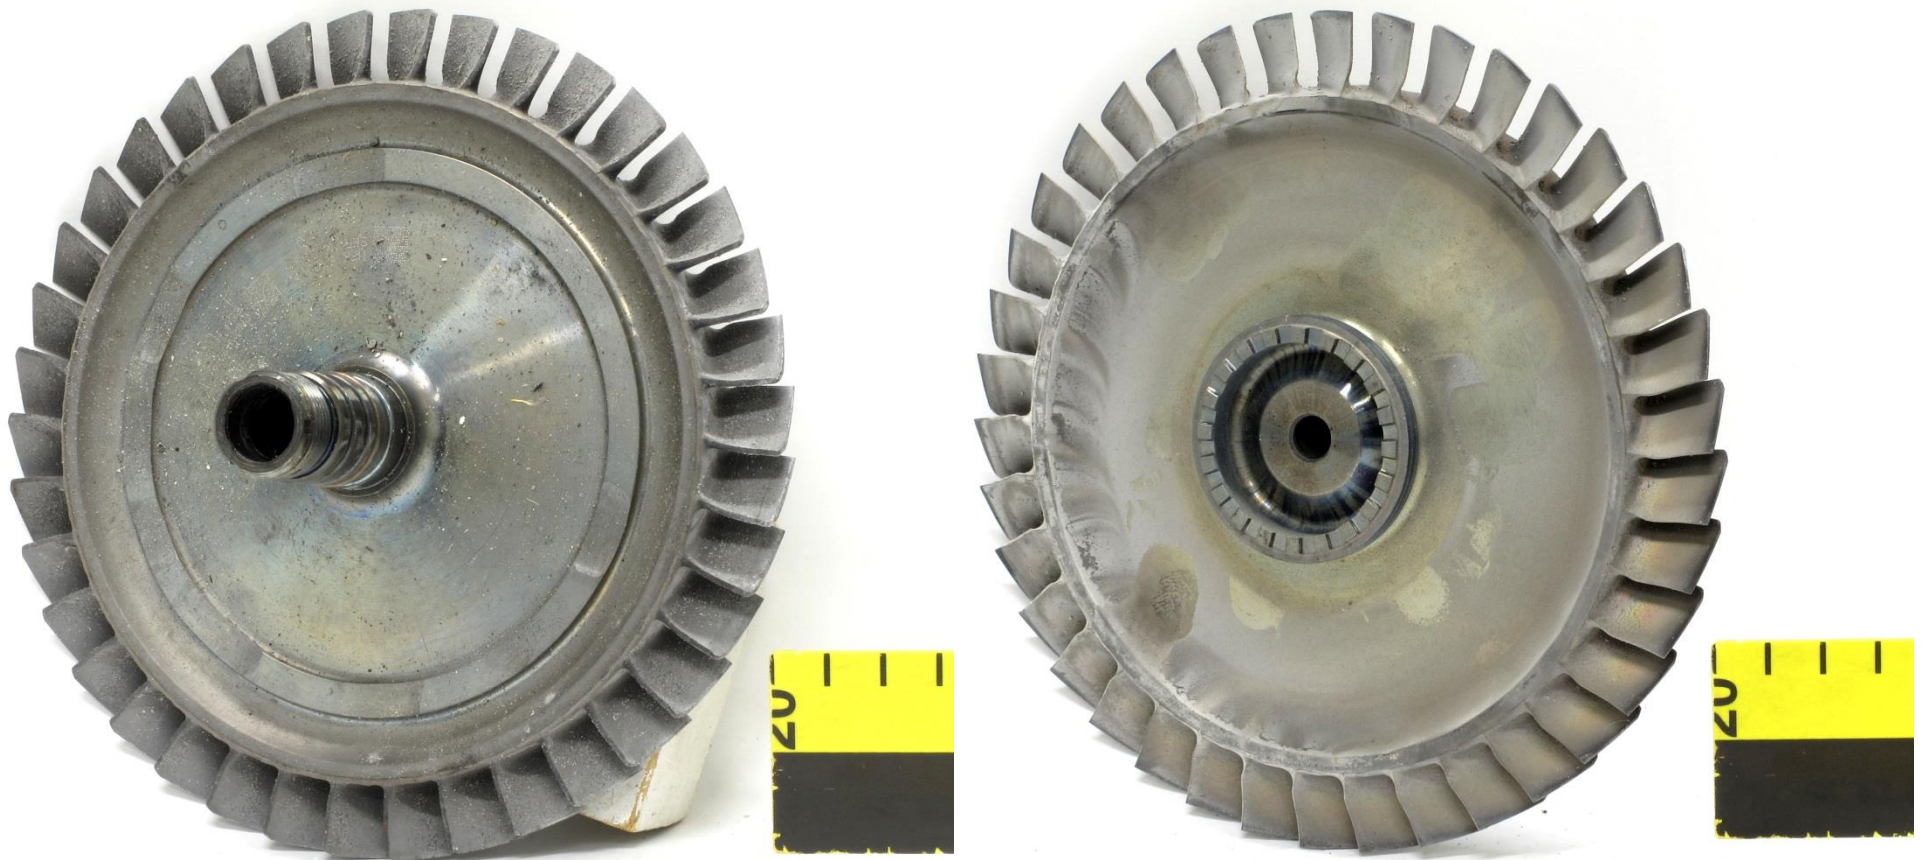
**Figure 83. Leading edge (left) and trailing edge (right) side views showing the first stage turbine wheel. The airfoils exhibited white powdery deposits and there was debris on the leading edge side web. Divisions = cm.**

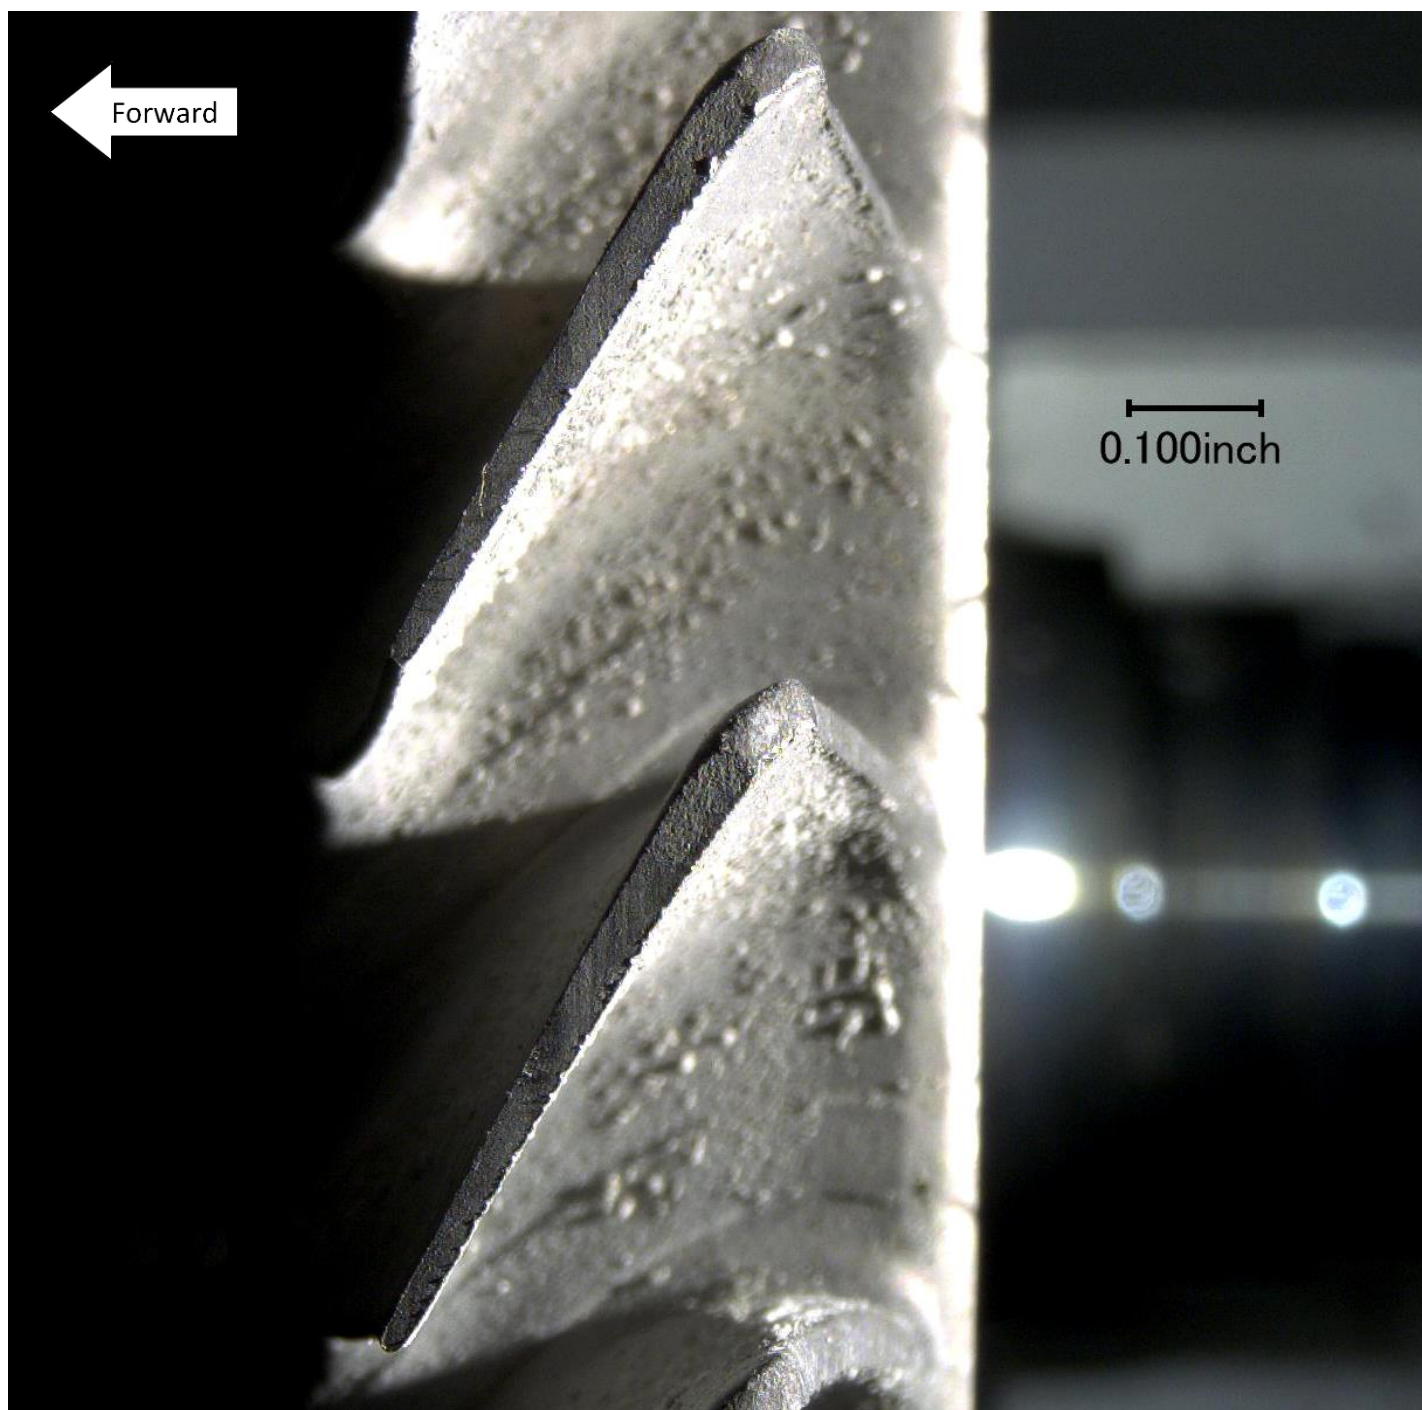
**Figure 85. Detailed view showing representative circumferential rub damage on the first stage turbine blade tips.**

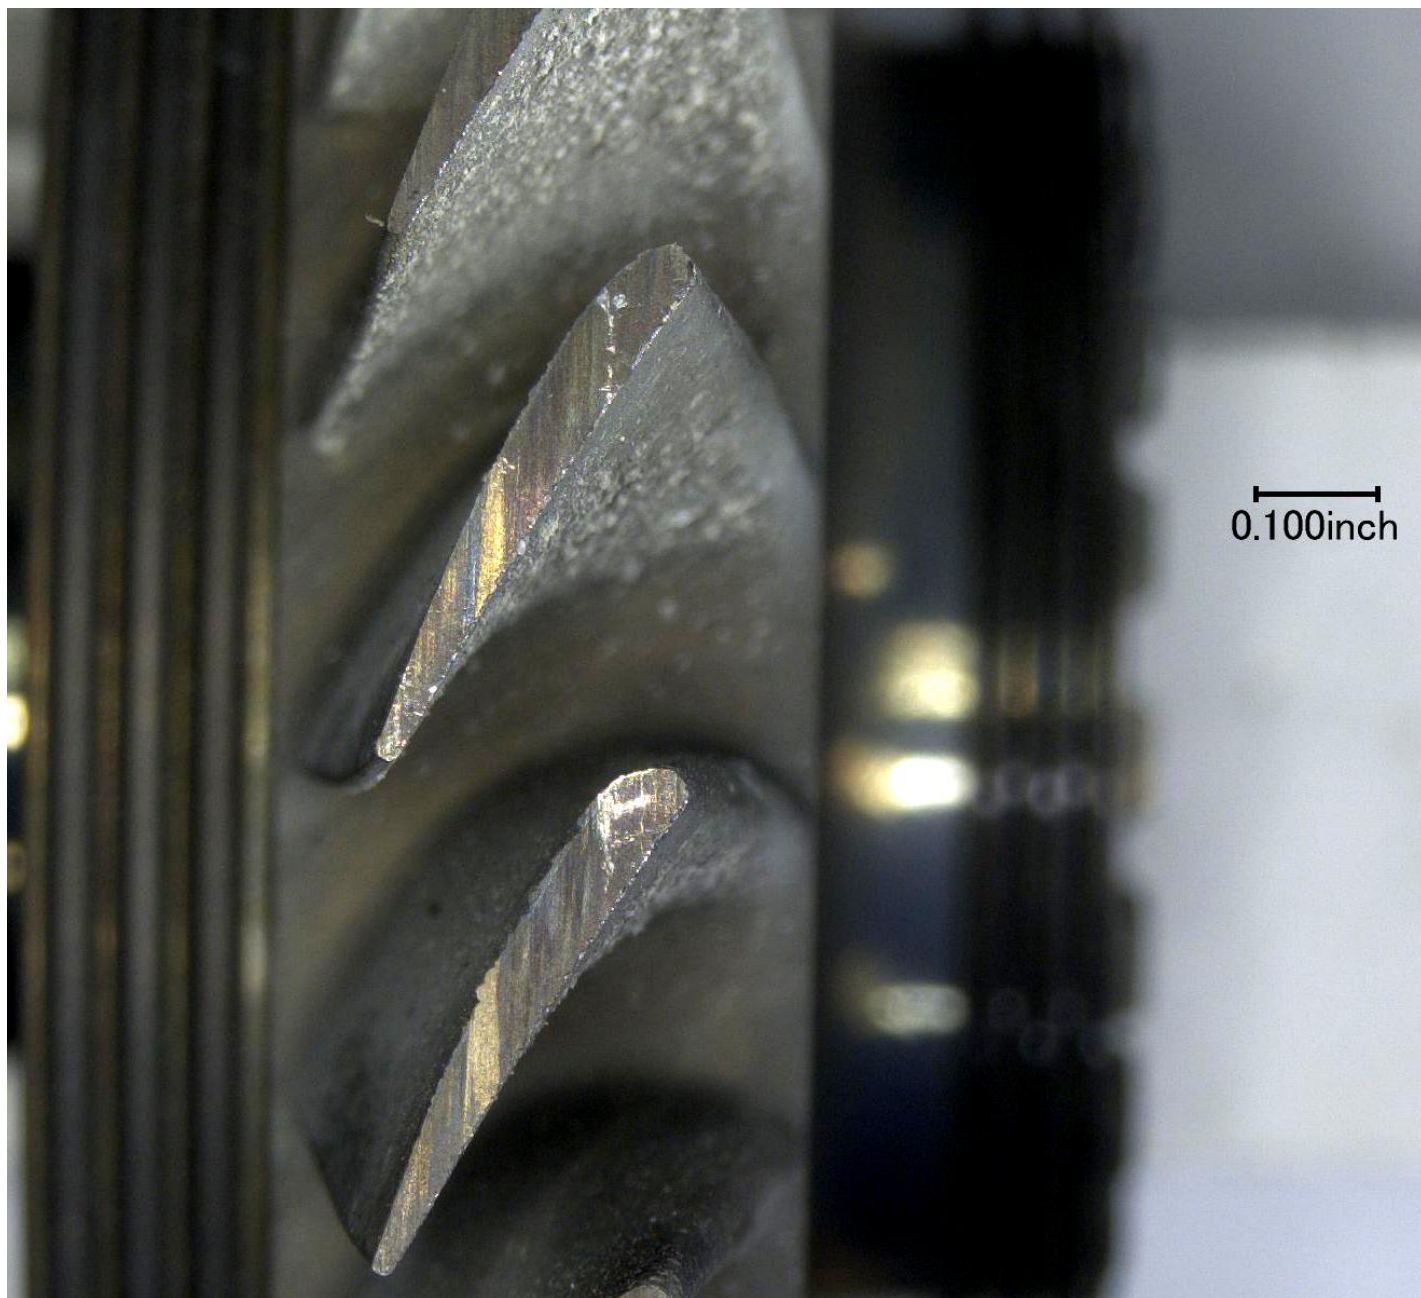
**Figure 94. Detailed view showing representative circumferential rub damage on the second stage turbine blade tips.**
