# NATIONAL TRANSPORTATION SAFETY BOARD

## MATERIALS LABORATORY FACTUAL REPORT

Report No. 21-027

Place : Cash, Arkansas  
Date : January 4, 2021  
Vehicle : Hawker Beechcraft G58, N325GC  
NTSB No. : CEN21LA107  
Investigator : Michael Hodges, AS-CEN

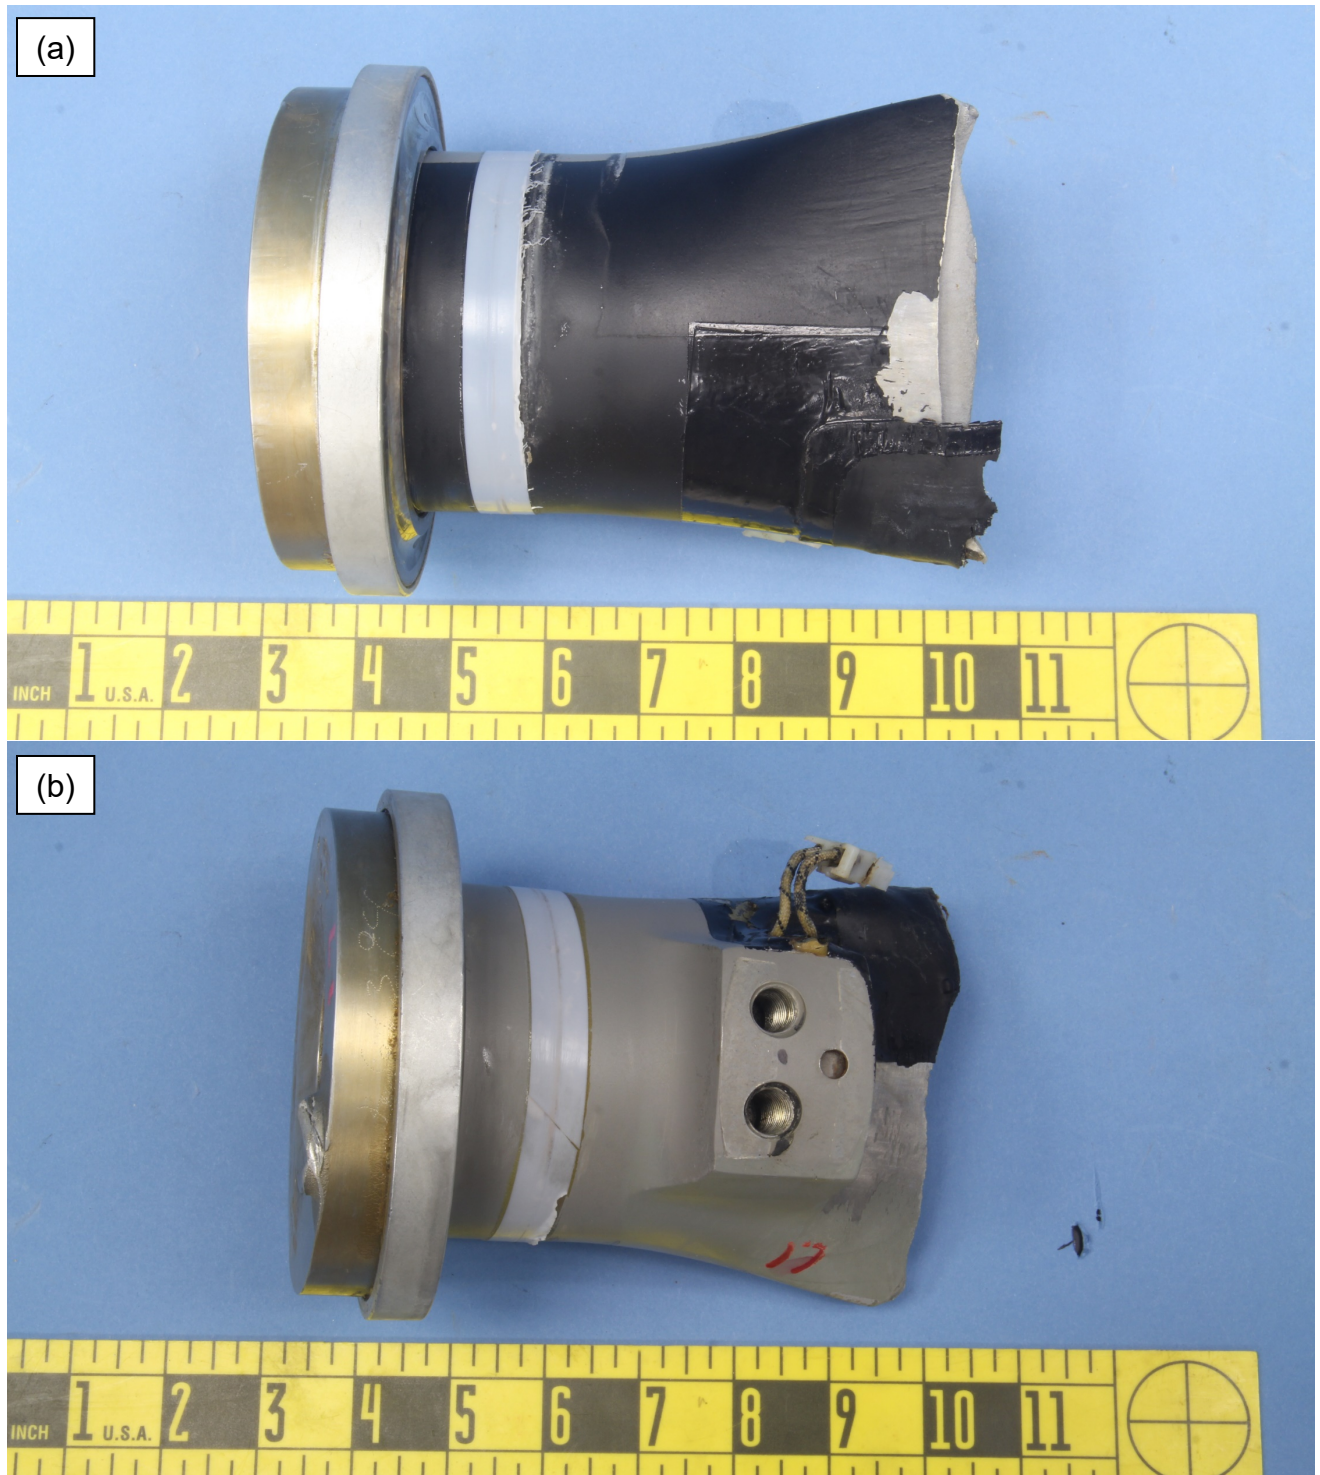
Figure 1 shows the propeller remnant from opposite sides, as received. The remnant had fractured between 4.93 and 5.24 inches above the root flange outboard surface. The fracture surface is depicted in Figure 2, as received. This fracture surface exhibited a general cup shape, with the outer surface protruding upward and the inner regions recessed around the internal cavity. The aft side exhibited a small flatter region, as shown on the bottom of Figure 2b.

Figure 1 – View of the propeller fragment as received from (a) the aft face and (b) the forward face.

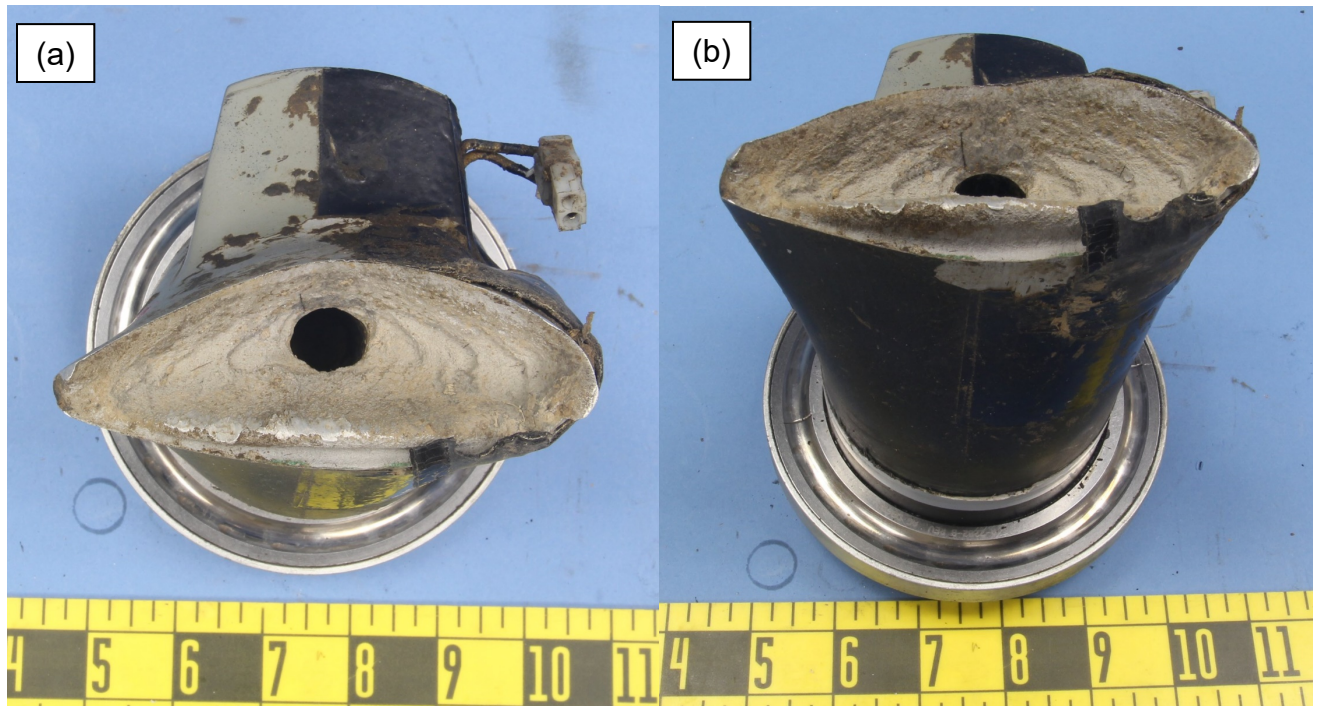
Figure 2 – View of the propeller remnant fracture surface from (a) an oblong view and (b) an angled view.

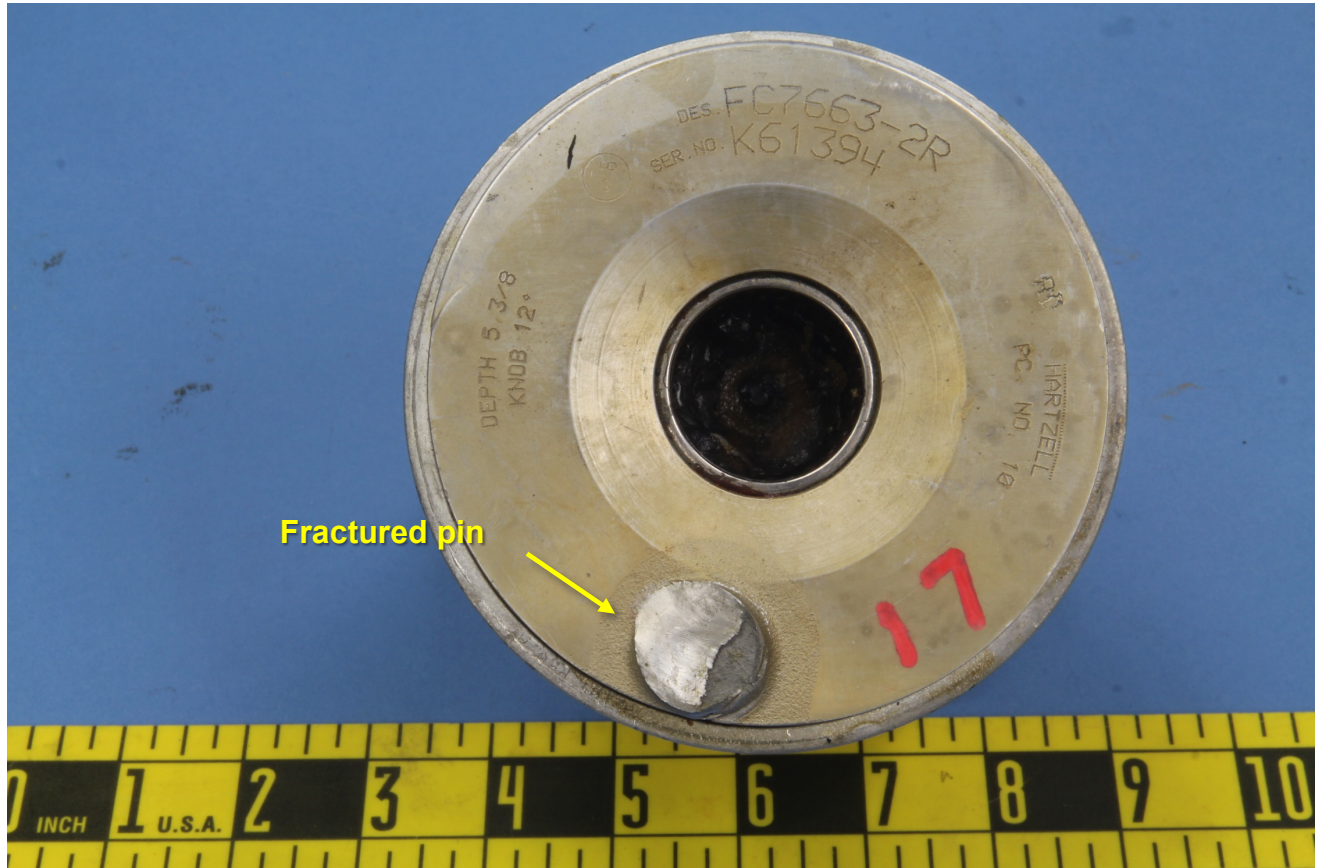
Figure 3 shows the inboard face of the propeller blade root. This face exhibited three sets of markings, stating:

DES. FC7663-2R  
SER. NO. K61394

HARTZELL PC. NO. 10

DEPTH 5 3/8  
KNOB 12°

Figure 3 – View of the inner flange root face of the propeller remnant, as received.

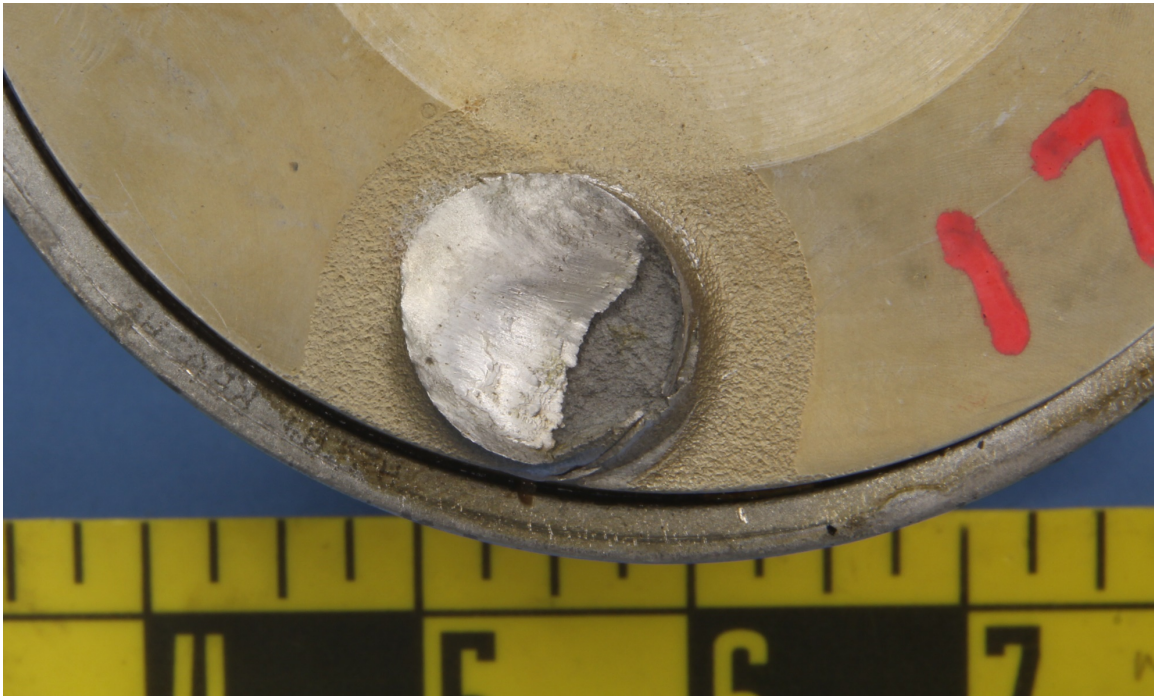
In addition, the number '17' had been handwritten on this face. Of note was the condition of the pitch-change pin, which had fractured as highlighted in Figure 4. Most of the pin fracture surface exhibited a smooth reflective luster with parallel streaks. These features were consistent with post-fracture smearing damage. The remainder of the pin fracture exhibited a rough, flat texture with a dull gray luster.

The features on the blade fracture surface were consistent with fracture of the propeller in bending overstress. The fracture direction was consistent with bending aft ward. The pin on the inboard face exhibited features consistent with having fractured from shear overstress.

Figure 4 – Closer view of the fractured pin on the blade root shown in Figure 3.

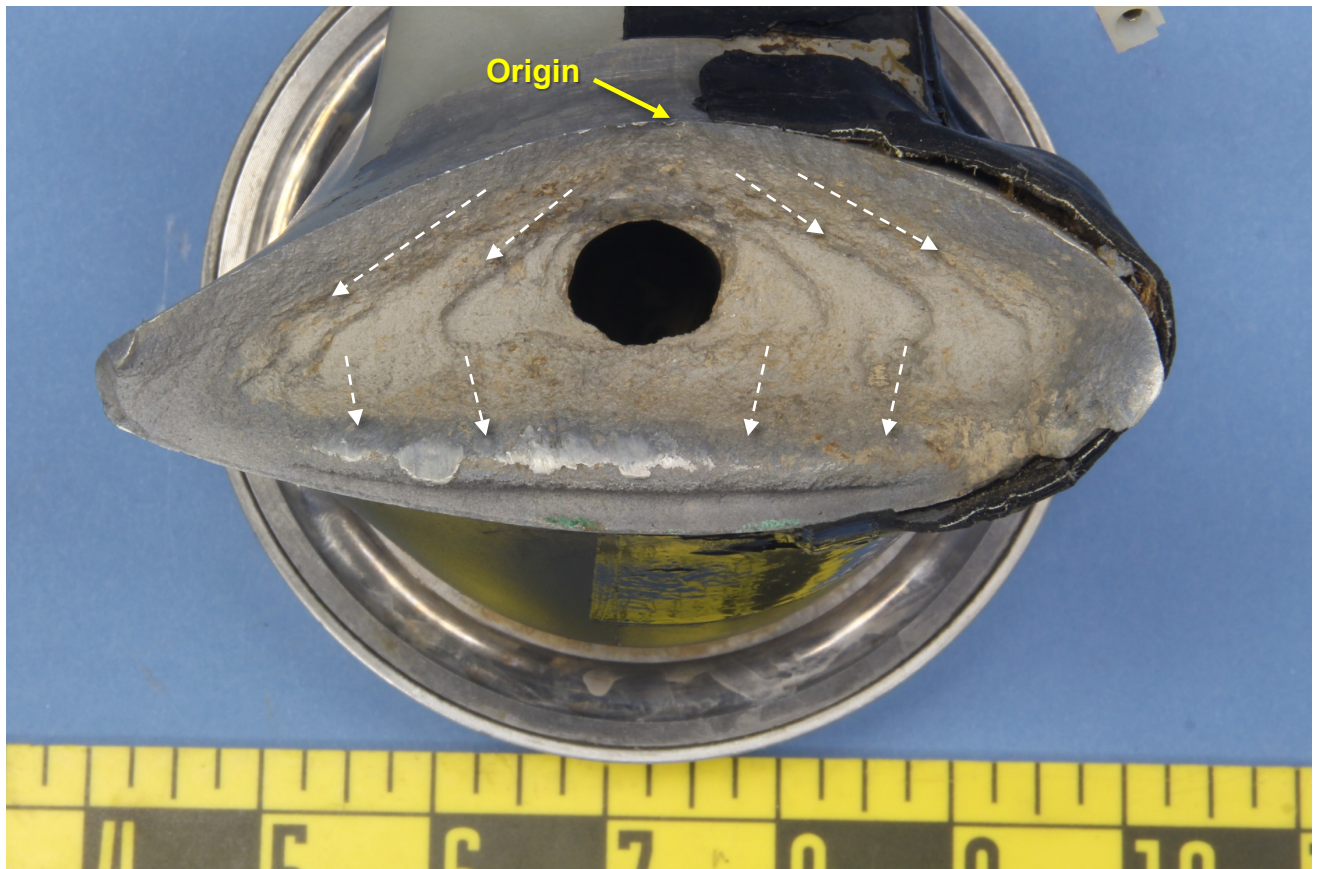
The fracture surfaces were cleaned using a mild soap detergent in an ultrasonic bath. In addition, the caked and packed dirt in the internal blade cavity was removed. The cleaned fracture surface is shown in Figure 5. This fracture surface exhibited features such as river patterns and flow marks consistent with the direction of fracture. These features were consistent with fracture from the forward face of the propeller towards the aft. The cup-shaped fracture surface exhibited shear lips around much of the periphery. The lower portion (aft side) of the fracture surface in Figure 5 exhibited a protruding ridge, consistent with a cantilever curl. The aftmost flat surface was consistent with localized compression. These features were consistent with bending stresses toward the aft direction.

Figure 5 – View of the propeller remnant fracture after cleaning, annotated to show the general fracture directions as exemplified by the river patterns.

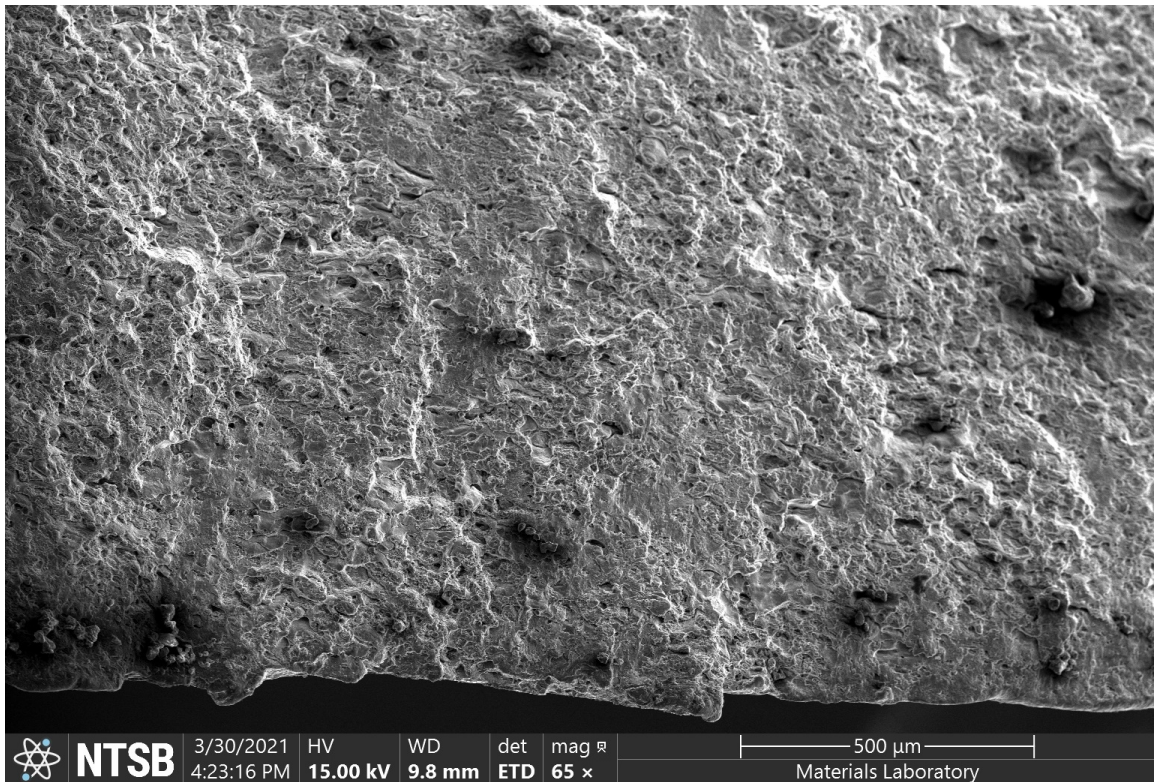
The origin on the forward edge of the blade fracture surface and the inboard pin fracture surface were excised and inspected using a scanning electron microscope (SEM). A typical area of the forward edge of the propeller remnant fracture surface is shown in Figure 6. The surface exhibited a rough undulating surface texture. Closer examination of this region revealed dimpled rupture, as illustrated in Figure 7. These features were consistent with overstress fracture and were found throughout the examined fracture surface. There were no indications of features consistent with other fracture modes.

Figure 6 – Secondary electron (SE) micrograph of the beginning of the remnant fracture on the forward edge.

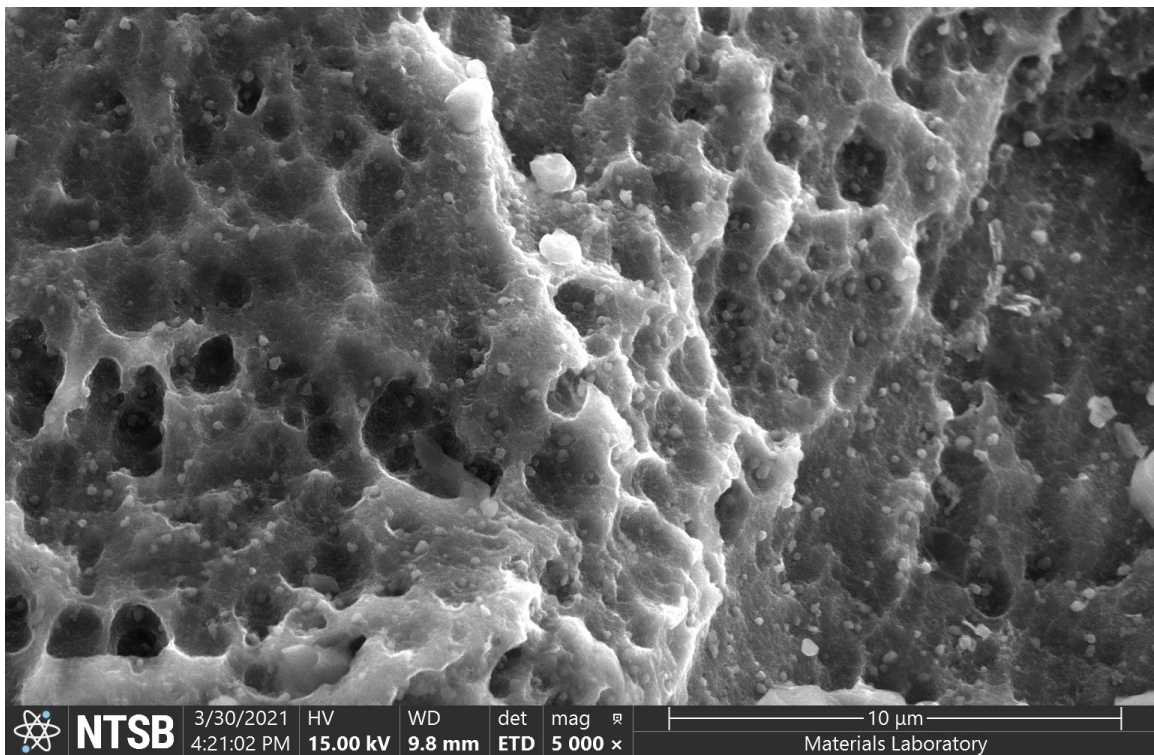
Figure 7 – SE micrograph of a closer view of the Figure 6 fracture surface, showing dimpled rupture.

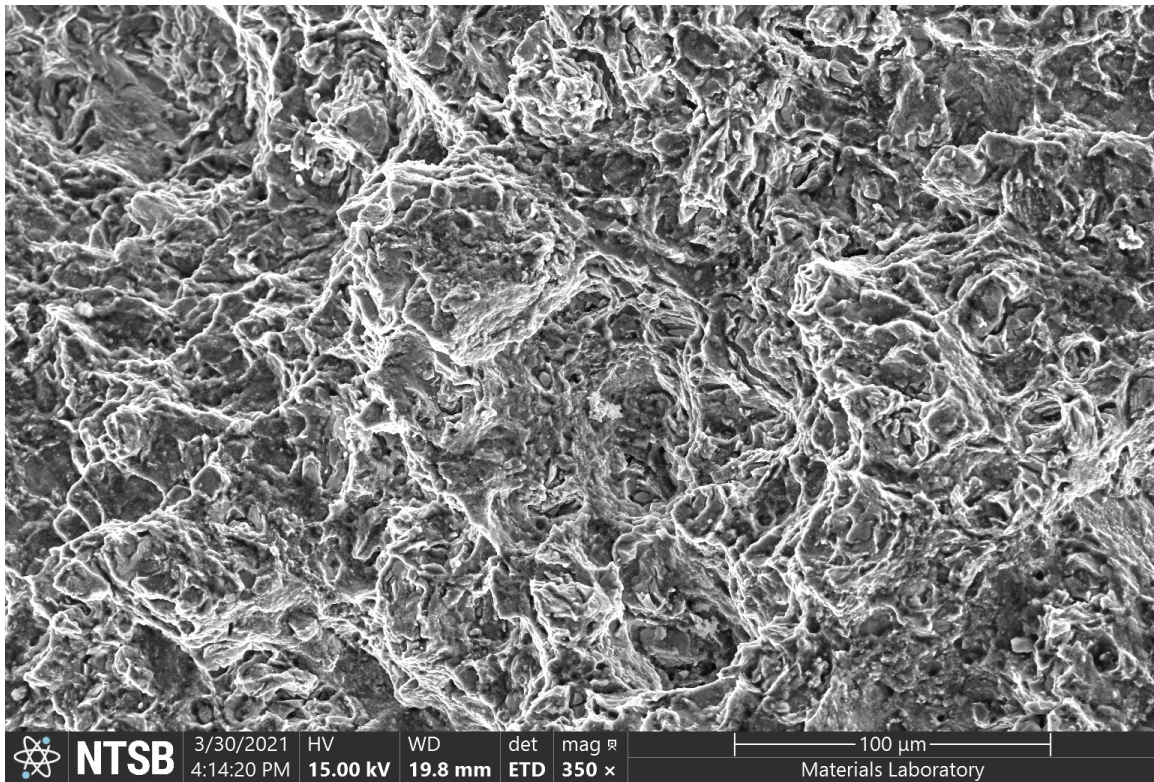
Figure 8 shows a typical region of the undamaged portion of the pin fracture surface. As shown in Figures 9 and 10, this fracture surface exhibited dimpled rupture, consistent with overstress fracture.

Figure 8 – SE micrograph of a typical area of the undamaged pin fracture surface.

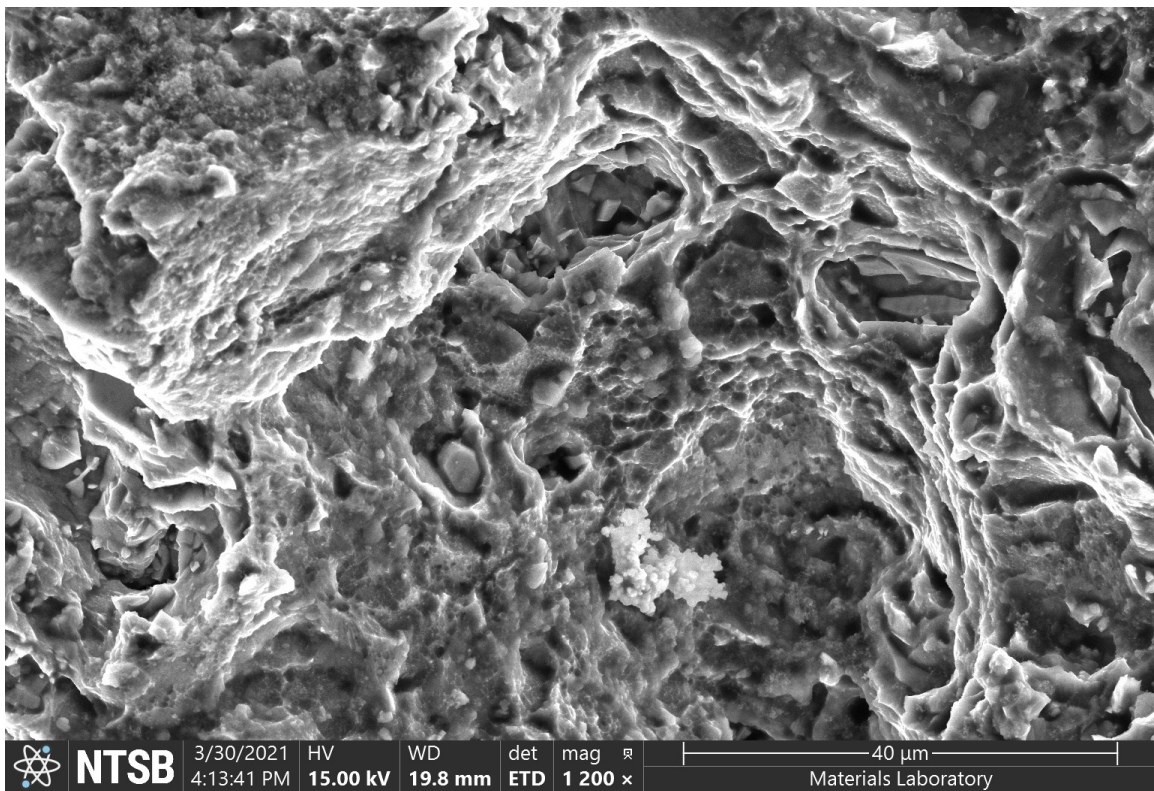
Figure 9 – SE micrograph of a closer view of Figure 8, showing dimpled rupture.

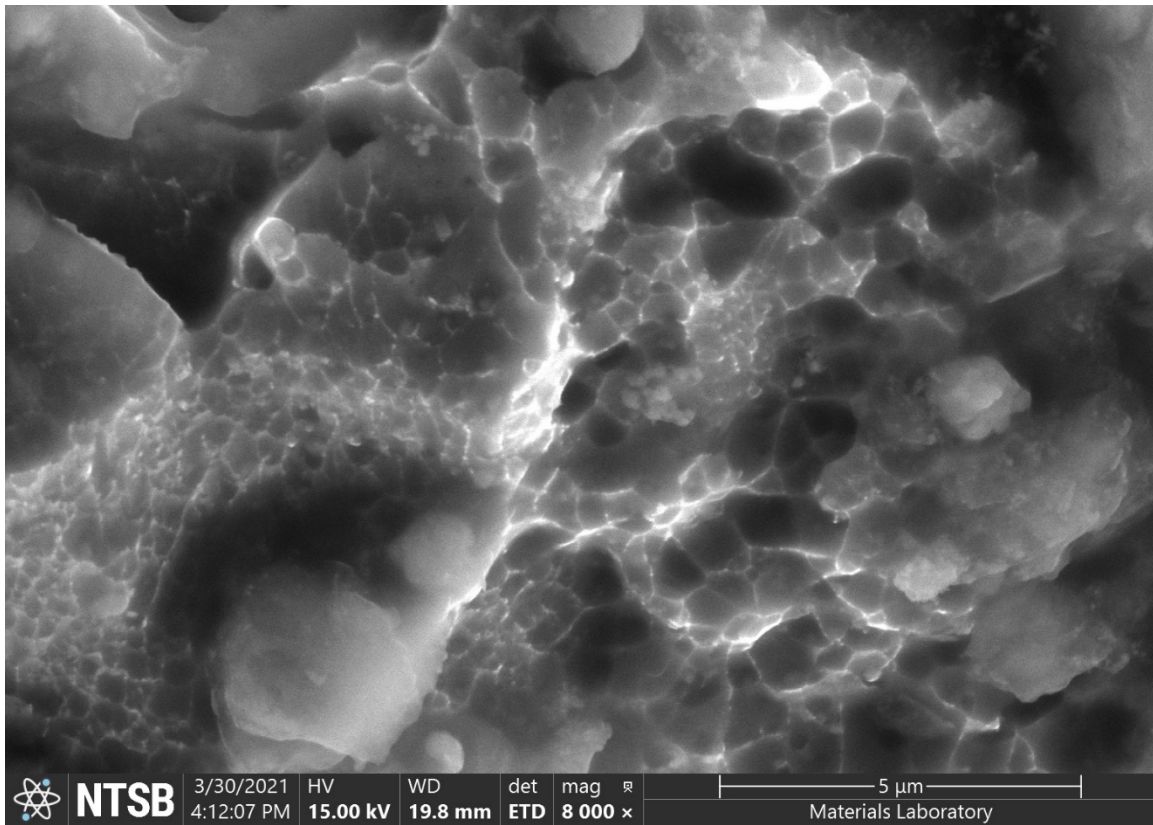
Figure 10 – SE micrograph of dimpled rupture at a higher magnification from Figure 9.
