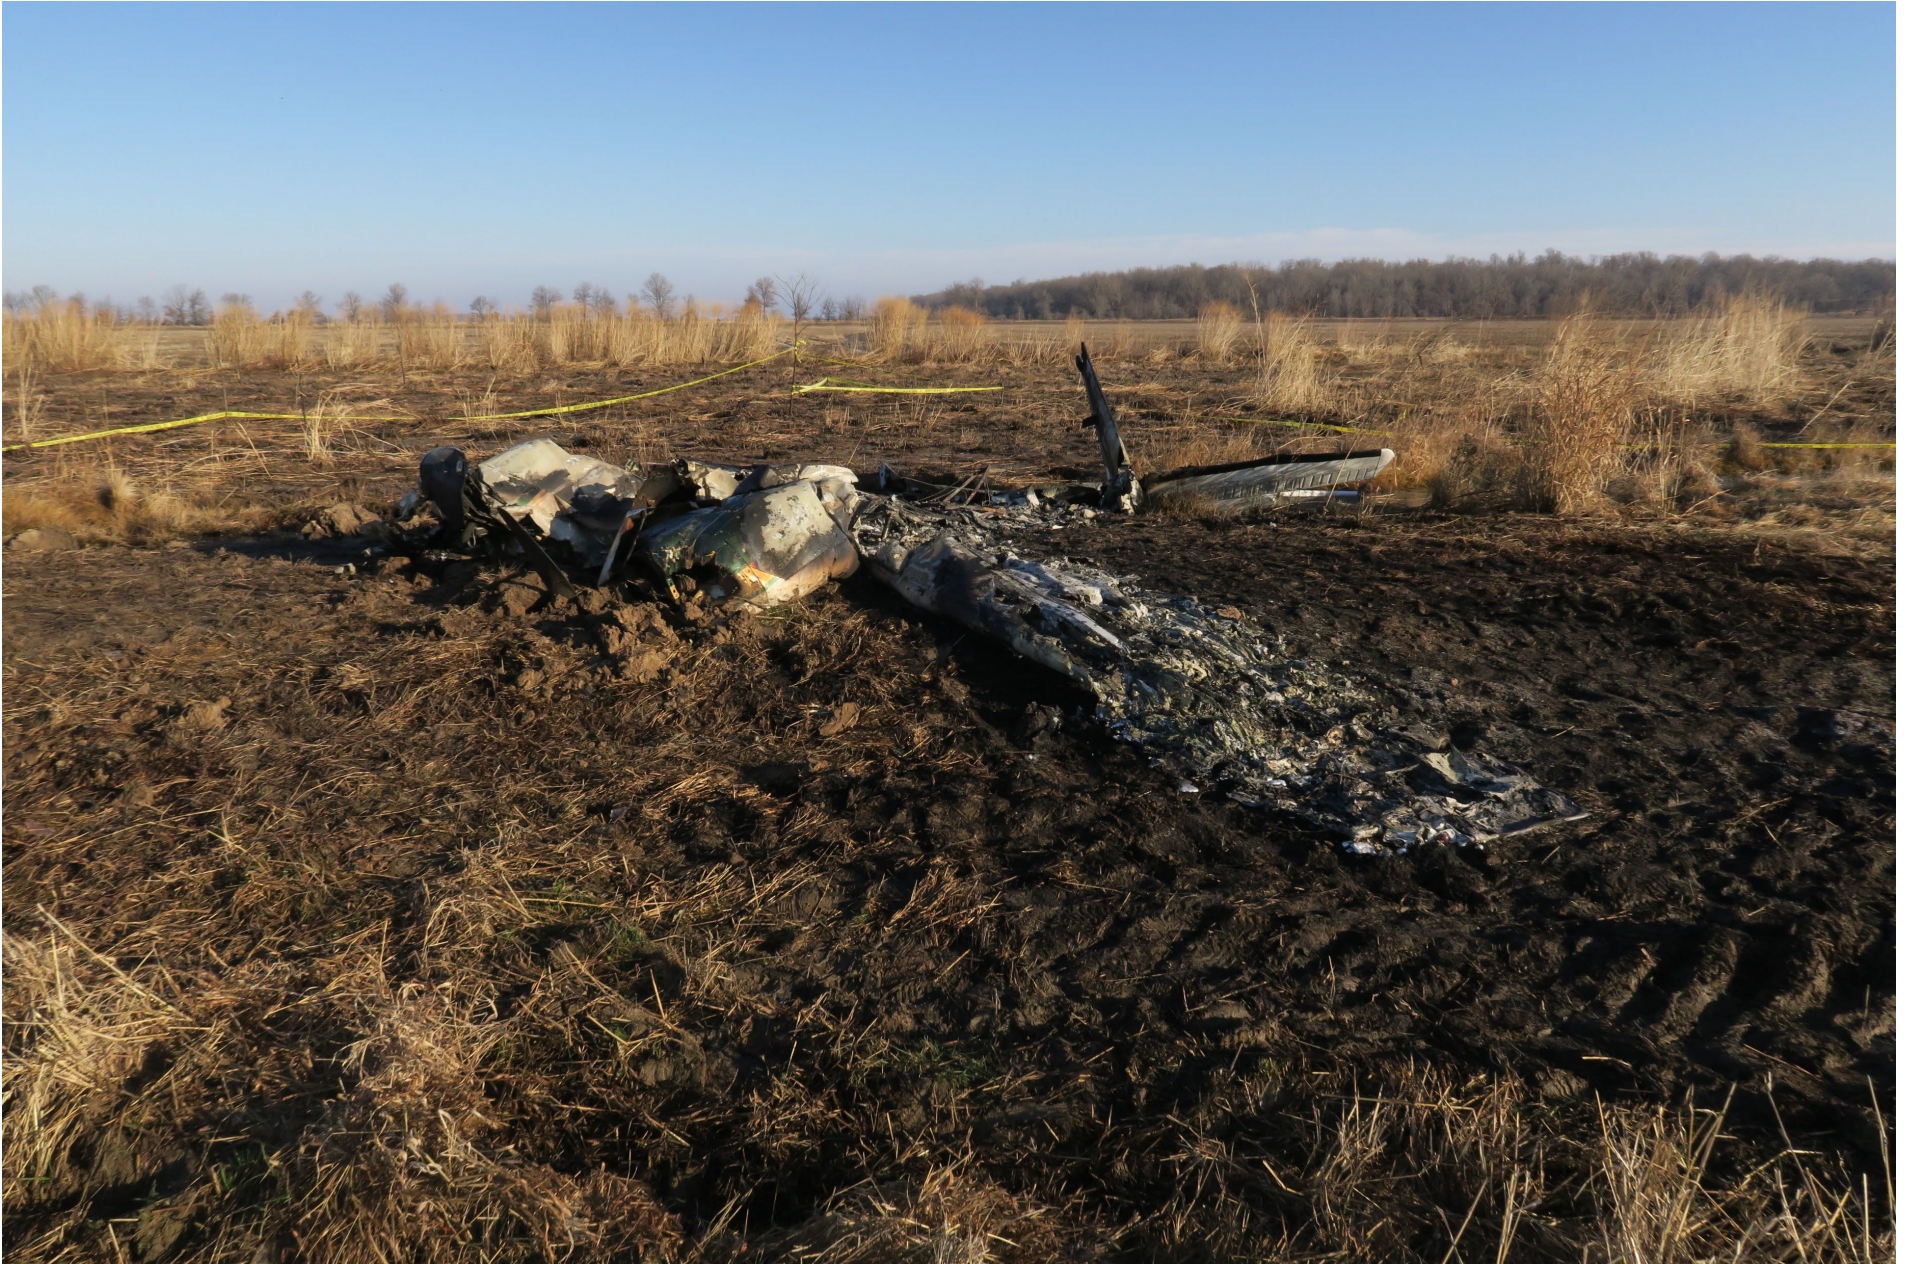
**Photo 1 – View of the wreckage at the accident site (courtesy of Textron Aviation).**

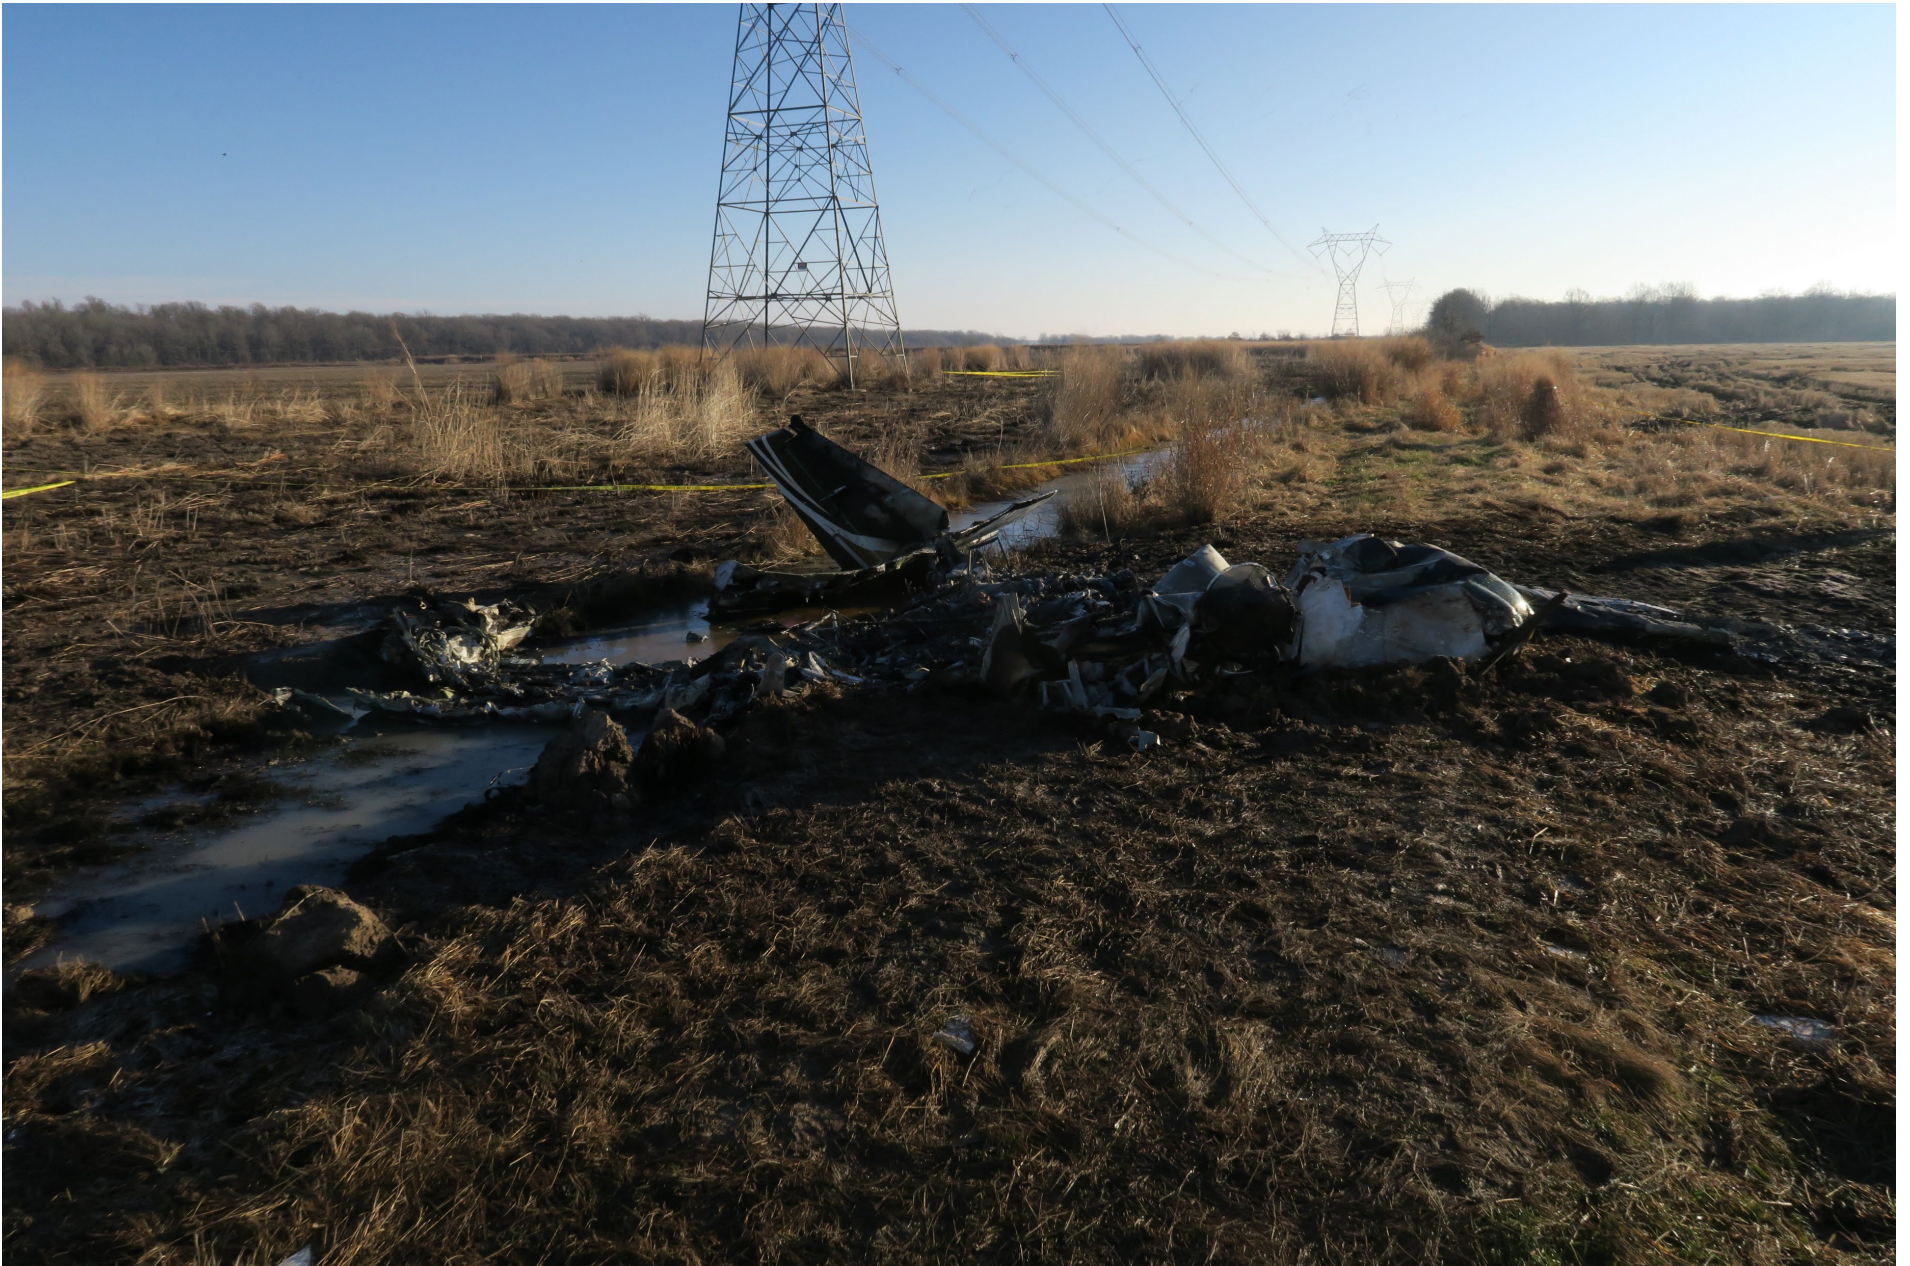
**Photo 2 – View of the wreckage at the accident site (courtesy of Textron Aviation).**

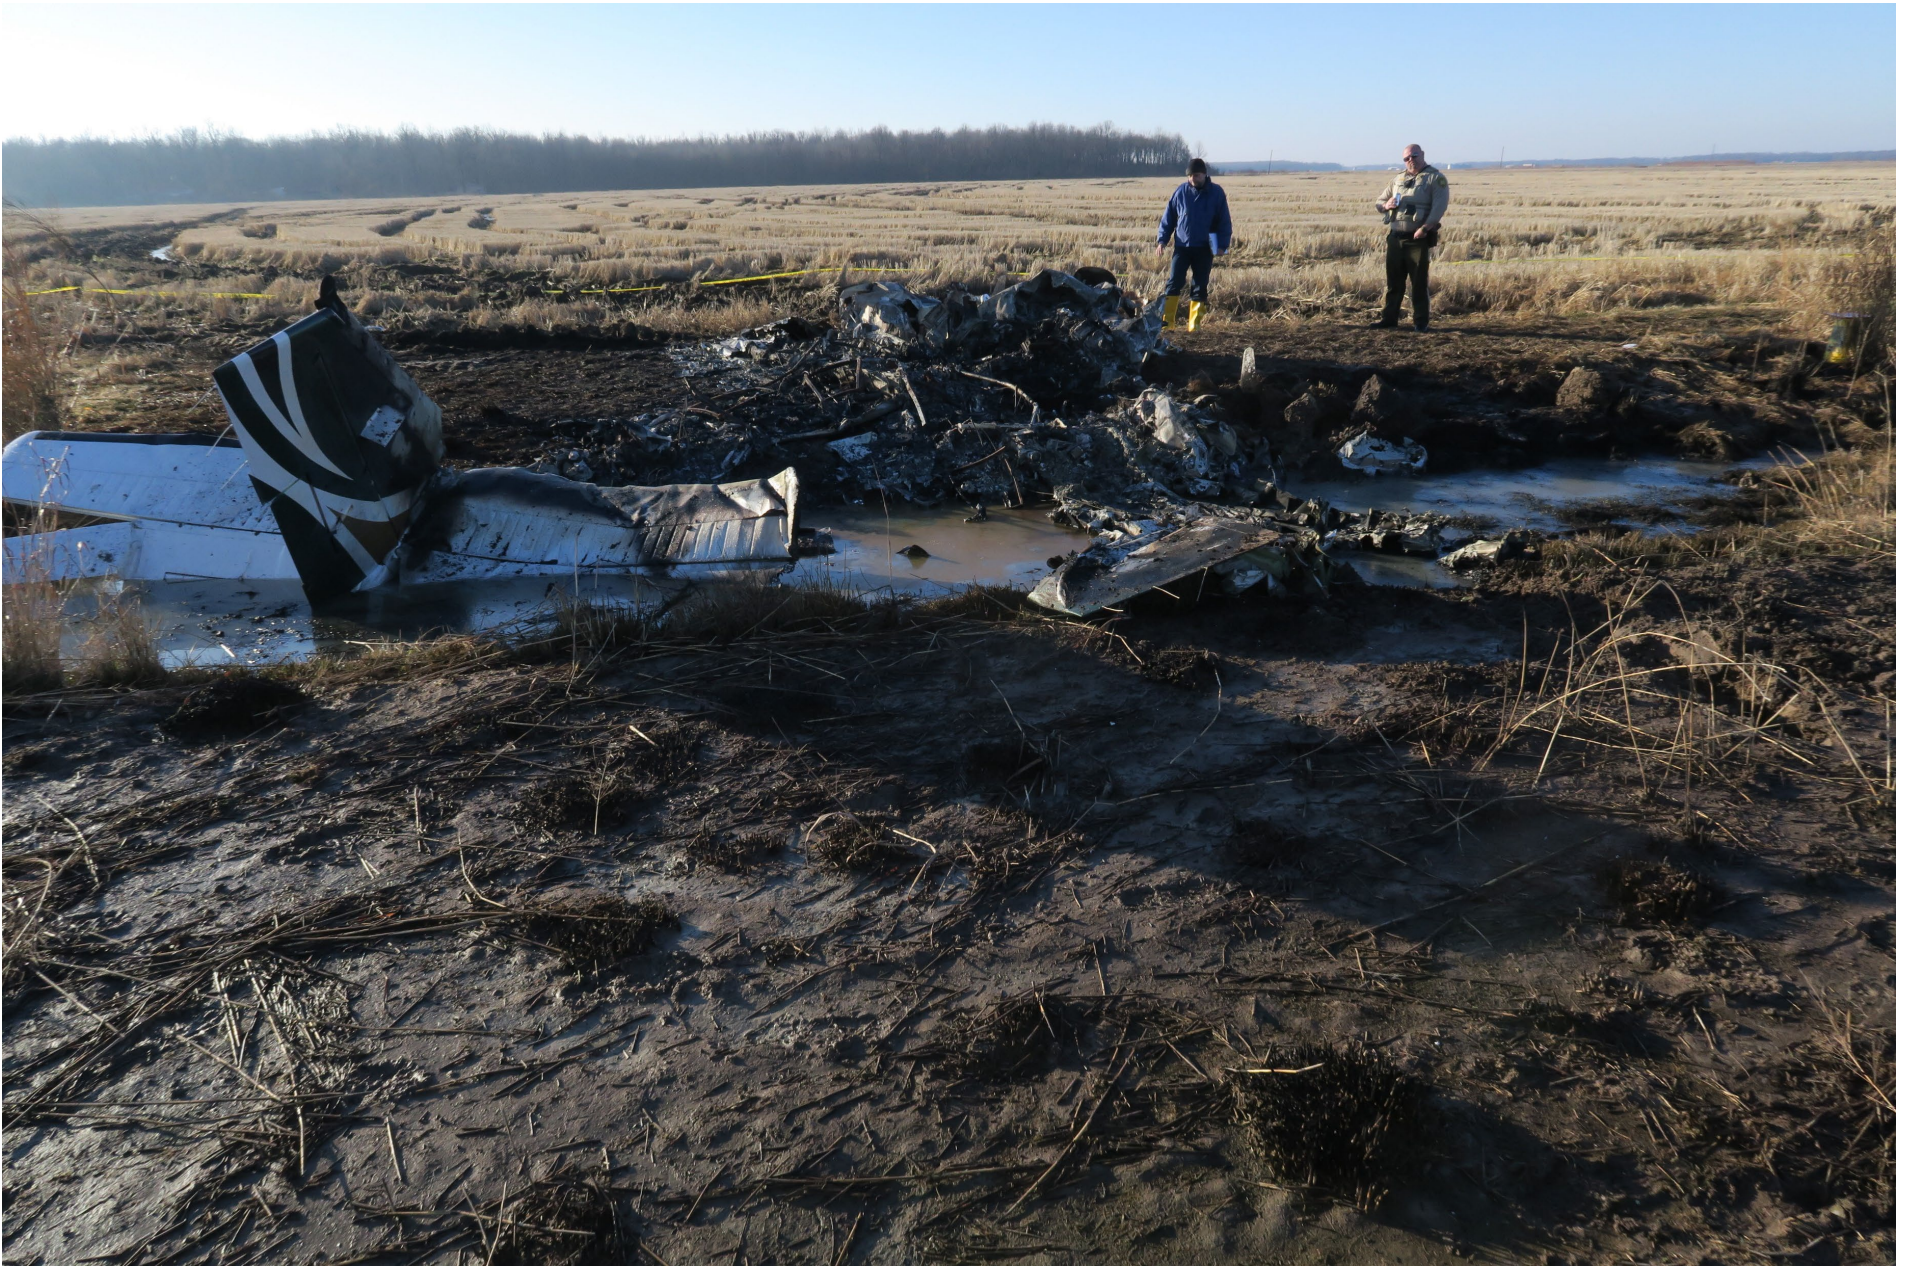
**Photo 3 – View of the wreckage at the accident site (courtesy of Textron Aviation).**

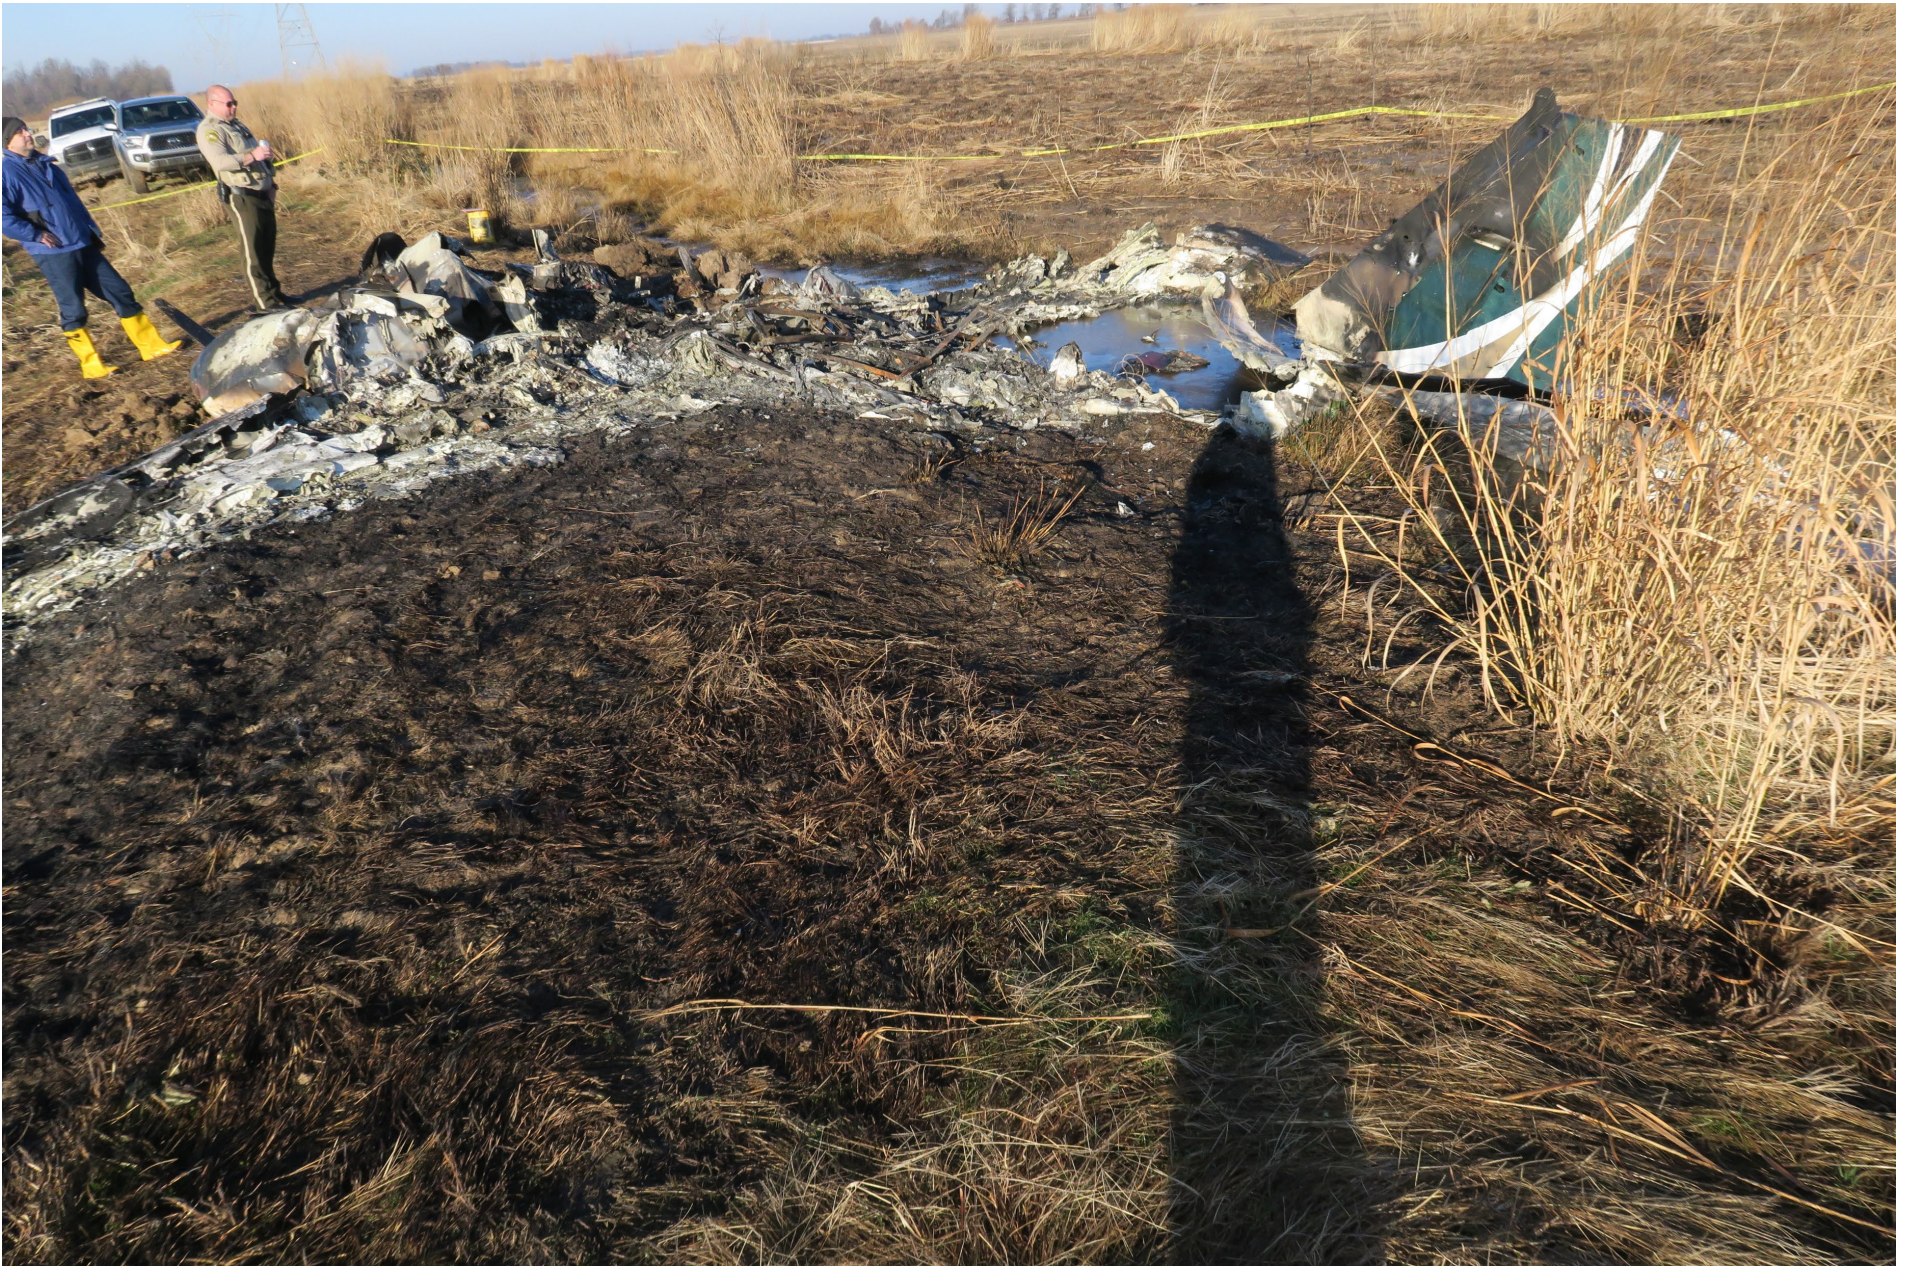
**Photo 4 – View of the wreckage at the accident site (courtesy of Textron Aviation).**

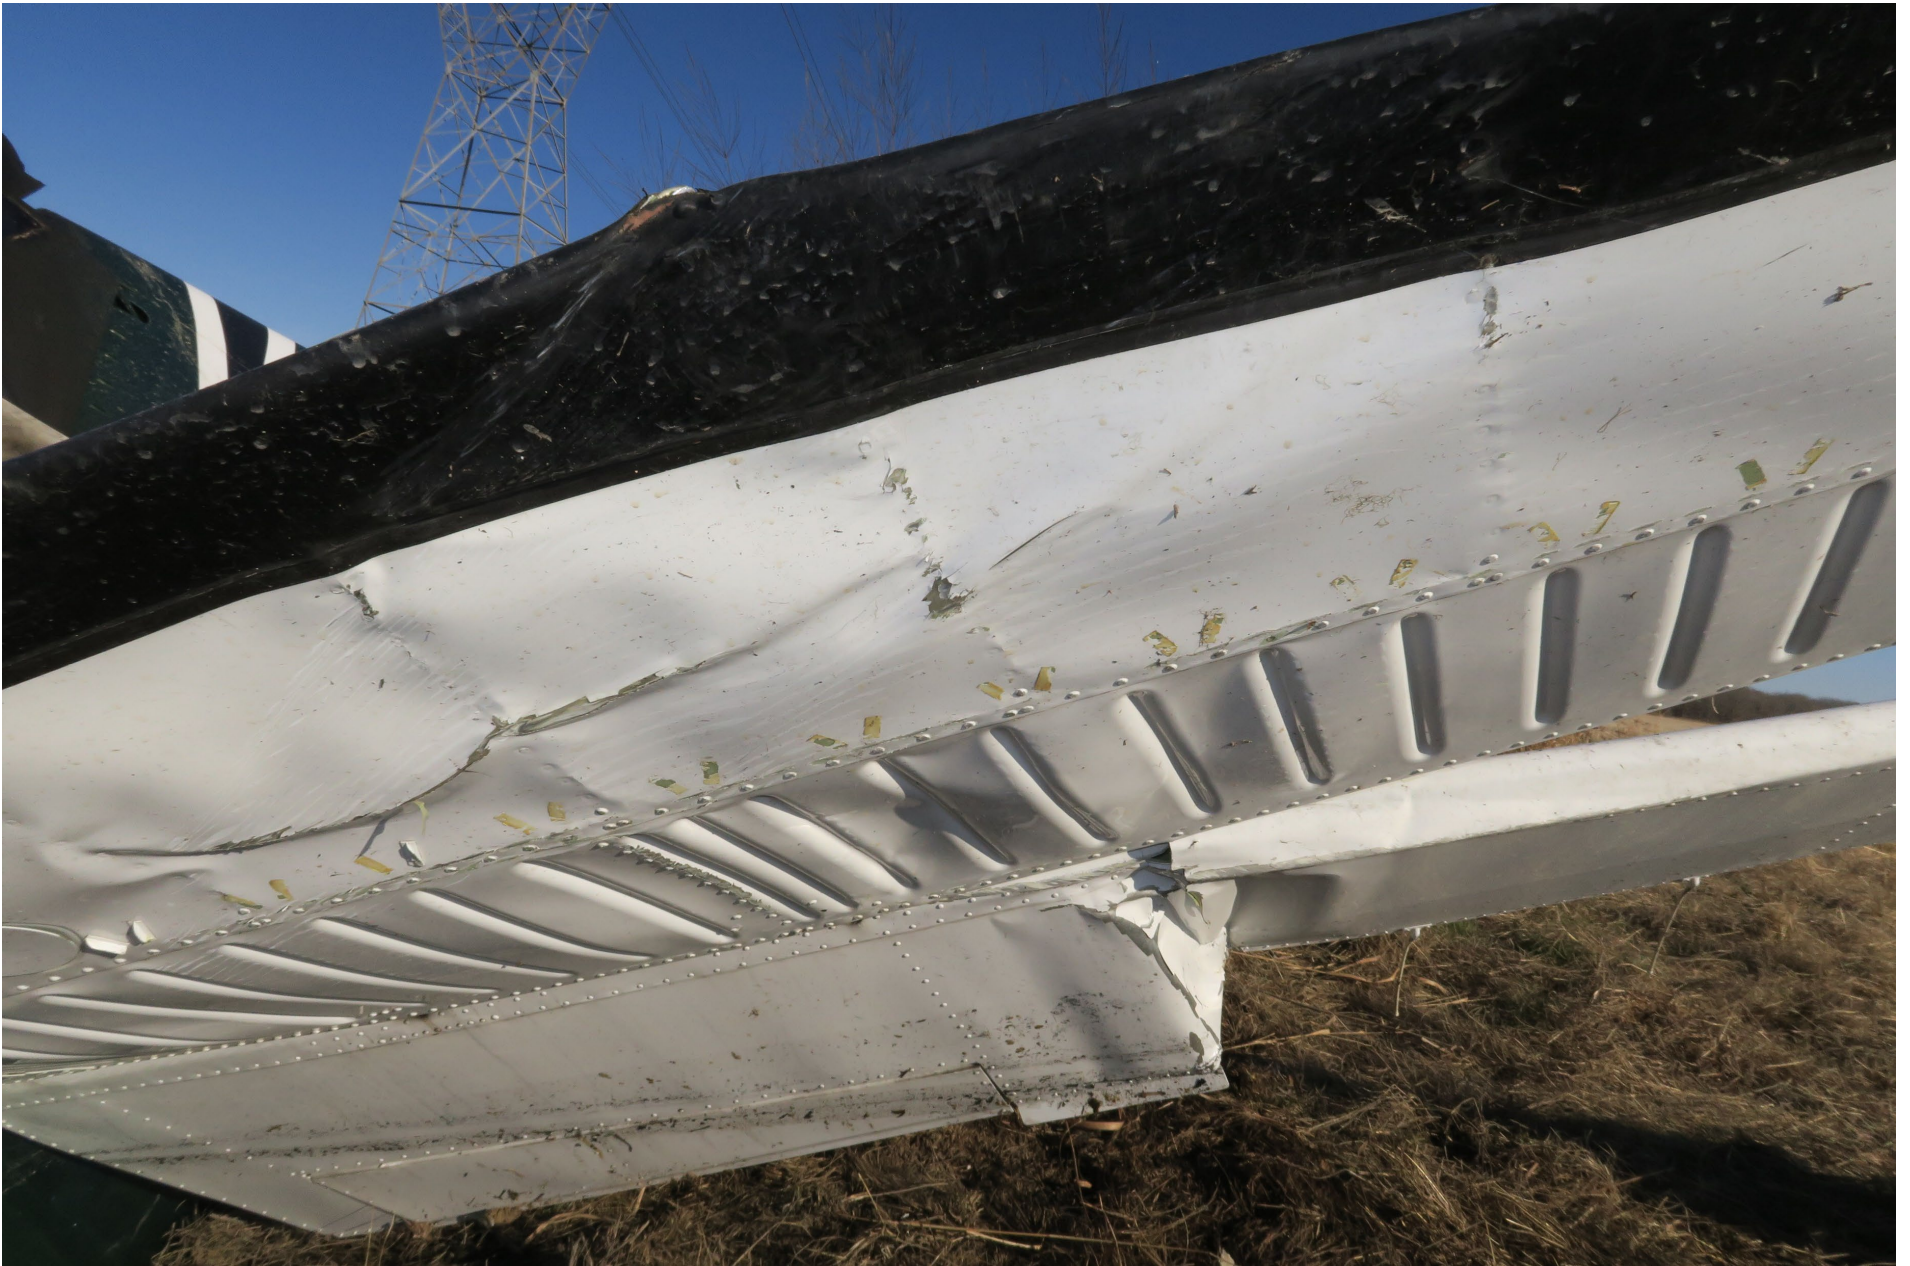
**Photo 5 – View of the left horizontal stabilizer showing a wire strike (courtesy of Textron Aviation).**

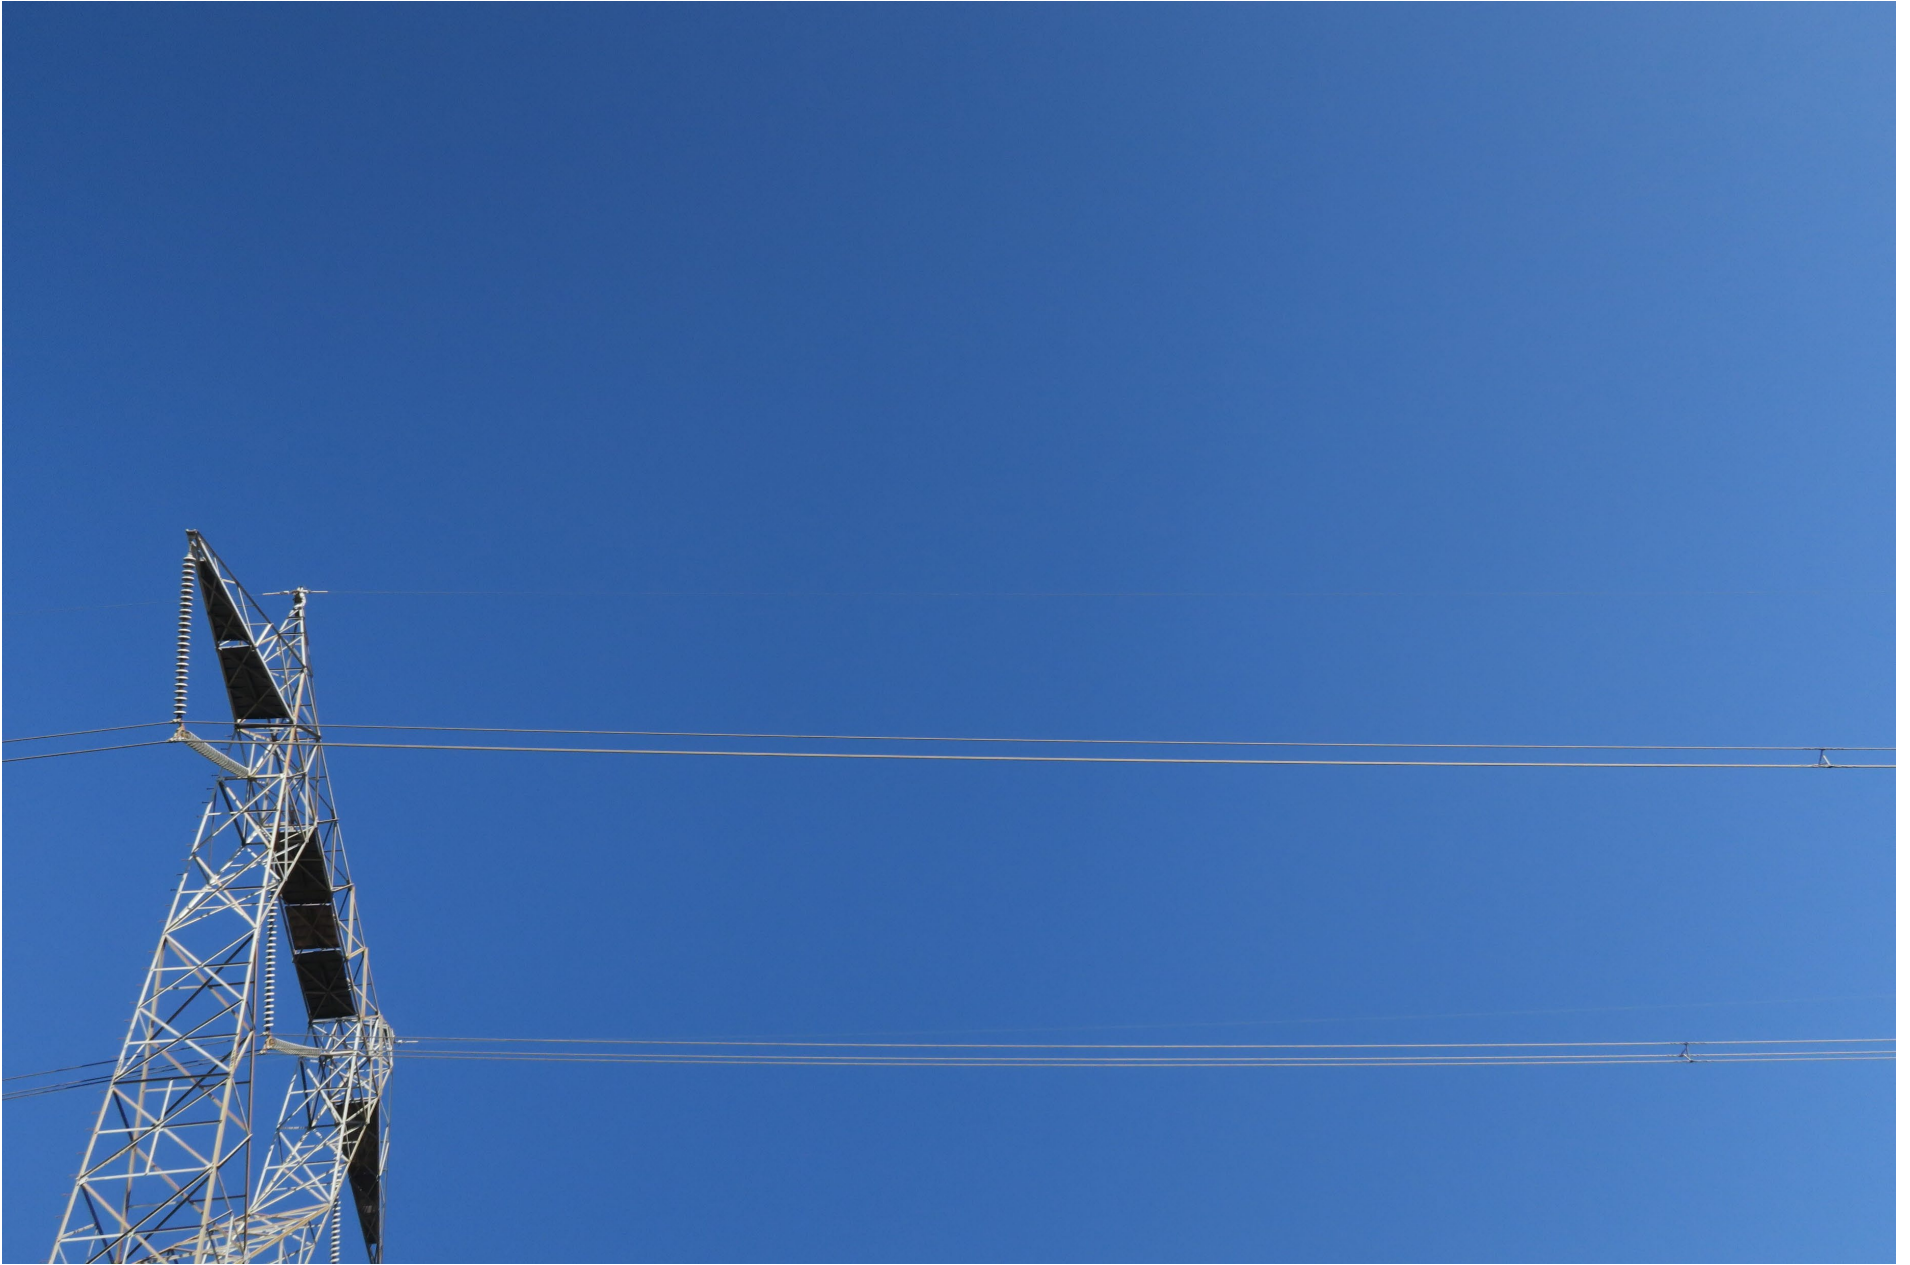
**Photo 6 – View of the power lines at the accident site (courtesy of Textron Aviation).**

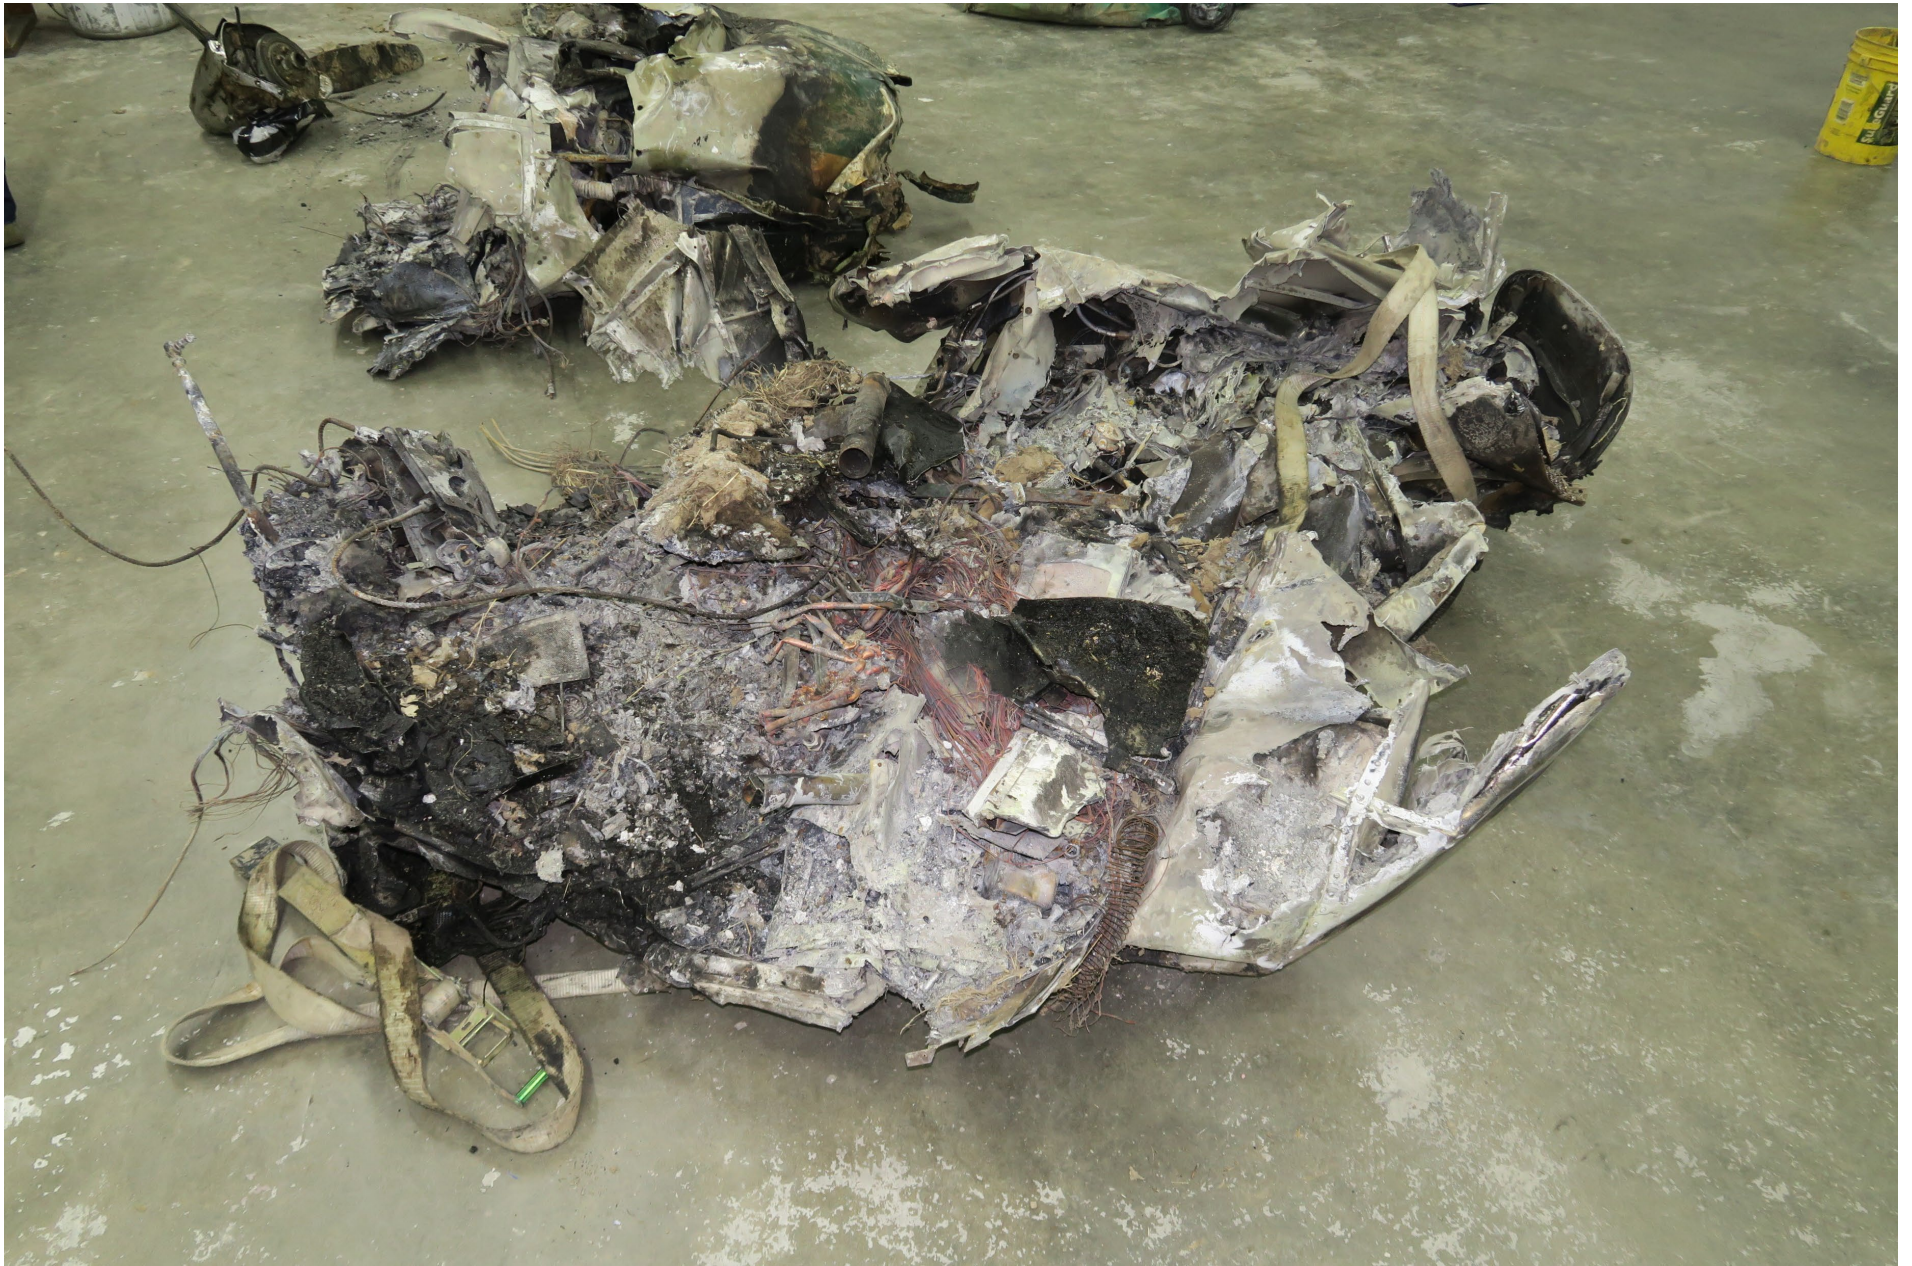
**Photo 7 – View of the airframe being laid out (courtesy of Textron Aviation).**

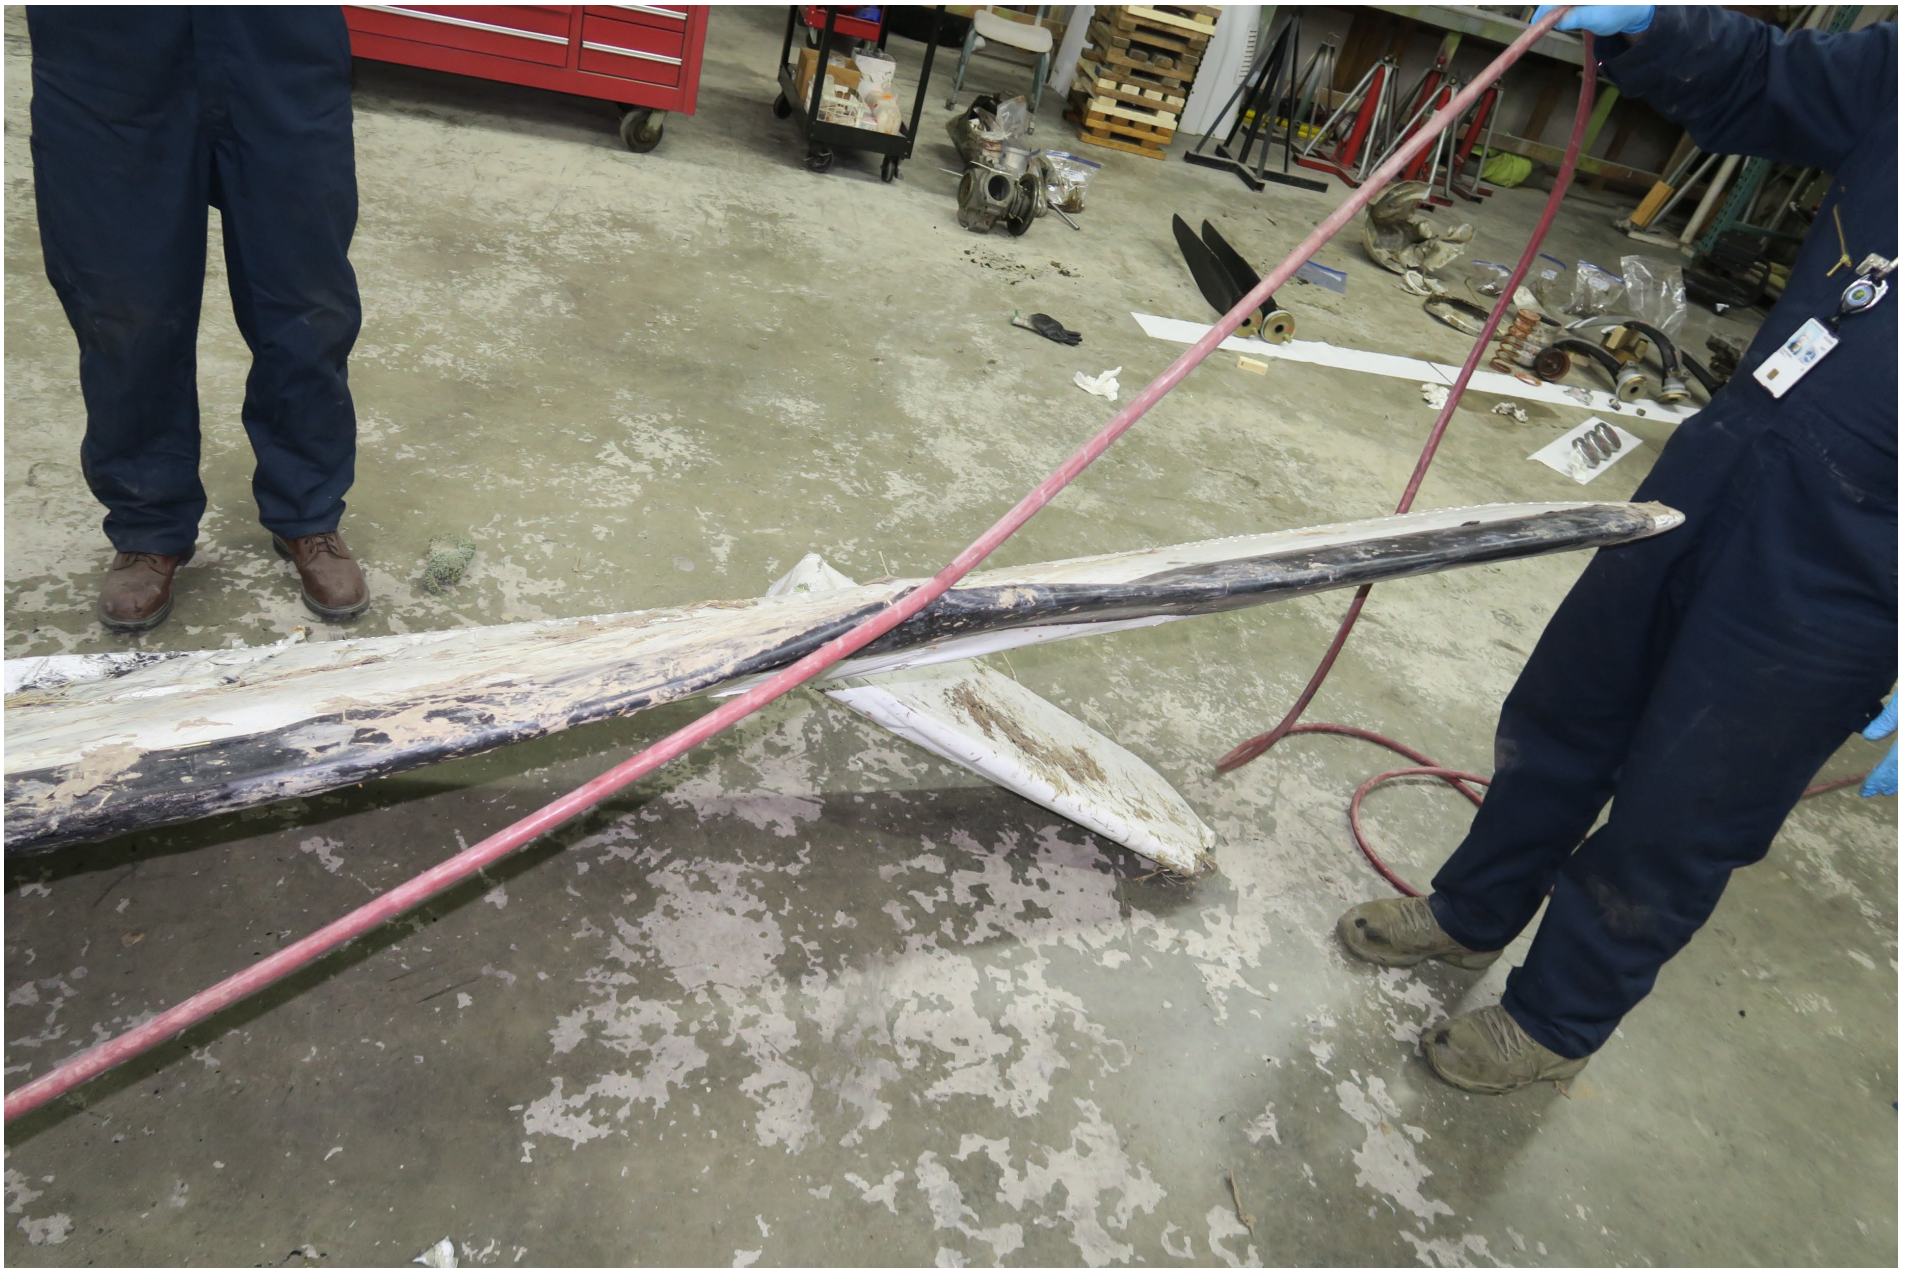
**Photo 8 – View of the left horizontal stabilizer showing the wire strike area (courtesy of Textron Aviation).**

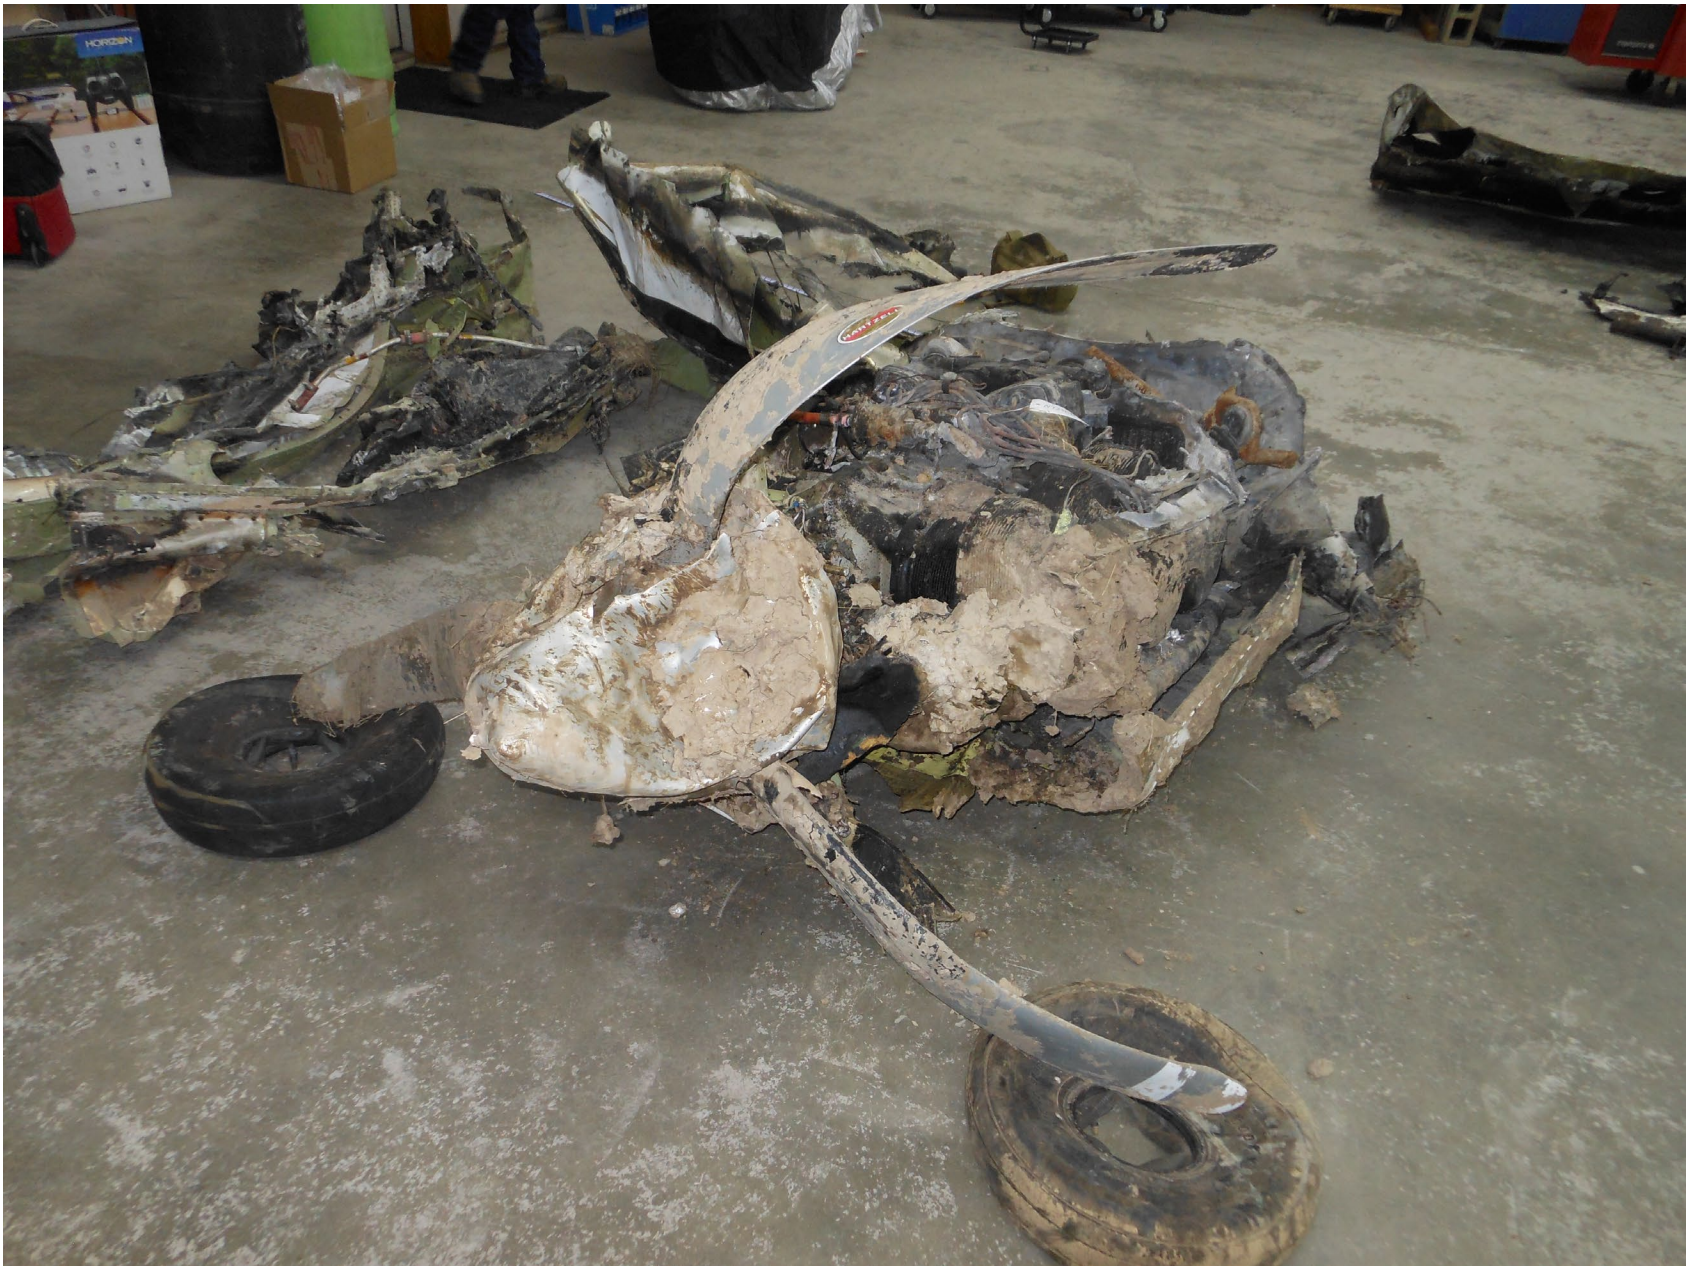
**Photo 9 – View of the right propeller (courtesy Hartzell Propeller).**
