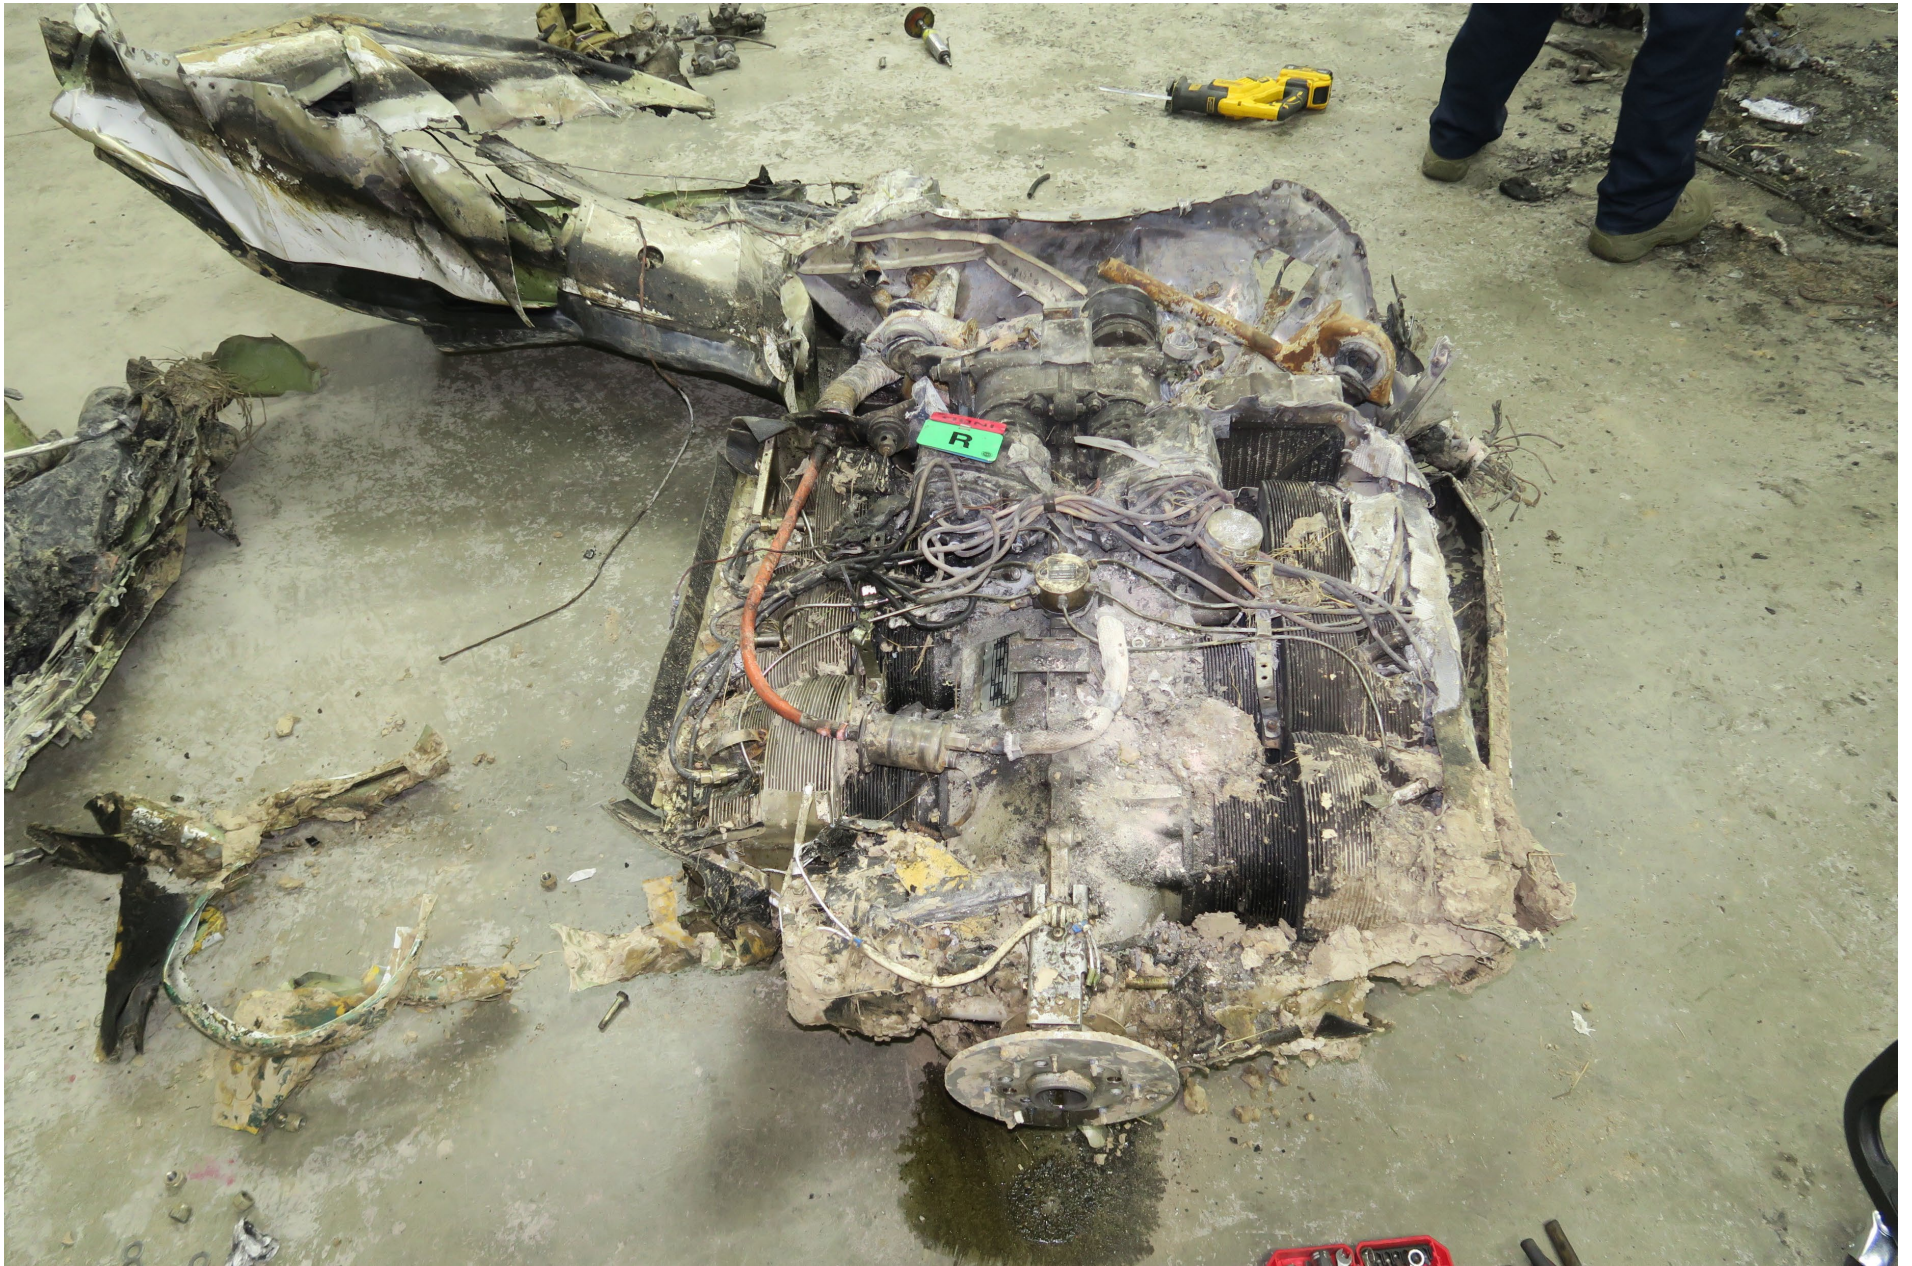
**Photo 10 – View of the right engine (courtesy of Textron Aviation).**

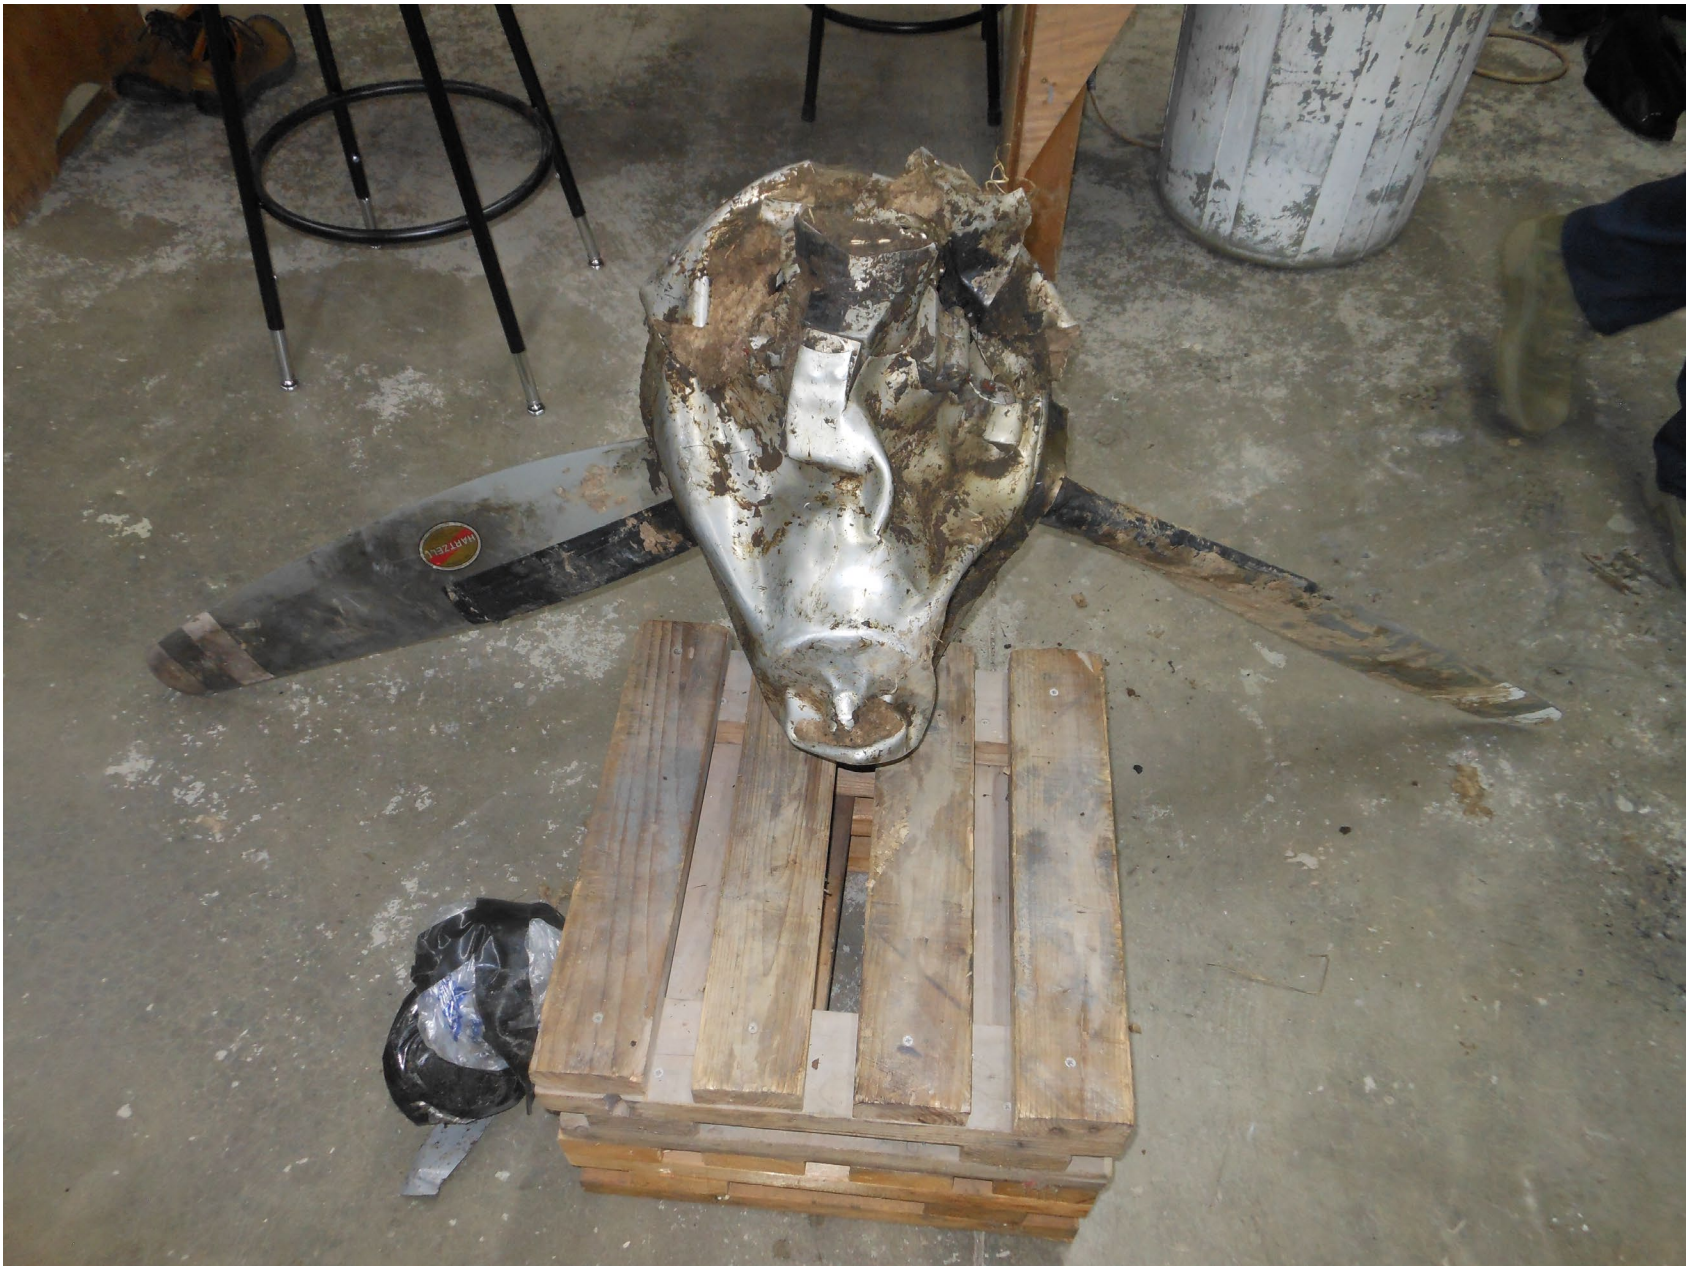
**Photo 11 – View of the left propeller (courtesy of Hartzell Propeller).**

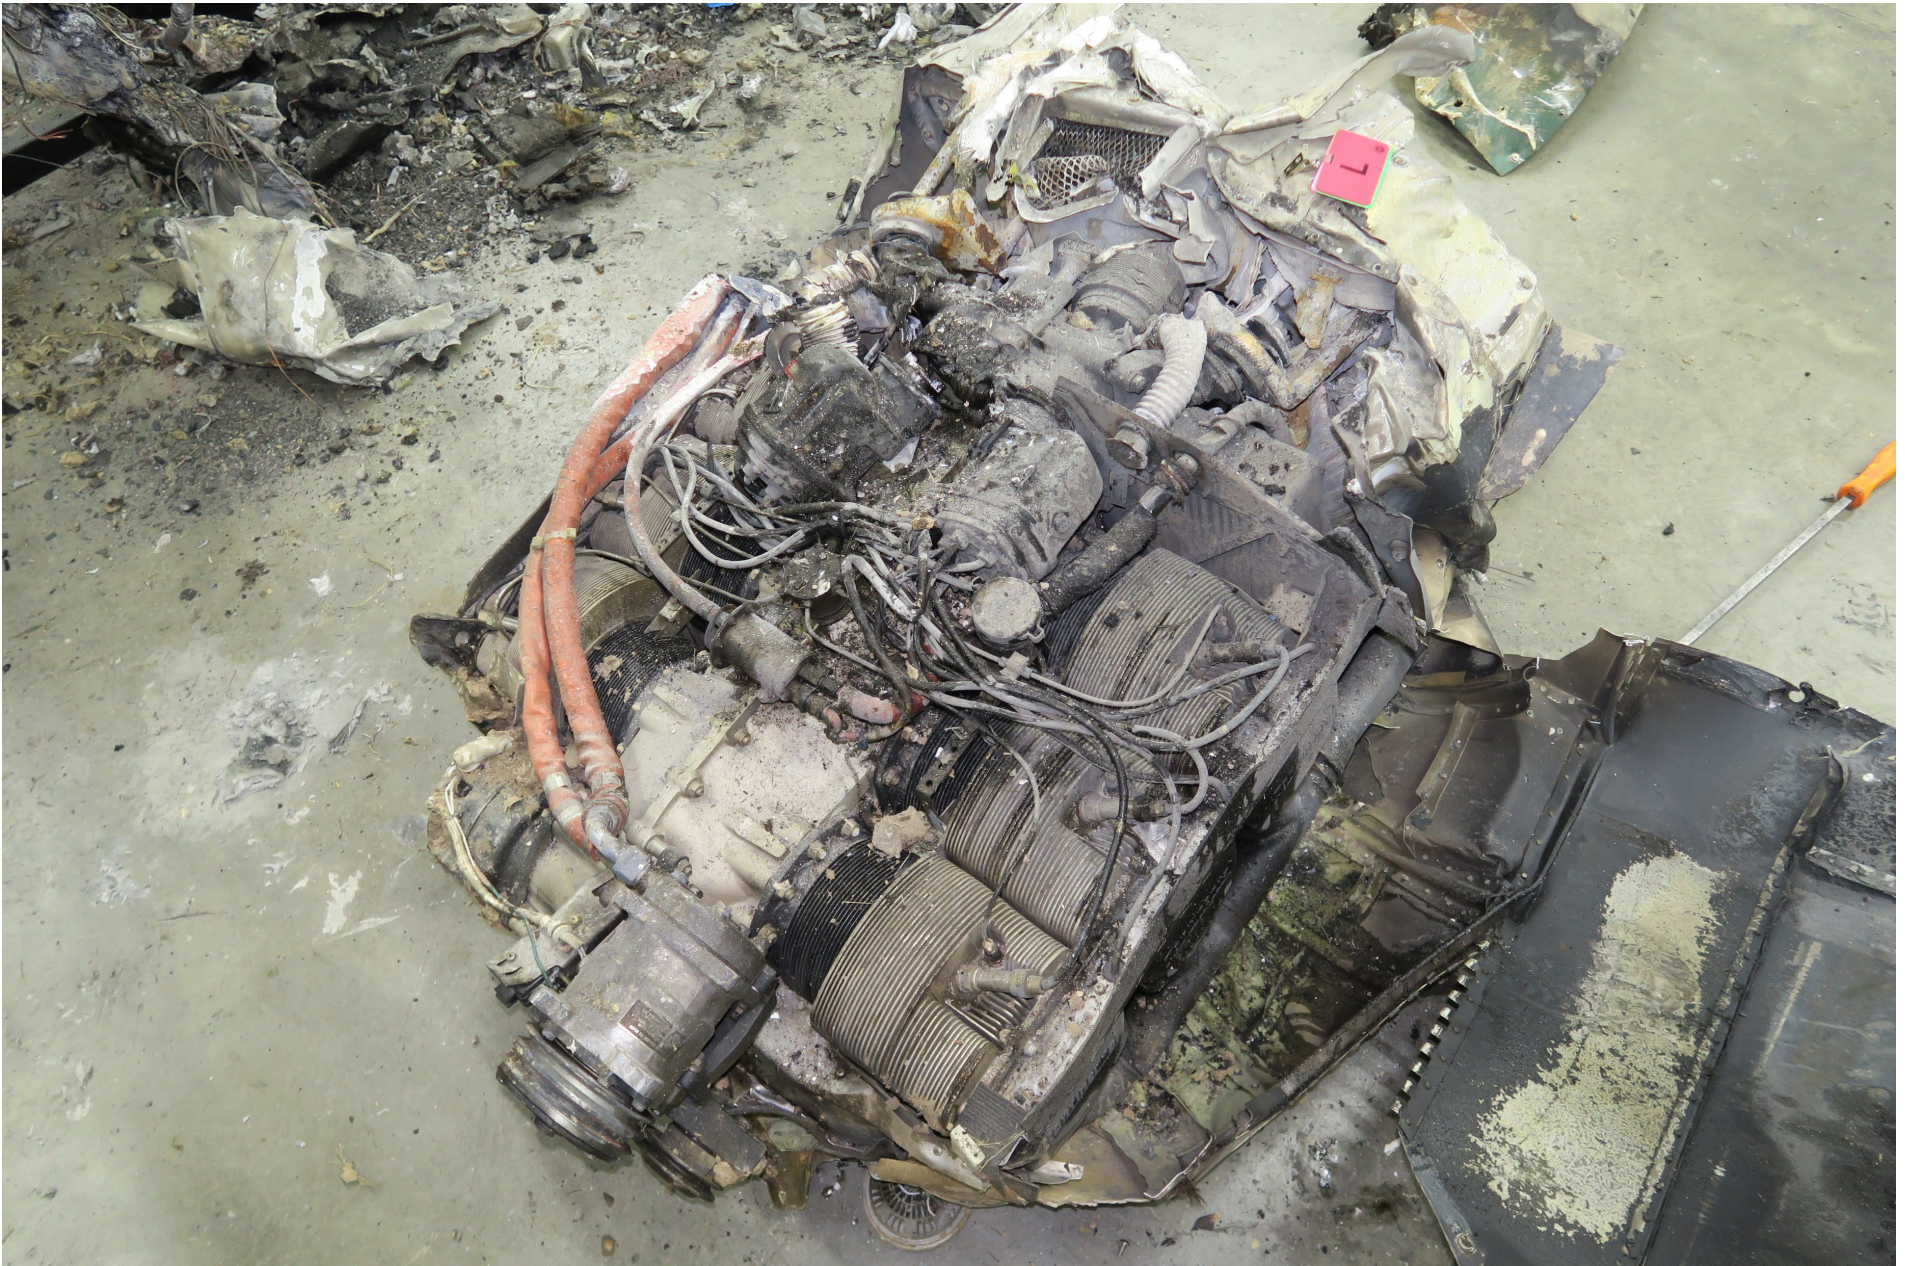
**Photo 12 – View of the left engine (courtesy of Textron Aviation).**

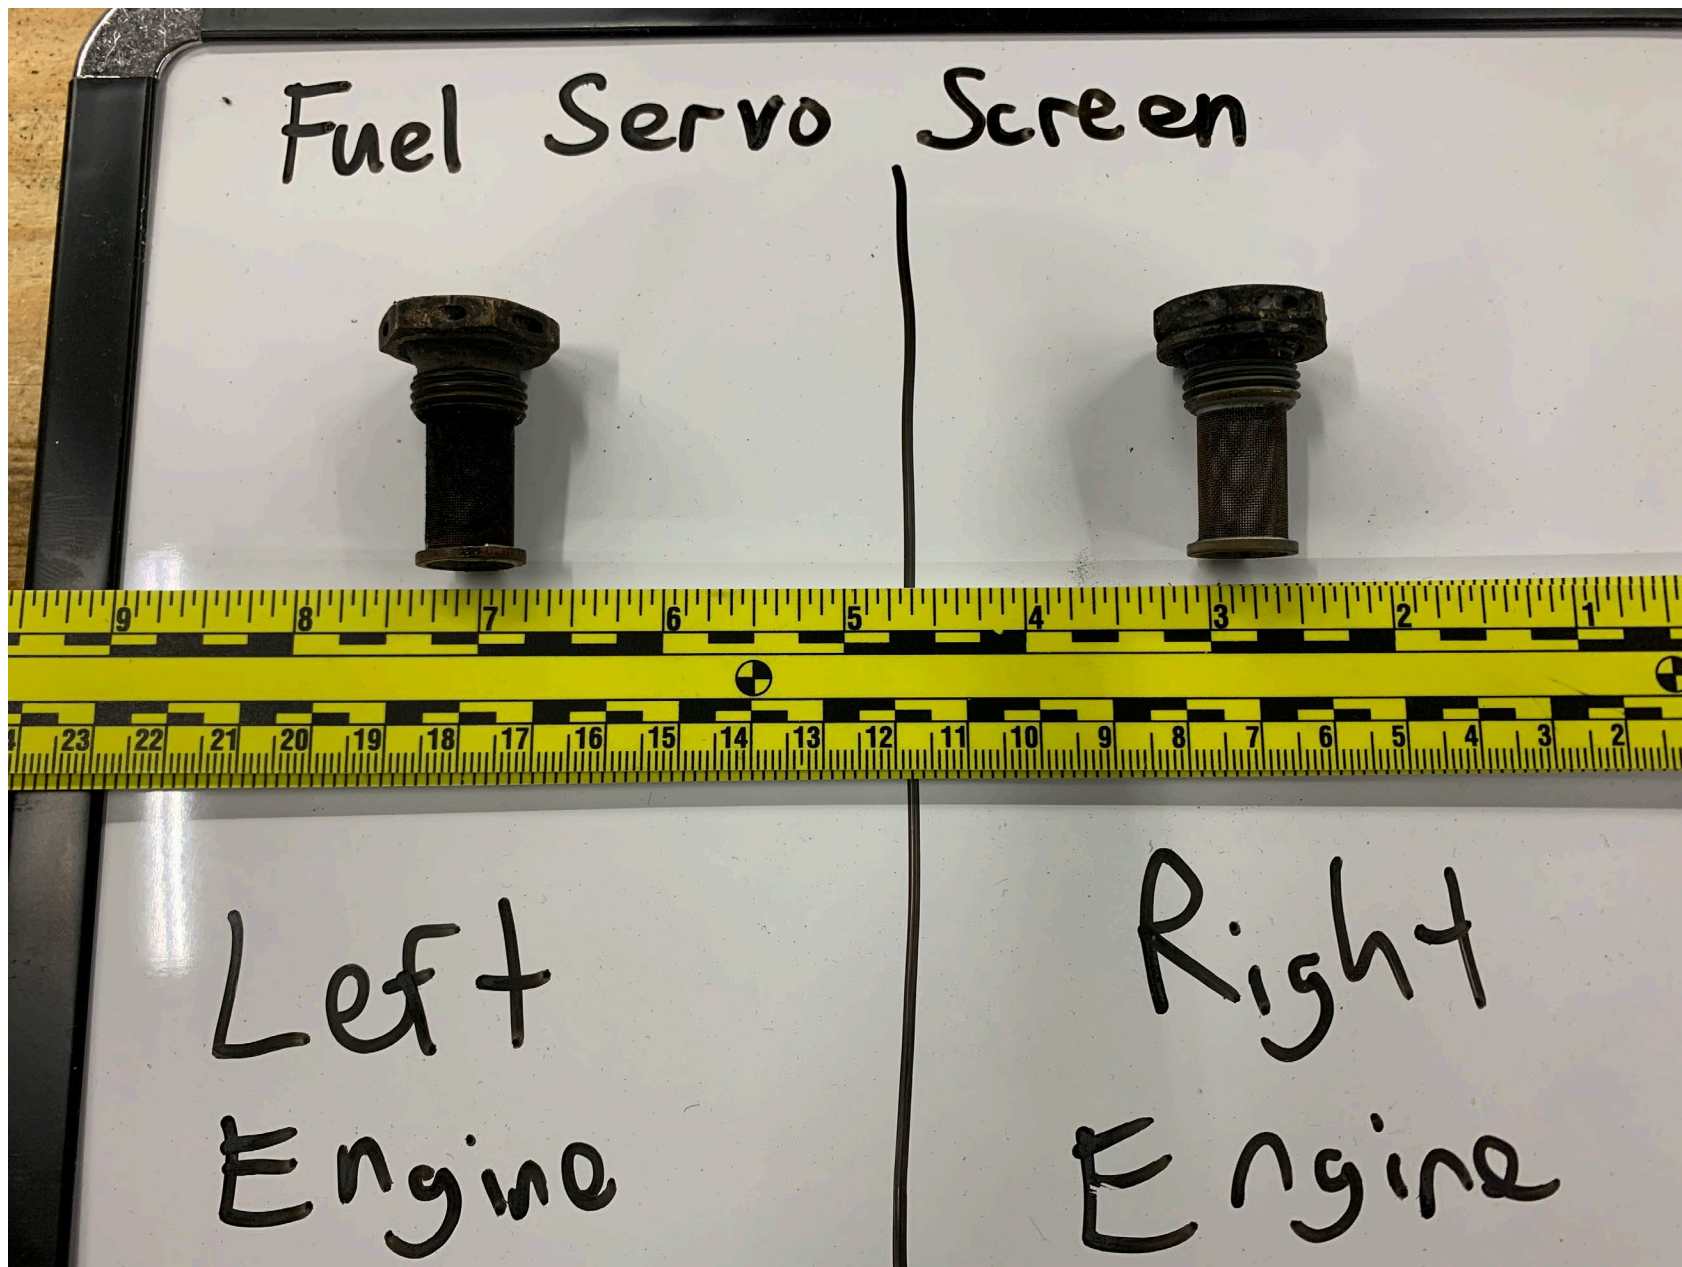
Photo 13 – View of the fuel servo screens for the left engine and the right engine.

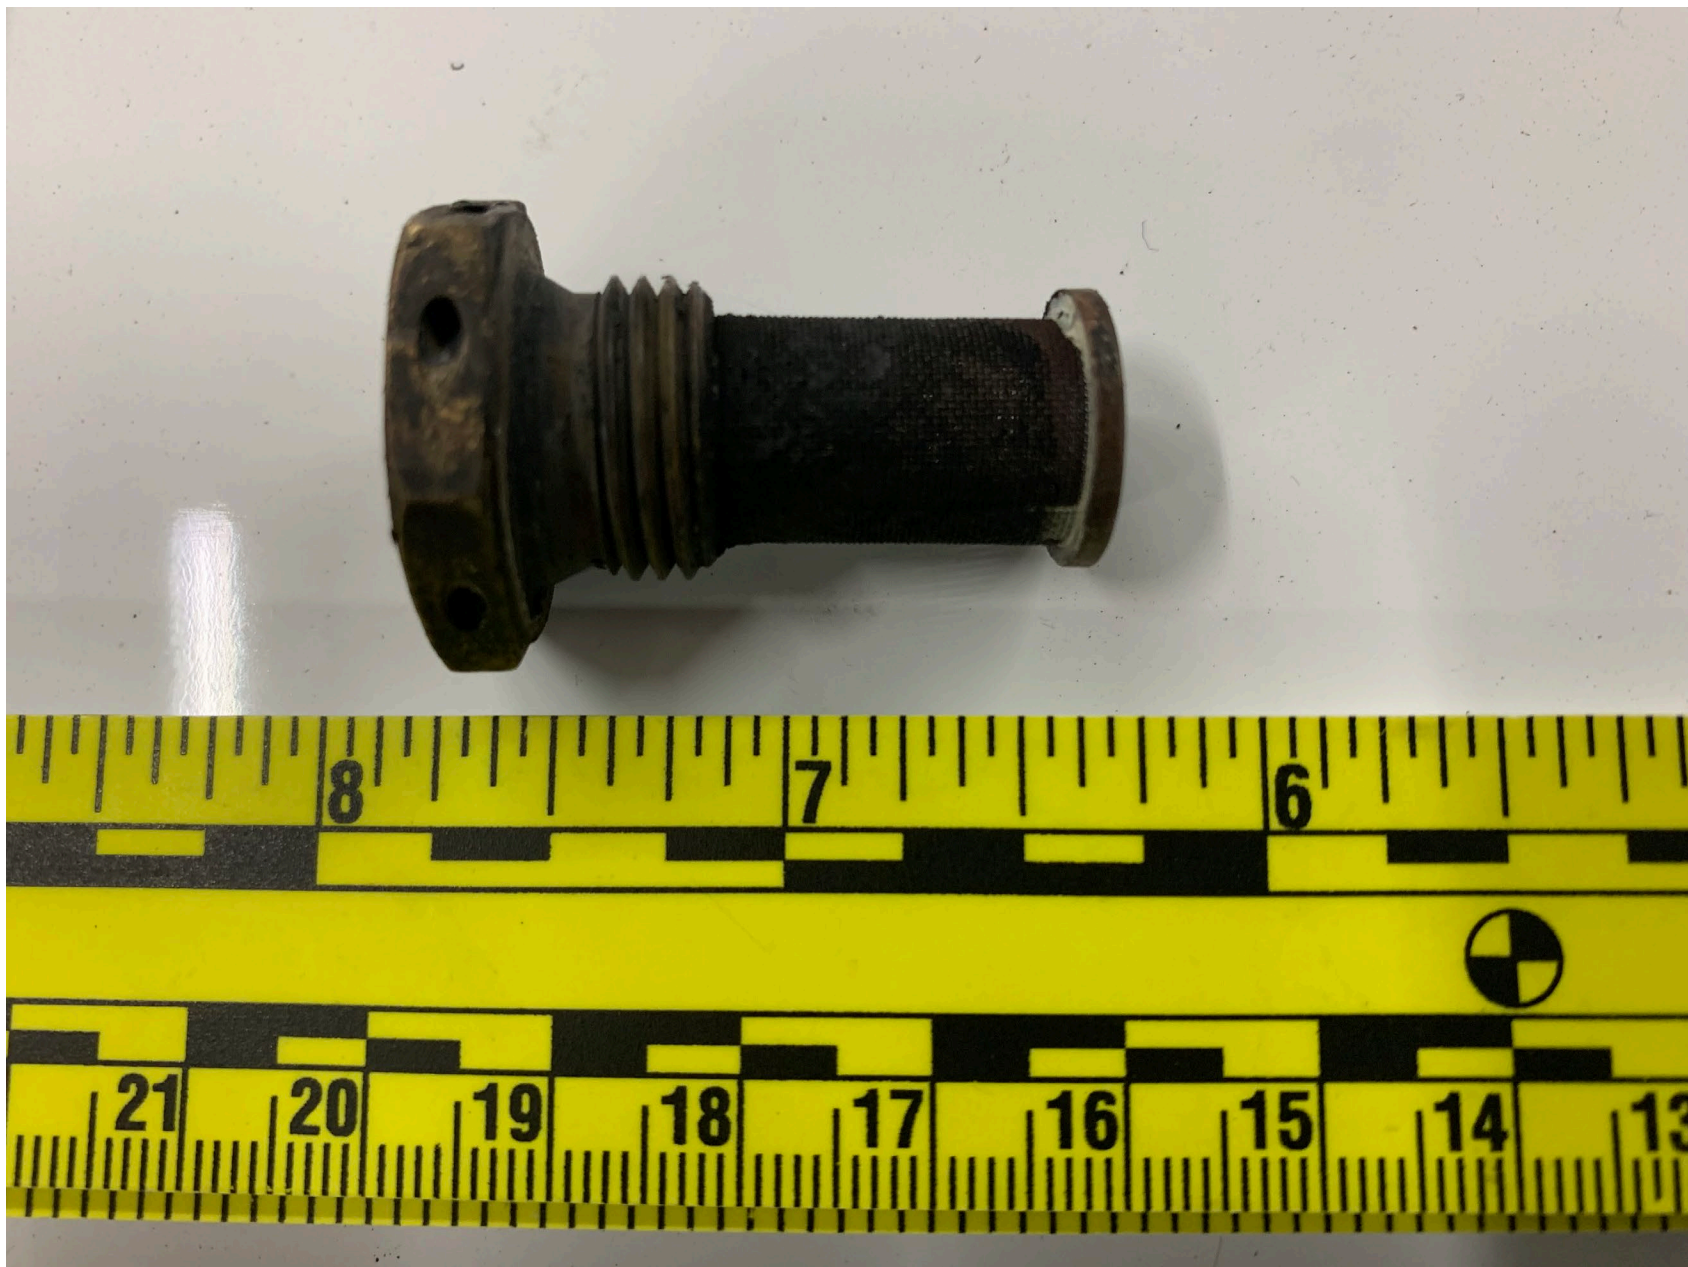
**Photo 14 – View of the fuel servo screen for the left engine.**
