## **NATIONAL TRANSPORTATION SAFETY BOARD**

# **AIRFRAME AND ENGINE EXAMINATION**

**CEN21LA109**

Location: Albany, TX  
Date: January 9, 2021  
Aircraft: Robinson R44, Registration N322SH, Serial #13391  
NTSB IIC: Samantha Link

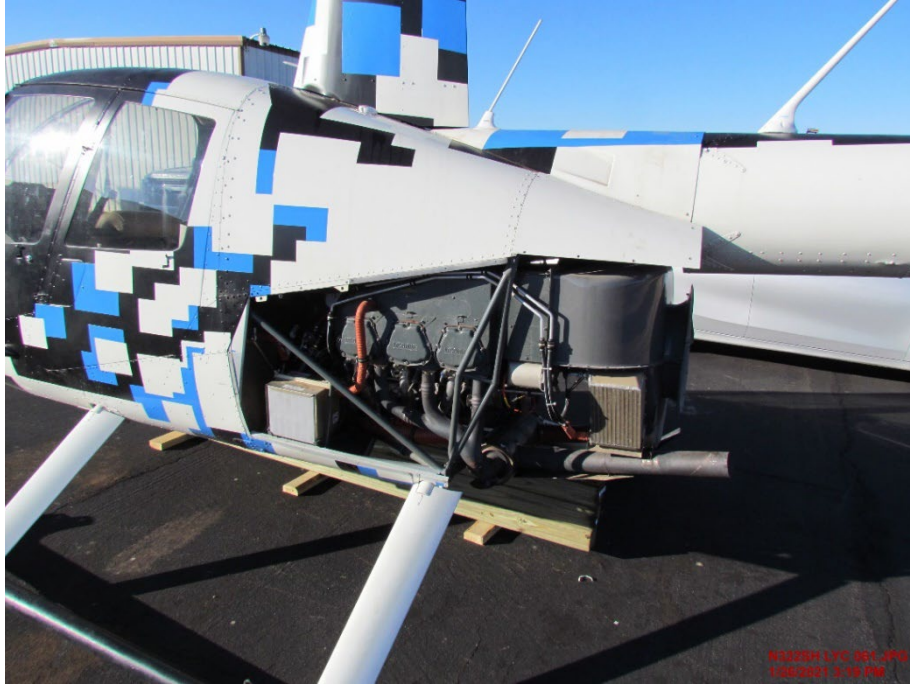
Figure 3: Engine Compartment

- The airframe was properly secured to facilitate an engine run.
- An initial overview examination of the airframe and engine did not reveal any catastrophic anomalies.
- The V-Belts were examined and exhibited normal operating signatures.
  - They were cut from the engine to facilitate an engine run.
- The engine started easily and operated normally.

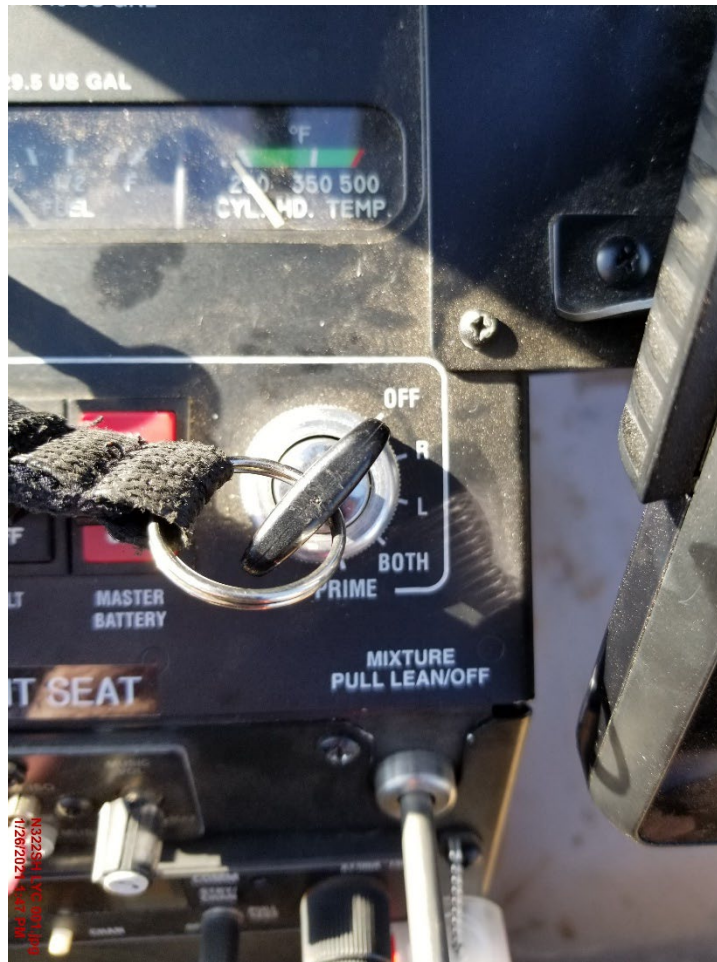
Figure 5: Ignition Switch

- Right position: the engine RPM did not change
  - Both position: The engine RPM was consistent and continuous
  - Off position: The engine continued to run consistently. The key was jiggled, manipulated, and even removed from the ignition switch, but the engine continued to run. The key was then cycled several times between all positions with the same indications.

- The engine was shut down after about 13 minutes of operation.
- The ignition switch was confirmed to be wired properly and electrical continuity was established from the ignition switch to the magnetos.

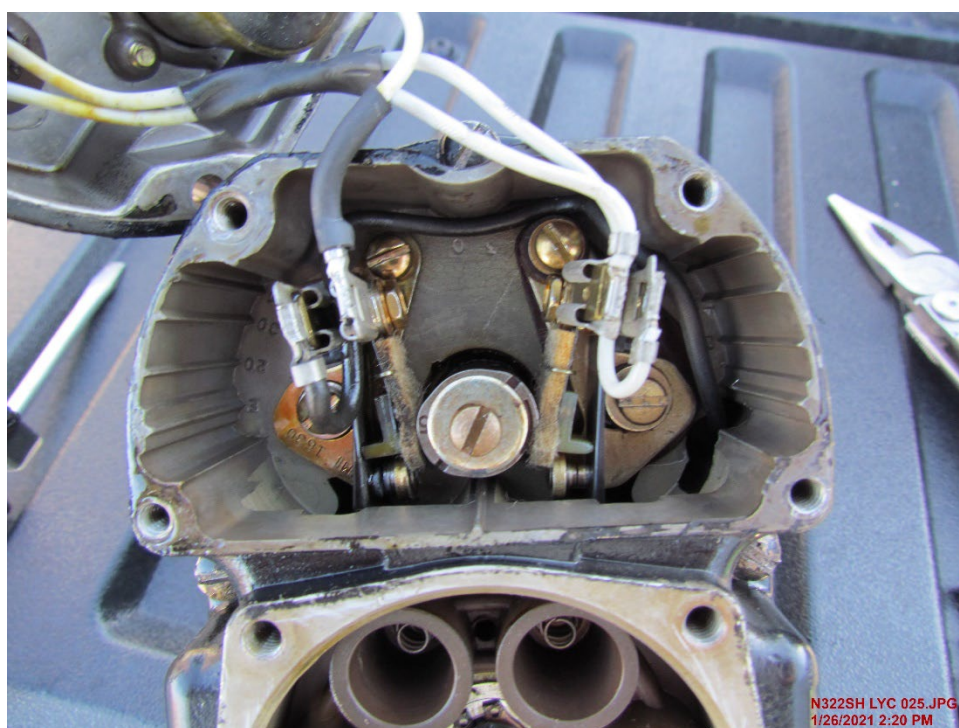
Figure 7: Cap Removed from Right Magneto

- The magnetos were removed from the engine and the caps were removed.
  - All internal components were consistent with normal operations.
  - There were no abnormal indications or discoloration.

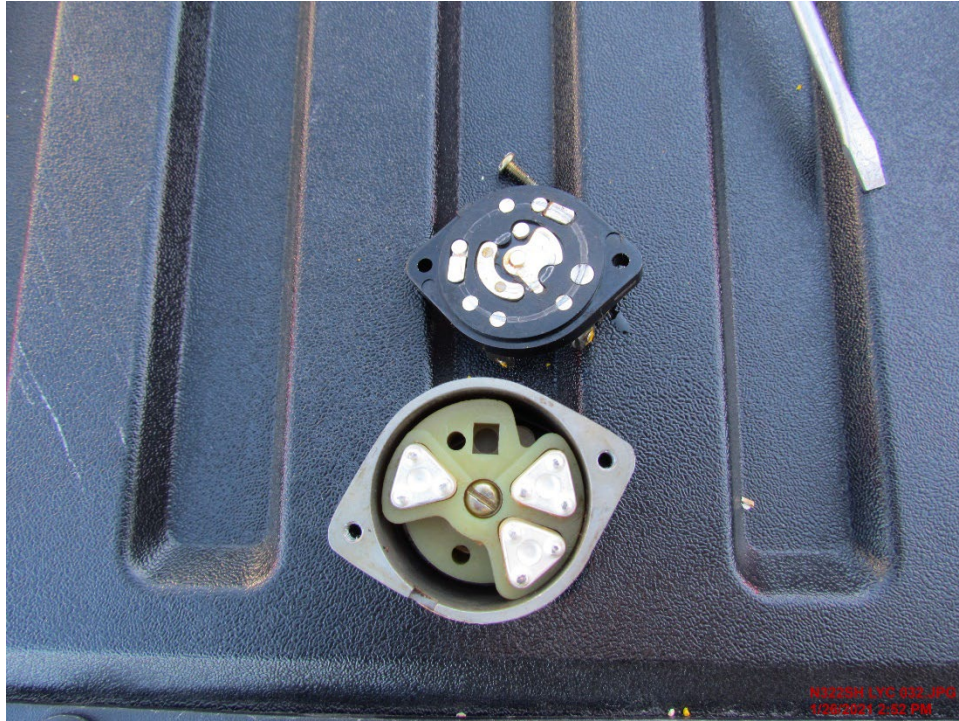
Figure 10: Inside of the Ignition Switch

- The ignition switch was also removed and disassembled, with no anomalies noted.
- Mr. Helgeson provided the below photographs from the examination:
