## RECORD OF MEMORANDUM

**Date: June 16, 2022**  
**NTSB Accident Number: CEN21LA109**

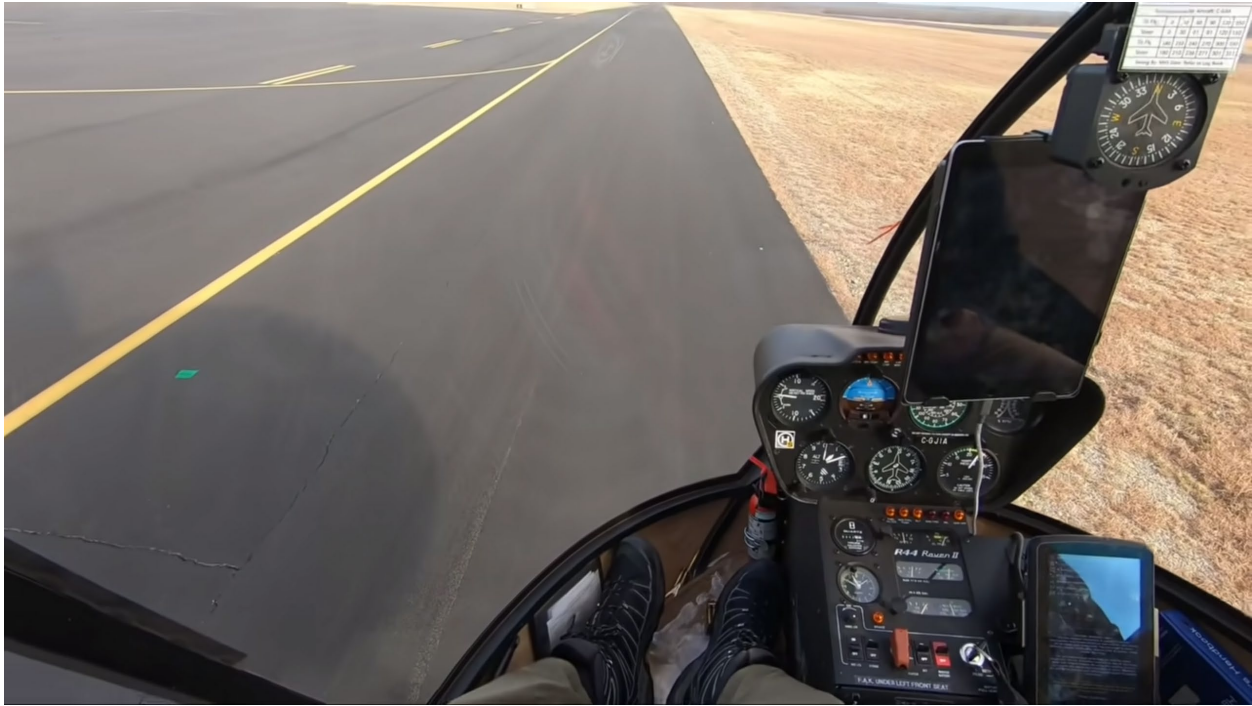
- The video started with the helicopter in a hover for about 36 seconds.
  - The key was visibly in the “off” position.
  - The pilot turned on the communications radio; No other switches or instruments were touched on the instrument panel.

*Figure 1 During the Takeoff Sequence*

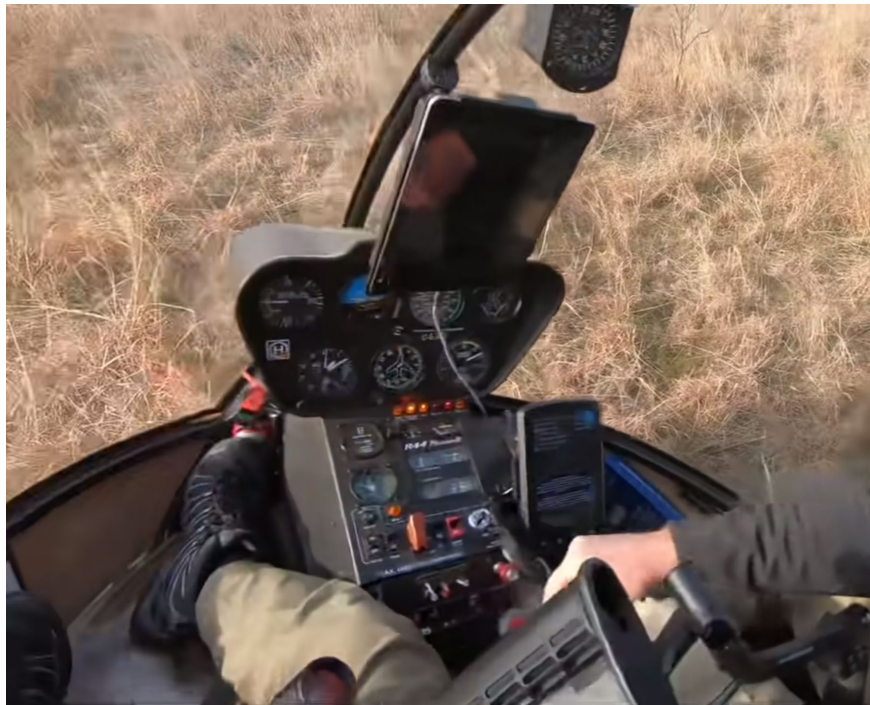
- The RPM gauge was shadowed and unreadable.
- The pilot immediately conducted a left turning autorotation to a field.
- After the helicopter came to rest, the video showed the pilot swiftly shutting down the helicopter. His fingers touched the key, but the key position did not appear to change. As he touched the master switch, he abruptly paused, turned toward the front passenger, and smiled. He then stated, “it’s alright,” and turned off the master switch.

*Figure 2: After Impact and Pilot Shutdown.*
