# NATIONAL TRANSPORTATION SAFETY BOARD

## Onboard Image Recorder – Video Files

Specialist's Factual Report  
By W. Deven Chen

| NTSB Number: | CEN21LA119 |

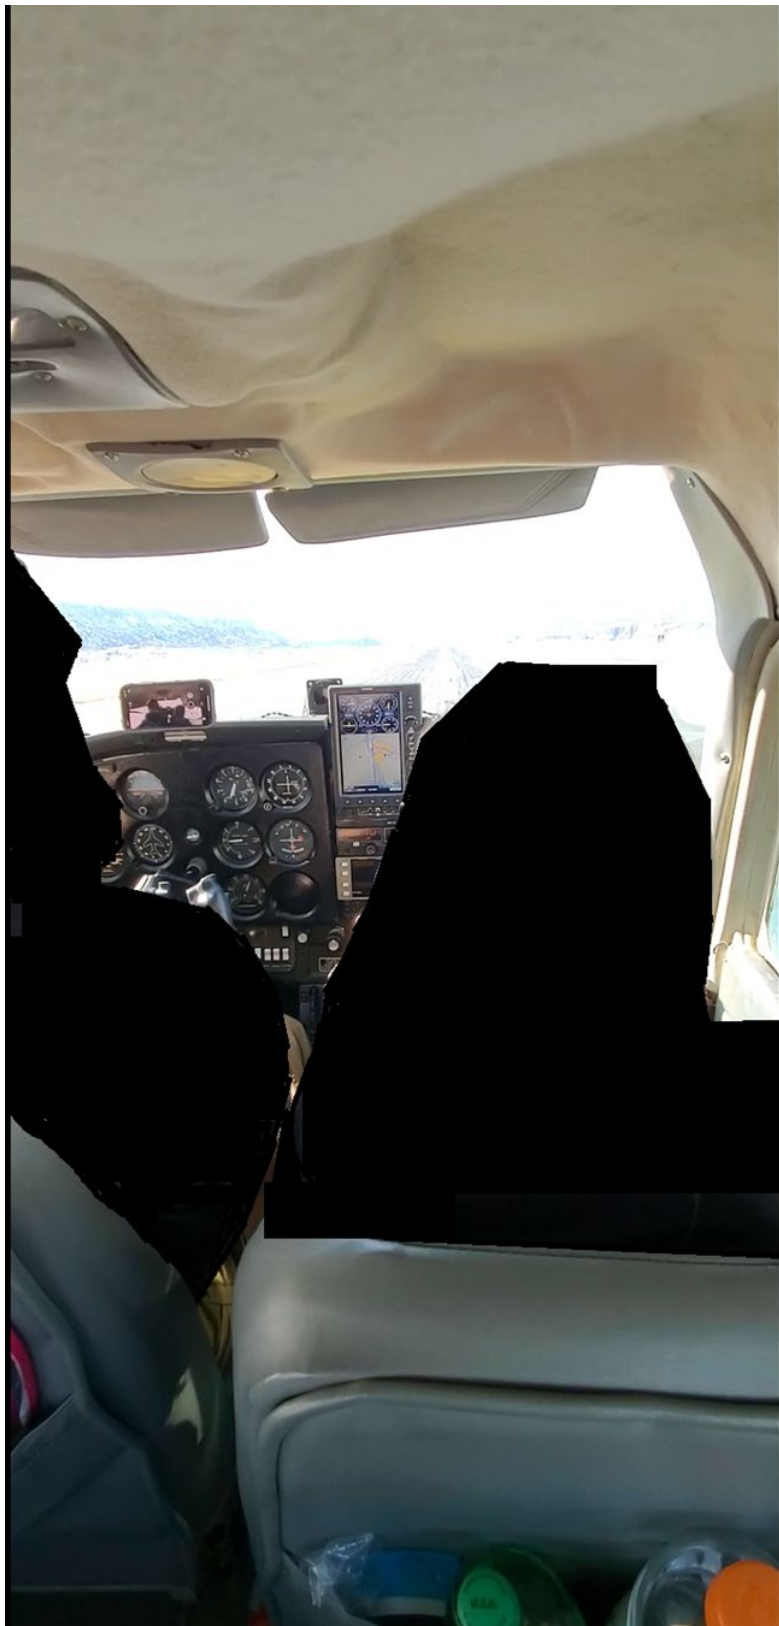
The video began at 14:05:38, as the aircraft was taxiing on the runway. Figure 1 is a screenshot of the camera's view. The pilot was sitting in the left seat, and a minor was sitting in the right seat. The pilot and the minor are redacted in figure 1. There was another cellphone mounted on the glareshield near the pilot. The screen of the cellphone was projecting camera view of a GoPro camera mounted in the cockpit. The view on the screen of this cellphone indicated that the recording of the GoPro camera was not activated during the time of the cellphone recordings.

**Figure 1: Screenshot of the camera view at the beginning of the video to illustrate the field of view.**

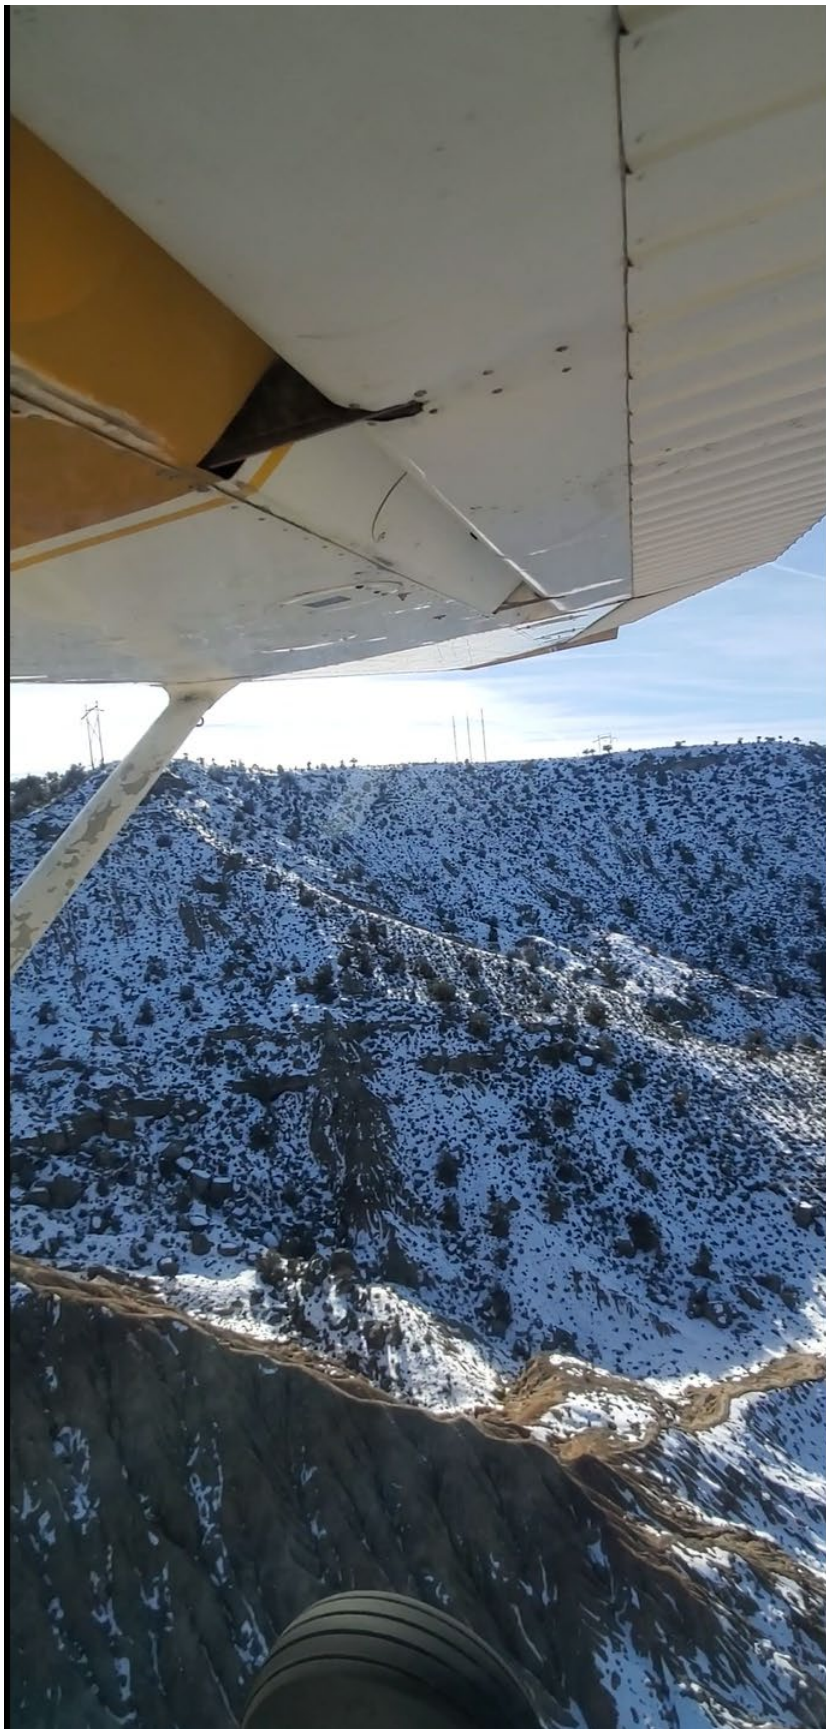
The video began at 14:10:00. The pilot was still the sole manipulator of the aircraft's controls. At 14:10:10, as the camera turned to the right, a mountain came into view. Figure 2 is a screenshot at this time. Electric power lines were visible on the top of the mountain. The figure shows that the aircraft was flying at an altitude lower than the power lines. At 14:10:12, the camera turned back toward the front of the aircraft. At 14:10:13, the aircraft experienced an abrupt slight right roll, then returned to level. At 14:10:14, the camera view turned to the floor of the aircraft. At 14:10:15, a sound of impact was audible, and the camera view was rotating. At 14:10:17, a sound of impact of the aircraft with terrain was audible. The video ended at 14:24:20.

**Figure 2: Screenshot at 14:10:10.**
