**Beechcraft**

## Air Safety Investigations Aircraft Incident/Accident Technical Report

| Aircraft Incident/<br>Accident Information | Year: 1972 | Make: Cessna | Model: 172L |
| Chief Air Safety Investigator: Andrew L. Hall | | Report #: ASI-21-AL-T | Report date: 05-07-21 |

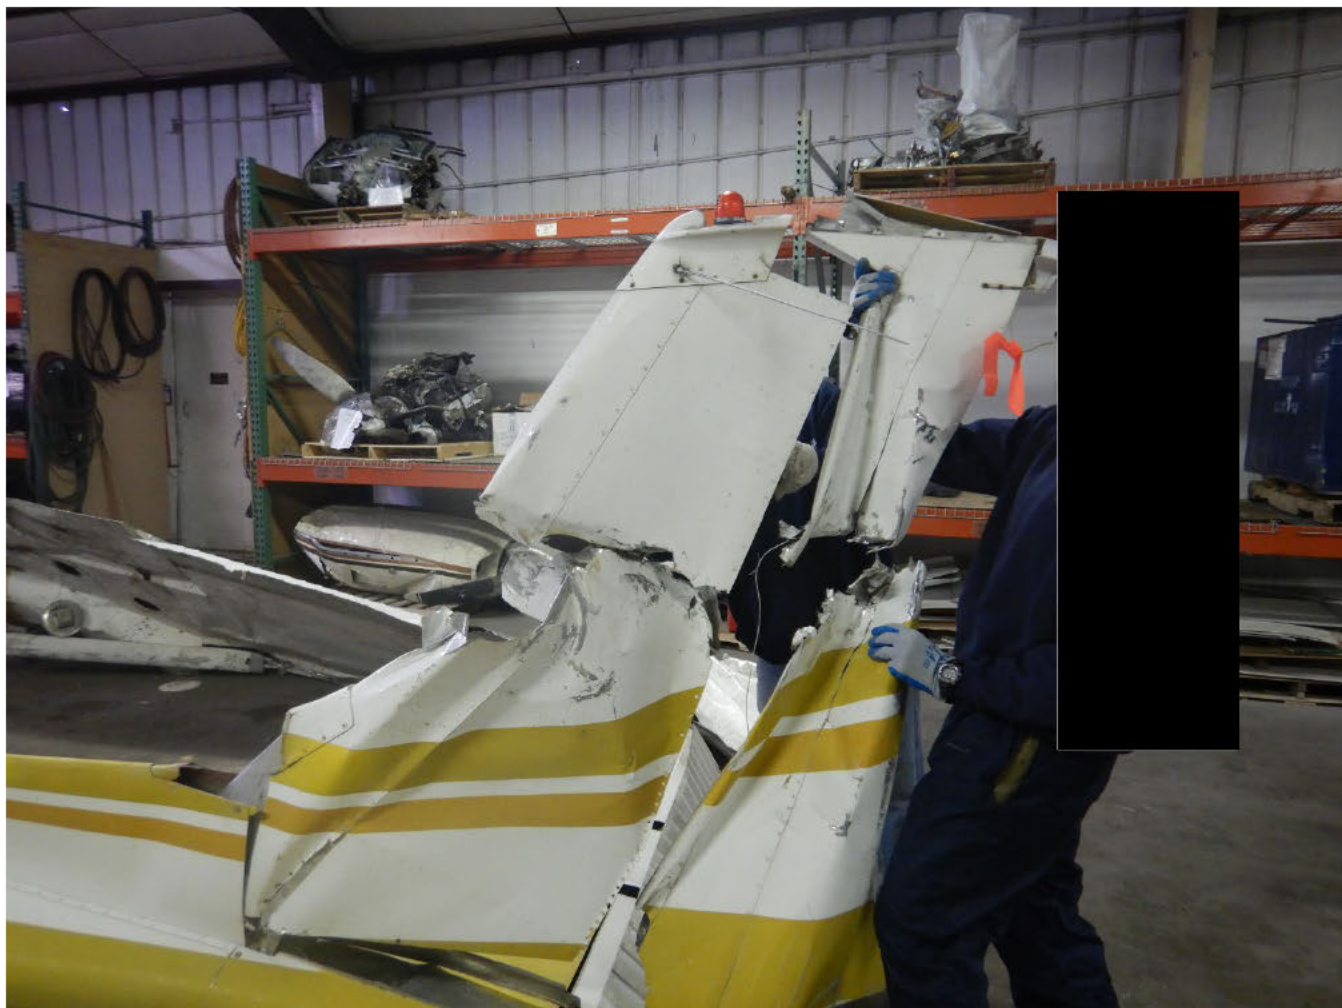
The ailerons and flaps were observed attached to the wings. The elevator forward bellcrank push rod, which attaches the control column to the cable bellcrank, was observed separated with impact damage. All primary flight control cables were attached to their input devices and to the control surfaces, and all flight control cables were observed with tension overload type separations. All wing and horizontal stabilizer flight control surfaces were observed attached in their respective locations. The flaps were observed in the up position. The right elevator torque tube rivets were observed sheared. Both control yokes were observed separated from the aileron/elevator input mechanism. The rudder control bellcrank at the base of the rudder was observed separated from the rudder. The bottom half of the vertical stabilizer and rudder were observed separated from the aft fuselage. The bottom half of the rudder was observed separated from the vertical stabilizer. The top two feet, approximately, of the vertical stabilizer and rudder were observed separated from both the vertical stabilizer and main rudder. The rudder balance weight was observed separated from the top of the rudder.
