## **EXAMINATION SUMMARY**

NTSB ACCIDENT NUMBER: CEN21LA119

AIRCRAFT REGISTRATION/AIRCRAFT TYPE: N4376Q, Cessna 172L  
ACCIDENT LOCATION: Silt, CO

### DRAFT FACTUAL NOTES / NARRATIVE

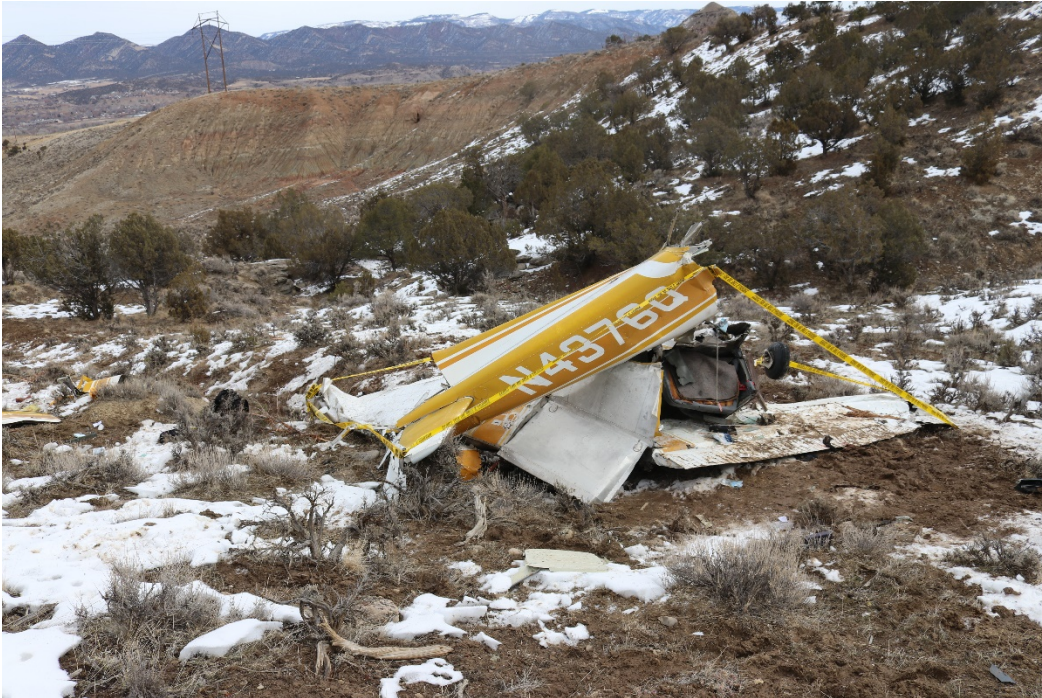
The main wreckage was located about 3 miles east of RIL in an area of rising terrain. The first piece of debris was located about 25 ft past a set of high-tension transmission wires that are estimated to be about 100ft tall and extended about 670 ft along a heading about 160°. About 75 ft past the initial piece of debris, the upper 2ft of vertical stabilizer and rudder was located. The initial ground scar was located about 475 ft beyond the transmission wires and consisted of a damaged tree and sheet metal consistent with the color of the airplane. The main wreckage came to rest inverted about 600 ft from the transmission wires. The wings separated from the fuselage at the lower lift strut attach points.
