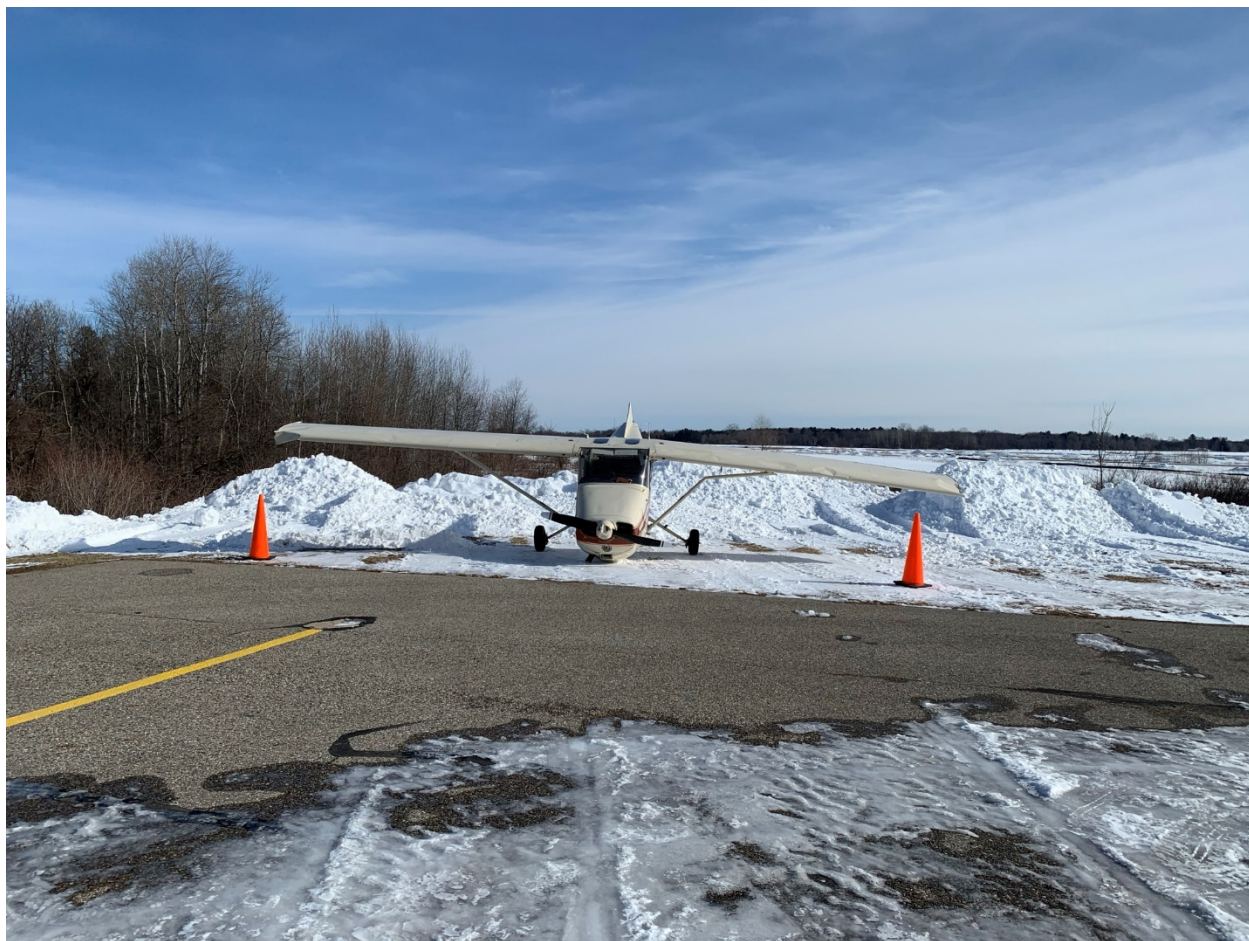
**Photo 1: Aircraft Damage to Left Wing and Left Wing Strut**

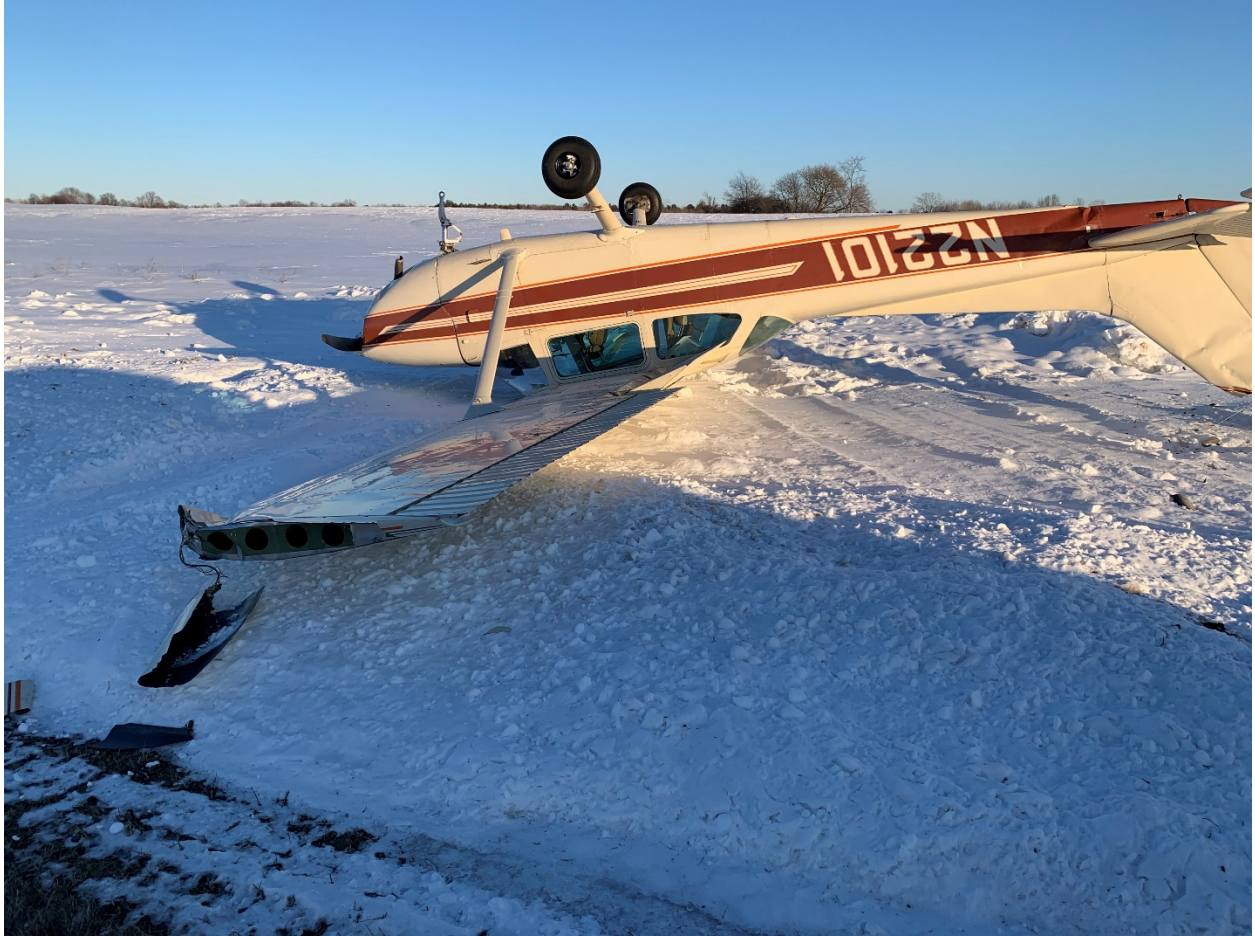
**Photo 2: Aircraft Damage to Empennage**
