**NATIONAL TRANSPORTATION SAFETY BOARD**

**INVESTIGATION SUMMARY**

**CEN21LA121**

On February 2, 2021, at 1744 central standard time, a Cessna 182Q airplane, N4765N, was destroyed when it was involved in an accident near Hackberry, Louisiana. The private pilot and flight instructor were fatally injured. The flight was operated as a Title 14 *Code of Federal Regulations* Part 91 instructional flight.

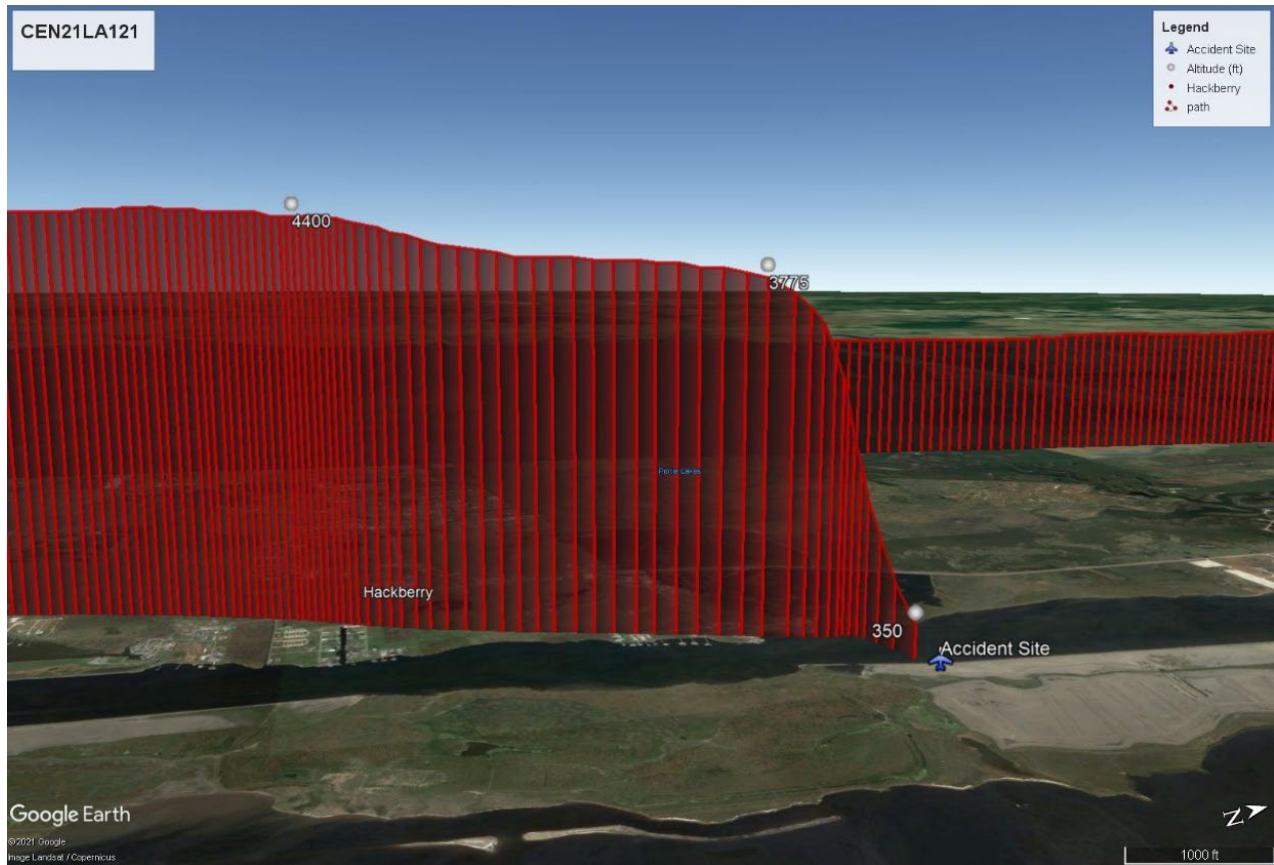
The recorded ADS-B data revealed that the airplane departed again at 1713 and proceeded south toward the Gulf coast. The data showed that the airplane maneuvered near the coast then proceeded north as the altitude and airspeed increased. The airplane reached about 4,500 ft above ground level (agl), as the airspeed decreased. The airplane began a slow descent, which increased rapidly until the final recorded point. In the last 12 seconds of recorded data, the airplane made a

right turn and had descended about 3,200 ft. Figure 1 shows the end of the recorded flight track and the accident location.

Figure 1. The recorded flight path and accident location overlaid on Google Earth.
