## The National Transportation Safety Board

Office of Aviation Safety  
Central Region  
Memorandum for the Record  
Summary of FAA Inspector  
Findings  
CEN21LA134  
Indianapolis Indiana  
February 21 2021

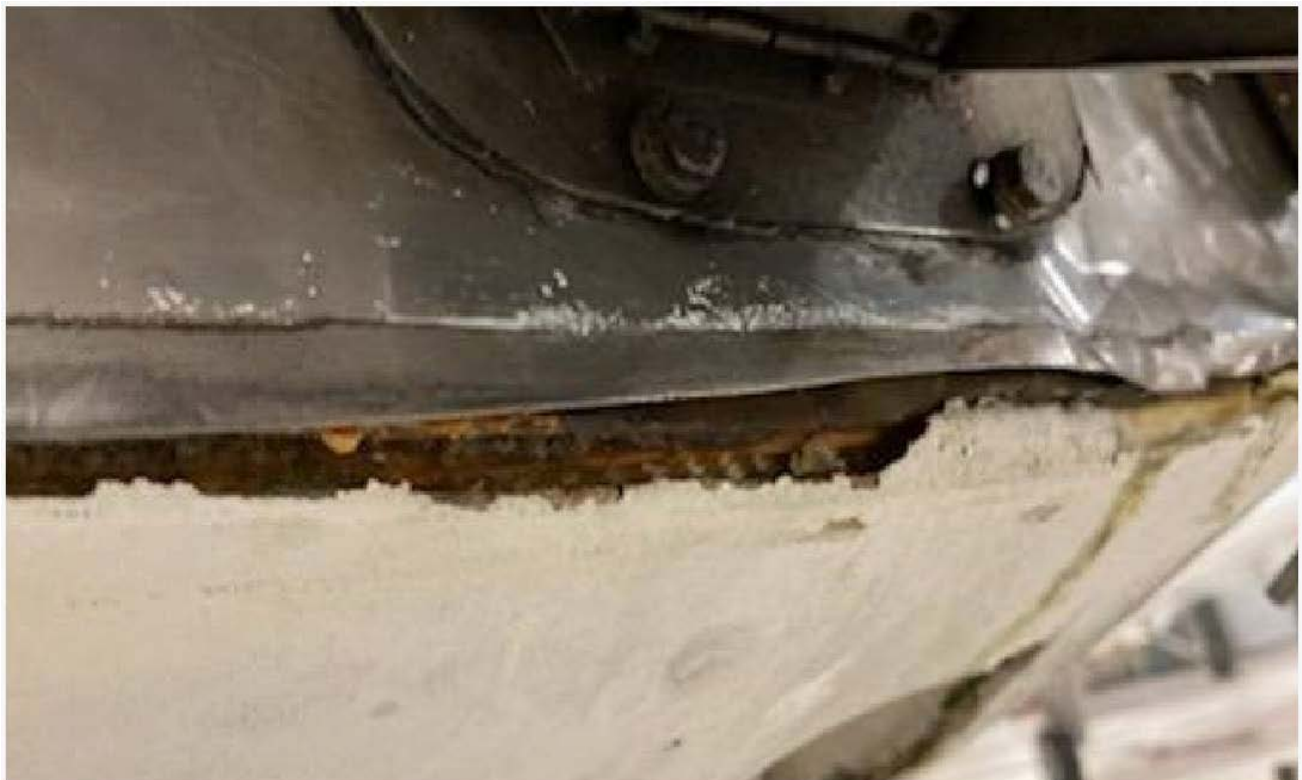
- The nose wheel of the airplane was located about 2,100 feet adjacent to runway 23 and IND. The same runway that the pilot performed the touch and go “bounced” landing.
- Inspection of the nose landing gear did not reveal any pre-existing defects on the separated nose landing gear.
- Inspection of the airplane showed structural damage (deformation) of the composite firewall, resulting from the landing with no nose landing gear at UMP. See photo below.
