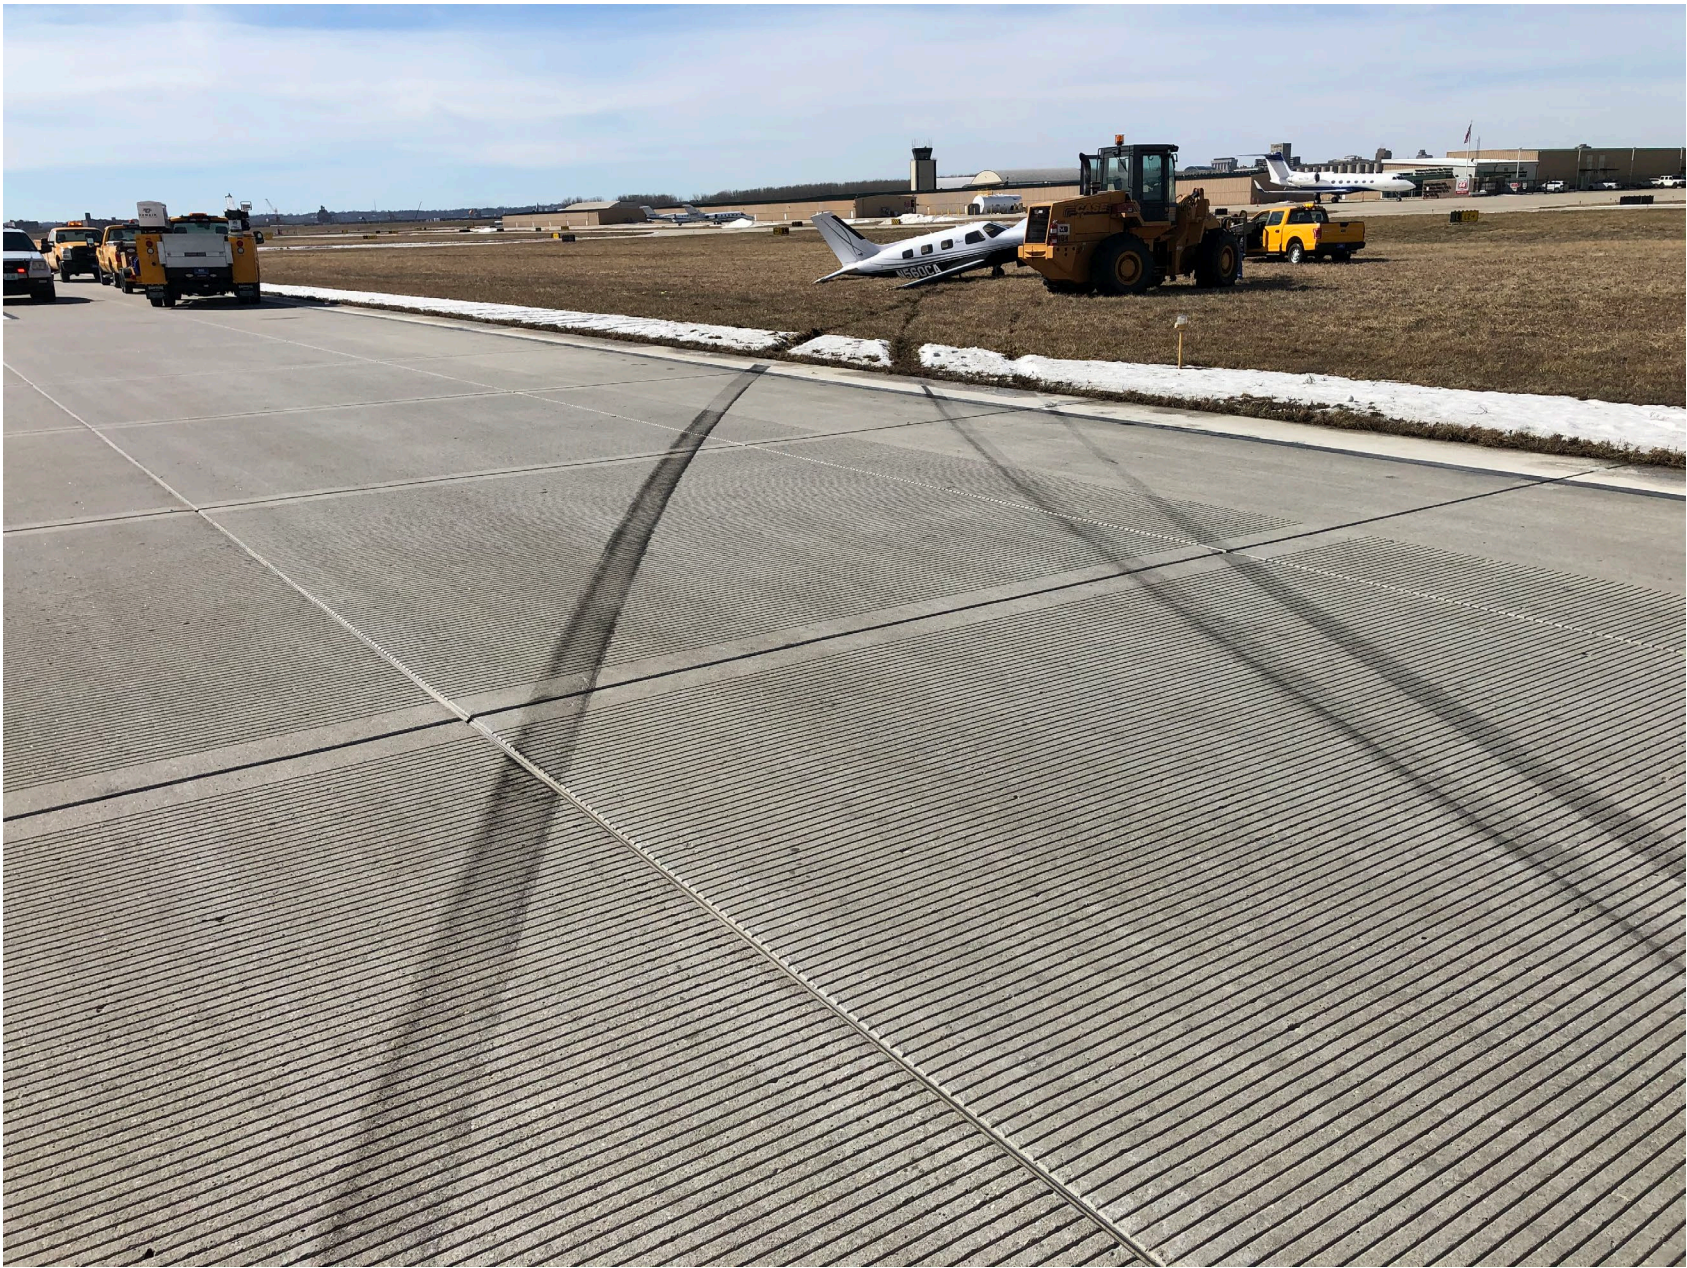
**Photo 1 – Airplane At Accident Site (Photo from MKC Airfield Ops)**

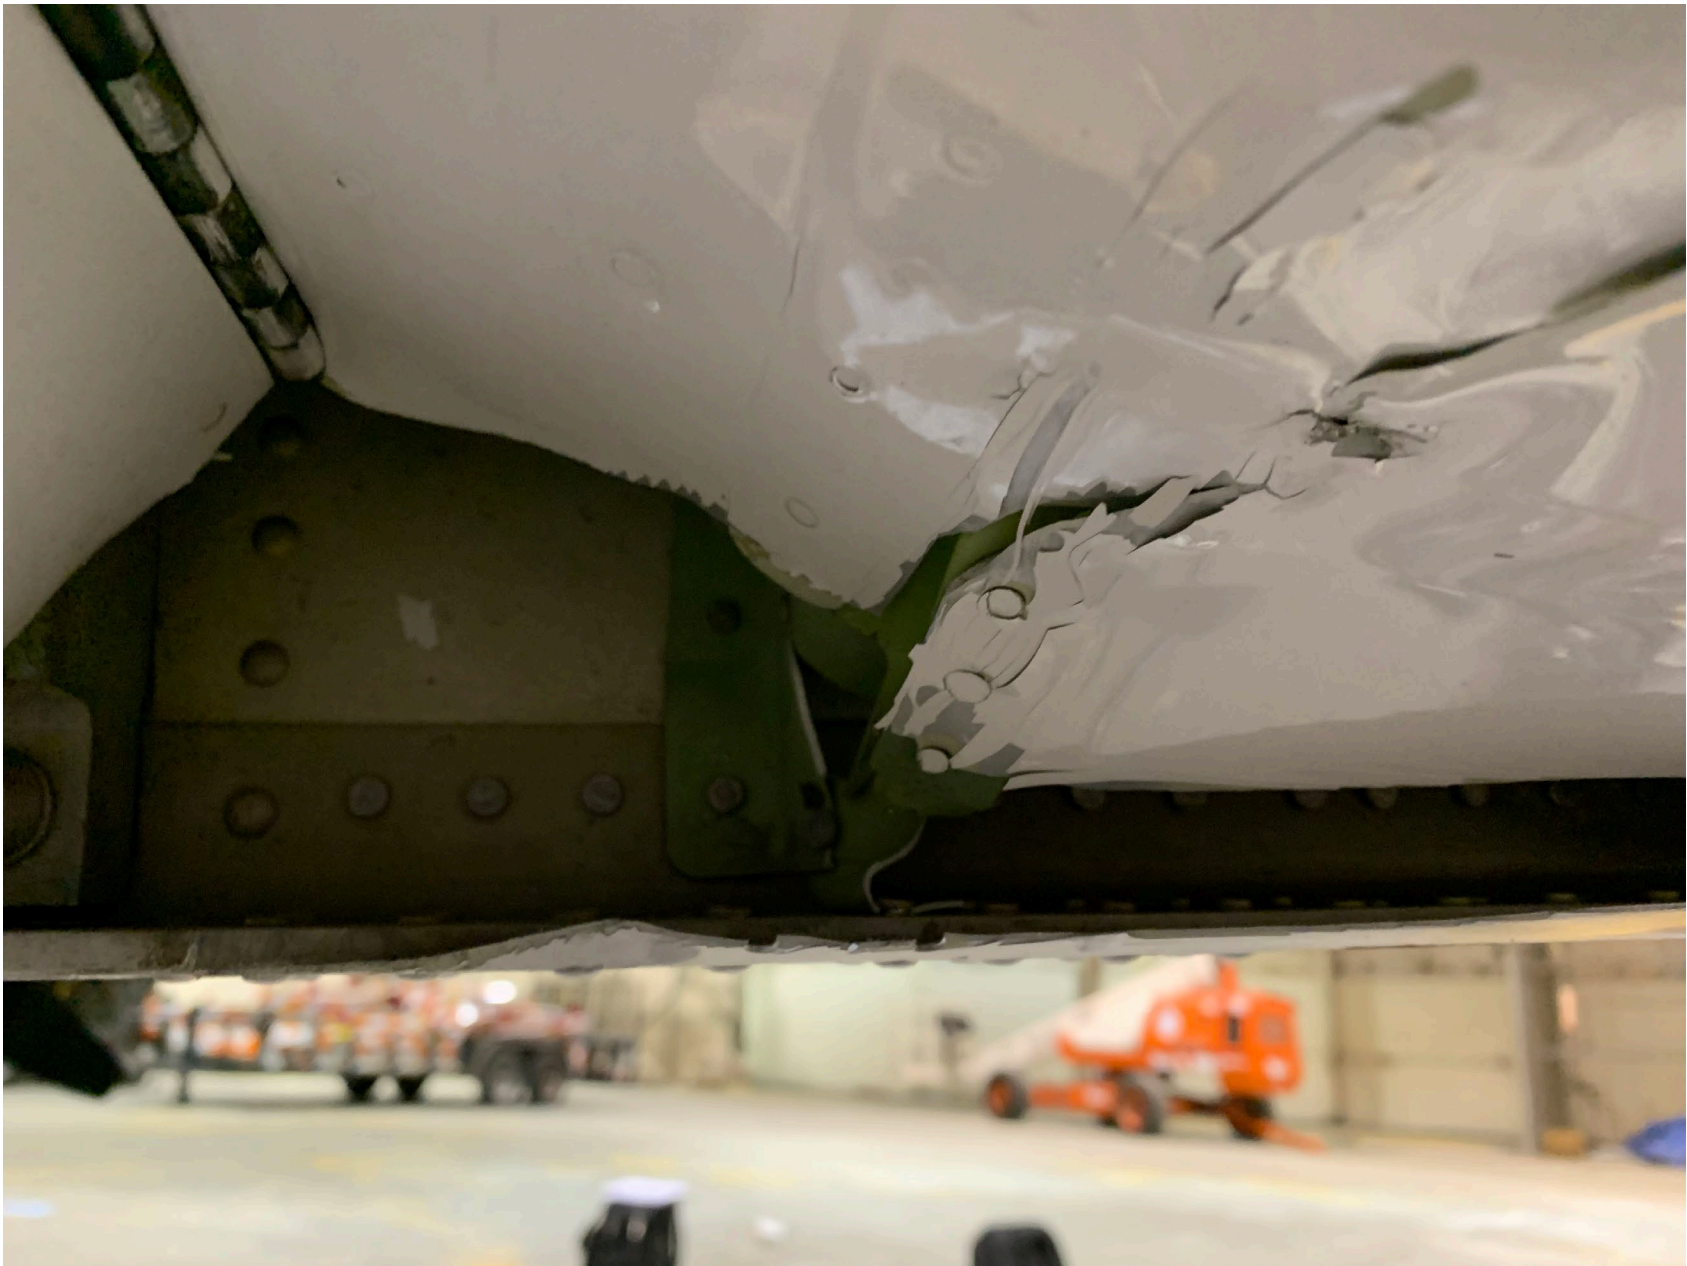
**Photo 2 – Right Wing Damage (FAA Photo)**
