# NATIONAL TRANSPORTATION SAFETY BOARD

## MATERIALS LABORATORY FACTUAL REPORT

Report No. 21-035

Place : Oshkosh, Wisconsin  
Date : February 27, 2021  
Vehicle : Piper Pa-23, N1460P  
NTSB No. : CEN21LA147  
Investigator : Timothy Sorensen, ASI-CEN

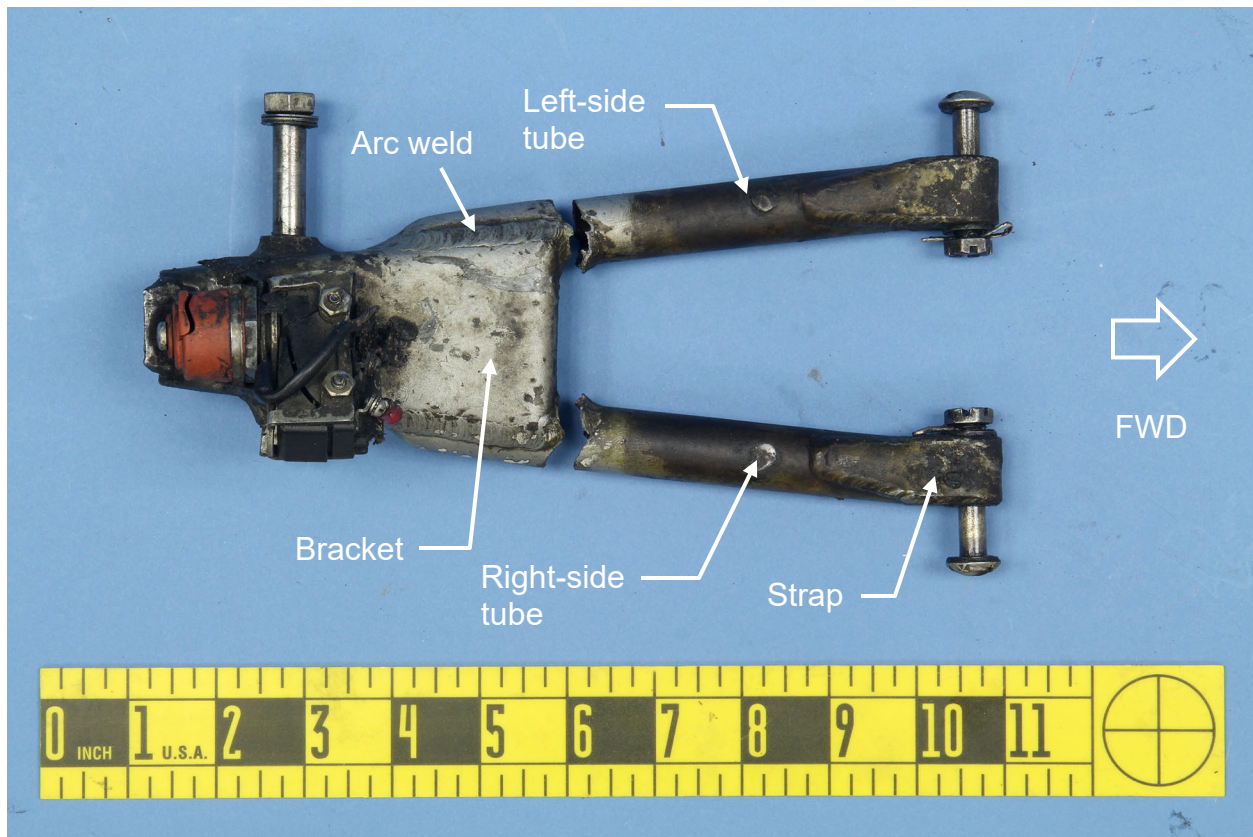
A nose landing gear lower drag link, fractured into three pieces was submitted to the NTSB Materials Laboratory for examination, as shown in figure 1. The drag link consisted of a bracket at the aft end with two tubes that extended forward, one on each side of the bracket. A strap was welded onto the forward end of each tube. Bushings were press-fit into each strap and into the left and right sides of the bracket, allowing the assembly to be connected to the landing gear strut tube at its forward end and to the upper drag link at its aft end.

**Figure 1:** Fractured lower drag ling as received.

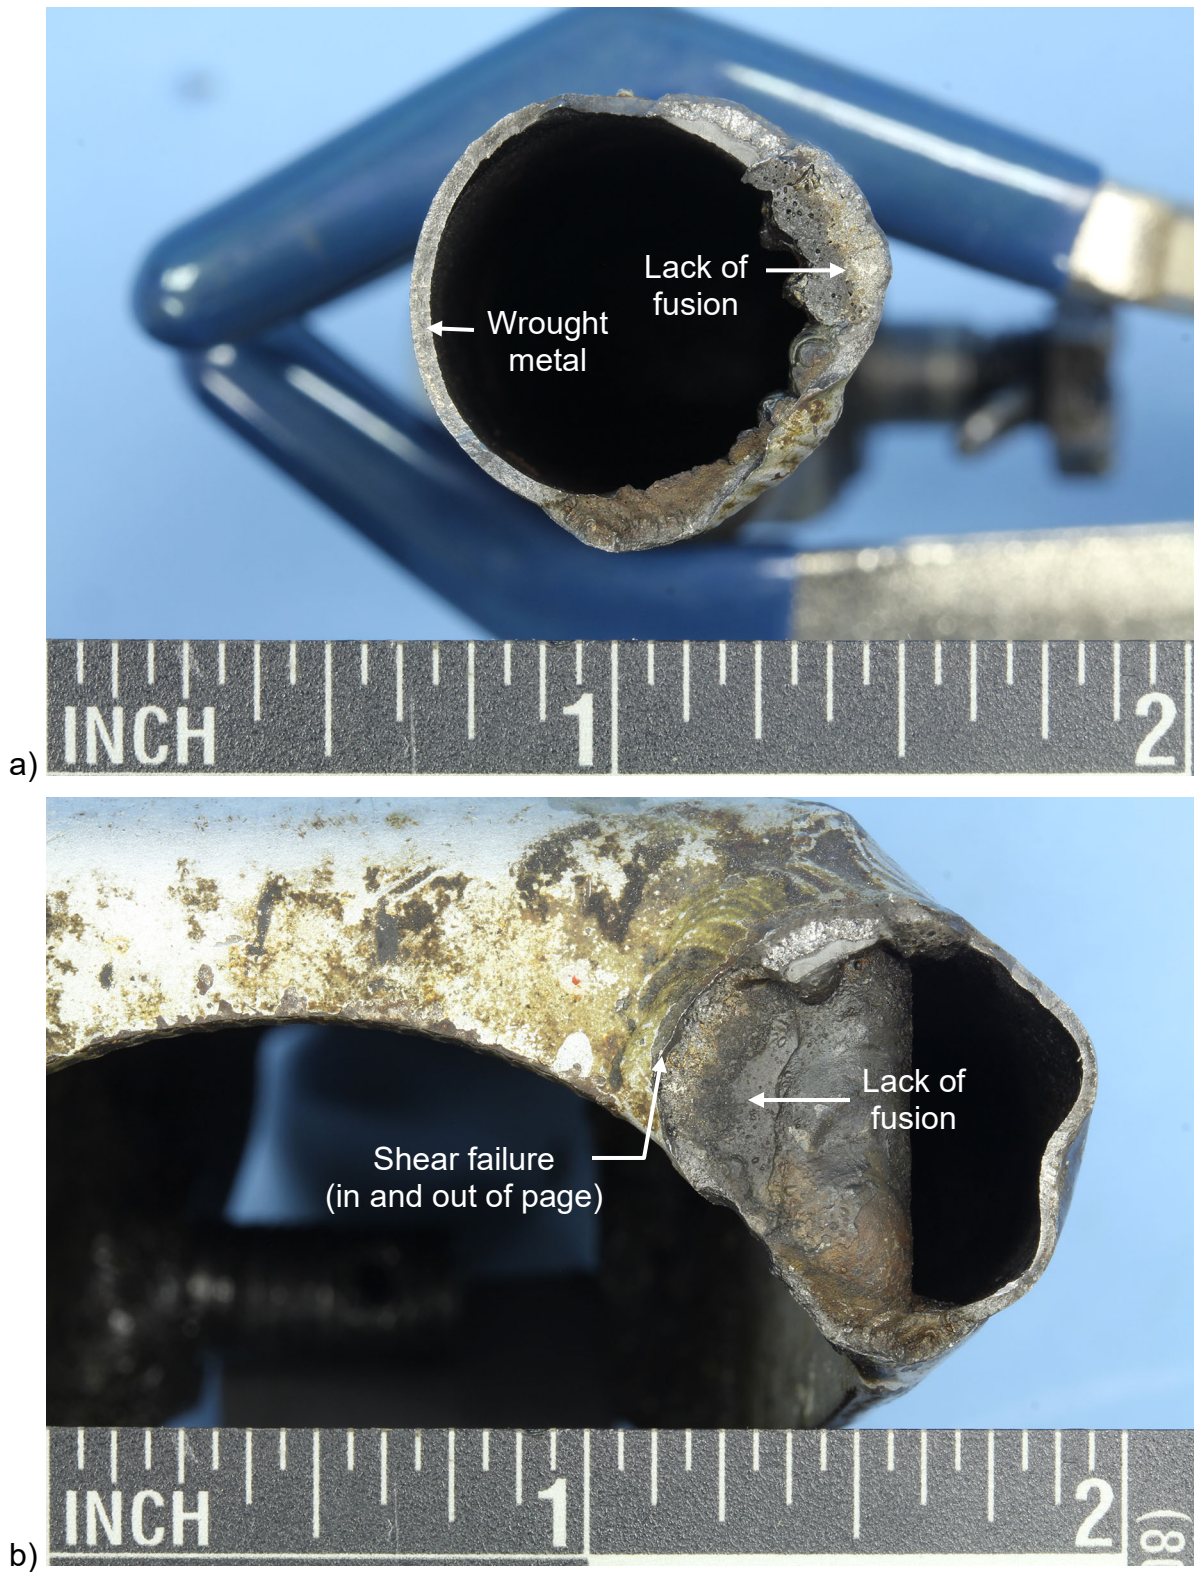
The tubes were joined to the bracket by arc welds. To facilitate this, each tube had been sectioned in the longitudinal direction at its aft end, removing approximately half of the tube circumference over an approximately 1.75-inch length. The tubes were positioned against the bracket, with the longitudinal cuts on the left or right side of the bracket and the circumferential cuts butted against the forward face of the bracket. The tubes were then welded to the bracket along the entire perimeter of the cuts. Both tubes had fractured in the transverse plane in-line with the forward end of the bracket and at the transition from split tube to unsplit tube, as shown in figures 2 and 3. The fracture surfaces were examined and exhibited 45 degree slant fractures through most of the wrought tube material. Along the welded region, the weld metal had not completely fused to the bracket, resulting in a lack-of-fusion region, as indicated in figures 2 and 3. Toward the toe of the weld, the metal had apparently fused to the bracket and the weld metal failed in shear at this point, as indicated in figures 2b and 3b.

**Figure 2:** Fractured left-side tube: a) forward fracture and b) aft fracture.

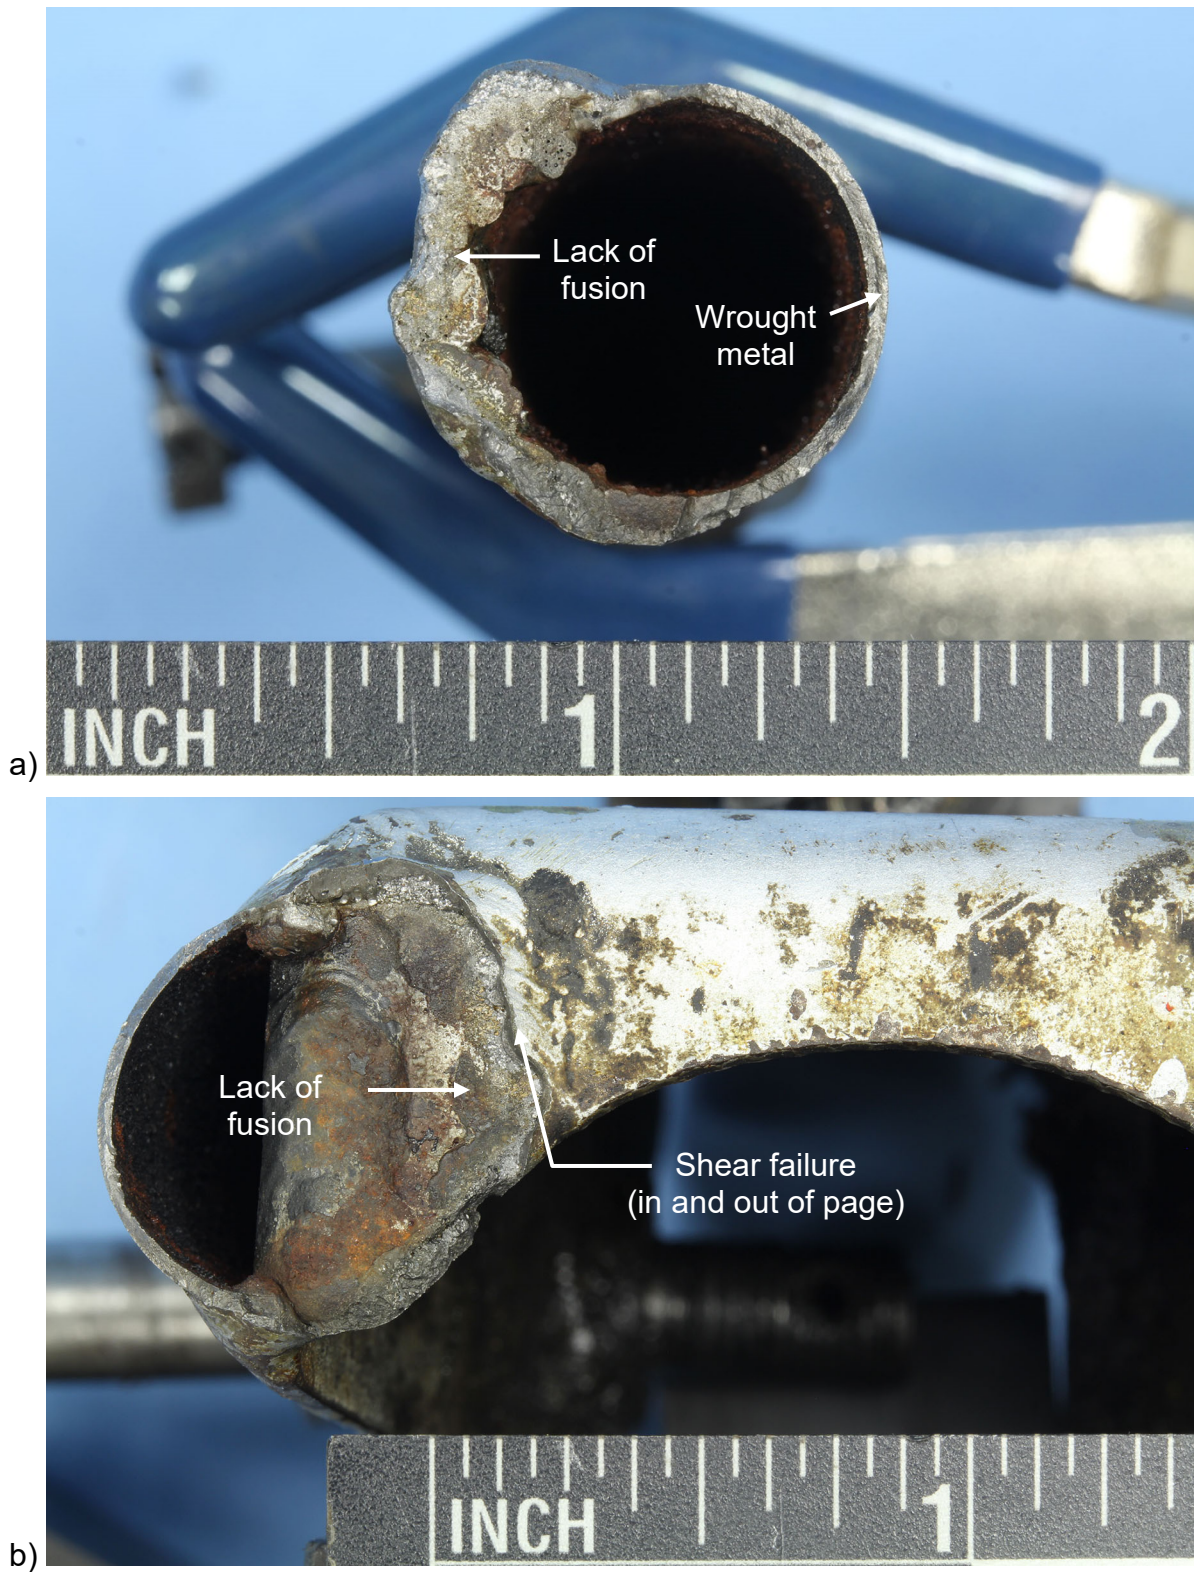
**Figure 3:** Fractured right-side tube: a) forward fracture and b) aft fracture.

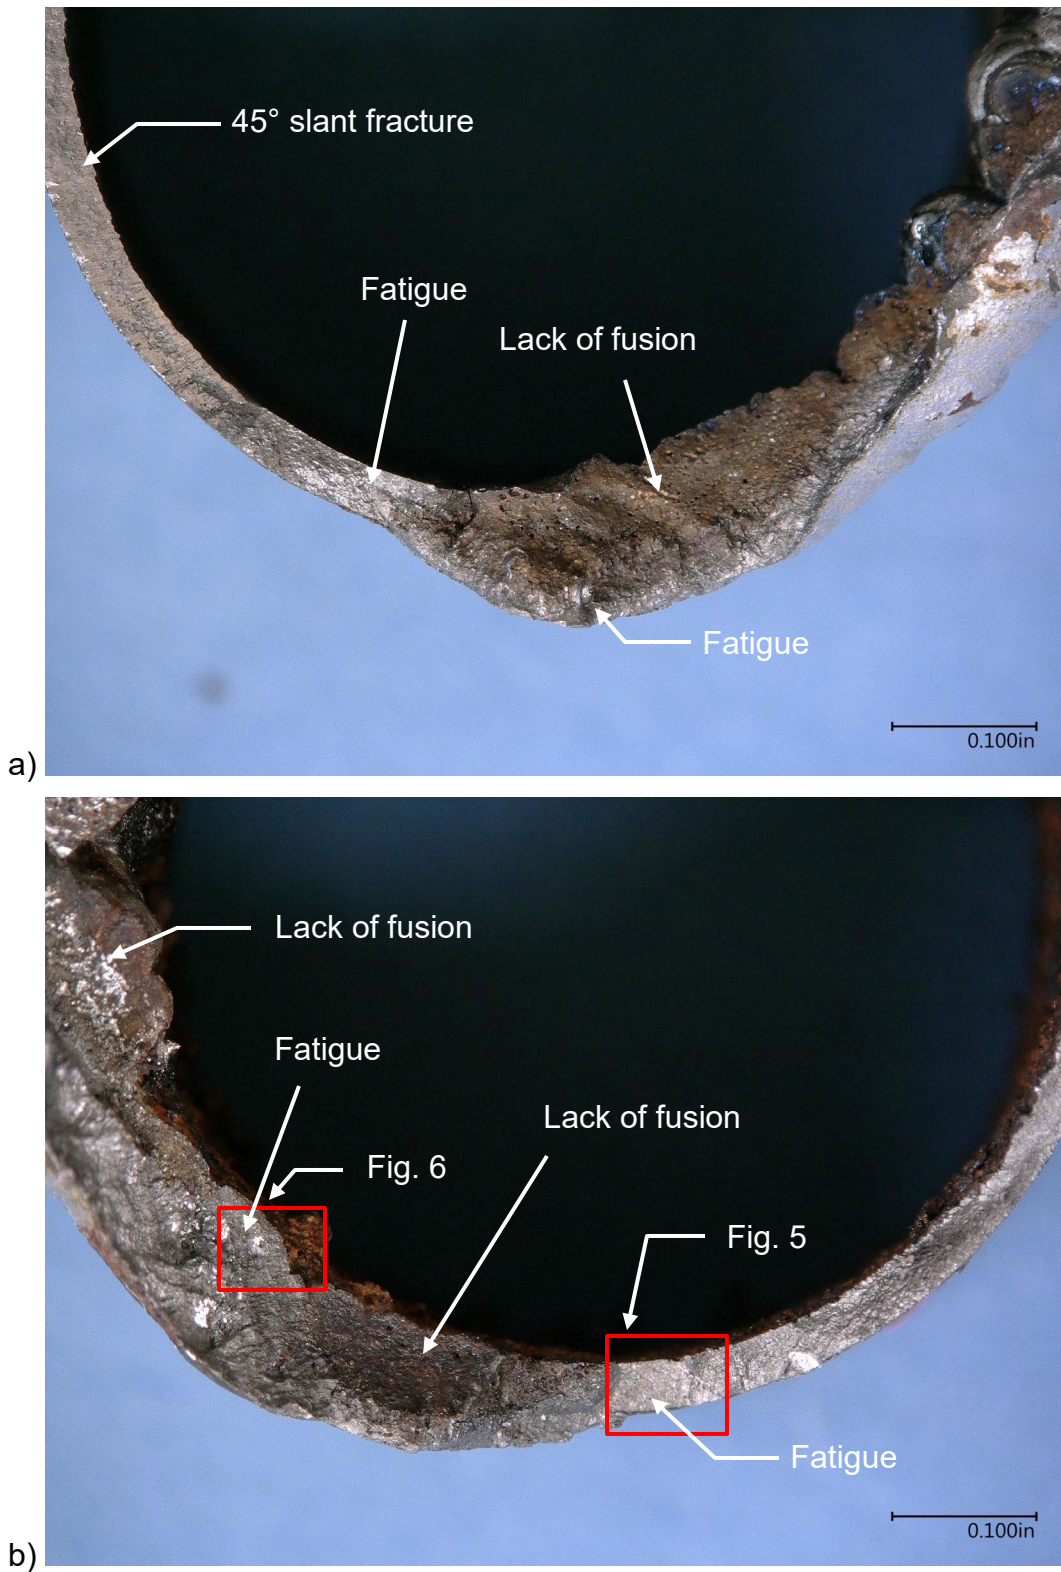
Multiple crack origins were observed near the bottom of each tube in the wrought material and tearing was observed at the top of each tube, consistent with crack initiation along the lower portions of each tube. Digital microscope images of the origin areas of

the left and right tubes are shown in figures 4a and 4b, respectively. The tube ends were sectioned from the rest of the tube, cleaned with an alkaline detergent, and sonicated in acetone, in accordance with standard laboratory procedures. The origin areas were then examined using a scanning electron microscope. The fracture surfaces had a predominantly rubbed appearance and there were no apparent oxidation, corrosion, or environmental products on the fracture surface. Examination by electron microscope revealed isolated areas that were not damaged. Such images from the right-side tube are shown in figures 5 and 6. Figure 5 shows striated features that were observed in the wrought material starting along the outer diameter, consistent with fatigue crack propagation. Figure 6 shows striated features that were observed starting near the boundary with the lack-of-fusion region and progressing radially outward. Similar features were observed on the left-side tube (not shown) but with crack initiation in the wrought material starting near the inner diameter. Much of the 45° slant fracture region was rubbed and well-defined transition to final overstress could not be determined.

**Figure 4:** Image of the fracture origin areas for the a) left-side tube and b) right-side tube.

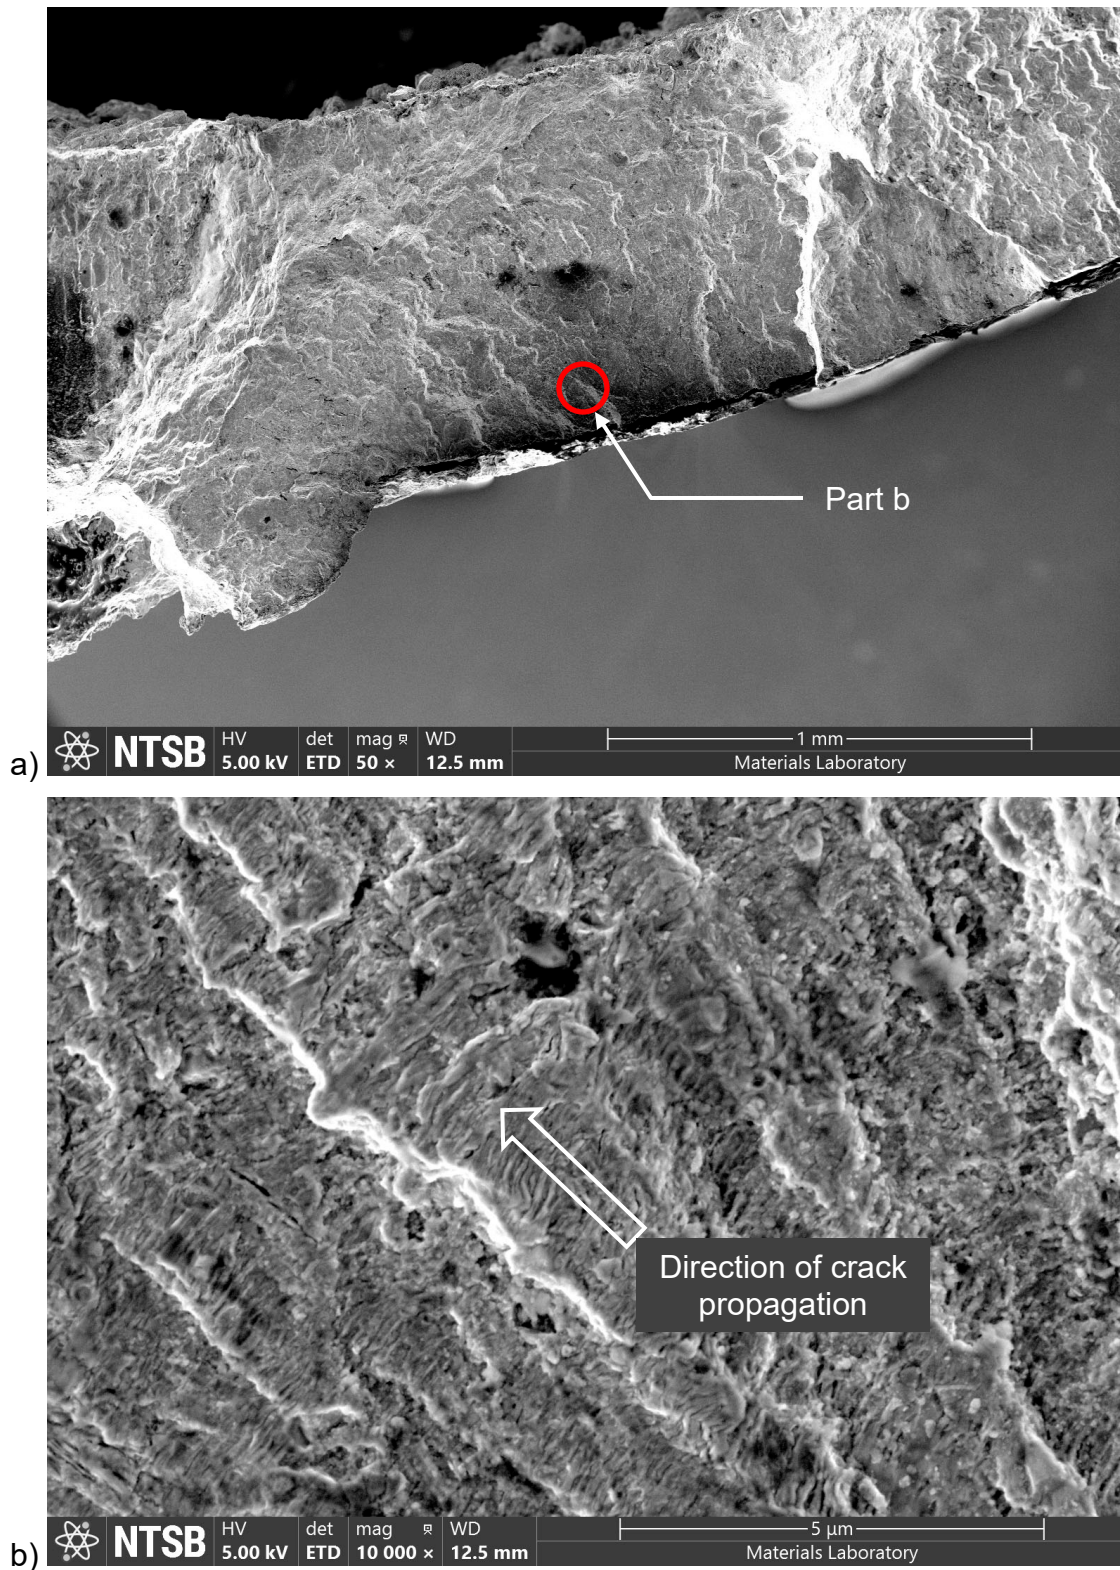
**Figure 5:** Scanning electron microscope images at the location indicated in figure 4b (right-side tube): a) overview image and b) higher magnification image showing striations consistent with fatigue crack propagation.

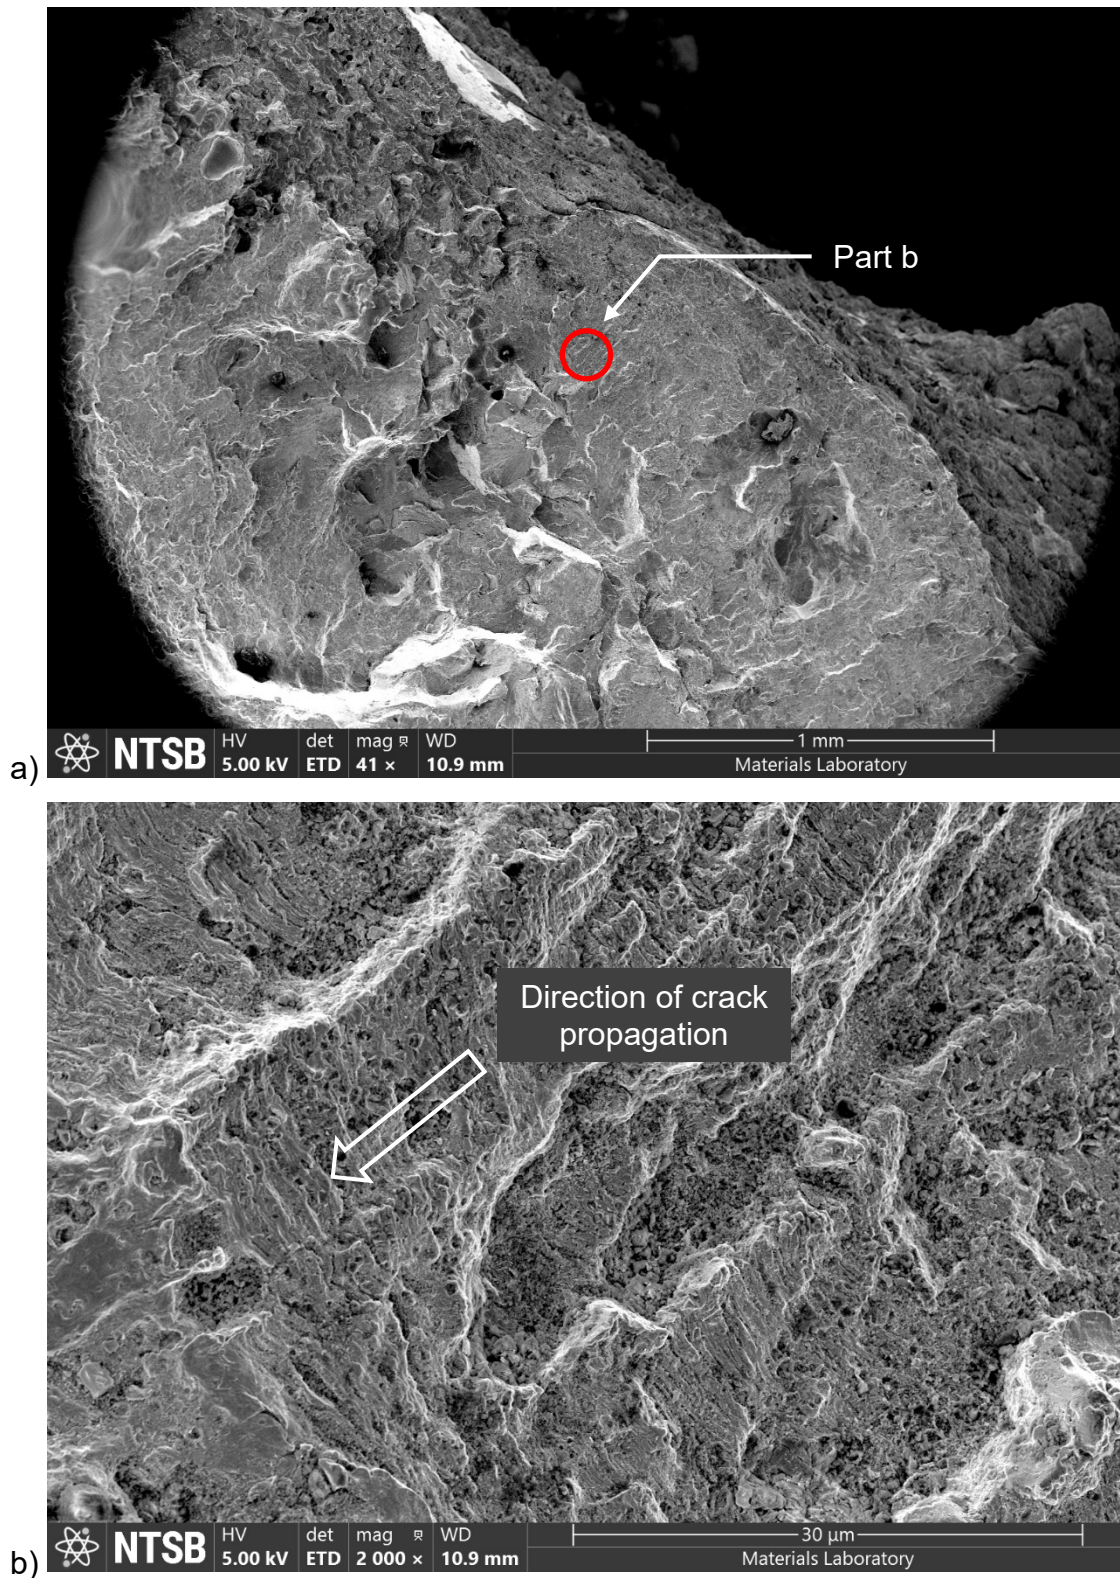
**Figure 6:** Scanning electron microscope images at the location indicated in figure 4b (right-side tube): a) overview image and b) higher magnification image showing striations consistent with fatigue crack propagation.
