## **NATIONAL TRANSPORTATION SAFETY BOARD**

# **ENGINE EXAMINATION**

**CEN21LA168**

Location: Prose Field Airport (XA0)  
Date: April 2, 2021  
Aircraft: Piper J3, C90  
NTSB IIC: Craig Hatch

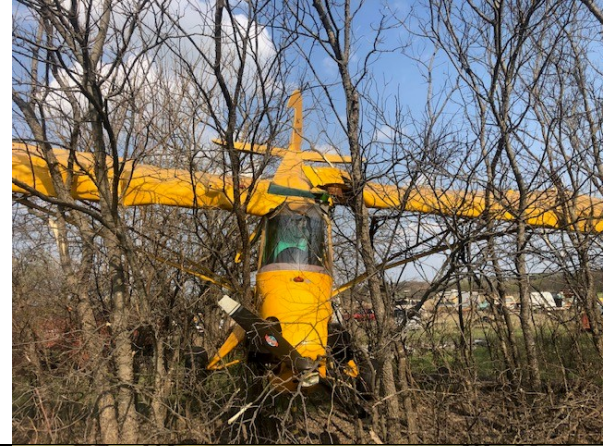
| | <p>Accident airplane in trees</p> <p>FAA photo</p> |

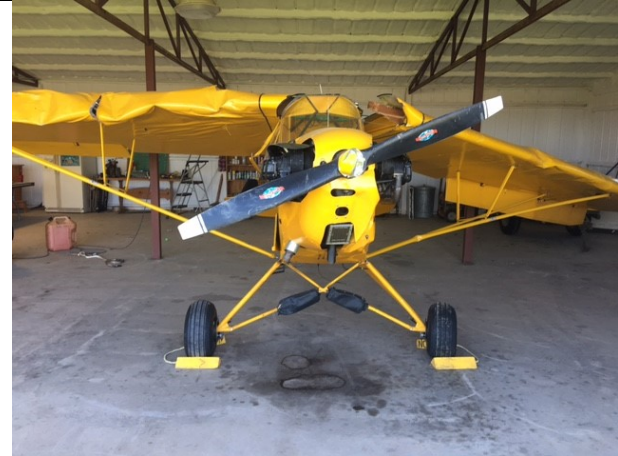
| | <p>Accident airplane in private hangar</p> <p>Photo courtesy of AIG</p> |

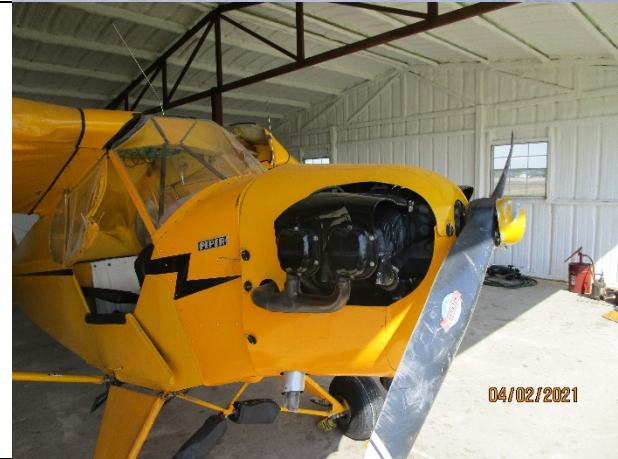
| | <p>Before exam</p> |

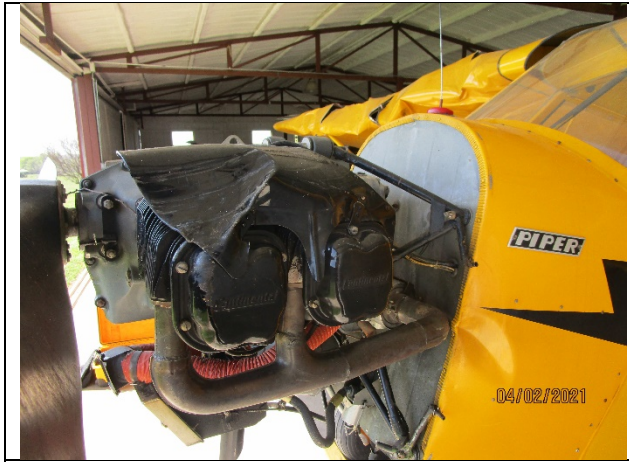
Cowling removed, fuel was light blue and free of contaminants. Engine controls in place
