**From:** Fox Todd  
**Sent:** Wednesday, February 8, 2023 10:17 AM  
**To:** LARIMORE Bryan (SAFRAN HELICOPTER ENGINES USA)  
**Cc:** Fox Todd; Rodi Jennifer  
**Subject:** RE: CEN21LA187 - Engine Run Report  
**Attachments:** A-2021-004 Engine Exam Report.pdf

| <b>INVESTIGATION REPORT</b> | Preliminary <input type="checkbox"/> |

| Data | | | | |
|---|---|---|---|---|
| EC120 | 1403 | N421PB | | |
| Arrius 2F | 34455 | 1432.7 as of 18FEB21 | | |

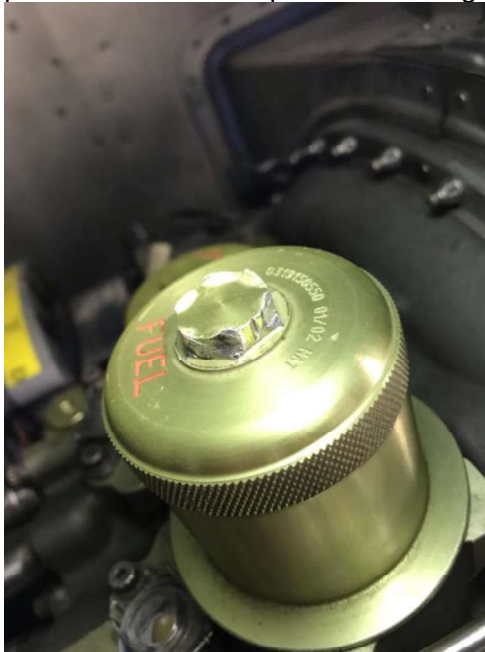
A visual examination of the engine did not reveal an obvious cause for the pilots reported loss of rotor RPM. It was noted that the main fuel filter cap had been rounded off and that the safety latch to prevent loosening of the fuel and oil caps was broken consistent with trying to remove either cap without loosening the safety first. Both fuel and oil caps were found tight. Rigging between twist grip and throttle was checked and found good as well as collective to anticipator. All fuel lines found tight and no evidences of leaks. No disassembly was performed in order to preserve the engine as original state as possible for test at a later date.

Fuel Filter Cap onsite

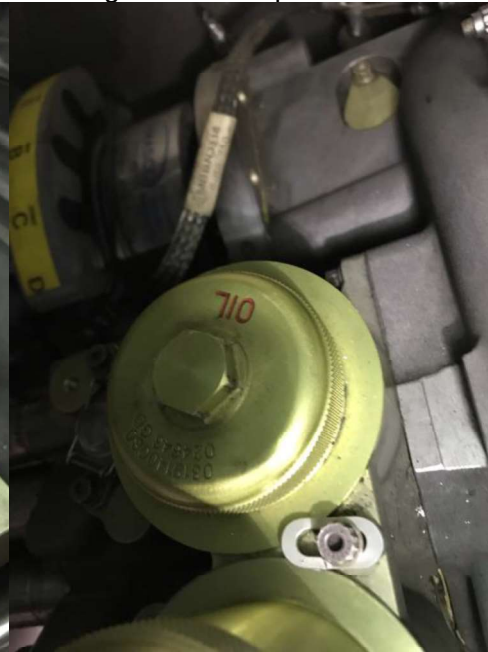
Cap Safety onsite

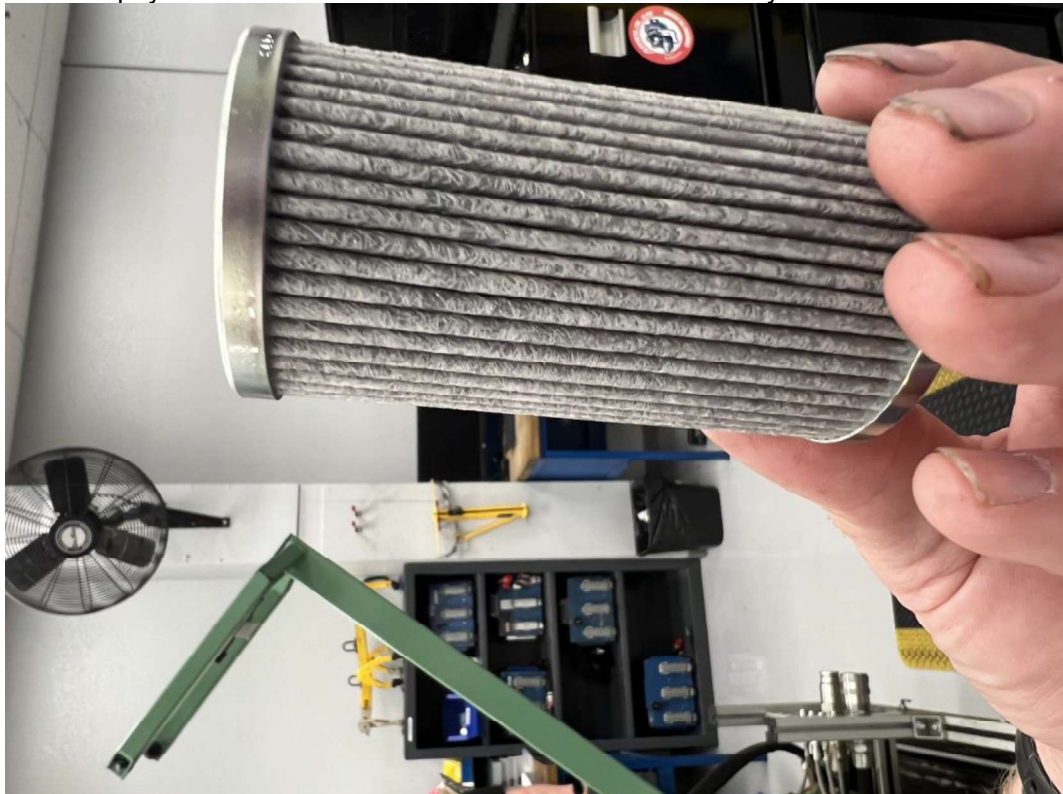
Examination of the main fuel filter showed discoloration compared to a new filter however physical contamination was not visible to the naked eye.

Accident filter upon removal

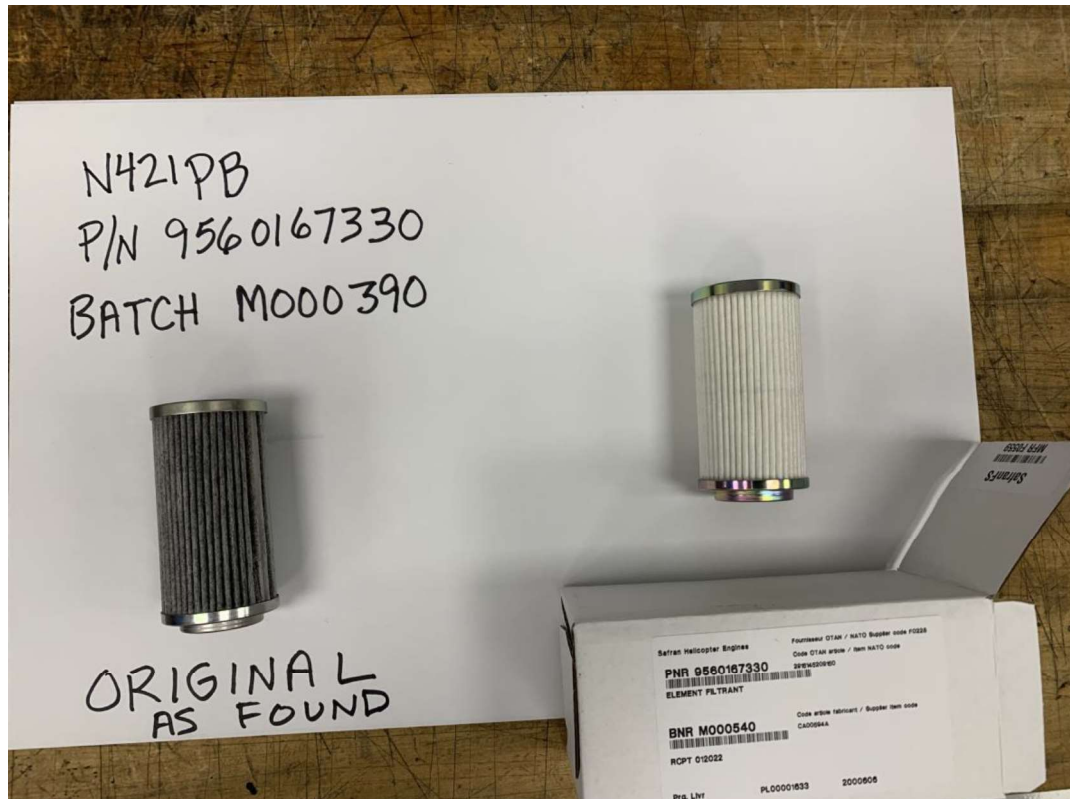
Accident filter compared to a new filter

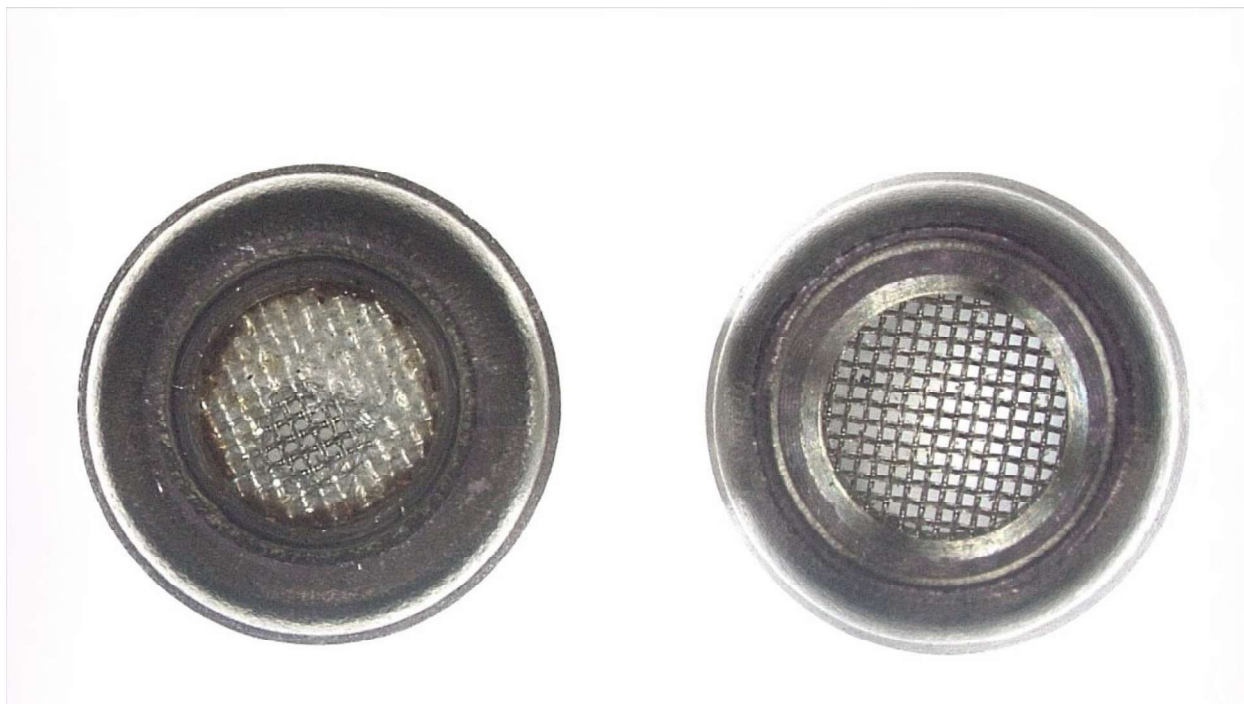
The right injection manifold was tested second and the flow was well below limits with an average flow of 4.3 (limits  $21.2 \pm 0.8$  l/ph) and max deviation of 0.2 (limits  $\leq 1.6$  l/ph). It should be noted that the right injection manifold houses a filter at the entrance of the manifold that protects both manifolds where they connect in line to the adjusted valve.

The original filter was removed and a new filter installed and the right injection manifold was flow tested again. With the new filter installed the manifold flowed within limits with an average flow of 20.9 (limits  $21.2 \pm 0.8$  l/ph) and a max deviation of 1.0 (limits  $\leq 1.6$  l/ph).

Accident manifold filter on left. New exemplar filter on right.

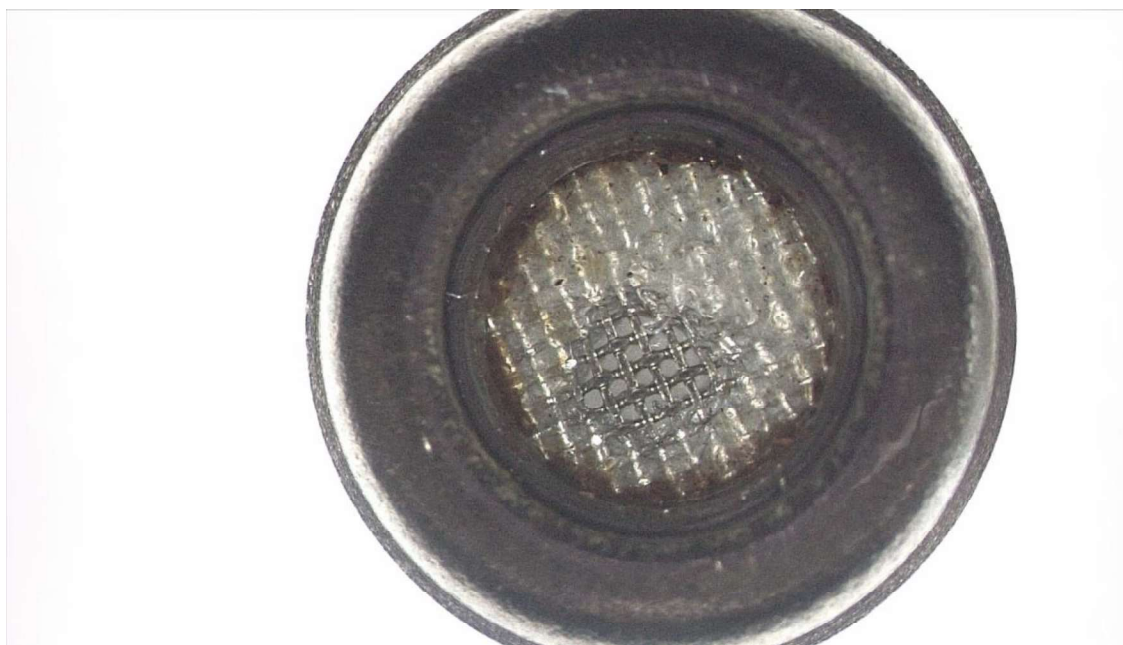
| Data | | | | |
|---|---|---|---|---|
| Test cell run was able to confirm the pilot's report of main rotor droop. While applying a load to the engine the Nf would droop and Ng was unable to accelerate above $\approx 83\%$ . It was found that contamination had clogged the injection manifold filter by approximately 75% restricting the amount of fuel that could be delivered to the gas generator. The main fuel filter was also found clogged with contamination and caused an electric pre-clogging indication as well as a physical bypass indication ( $\Delta P$ ). Contamination was found in the main fuel filter, fcU fuel filter, injection manifold filter, and throughout the fuel control unit. | | | | |

Close up of accident manifold filter

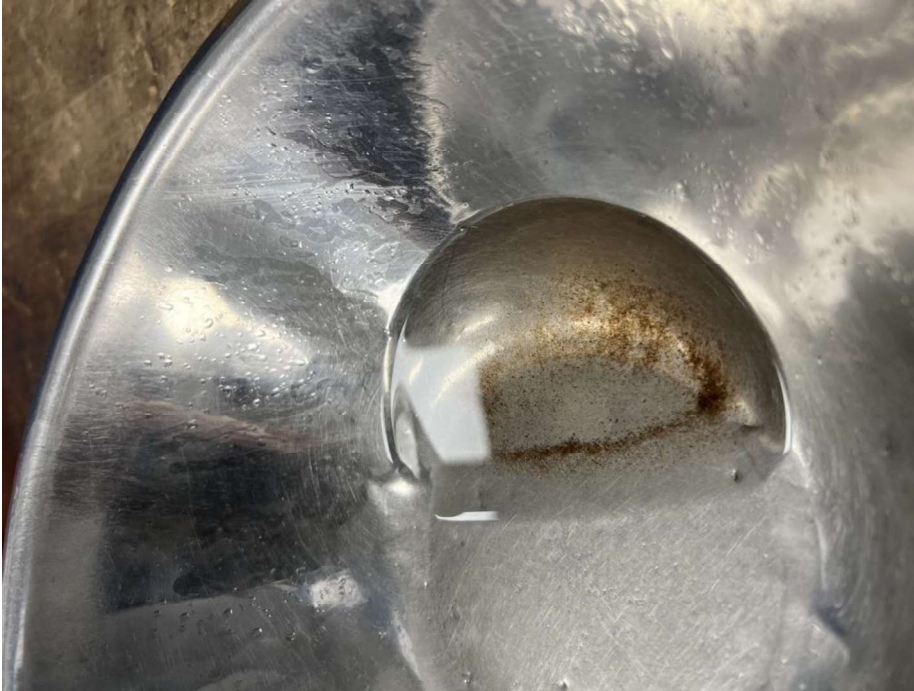
Fuel Control Unit (FCU) filter was removed for examination. The escaping fuel was captured in a clean stainless steel bowl. Physical contamination was observed in the bowl. These particles were captured in a clean sample bottle for analysis at a laboratory.

Contamination captured when FCU filter was removed

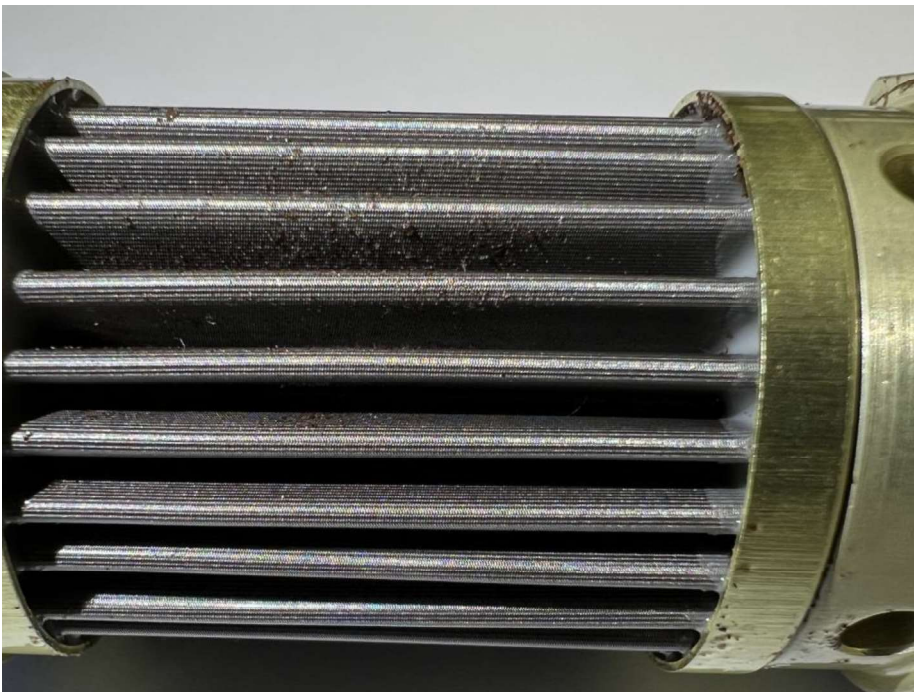
20 micron FCU filter

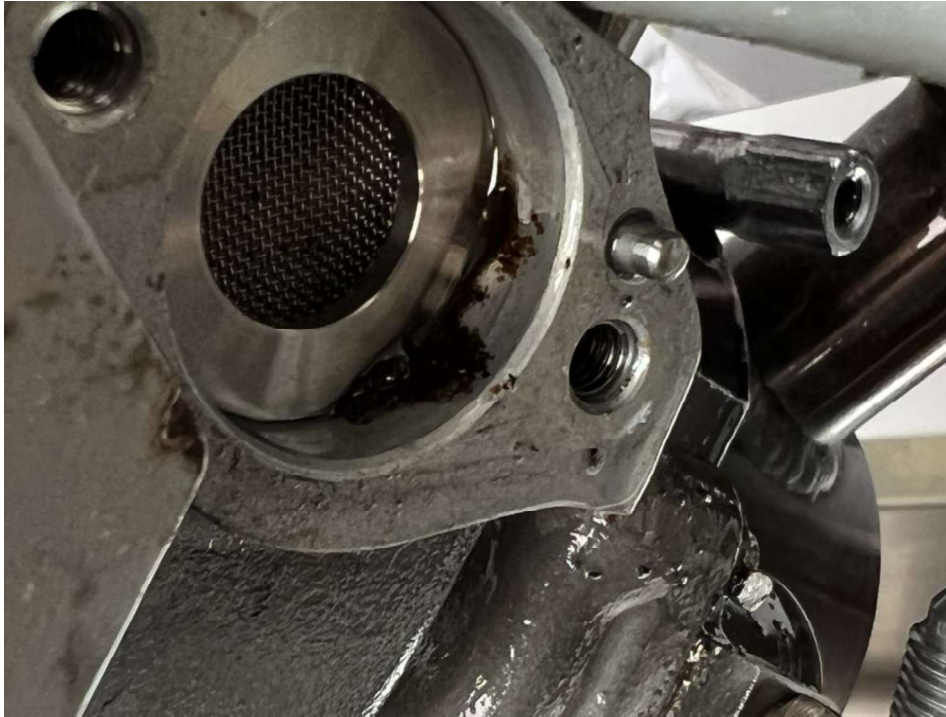
The FCU was disassembled and the same contamination found in the filter was found throughout the FCU.

Contamination in FCU

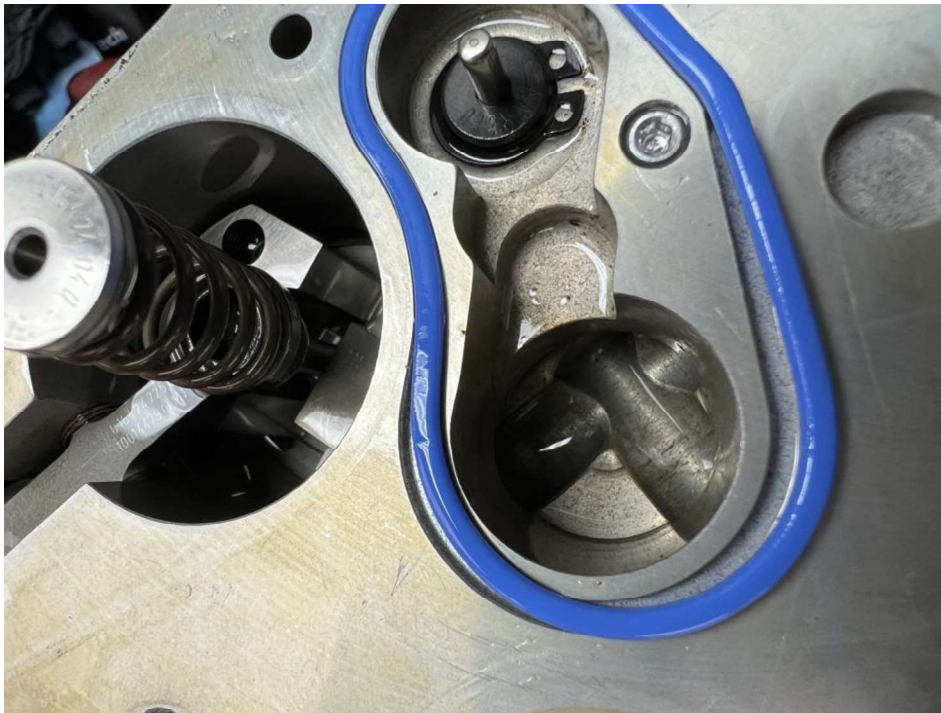
Contamination in FCU

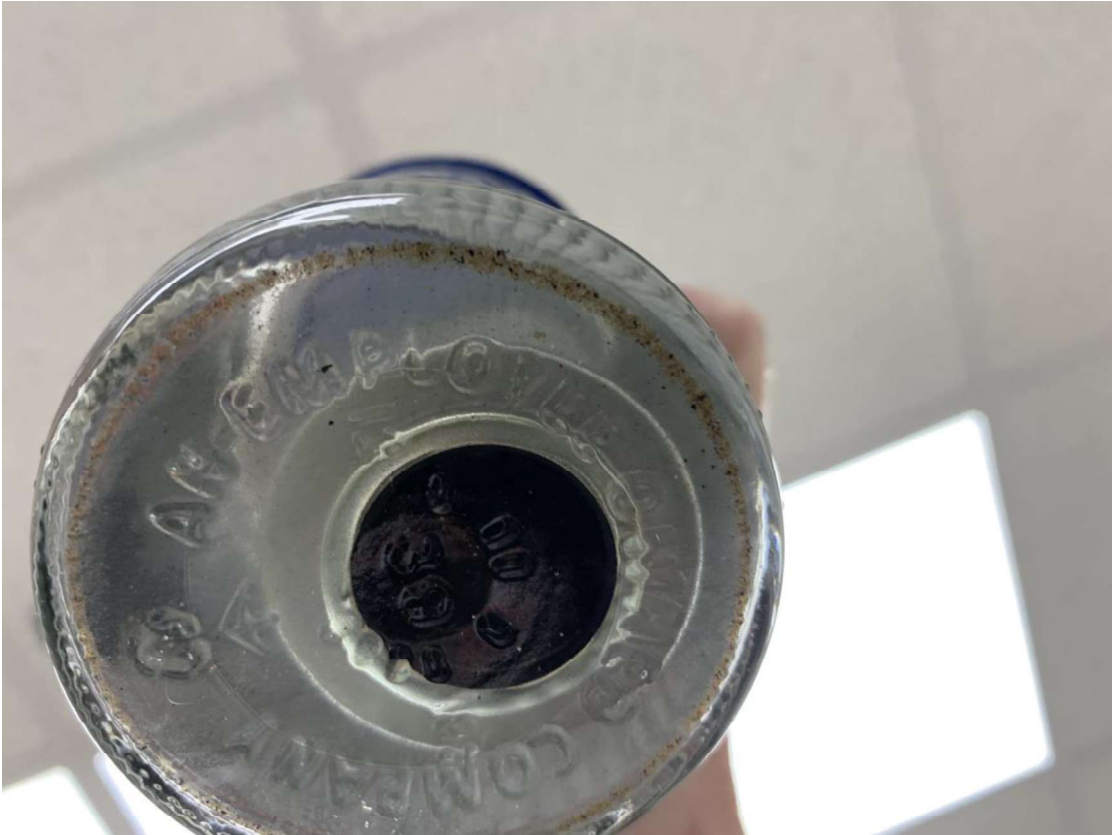
The accident main fuel filter was placed in a jar and agitated. The same particles observed in the FCU filter could be observed in the bottom of the jar.

Particle contamination found in main fuel filter

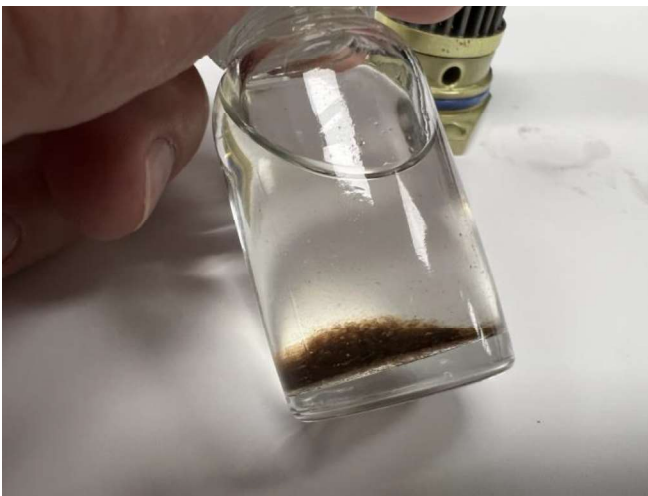
A sample of the captured contamination was sent to JET-CARE laboratory for analysis. The lab was able to identify the elemental composition however they could not identify the material as a whole or the origin. The sample was sent to the NTSB lab with the same results.

Sample sent to JET-CARE and NTSB

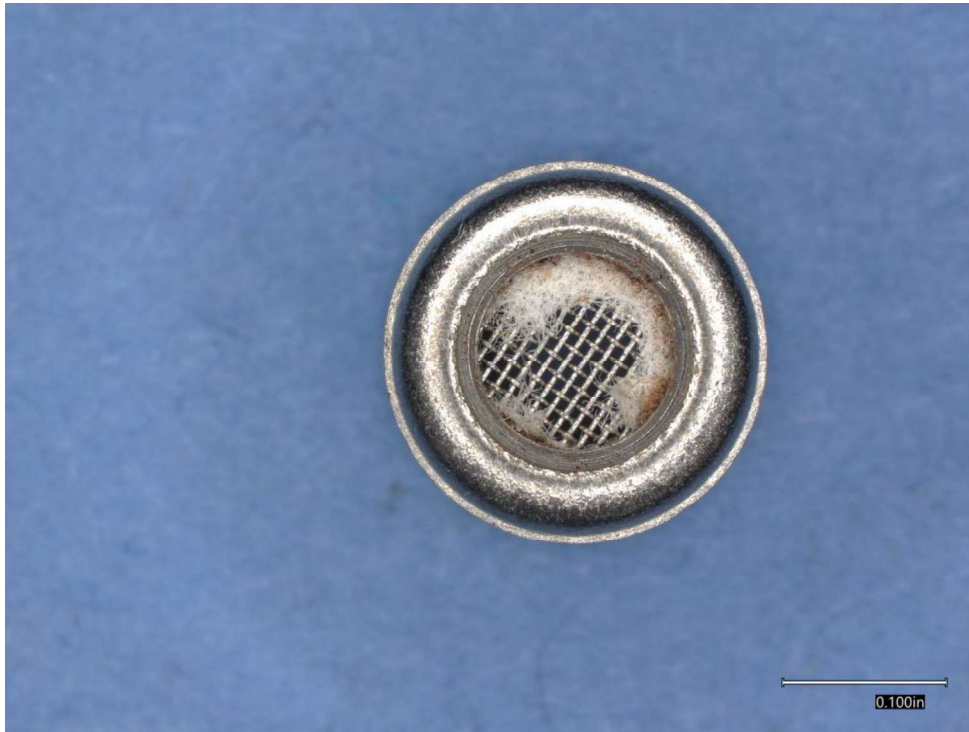
The manifold filter was sent to the NTSB laboratory for analysis. The FTIR spectrum was consistent with a cellulosic material likely a cloth or paper source.

Accident manifold filter with residual fuel removed.
