**Record of Examination**  
**CEN21LA208**  
**Date of Examination: August 2, 2021**  
**Performed By: Mitchell Gallo**

The aircraft, a Beech Aircraft Corporation 23, serial number M102, N2378Z, was examined by the NTSB Investigator-In-Charge at Beegles Aircraft Service, Greeley, Colorado, on August 2, 2021.

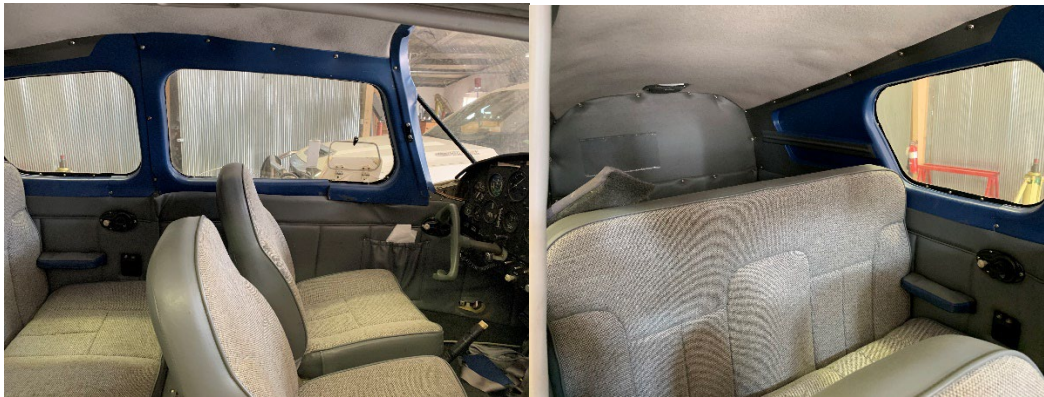
**Photo 1: Front and Rear Seats**

The aircraft was not equipped with shoulder harnesses. Photo 1 shows the aircraft front and rear seats without shoulder harnesses.

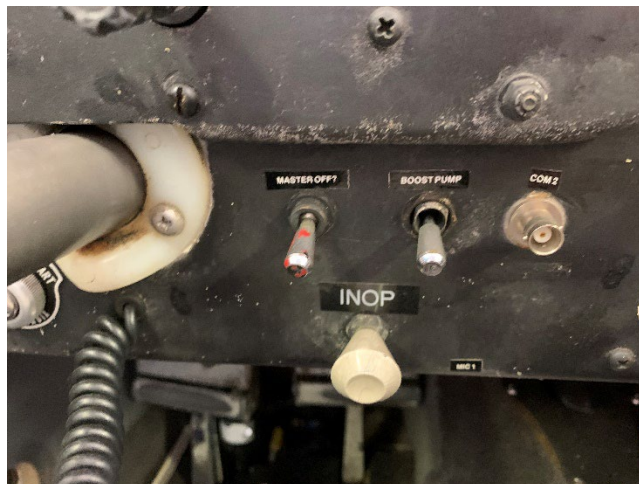
**Photo 2: Unmarked Cockpit Control**

There was an unmarked cockpit push-pull control with a label of "INOP" shown in Photo 2.

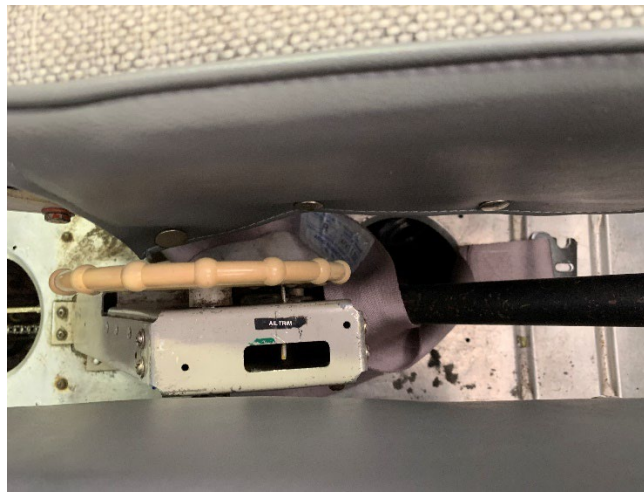
**Photo 3: Elevator Trim Control**

The cockpit elevator trim control was labeled "AIL" and had no nose-up and nose-down range markings of as shown in Photo 3.

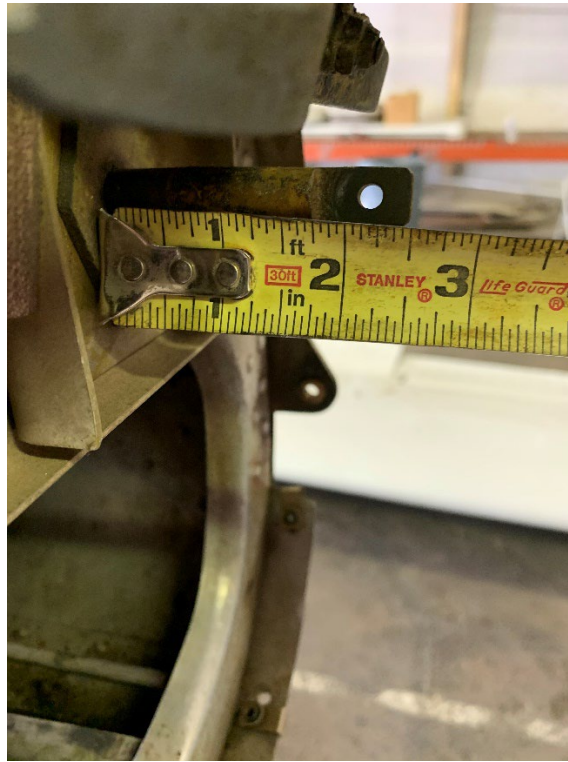
**Photo 4: Elevator Jack Secure Extension**

The elevator trim jack screw was extended approximately 2 ½ inch as shown in Photo 4, which equated to approximately a slightly elevator trim tab down from neutral.

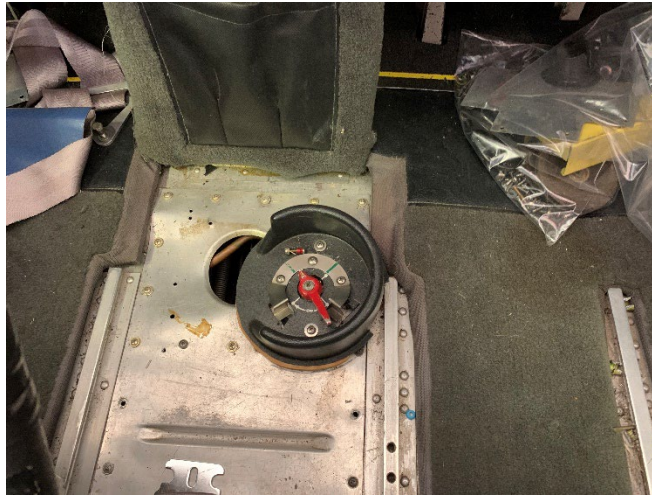
**Photo 5: Fuel Selector Control**

The cockpit fuel selector was positioned to the left limit of travel. The fuel selector position markings were covered by a metal piece installed on top of the unit shown in Photo 5. During rotation of the fuel selector by hand, there were no detents felt, and the selector moved freely through the left and right detents.

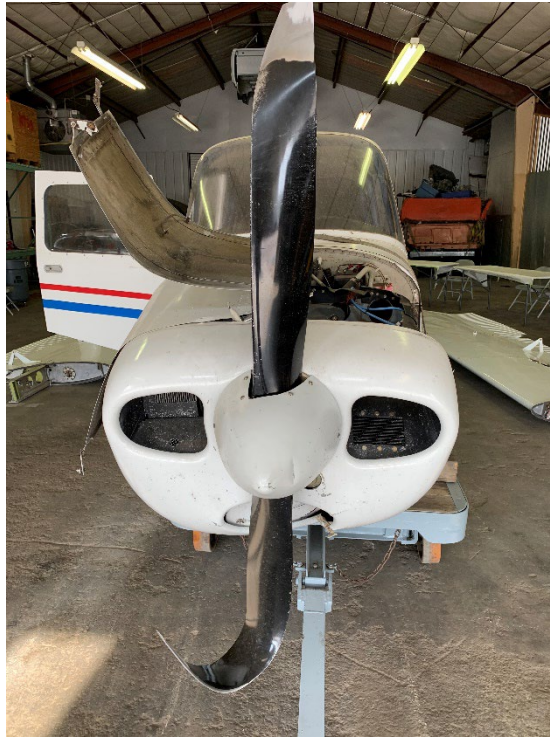
**Photo 6: Propeller**

The propeller exhibited bending and twisting as shown in Photo 6. The propeller hub had the following markings:

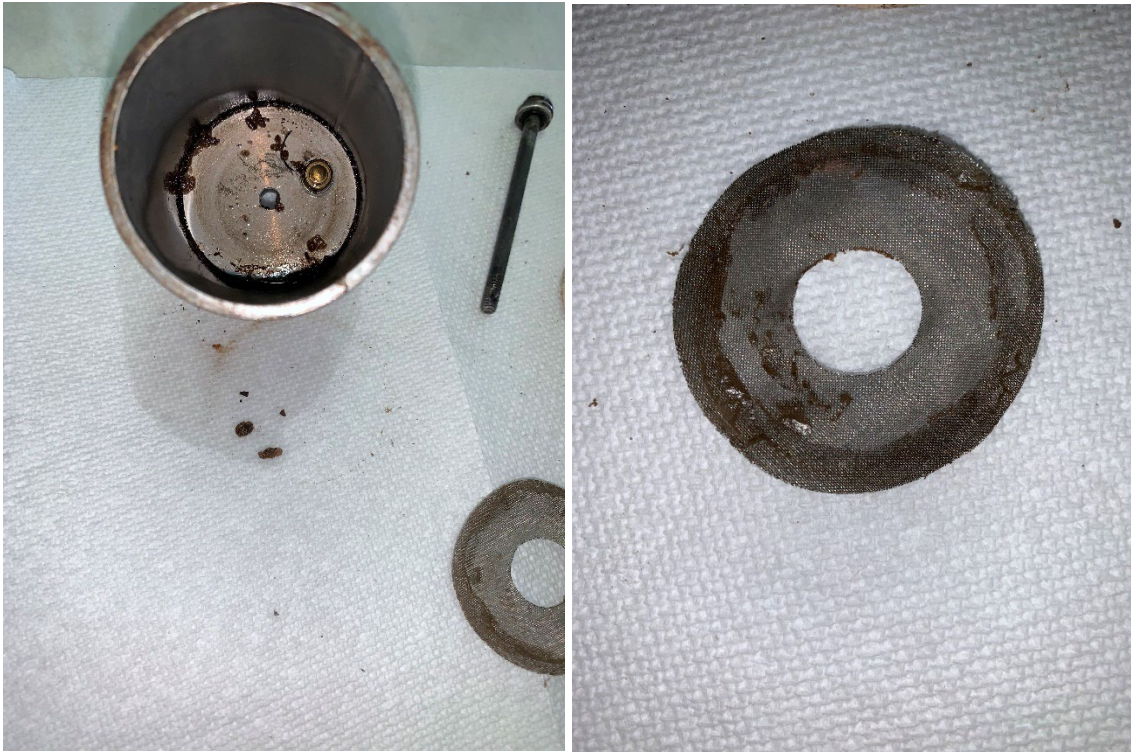
**Photo 7: Gascolator and Gascolator Screen**

The gascolator was removed and disassembled. The gascolator was full of a blue color liquid consistent with 100 low-lead aviation fuel. The bottom of the gascolator contained a black color non-metallic debris, and the gascolator screen had a contaminant that did not obstruct an estimated 80% of screen shown in Photo 7.

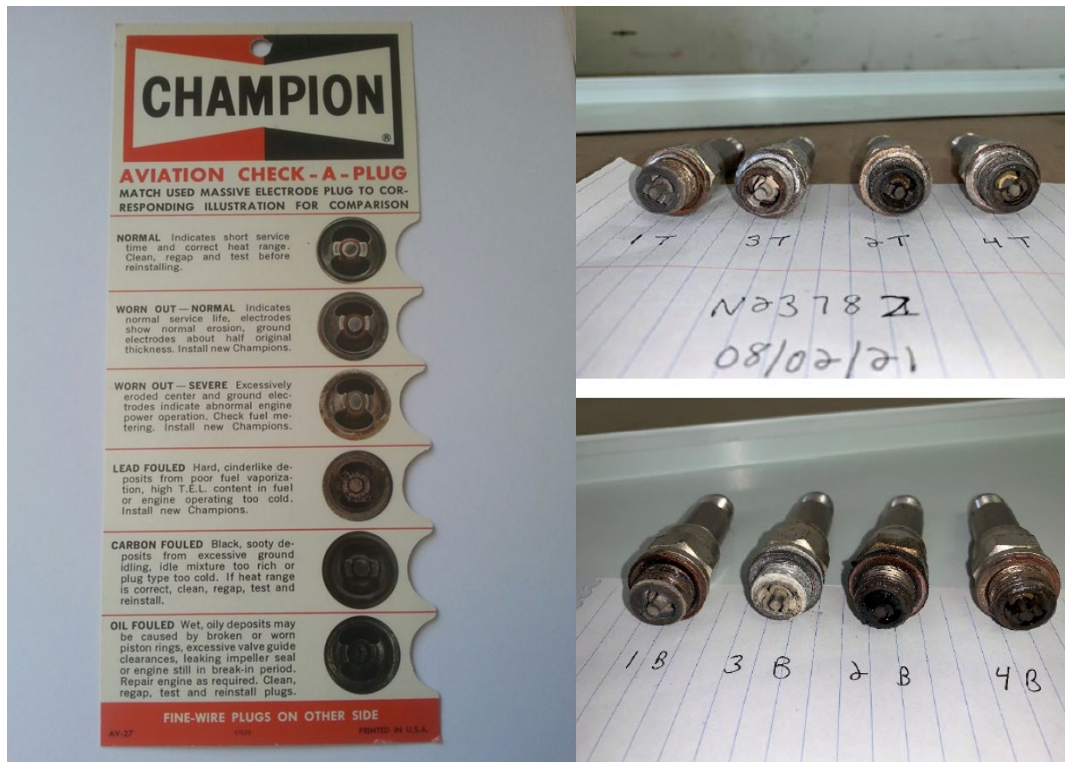
**Photo 10: Top (T) and Bottom (B) Spark Plugs from 1 to 4**

The ignition harness was attached and secured at both magnetos and at all spark plugs. Both magnetos were attached, secure, and were unable to be rotated/moved while mounted to the engine accessory case using hand pressure. Engine to left magneto timing was about 26° before top dead center (BTDC), and the engine to right magneto timing was about 25° BTDC. The engine data plate indicated the spark advance for the engine was 25°. Both magnetos were removed for bench testing and a check of internal timing. All plugs were of the massive electrode type and displayed “normal wear” consistent with the Champion Aviation Service Manual AV-6R. Comparative spark plug features of the top and bottom spark plugs with the Champion Check-A-Plug chart is shown in Photo 10.

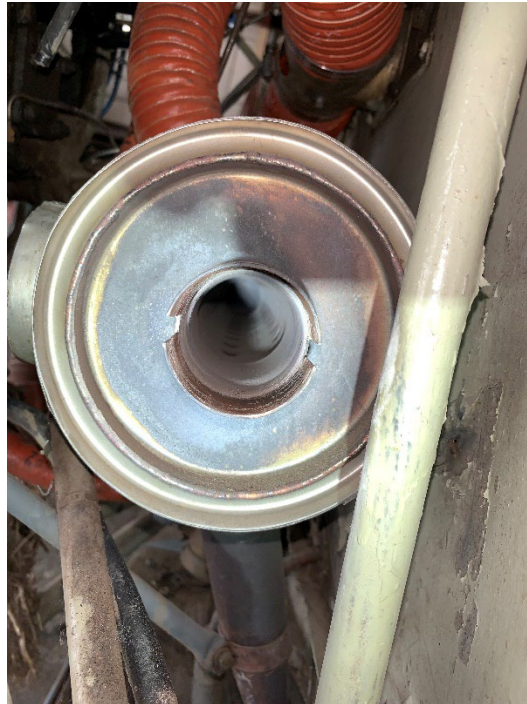
**Photo 11: Internal View of Heat Exchanger**

The exhaust system was intact and secure. The exhaust heat exchanger was unobstructed as shown in Photo 11.

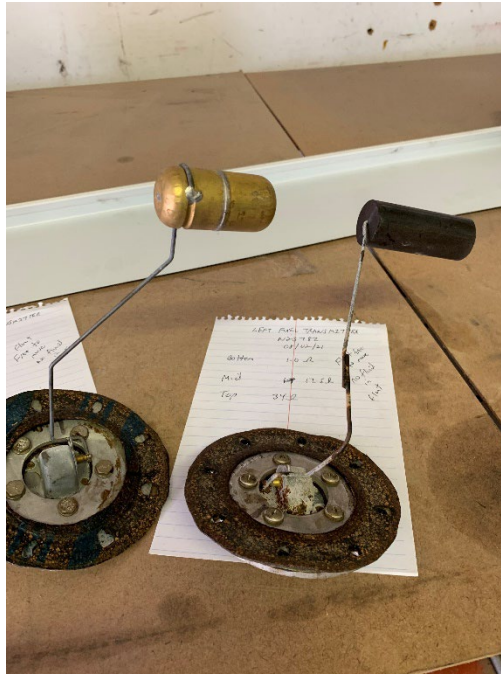
**Photo 12: Fuel Transmitters**

The left and right fuel transmitters were removed from their respective fuel tanks. Both fuel transmitter float arms were moved full travel by hand and no binding or sticking was present. The fuel transmitters are shown in Photo 12. The left transmitter had a white colored residue at its base. The left transmitter float was a made of solid non-metallic material, and the float arm was soldered together about mid length of the arm. The right transmitter float was metallic and did not contain liquid within the float. The resistive values of both transmitters were measured at the approximate bottom, middle, and upper float travel positions using a multimeter and those values are shown in Figure 1.
