## Mike's Aircraft Fuel Metering Service

I have had a chance to tear down and visually inspect the condition of the Marvel Schebler carburetor that you sent to us from Accident Number CEN21LA211 (Model MA-4SPA, P/N 10-5217, S/N 75958110). It was reported to us that this was involved in an engine fire that occurred after landing. This was a teardown inspection only. I did not clean or do any additional inspection other than the visual teardown inspection. I will detail the various components below.

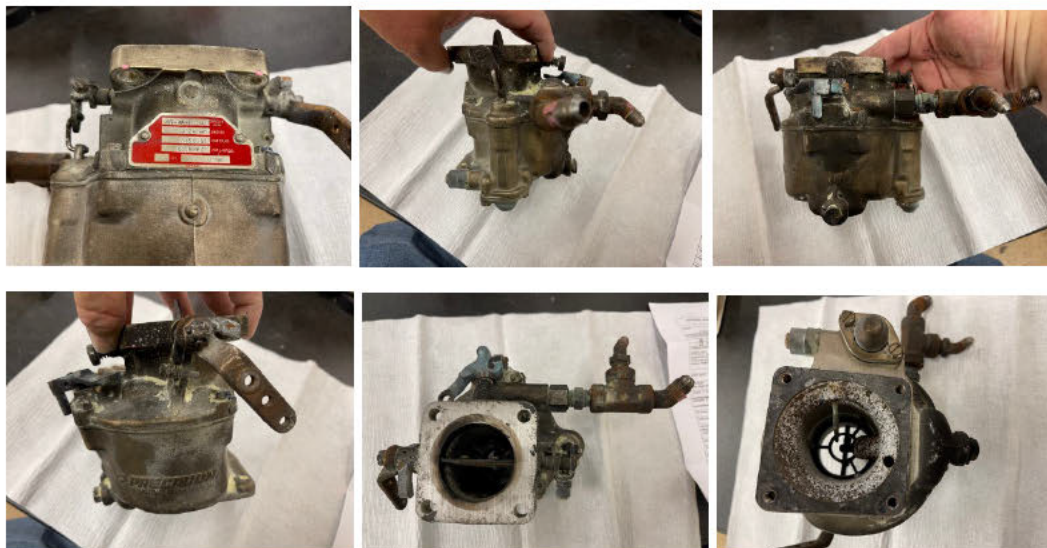
The exterior shows signs of some heat, soot, and extinguishing agent along with some common surface corrosion. All parts appeared to be assembled correctly and no signs of a leak.

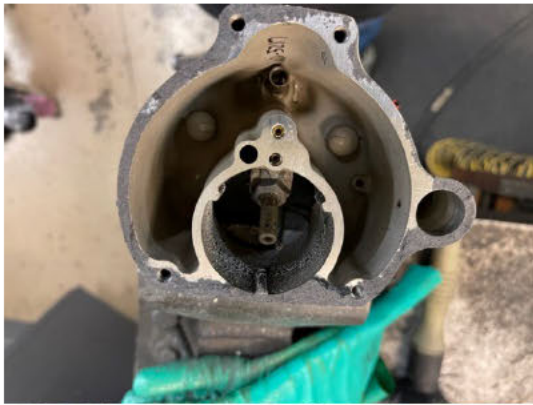
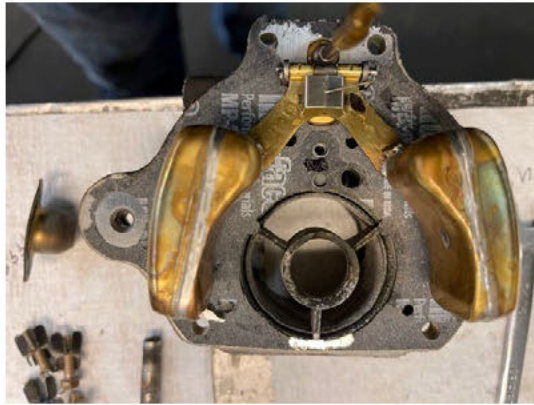
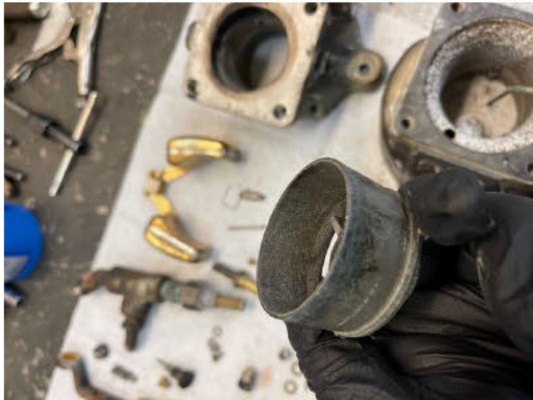
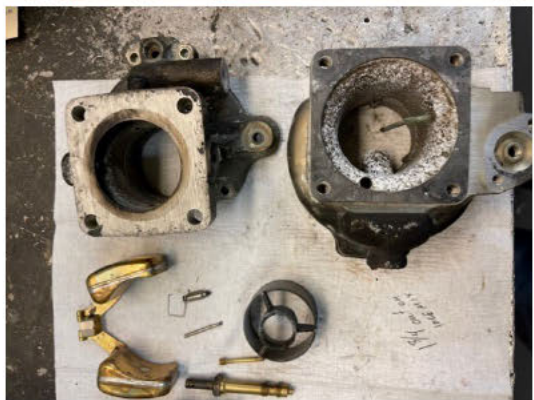
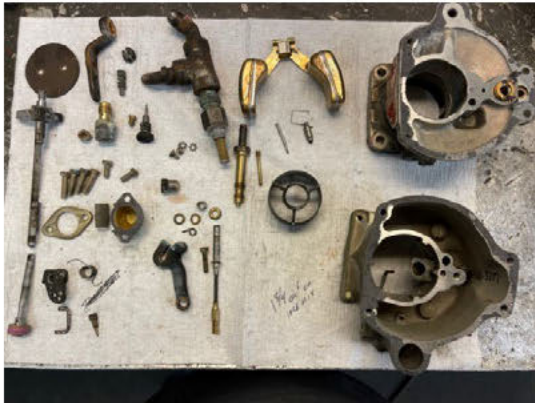
During disassembly, nothing abnormal was noted. It appeared to be assembled correctly. The inside of the bowl was clean and did not show any signs of discoloring from heat. The float appeared to be set correctly. This unit did have a PMA brass float installed instead of the Marvel Schebler blue epoxy float. The float appeared to be in serviceable condition. The venturi did show a small amount of blue fuel stain where it fits against the throat of the throttle body. This did not appear to be excessive; some is usually found on normal teardown of an in-service carburetor. The throttle shaft had some wear but was normal wear. The needle/seat assembly, mixture control shaft, nozzle, idle tube, and accelerator pump appeared to be in serviceable condition. The throttle lever appeared serviceable, but the mixture lever appeared to have some discoloration from the heat and/or soot. The 4 screws that attach the throttle body and bowl were tight and no movement was observed between the halves. All lock washer appeared locked and undisturbed. The finger screen on the inlet adapter was clean.

In conclusion, I found nothing out of the normal visual wear and tear on the unit other than the signs of the fire. Due to the corrosion on the throat of the unit and the close proximity of an engine fire, I would recommend replacing versus trying to overhaul this unit.
