# National Transportation Safety Board

CEN21LA213

## **MATERIALS LABORATORY**

Factual Report 23-026

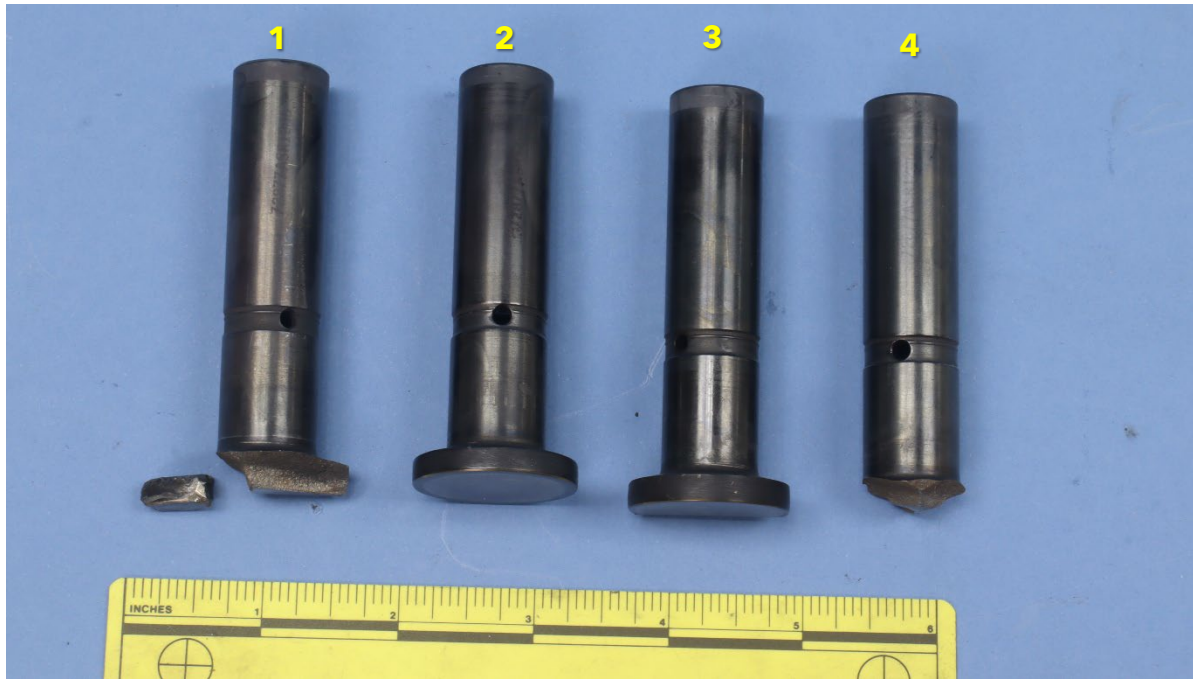
Figure 1 shows the four tappets from the intake side of each of the four cylinder positions. They were annotated based on their cylinder position in the figure. Three of the four tappets had fractured on the flanged head, with only the #2 tappet remaining intact.

**Figure 1.** The intake tappets, as received, annotated by cylinder position.

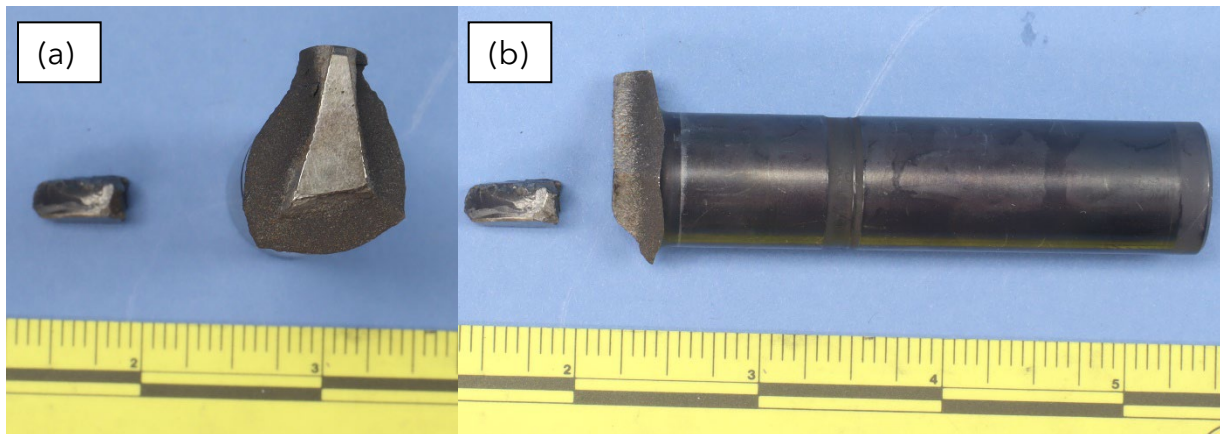
Figure 2 shows the #1 intake tappet from the head and side. The head exhibited three angled fractures, leaving a portion of the face that had been in contact with a camshaft lobe.

**Figure 2.** The #1 intake tappet with the remnant recovered viewed from (a) the fractured head and (b) the side.

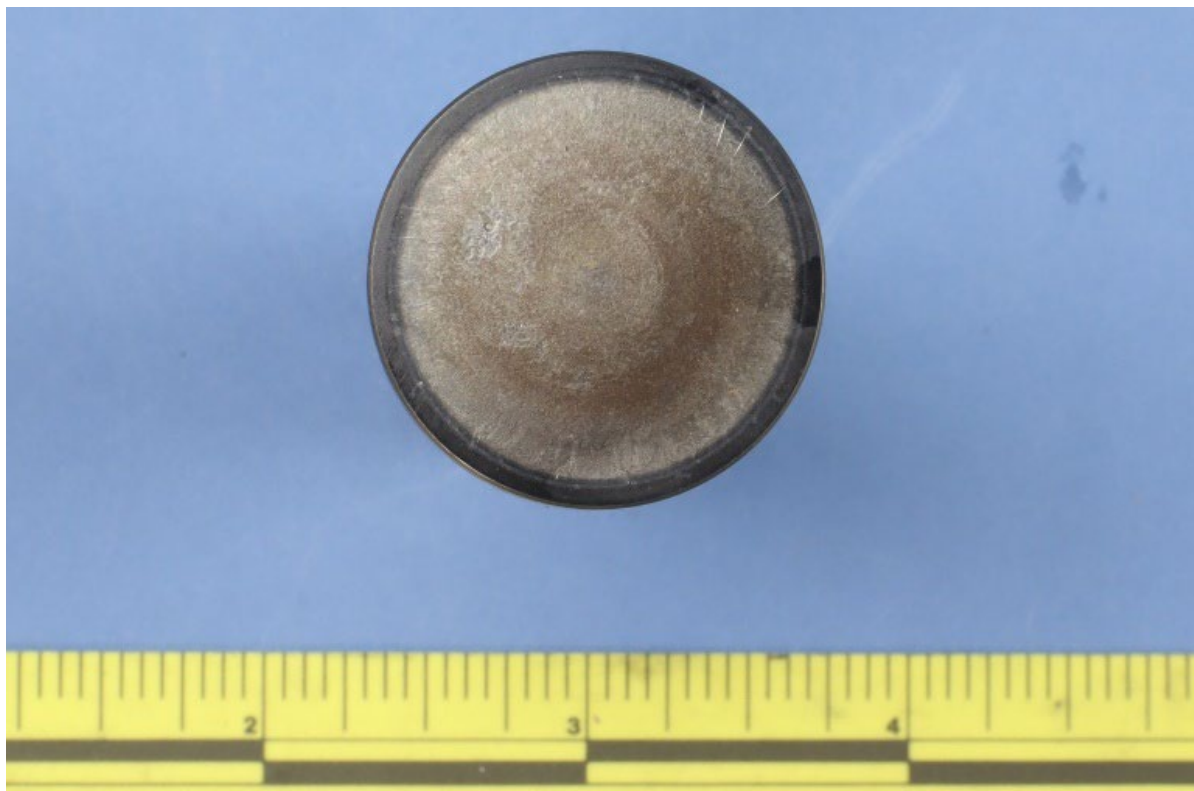
In contrast, the intact #2 tappet head face, shown in Figure 3, did not exhibit any chips or fractures. This tappet face did display small (approximately 1/8 inch long) radial features around the periphery. A closer examination of the face found small depressions near the center (see Figure 4 and Figure 5). These areas were consistent with pitting on the surface, as illustrated in Figure 6. In addition, the radial features were shown to be straight in morphology and tapered at each end—these

**Figure 3.** View of the #2 intake tappet head, as received.

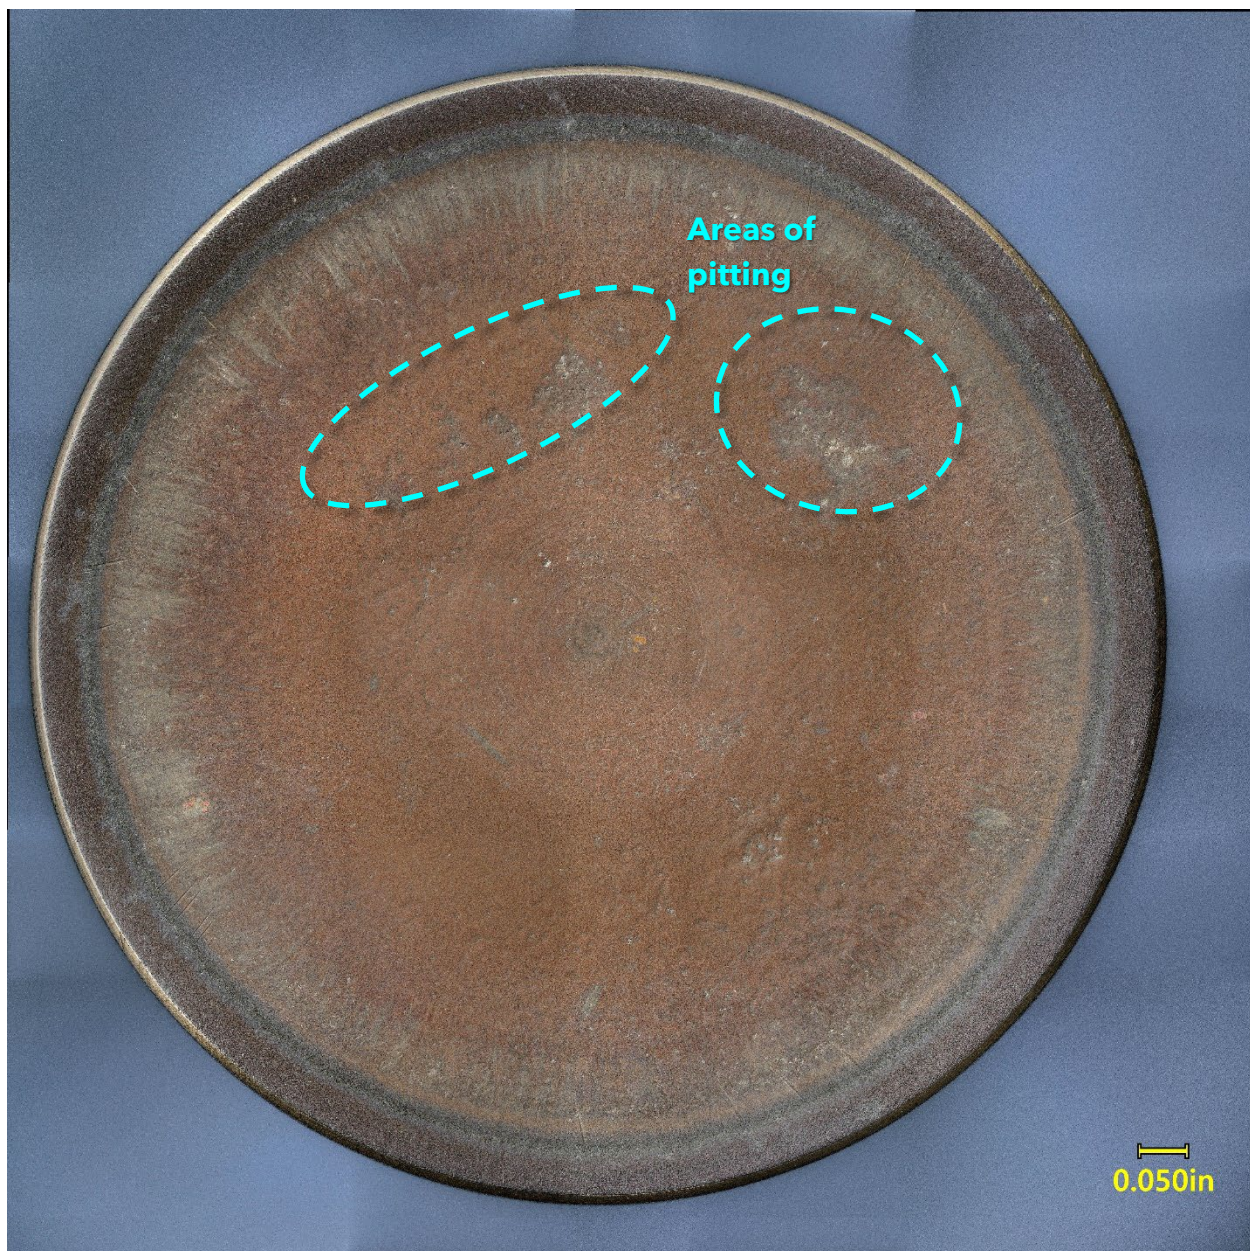
**Figure 4.** Closer view of the face of the #2 intake tappet head, using optical shadowing to show a band of pitting in the upper part of the figure.

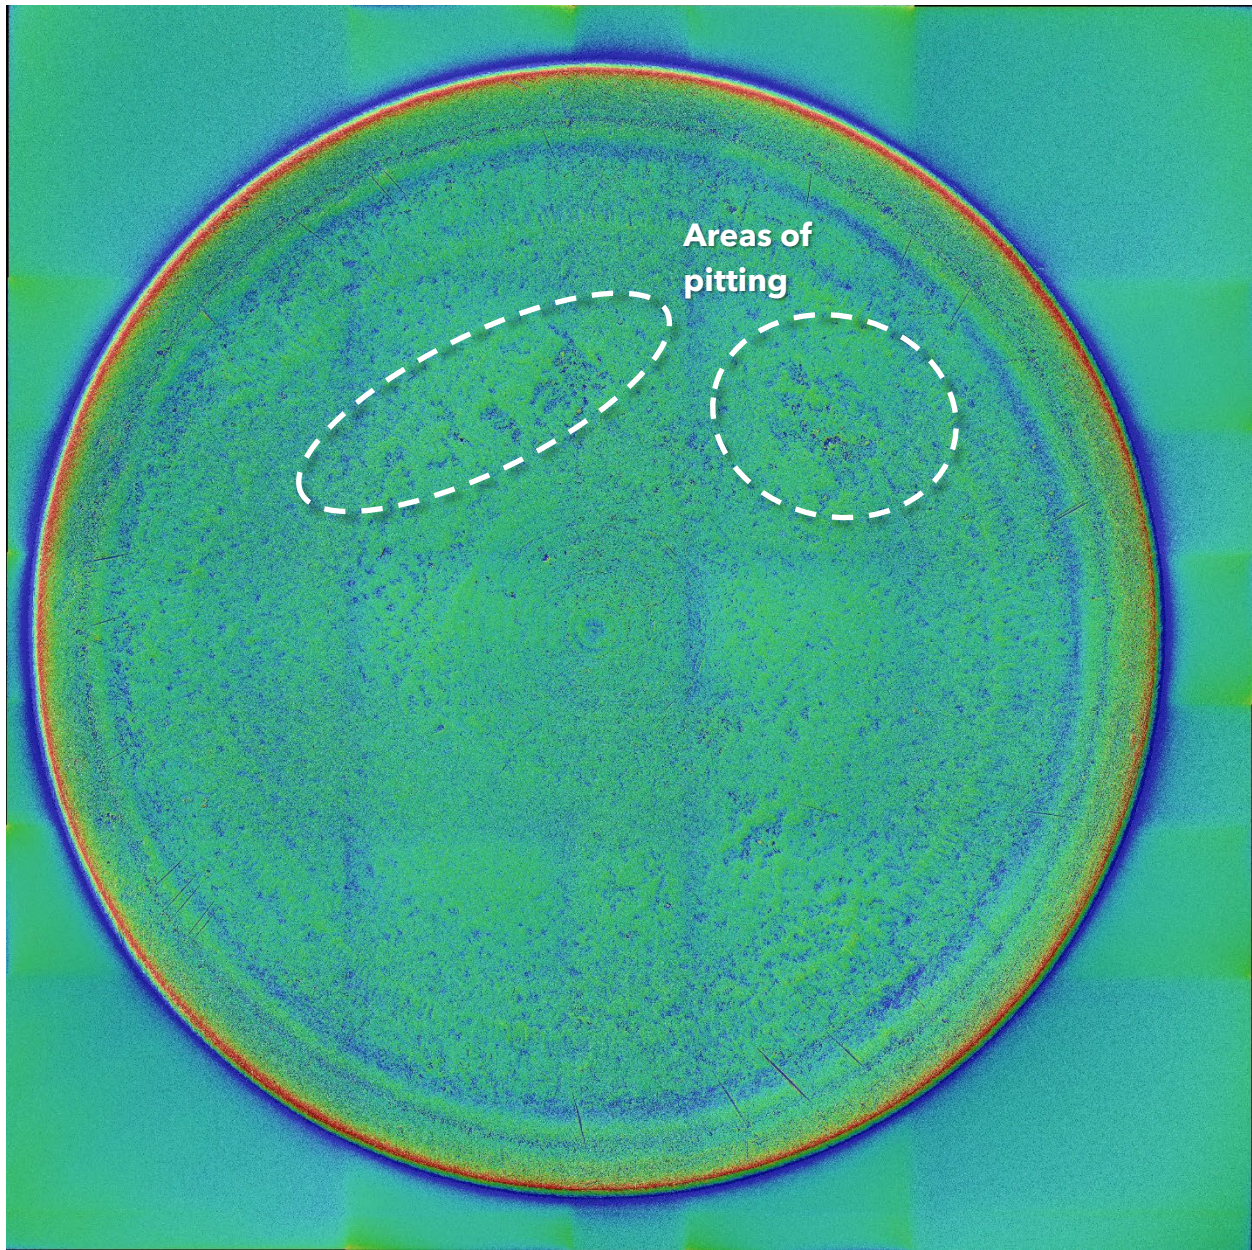
characteristics were consistent with scratches imparted to the surface. The false color image in Figure 5 demonstrates these qualities of the surface scratches.

**Figure 5.** False color overlay of the #2 tappet head face in **Figure 4**, showing the depressed areas (blue) corresponding with pitting and radial scratches. The red areas around the edge are the highest relative elevation.

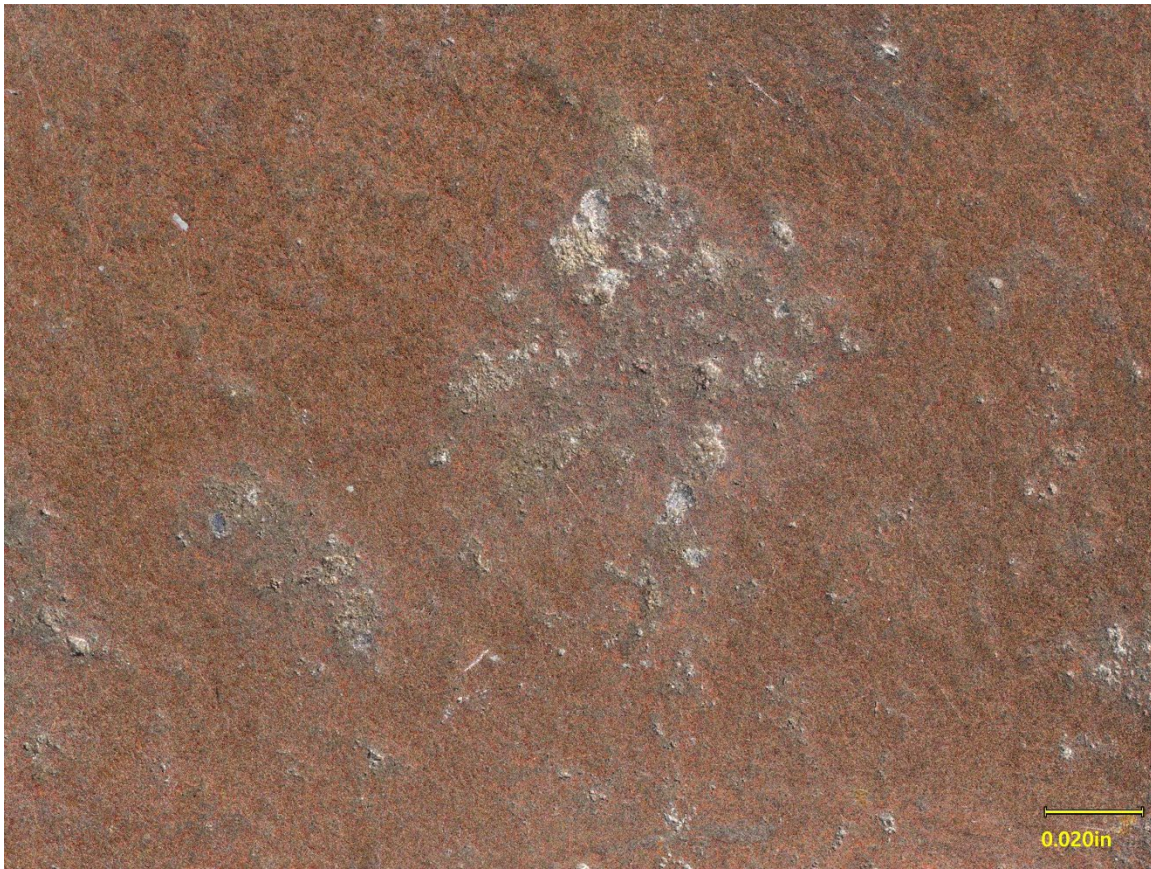
**Figure 6.** Closer view of the pitting on the surface of the tappet in **Figure 4**.

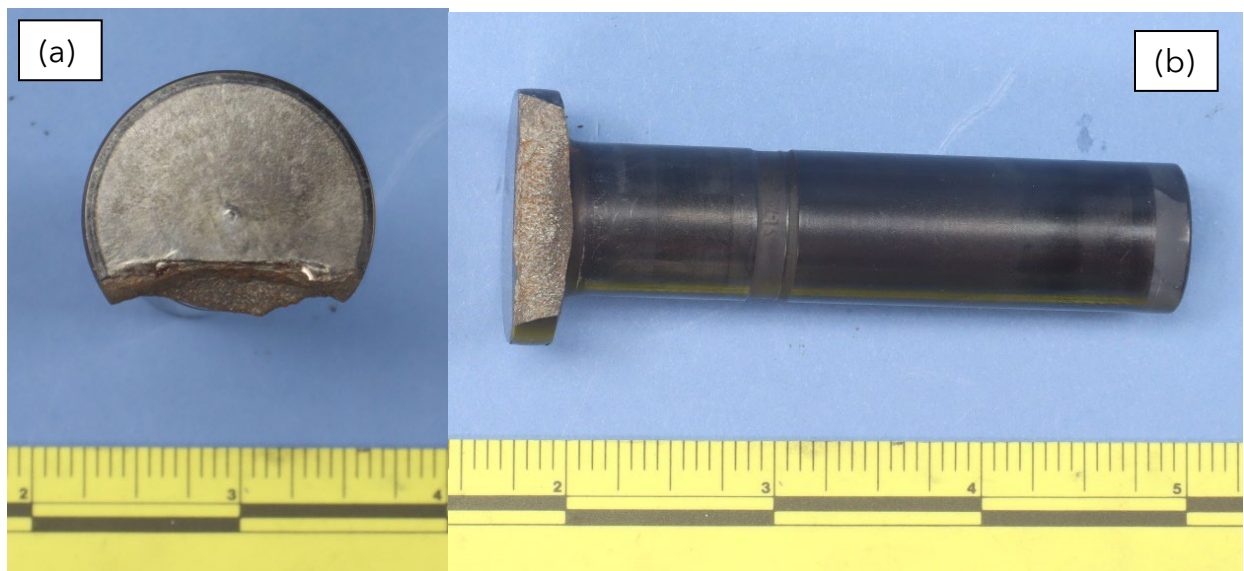
Figure 7 shows the #3 tappet remnant, viewed from the head and side. About 1/3 of the tappet head had fractured and separated, leaving a jagged chord-oriented fracture surface coincident with the hollow tappet stem. The tappet from the #4 intake position was completely absent from the head, exhibiting two oblique fractures. This fractured remnant is depicted in Figure 8.

**Figure 7.** View of (a) the fractured head and (b) the side of the #3 intake tappet.

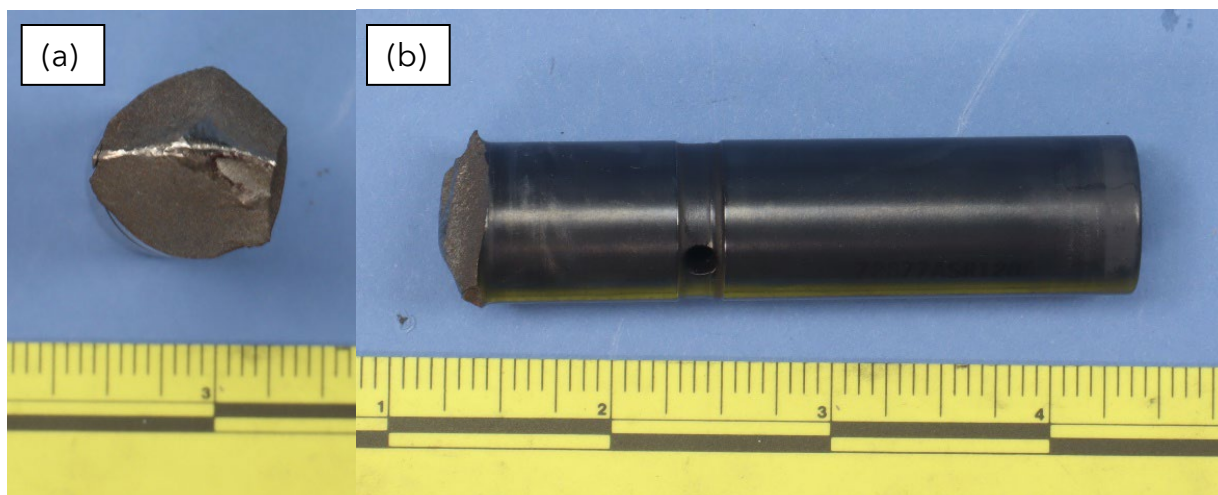
**Figure 8.** View of (a) the fractured head and (b) the side of the #4 intake tappet.

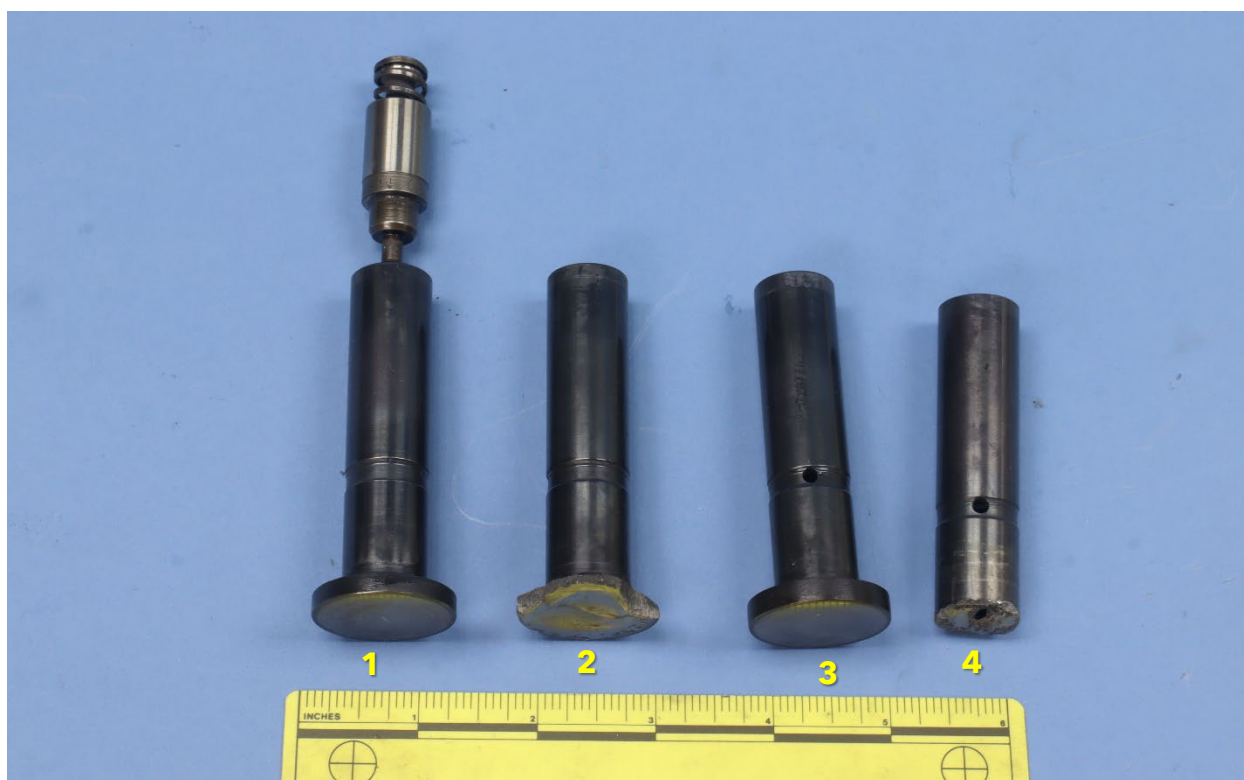
Figure 9 shows the four tappets and their remnants from the exhaust positions; each was annotated based on their positions from the engine. In this batch, the #1 and #3 tappets were intact, whereas the #2 and #4 tappets had fractured.

**Figure 9.** The exhaust tappets and #1 plunger piston as received, annotated by cylinder position.

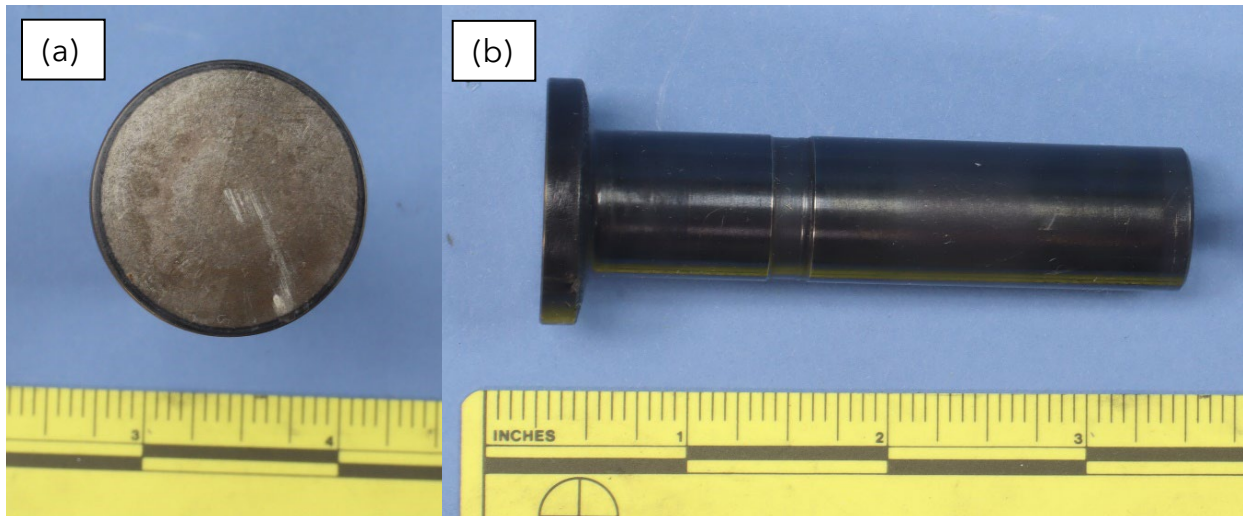
Figure 10 shows the head and side of the #1 exhaust tappet. The face of the head exhibited a radial streak from the center towards an edge. There were no other indications of damage on this part. The #3 exhaust tappet showed no visible features indicating damage, wear, or cracking.

**Figure 10.** View of (a) the head and (b) the side of the #1 exhaust tappet.

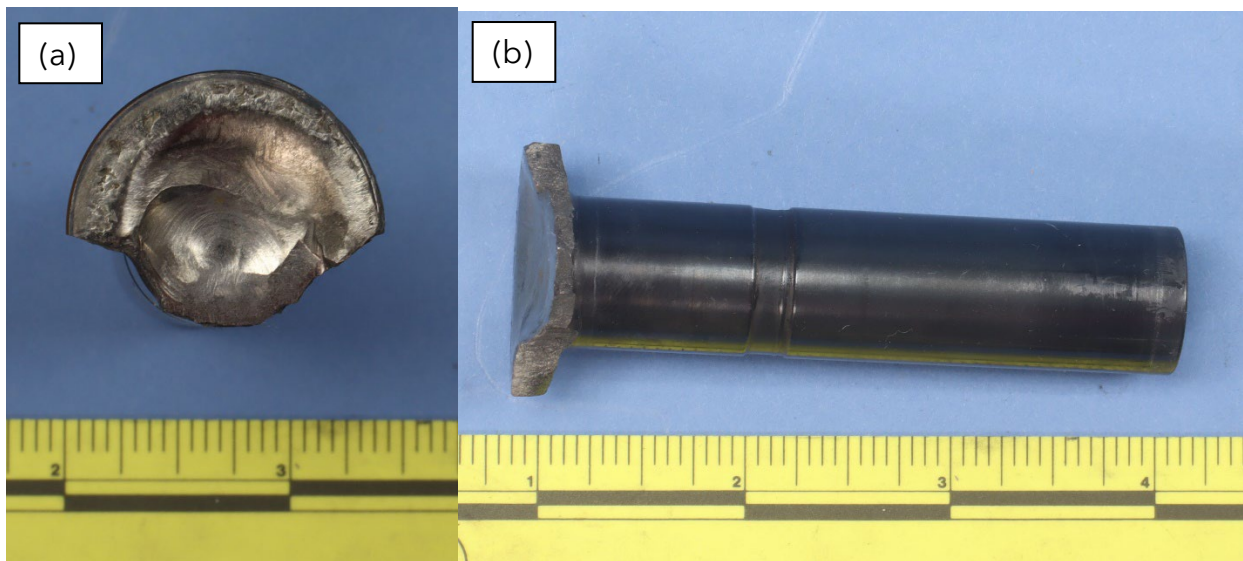
Figure 11 shows the #2 tappet, which retained about 2/3 of the head area. However, unlike the other damaged tappets, most of the head face had been worn away, and the remainder of the head exhibited a depression most pronounced corresponding with the stem (see Figure 11b). The #4 tappet head was absent, leaving a flat, perpendicular fracture across the stem, deep enough to open to the interior cavity.

The #2 exhaust tappet exhibited a thickness of 0.189 inches along the periphery of the head. However, this decreased to 0.088 inches at the fracture surface adjacent to the stem, consistent with wear and material spalling.

**Figure 11.** The #2 exhaust tappet shown from (a) the head and (b) the side.

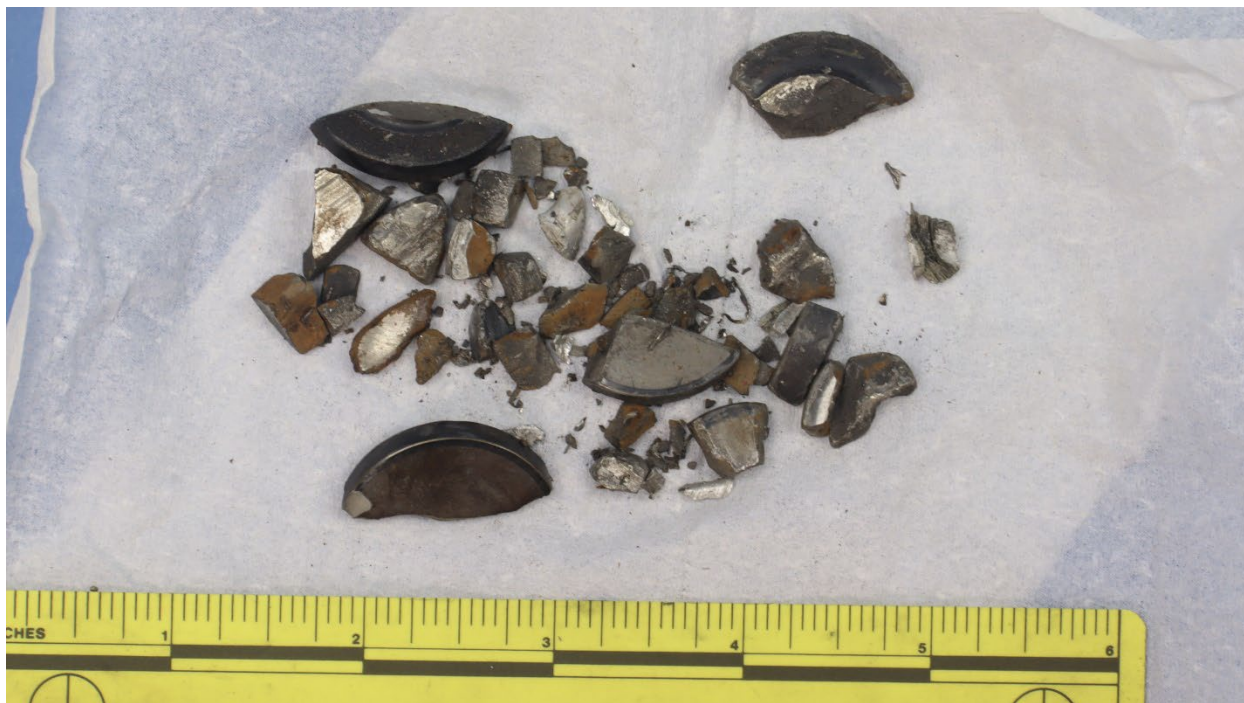
Some assorted but uncategorized fractured tappet remnants had been recovered and shipped together, as shown in Figure 12. Most of these had been fractured after separating from their tappet bodies, with the fracture surfaces smeared and worn.

**Figure 12.** Loose debris recovered from the engine.

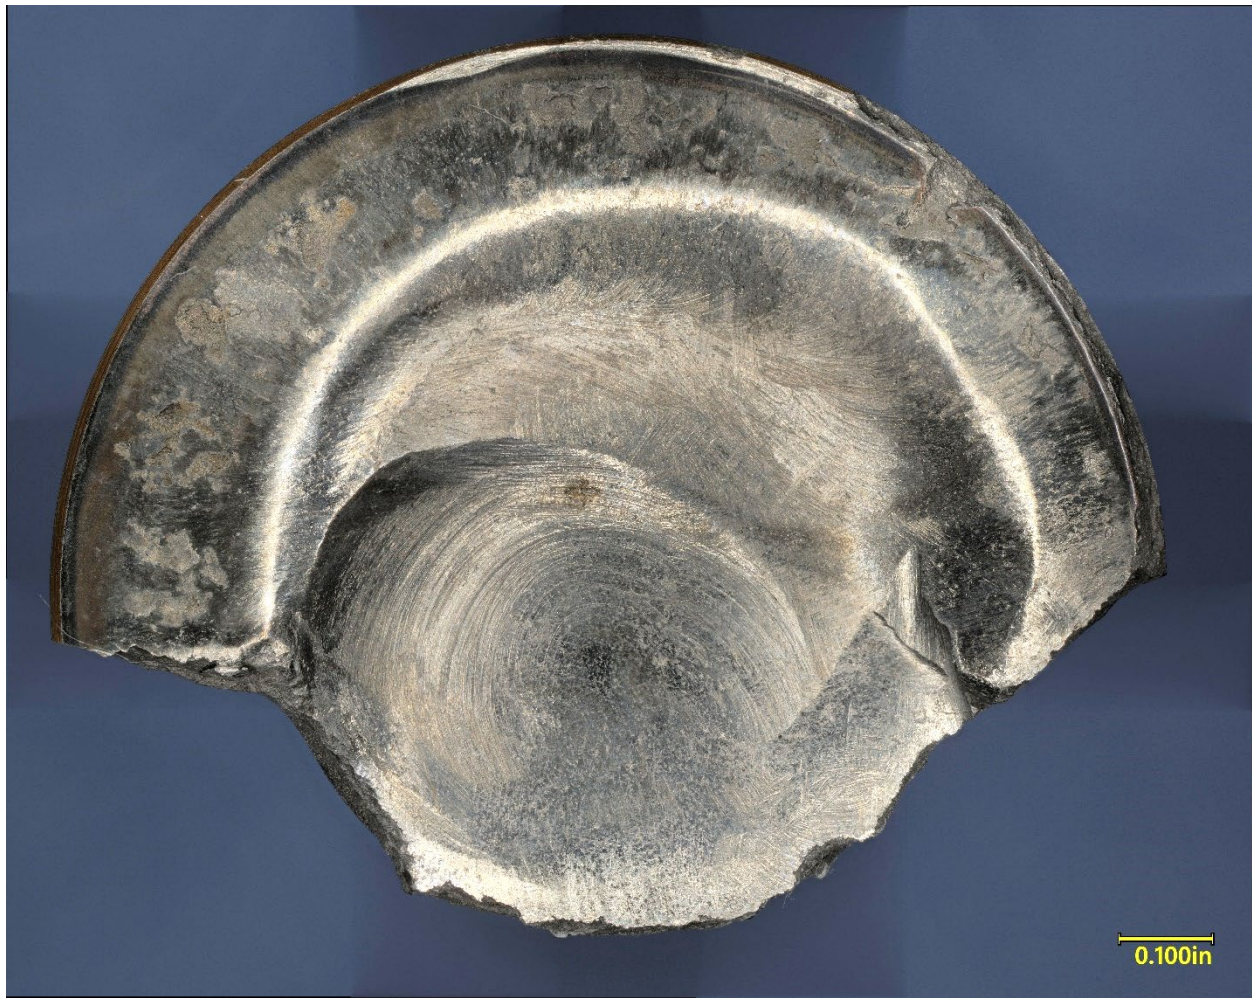
Several of the damaged and fractured tappets were examined further. Of note was the #2 exhaust tappet, the only one that underwent wear on the head significant enough to change its geometry. Figure 13 shows a montage of the head face, which was reflective and consistent with polishing from repeated contact with the mating camshaft lobe. The depression at the center of the tappet head corresponding to the stem exhibited circular wear marks. The fracture surface on the bottom of the figure was circular, conforming to the geometry of the stem radius. Figure 14 shows the

**Figure 13.** View of the #2 exhaust tappet head.

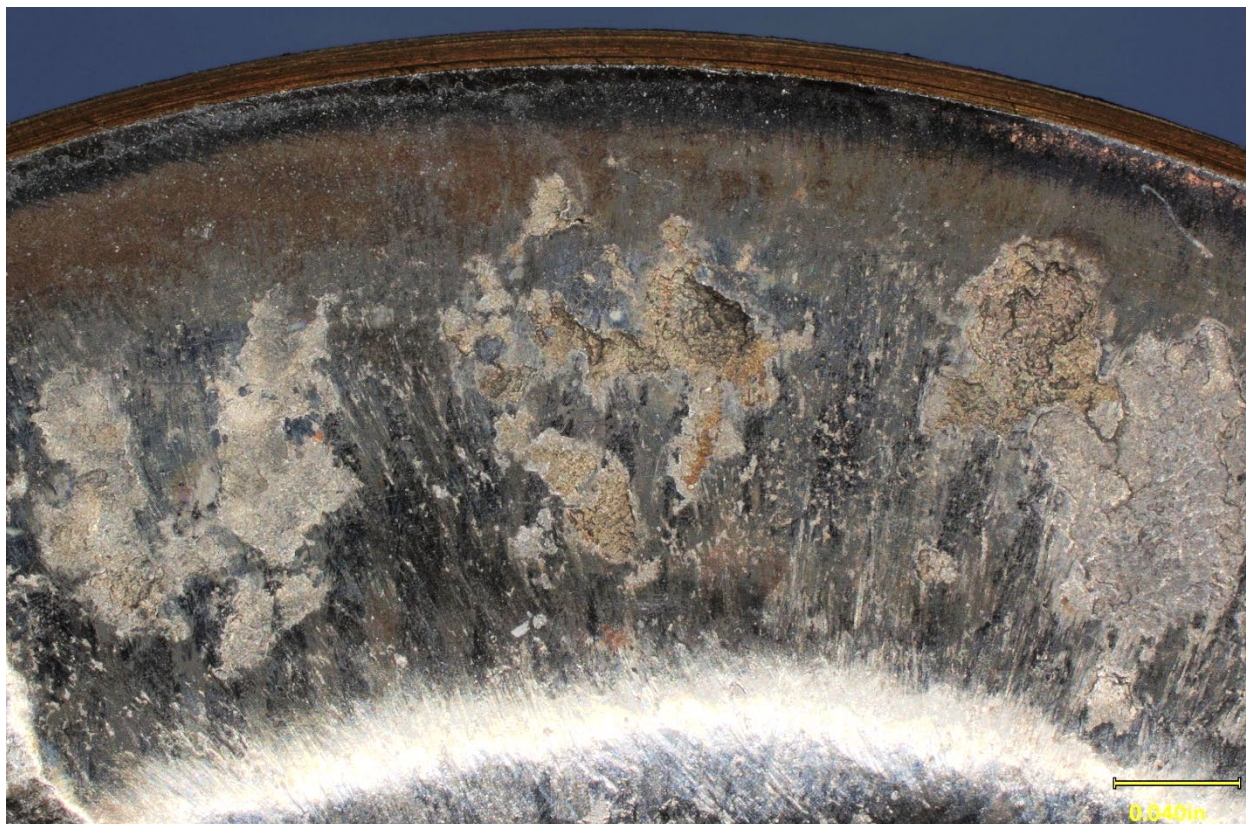
widespread spalling of the remaining surface, demonstrating the degree of material loss on this part. There were also smaller divots, consistent with the pitting observed in the #2 intake tappet face shown in Figure 6.

**Figure 14.** Worn areas of the #2 exhaust tappet head, showing spalling and pitting.

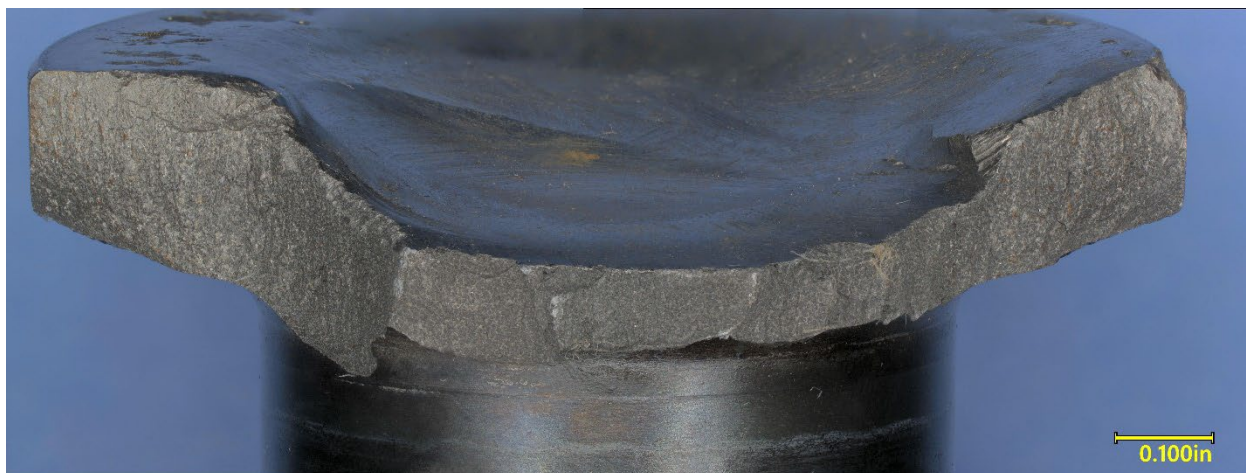
Figure 15 shows the fracture surface of the #2 exhaust tappet. The surface exhibited several ridges, separated by vertical angled edges. The fracture was rough in texture, with a general dull luster. Figure 16 shows a closer view of the part of the fracture surface near the stem radius. This area exhibited crescent-shaped morphologies adjacent to the edge with the worn head face. Radial marks and chevron marks were present on the surface consistent with fracture proceeding from the head face toward the underside.

**Figure 15.** View of the fracture surface on the #2 exhaust tappet head.

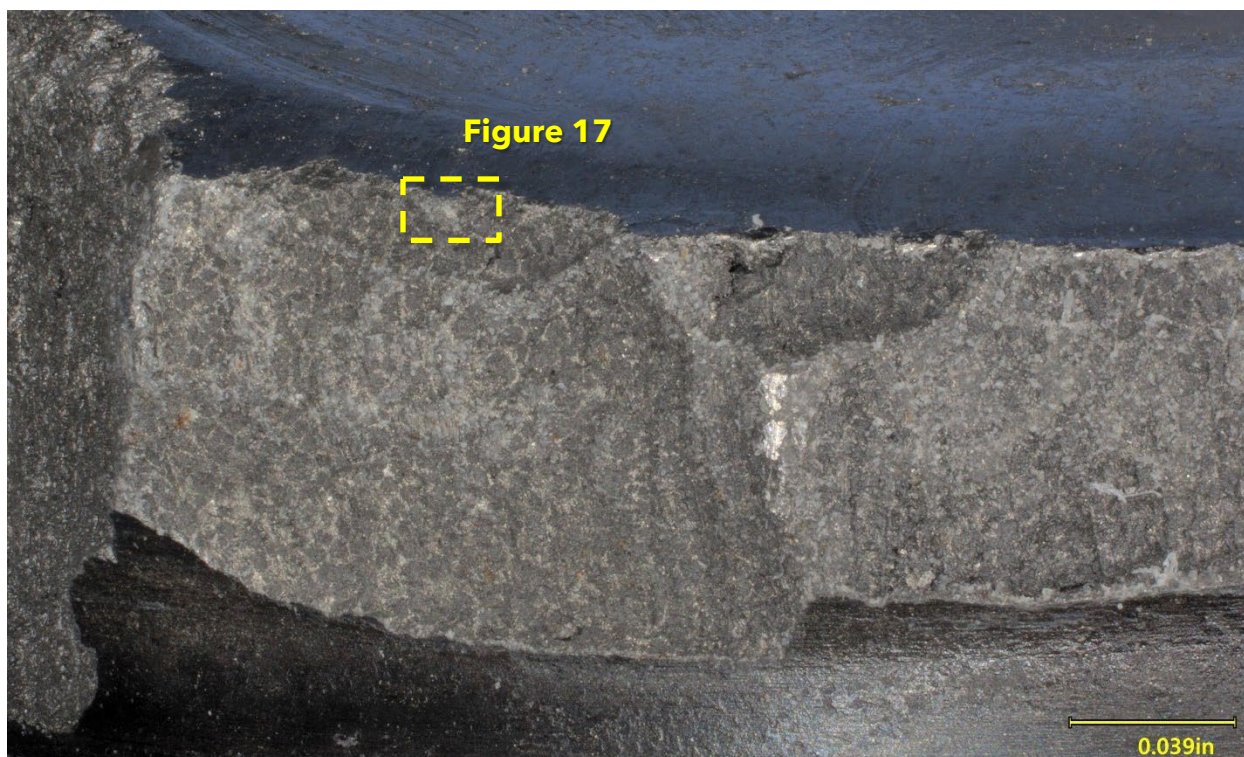
**Figure 16.** Closer view of initial fracture areas of the #2 exhaust tappet head.

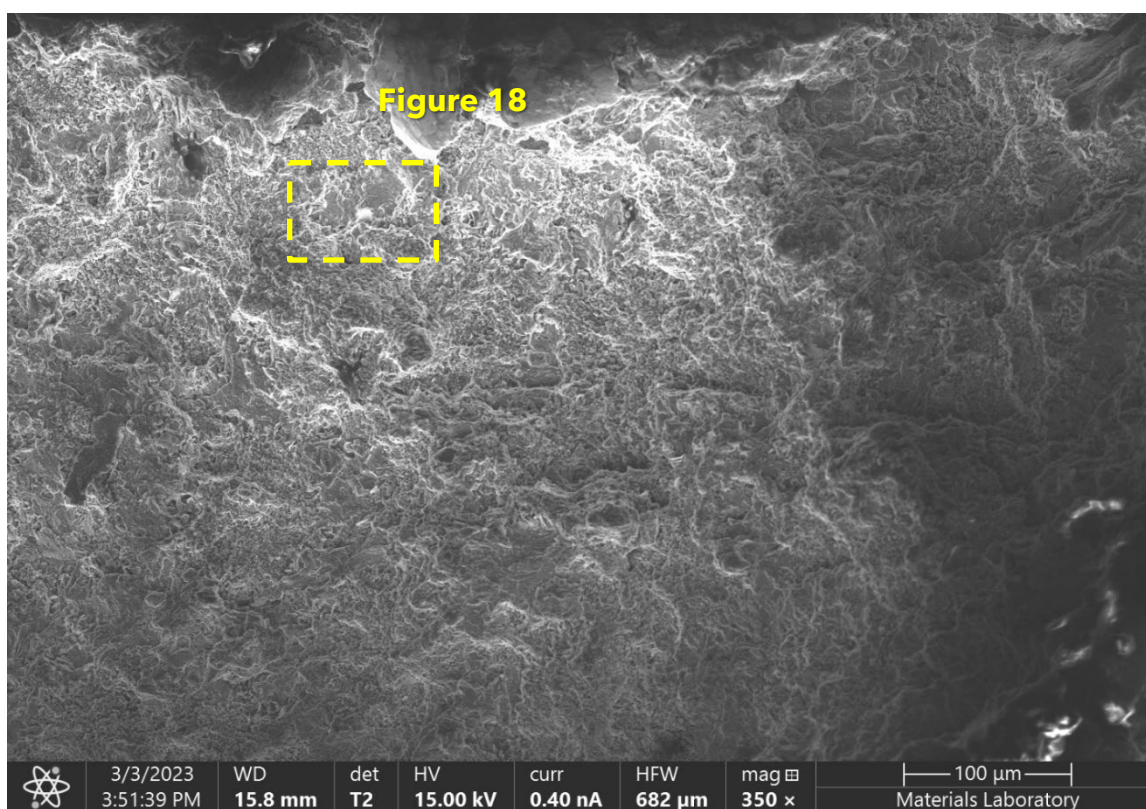
This fracture surface was examined using a field-emission scanning electron microscope (SEM). Figure 17 shows a closer view of the boxed area in Figure 16, which was a portion of the fracture surface edge with the worn head face. The edge exhibited some rounding downward over the fracture surface, consistent with continued wear after fracture. The surface was mottled and rough, with radiating patterns emanating from the boxed area along the rounded surface edge.

**Figure 17.** Secondary electron (SE) micrograph of the #2 exhaust tappet fracture edge from **Figure 16**.

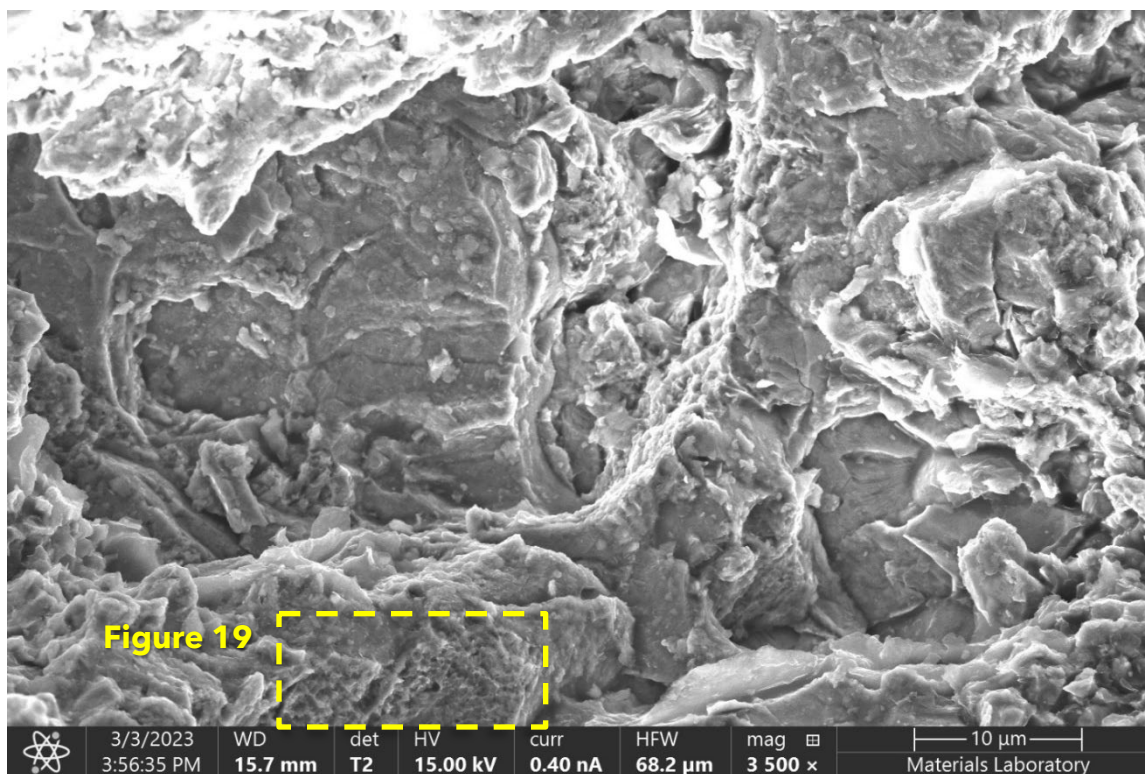
The area near the edge shown in Figure 18 revealed faceted features with small steps and fanlike orientations. These features were consistent with cleavage fracture.<sup>1</sup> The area at the bottom of Figure 18 is highlighted in Figure 19. This area exhibited dimpled rupture on the facet. Both these types of features were consistent with overstress fracture.

**Figure 18.** SE micrograph of the boxed area in **Figure 17**, showing cleavage.

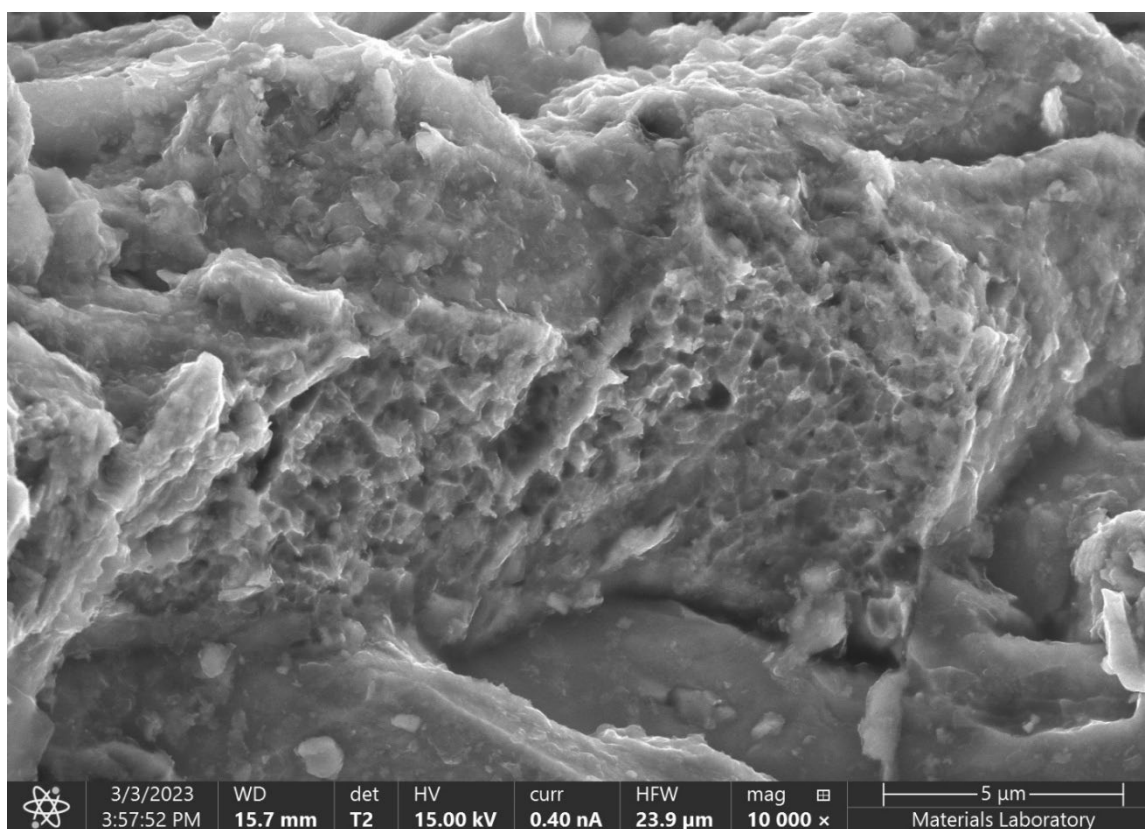
**Figure 19.** SE micrograph of dimpled rupture from the bottom of **Figure 18**.

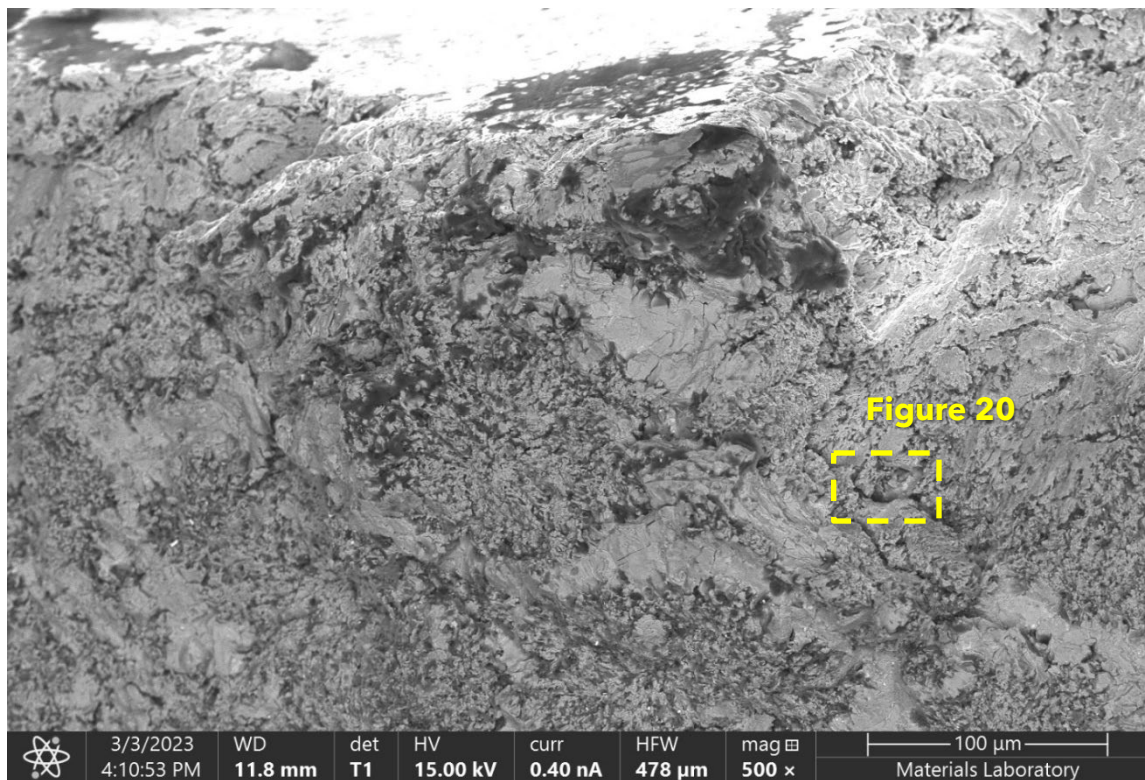
Another area along the #2 exhaust tappet fracture surface edge is shown in Figure 20. The backscattered image demonstrates darker-contrasting dissimilar material on the surface, consistent with post-fracture contamination. The lighter gray areas that were smoother in contrast were consistent with localized smearing, indicative of post-fracture damage to and wear of the fracture surface features.

**Figure 20.** Backscattered electron (BE) micrograph of an edge of the #2 exhaust tappet fracture, towards the right of **Figure 17**.

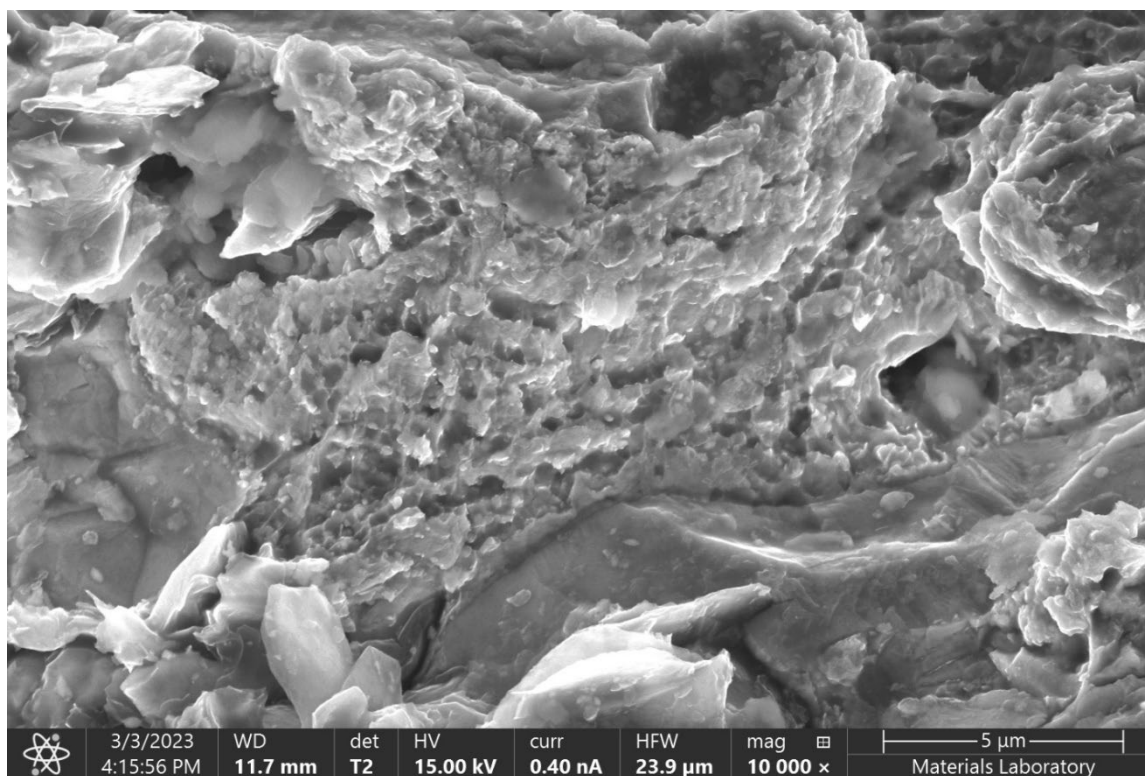
The boxed area is highlighted in Figure 21. Like in the previous region examined on this fracture surface, dimpled rupture was observed along with flatter facets and fan-shaped stems. These features, mixed dimpled rupture and cleavage, were consistent with overstress fracture of the tappet head. No other features consistent with other fracture modes were found.

**Figure 21.** SE micrograph of dimpled rupture in an area in **Figure 20**.

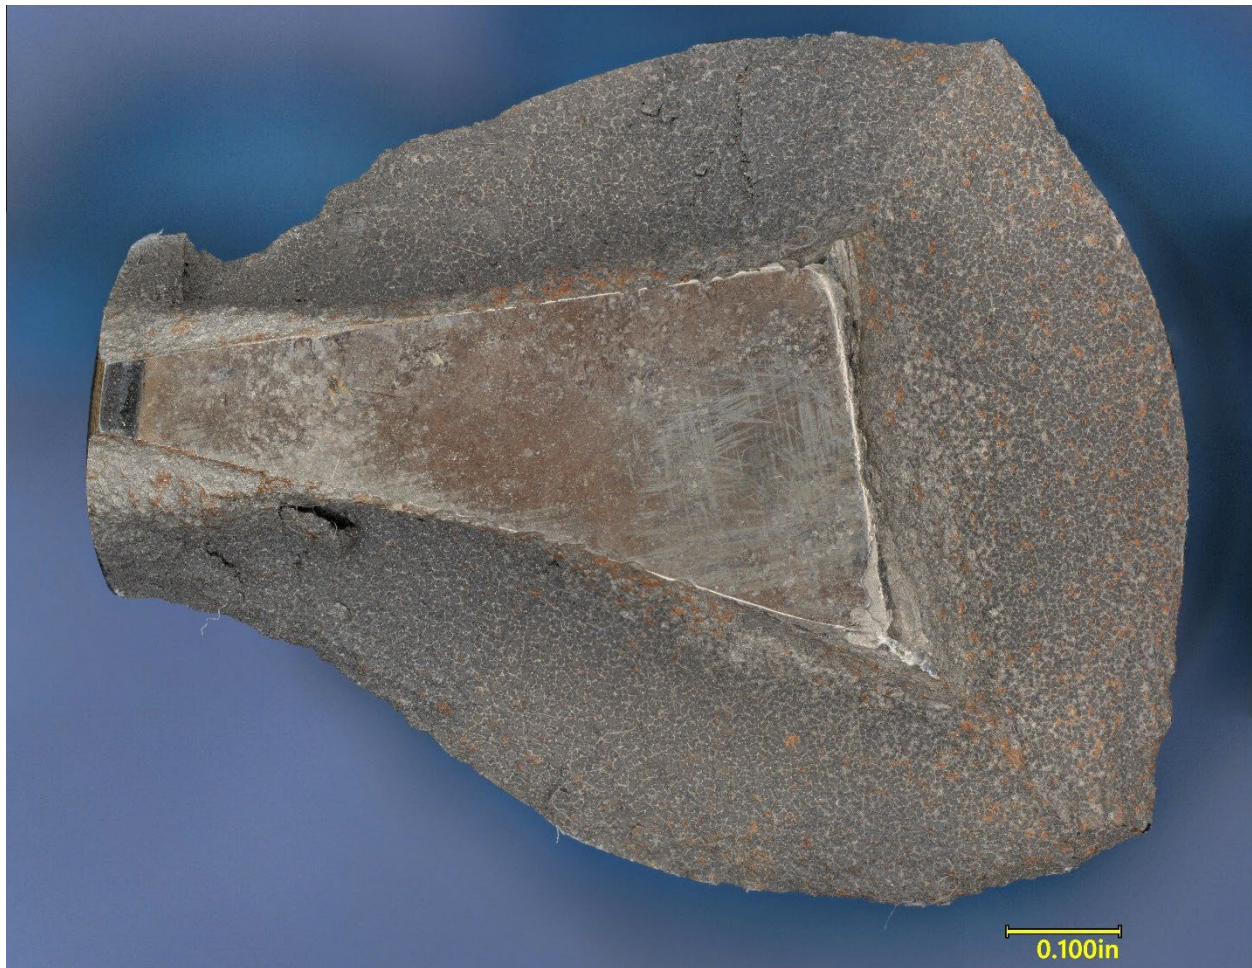
The fractured head of the #1 intake tappet is illustrated in Figure 22, showing the trapezoidal remnant of the face and the angled fractures. Of note was the fracture facing the right in Figure 23, highlighted in Figure 24. The fracture surface exhibited

**Figure 22.** Planar view of the #1 intake tappet fractures.
