# National Transportation Safety Board

CEN21LA213

## **MATERIALS LABORATORY**

Factual Report 23-026

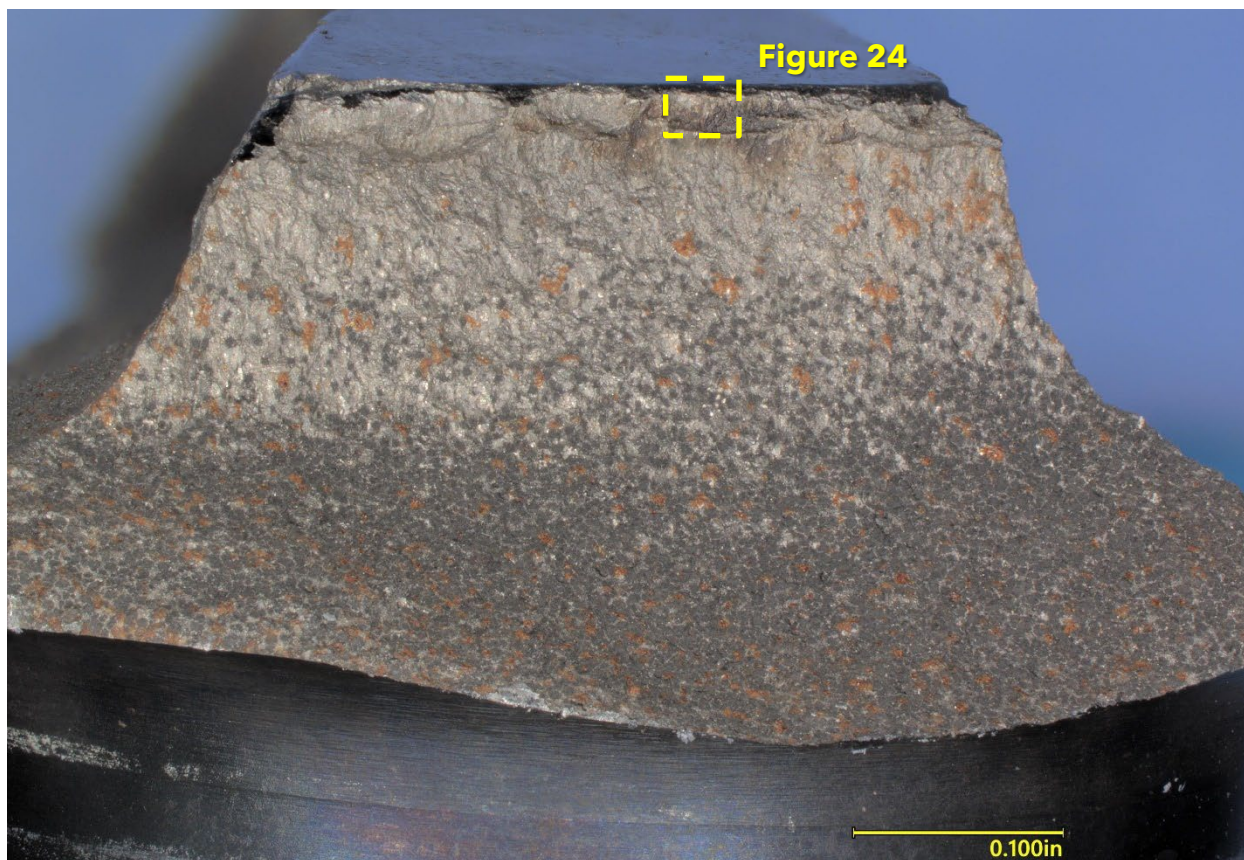
small pit-like or thumbnail-shaped features along the edge with the remnant of the face. This edge was examined using an SEM.

**Figure 23.** The right fracture surface edge of the #1 intake tappet in **Figure 22**.

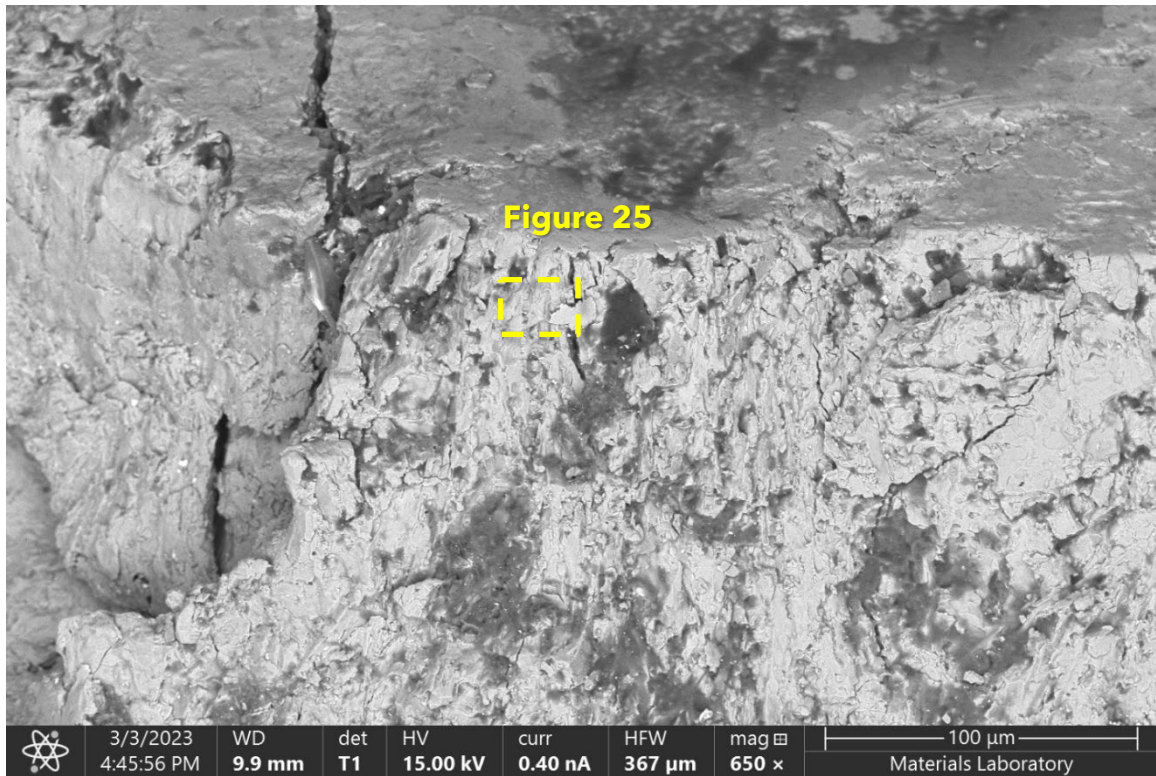
Figure 24 shows an area of the fracture surface on the edge of the #1 intake tappet face, as annotated in Figure 23. This fracture area exhibited a perpendicular crack to the fracture surface, shown on the left side of Figure 24. The surface exhibited darker-contrast nonconductive material, consistent with post-fracture contamination. The fracture surface exhibited downward-spreading radial marks, consistent with fracture from the head face toward the stem.

**Figure 24.** BE micrograph of the fracture edge of the #1 intake tappet in **Figure 23**.

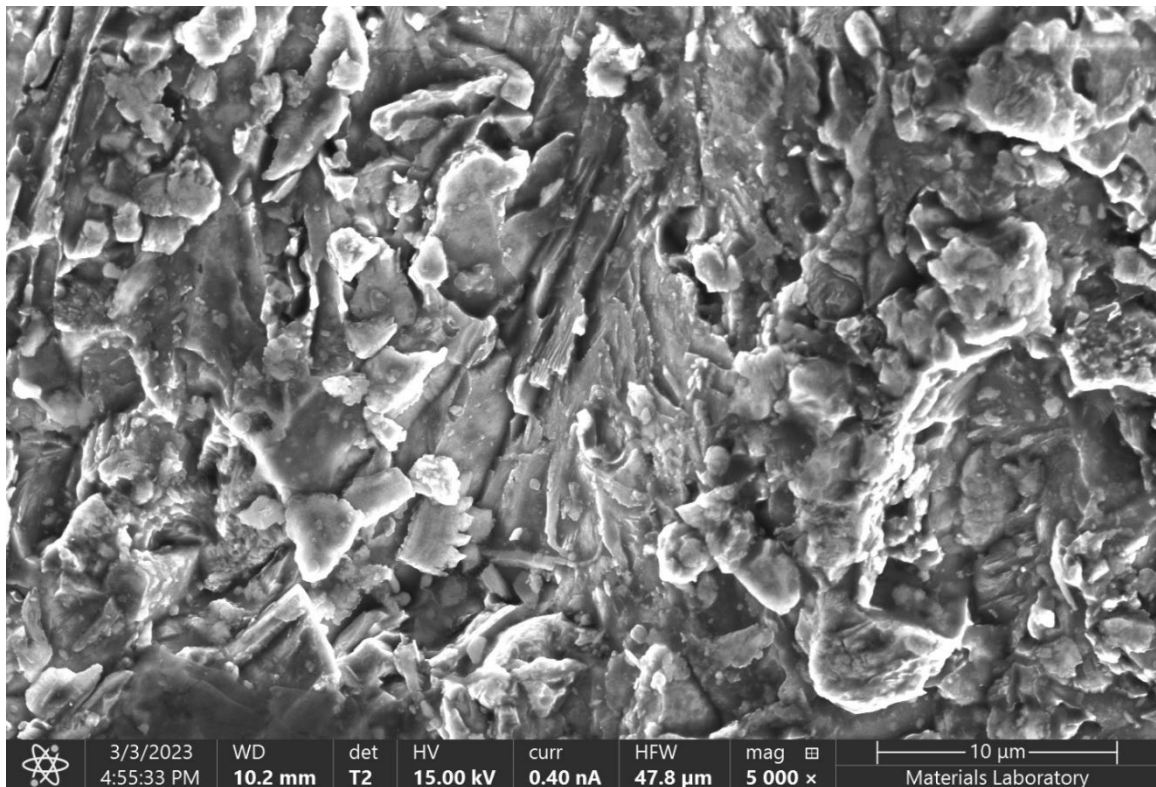
When examined closer, the fracture surface exhibited cleavage features—fan-shaped steps and ridge-like characteristics (typified in Figure 25). Isolated areas of dimpled rupture were also observed. These features were consistent with overstress fracture of the tappet head. No other features indicative of other fracture modes were observed.

**Figure 25.** SE micrograph of cleavage facets on the #1 intake tappet fracture.

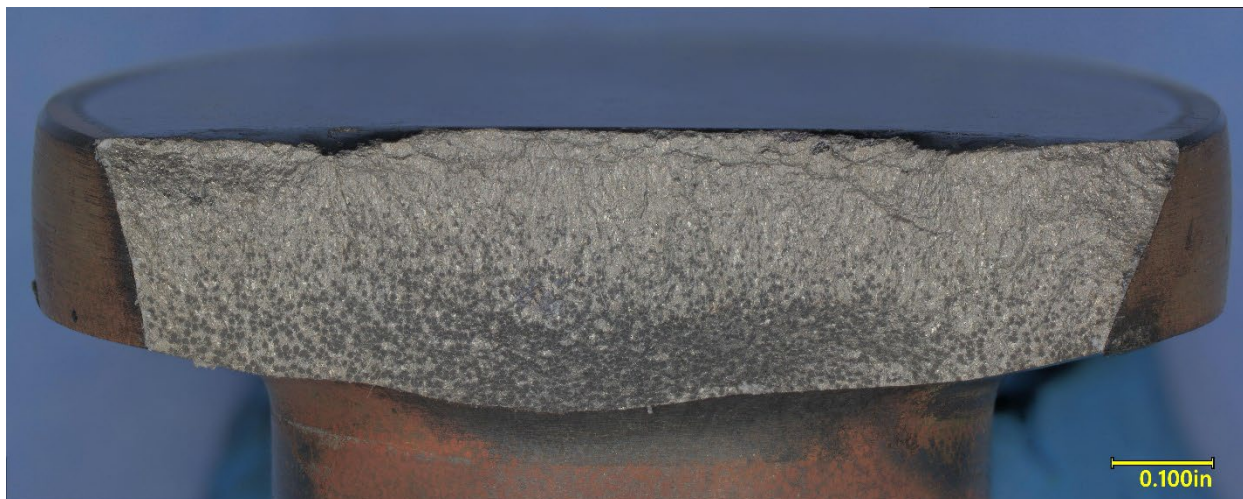
Figure 26 shows the #3 intake tappet head fracture, exhibiting downward-radiating river patterns and chevron marks. This was most pronounced in the two rounded areas towards the left and right of the edge with the face. The left area is illustrated in Figure 27, showing radiating lines emanating from this feature along the edge.

**Figure 26.** View of the #3 tappet head fracture surface.

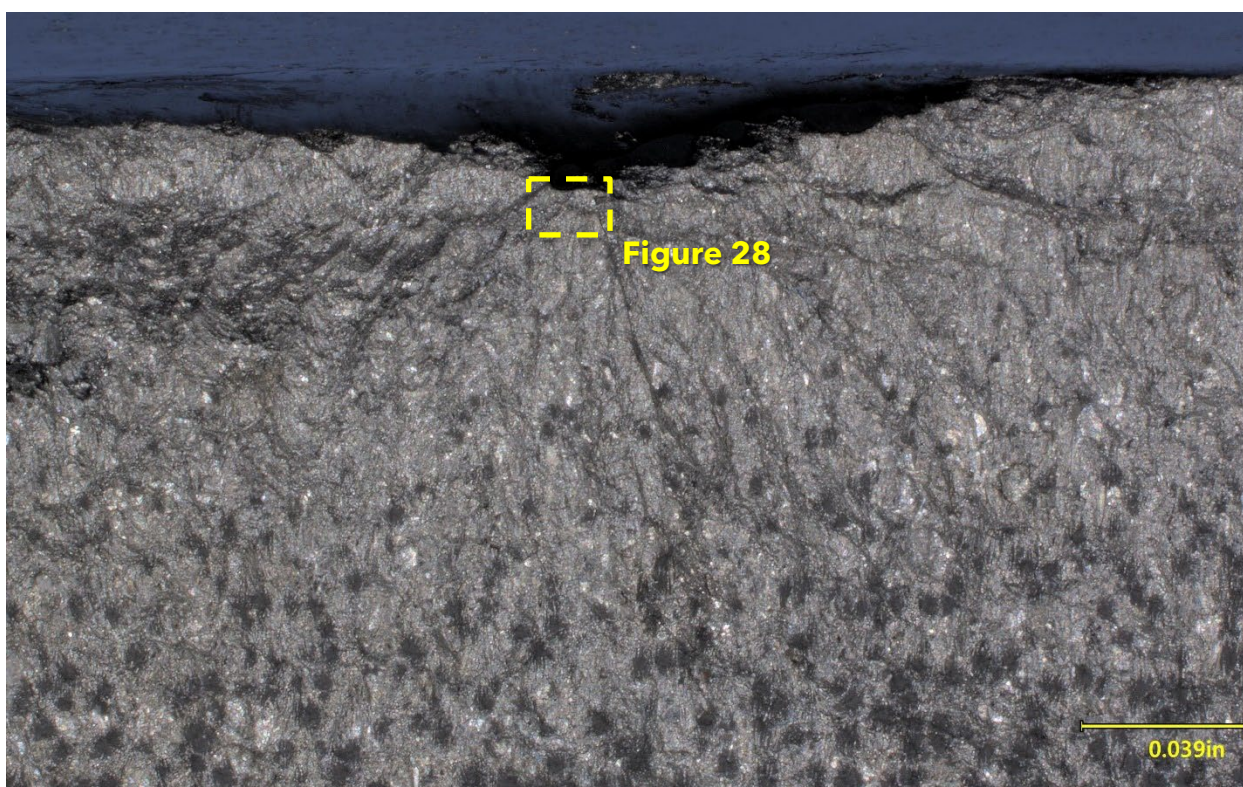
**Figure 27.** Initial areas of the #3 intake tappet fracture surface.

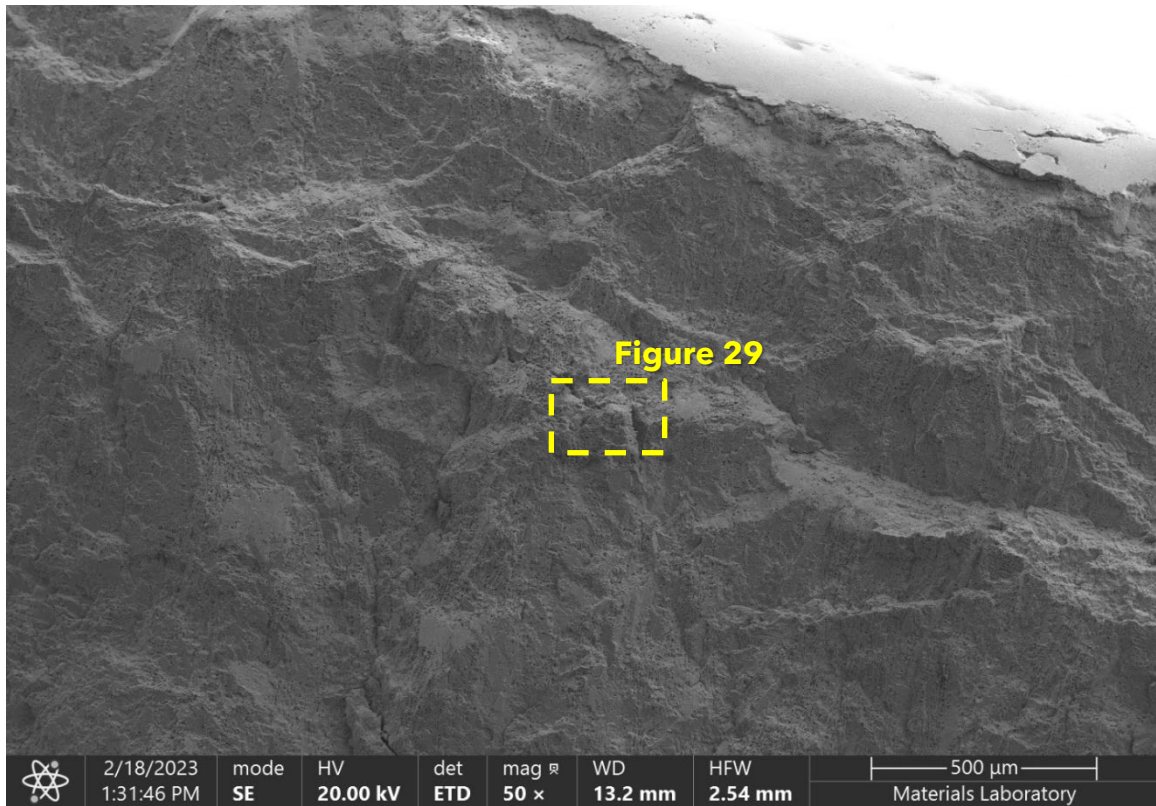
This area of the fracture surface annotated in Figure 27 was examined using an SEM, as illustrated in Figure 28. Like the other tappet fractures, the #3 intake tappet surface exhibited a rough texture with a faceted undulating morphology. A closer view in Figure 29 showed many of the microscopic features had been obliterated, consistent with post-fracture smearing damage. The areas that were undamaged exhibited characteristics consistent with overstress fracture. As illustrated in Figure 30, this surface displayed cleavage facets and steps, along with areas of ductile tear ridges.

**Figure 28.** SE micrograph of the edge of the fracture surface of #3 intake tappet.

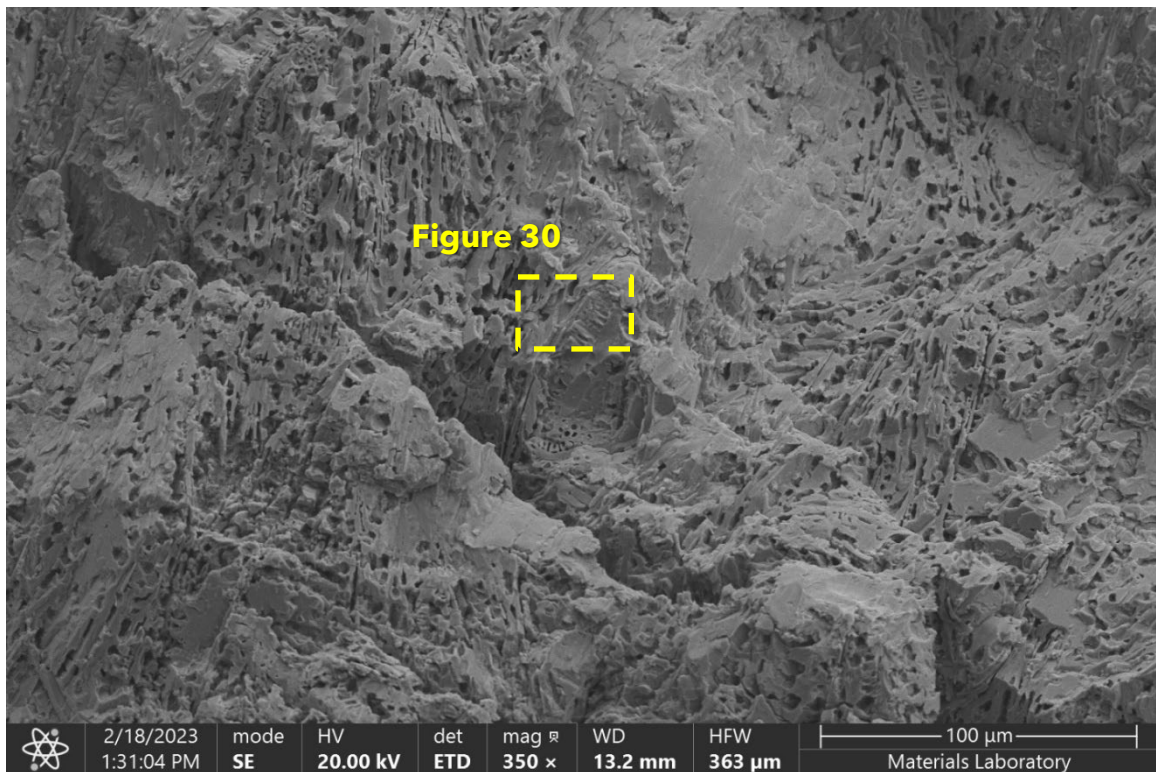
**Figure 29.** SE of the fracture surface of the #3 intake tappet, showing smearing damage.

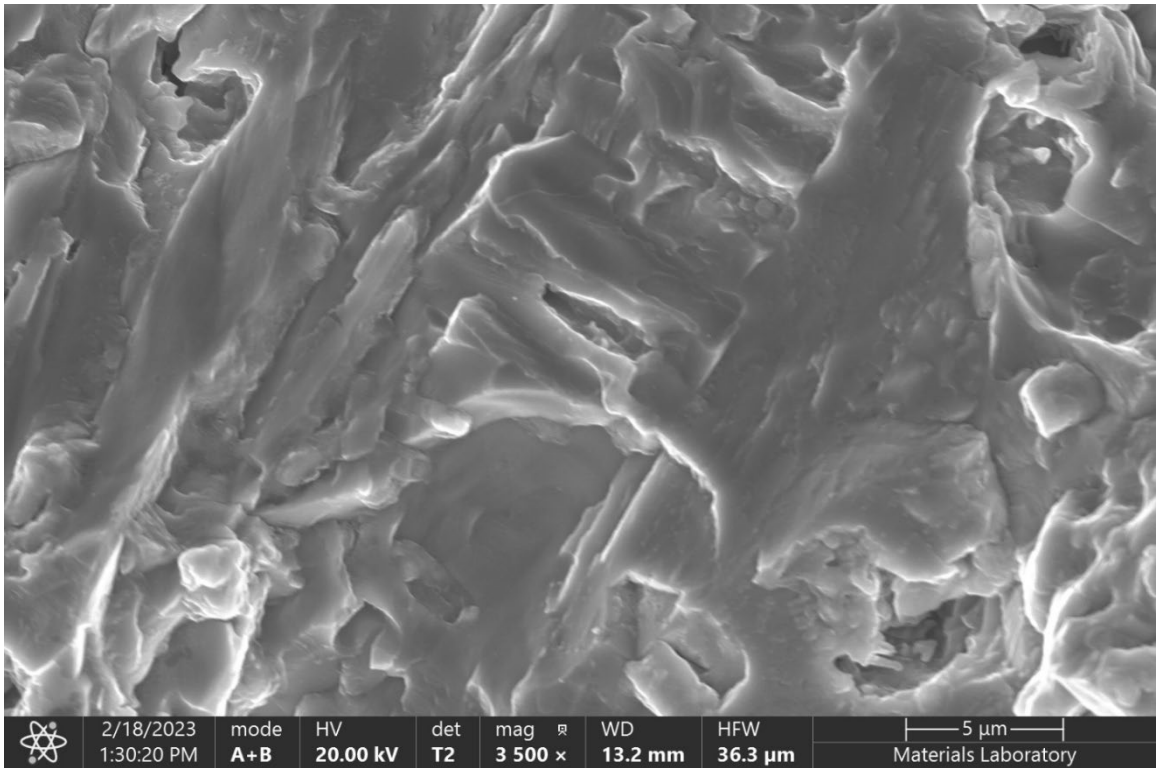
**Figure 30.** SE micrograph of the boxed area in **Figure 29**, showing cleavage steps and ductile tearing.
