## TUL AC Accident,Incident,Damage

### Tulsa International Airport Airport Safety Division Report of Aircraft Accident, Incident, or Damage

Make and Model: Cessna Skylane C182 Year: 1980

Reg. #: N8051B Date: 5/13/2021 Time: 01:09

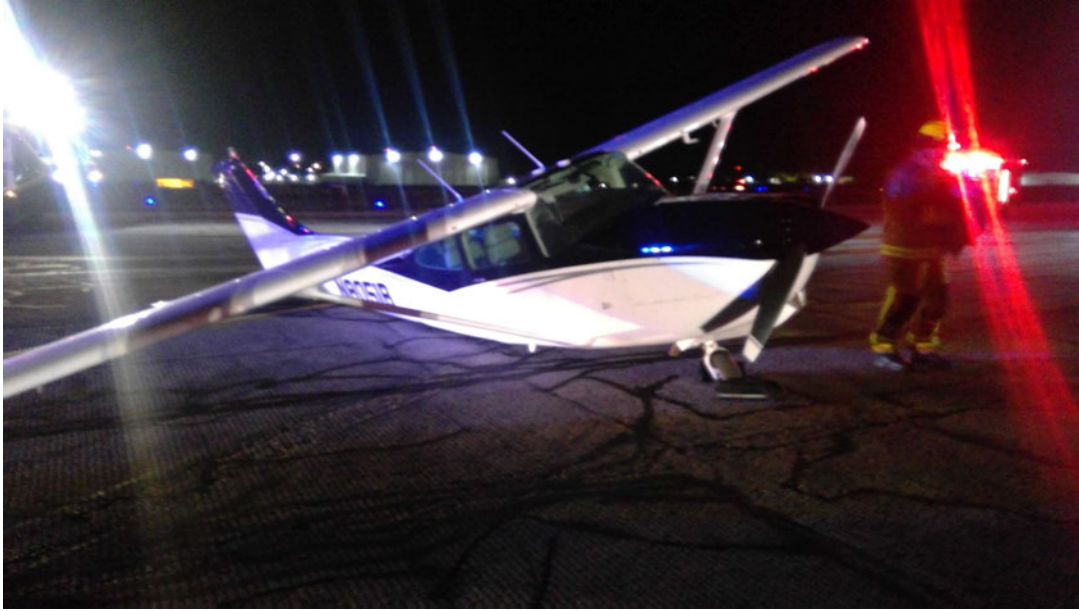
1

Extent of damage to aircrat: elevator and belly damage
