**Air Tractor, Inc.**  
Accident Investigation

**AIRFRAME REPORT**

**CEN21LA223**

**5/18/21**  
**Clayton, LA**

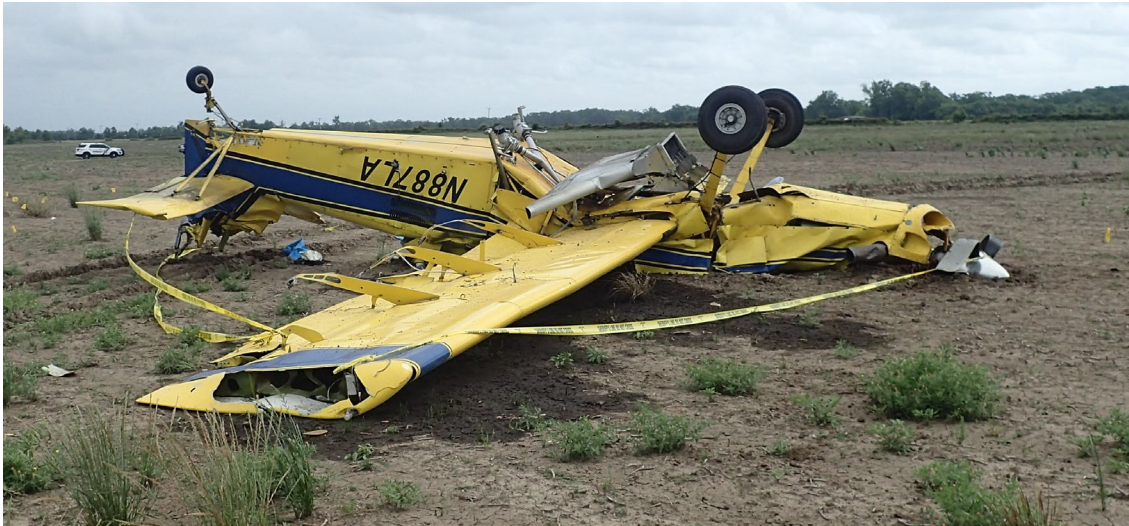
Small fragments of yellow paint and clear, tinted, plastic, consistent with the cockpit windows were found aft of the main wreckage. There were no discernable ground scars leading up to the wreckage. There were no signs of pre- or post-impact fire. The aircraft was found upside down with a heading of 122° (magnetic).

**Overview of Wreckage (Looking North-Northeast)**

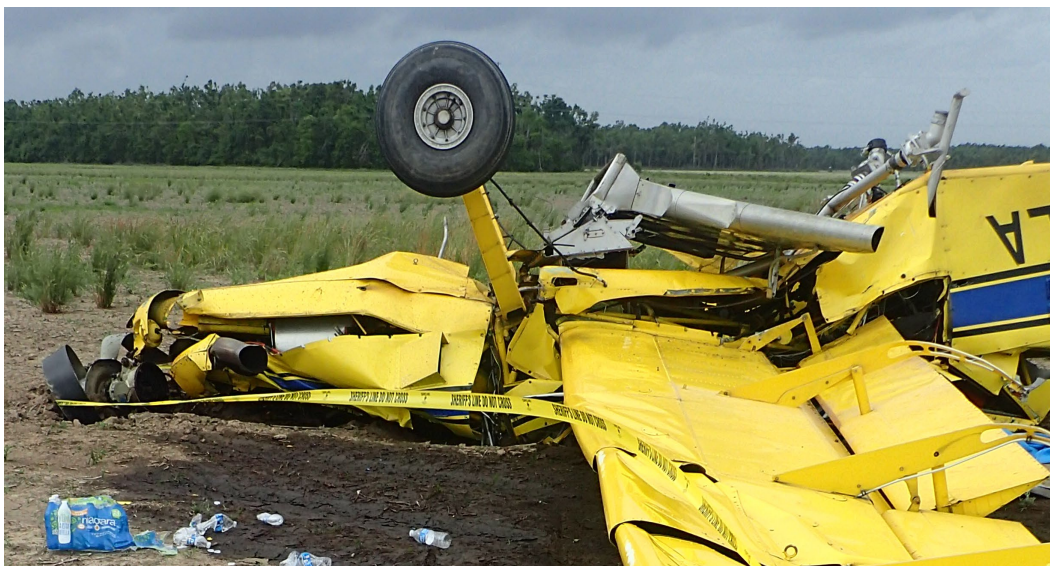
The fuselage was found upside down with crush damage to the forward fuselage in the downward direction. The forward fuselage frame was found fragmented. The fuselage aft of the cockpit was found with minor damage.

**Forward Fuselage Wreckage**

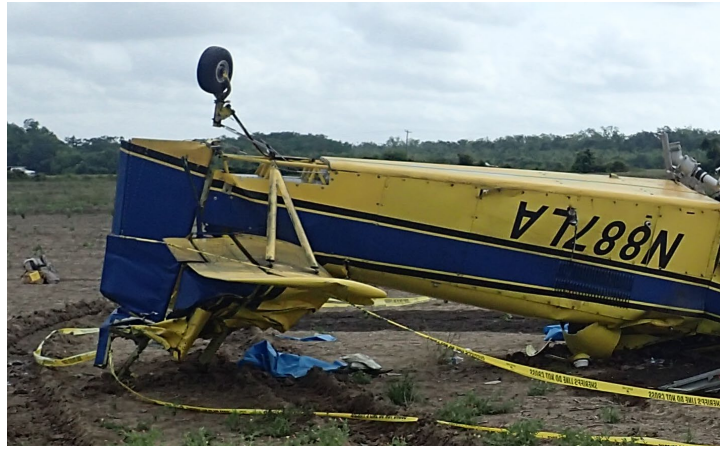
**Aft Fuselage Wreckage**

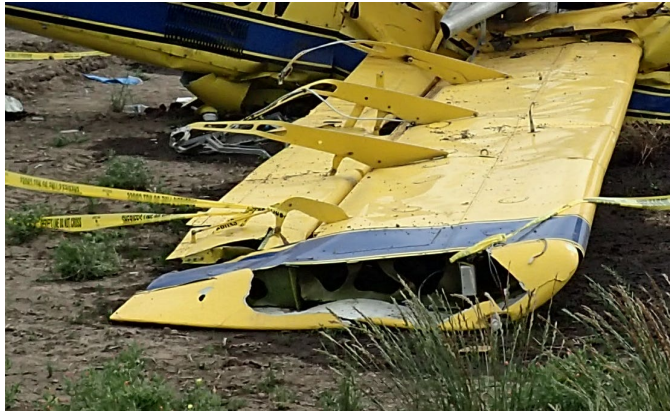
The left wing was found with crush damage in the downward direction. Fragments of red glass were found on the ground near the left wing tip. The left aileron and flap were found attached to the wing. The inboard trailing edge rib was found pressed up against the outboard end of the aileron. The inboard end of the aileron was pressed against the outboard end of the flap. The inboard end of the flap was found with crush damage in the outboard direction.

**Left Wing Wreckage**

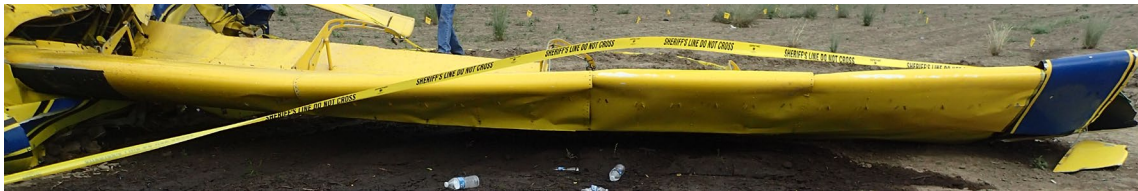
The right wing was found with crush damage in the downward direction with the outboard leading edge bent down. Fragments of green glass were found on the ground near the wingtip. The right aileron and flap were found attached to the wing with relatively little damage.

**Right Wing Wreckage**

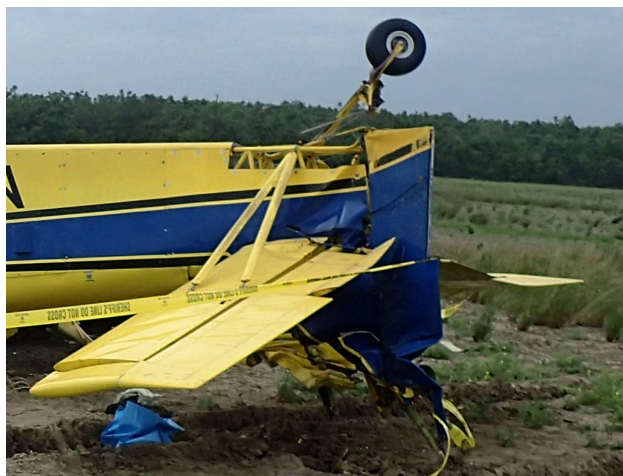
The empennage surfaces were present at the aft end of the fuselage. The vertical fin was found attached to the aft fuselage with crush damage in the downward and aft direction. The rudder was found attached to the vertical fin. The top of the rudder exhibited crush damage in the downward direction. Fragments of the fiberglass rudder tip were found in an impact crater below the rudder wreckage.

**Empennage Wreckage**

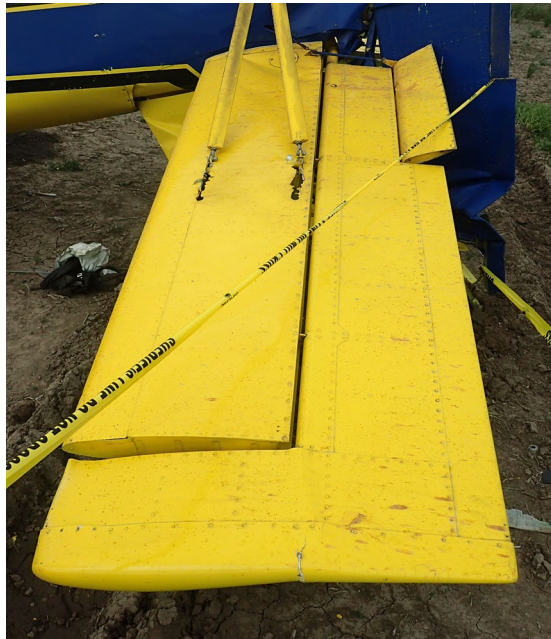
The left horizontal stabilizer was found attached to the fuselage bent in the downward direction outboard of the V-strut attach point. The left elevator remained attached to the horizontal stabilizer. The left elevator was found bent downward outboard of the V-strut. The right horizontal stabilizer was found rotated upward at the fuselage attach point. The stabilizer brace assembly was found separated, displaced inboard. The leading edge of the right elevator balance horn was found with crush damage in the down and aft direction.

**Right Horizontal Stabilizer**

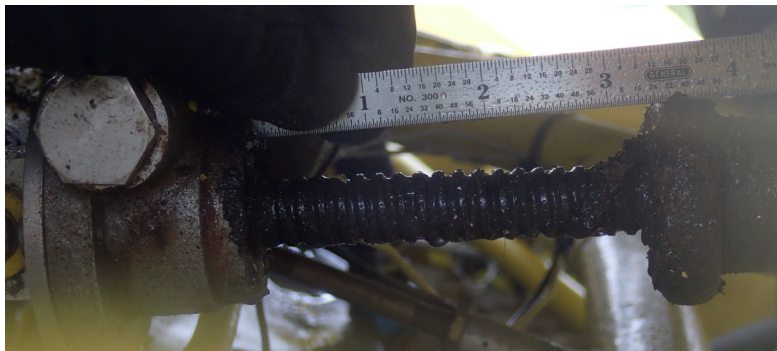
The flap actuator was found near the fully extended position. The extension of the flap actuator measured approximately 3 1/4 inch, which corresponds to a flap extension of 25.4°. The flap control system was found to be continuous from the flap actuator to the flap arms. The aileron drooping system was found to be continuous.

**Flap Actuator**

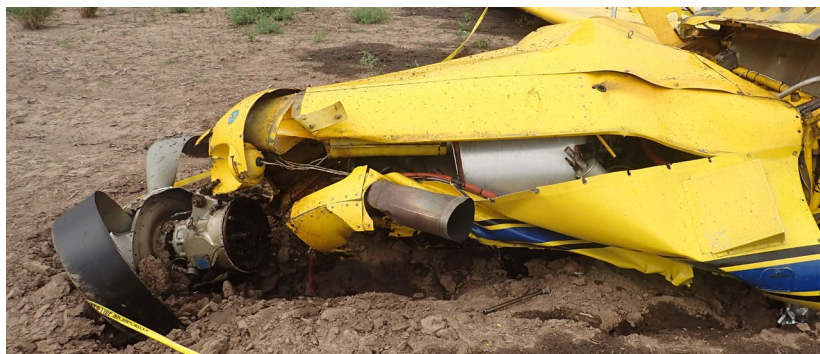
The powerplant remained attached to the engine mount and fuselage. The engine was found to have separated at the "A" flange. The reduction gearbox and propeller were found at the front of the main wreckage near the main powerplant wreckage.

## Engine Wreckage

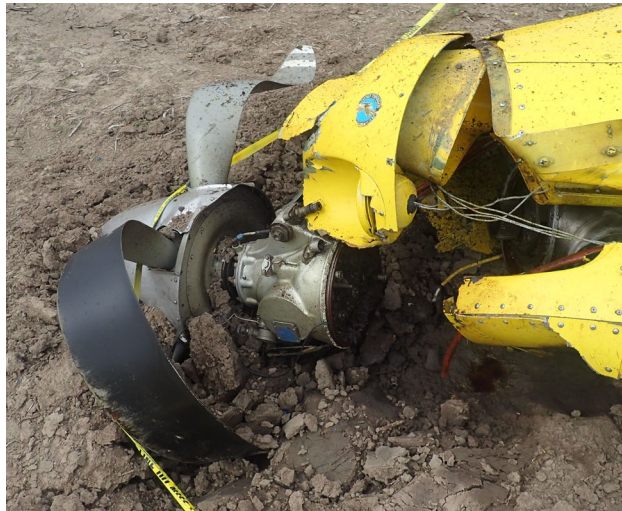
The engine was equipped with five-bladed constant speed, fully reversible, propeller. The propeller hub was found attached to the reduction gearbox. All propeller blade shanks were found attached to the propeller hub. Two of the propeller blades were found to have fractured near their shank. The fractured portions of the blades were found in the impact crater containing the propeller hub.

**Propeller Wreckage**
