## **NATIONAL TRANSPORTATION SAFETY BOARD**

### **INVESTIGATION SUMMARY**

**CEN21LA223**

Location: Clayton, Louisiana  
Date: May 18, 2021  
Aircraft: N887LA; Air Tractor AT802 s/n 502A-2887  
NTSB Investigator-in-Charge: Joshua Lindberg

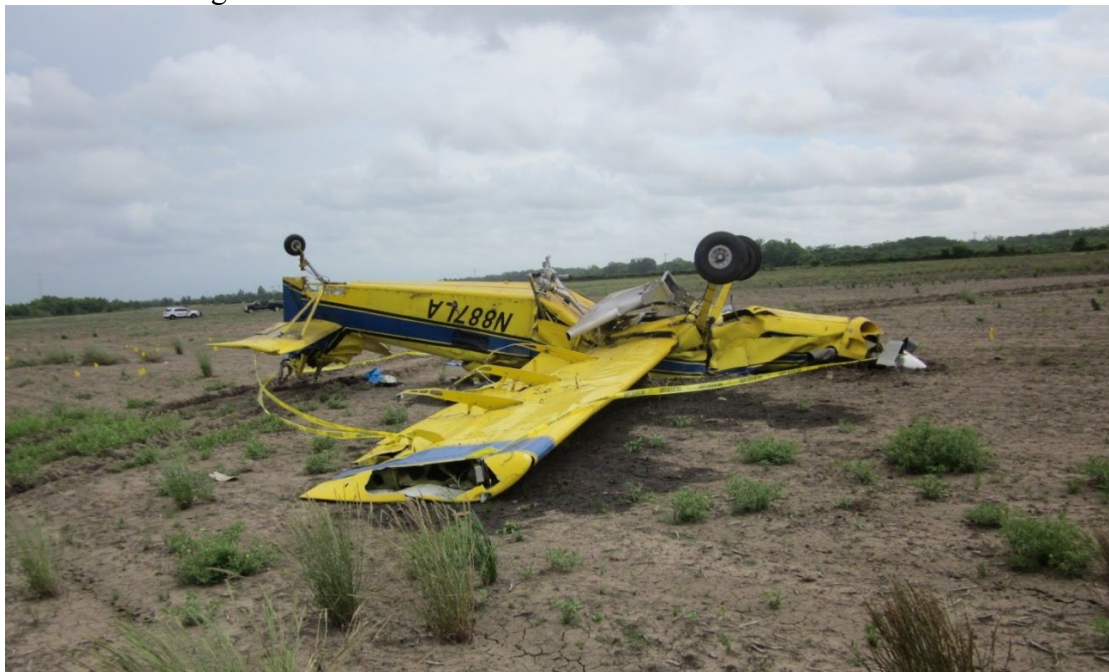
Figure 1 - The accident airplane where it came to rest inverted in a field

A postaccident examination revealed ground impact marks from the outline of the wings, which indicated that the airplane impacted the ground in a flat and wings level inverted attitude. The wing fuel tanks were found breached, and a significant amount of fuel was noted in the dirt under the airplane. The cockpit was crushed into the ground and partially buried. The propeller blades were twisted and bent and also partially buried in the ground. The flaps were found near full extension.
