**NATIONAL TRANSPORTATION SAFETY BOARD**

**Office of Aviation Safety**

**INVESTIGATION SUMMARY**

**CEN21LA224**

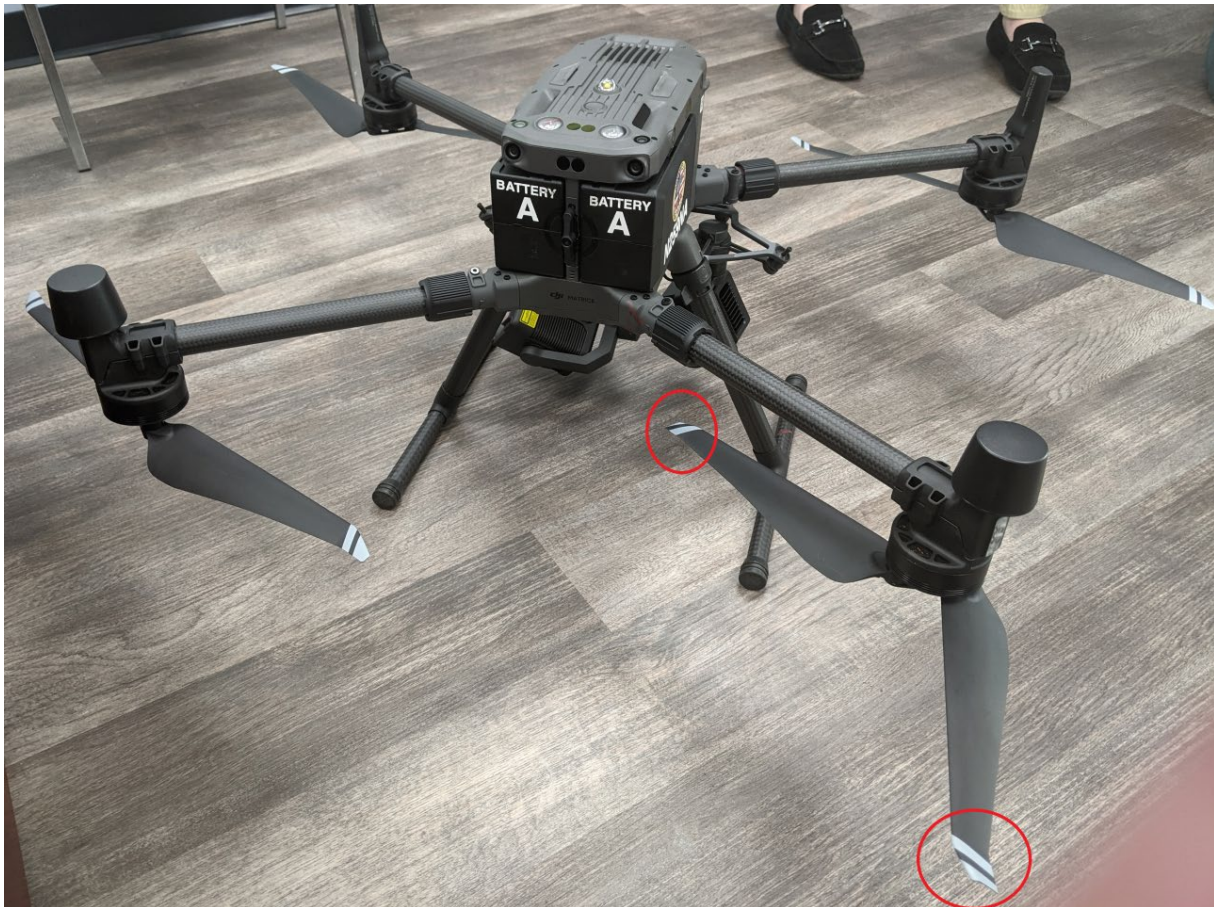
Two propeller blades chipped. No other damaged noted and all sUAS functions were normal.

Figure 1. Damaged propeller blades circled in red.

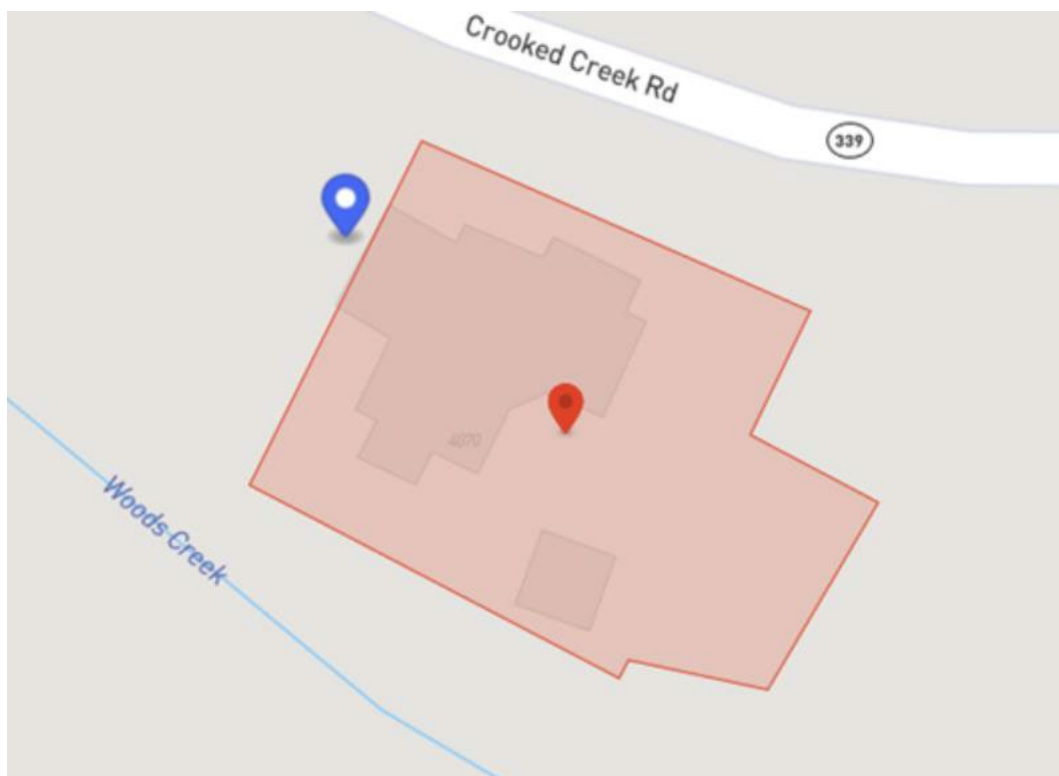
Figure 3. Accident location was just outside of DJI GEO Restricted Zone (prison)

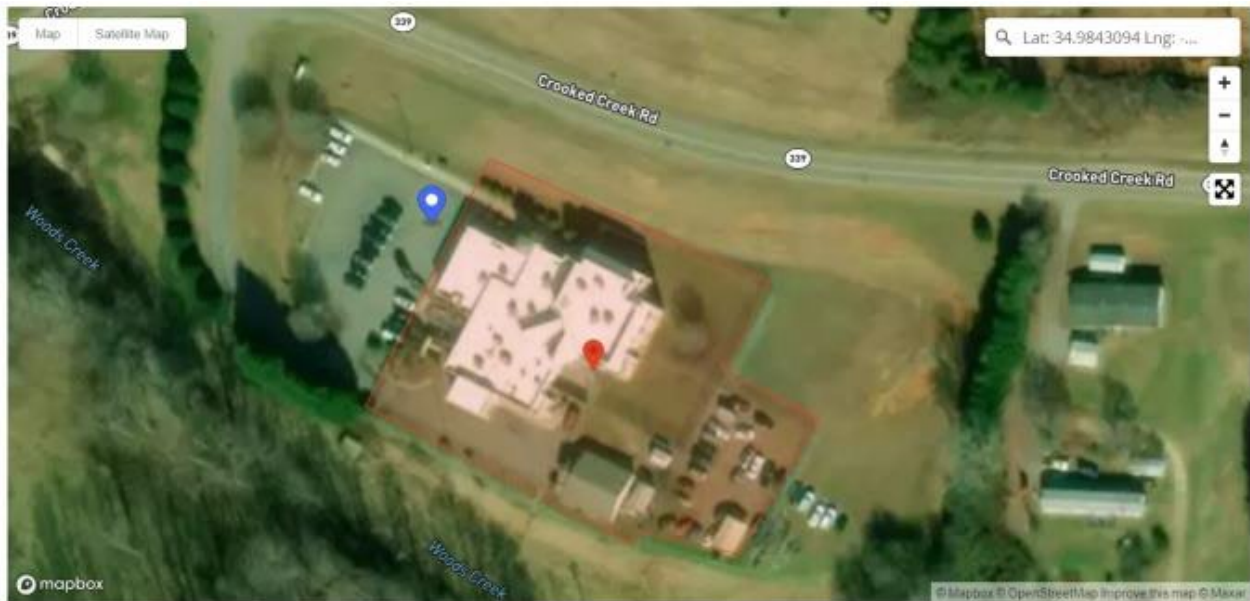
- T=0s, Power-on at 10:22:54 EDT local time on 05/06/2021 (Flight Controller time recorded as 09:22:54 EST).
- GEO database is on the aircraft. The database was released in December 2019.
- T=11s, Home point set at 34.9843050 x -83.8291285, 18.7 ft outside from the western border of the GEO Restricted Zone (prison).

Figure 6. Home point (blue) and GEO Restricted Zone (prison).

- Pilots should take restricted zones into consideration the in the operation area as part of pre-flight planning and avoid setting home points within their corresponding buffer zones. Operations in close proximity to GEO zones should be conducted after initiating an unlock of the geofencing zone, to avoid undesirable flight control restrictions. For a Restricted Zone, the unlock process involves completing an online form, which is processed by DJI. Public Safety agencies such as the Sheriff's Department can participate in the Qualified Entities Program which removes geofencing features entirely.

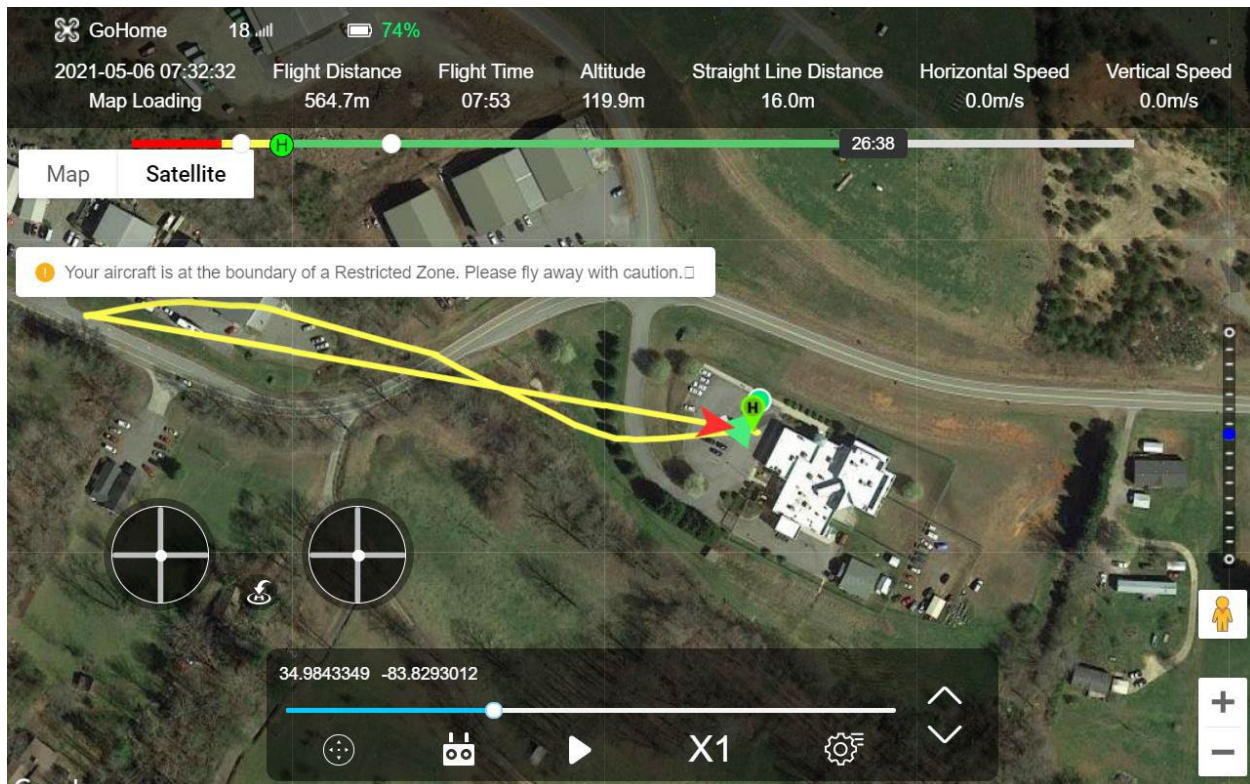
- T=584s, the aircraft returned to 56 ft from home point then stopped at the boundary of the restricted buffer zone. The app prompted a warning, the aircraft remained in RTH mode.
  - Note: A buffer zone is defined as an area with approximately 20 m (66 ft) width outside a No Fly Zone (NFZ). The purpose of a NFZ buffer zone is to account for estimation and control errors in order to avoid breaching the NFZ when the aircraft has forward speed. When approaching the buffer zone, the aircraft will reduce speed and stop at the buffer zone border.
- There was no pilot stick command input.

Figure 8. No pilot stick command input noted during RTH.

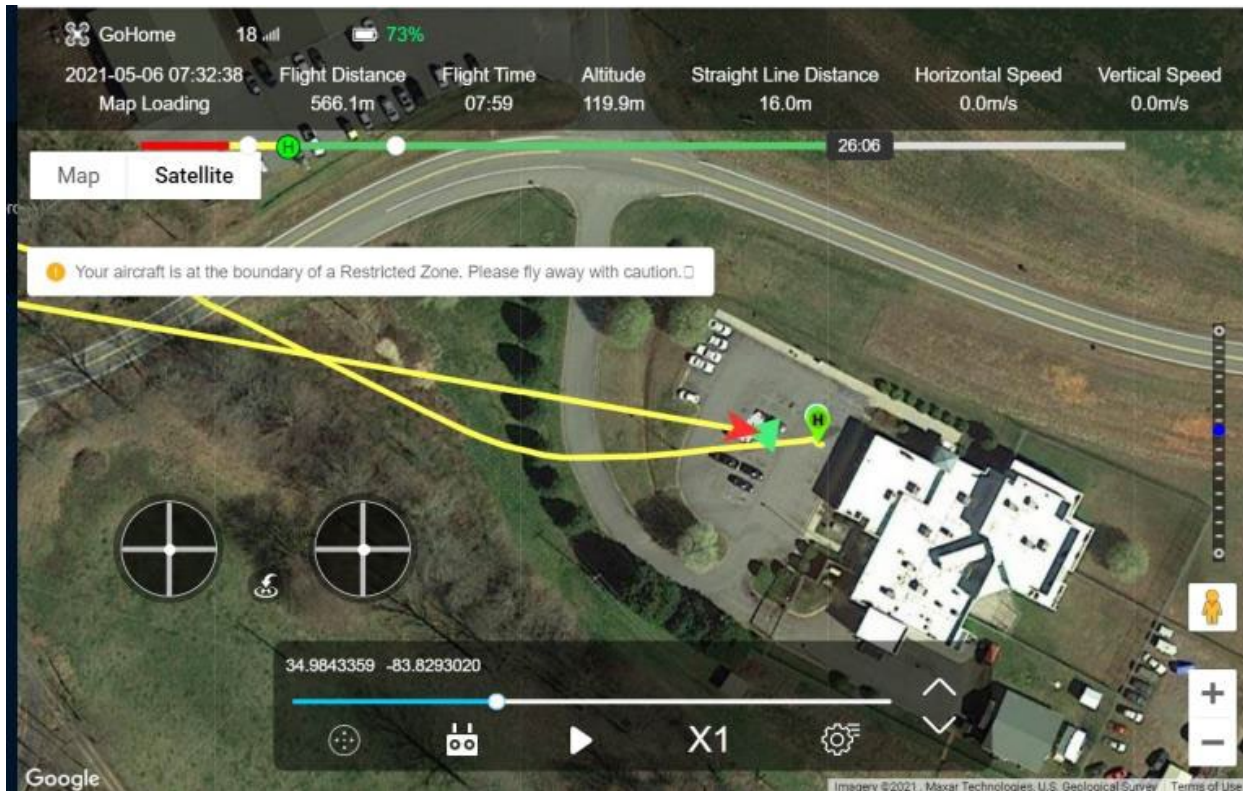
- T=686s, the aircraft hovered at approximately H=6.6ft. It recognized obstacles from this altitude and maintained current position.
- Multiple warnings were prompted on the app when the aircraft approached the Restricted Zone. Unit stopped approaching the Restricted Zone approximate 16 m away from the home point at around 34.9843413 x -83.8292948 as it reaches the buffer zone of the restricted area.

Figure 9. Warning at the boundary of the Restricted Zone.

- The aircraft would not ascend to preset RTH height since it was less than 50m (164ft) to the home point, as expected in the designed RTH function. It would not pitch forward either as it detected obstacles and reached the boundary of the geofencing restricted area buffer zone.

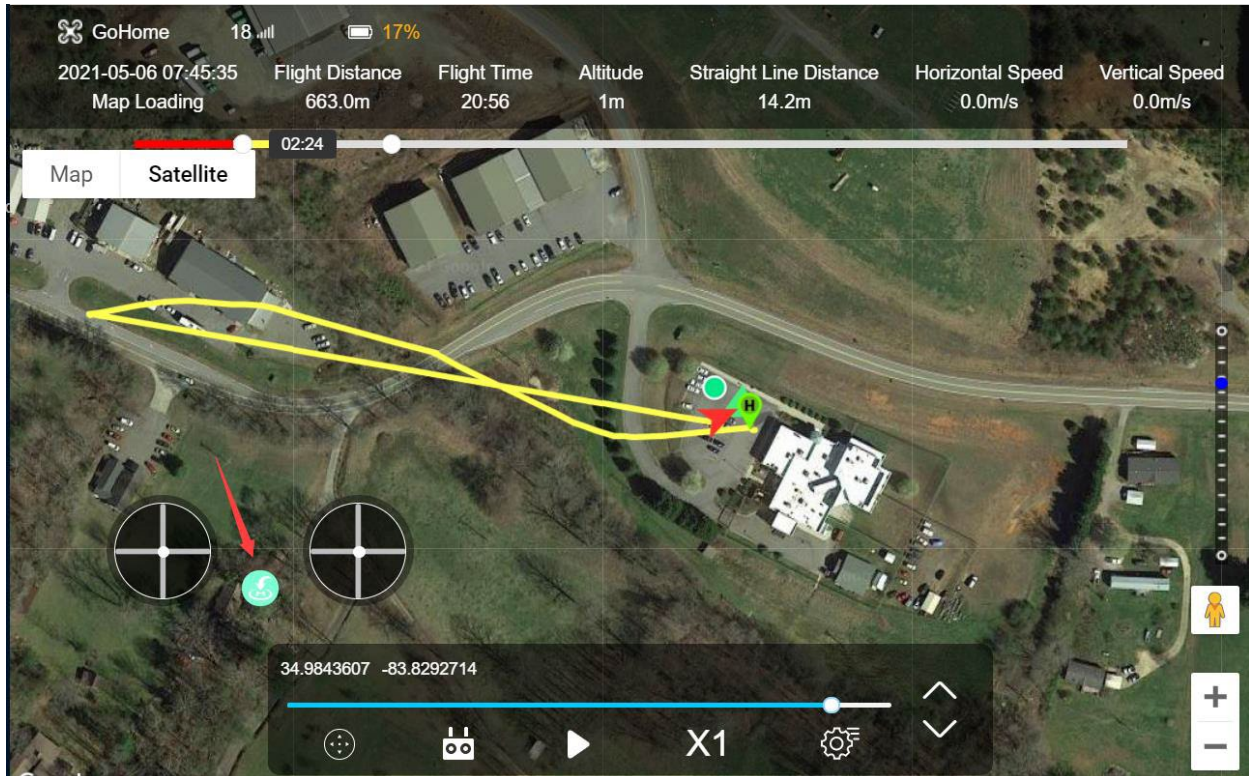
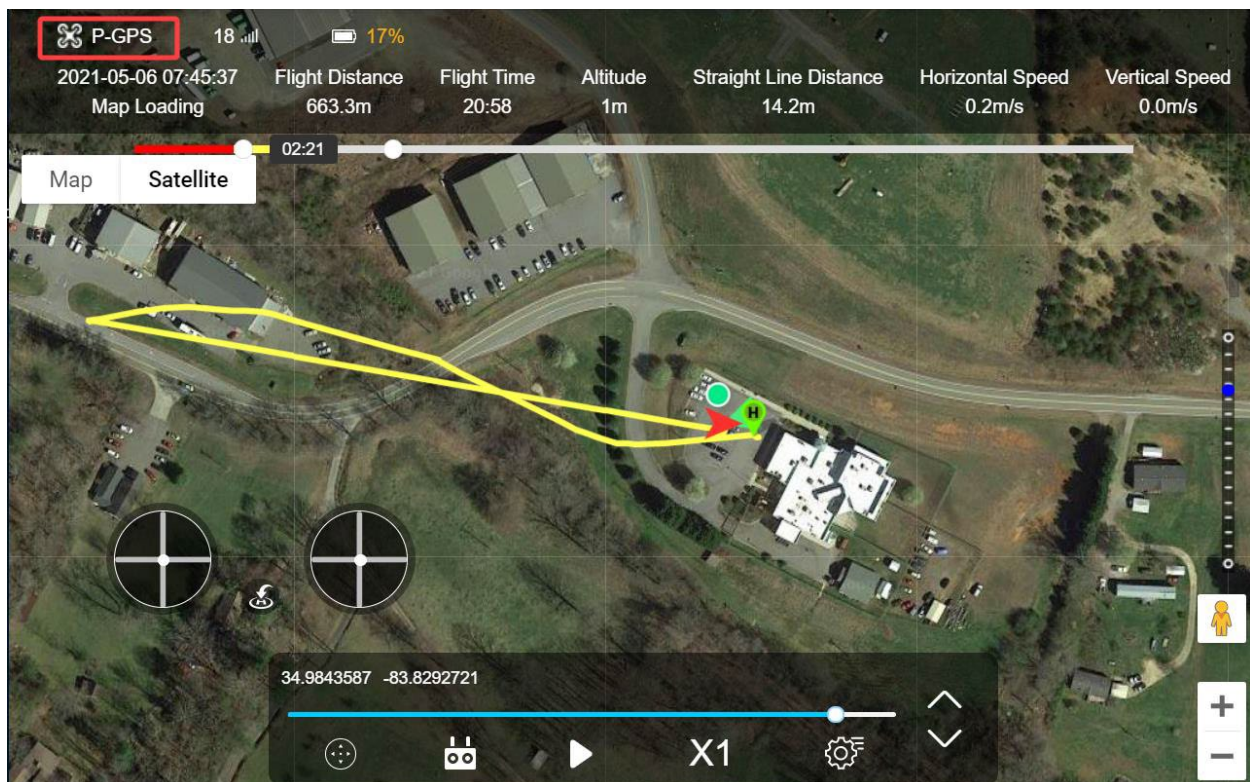
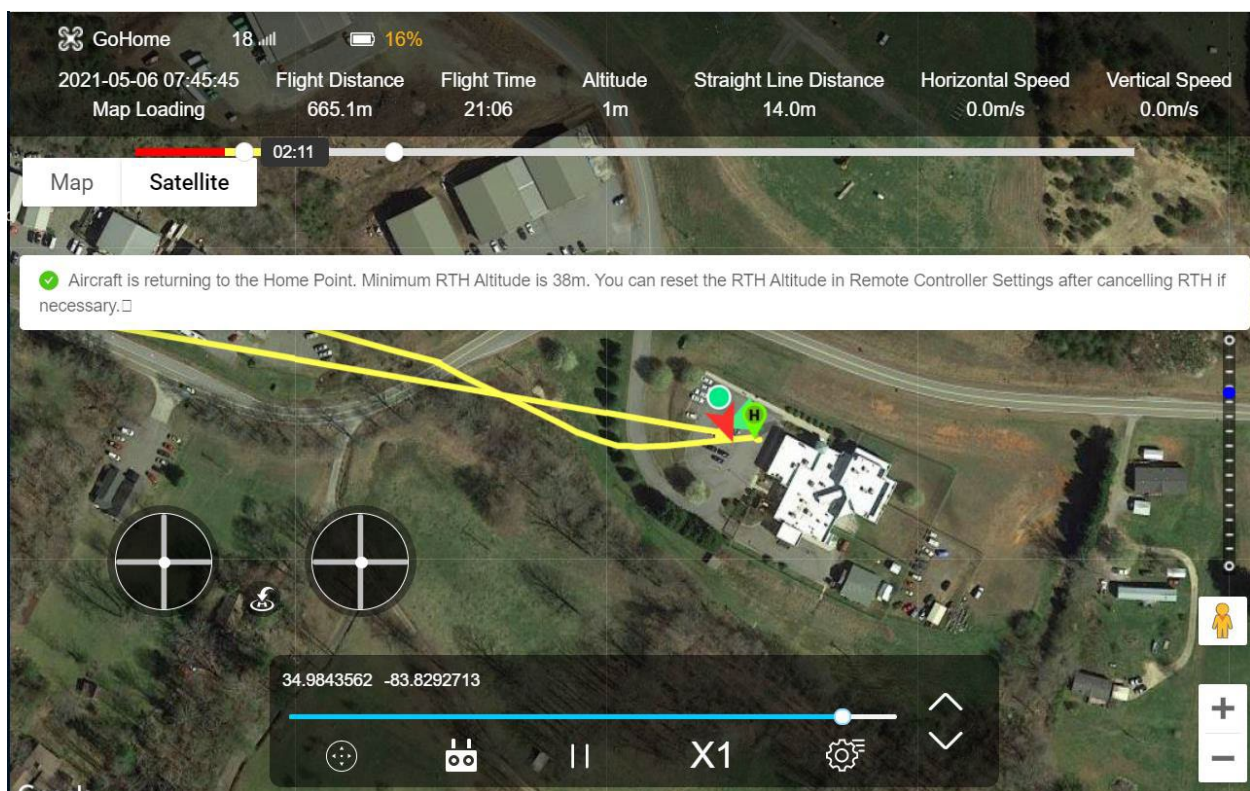
- T=1348s, the aircraft maintained height  $H=1\text{m}\sim 2\text{m}$  (3.6ft~6.6ft). The user exited RTH mode manually by pressing the RTH button, then entered RTH again 3 seconds later. This action initiated a new RTH starting location.
- 18 seconds later the pilot exited RTH mode manually by pressing the RTH button, then entered RTH again 3 seconds later.

Figure 10a. Sequence of RTH command.

- Quit RTH by pressing the Pause button or RTH button on RC or by pressing Smart RTH button in the app in order to fully control the aircraft by RC and find a place to land clear of obstacles (different to the home point).

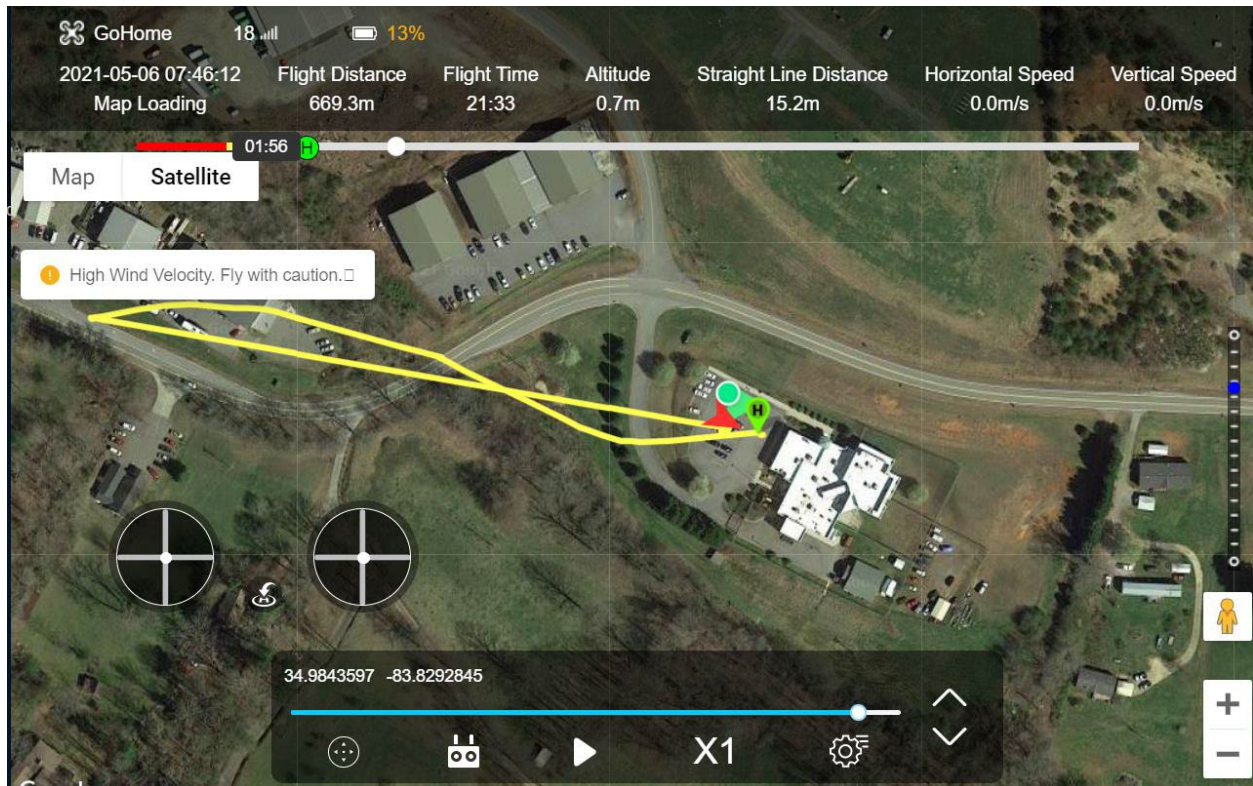
- The aircraft detected low altitude at approximately  $H=1\text{m}$  (3.3ft) during newly initiated RTH and started to ascend to the minimum RTH height of  $H=2\text{m}$  (6.6ft). The aircraft failed to ascend to the target height, despite increasing motor thrust output, indicating external force was exerted to the aircraft that prevented the aircraft from reaching the target height. The system prompted a high wind velocity warning as external force held the aircraft down.

Figure 11. High wind velocity warning due to external forces on the aircraft.

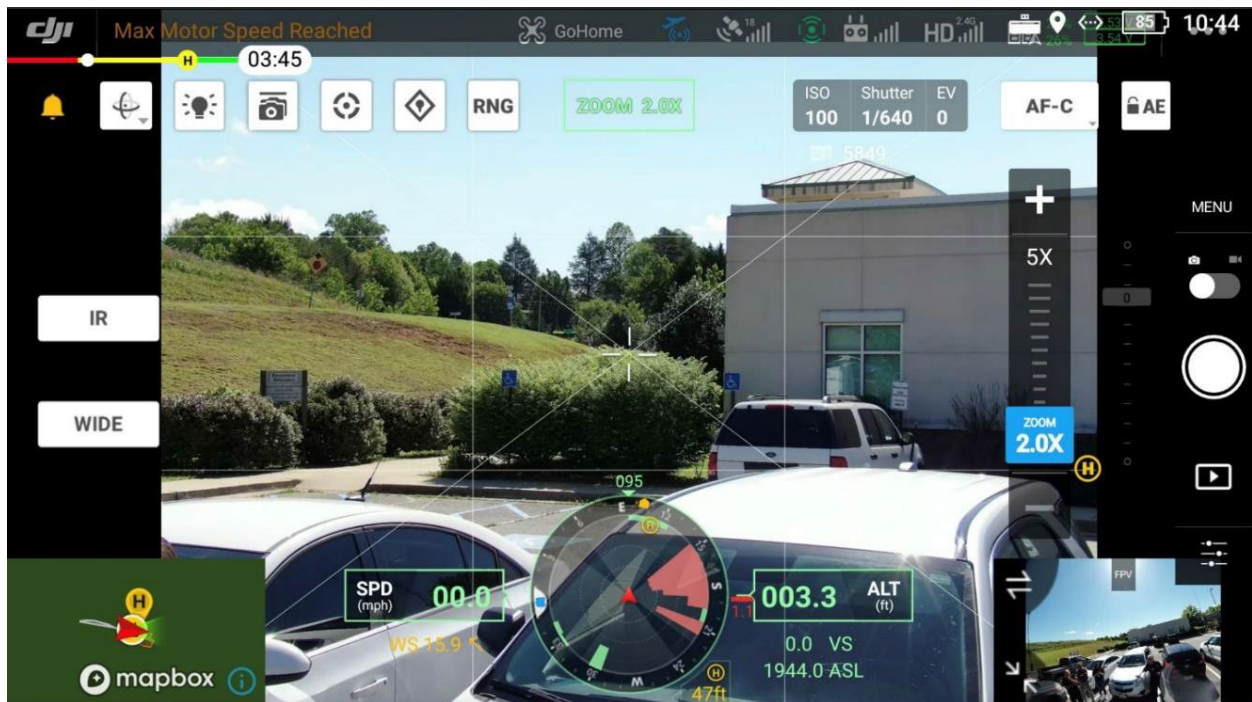
The obstacles seem to be cars parked at the location, as seen from the following photo taken from the aircraft:

Figure 13. Screenshot from app showing cars as obstacles during the accident sequence.

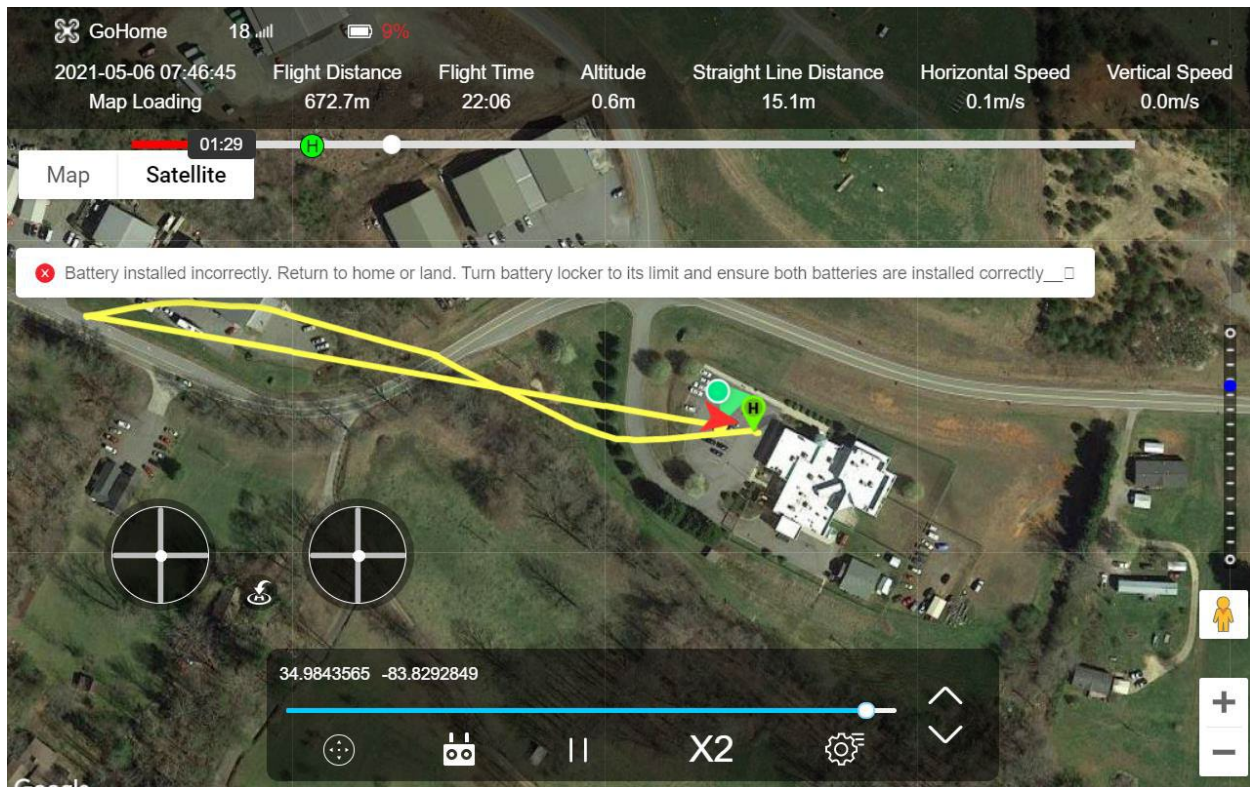
- As the battery level reaches 9%, battery installation error was prompted, indicating the battery was loosened by external force.

Figure 15. Battery installation error.

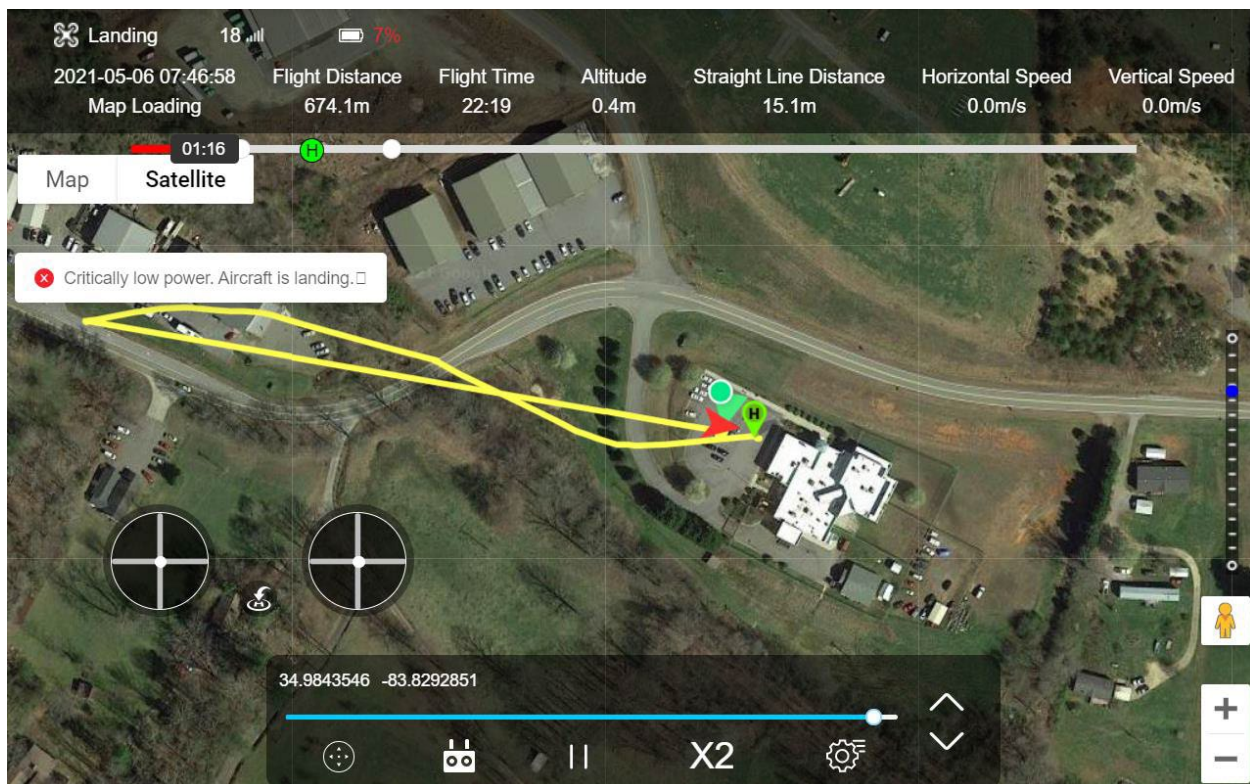
- As soon as the battery level reaches 7%, critically low battery auto landing was initiated.
- The aircraft failed to maintain altitude, despite increasing motor thrust output, indicating external force was exerted to the aircraft that prevented it from maintaining height. The aircraft eventually lost balance.

Figure 16. Critically low power warning.
