CEN21LA237

Group Chair's Factual Report - Attachment #1

Woodward Fuel Control Teardown Report and As Received Test Run Sheets

February 28, 2023

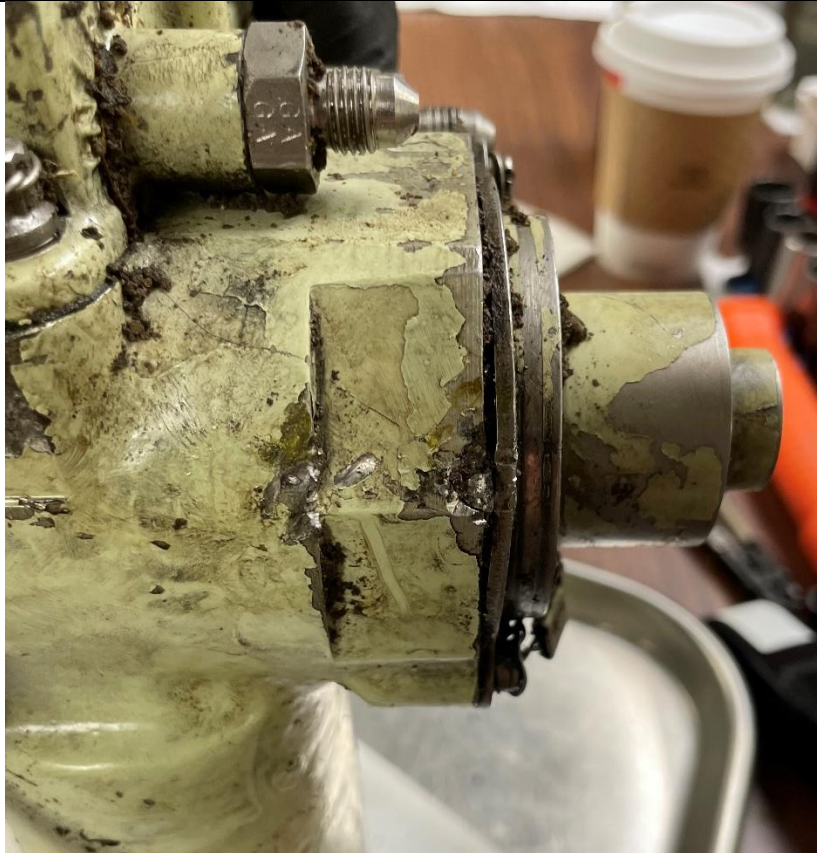
Figure 1. Damage to Housing

Minor damage was observed on the housing near the Pt2 bellows (see Figure 1) and one of the attachment screws was missing with damage to the main cover (see Figure 2). The inlet fuel filter and the inlet transfer tube that mates with the fuel pump were also missing. The power lever, speed setting lever, and drive shaft were all free to rotate normally.

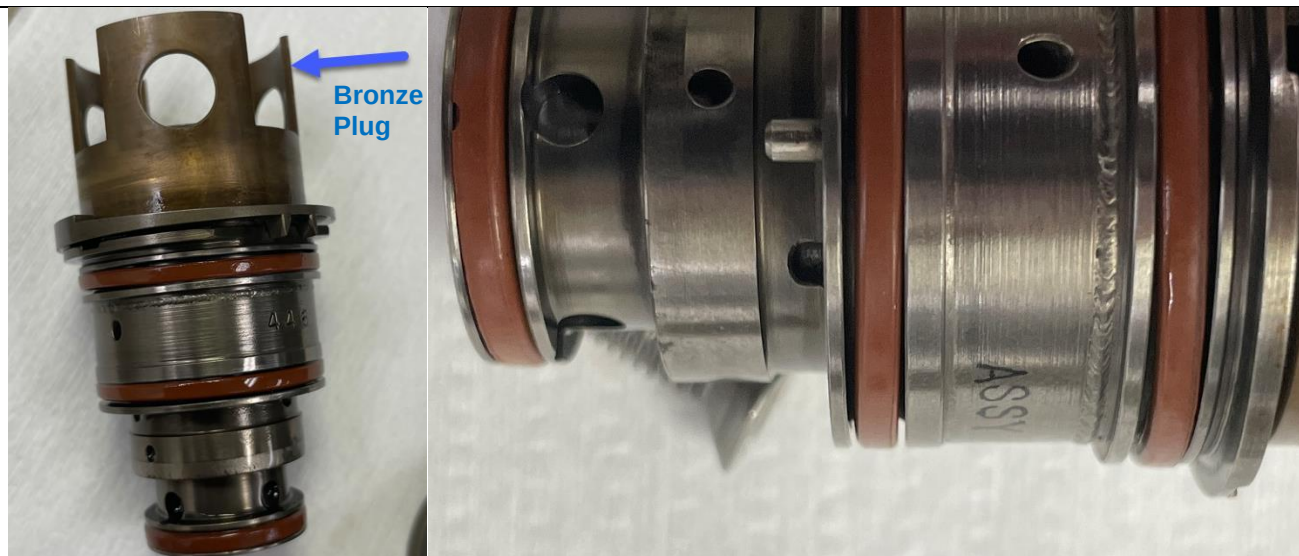
Figure 3. Bypass Valve

The bypass valve was then removed for inspection. The purpose of the bypass valve is to maintain a constant pressure differential (P1-P2) across the metering valve and bypass excess flow back to the fuel pump. The bronze bypass plug (see Figure 3) was stuck in the valve sleeve but the plug does not move during operation, therefore it would not have affected the function of the valve. The valve piston was free to move smoothly. The o-rings on the bypass valve sleeve were found to be red fluorosilicone and were visibly compression set. Woodward began using blue fluorosilicone o-rings instead of red fluorosilicone in 1983 due to the blue o-ring material being less susceptible to compression set. The o-rings were replaced and the unit was re-tested. There was no change in performance on the Standard Day Accel schedule. The bypass valve was then replaced with a valve from an engineering house unit. The Standard Day Accel schedule was rerun and no significant change in performance was observed. Rich fuel flows on the Accel schedule would not contribute to the reported loss of thrust. The Accel schedule limits fuel flow during start and acceleration of the engine up to the required engine speed. At takeoff the engine speed is controlled by the propellor governor and fuel flow is determined by the power lever schedule.
