**Date of Accident:** May 27, 2021

**NTSB File No.:** CEN21LA237

**Aircraft:** Schweizer/Grumman G-164B Ag Cat  
With Honeywell TPE331 conversion

**PROPELLER TEARDOWN REPORT**

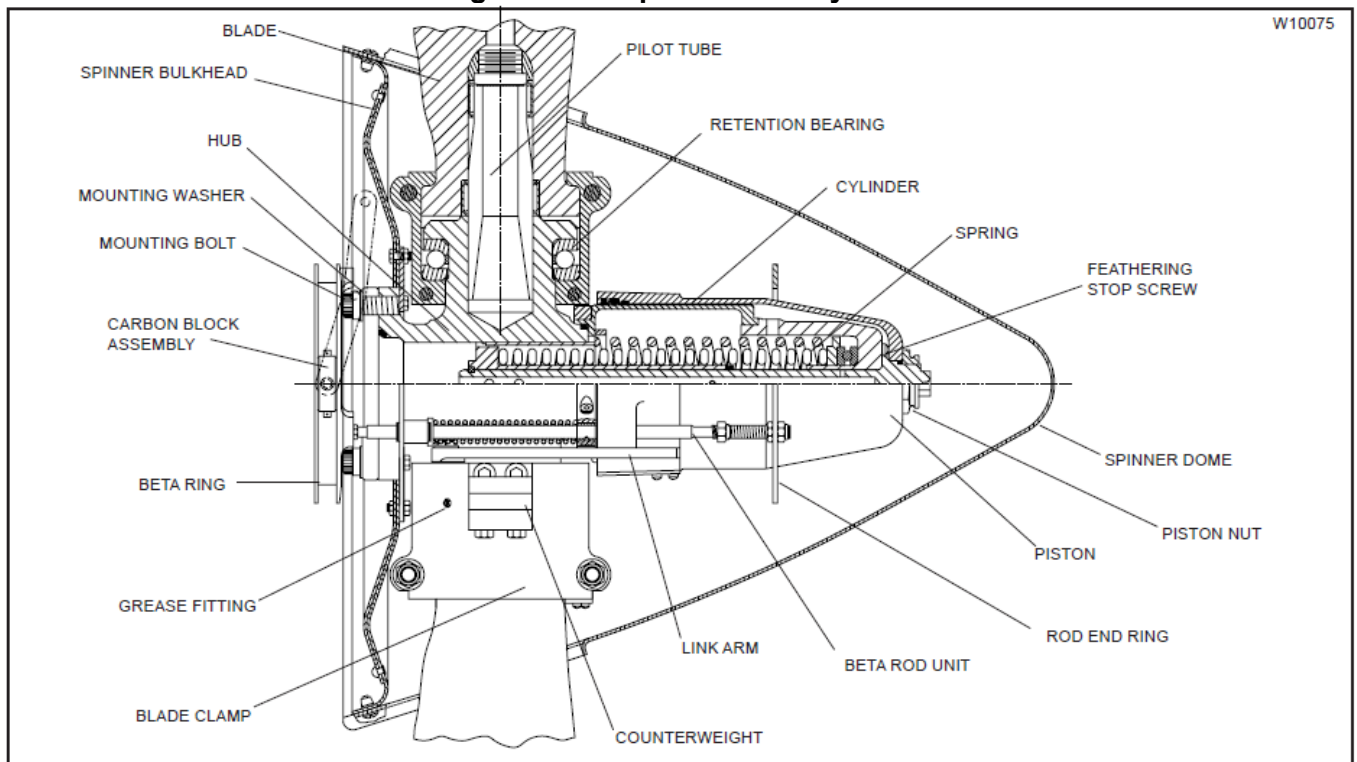
**Figure 1 – Propeller Cutaway Sketch**

**Propeller Description:** The propeller examined was a 102.5" diameter, Steel Hub Turbine Series, 3-blade, feathering, reversing, pressure-to-decrease pitch. Oil pressure from the propeller governor is used to move the blades to the low pitch (blade angle) direction. A spring and counterweights move the blades to the high pitch/feather direction in the absence of governor oil pressure. The propeller incorporates start locks to keep propeller blade angle low to minimize the starting torque. The blades are of aluminum construction. The hub and clamps are made of steel alloy. Installation Data Sheet No. 1735 provides additional propeller installation data. Propeller rotation is clockwise as viewed from the rear. A propeller cutaway sketch is shown in Figure 1.

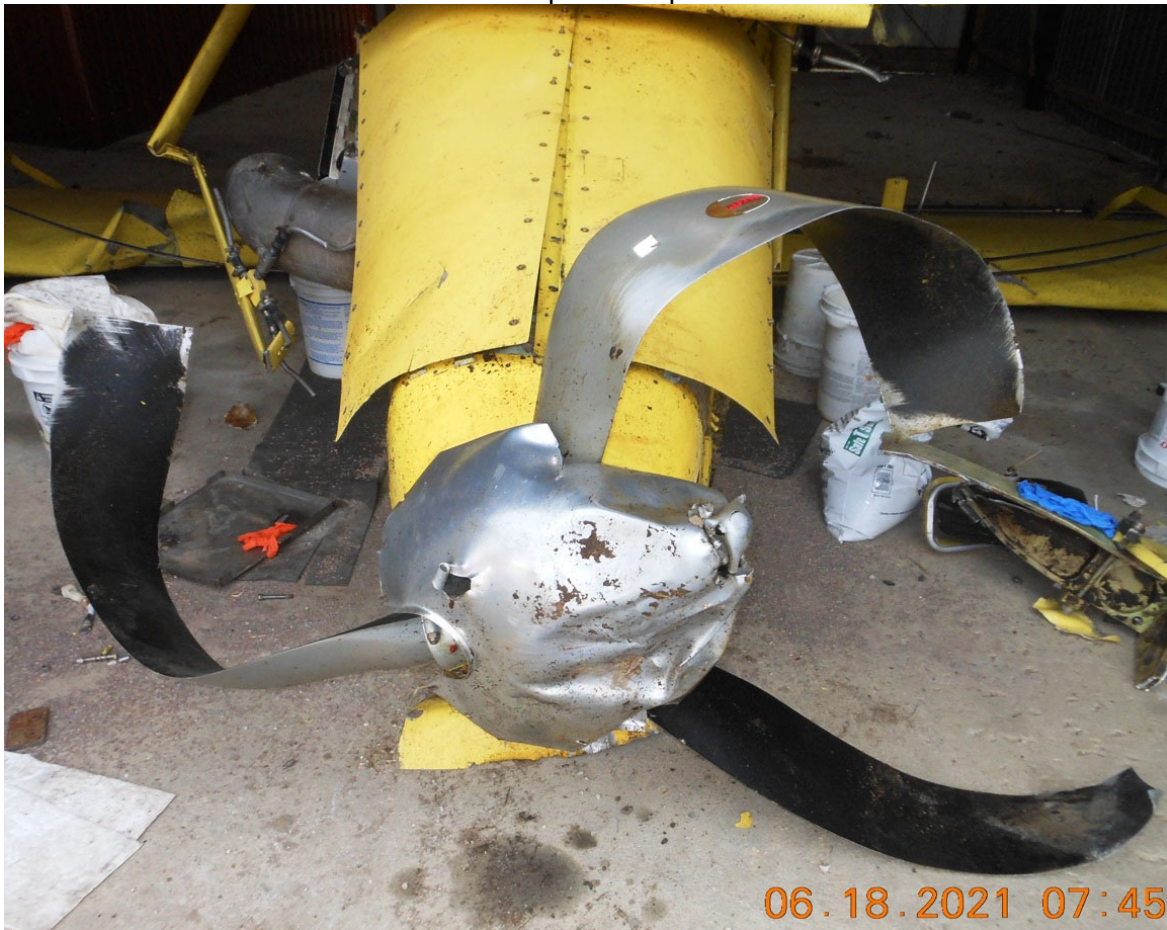
The propeller remained attached to the engine propeller shaft flange and was presented for examination as shown in Photo #1. All eight propeller mounting bolts were present, secure and lock-wired. The spinner dome was crushed and torn in various locations with spiral scoring marks and deformation opposite rotation. The hydraulic unit was fractured from the hub (Photo #2) and found loose inside the spinner dome. All three link arms had detached from their respective clamps/link screws. All three blades remained secure in their clamps with no indication of slippage. The spinner bulkhead had impact marks at blades #1 and #3 consistent with counterweights contacting due to forceful rotation towards low pitch. The guide collar with the start locks was missing and presumed not recovered from the crash scene. All three blades exhibited tip fractures that varied in length. All three blade/clamp assemblies could be rotated on the hub by hand force. All three blades exhibited bending aft, bending opposite rotation, twisting toward low pitch and chordwise/rotational scoring on both camber and face side. The mounting flange surface was intact and undamaged. The feathering spring assembly was intact and loaded with the forward and aft spring retainers in-place. The beta rod was bent and fractured aft of the pitch change rod (Photo #2); there was no attempt to remove the feathering spring assembly, pitch change rod and low pitch stop sleeve.

Photo #1 –Propeller as-presented

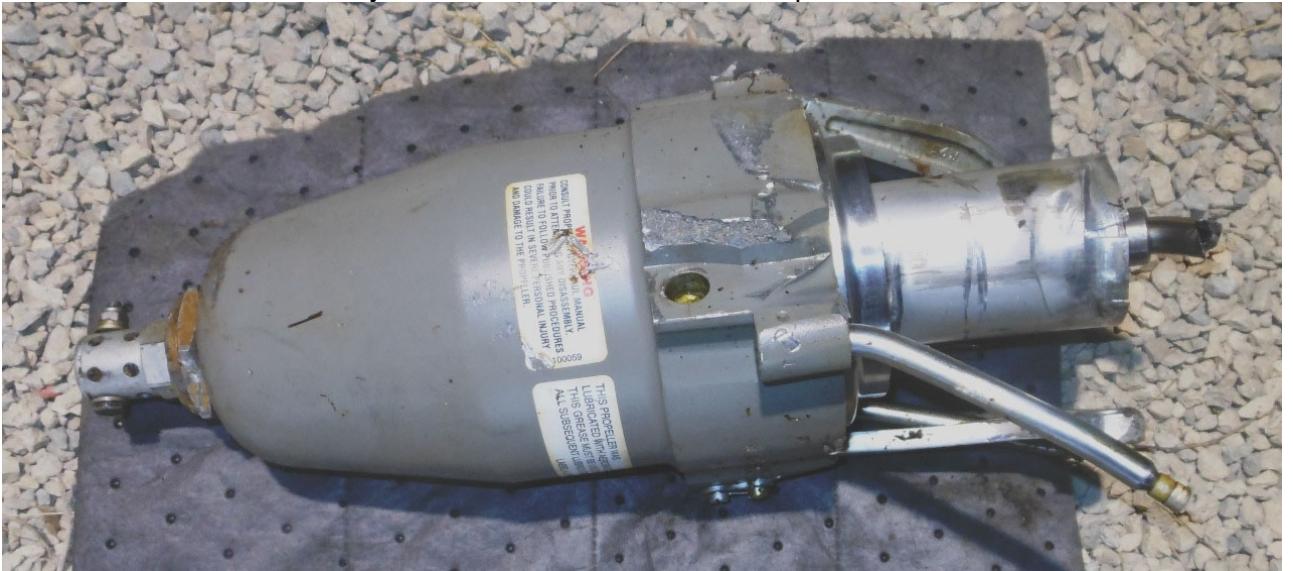
The piston nut was removed to remove the piston. All three link arm attachment points on the piston were damaged. Two of the three guide rods were bent, the third guide rod was missing and was fractured at its piston attachment point. There were no remarkable marks on the internal surface of the piston that would indicate a blade angle at impact (Photo #3). The cylinder appeared undamaged but had scuff marks starting at approximately 2.01" from the top corner (Photo #5) and progressing toward low pitch (approximately equivalent to a 9° blade angle). The ceiling of the piston and the feather stop screws were not remarkably damaged indicating the propeller was not feathered at impact (Photo #4). The pitch change rod appeared bent at the aft end with the feathering spring retained and compressed. The spring sleeve was bent/dented/creased and split near the aft end.

Photo #2 – Hydraulic unit as-recovered from spinner dome

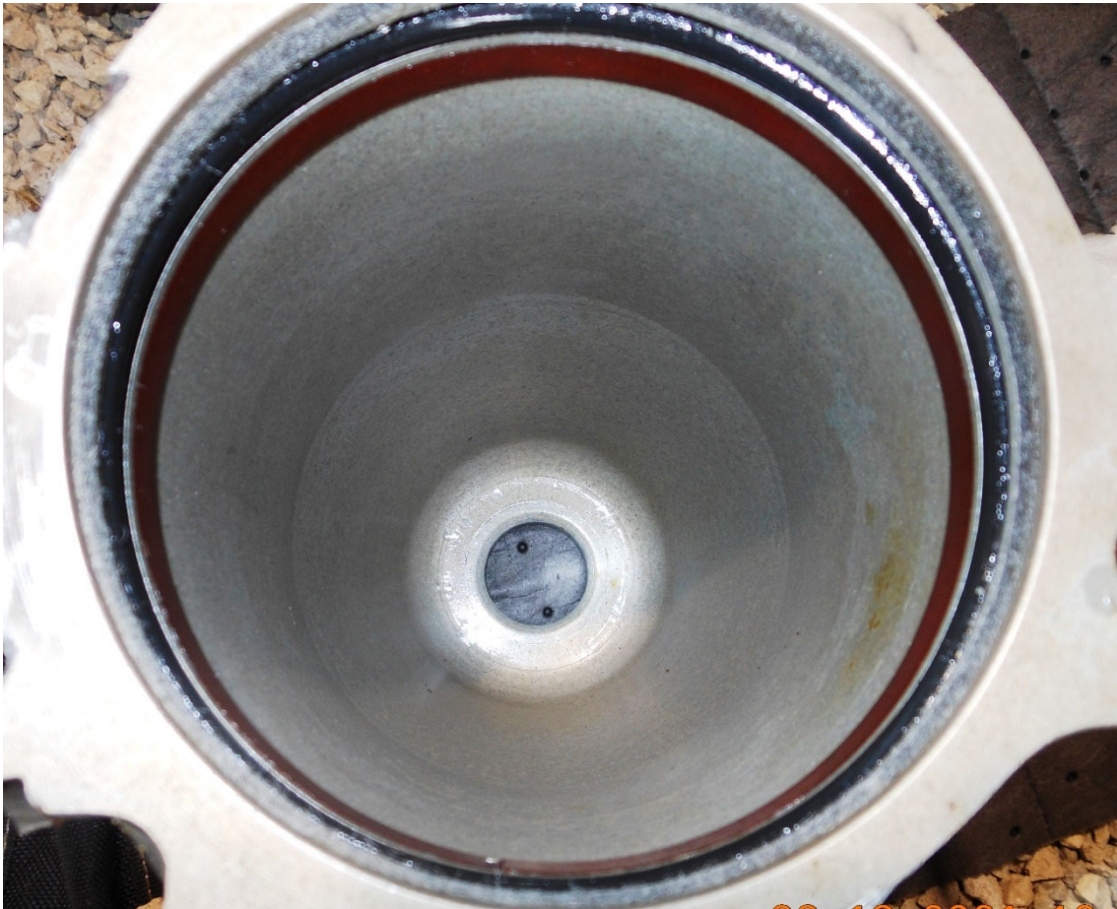
Photo #3 – Piston internal surface

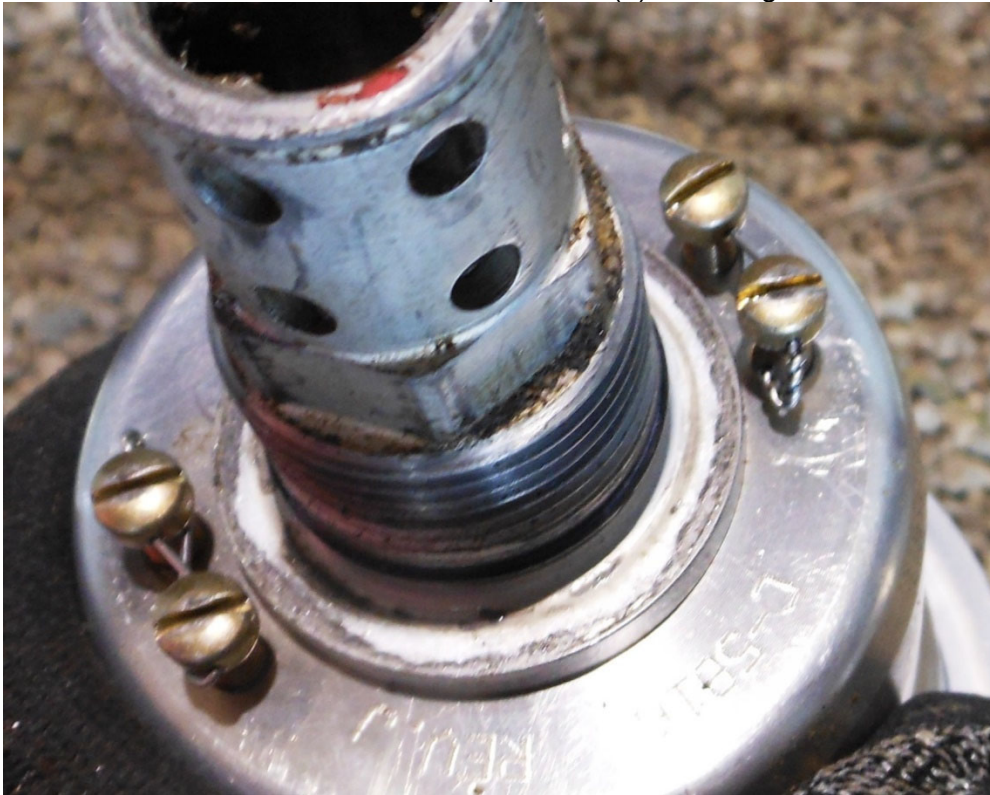
Photo #4 – Feather stop screws (4) undamaged

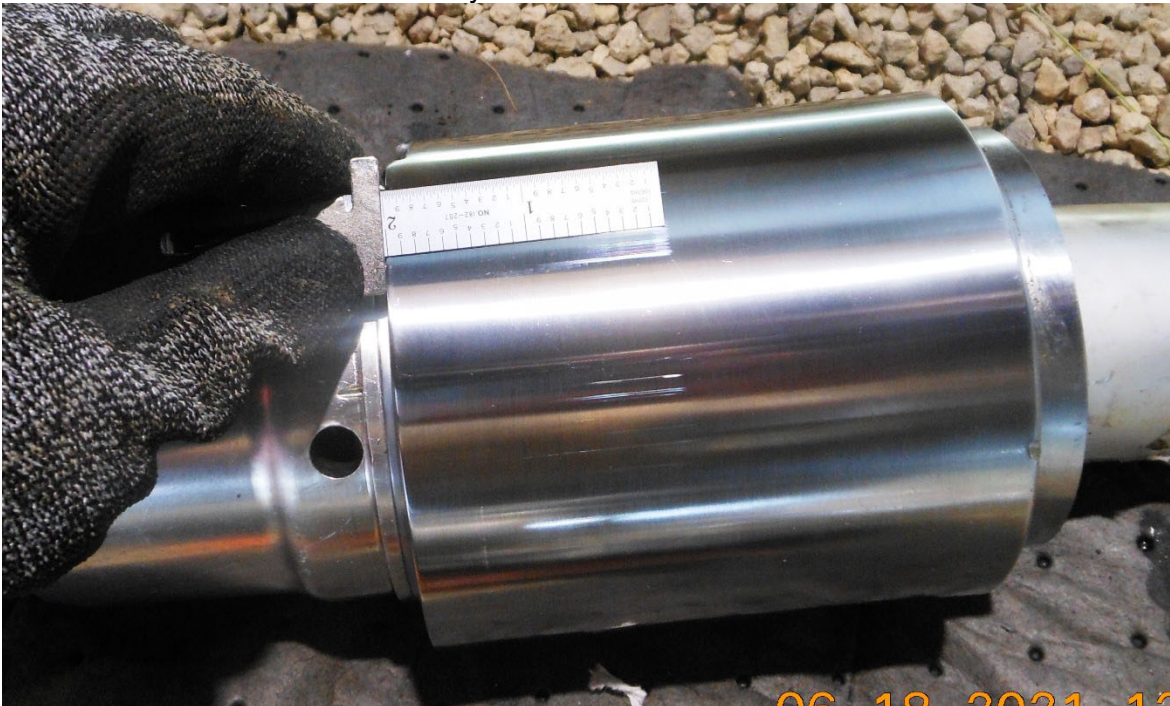
Photo #5 - Cylinder scuff marks measured

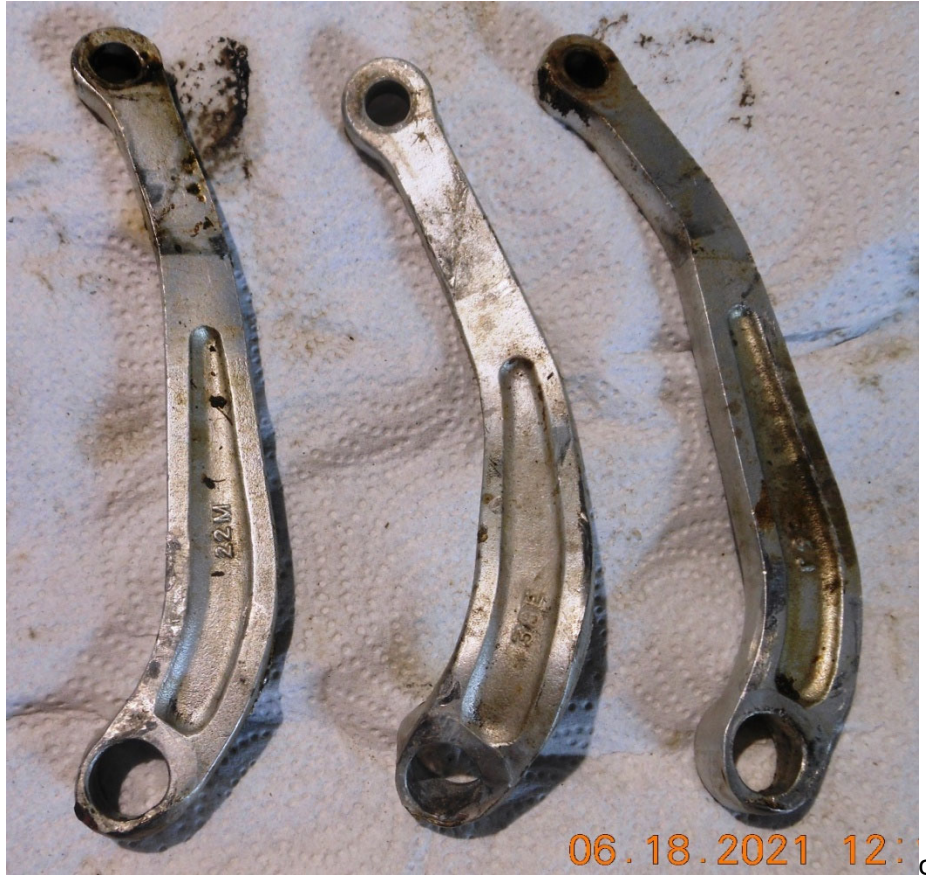
All three link arms were bent in compression and the link screw holes elongated (Photo #6).

Photo #6 – Link arms

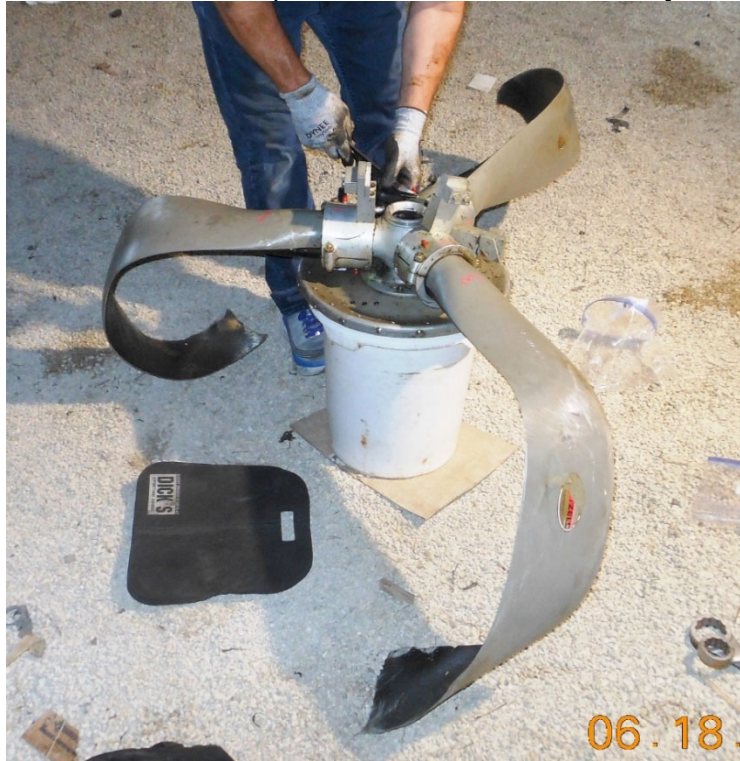
The propeller was removed from the engine for disassembly as shown in Photo #7. The mounting flange appeared undamaged. The hub unit was intact and exhibited clamp contact marks on the forward side of the hub arm. All three bearing assemblies were intact and rotated smoothly. All three pilot tubes appeared intact and undamaged. There were thread whiskers on the cylinder mounting threads.

Photo #7 – Propeller removed for disassembly

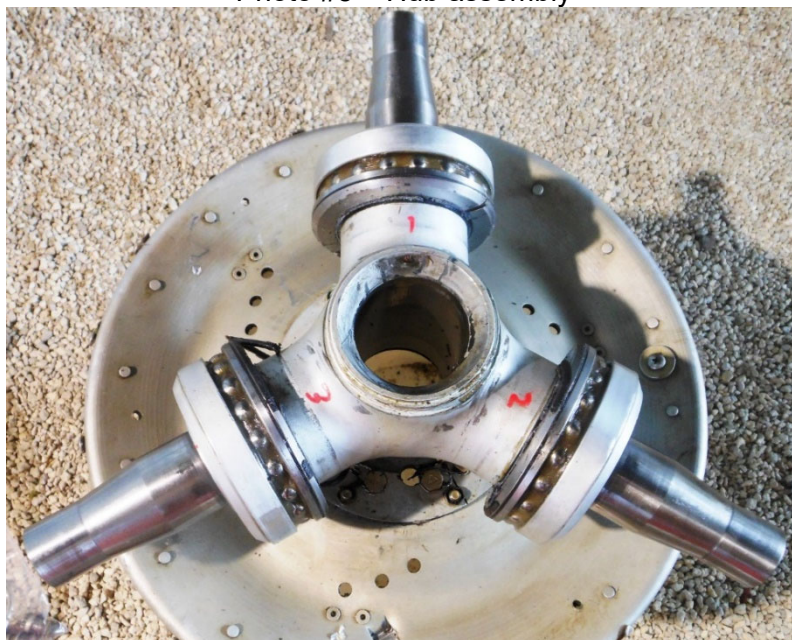
Photo #8 – Hub assembly

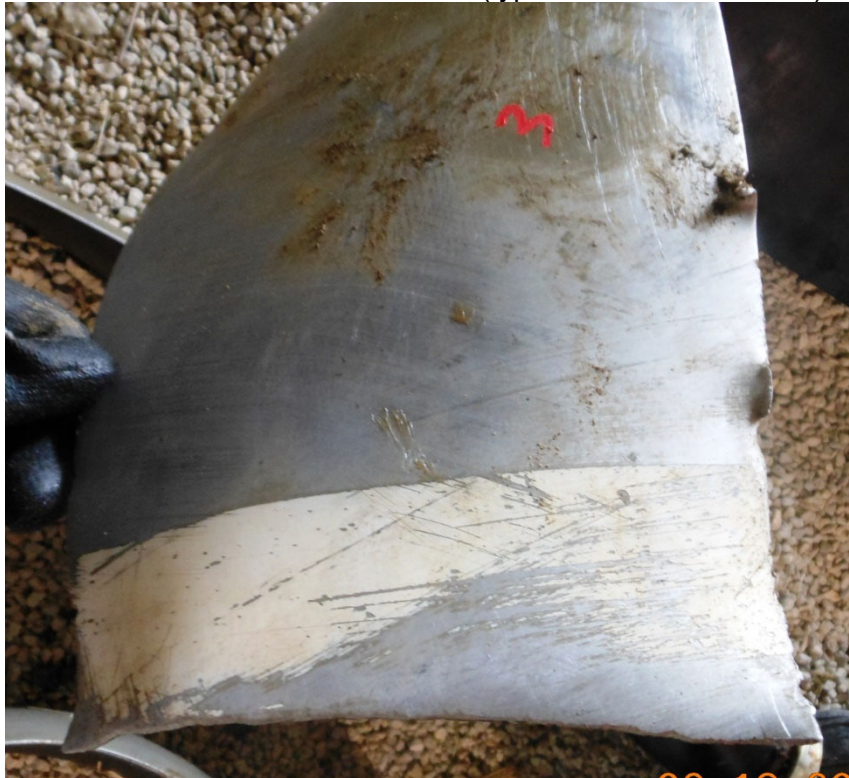
All three blades had chordwise/rotational scoring on the camber side similar to those on Blade #3 shown in Photo #9. Blade #3 had leading edge gouging with material deformation toward high pitch (Photo #10). All three blades had some chordwise/rotational scoring on the face side (Photo #11). Three tip fragments were recovered at the crash scene (Photo #12). Photo #13 shows the progressive aft bending in the 2-3-1 sequence (right-to-left). Photo #14 shows the degree of bending opposite rotation. Photo #15 shows the Blade #3 butt with an impact impression around the circumference of the pilot tube bore bearing, and the re-stamping of the diameter designation.

Photo #9 – Blade #3 camber side (typical of all three blades)

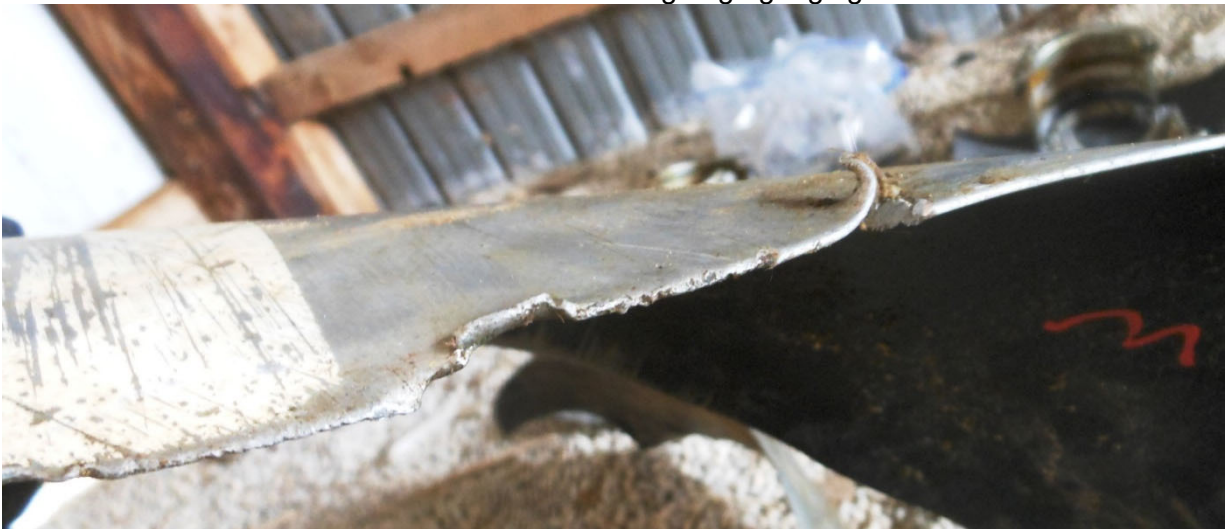
Photo #10 – Blade #3 leading edge gouging

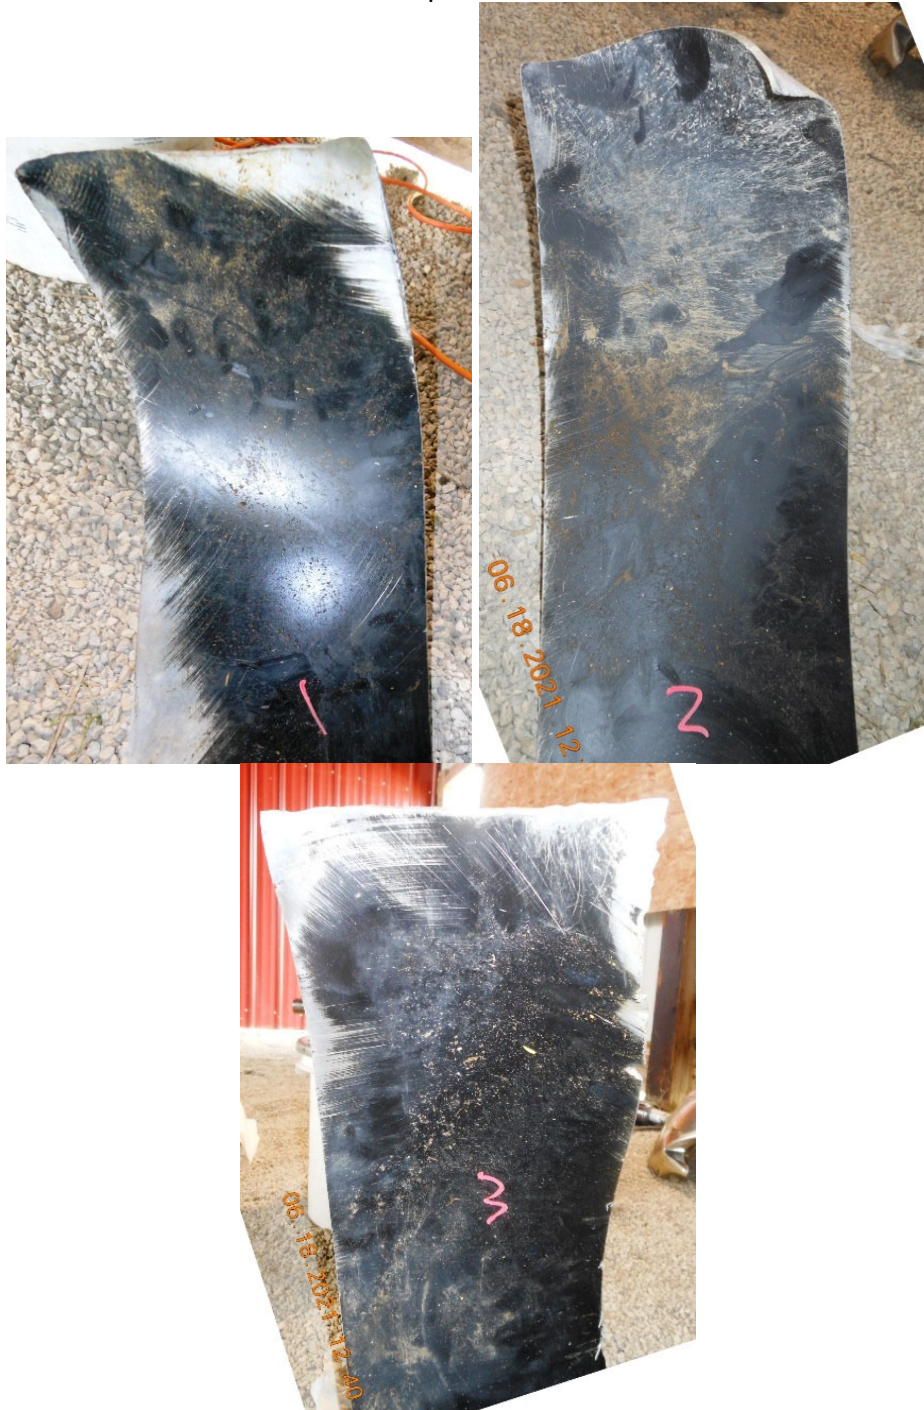
Photo #11 – Propeller blades face side

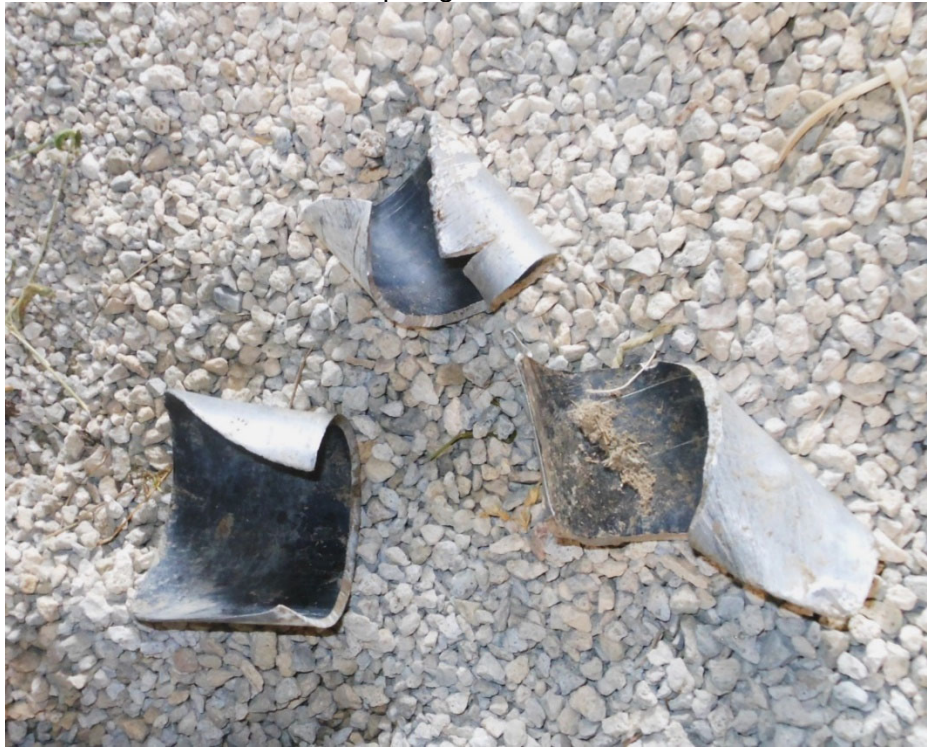
Photo #12 – Fractured tip segments recovered at crash scene

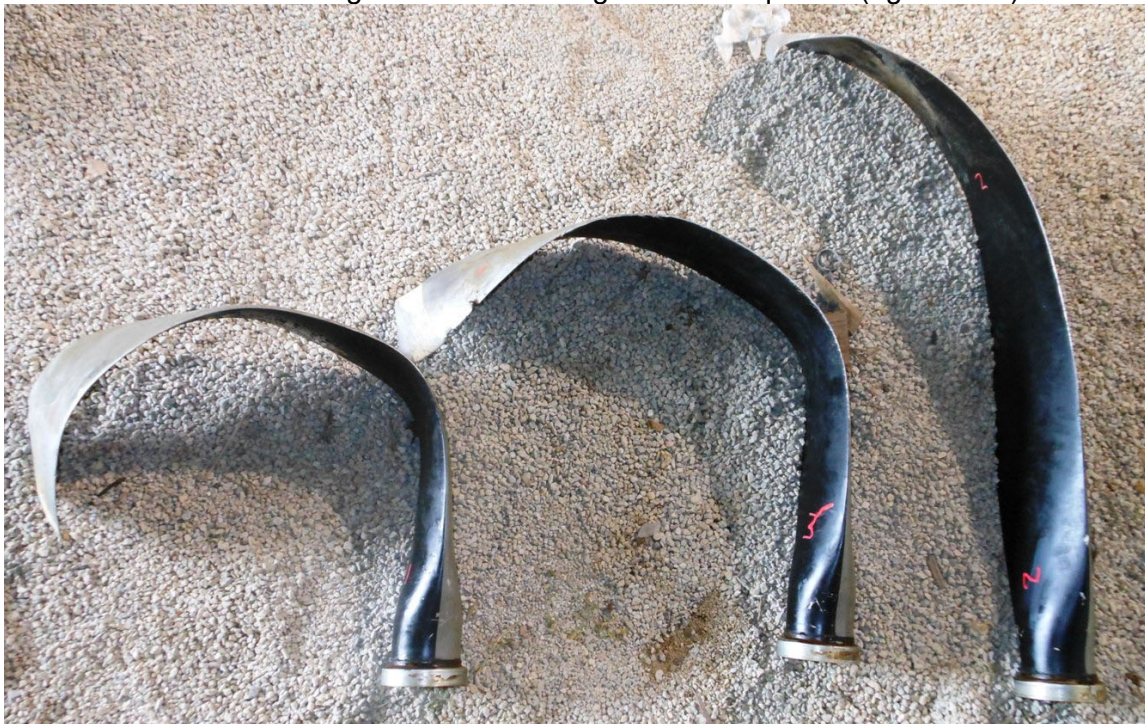
Photo #13 – Progressive aft bending in 2-3-1 sequence (right-to-left)

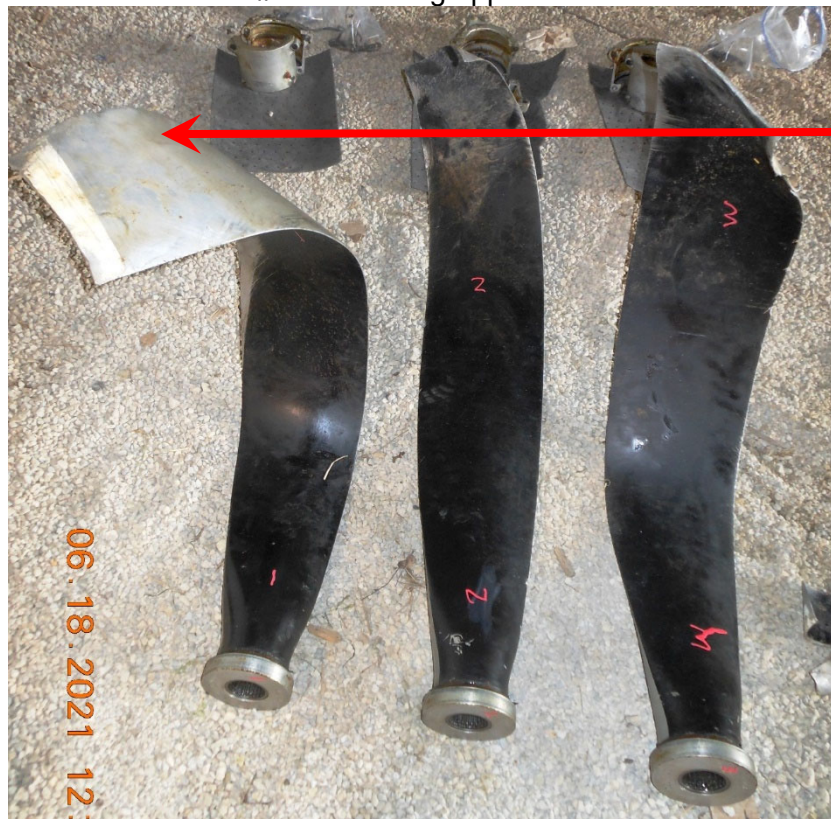
Photo #14 – Bending opposite rotation

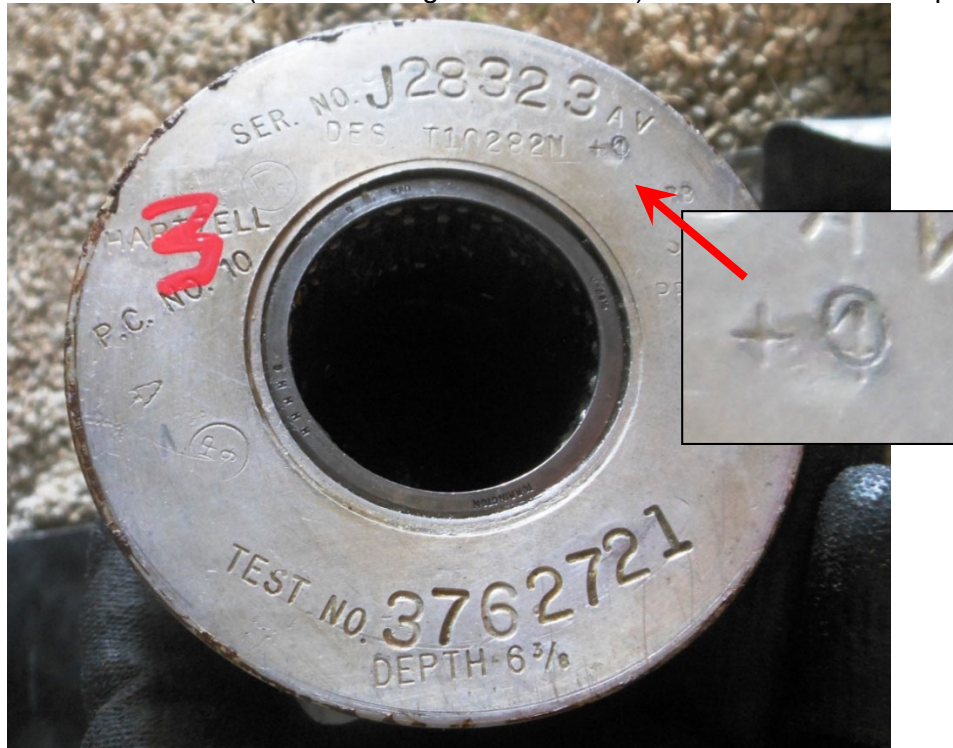
Photo #15 – Blade #3 butt (similar damage on #1 and #2) with diameter re-stamping

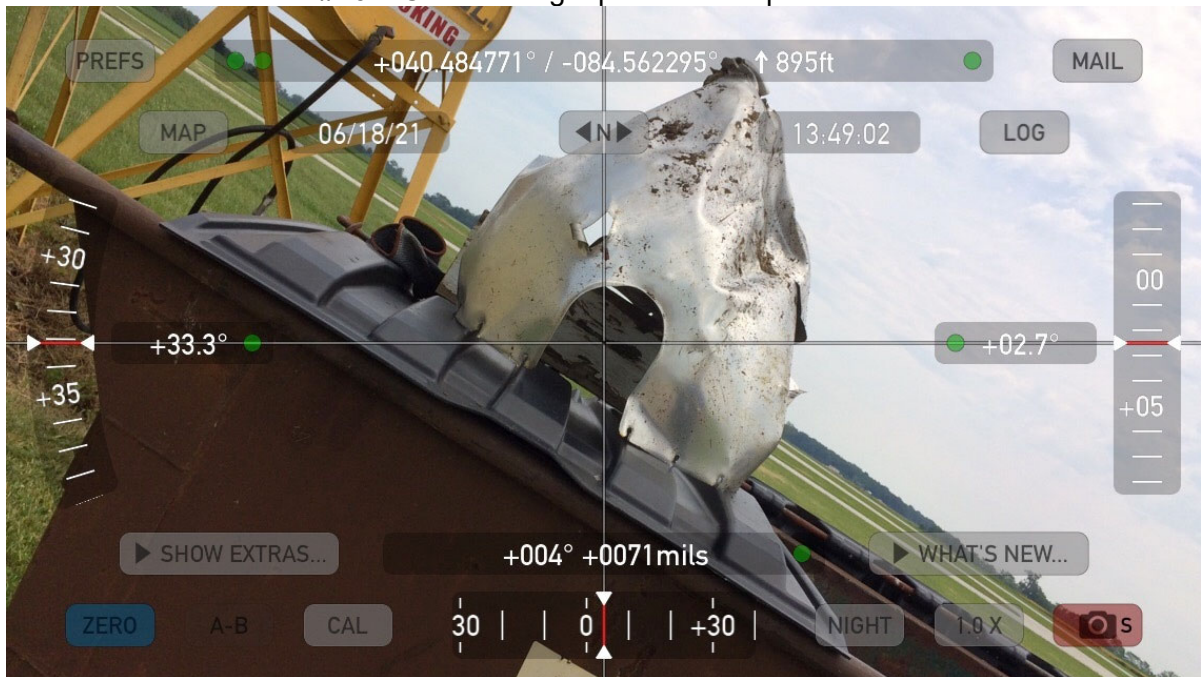
A counterweight puncture mark on the spinner dome suggested the propeller was operating in the normal range of operation at approximately 24° blade angle at impact. There was no damage to indicate the propeller was feathered or in the beta/reverse range at the time of impact. All three blade shanks remained attached via the retention clamps and no pilot tubes were fractured. All three blades were fractured near the tip. Blade damage that included chordwise/rotational scoring on both camber and face sides, bending opposite rotation, leading edge gouging with material deformation towards high pitch and progressive compound bent/twisting was consistent with impact while rotating at a moderate power setting.

There was a counterweight puncture in the spinner dome measured to be approximately 33-35° as shown in Photo #16. This counterweight angle is approximately equivalent to a 24° blade angle.

Photo #16 – Counterweight puncture in spinner dome
