**HONEYWELL WRECKAGE REVIEW NOTES**  
**Celina, OH**  
**Grumman G-164B, Registration N8376K**  
**May 27, 2021**  
**NTSB Investigation CEN21LA237**

On May 27, 2021, a Grumman G-164B Agricultural aircraft crashed inverted into a waterway shortly after takeoff from the Lakefield Airport near Celina, Ohio. The aircraft was conducting aerial application in the area. The pilot sustained serious injuries. Aircraft damage was substantial. The aircraft was relocated to a hangar at the Lakefield Airport where a wreckage review was conducted on June 18, 2021. Representatives of Honeywell, Hartzell, FAA-FSDO Columbus, and the airport manager attended the review.

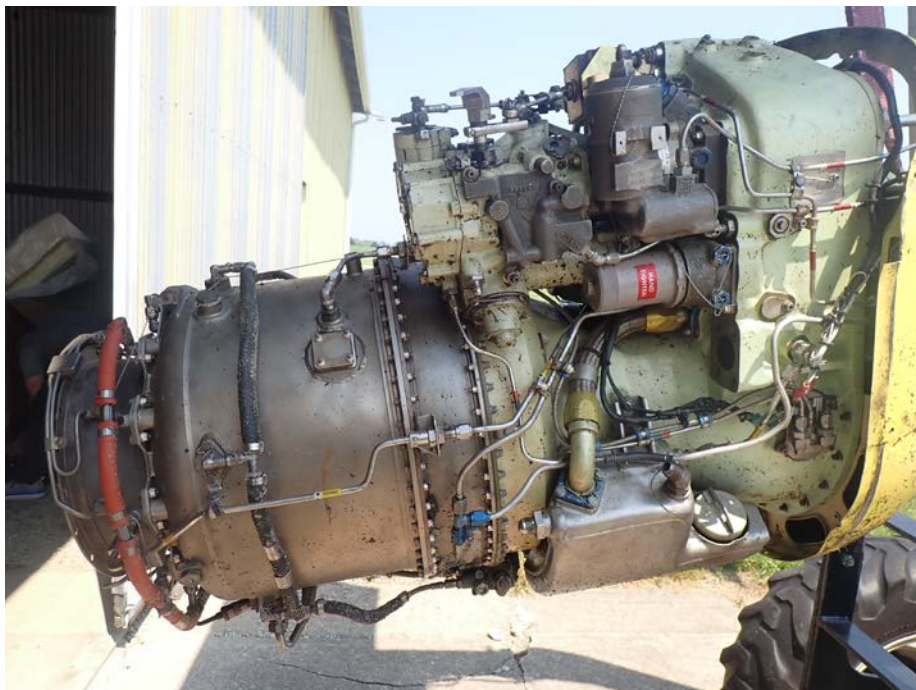
Figure 6. Engine S/N P-92143

- The engine was intact with no evidence of impact or fire damage ([Figure 6](#)).
- The engine data plate identified the engine as ([Figure 7](#))
  - o TPE3311-1-151A

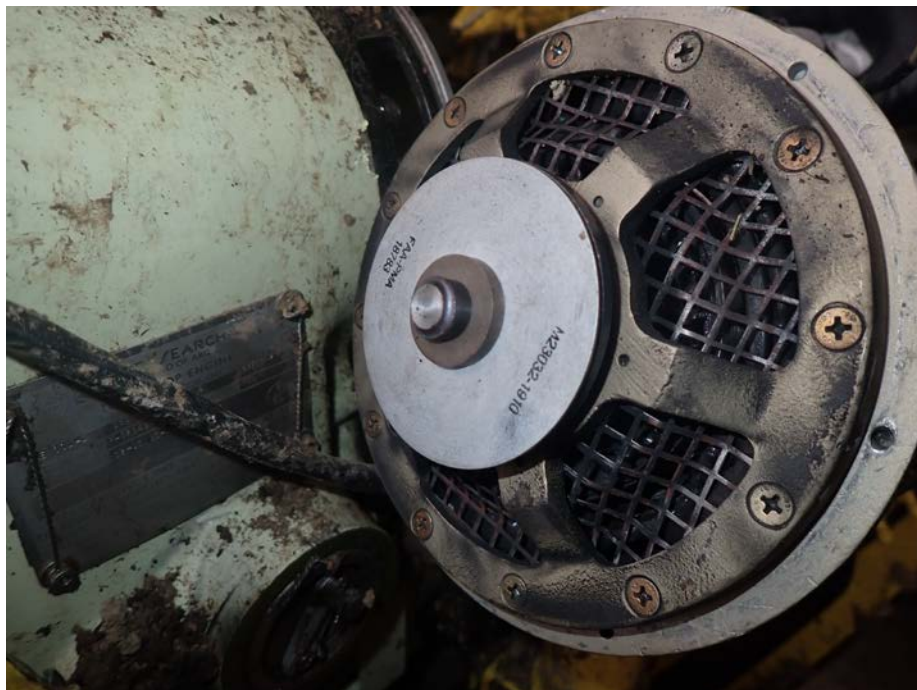
Figure 8. Engine SN P-92143 Starter Shaft

- o Part No. 893250-2
  - o Serial No. P-92143
- Starter shaft was sheared ([Figure 8](#)) with the spline end remaining in gearbox ([Figure 9](#)). The starter remained with aircraft and was not returned with the engine.

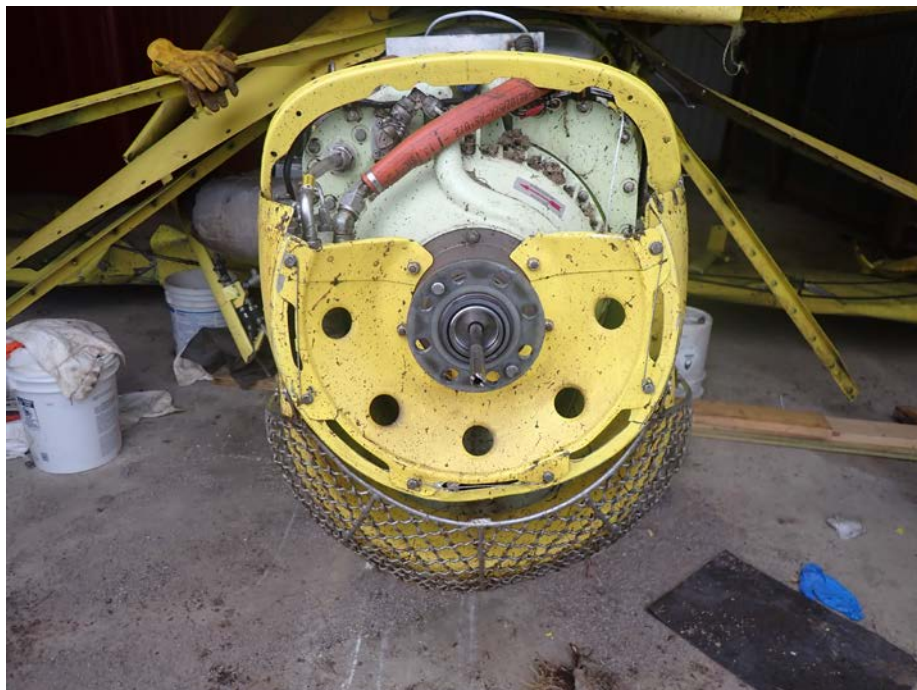
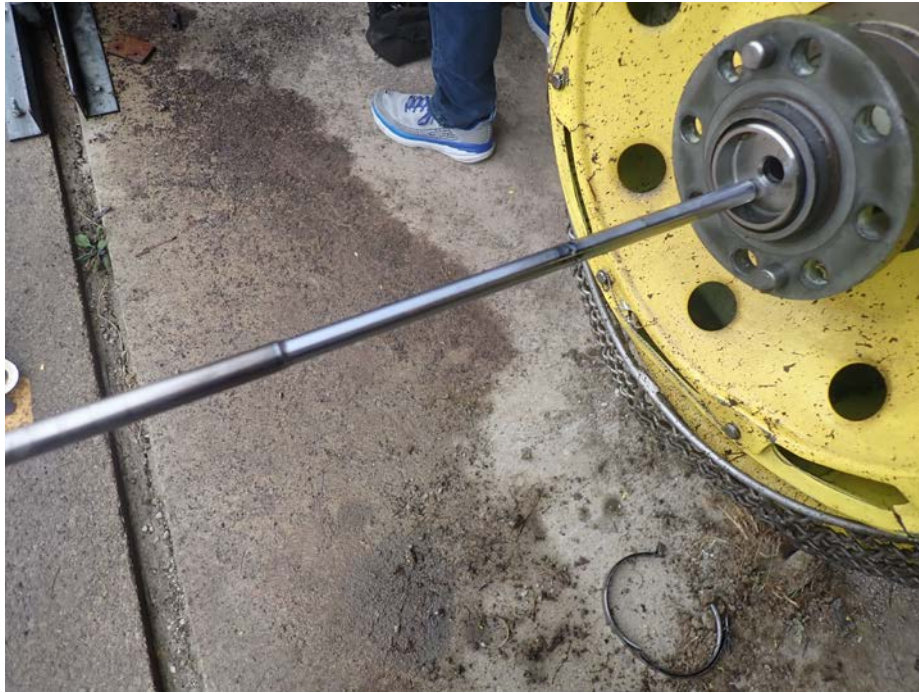
- The Beta tube was broken forward of the propeller flange ([Figure 10](#) and [Figure 11](#)).
- Linkage to propeller pitch control (PPC) was not connected.

Figure 10. Engine SN P-92143 Beta Tube

Figure 11. Engine SN P-92143 Beta Tube

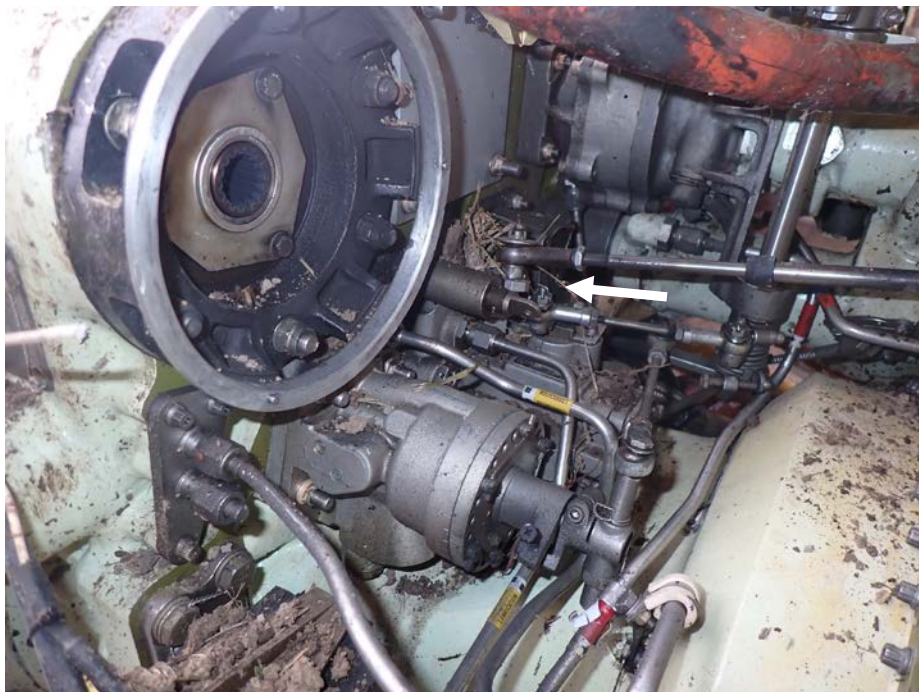
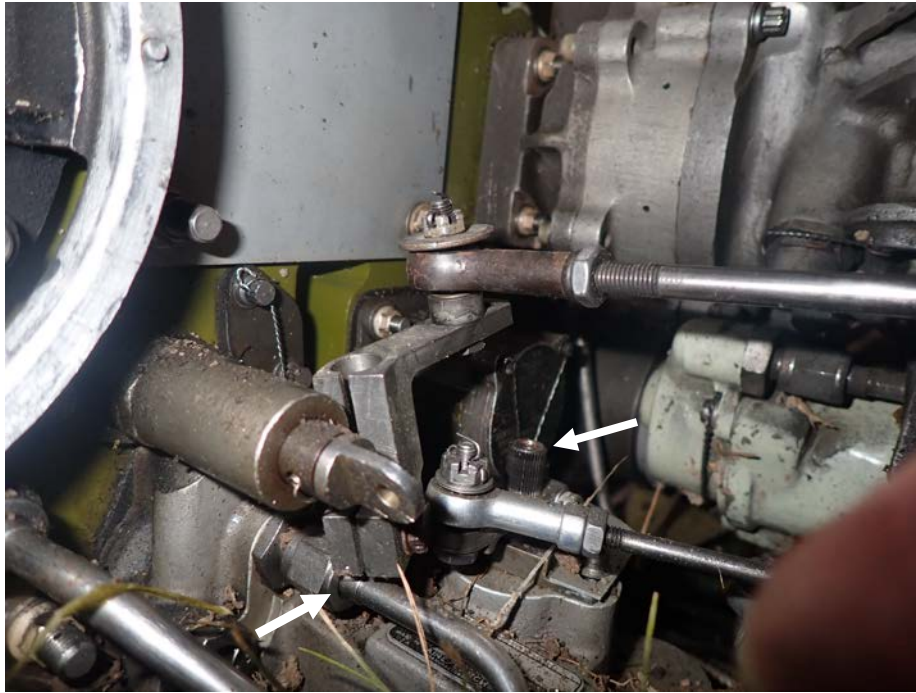
- o Bracket was off the PPC spline shaft ([Figure 12](#) and [Figure 13](#)).
  - o Bolt does not appear to be tight and no safety wire was present ([Figure 14](#)).

Figure 12. Engine SN P-92143 Propeller Pitch Control Linkage

*Figure 13. Engine SN P-92143 Propeller Pitch Control Linkage*

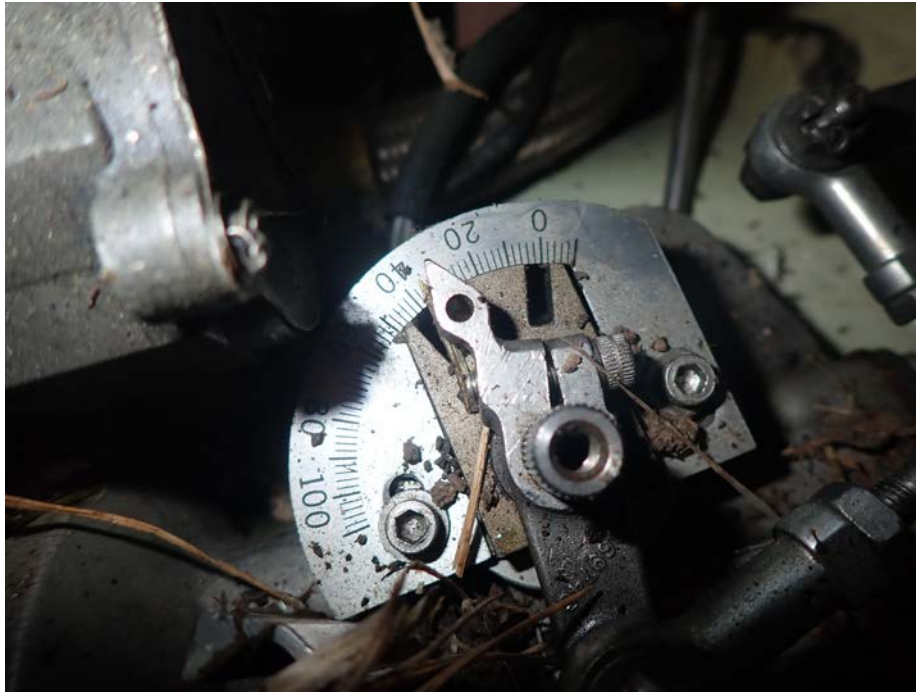
Figure 15. Engine S/N P-92143 Propeller Pitch Control

- o PPC was at approx. 30 degrees ([Figure 15](#)).
- FCU was at 9 degrees on speed input ([Figure 16](#)) and 28 on Power Lever ([Figure 17](#)).
- Gearbox oil bypass popped / actuated ([Figure 18](#)).

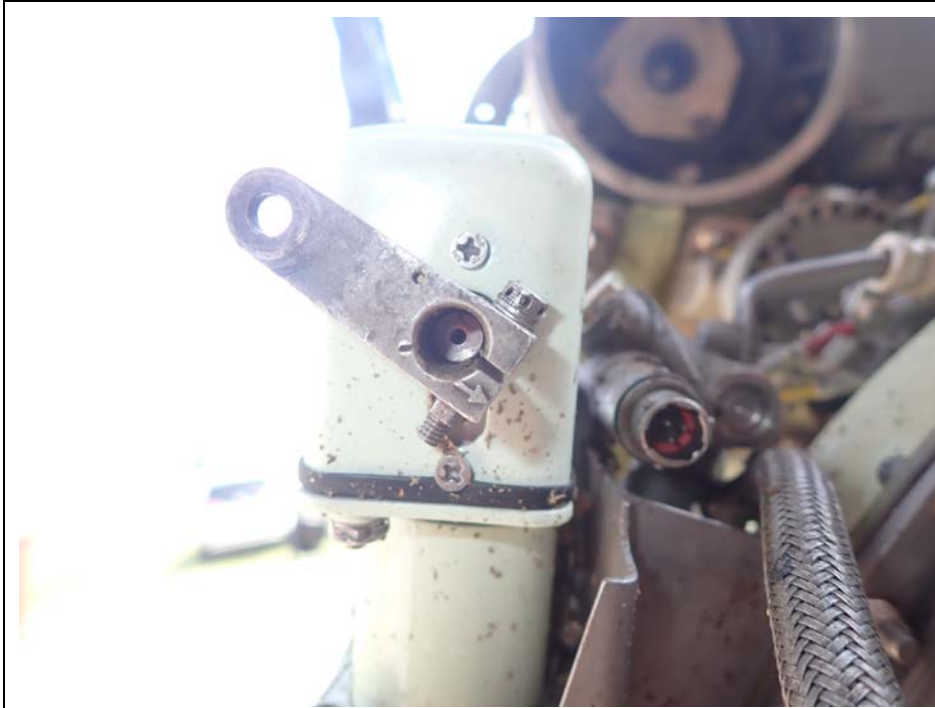
Figure 19. Engine S/N P-92143 Fuel Shut Off Valve

- FSOV index mark on the shaft was at top, 0 degrees ([Figure 19](#)).
  - o Arm at 10 o'clock ALF
- Aft mount bolt was sheared with head and nut missing ([Figure 20](#)).

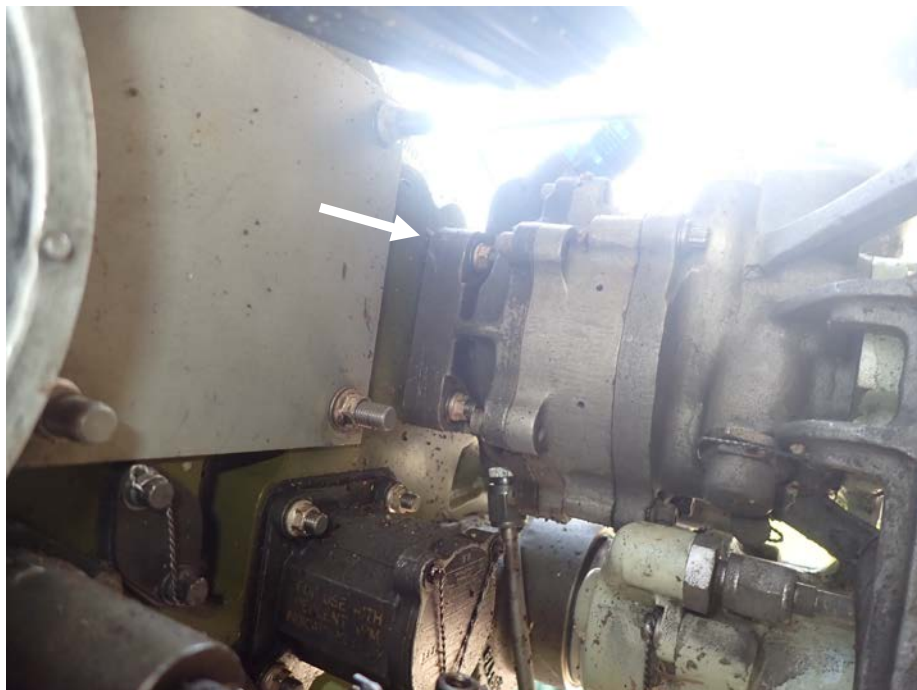
Figure 22. Engine S/N P-92143 Fuel Pump Mount to Gear Mount

- o Remainder of bolt stayed in plenum ([Figure 21](#)).
- Gearbox studs for fuel pump mount slightly pulled, creating a gap between the fuel pump and gearbox housing ([Figure 22](#)).

- o Pump and FCU was slightly loose to gearbox
  - o FCU and pump interface appears to be tight
- Power lever in cockpit at red hatched area on scale next to lever ([Figure 23](#)).

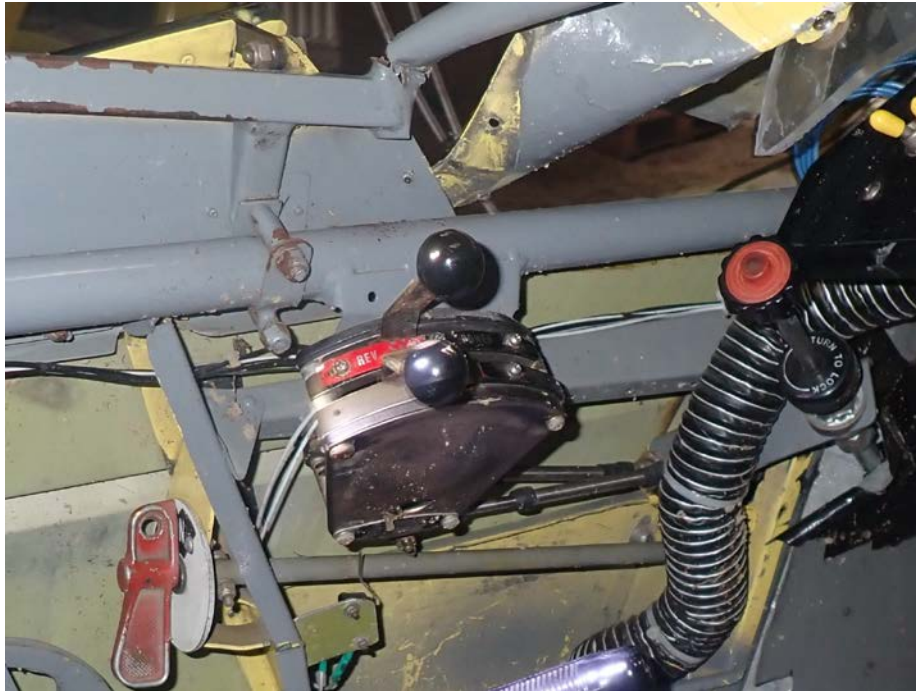
Figure 23. Grumman G-164B Registration N8376K Power and Speed Levers

- Speed lever slightly aft of power lever ([Figure 23](#)).

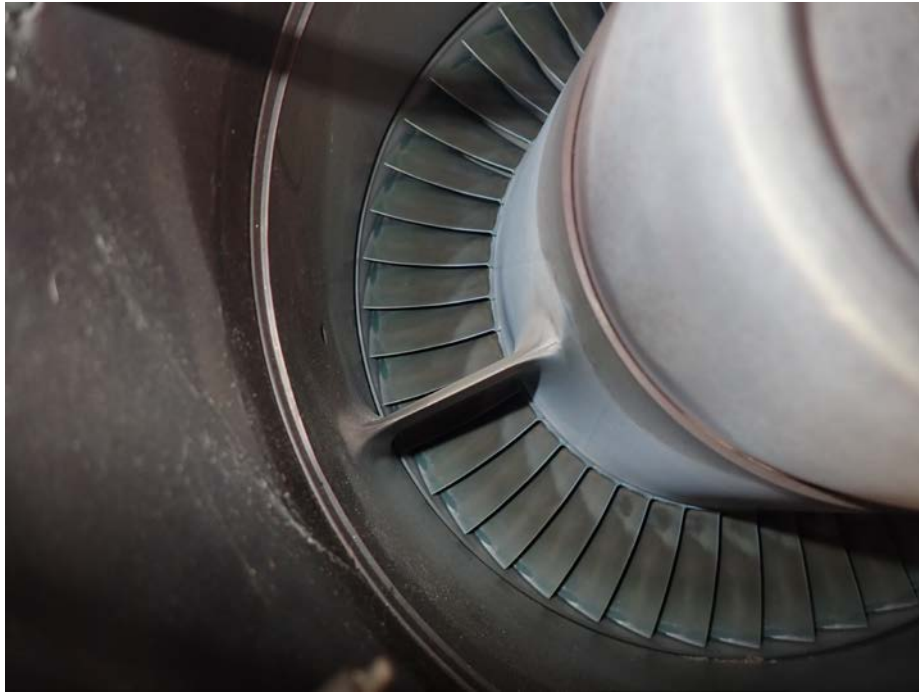
**Figure 25. Engine S/N P-92143 Third Stage Turbine Rotor**

- With the speed lever in the full aft position,
  - o FCU 6 – 8 degrees
- The linkage for the PLA was reconnected to PPC and the power lever was actuated:
  - o Full forward, PPC at 100, FCU at 98
  - o Full aft, PPC 4, FCU 0
- The engine turbine rotated freely with the propeller.
- There was no bending of first stage compressor impeller blades observed ([Figure 24](#)).
- The third stage turbine rotor was intact however; the blades tips were white in color ([Figure 25](#)).
