# National Transportation Safety Board

CEN21LA237

## **POWERPLANTS**

Group Chair's Factual Report

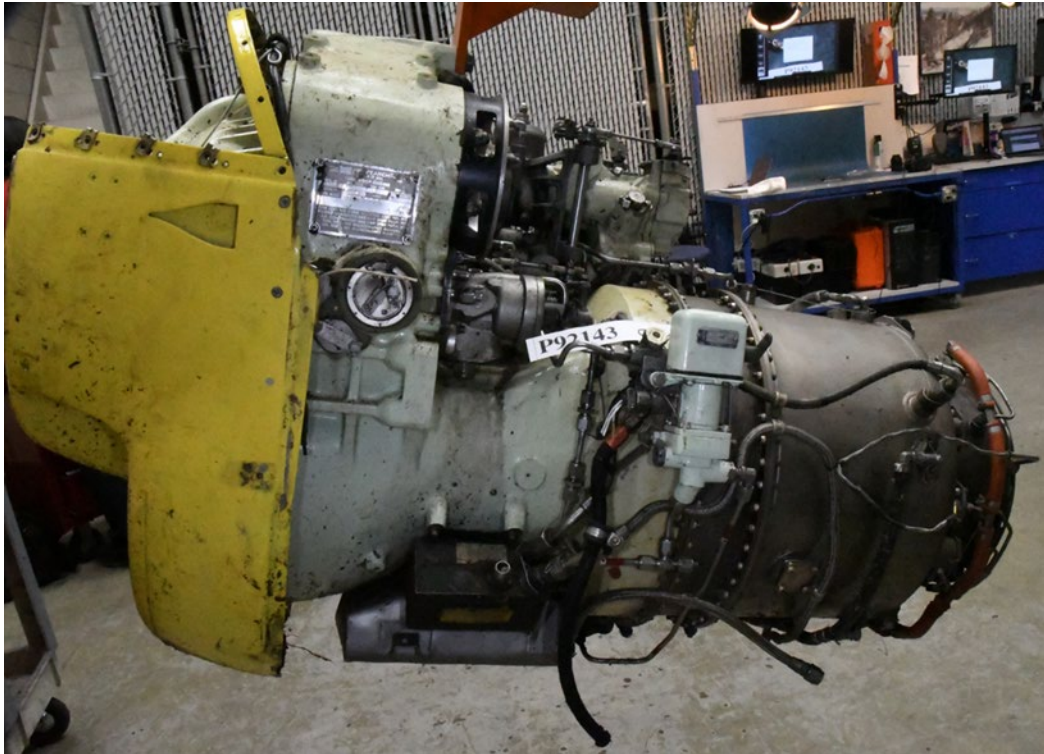
**Photo 2- Left Side of Engine, as Received**

The engine was secured in a cardboard shipping box in the Honeywell Product Integrity Laboratory when the investigation team arrived (**Photos 1-4**). Earthen debris was adhered to the engine cases, external accessories, and lines. There was no evidence of undercowl engine fire or radial uncontainment. The 1<sup>st</sup> stage impeller was manually rotated by hand through the inlet and there was concurrent rotation of the 3<sup>rd</sup> stage turbine. The fuel pump mount studs on the accessory gearbox

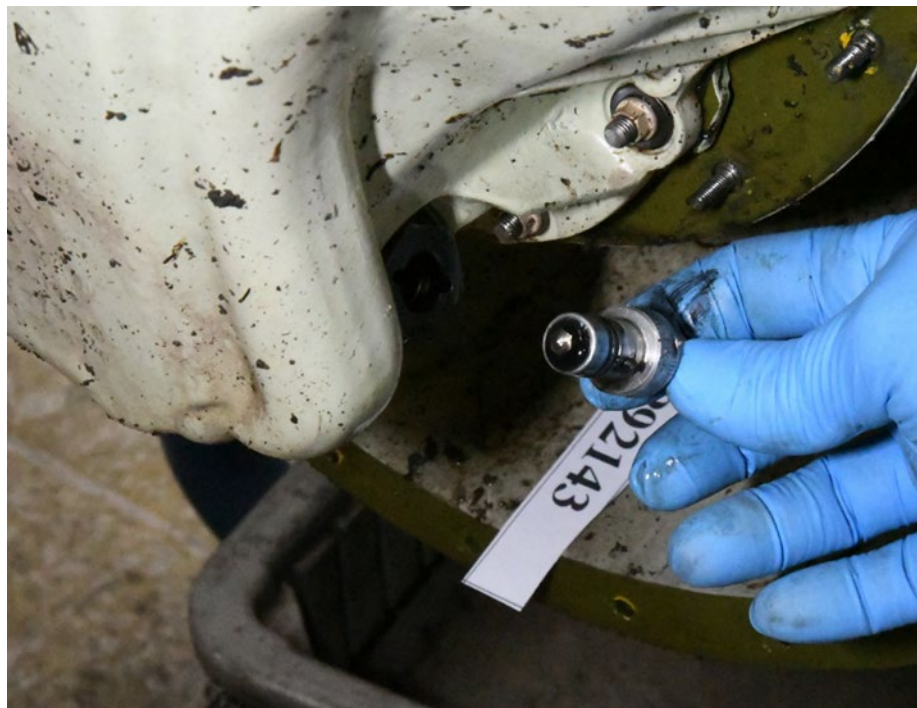
**Photo 5- Magnetic Chip Detector**

(AGB) were partially pulled out the gearbox case, but the fuel pump drive shaft remained engaged. The lower forward edge of the fuel tank exhibited impact deformation. The magnetic chip detector was free of debris/metallic "fuzz" (**Photo 5**). The oil filter bypass indicator was extended (bypass mode) on the AGB case.

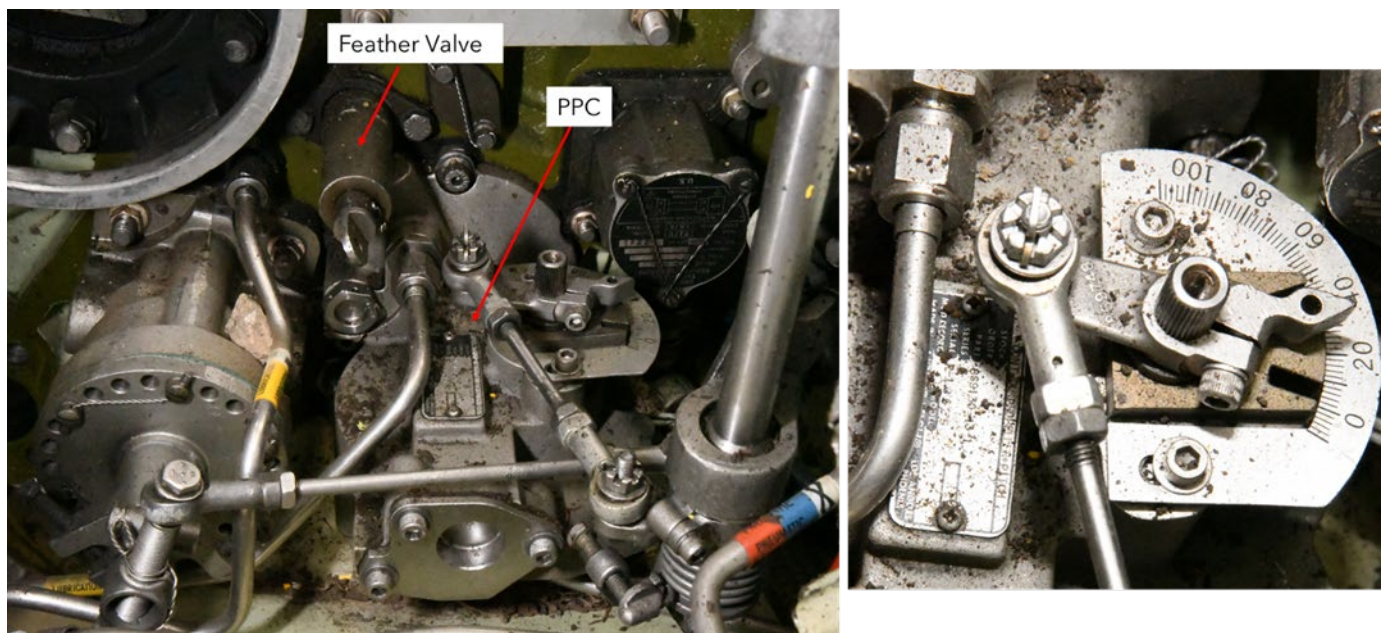
**Photo 6- (L) Propeller Pitch Control and Feather Valve, (R) Propeller Pitch Control Position Indicator**

According to Honeywell, the propeller pitch control (PPC) linkage arm was found disengaged from the PPC input shaft when the airplane wreckage was

documented on scene. The PPC indicator dial was aligned with the 28 degree mark<sup>1</sup> (**Photo 6**). The fuel control unit (FCU) was intact, and the power lever indicator dial was aligned with the 20 degree mark (**Photo 7**). The fuel shutoff valve (FSOV) remained secured to the engine and the scribe mark on the input shaft was at the 12 o'clock (auto) position<sup>2</sup> (**Photo 8**). Following FSOV removal, a low pressure air check was performed, and air did not pass through the valve. The fuel and oil filters were both free of debris. After the propeller governor was removed, a section of the governor spider gasket was found broken and it partially obstructed the check valve orifice (**Photo 9**). The torsion shaft aft spline was separated 1¼ inch from the aft end (**Photo 10**)<sup>3</sup>. During on scene documentation, Honeywell also noted that the feather valve linkage was not connected.

<sup>1</sup> According to Honeywell, when the engine is rigged in accordance with the maintenance manual procedure, the PPC dial and FCU power lever indicators dial should point to the same value.

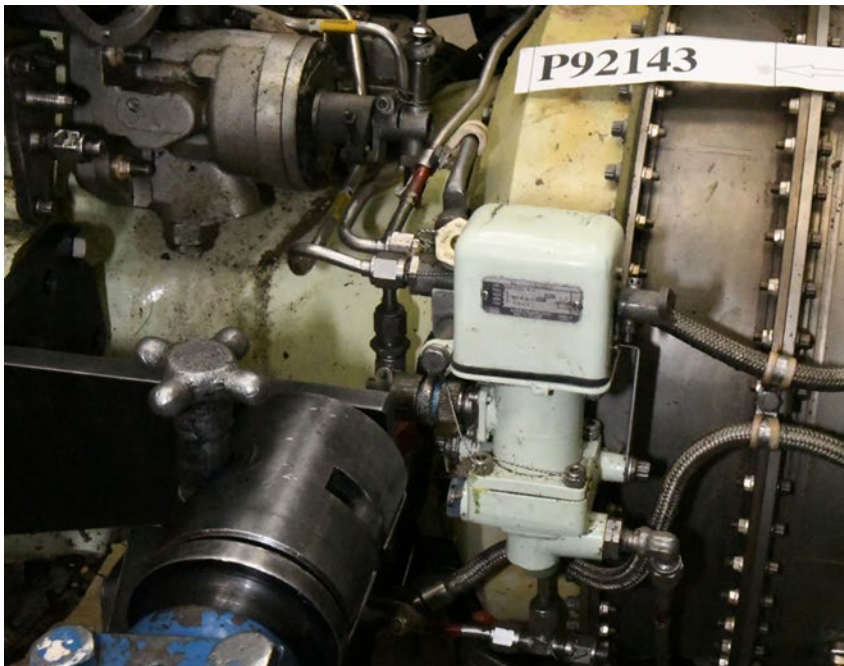
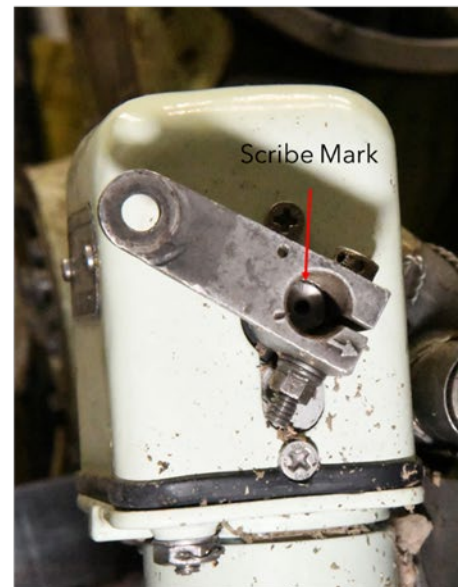
**Photo 8- Fuel Shutoff Valve, Input Shaft Scribe**

<sup>2</sup> The fuel shutoff valve indicator is aligned with the 12 o'clock position in auto mode or the 3 o'clock position when the condition lever is retarded to the emergency shutoff position in the cockpit. According to Honeywell, the fuel shutoff valve is in the closed position at either the 3 or 9 o'clock positions.

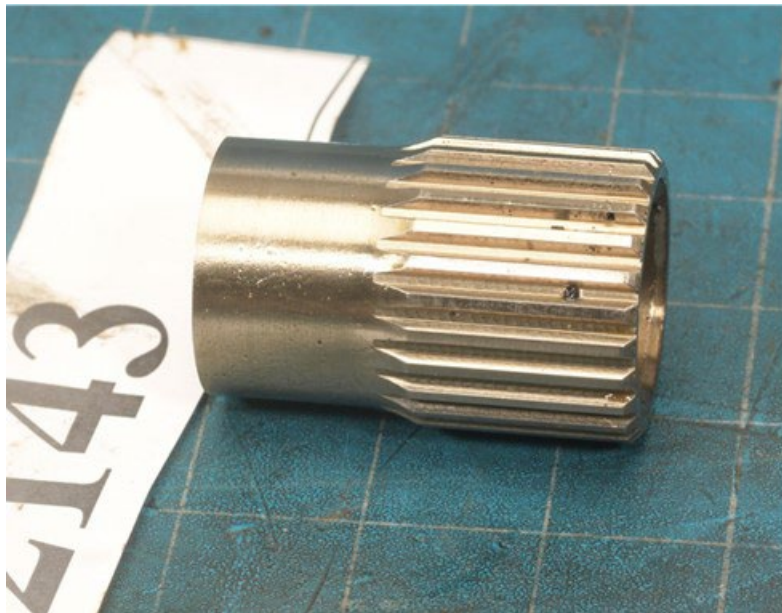
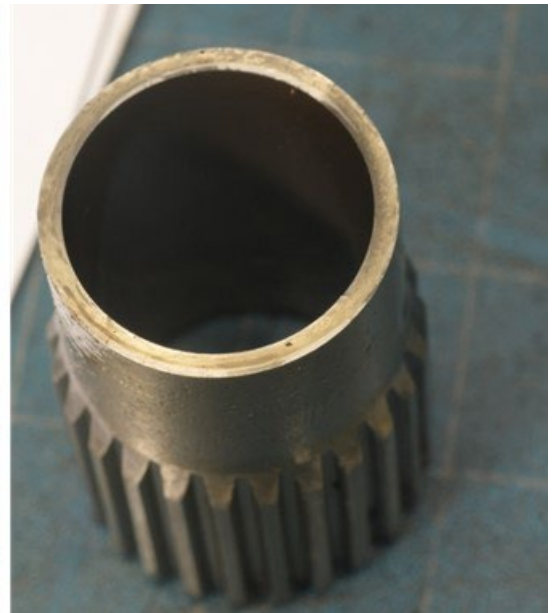
**Photo 10- Torsion Shaft, Aft Spline Separated**

<sup>3</sup> According to Honeywell, separation of the torsion shaft forward of the aft spline are commonly seen during the teardown of accident engines. The break is caused by torsional overload of the shaft associated with a sudden stoppage of the propeller, typically associated with propeller strikes with the ground, runway, or trees.

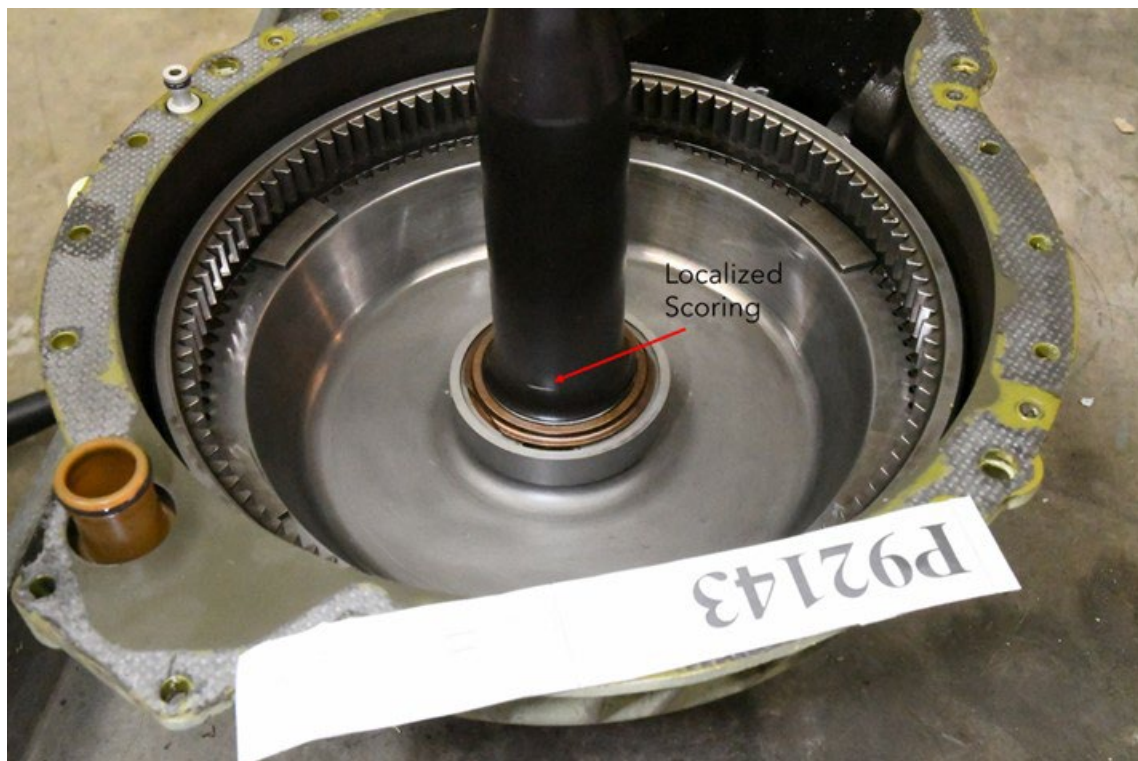
**Photo 11- Propeller Shaft**

The nose cone and propeller shaft were both intact. The propeller shaft had one localized score mark  $\frac{1}{2}$  inch aft of the retaining nut and four axial score marks 3-4 inches aft of the retaining nut (**Photo 11**). The ring gear, sun gear, bull gear and planet gears were intact and rotated smoothly. The diaphragm assembly was intact, appeared undamaged, and all gears rotated smoothly (**Photo 12**). The torque sensor assembly was in good condition and rotated smoothly.

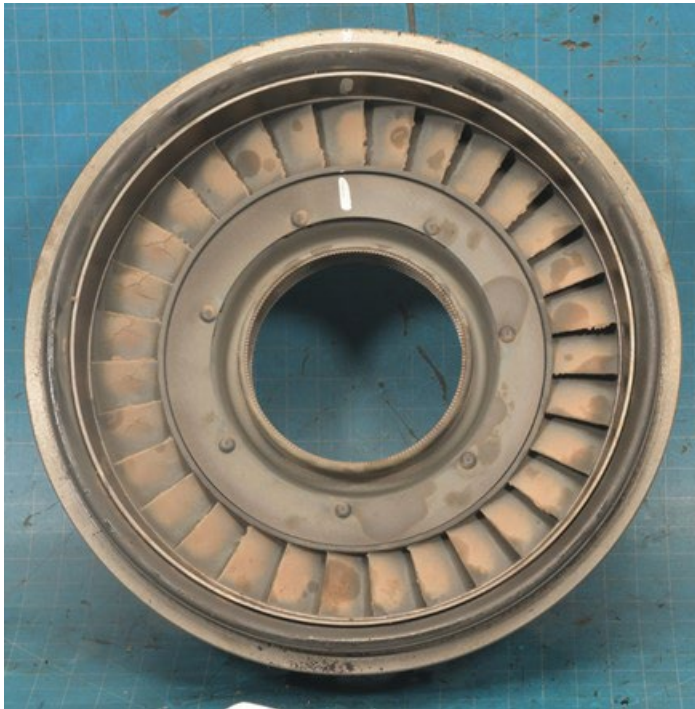
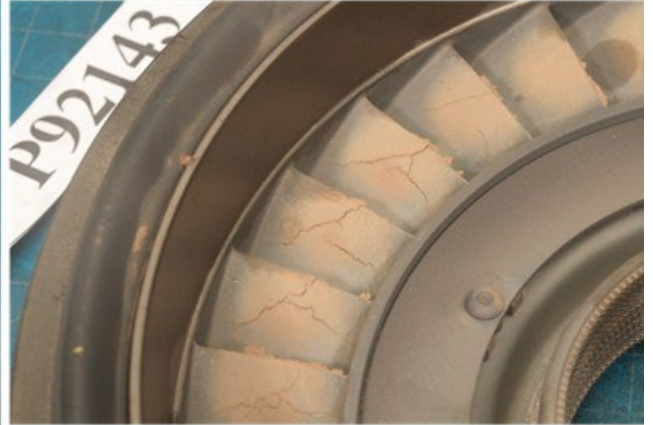
**Photo 13- (L) 2<sup>nd</sup> Stage Turbine Stator, Suction Side, (R) Suction Side Vane Cracks**

The 1<sup>st</sup> stage turbine rotor blades were all complete and appeared undamaged. Light rotational scoring was observed on the 1<sup>st</sup> stage turbine shroud from the 9 to 10 o'clock positions, coincident with the trailing edge of the turbine blades. The 2<sup>nd</sup> stage turbine blades were complete and appeared undamaged. The 2<sup>nd</sup> stage stator had six vanes with cracks on the suction side surface between the 9 and 10 o'clock positions (**Photo 13**). The 3<sup>rd</sup> stage turbine rotor blades were intact but had white discoloration near the trailing edge tip on the pressure side and along the full blade tip on the suction side. The 3<sup>rd</sup> stage stator had rotational scoring over approximately 90 degree arc of the aft inner diameter vane platform. Metal spray<sup>4</sup> was present on the 3<sup>rd</sup> stage stator suction side vane surfaces (**Photo 14**). The curvic couplings of all three turbine stages were in good condition and the contact marks were consistent with nominal assembly. Dirt was adhered to the blade/vane surfaces of all three stages (**Photo 15**). The rear (turbine) bearing was oil wetted and rotated smoothly.

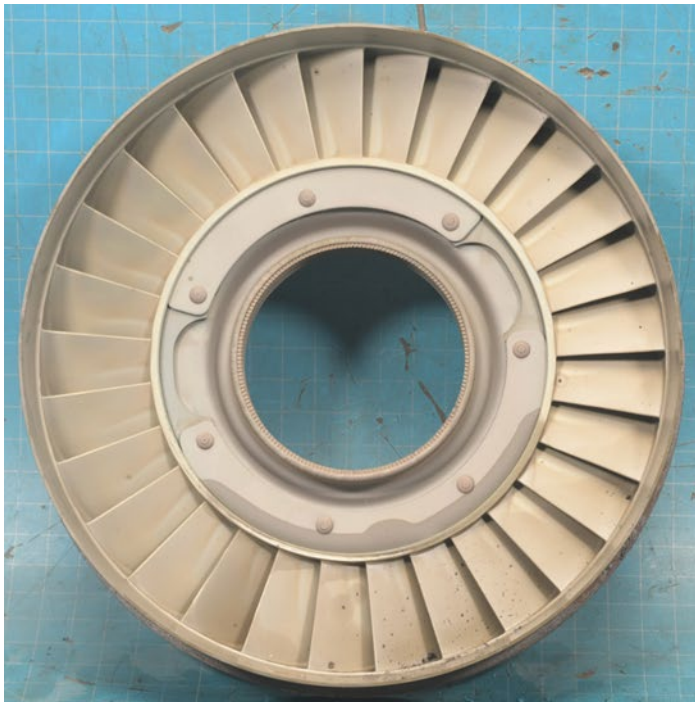
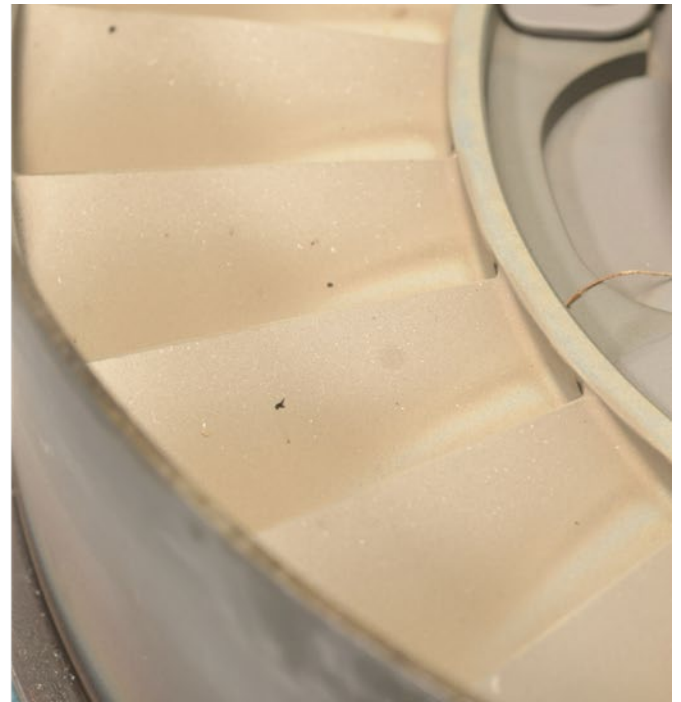
**Photo 14- (L) 3<sup>rd</sup> Stage Stator, Suction Side, (R) Light Metal Spray, Suction Side Vanes**

<sup>4</sup> Metal spray are molten metal deposits that occur when metal is liberated due to rub or internal failure and then passes through the combustor where it is melted and subsequently adheres to surfaces downstream.

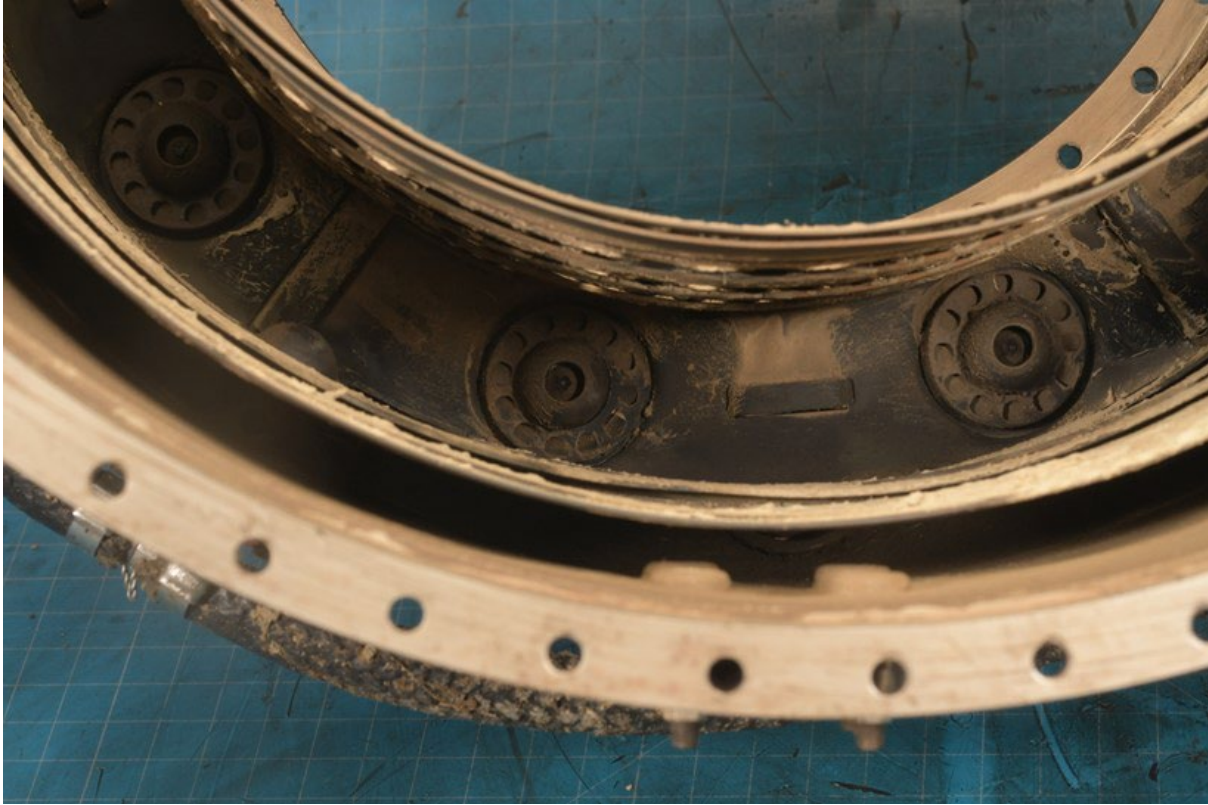
**Photo 16- Combustion Liner, Fuel Nozzles**

The combustion liner was intact and had no indications of fuel nozzle streaking or uneven wear (**Photo 16**). All the fuel nozzles were properly seated. Earthen debris was adhered to the combustion liner walls. There was no metal spray visible in the combustor.

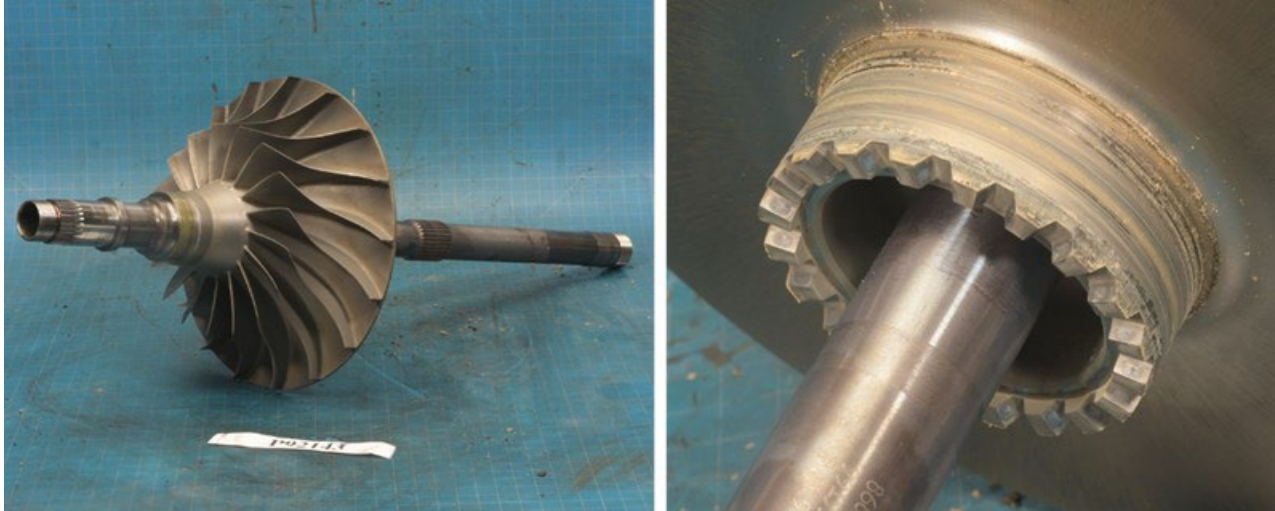
**Photo 17- (L) 1<sup>st</sup> Stage Compressor Impeller, (R) Aft Hub Rotational Scoring**

The 1<sup>st</sup> stage compressor impeller was intact. All impeller blades had light 360 degree tip rub at the exducer. There was light 360 degree rotational scoring on the aft hub, forward curvic coupling (**Photo 17**). The main shaft was intact and appeared undamaged. The 1<sup>st</sup> stage shroud had yellow/green discoloration. The shroud had 360 degree rub at the exducer and light rub at the knee<sup>5</sup> from the 7 to 1 o'clock positions (**Photo 18**).

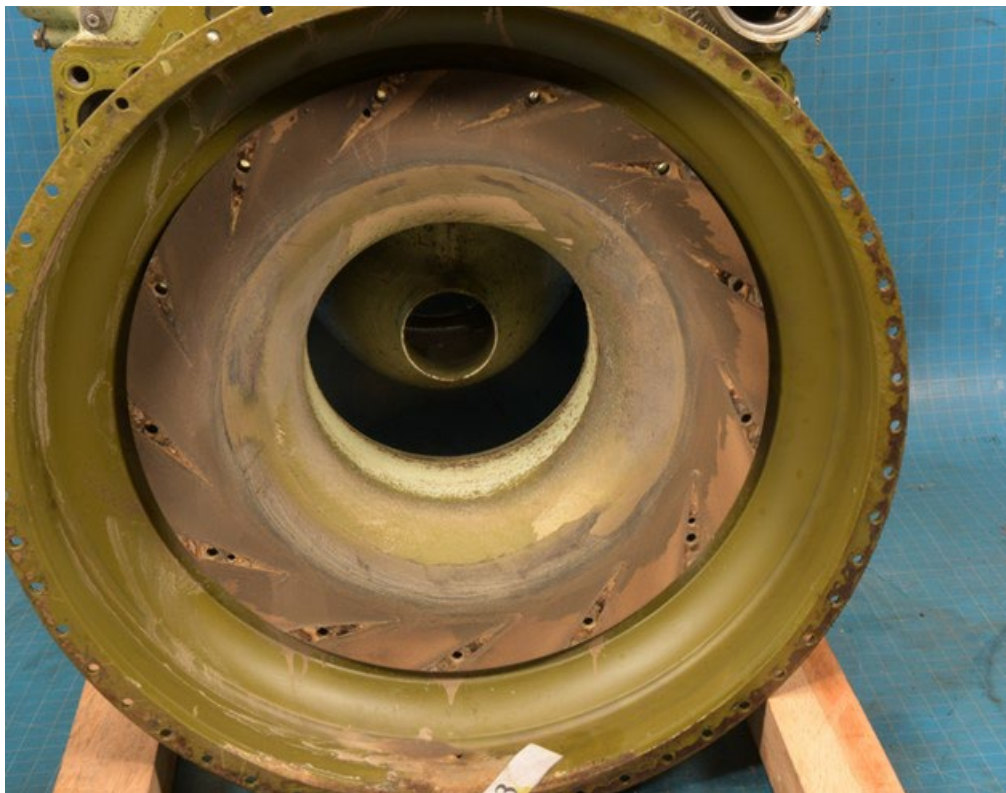
**Photo 18- 1<sup>st</sup> Stage Compressor Shroud**

The curvic couplings of both compressor stages were in good condition and the contact marks were consistent with nominal assembly. Dirt was adhered to the blade and shroud surfaces of both stages. The yellow/green discoloration noted on the 1<sup>st</sup> stage compressor shroud was observed throughout the compressor section. The front (compressor) bearing was oil wetted and rotated smoothly.

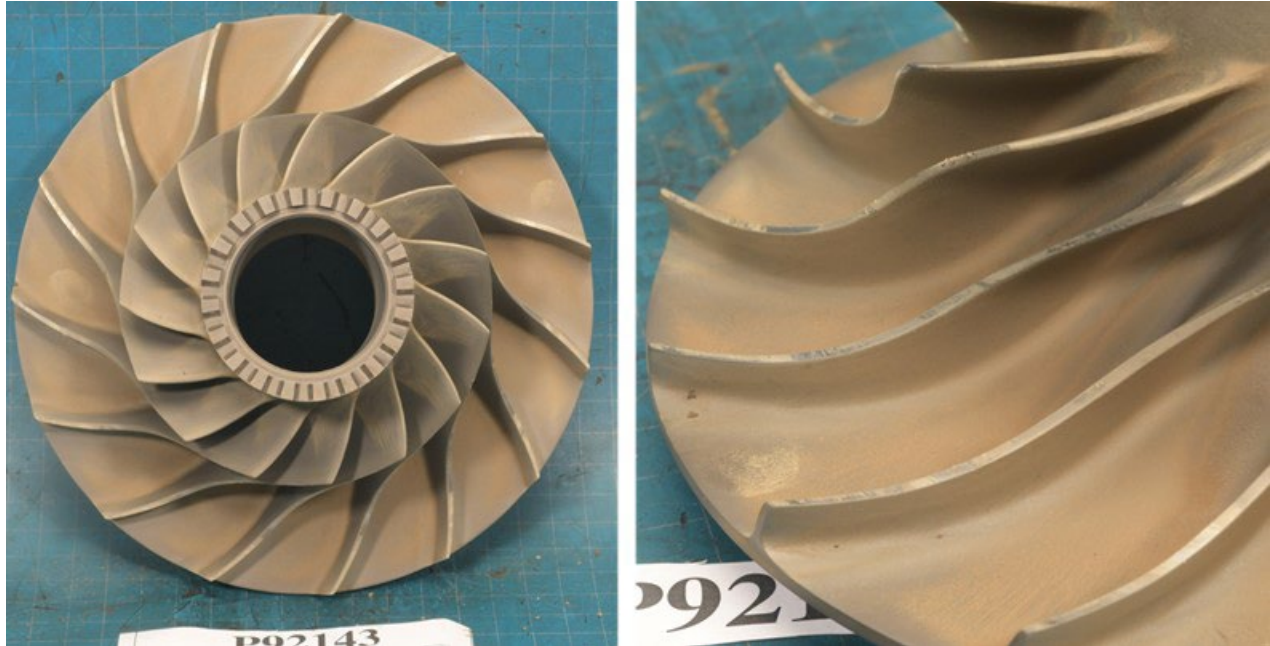
**Photo 19- 2<sup>nd</sup> Stage Compressor Impeller**

The 2<sup>nd</sup> stage compressor impeller blades were all complete (**Photo 19**). The impeller blades tips had light tip rub from the inducer to the exducer. The impeller had 360 degree rotational scoring on the hub aft of the forward curvic. The 2<sup>nd</sup> stage impeller shroud had light 360 degree rotational scoring at the inducer, knee, and exducer (**Photo 20**).

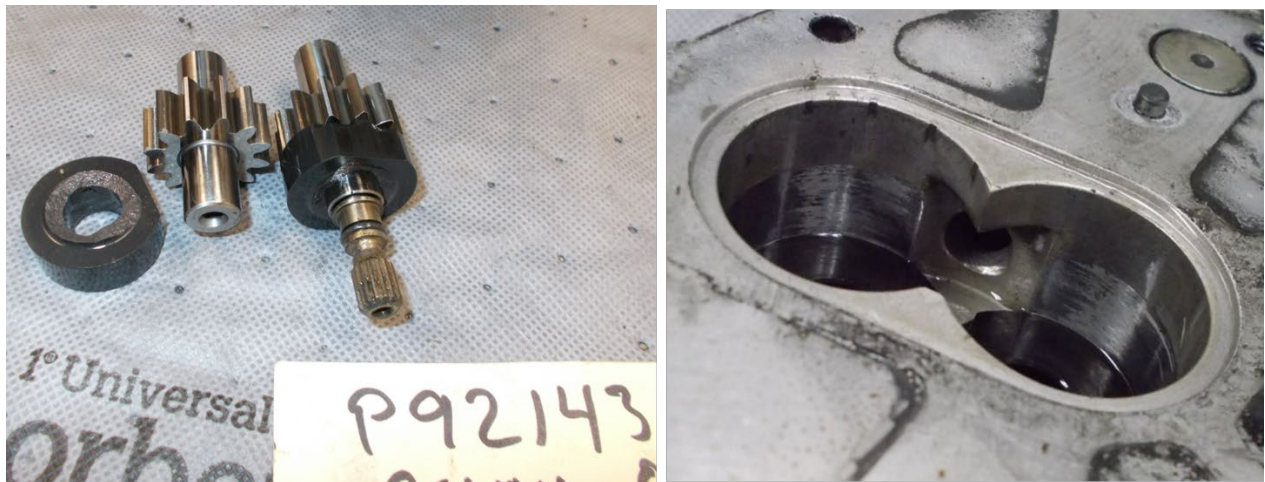
**Photo 21- (L) High Pressure Gear Stage Carbon Bushing Fracture, (R) Drive and Idler Gear Center Bore Scoring (Photos Courtesy of Honeywell)**

The fuel pump was examined and tested at Honeywell in Phoenix, Arizona. The fuel pump was unable to hold pressure during bench testing and was subsequently disassembled. The high pressure gear stage carbon bushing was found fractured. According to Honeywell, fracture of the carbon bushing is common during impact.

The fuel pump was tested at Honeywell in Phoenix, Arizona under FAA oversight on November 10, 2022. During initial bench testing, the pump could not be pressurized for testing and was subsequently disassembled for visual examination. The carbon bushing on the high pressure gear stage was found broken. Rotational scoring was observed in the center bores of the drive and idler gears (**Photo 21**). The relief valve was functionally tested and operated normally. According to Honeywell engineering, the carbon bushing fracture was consistent with impact damage.

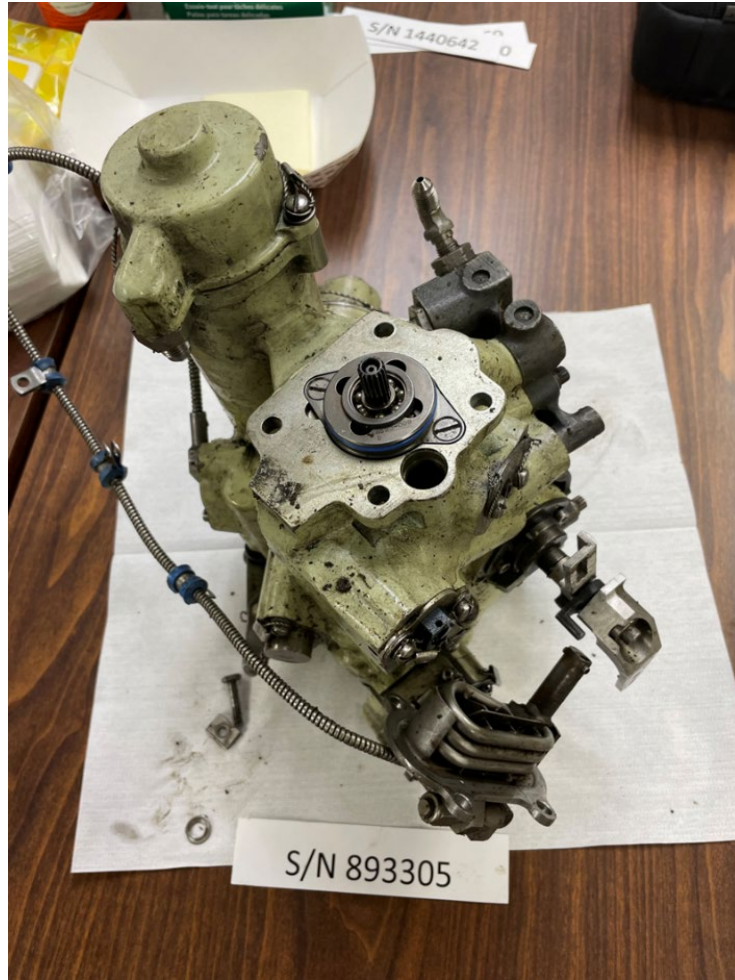
**Photo 22- FCU, as Received at Woodward**

The FCU was shipped to Woodward in Loves Park, Illinois for examination and testing with party members from Honeywell and the NTSB present between August 24-25, 2022 (**Photo 21**). The FCU housing had minor damage near the Pt2 (inlet total pressure) bellows and one of the main cover attaching screws was separated and missing. The power lever, speed setting lever, and driveshaft all rotated freely. The inlet fuel filter and inlet transfer tube that mate the FCU with the fuel pump were removed during the engine teardown and were not shipped to Woodward. A slave filter and transfer tube were installed to perform as-received bench testing.

During initial startup, a leak was observed from the overboard drain port. The leak decreased when boost pressure was increased to the normal setting of 15psi. The Standard Day Acceleration Schedule discharge fuel flow readings were high at all test points. The discharge fuel flow and P1-P2 pressure increased irregularly with speed input. The bypass valve was removed, and the bronze bypass plug was found stuck in the valve sleeve. The bypass plug o-rings were red and were visibly compression set. According to Woodward, red o-rings were replaced with blue o-rings in 1983. New o-rings were installed on the bypass plug and the Standard Day Acceleration Schedule was run again with similar high fuel flow discharge readings. The bypass plug was then replaced with a Woodward slave unit and the fuel flow discharge readings remained high.

Woodward engineering was unable to determine the cause of the out of limits bench test readings recorded during the Standard Day Acceleration and Deceleration Schedule runs. According to Woodward, the Acceleration Schedule controls start and acceleration fuel flow up to approximately 65% engine speed. At takeoff, the engine speed is controlled by the propeller governor and fuel flow is determined by the power lever schedule.

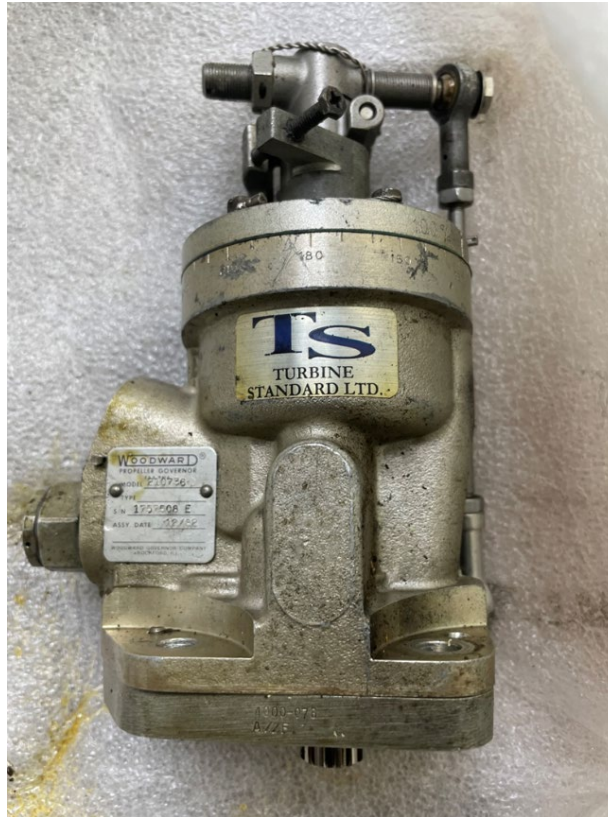
**Photo 23- Propeller Governor, as Received at Woodward**

The propeller governor was shipped to Woodward in Loves Park, Illinois for inspection and testing with party members from Honeywell and the NTSB present between August 24-25, 2022 (**Photo 23**). The governor was received intact with minimal damage. All as received test points were within the expected range for similar service run units according to Woodward. The propeller governor run sheet is available in the docket titled "Attachment 2- Woodward Propeller Governor Test Run Sheet."
