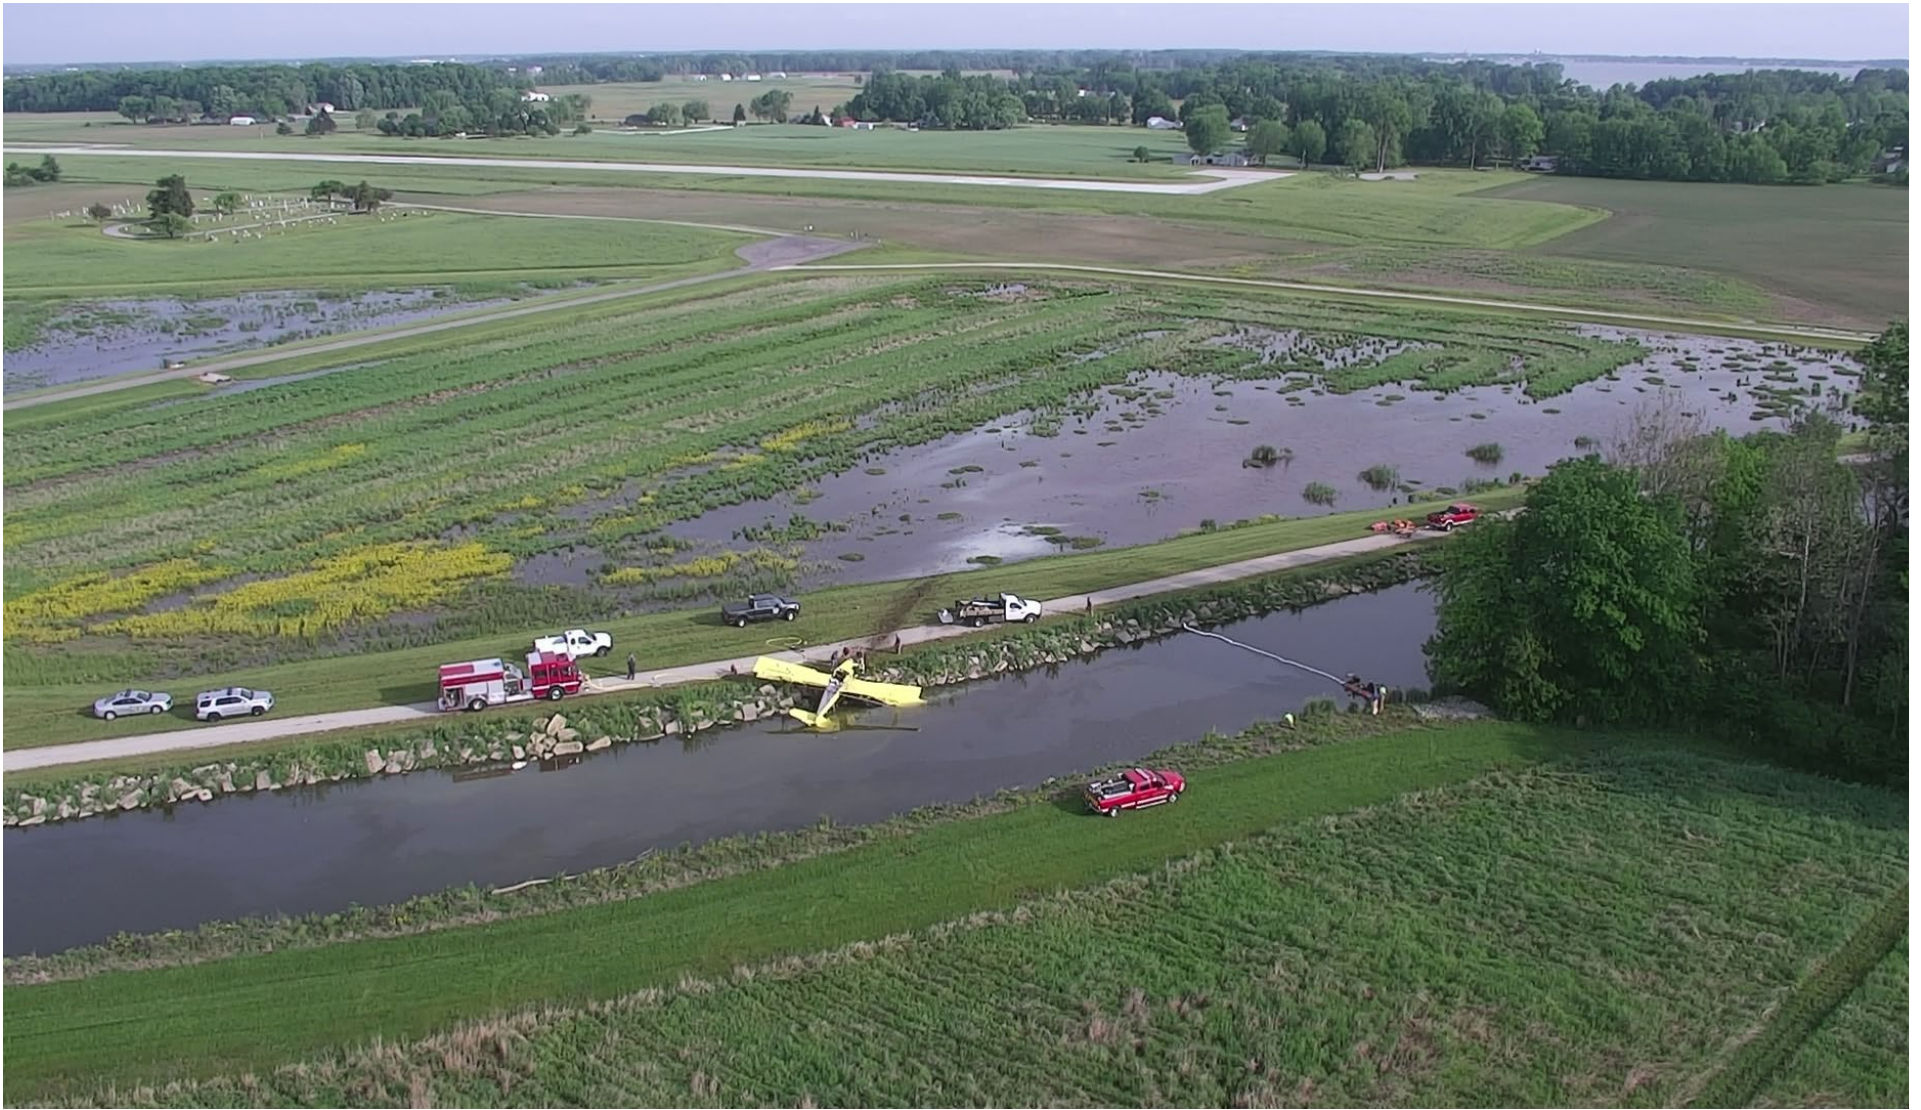
Photo 1 - Aerial Photo of Accident Site (Ohio State Highway Patrol Photo)

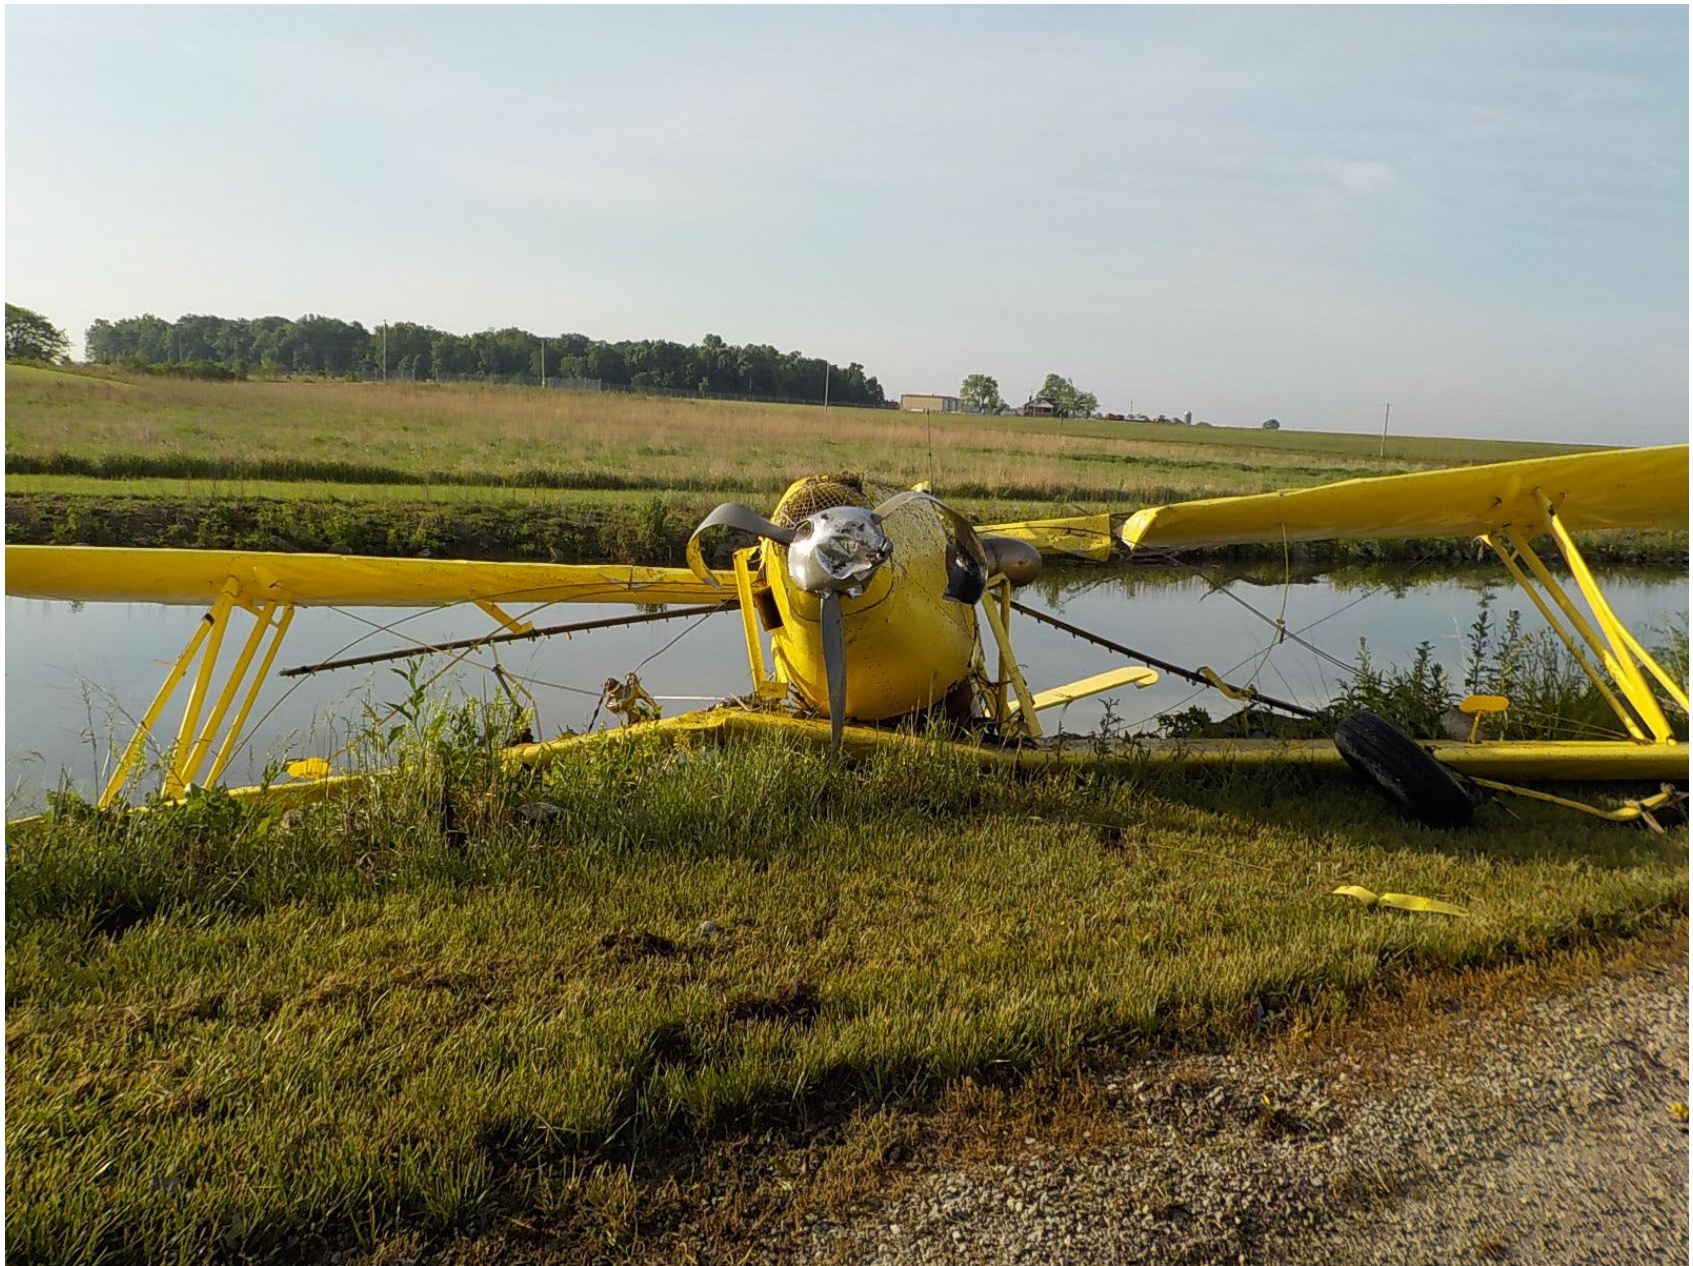
Photo 2 - Main Wreckage, Front (Ohio State Highway Patrol Photo)

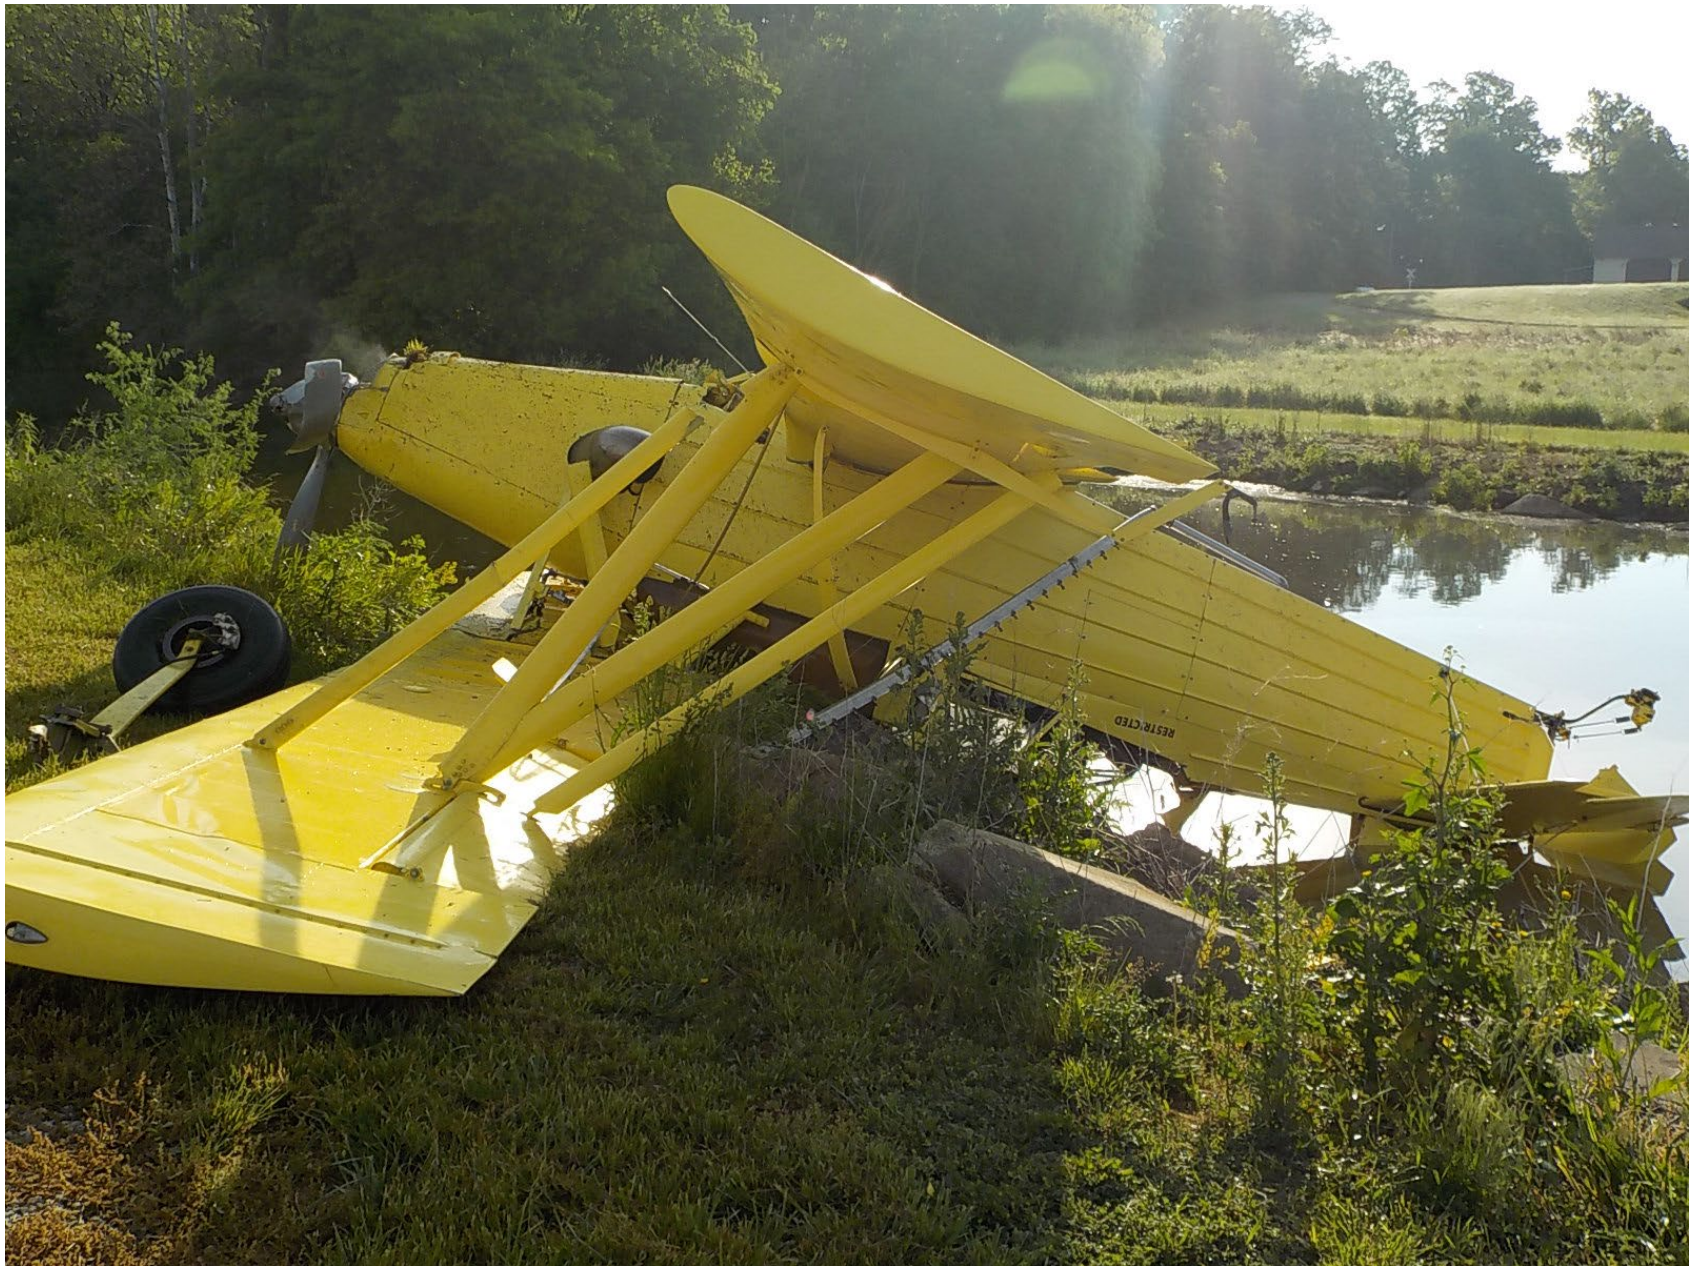
Photo 3 – Main Wreckage, Right (Ohio State Highway Patrol Photo)

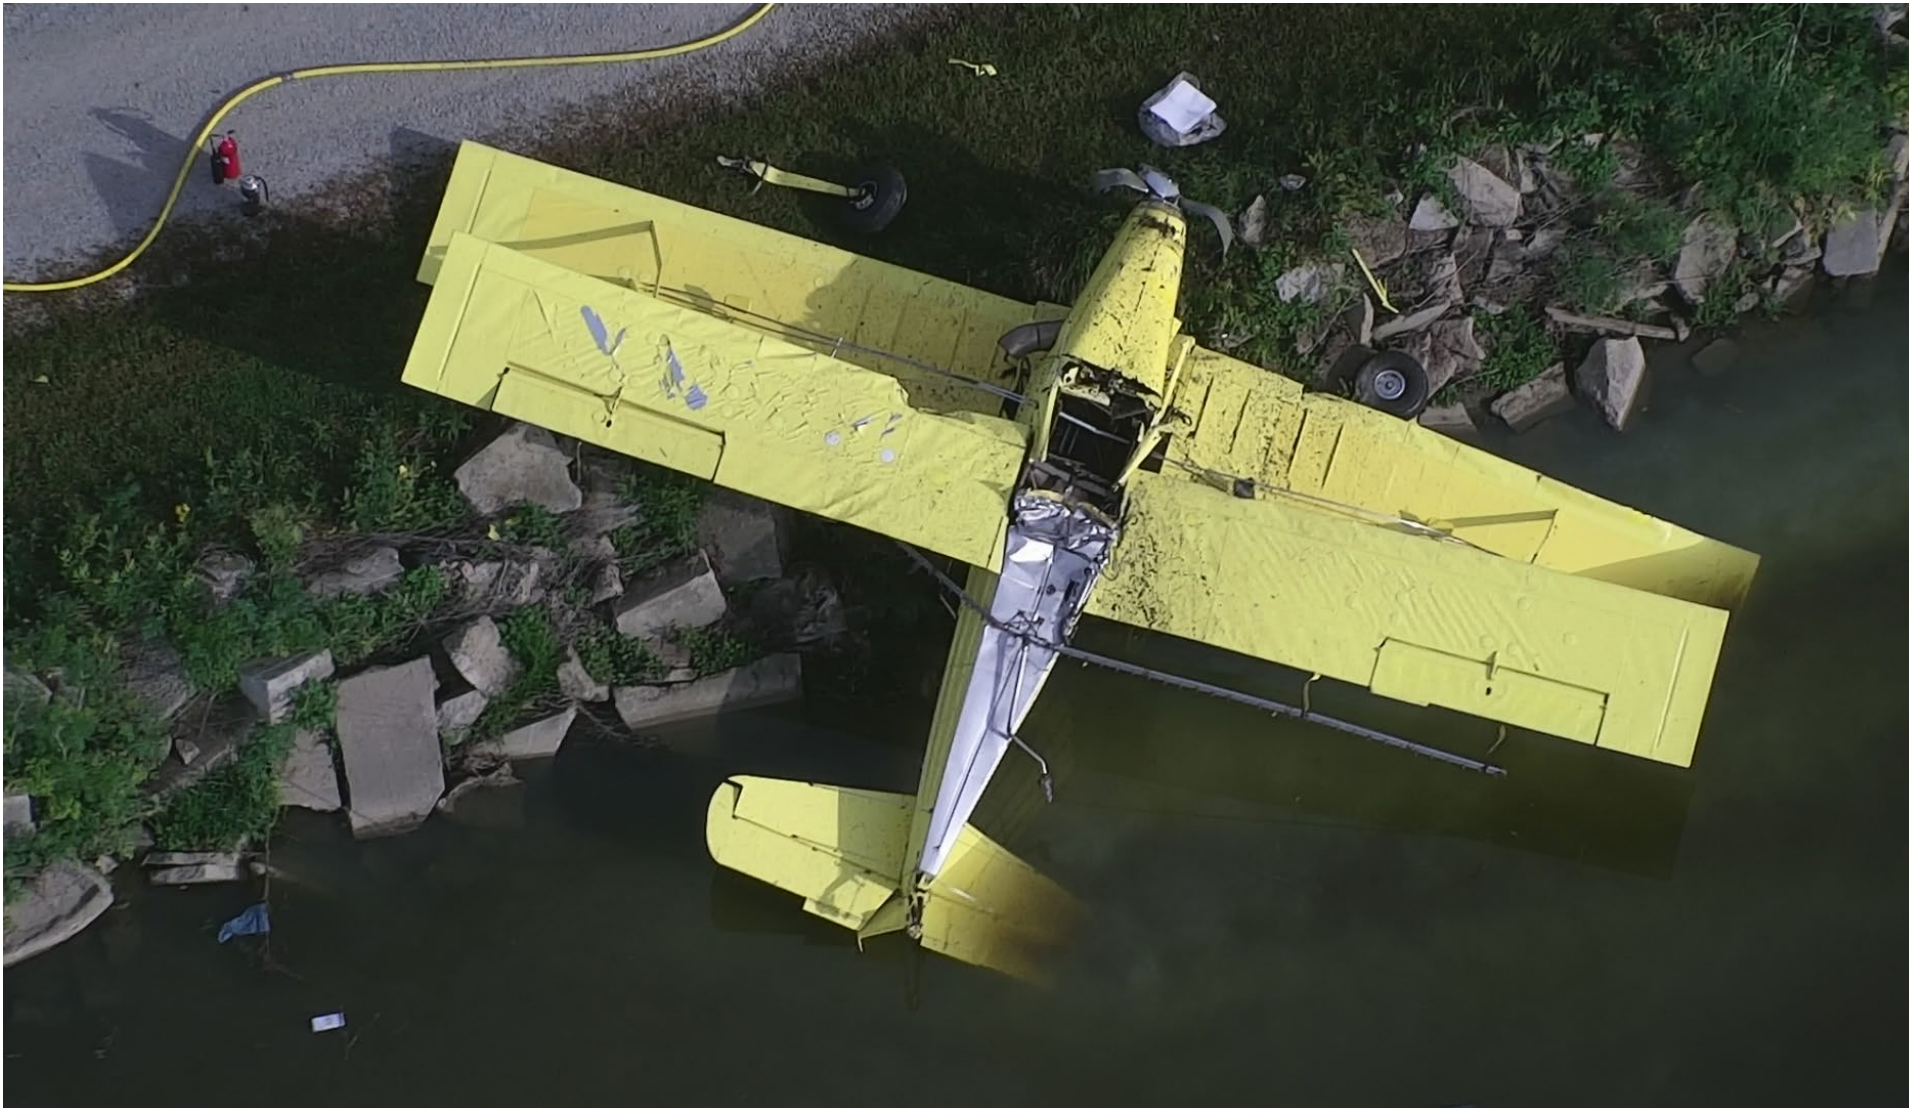
Photo 4 – Aerial Photo of Main Wreckage (Ohio State Highway Patrol Photo)

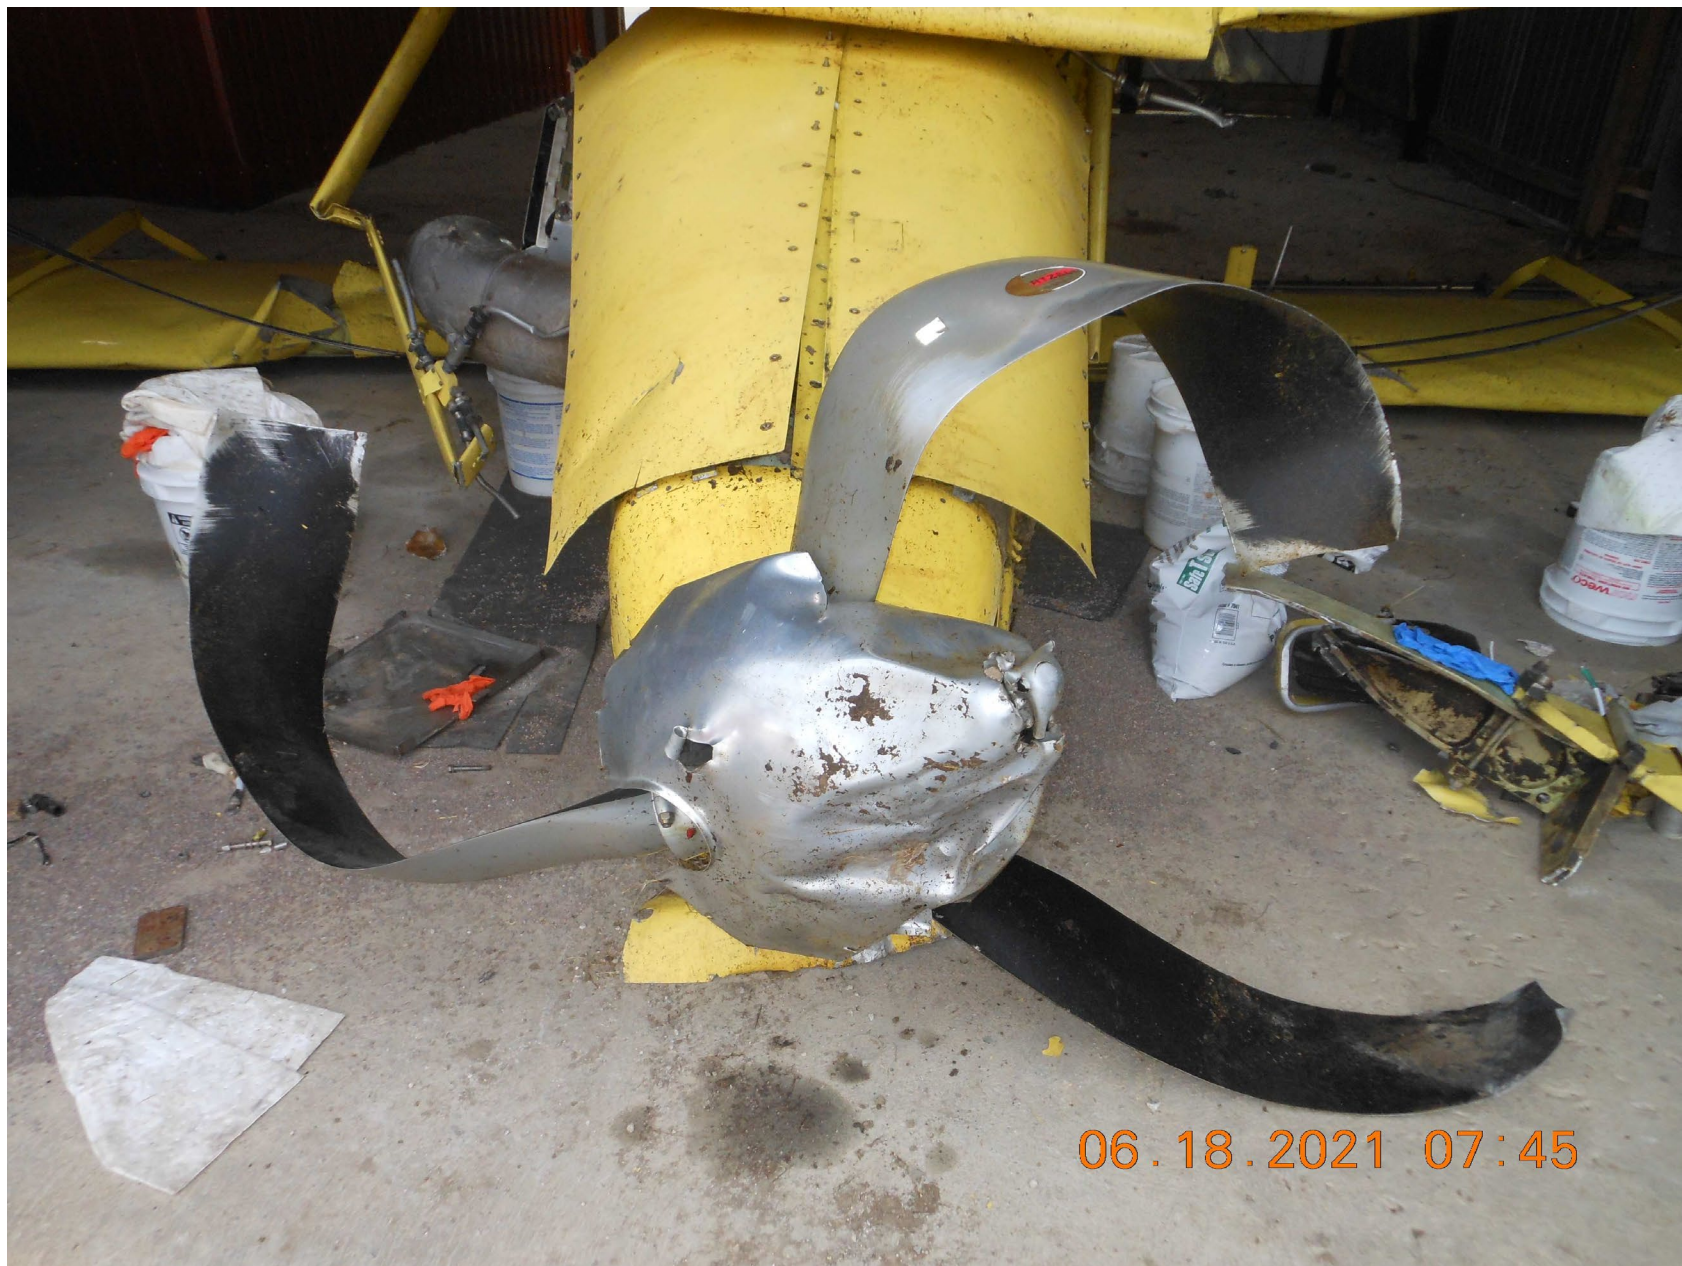
Photo 5 - Propeller (Hartzell Propeller Photo)

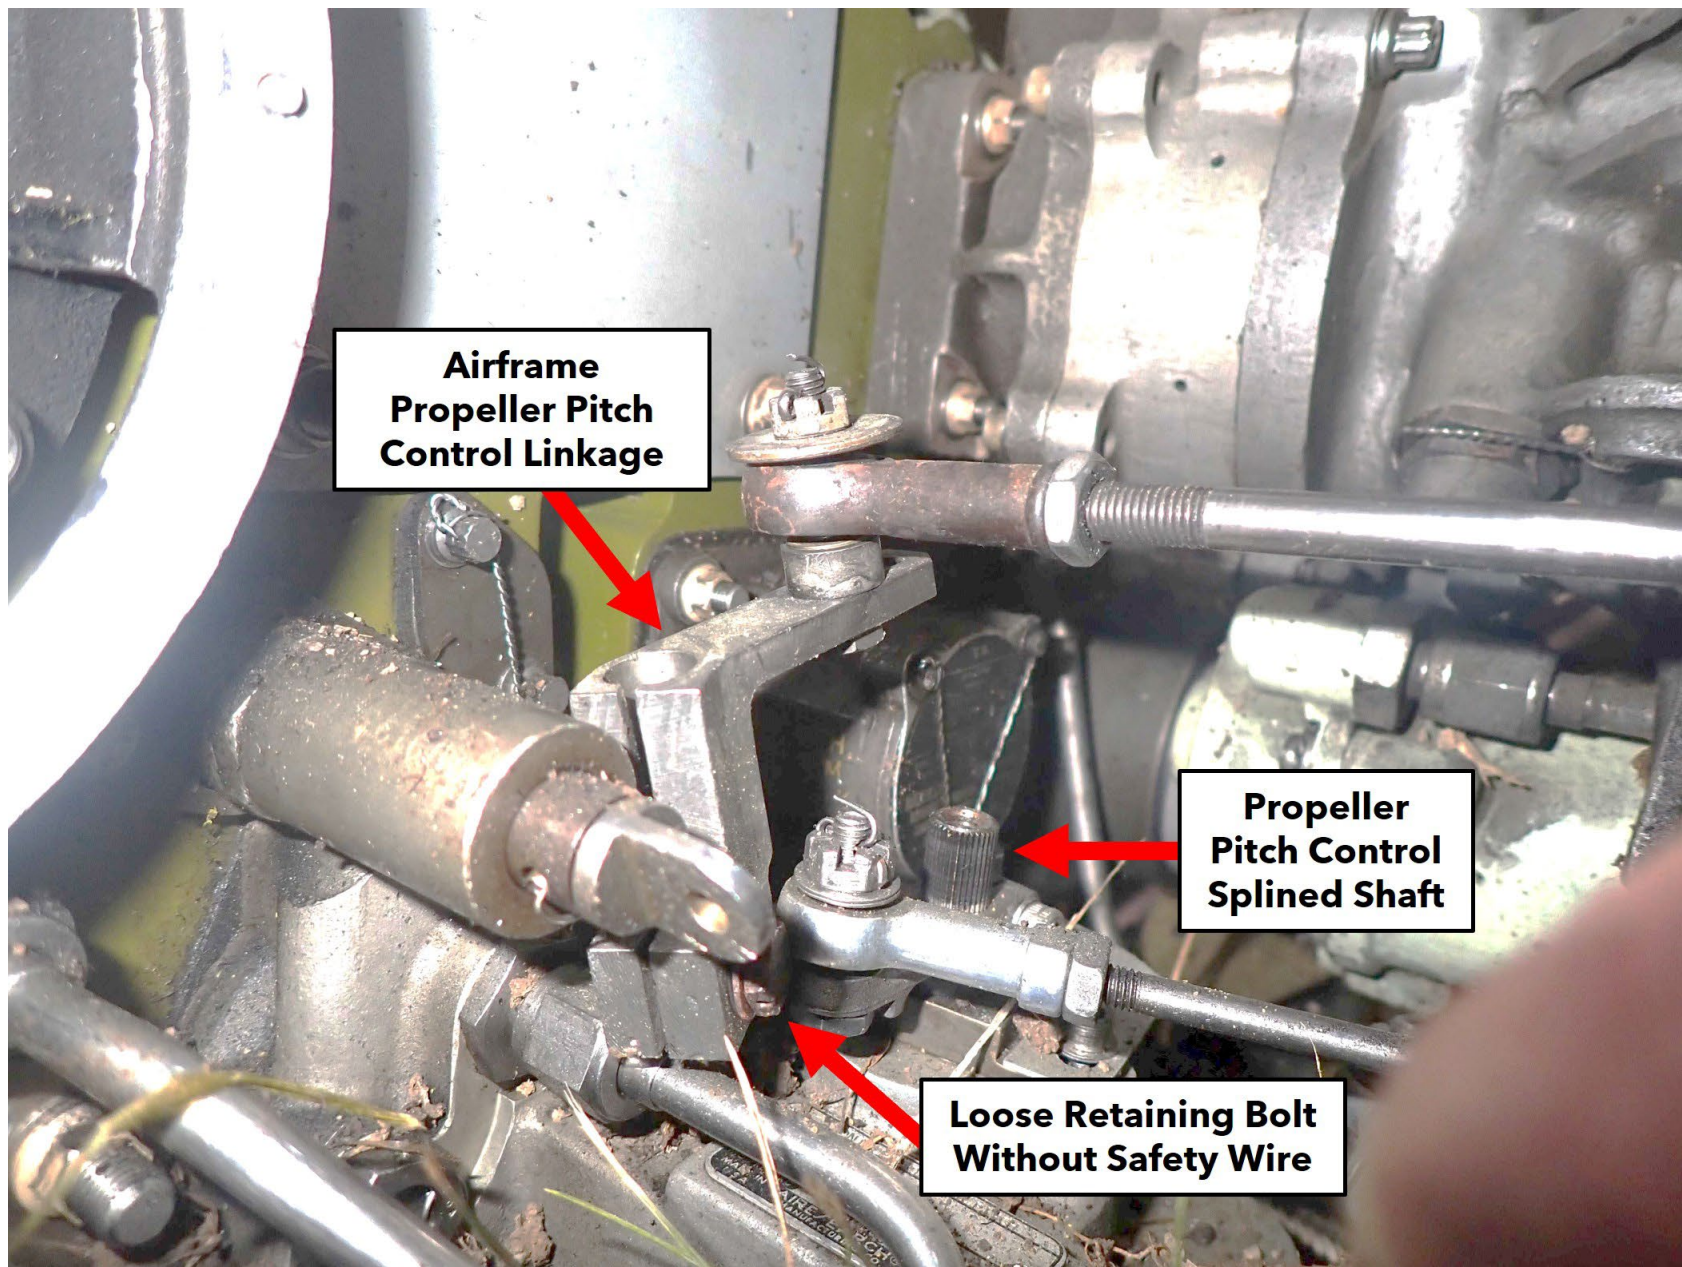
Photo 6 - Airframe Propeller Pitch Control (PPC) Linkage Disconnected from PPC Splined Shaft  
(Honeywell Aerospace Photo)
