# NATIONAL TRANSPORTATION SAFETY BOARD

MATERIALS LABORATORY FACTUAL REPORT

Report No. 22-004

Place : Fort Collins, Colorado  
Date : May 28, 2021  
Vehicle : Pipistrel Alpha Trainer, N119JP  
NTSB No. : CEN21LA241  
Investigator : Samantha Link, ASI-CEN

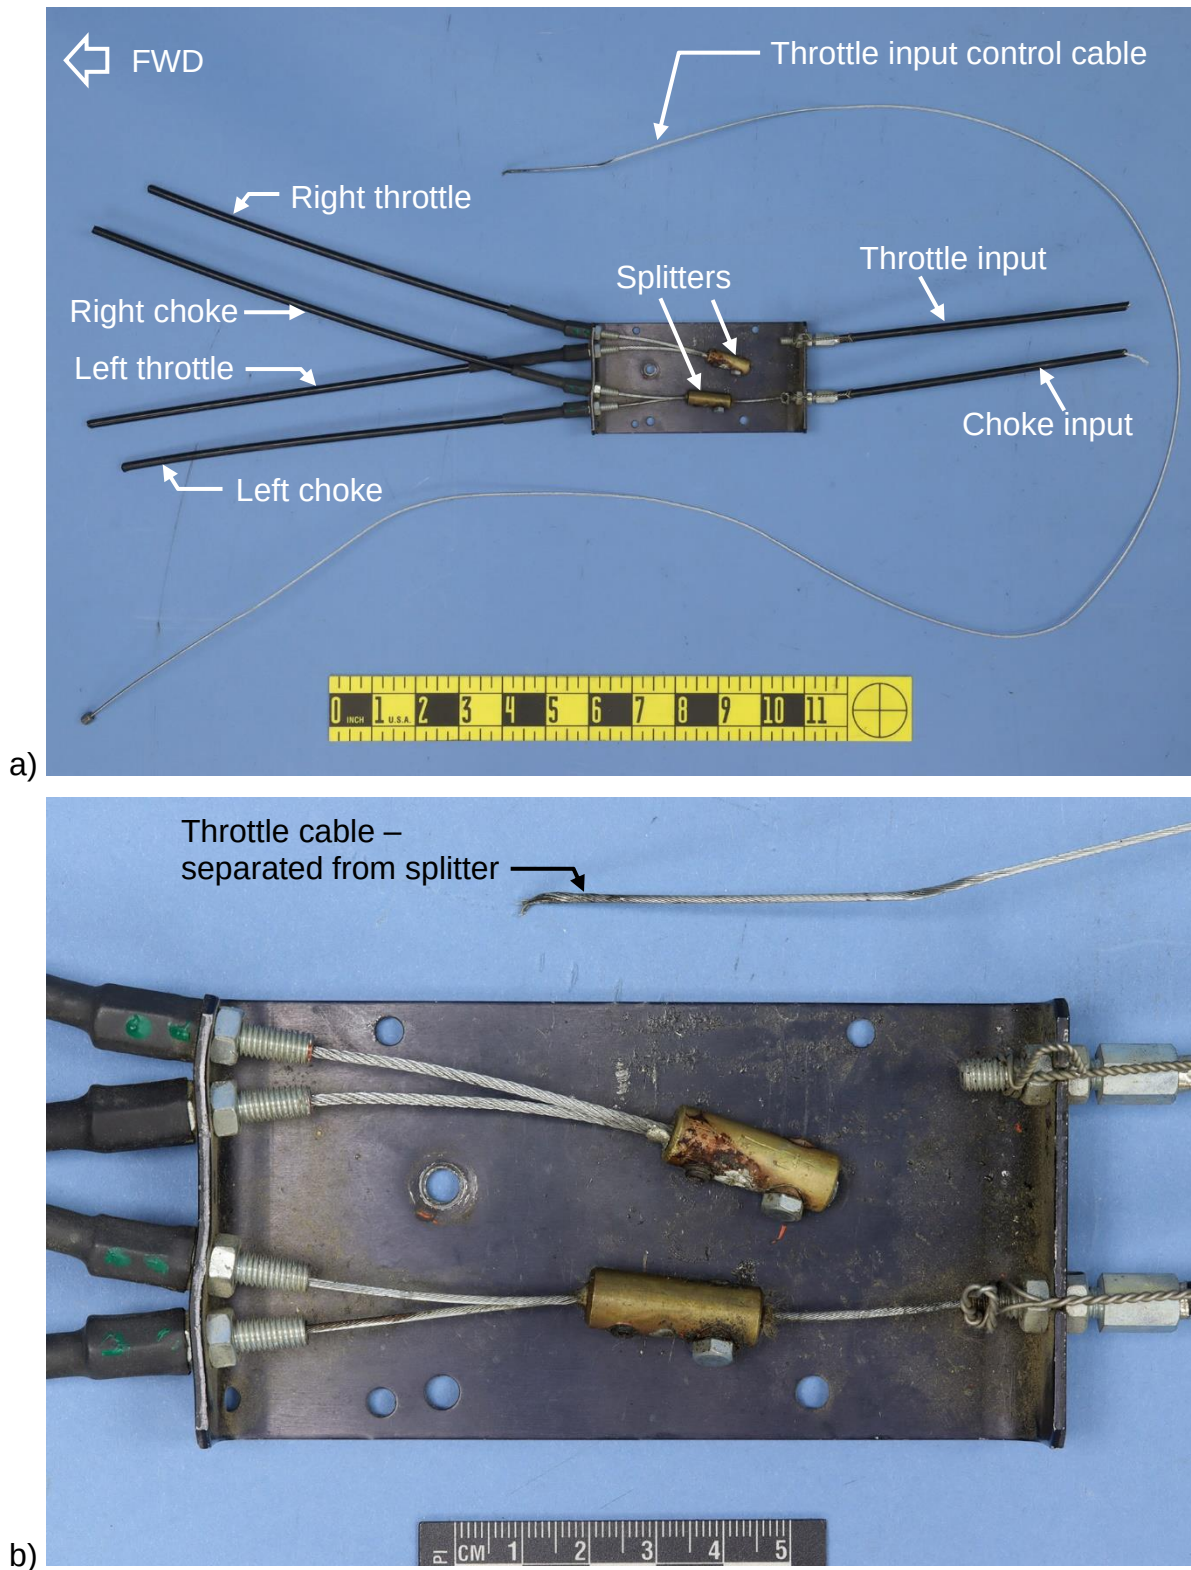
A throttle and choke cable-splitting assembly and a separated throttle input cable were submitted to the NTSB Materials Laboratory for examination, as shown in figures 1a and 1b. The cable splitting assembly is part of the throttle and choke (carburetor) control system (see Appendix A). By design, individual Bowden cables from the cabin throttle and choke controls run forward, attaching to the aft end of the splitter assembly's metal bracket. The inner cables extend forward into cable splitters, shown in figures 2a and 2b for the throttle and choke, respectively. Two cables are joined to each of the splitters at their forward ends. Bowden cables attached to the forward end of the assembly bracket then continue the cable runs toward the left and right bank throttle and choke controls (four cables in total). As seen in figure 1b, the throttle input cable had separated from its splitter assembly, thereby disabling throttle control.

**Figure 1:** a) Splitter assembly and throttle input cable as received and b) higher magnification image of the splitter assembly.

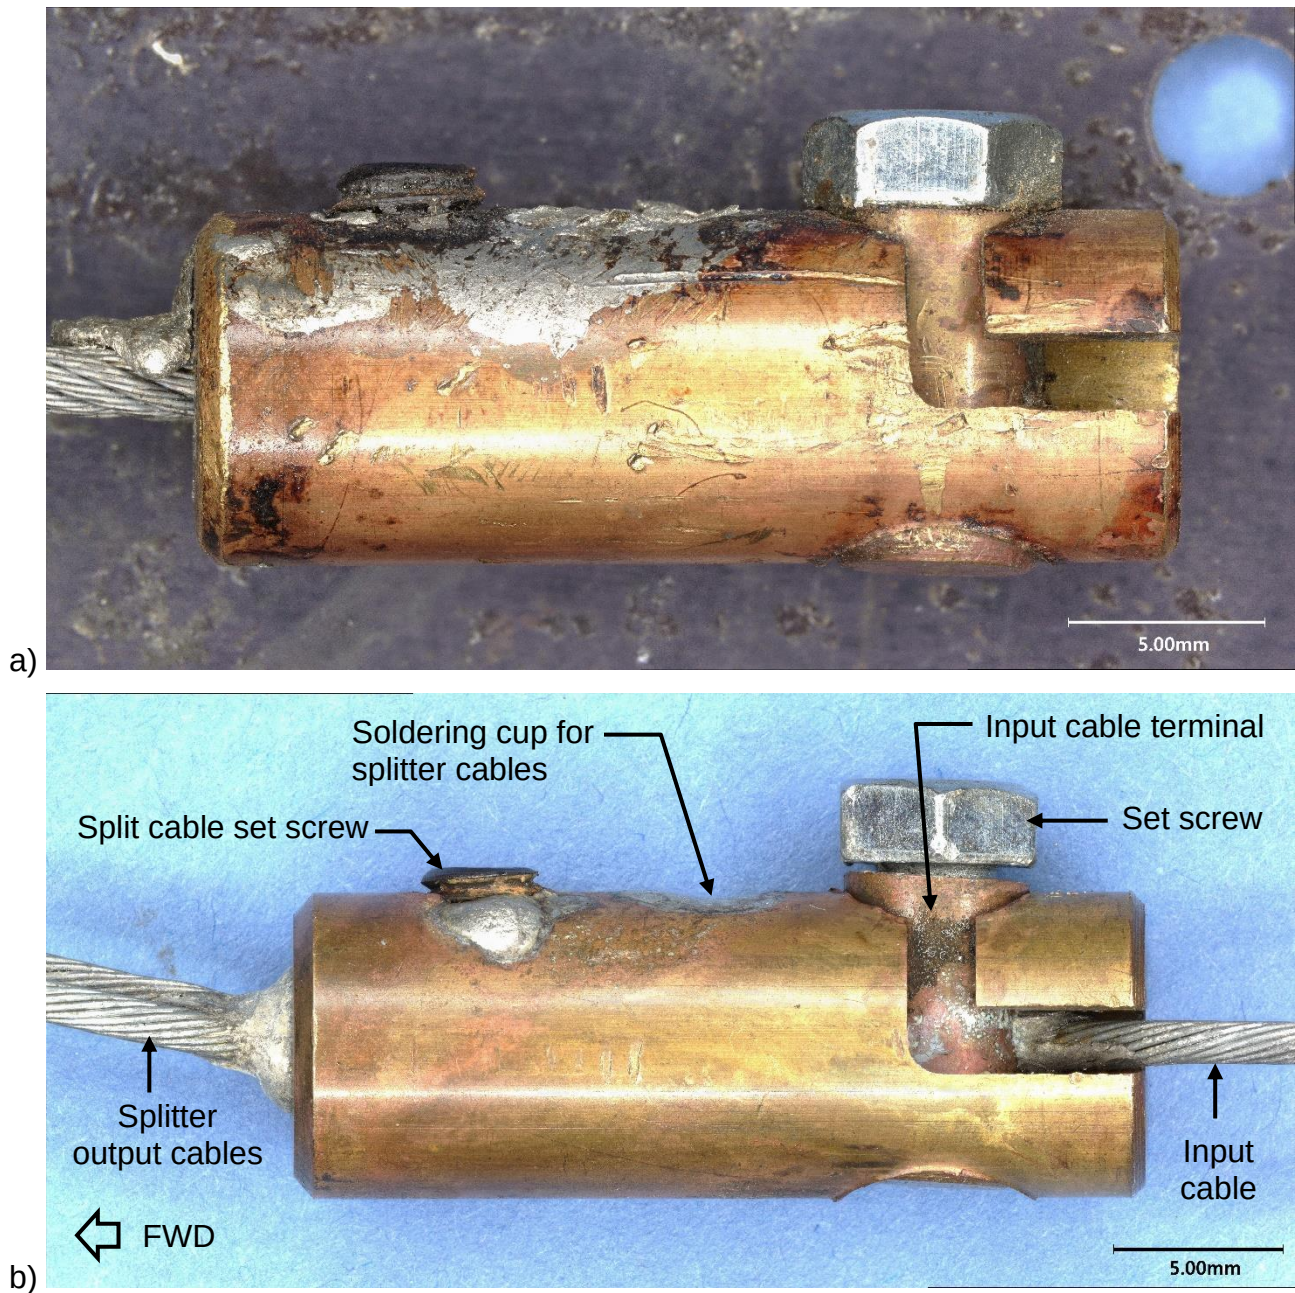
The splitters are assembled using a soldering procedure (see figure 2b). The splitter fitting has a hole in its forward end into which two splitter cables are inserted. The cables are coated with a flux paste, inserted into the fitting, and clamped with a set screw. The cables are then joined to the fitting by introducing solder into a solder cup, located on the top side of the fitting, and connected to the cable hole. At the input end, the input cable is coated with a flux paste, inserted into a terminal fitting, clamped with a set screw, and joined to the terminal by solder introduced through a hole at the forward end of the terminal (see below). The terminal is then inserted into a through-hole on the side of the splitter fitting, with slots machined to accommodate insertion and rotation of the input cable.

**Figure 2:** a) Throttle control cable splitter, as received and b) choke control cable splitter after cleaning in toluene to remove grease and dirt.

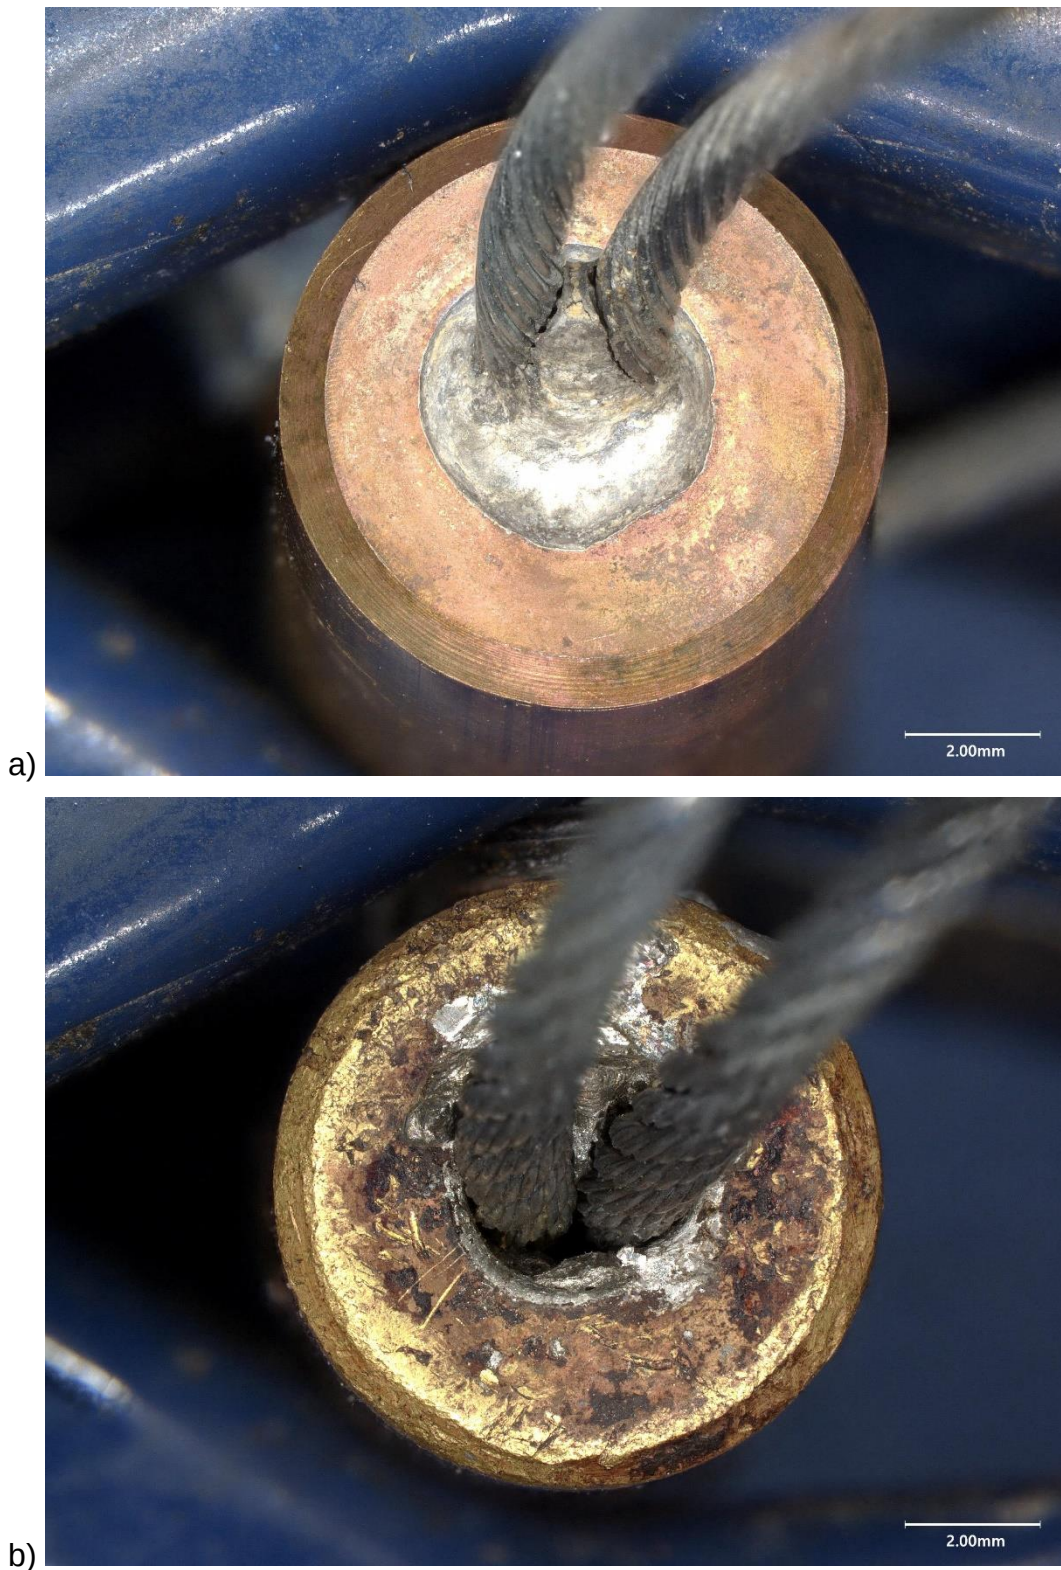
The throttle control splitter fitting exhibited features consistent with a lack of filling and wetting of the solder joints. Examination of the choke control splitter fitting (figure 3a)

indicated that the cable hole was filled with solder and the solder extended forward, wetting the cables. Examination of the throttle control splitter fitting (figure 3b) revealed a void within the fitting where the solder had not filled the joint and had not wet the cables. Similarly, the choke control input cable's terminal fitting (figures 4a and 4b) exhibited solder filling the joint at the inlet and outlet of the terminal and solder wetting the cable at its inlet. By contrast, the throttle control cable's input terminal fitting (figures 5a and 5b) exhibited a void within the joint where the cable entered the terminal, while the forward end, where solder was fed into the joint, was filled.

**Figure 3:** a) Output end of the choke control splitter fitting showing filling and wetting of the solder and b) output end of the throttle control fitting showing lack of filling and wetting of the splitter cables within the fitting.

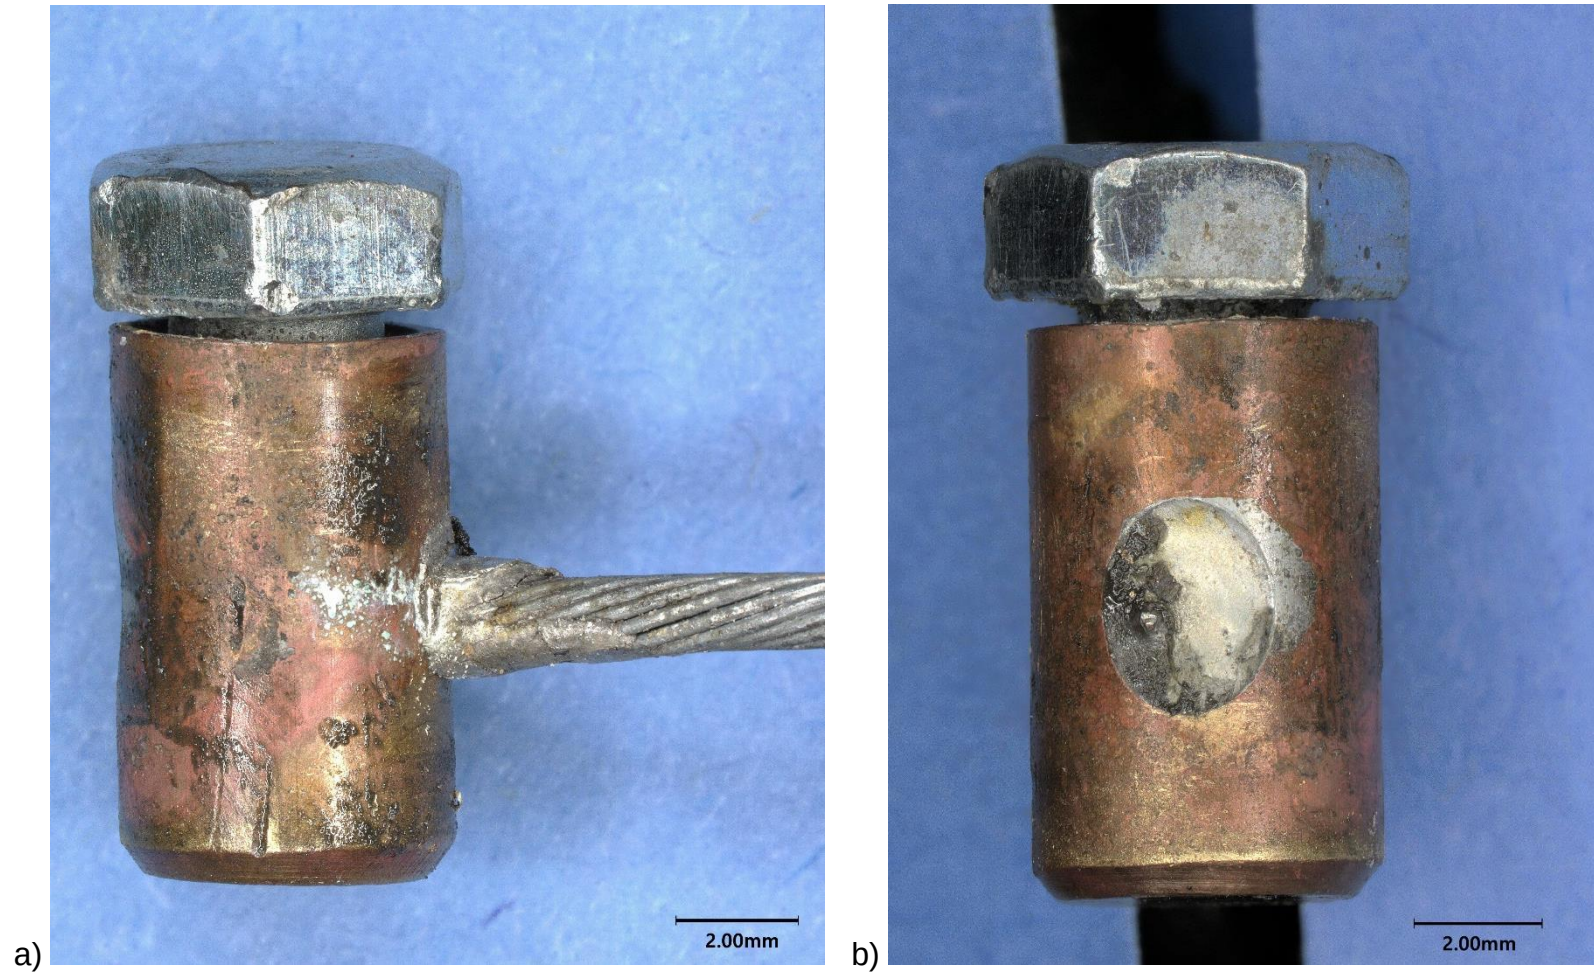
**Figure 4:** Images of the choke control input cable terminal: a) side view showing solder filling the joint and wetting the input cable and b) forward end view showing solder at the solder inlet.

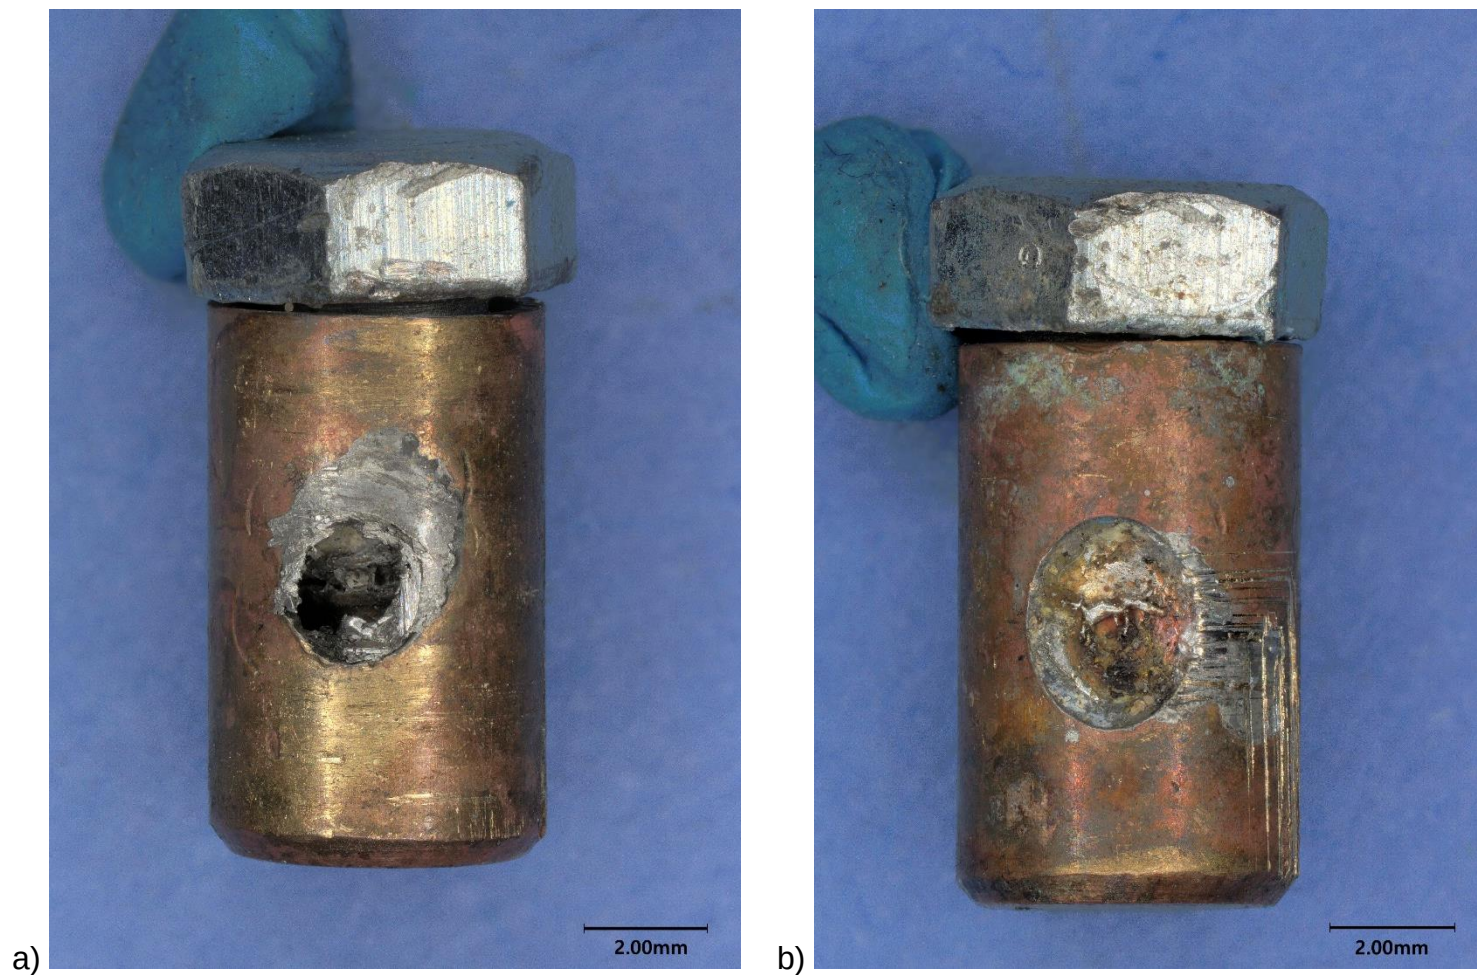
**Figure 5:** Images of the throttle control input cable terminal: a) cable inlet showing a void within the terminal and b) forward end view showing solder at the solder inlet.

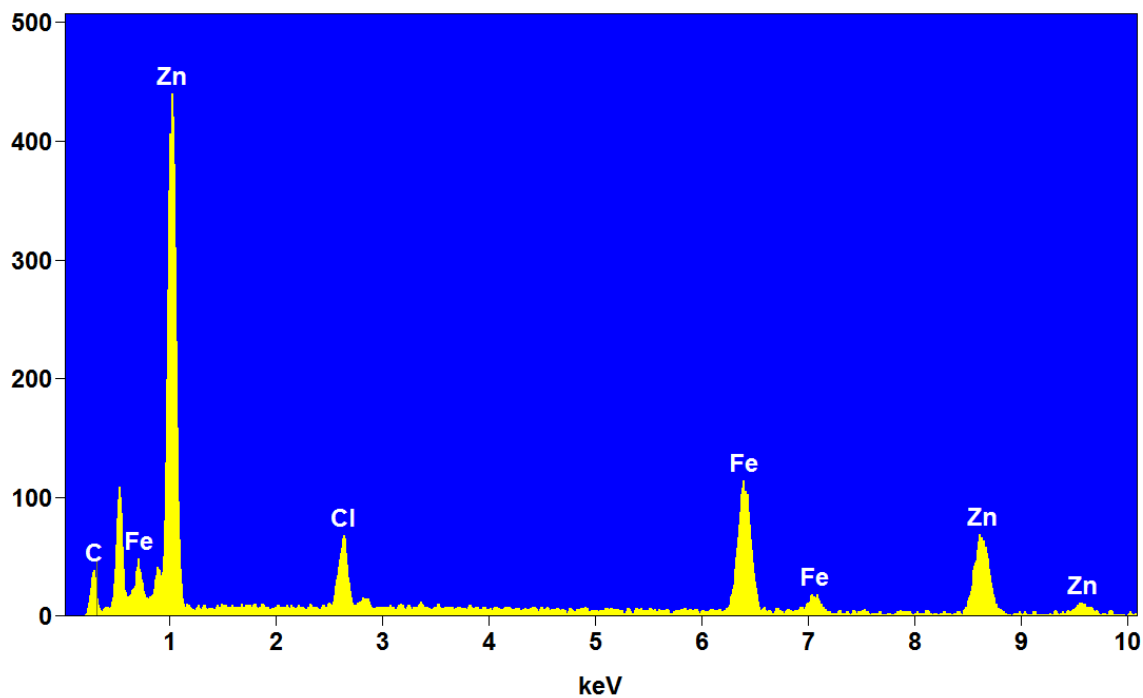
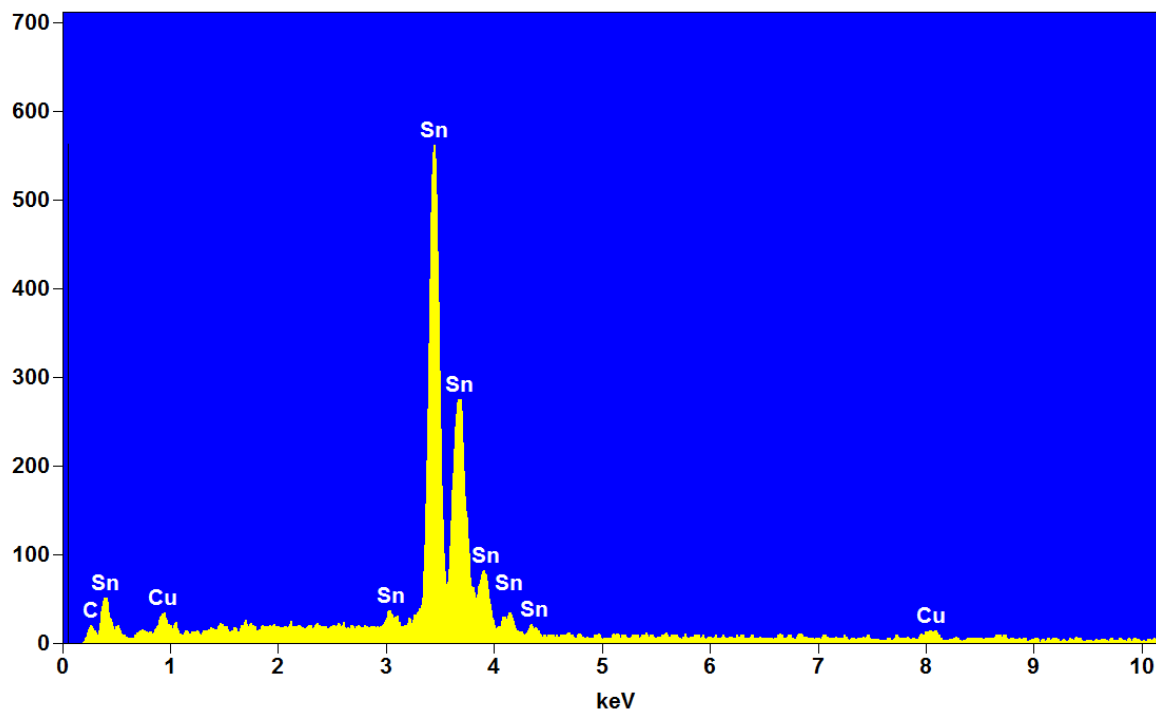
The composition of the cable and the solder was examined using an electron microscope (SEM) equipped with an energy dispersive x-ray spectrometer (EDS). A piece of the throttle input cable was sectioned and cleaned in accordance with standard laboratory procedures. The throttle and choke input terminal fittings were ground at their forward end (where solder was added to the joint) on silicon carbide paper until the solder joint's surface layer was removed. The resulting EDS spectra for the cable surface and solder from the throttle terminal fitting are shown in figures 6a and 6b, respectively. The cable spectrum consisted primarily of iron (Fe) and zinc (Zn), consistent with a zinc-coated steel cable. The solder spectrum consisted primarily of tin (Sn) and copper (Cu). The EDS spectrum for the solder from the choke input terminal fitting (not shown) was nearly identical to the spectrum from the throttle fitting.

**Figure 6:** Energy dispersive x-ray spectra from: a) the throttle input cable surface and b) the throttle input terminal fitting solder joint.

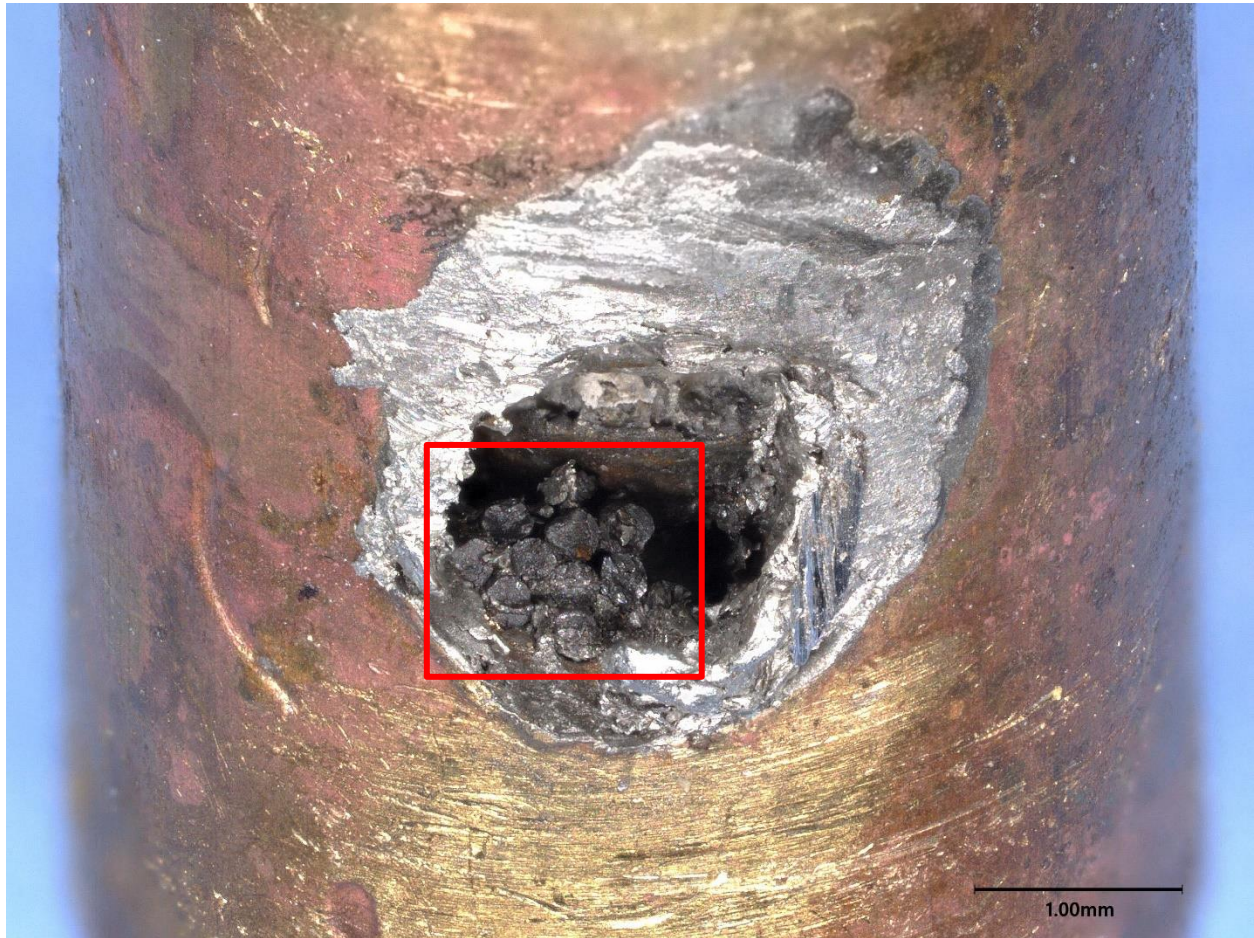
**Figure 7:** Higher magnification image at throttle control cable inlet showing fractured wire ends.

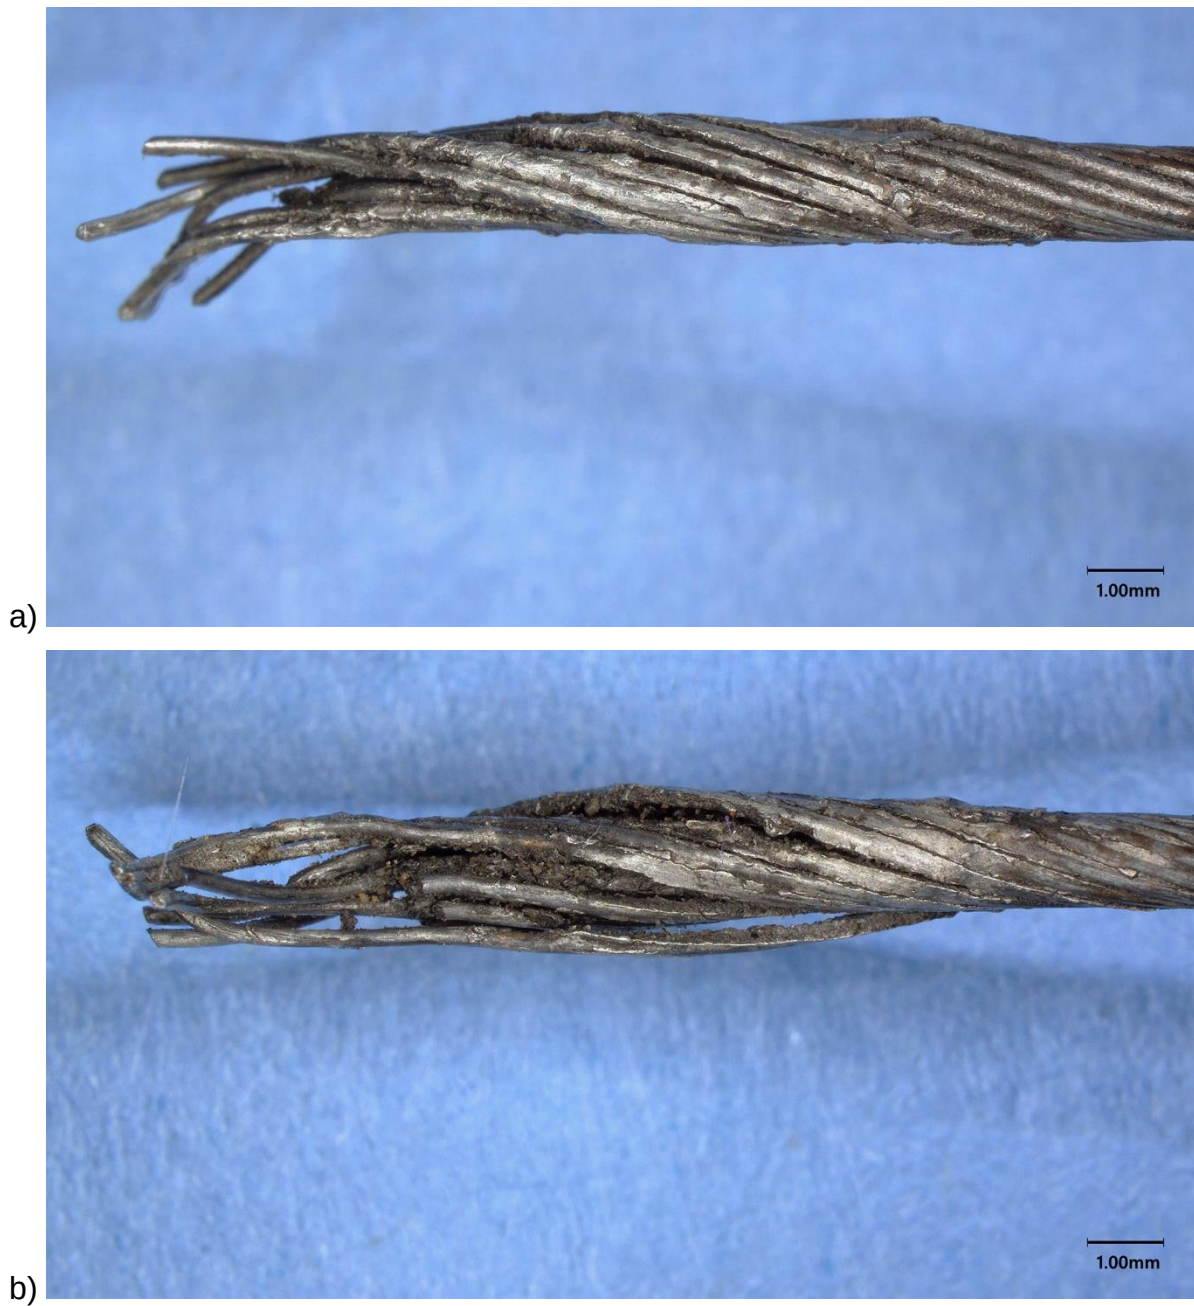
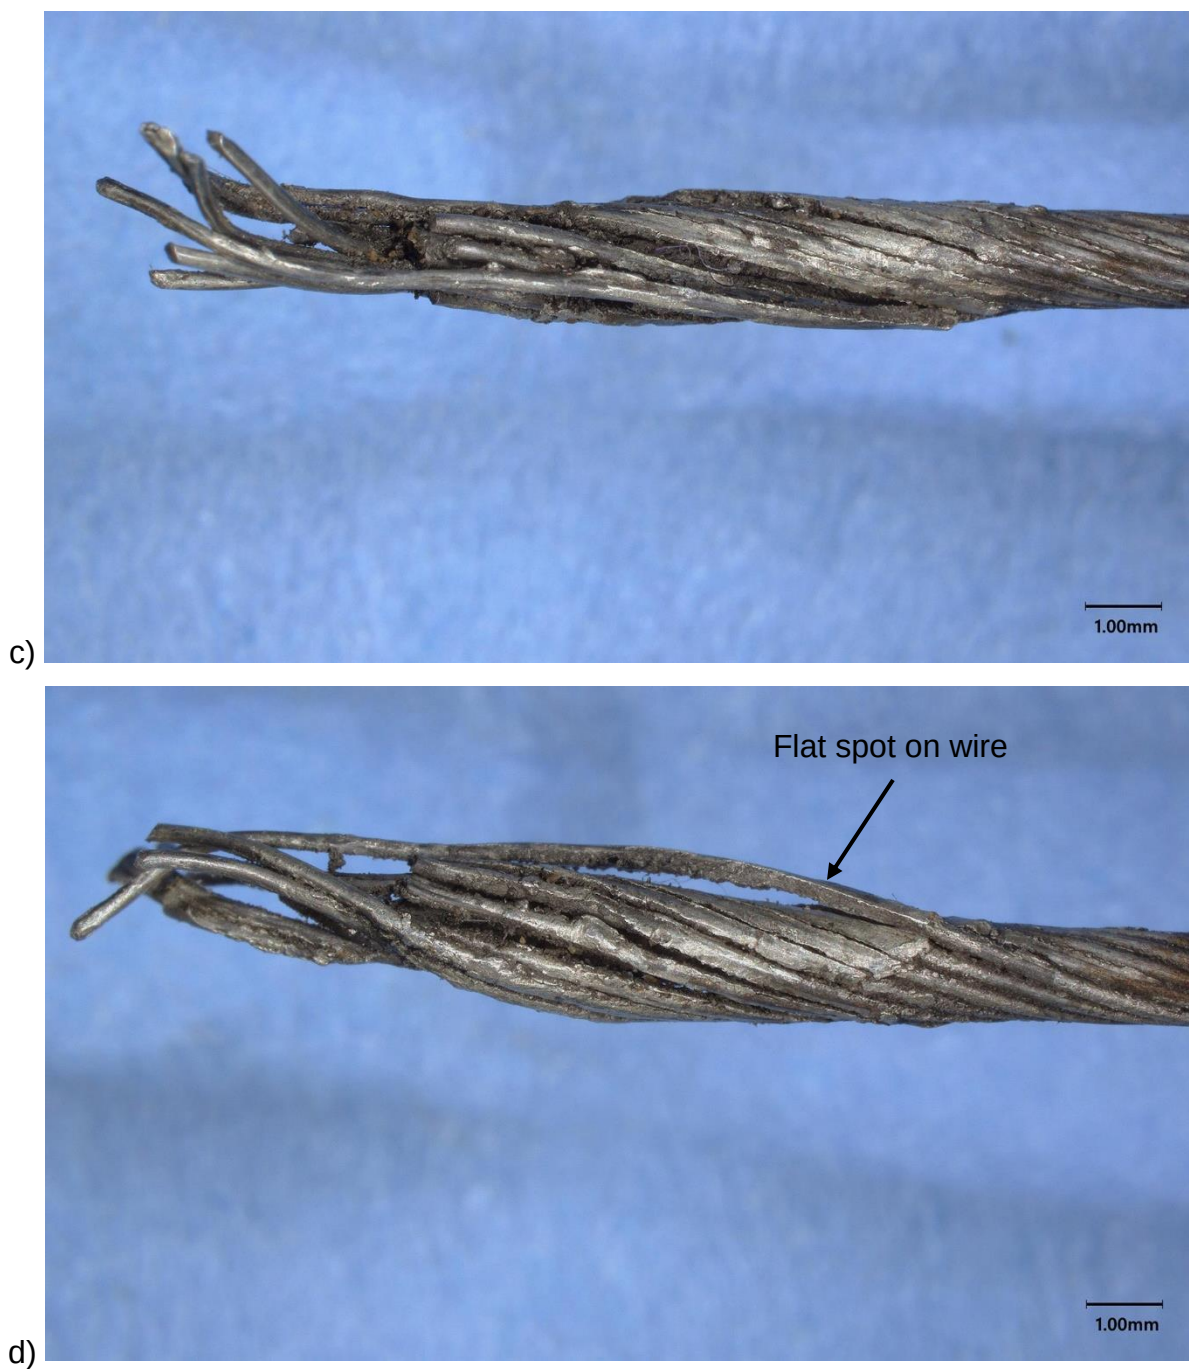
The throttle control input cable exhibited fractures and wear of multiple strand wires at its connection with the terminal fitting. The cable was composed of 19 wires, each wire approximately 0.25 mm in diameter, and the cable diameter was approximately 1.25 mm (as measured on a calibrated optical image). Examination of the fitting's inlet hole with the aid of a stereomicroscope revealed fractured wire ends still attached to the terminal fitting, as shown in figure 7, as did examination of the cable end itself (figures 8a – 8d). In total, 11 wires appeared fractured and 8 appeared intact. Some of the outer strand wires exhibited wear on their outward-facing surfaces, creating flat spots, such as the one indicated in figure 8d.

**Figure 8:** Images of the throttle control input cable at its insertion end into the terminal fitting:  
a) side view; b) side view rotated 90°;

**Figure 8 (cont.):** c) side view rotated 180°; and d) side view rotated 270°.

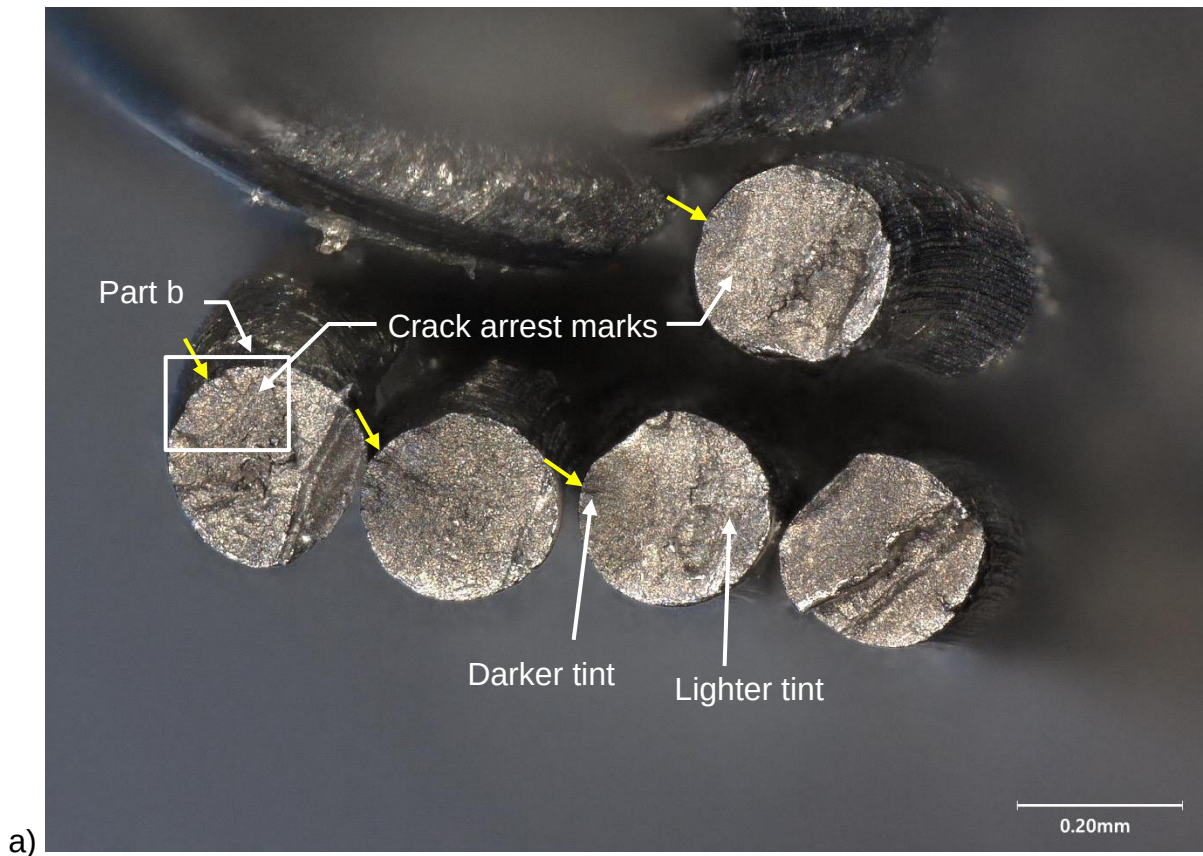
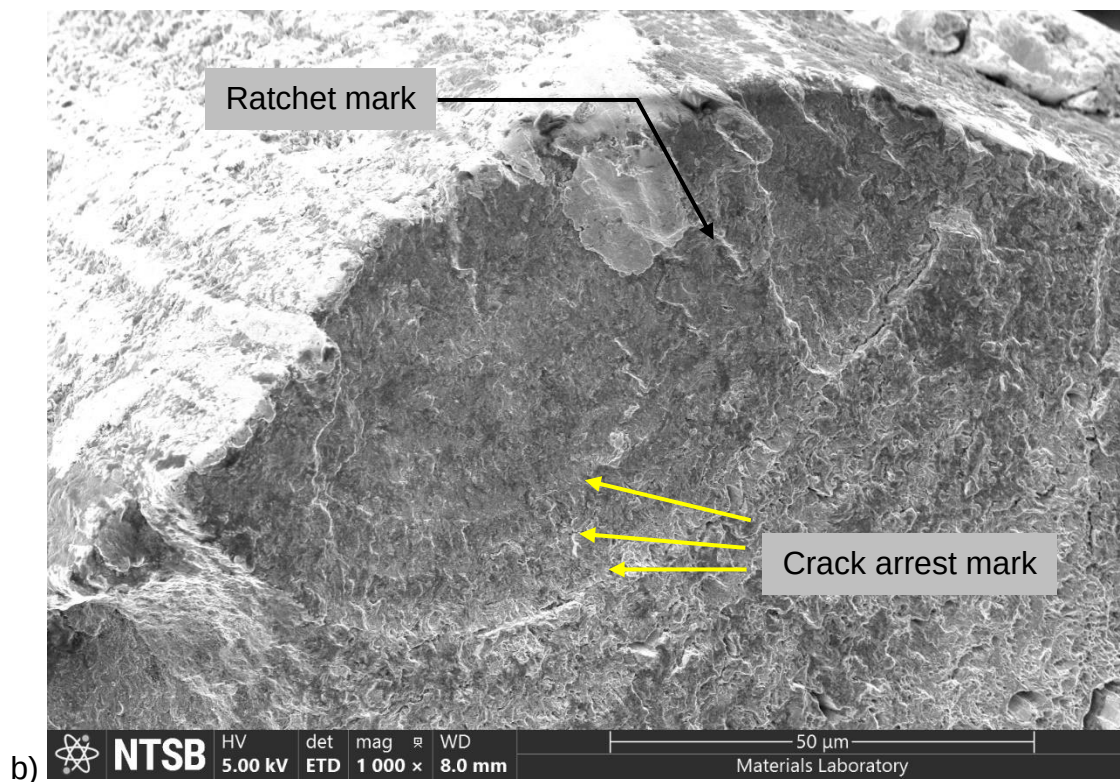
The wire fractures exhibited features consistent with a progressive fracture. The five wires shown in figure 9a were fractured in the transverse plane with no apparent necking or cup/cone-type fractures (one wire, not shown, appeared to exhibit necking and a second wire was indeterminate). As oriented in figure 9a, the fractures exhibited a progressive tint, with the darkest tint near the 10 to 11 o'clock position. Examination using a scanning electron microscope (SEM) revealed ratchet marks and curvilinear crack arrest marks, such as those shown in figure 9b, emanating from the same regions. At higher magnification, the fracture surfaces exhibited a smeared appearance that had destroyed the original fracture features. Taken as a whole, the features were consistent

with progressive fractures originating approximately between the 10 and 11 o'clock positions (indicated by yellow arrows), as oriented in figure 9a.

**Figure 9:** a) Digital optical microscope image of throttle control cable fractured strand wires; and b) SEM image at the location indicated in part a).
