## RECORD OF CONVERSATION

**Date: July 30, 2021**  
**Person Contacted: Mr. Joseph Chavez (FAA Inspector)**  
**NTSB Accident Number: CEN21LA241**

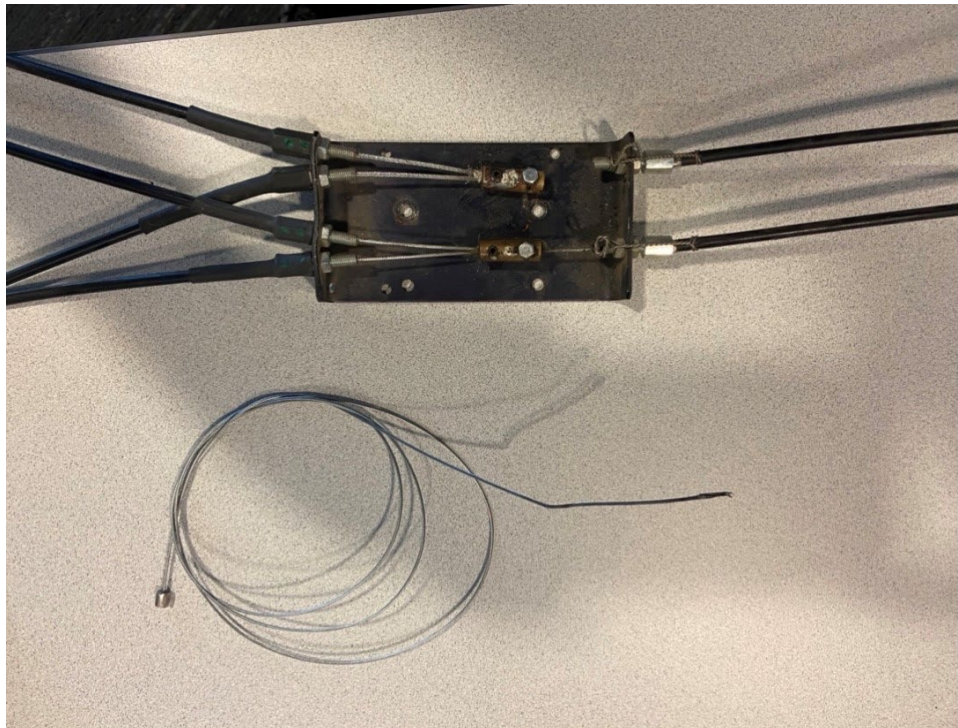
*Figure 1: Throttle/Choke Assembly*

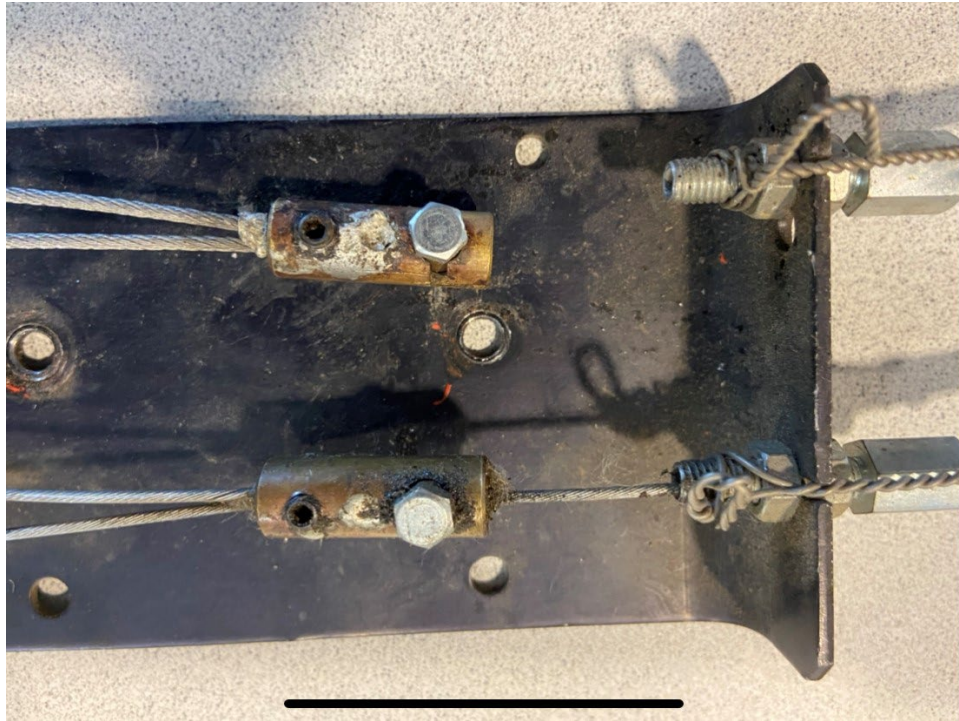
*Figure 2: Close View of Throttle/Choke Assembly*

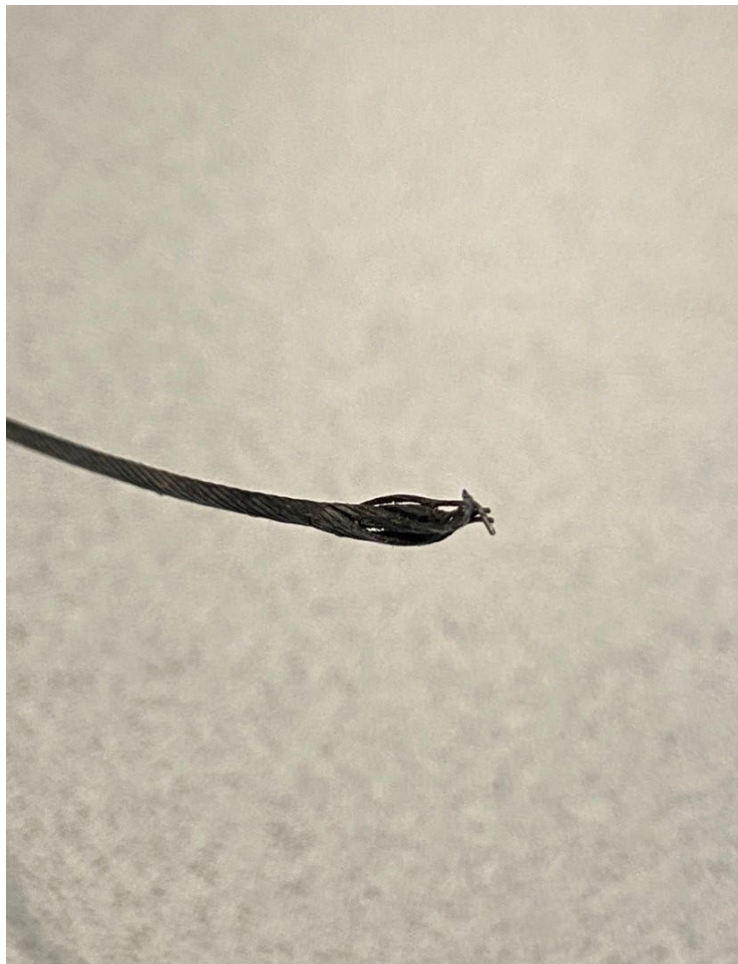
During a telephone conversation with Mr. Chavez, he reported that the throttle cable from the cockpit appeared to be fractured near the throttle/choke assembly. The remaining portions of the throttle cable did not have any abnormal or abrupt bends, nor did it show indications of rubbing on other engine components. Mr. Chavez removed the throttle/choke assembly, along with the throttle and choke cables for shipment to the NTSB materials laboratory. He also shared the below photos:

*Figure 3: Throttle Cable Fracture*

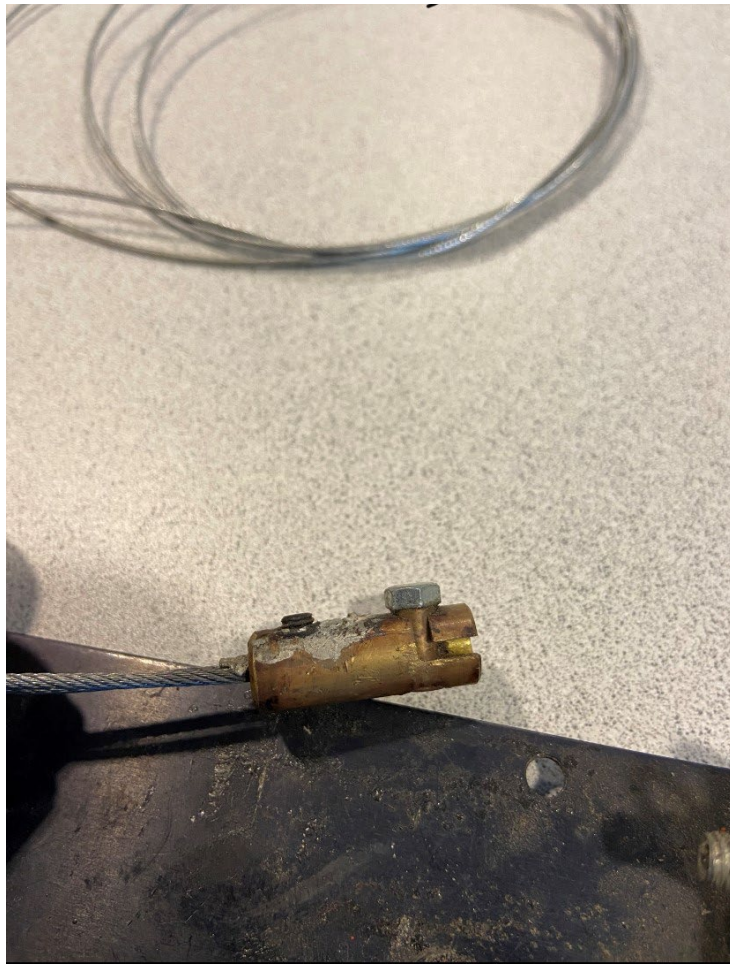
*Figure 4: Throttle Cable Splitter*
