**NATIONAL TRANSPORTATIONS SAFETY BOARD  
Office of Aviation Safety  
Washington, DC 20594**

**SUMMARY OF ENGINE/AIRFRAME EXAMINATION**

-- CEN21LA243 --

Location: San Angelo, Texas  
Aircraft: N274CV, Vans RV8

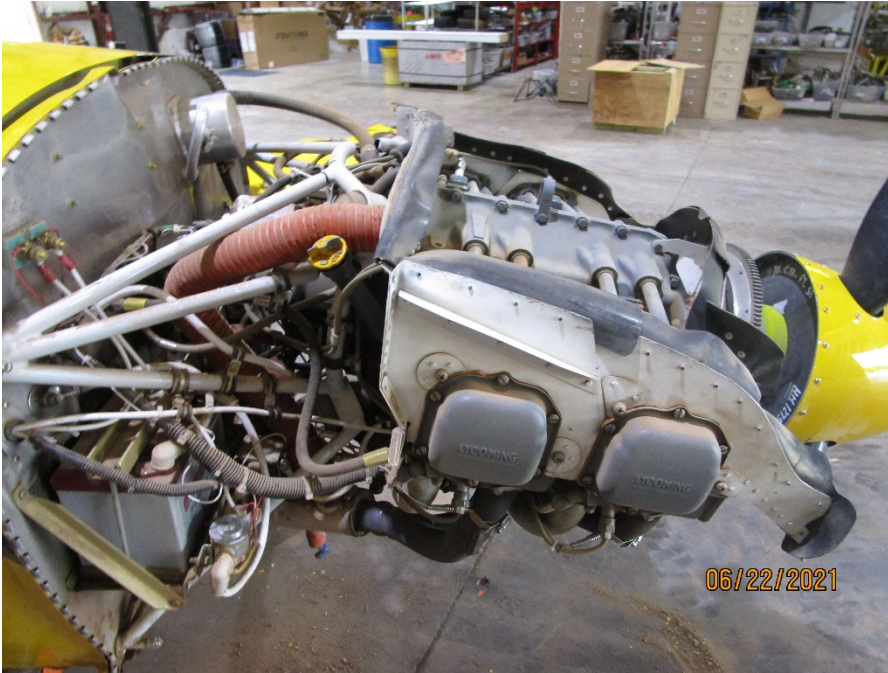
- Engine remained attached to the airframe, but engine mounts were broken.

Engine cowling removed for access

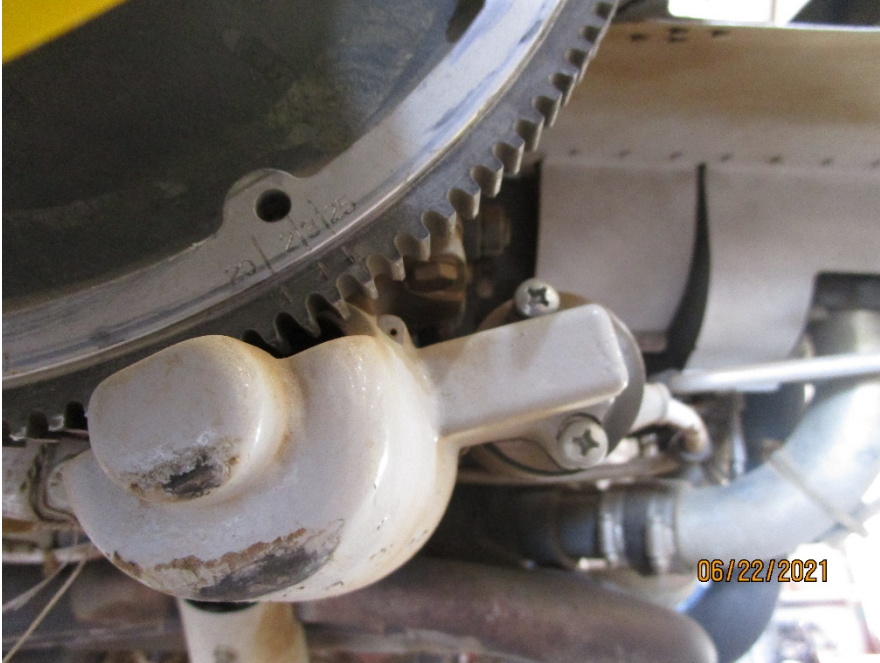
- Propeller remained attached to the crankshaft flange. 3 bladed Sensenich fixed pitch.
- One blade remained; the two other blades were broken off/separated during the accident.
- Removed top set of sparkplugs, appeared normal combustion.
- The engine was rotated by rotating the crankshaft/propeller. Rotation thru valve train, accessories, and to the crankshaft was observed.
- Both left and right fuel tanks were breached; root rib separated from skin.
- Both PFD and instrument panel had impact marks, likely from occupant.
- Pilot's 5 point harness appeared functional with no (first responder) cuts.
- The PFD SD card was a blank "space holder".
- Both magnetos were removed, and field tested; spark was observed on each terminal.

Verified engine timing

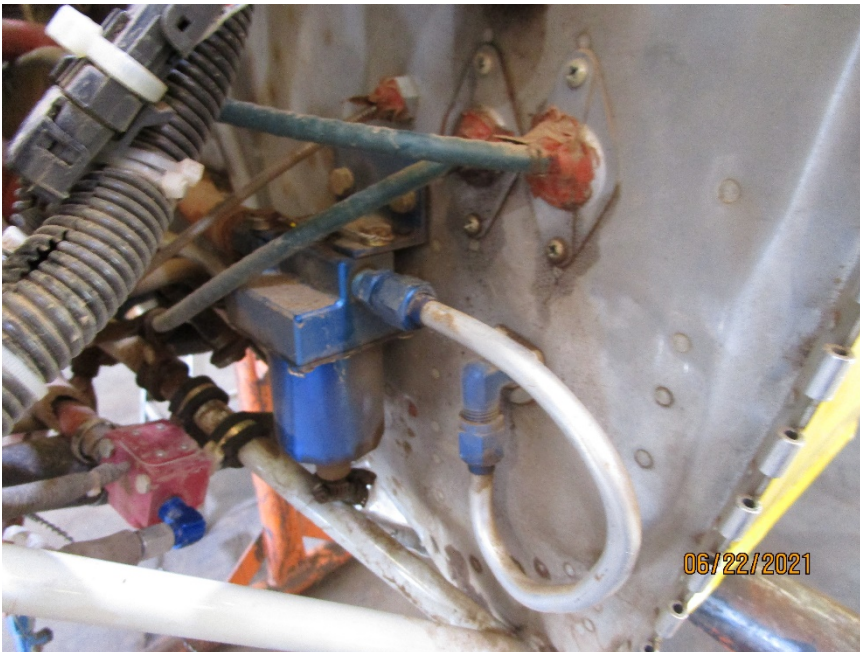
- Fuel routing appeared correct

Fuel from tank thru gascolator, then to fuel pump

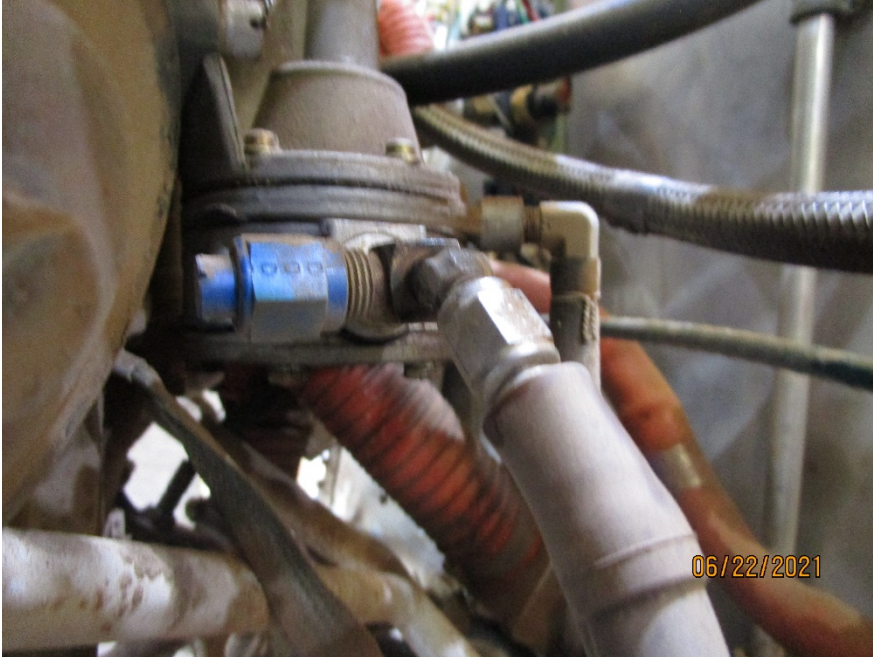
- Fuel pump (pressure side) fitting had two ports, #6 which was capped off and a #4 fitting which ran to the fuel flow transducer ("red cube").
- From the red cube to the inlet side of the carburetor; carburetor was impact separated from the sump.

Pressure side of fuel pump with fittings
