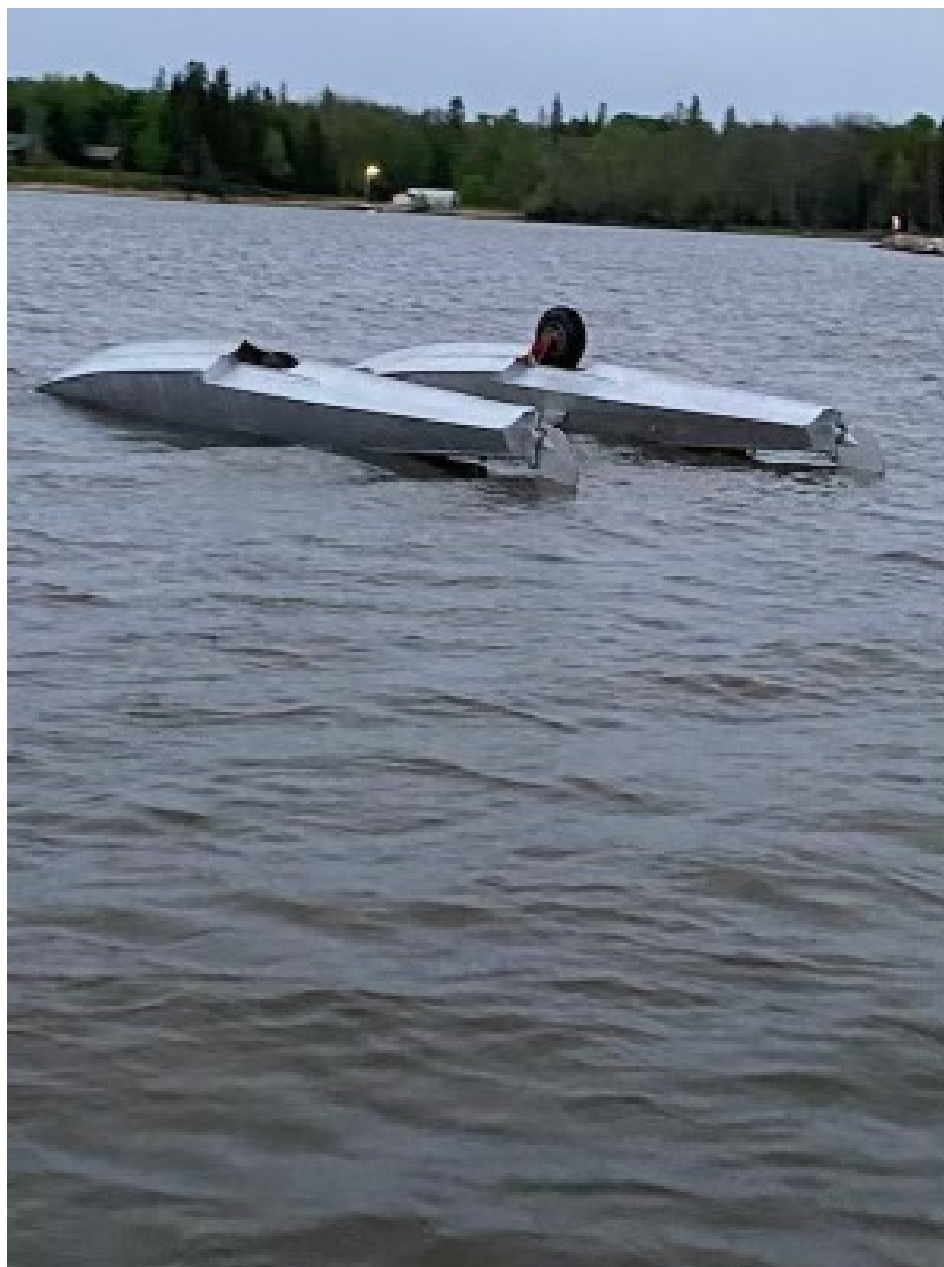
**Photo 1 – Accident Location (Photo provided by local law enforcement)**

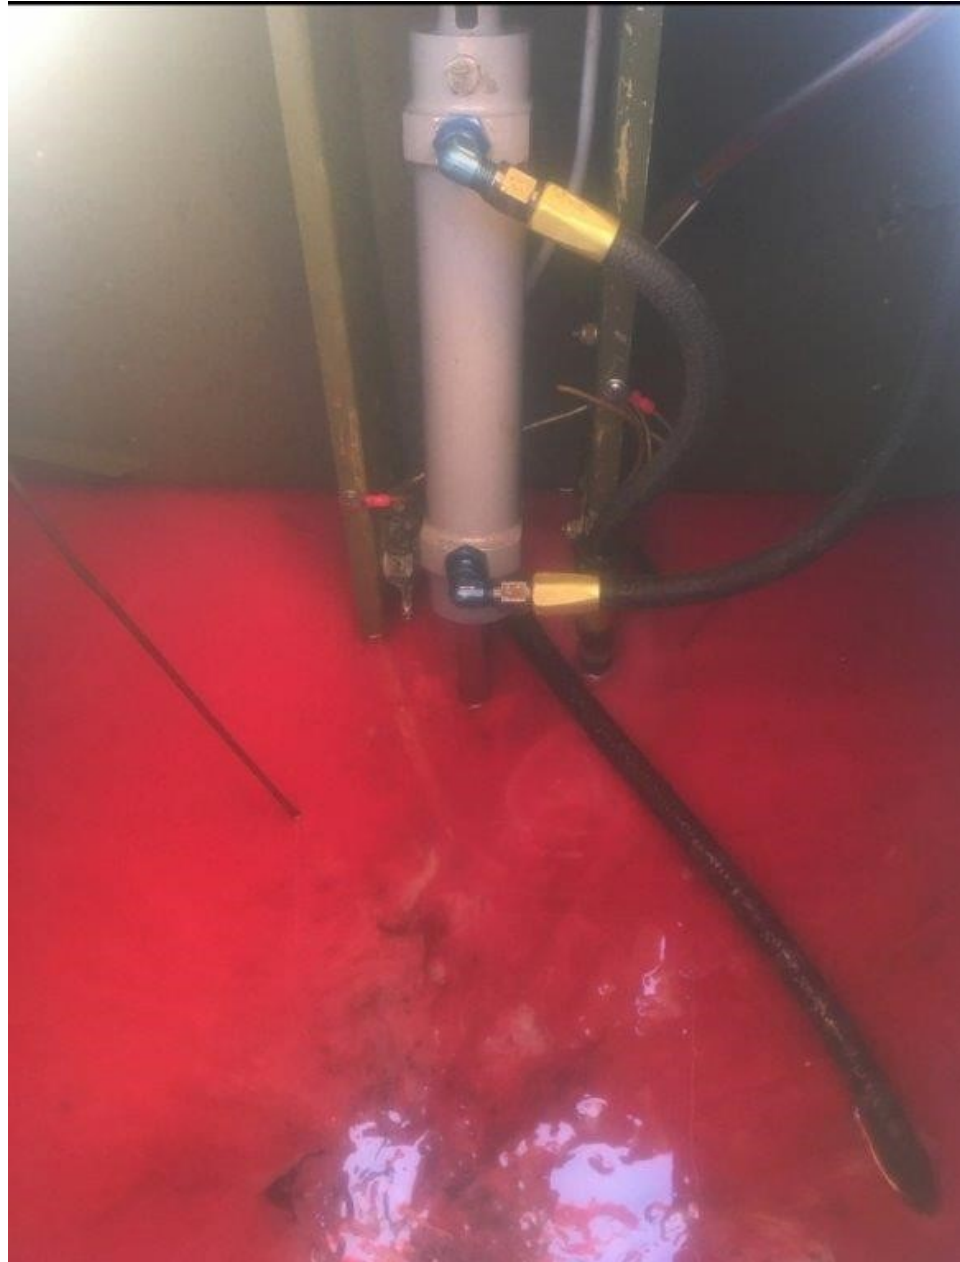
**Photo 2 – Left float hydraulic jack assembly (Photo provided by pilot/owner)**
