**NATIONAL TRANSPORTATION SAFETY BOARD**  
Office of Aviation Safety

**Actuator Examination Report**

**A. ACCIDENT      CEN21LA259**

Location:      Aspen, Colorado  
Date:      June 4, 2021  
Time:      0954 MDT  
Operator:      Private  
Aircraft:      Cessna 560XL  
Registration:      N615RG

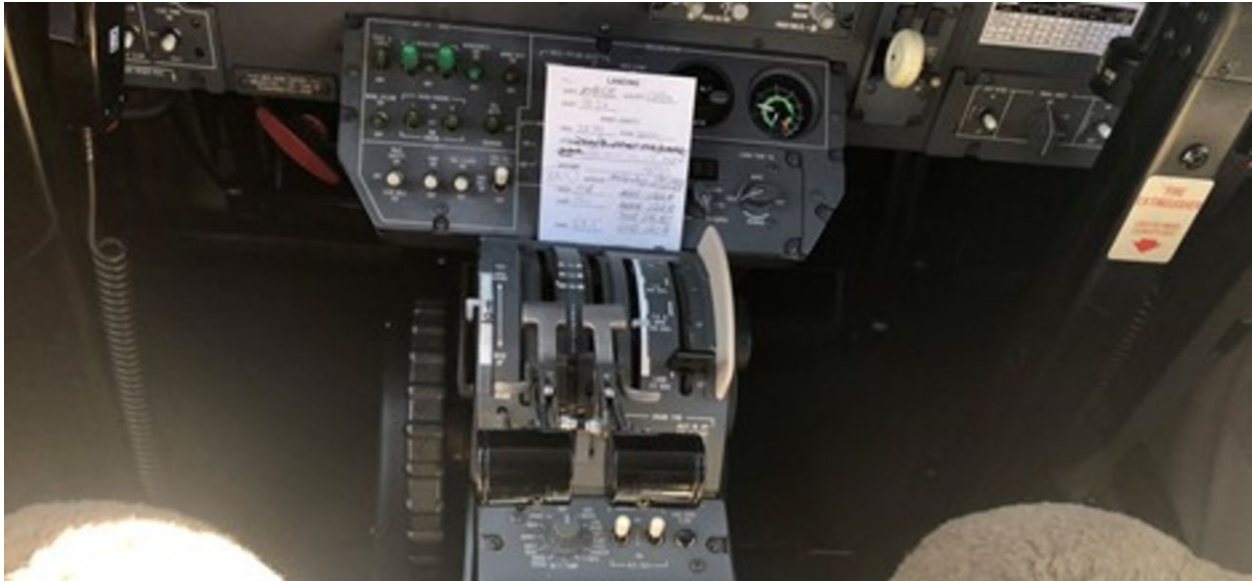
After the accident the right main landing gear was found retracted while the left main landing gear and nose gear were extended. The landing gear handle was found in the UP position. When asked, the crew could not recall manipulating the landing gear handle after the initial gear extension in flight. Figure 1 shows a post-accident view of the cockpit, throttle quadrant, and landing gear handle. The airplane has been retained for further examination and component testing.

*Photograph 1: Postaccident view of the cockpit, throttle quadrant, and landing gear handle*

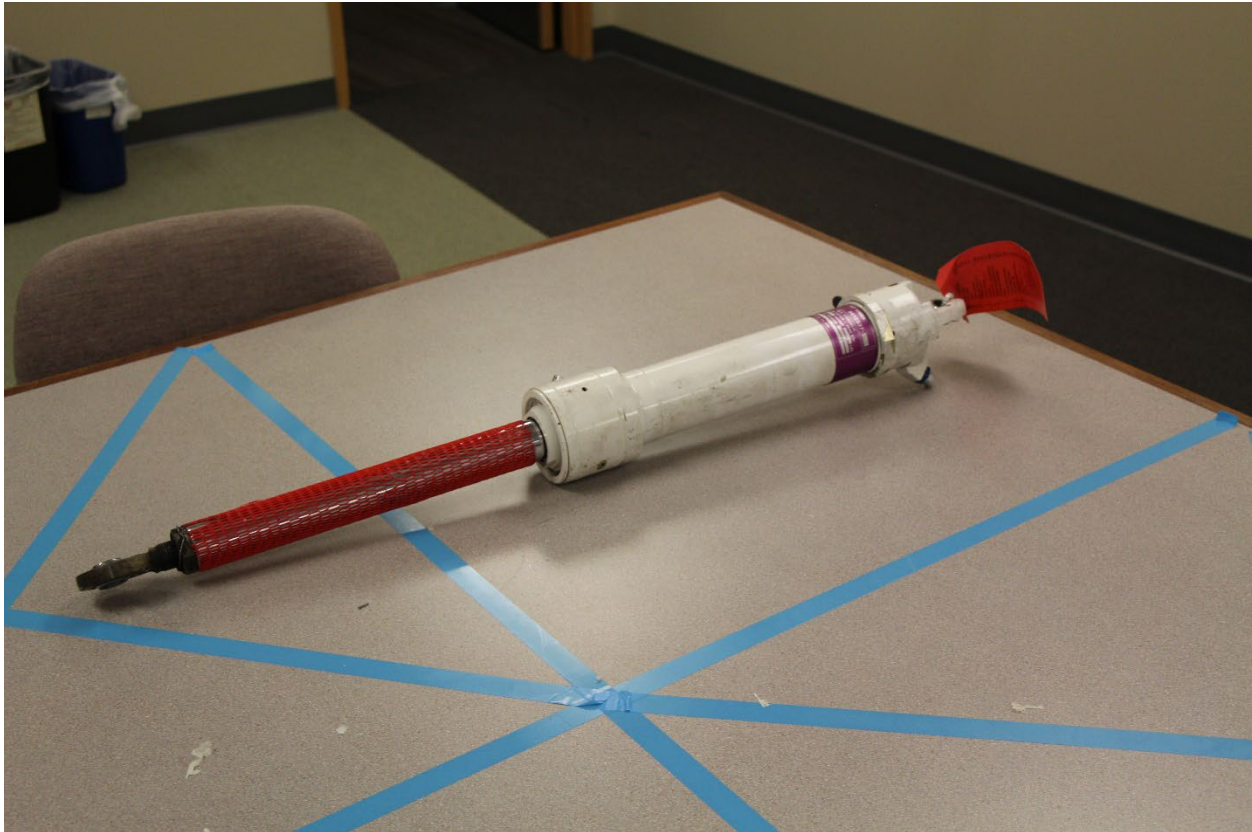
*Photograph 2: Hydraulic actuator as received*

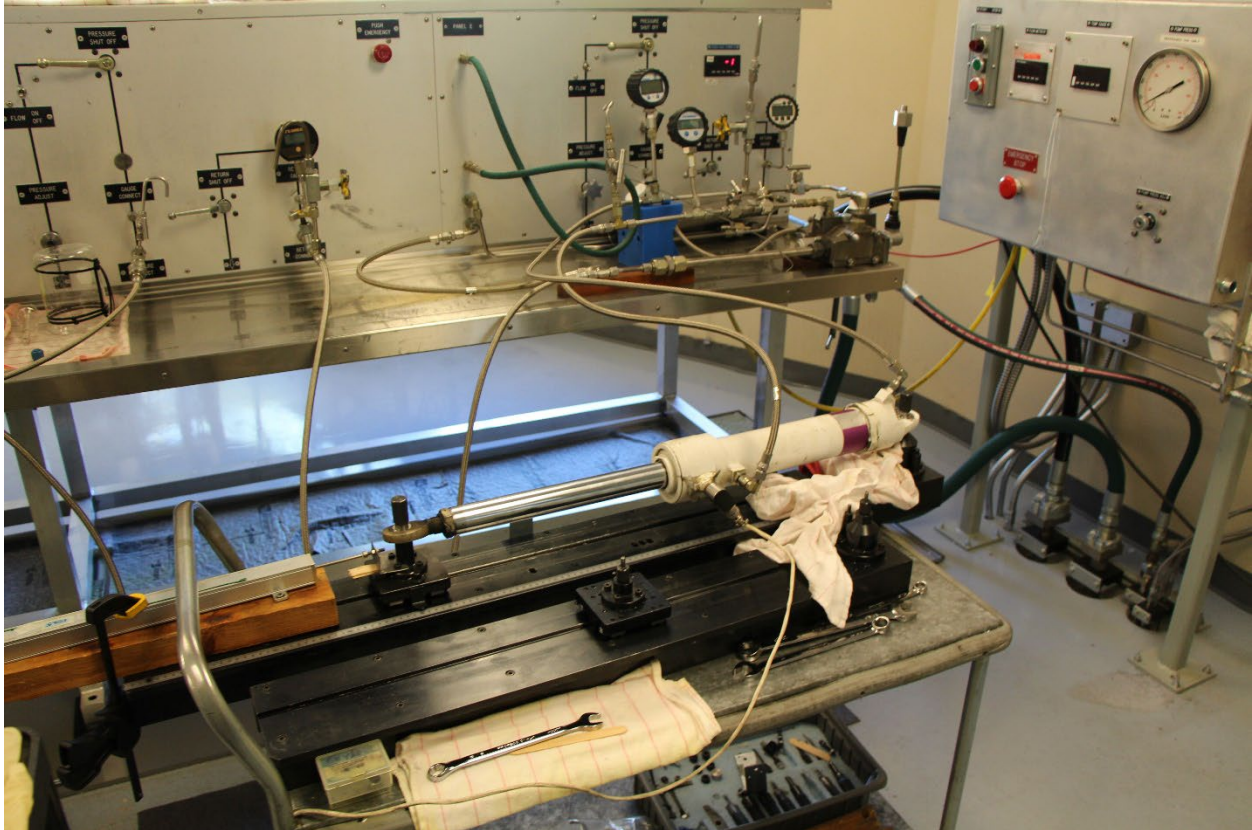
Photograph 3: Hydraulic actuator in test apparatus

The actuator passed most of the CMM tests with exception of two:
