National Transportation Safety Board  
Office of Aviation Safety  
Washington, DC 20594

CEN21LA259

## **AIRCRAFT SYSTEMS**

Location: Aspen, Colorado  
Date: June 4, 2021  
Time: 0954 Local Time  
Airplane: Cessna 560XL, Serial Number 560-5016, N615RG

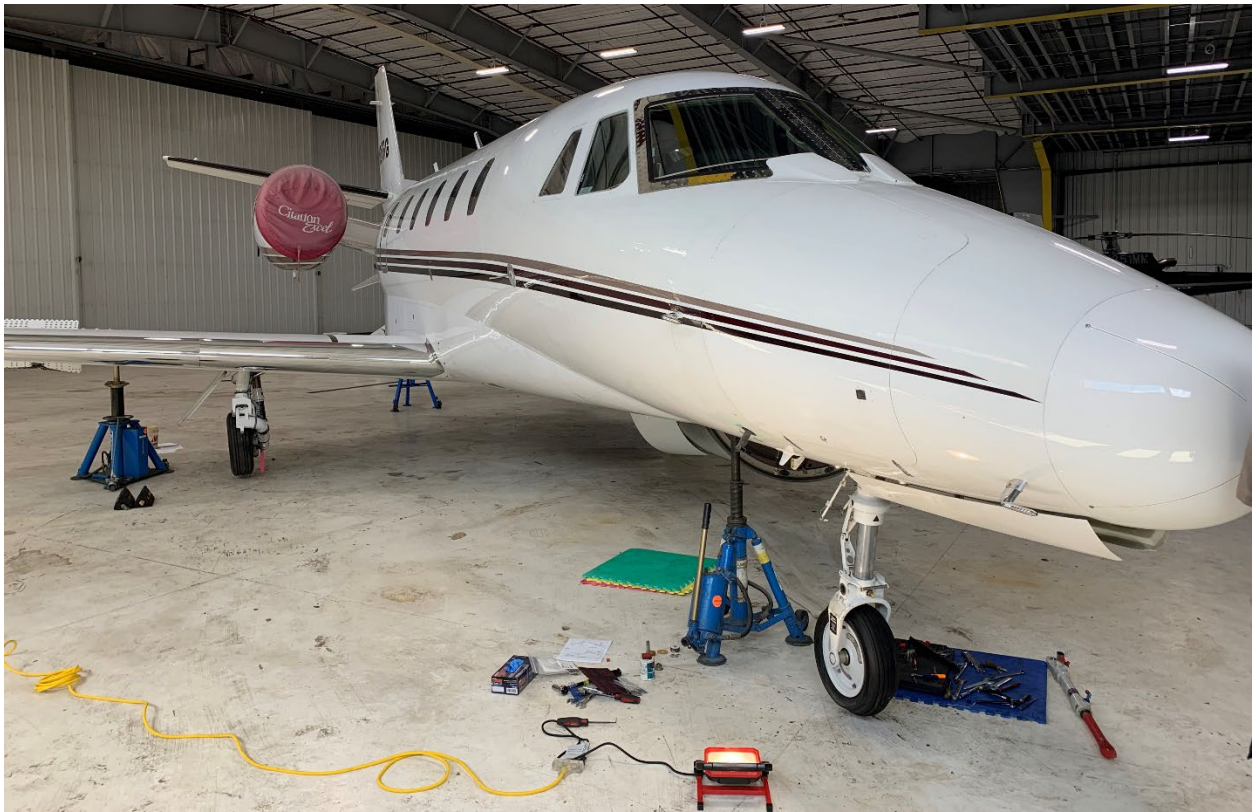
**Figure 3.** Airplane on jacks prior to Main Landing Gear strut tests.

Right Main Gear: At change of state, 7.9" of chrome showing.

Left Main Gear: At change of state, 7.95" of chrome showing.

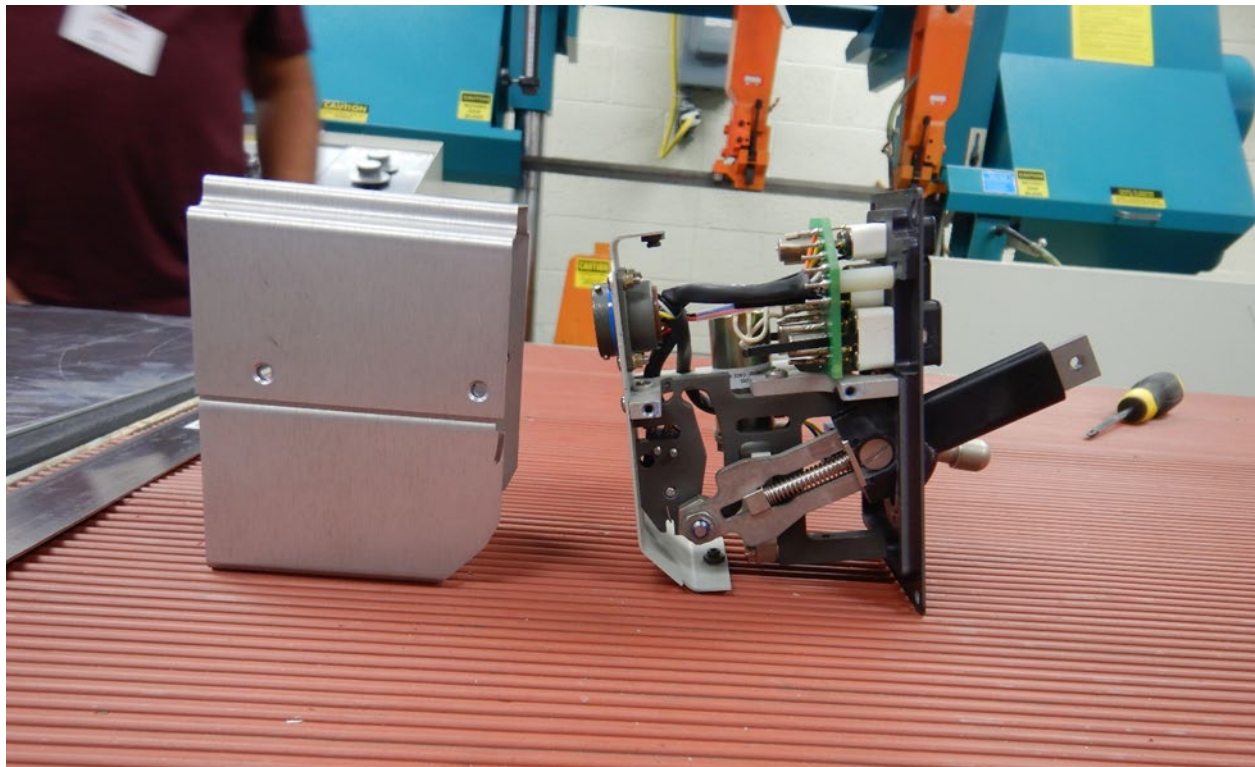
Visual inspection of the landing gear control handle was completed. No abnormal wear or damage was noted.

In addition, an X-Ray examination was accomplished by the Textron Aviation M&P labs. The X-ray examination was accomplished to view the existing internal component conditions. No abnormal conditions were noted.

**Figure 4.** The Landing Gear Control Handle (right) with outer case removed.

The outer (dust cover) case of the Landing Gear Control Handle was removed to inspect the internal components of the unit. The inspection of the Landing Gear Control Handle's internal components did not reveal any component damage or abnormalities.

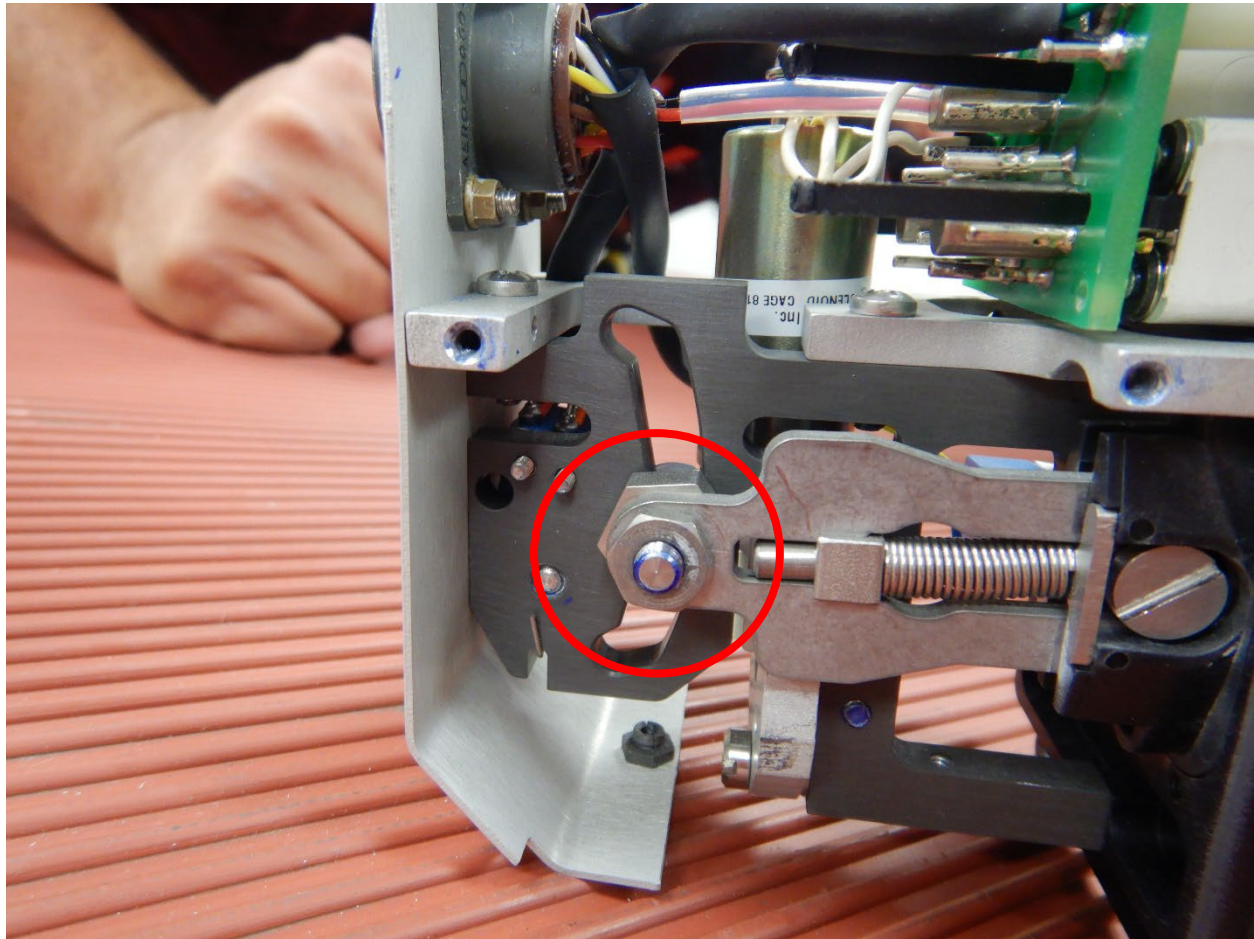
For ATP Section 5.1, Functional Test, the test elements were completed, with the unit passing all requirements except paragraph 5.1.1.5. ATP paragraph 5.1.1.5 requires that the landing gear handle returns to either the "UP" or "DOWN" position when released from any position. During the testing, the handle exhibited a tendency to stick in place when released. This tendency was repeated multiple times, with the handle released anywhere between mid-travel and within approximately 0.25 inch of the "RETRACT" detent. The handle remained in the position it was released in, on the retract half of the travel. When the handle was released on the "extend" side of travel, it would snap completely to the "extend" detent. When stuck in a position outside of the extend or retract detents, it would only transition further if vibration was applied to the case or the handle was manually transitioned.

It was noted that an "extend command" was provided as an output from the handle after moving less than 0.25" out of the "retract" position and the "extend command" was sustained throughout the remaining travel between the extend and retract detents. This allowed the handle to provide an "extend command" while the handle was stuck in a mid-travel position and with some vibration on the case, it

would slowly transition towards the retract position and would eventually move into the retract detent position and provide a "retract command." See Figure 6.

**Figure 6.** The landing gear handle in a "mid" position, circled in red.

While inspecting the internal components for a cause of the handle sticking, a small amount of white residue was noted near the pivot point of the handle. A sample of the white residue was taken and analyzed by the Textron Aviation M&P Laboratory.

Using Fourier Transform Infrared Spectroscopy analysis (FTIR), the white residue material was identified as a polymer matching the plastic of the handle in that area. The polymer also matched with Polyether Ether Ketone (PEEK)<sup>2</sup> from polymer data found in the Textron Aviation M&P laboratory's material library. The black plastic part of the handle is grooved in the area where the white powder was found. The white powder consists of fine particles of the PEEK-constructed part.
