## **NATIONAL TRANSPORTATION SAFETY BOARD**

# **AIRFRAME AND ENGINE EXAMINATION**

**CEN21LA265**

Location: Columbus, OH  
Date: June 14, 2021  
Aircraft: Cessna 180K, Registration N13159, Serial #18053166  
NTSB IIC: Samantha Link

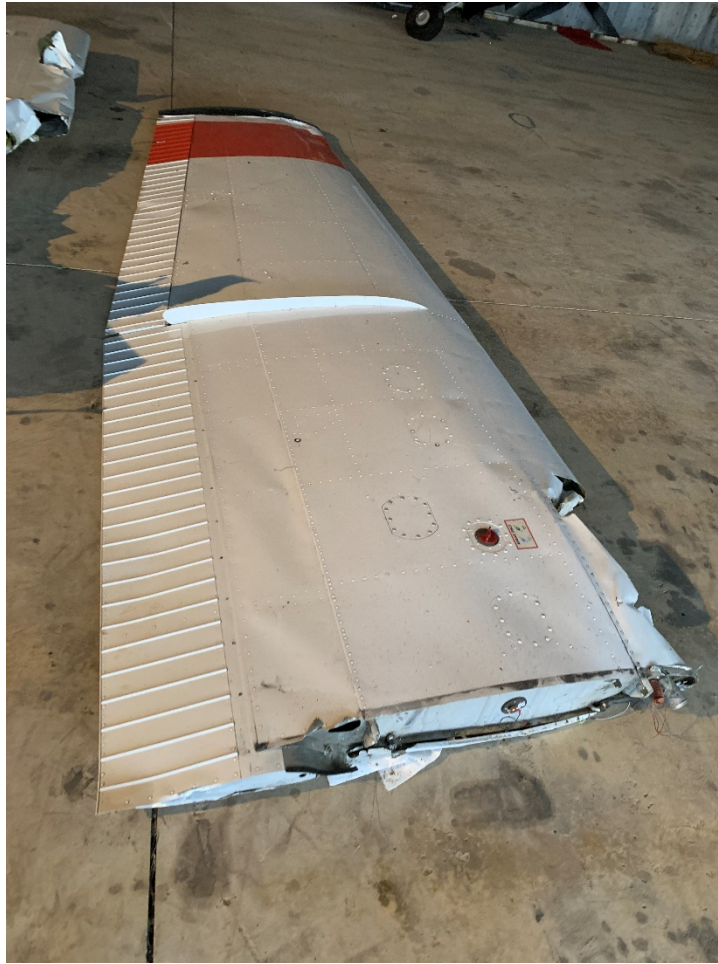
**Figure 3: Left Wing**

- The right fuel tank was intact, and no anomalies were noted inside of the tank.
  - Both fuel tank finger screens were clear of debris.
- A large circular dent consistent with tree damage was noted on the inboard portion of the left wing and left fuel tank.

- The left-wing fuel tank was breached.
  - Fuel cap remained in place and was secured.
- The left-wing fuel tank access panels were removed, and several things were noted within the fuel tank:

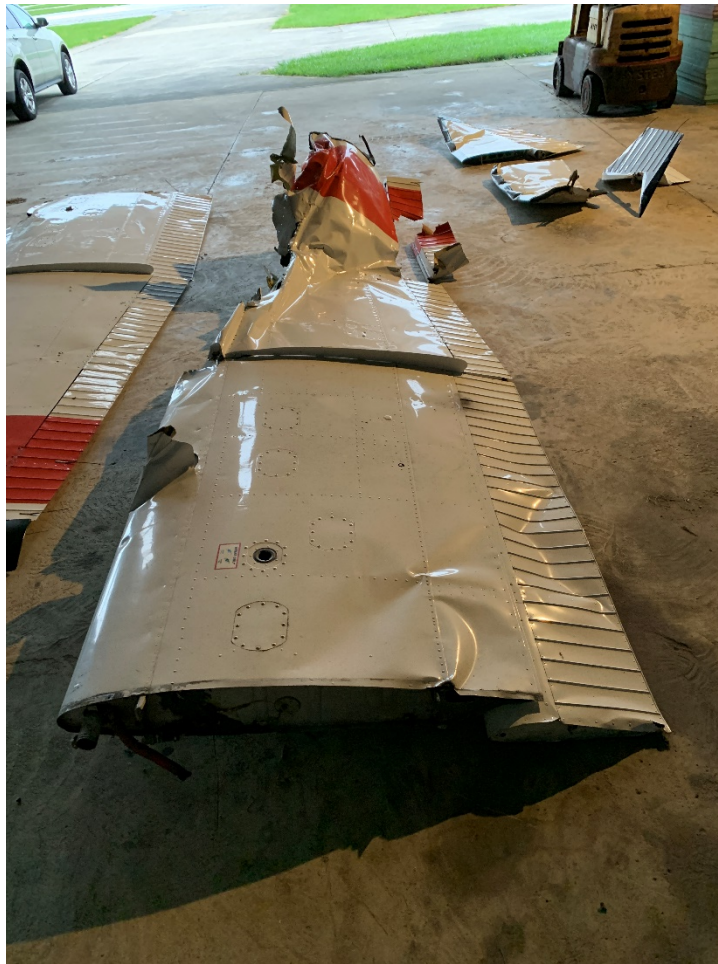
**Figure 4: Right Wing**

- The wings had been changed from bladder fuel tanks to integral fuel tanks.
- The right-wing leading edge was crushed aft consistent with impact damage.

- The outboard half was crushed further aft than the inboard.
- The right-wing fuel tank fuel cap was not present. The fuel tank access panels were removed:

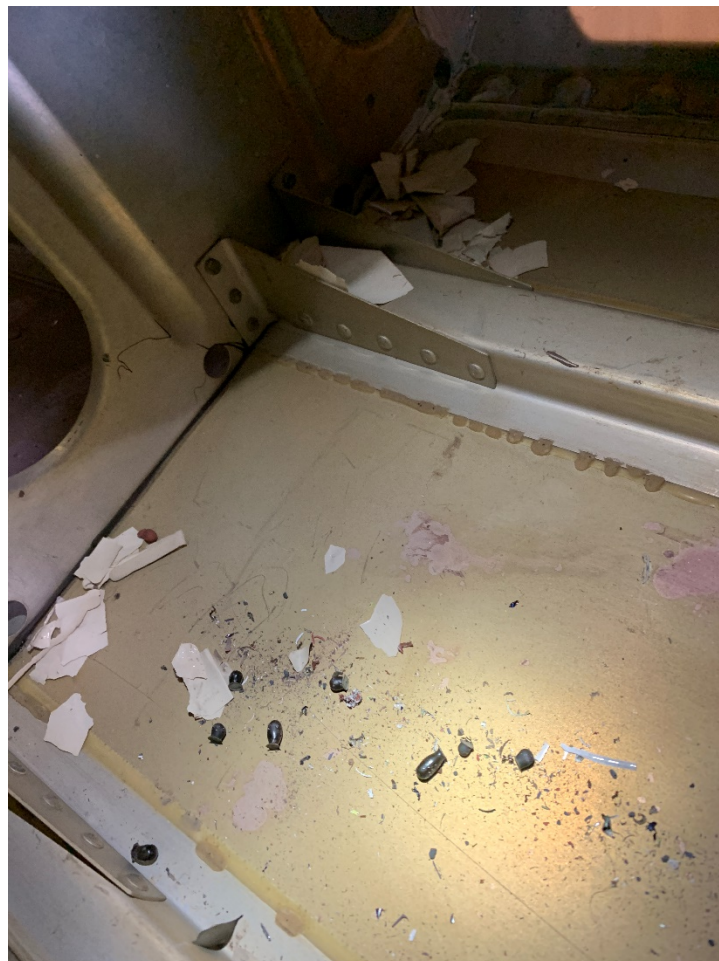
- Fragments of off-white sealant were found loose within the fuel tank. These fragments varied in size from very small to about an inch.
    - This sealant appeared to have been applied to the vertical and lower skin structure of tank. It is unknown when this application occurred.

- The sealant exhibited cracking and flaking. It easily flaked off when touched by a finger.
  - The middle and outboard wing drains had a grey color sealant observed over the off-white sealant.

Figure 7: Fragments of Sealant in the Left-Wing Fuel Tank

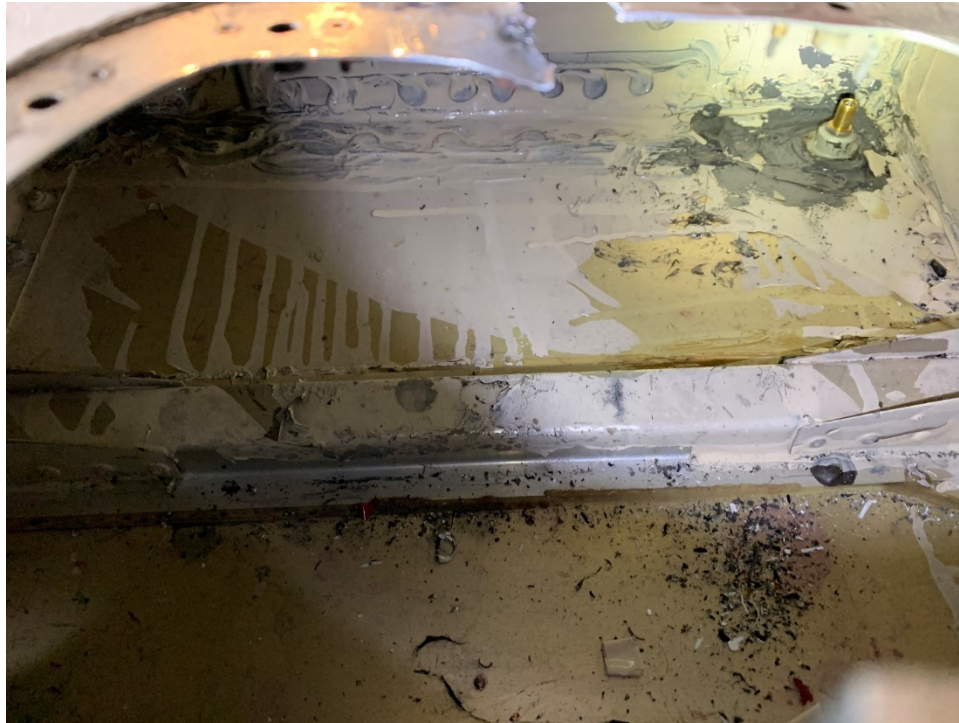
- About a dozen small globs of grey sealant were also observed loose in the fuel tank. Each were about  $\frac{3}{4}$  centimeter in length and about 2 millimeters wide.

Figure 8: Inside of Left Fuel Tank

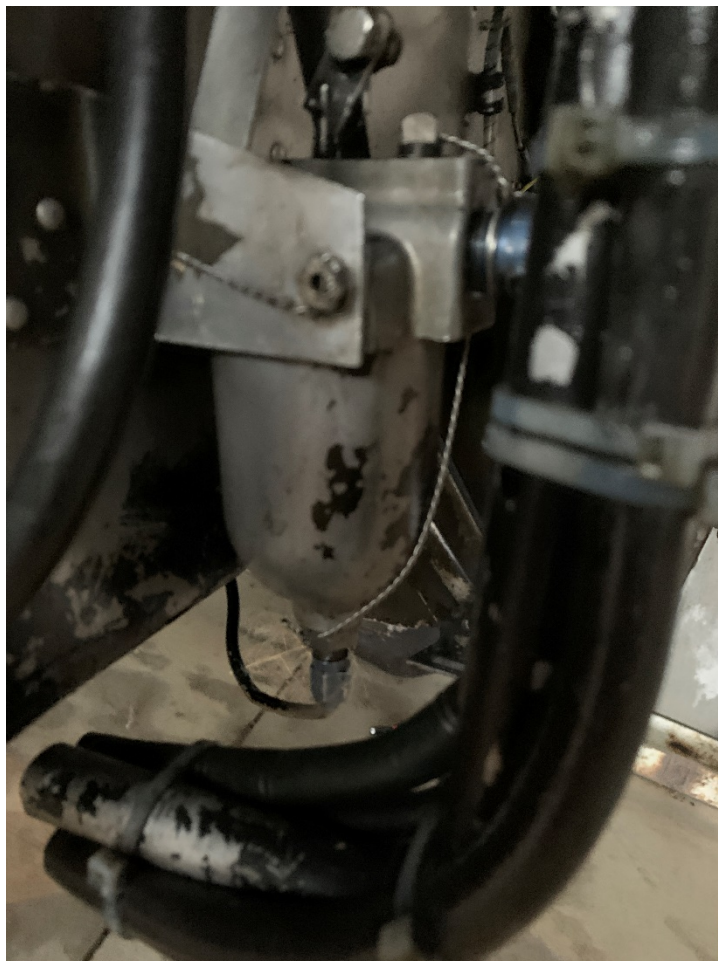
Figure 9: Fuel Strainer

- The finger screens were clear of debris.
- The fuel strainer was removed, and a lot of fuel exited from the strainer during the removal process.
  - The bowl was removed and was clear of debris.

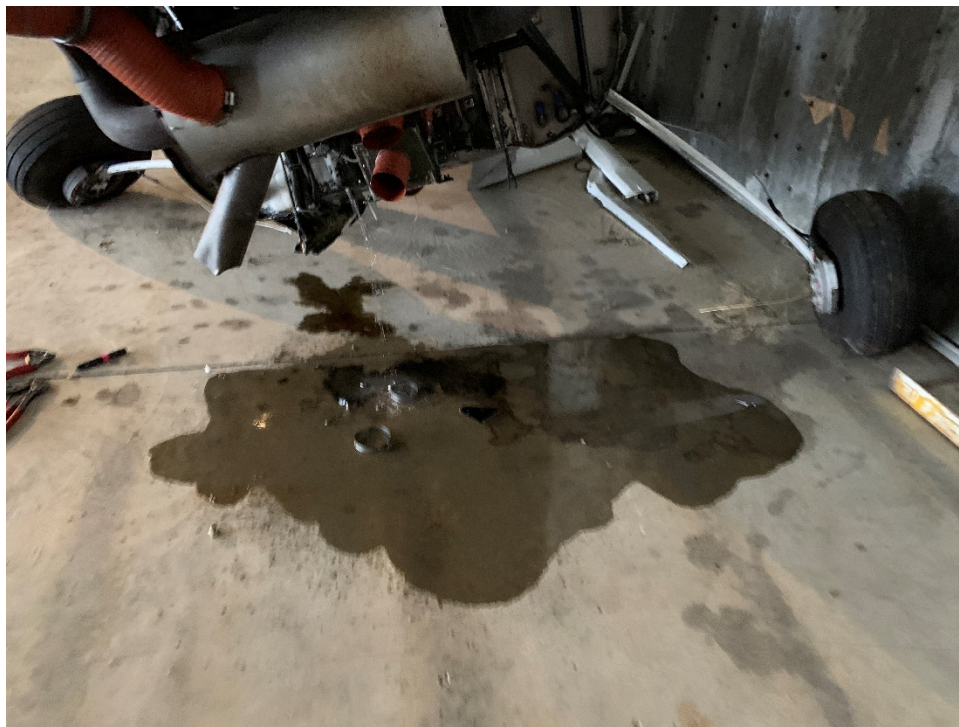
- No water was observed within the fuel that drained from the fuel strainer.
  - Minor dark substance was noted in the fuel strainer screen, but the screen was otherwise clear of debris.

**Figure 10: Fuel Draining from Fuel Strainer**

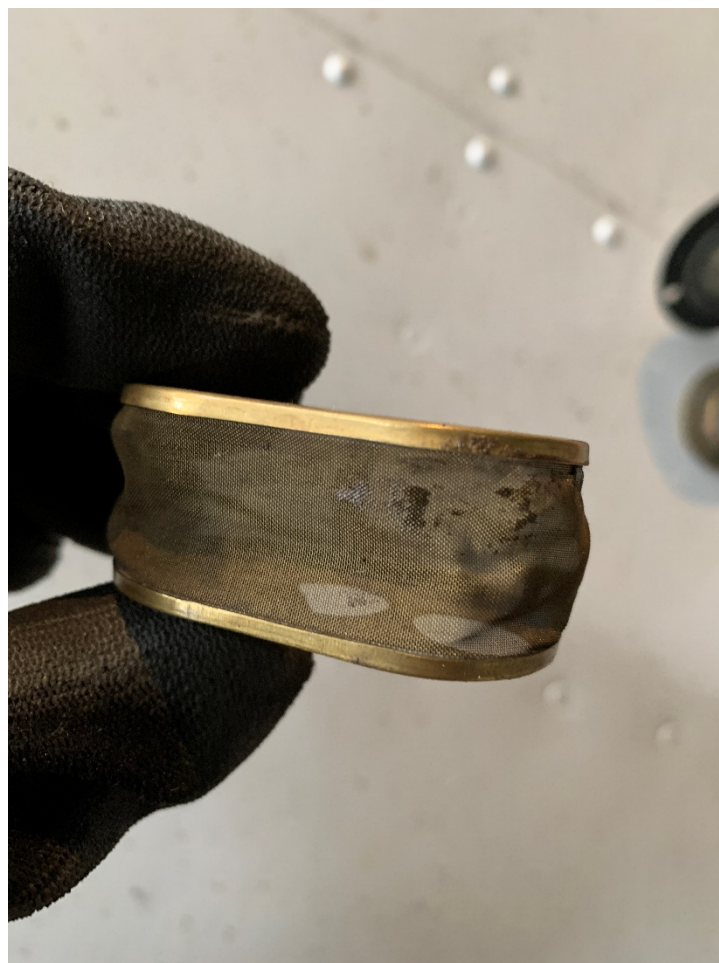
**Figure 11: Fuel Strainer Screen**

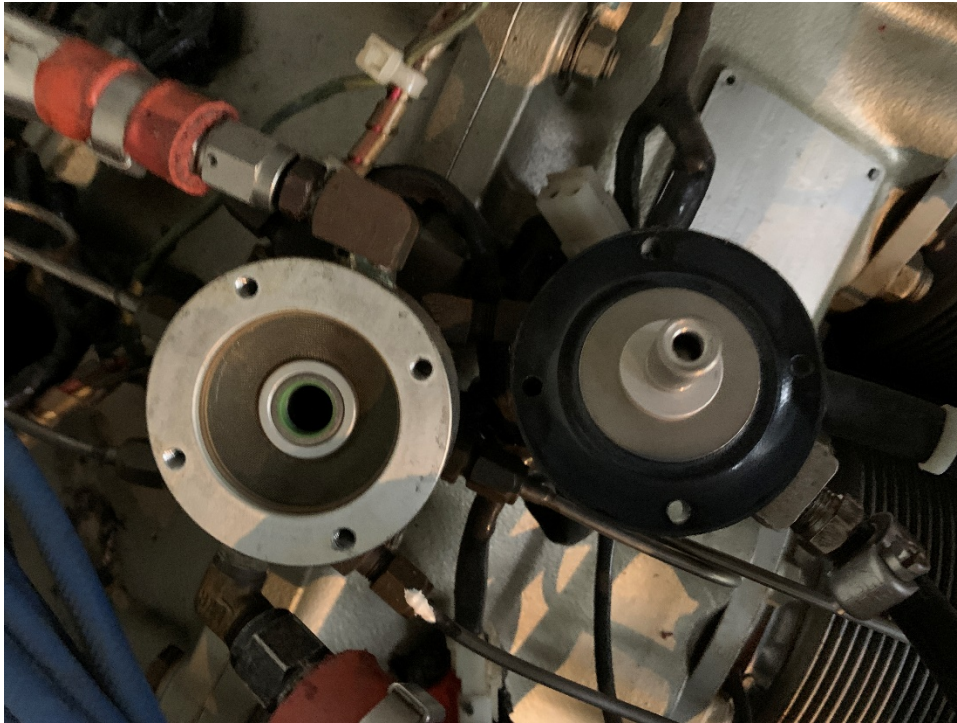
- The engine cowling was removed and there were no visual signs of catastrophic failure.
- The fuel distributor was disassembled:
  - No fuel was observed within the distributor.

Figure 16: Inside of Fuel Distributor

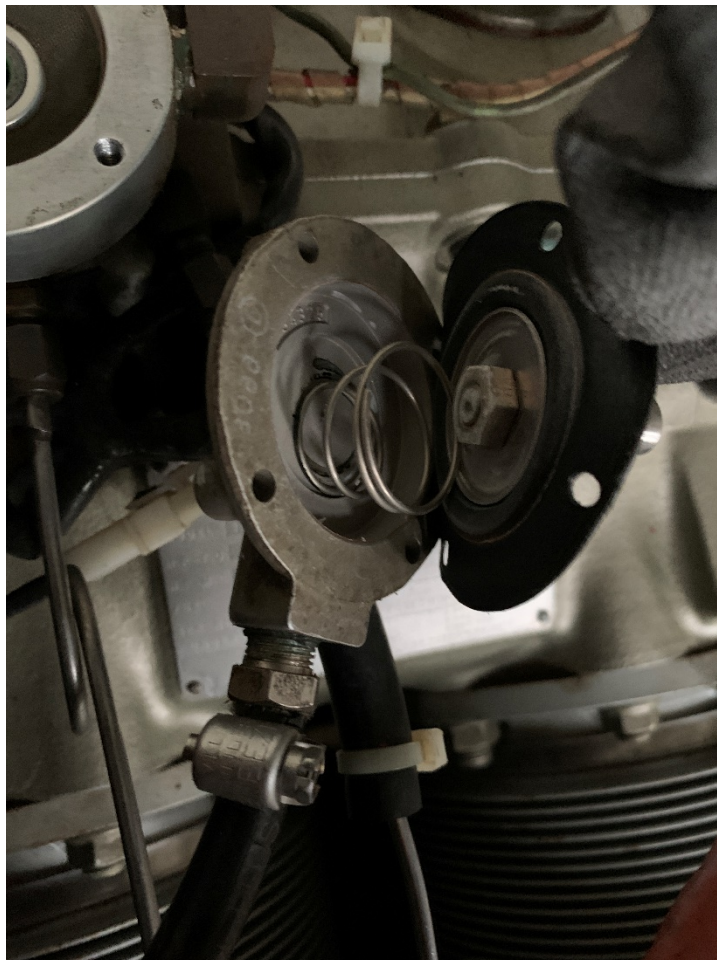
- The diaphragm was slightly stiffer than normal and stuck to the lid of the fuel distributor.
    - The spring was intact and exhibited black staining on the small side of the spring. Corresponding staining was noted on the lid of the fuel distributor.

- Dried white staining was noted on the larger side of the spring.
    - The spring and diaphragm were packaged for further examination at the NTSB materials laboratory.

Figure 17: Fuel Distributor Spring and Diaphragm

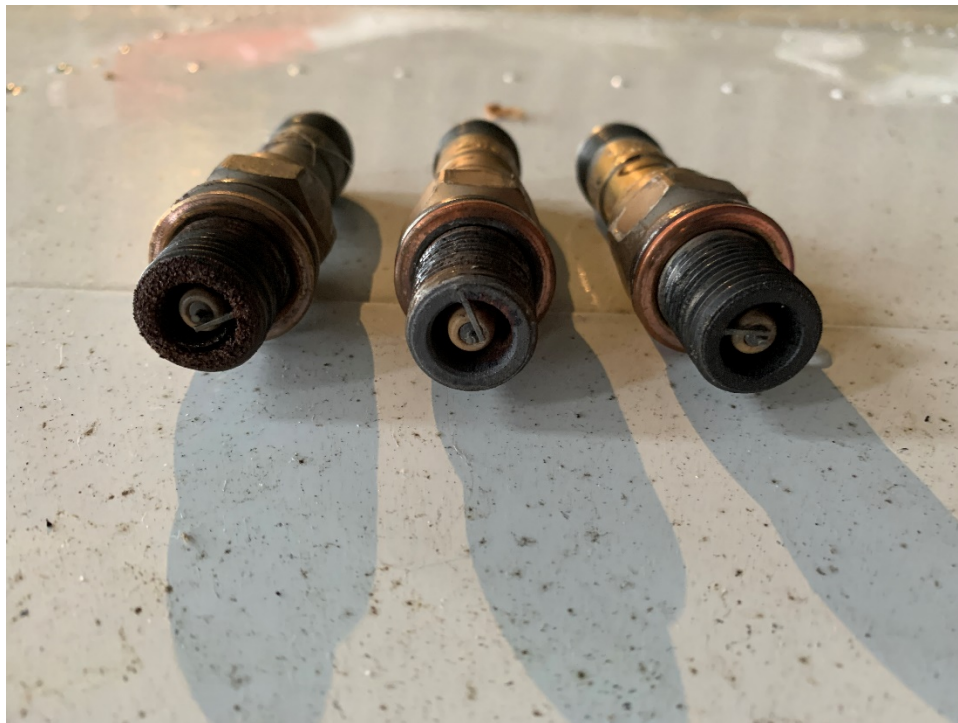
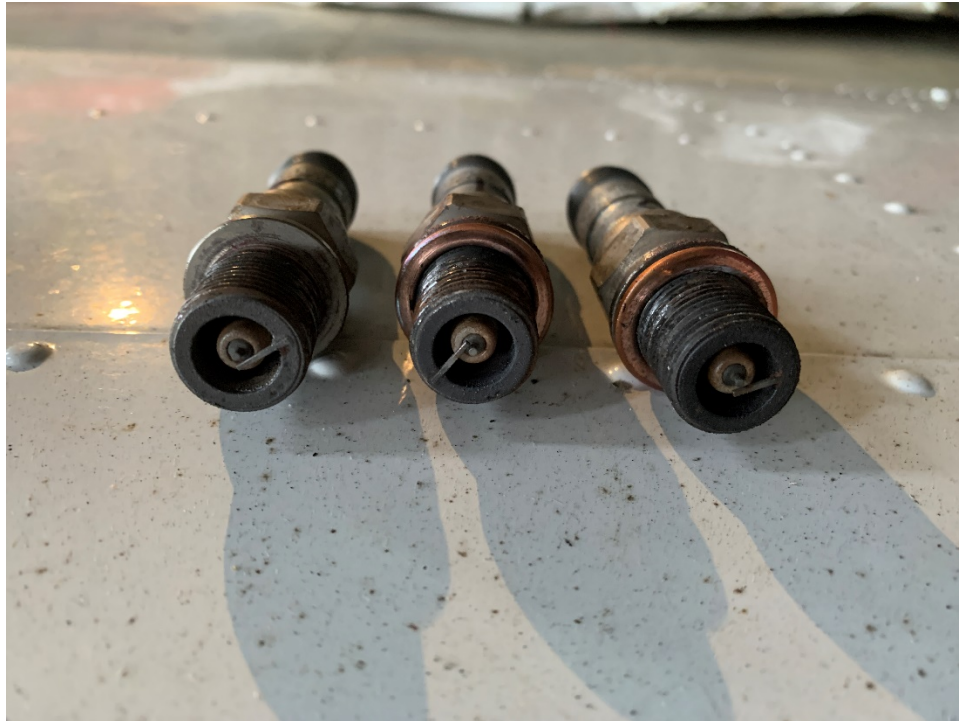
- Air was blown through the fuel transducer and no blockages were noted.
- The upper spark plugs were removed:
  - The number 1 spark plug exhibited heavy deposits that were dark in color.

- The number 2 spark plug was consistent with lean operations.
  - The number 3 spark plug was consistent with normal operations. With one small area of deposits.

- The number 4 spark plug was consistent with normal operations.
  - The number 5 spark plug was dark in color with some deposits.
  - The number 6 spark plug was dark in color.

Figure 21: Upper Spark Plugs cylinders: 1 3 5

Figure 22: Upper Spark Plugs cylinders: 2 4 6

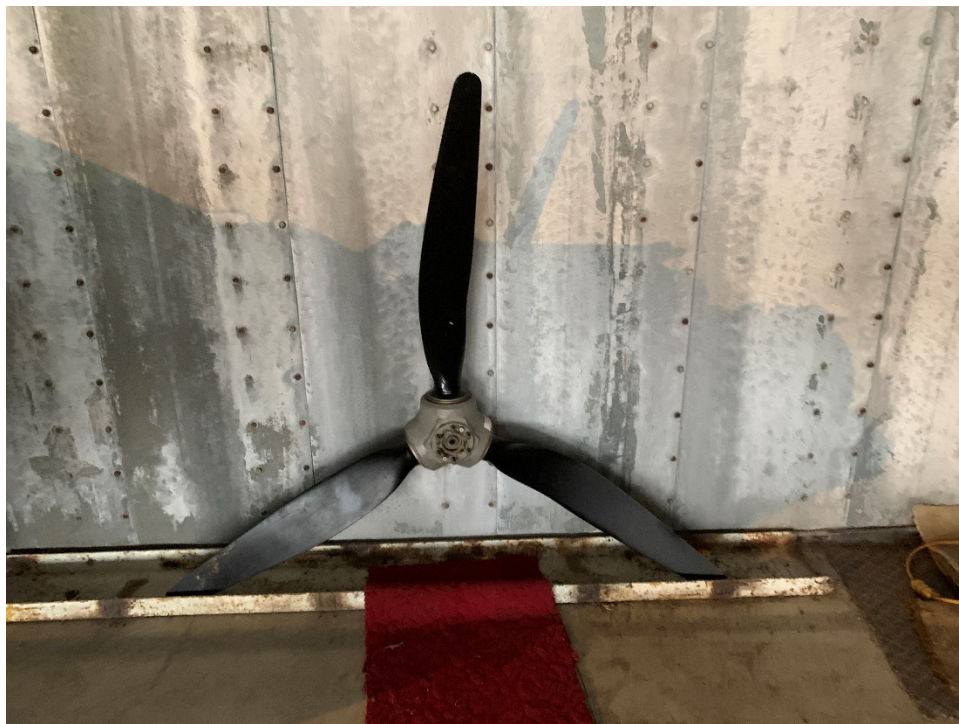
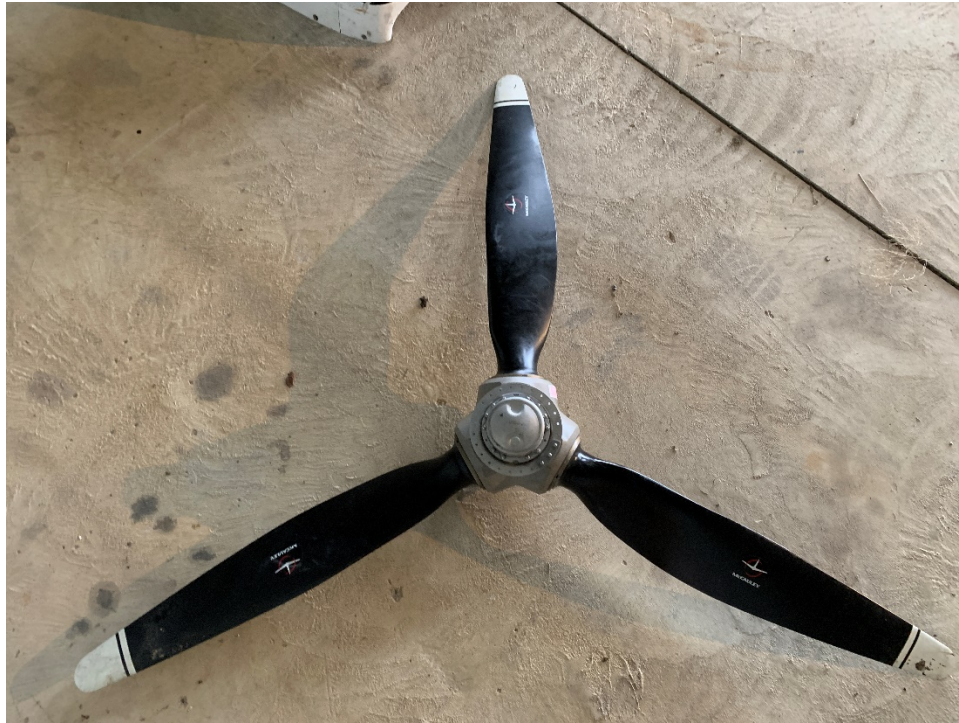
- The three bladed propeller assembly had been previously removed:
  - The three blades remained attached at the hub.
  - Two blades were bent aft about midspan.
  - The third blade was flattened.
  - None of the blades exhibited rotational scoring or markings.

Figure 25: Face side of Propeller Blades

Figure 26: Front of Propeller Blades
