# National Transportation Safety Board

CEN21LA265

## **MATERIALS LABORATORY**

Factual Report 22-057

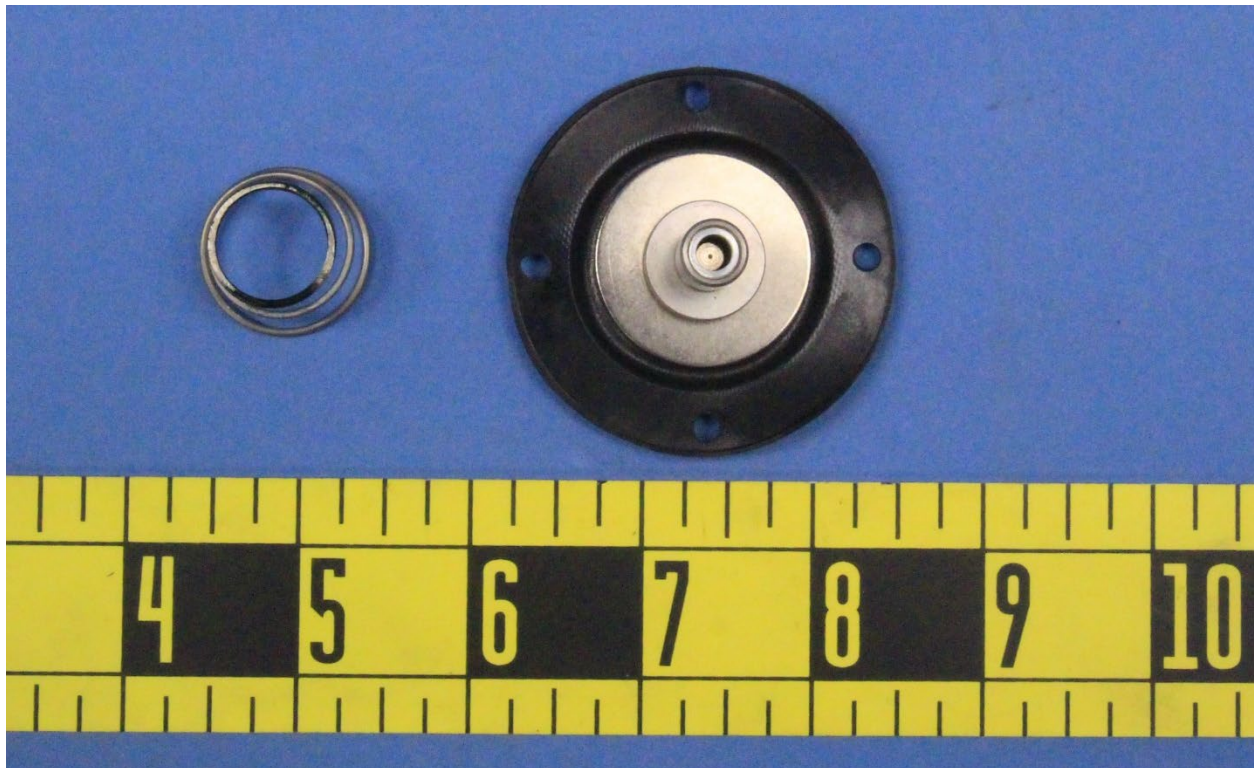
The fuel distribution diaphragm and springs as well as a sealant fragments from the fuel tank were submitted to the Materials Laboratory for examination. These components are show in Figures 1 and 2.

**Figure 1.** Overall photograph of fuel distributor spring and diaphragm.

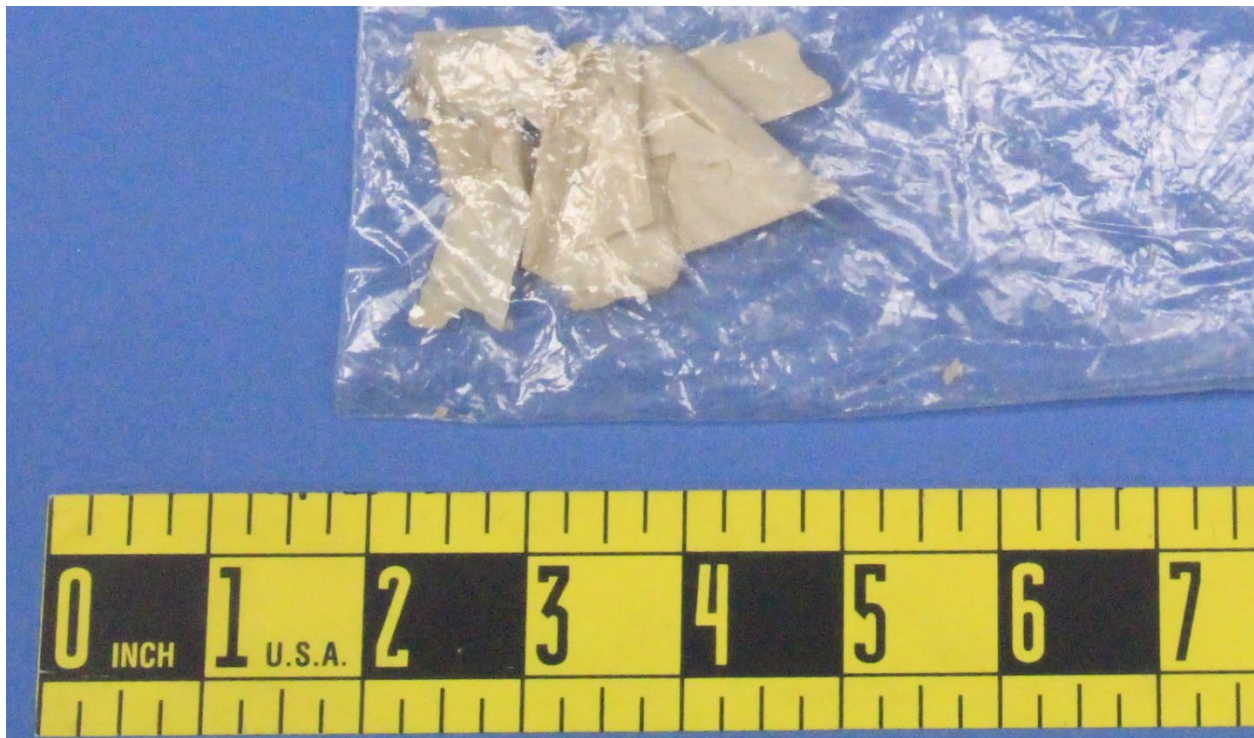
A sample of the known sealant sample from the left fuel tank was also examined by FTIR to determine if either residue matched the known sealant material. Spectral comparison of both samples found no correlation/match to the known sealant material.

**Figure 2.** Overall photograph of known sealant sample.

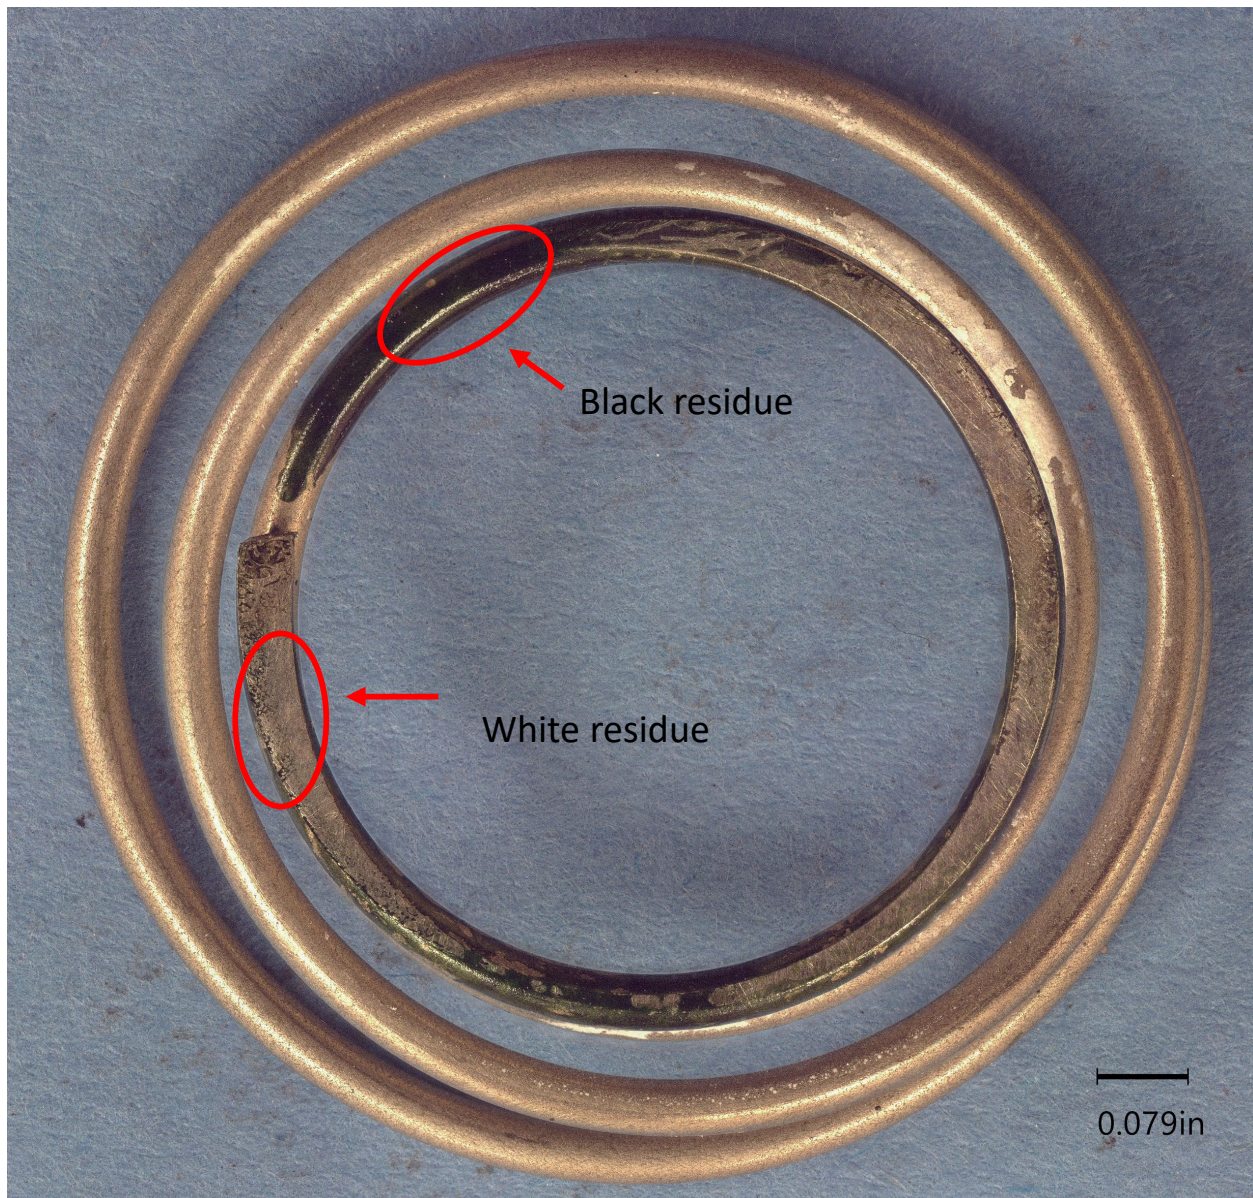
There were two visible areas of residue on the surface of the springs. A sample of white powdery residue was removed from the top of the spring and a sample of a darker material adhered to the mid-coil of the spring as shown in Figure 3 were removed from the surface of the spring for further analysis.

A spectral library comparison search was performed on the residue spectrum. The library search found a strong spectral matched to zinc stearate.

A spectral library comparison search was performed on the residue spectrum. The library search found no strong spectral matches, but the spectrum did have similarities to several polyamides

**Figure 3.** Close-up photograph of fuel distribution spring with sample areas marked.
