## Air Safety Investigations Aircraft Incident/Accident Technical Report

| Aircraft Incident/<br>Accident Information | Year: 1980 | Make: Cessna | Model: 180K |
| Chief Air Safety Investigator: Henry J. Soderlund | | Report #: ASI-21-CY-T | Report date: 03-14-22 |

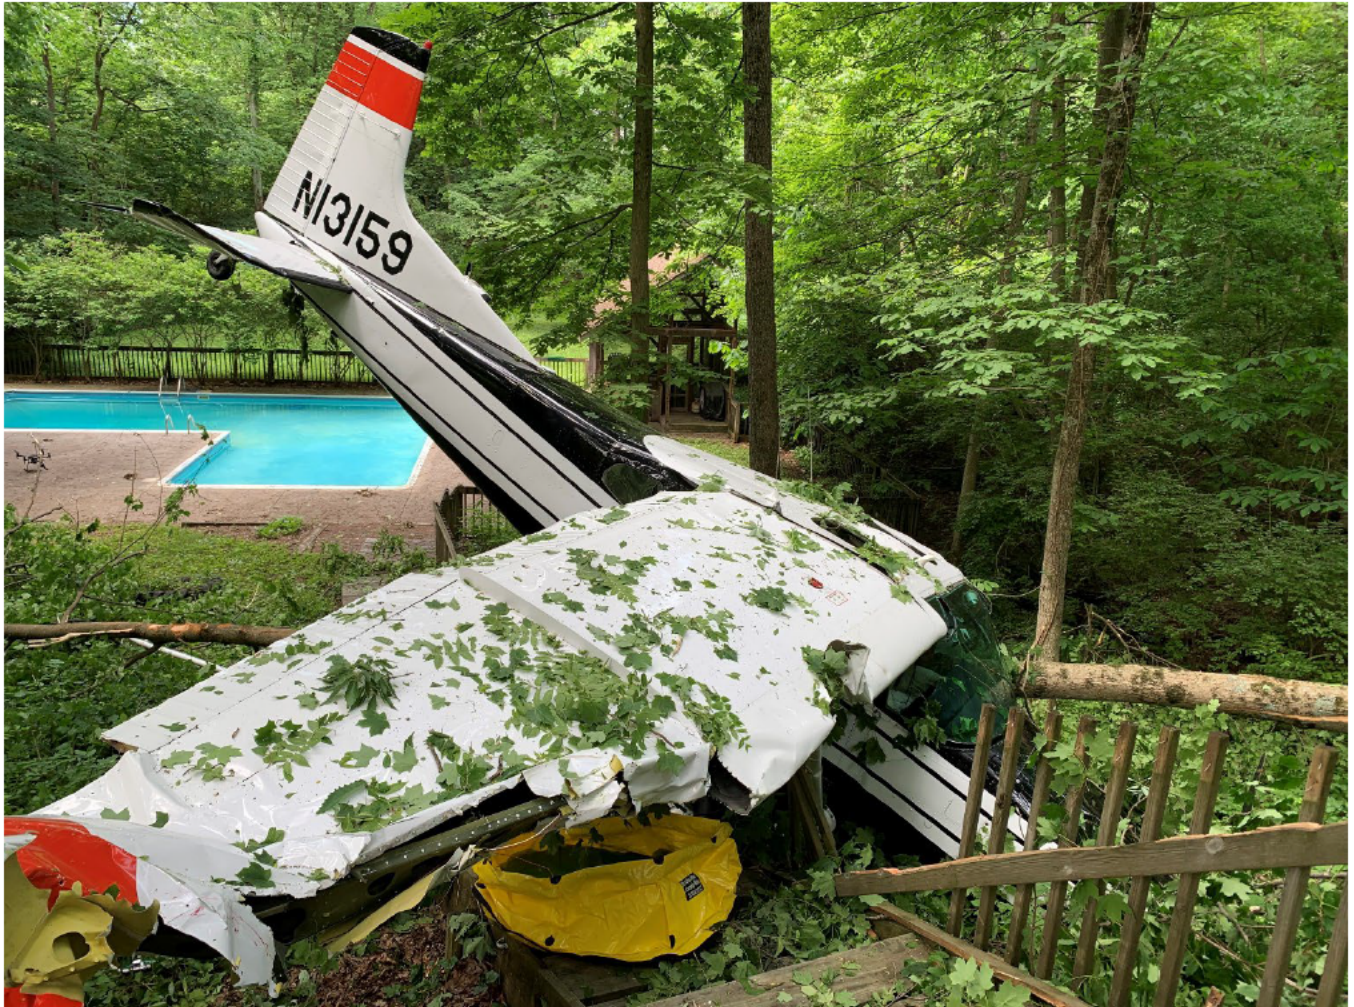
FAA On Site Photograph IMG\_0204.jpg

Photographs show the aircraft in a nose down attitude at the accident site.

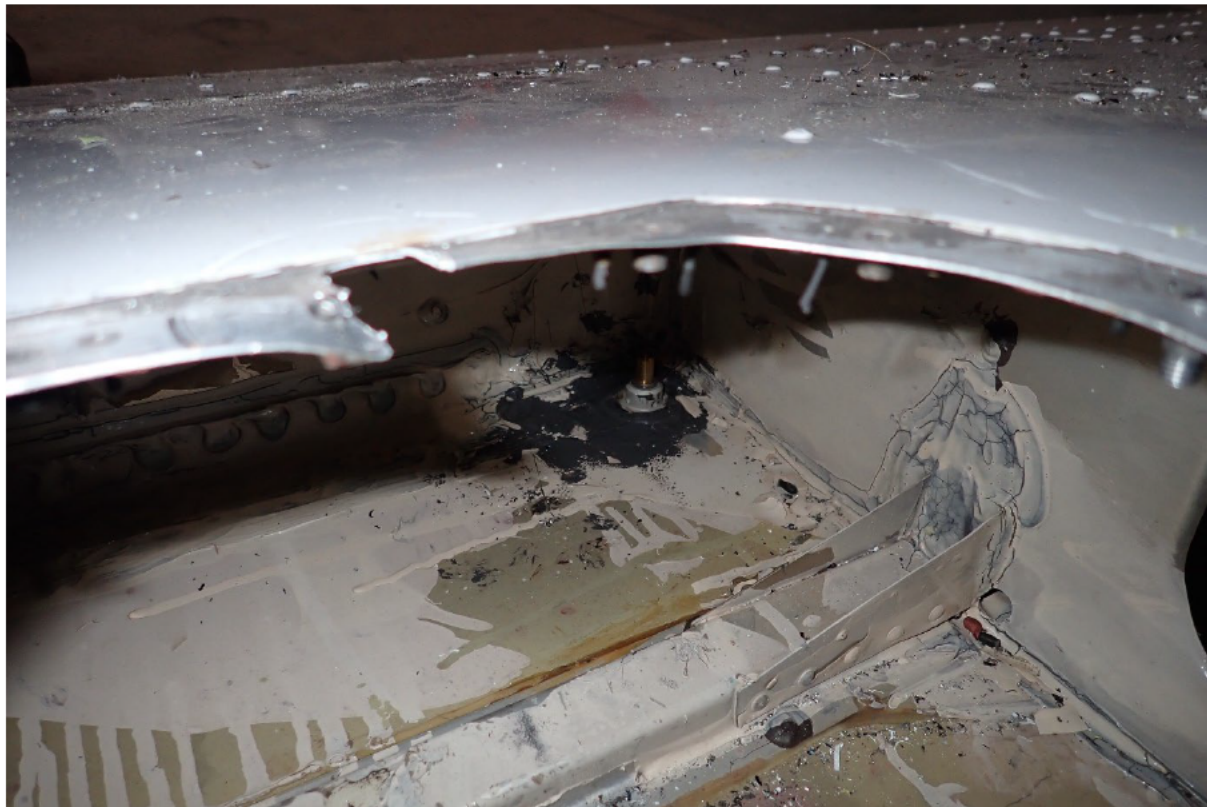
At an unknown time, a white sealer had been painted on a majority of the vertical surfaces and seams in the left tank. The sealer was cracked and only partially adhered to portions of the tank. Pieces of sealer, up to an inch in size and thinner than a piece of paper, were found loose in the bottom of the tank. A dark gray sealer was observed on top of the white sealer around the middle and outboard fuel tank drains.

TAI Wreckage Exam ASI-21-CY-052.jpg – Left fuel tank

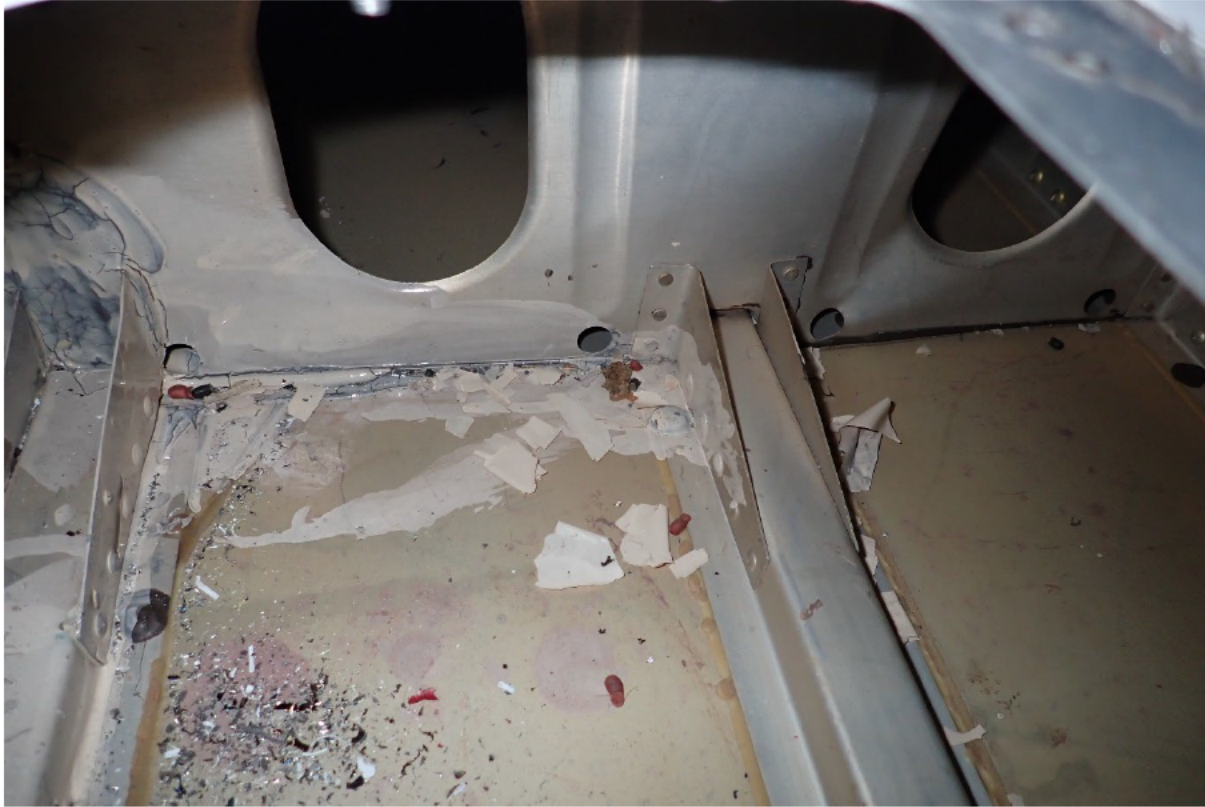
TAI Wreckage Exam ASI-21-CY-051.jpg – Interior of left tank

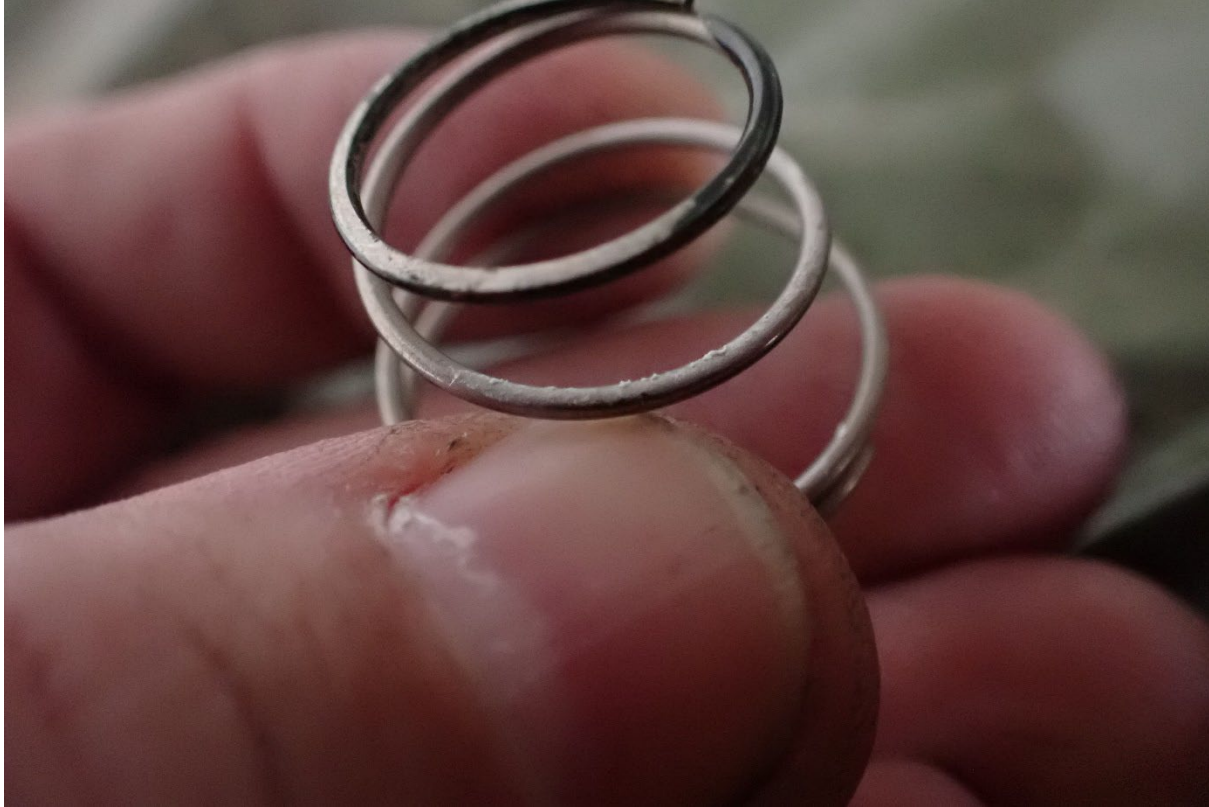
A white substance was observed adhered to a portion of the flow divider spring and the flow divider diaphragm was less pliable than normal. All of the fuel injectors were clear of debris except cylinder 2 which was partially obstructed. White combustion deposits were noted in cylinder 2 when it was examined with an endoscope; the other cylinders appeared normal. The cylinder 1 top spark plug was corroded. The cylinder 2 top spark plug electrode and insulator appeared lighter in color than the other top spark plugs.

TAI Wreckage Exam ASI-21-CY-104.jpg – Flow divider screen

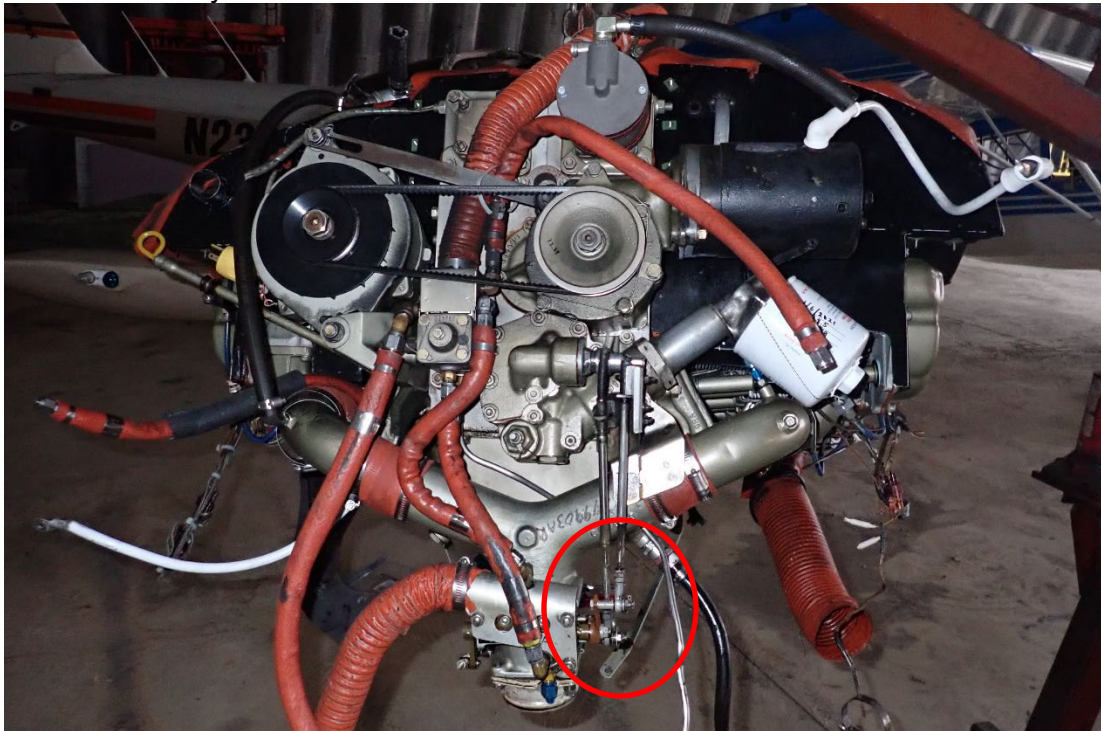
The throttle body became wet with fuel when air was blown into the fuel lines.

TAI Wreckage Exam ASI-21-CY-083.jpg (cropped) – Throttle body leakage circled
