# National Transportation Safety Board

CEN21LA271

## **AIRFRAME AND ENGINE EXAMINATION**

Location: Buena Vista, CO  
Date: June 14, 2021  
Time: 0700 MDT  
1400 UTC  
Airplane: Cessna T210L, N30286

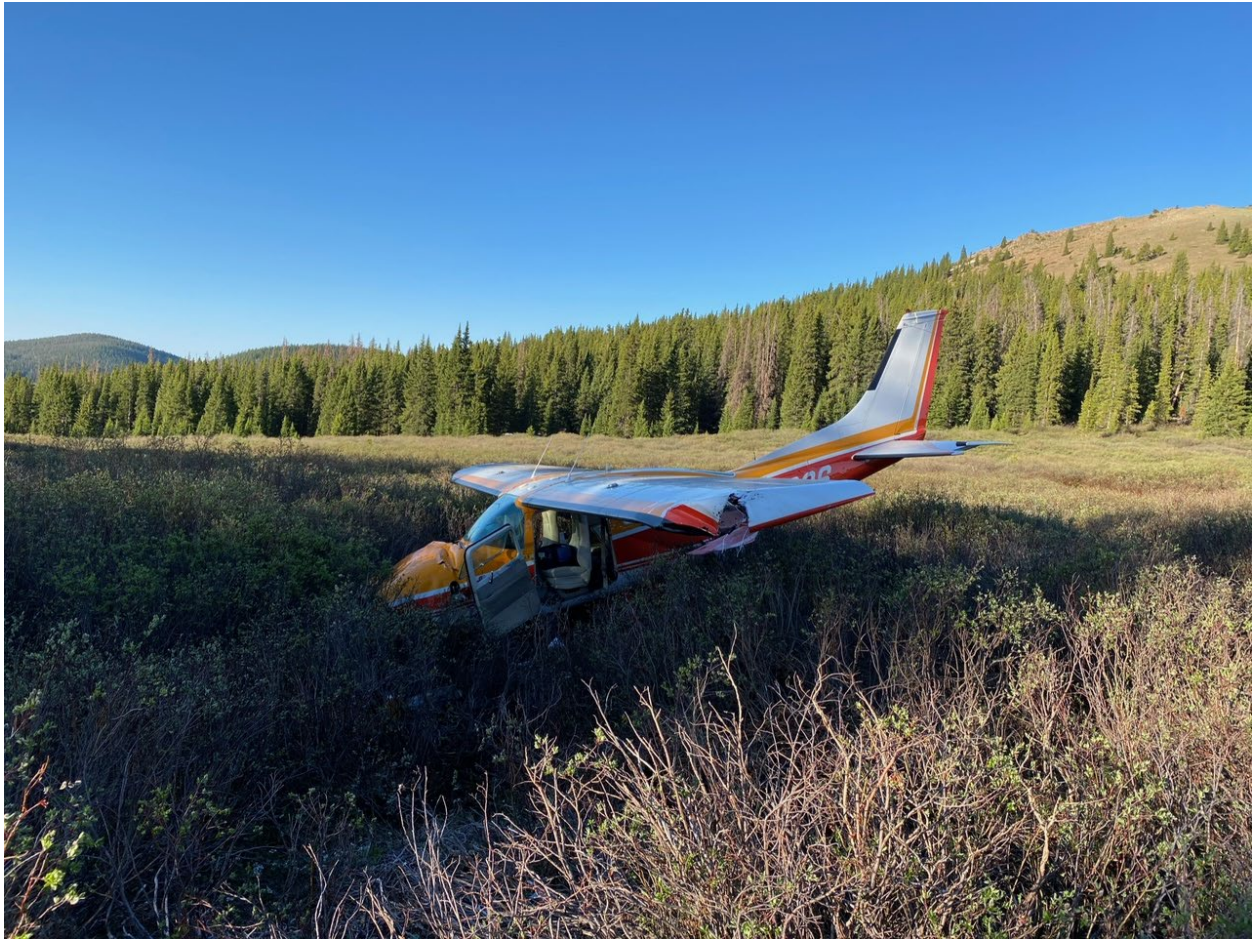
The pilot reported that the power loss felt like if someone had retarded the throttle, so he instantly pushed the throttle in and turned the auxiliary fuel pump on to the "high" position. It had no effect, so the pilot tried to restart the engine. It would not restart. The pilot located a flat, treeless area to put down in and configured the airplane for landing. On impact in a meadow, the landing gear sheared off and the airplane came to a stop upright. The airplane sustained substantial damage to the forward fuselage, firewall, and left outboard wing.

Figure 1: Accident Site

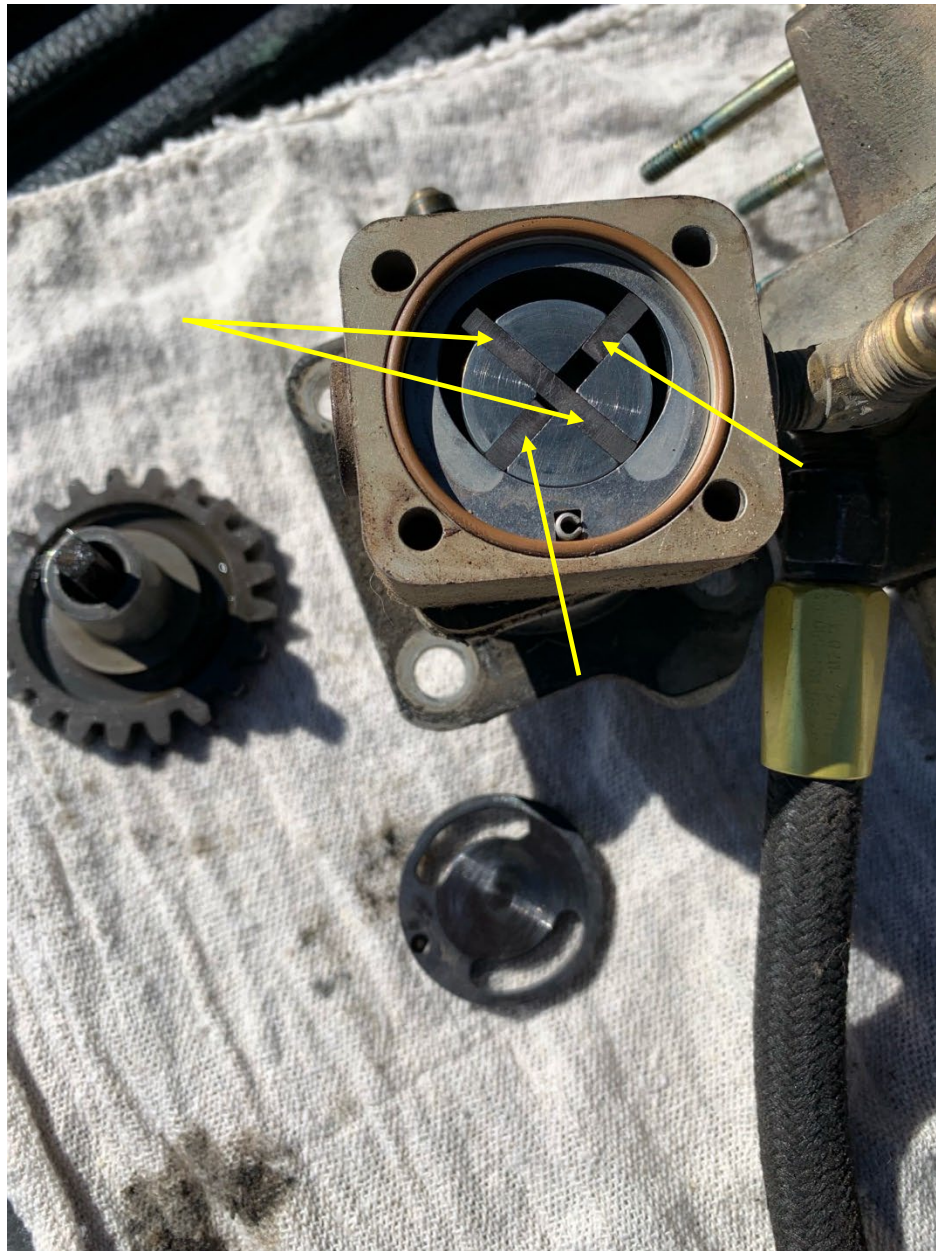
Figure 2. Engine Driven Fuel Pump, Vanes (Yellow Arrows) Installed

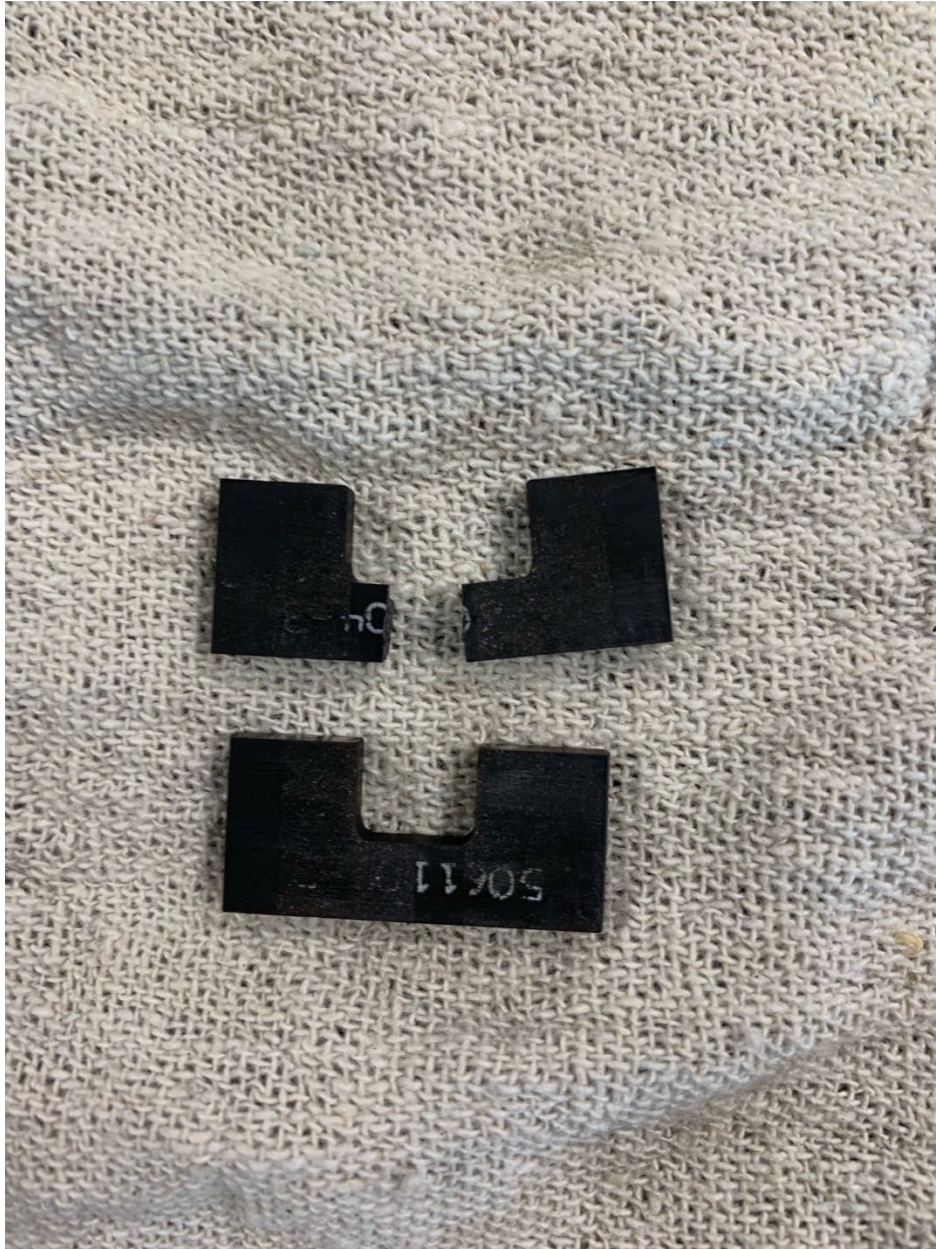
The pump was disassembled. One of the pumps two carbon vanes was fractured in half. No debris was observed in the pump housing. On consultation with the engine manufacturer, operation with the severed vane would likely cause fuel cavitation, which would result in a drop in pump outlet pressure. This would likely

cause a gradual decrease in engine rpm. Partial pressure should be restored by selecting the Low position on the fuel pump switch. This would allow the engine to continue to run normally. Actuation of the pump in the High position would flood the engine making a restart more difficult. It would necessitate clearing the flooded engine and using hot start procedures.

Figure 3. Vanes Removed. Fractured and Intact Vanes Observed.

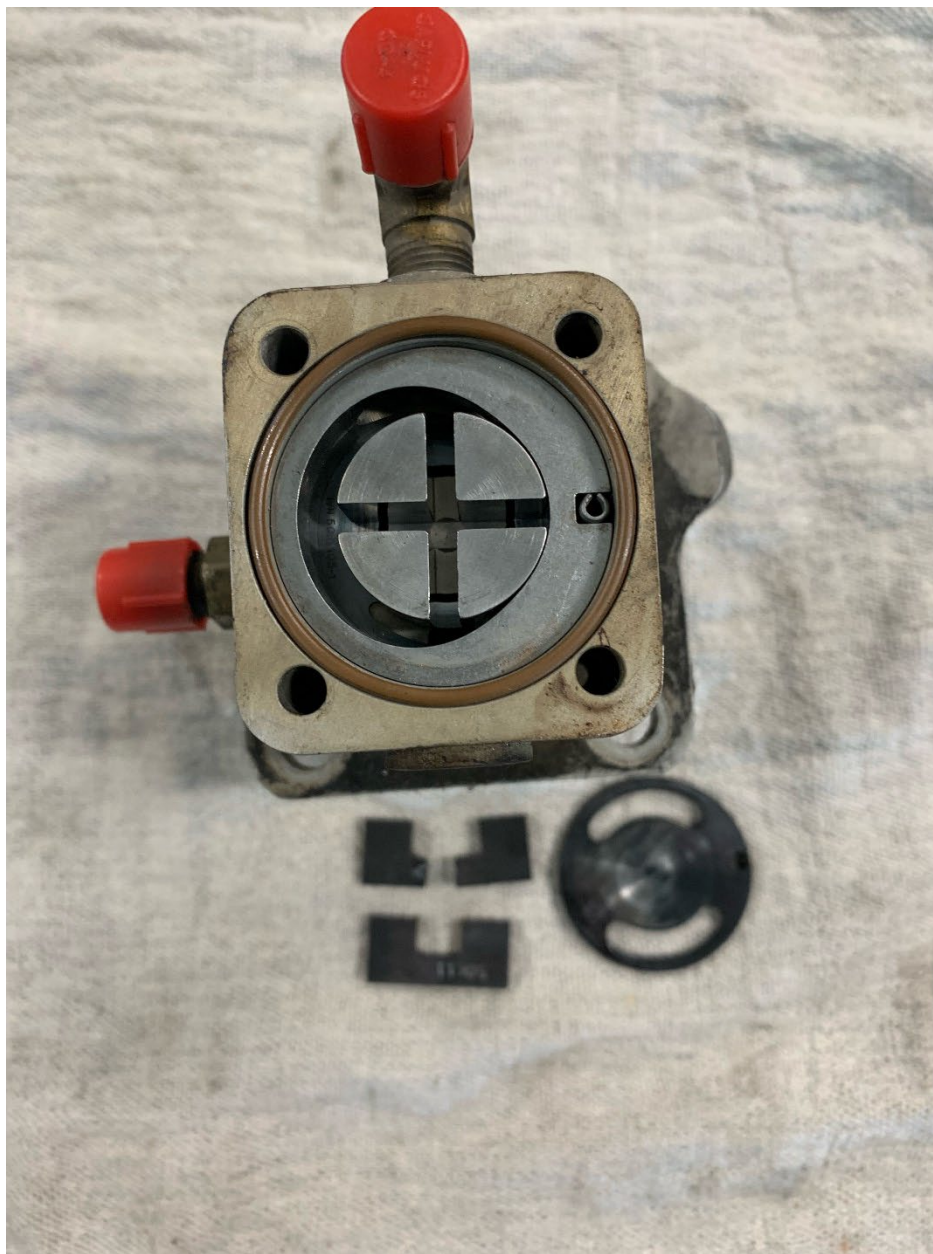
Figure 4. Disassembled Engine Driven Fuel Pump.
