Review and document all components of the torque sensor assembly. Analyze the debris of the submitted samples, oil filter, and magnetic chip detector.

| PART NAME: | Torque Sensor Assembly |
| MODEL/PROGRAM: | TPE331 |
| MODEL/PROGRAM S/N: | P92122C |

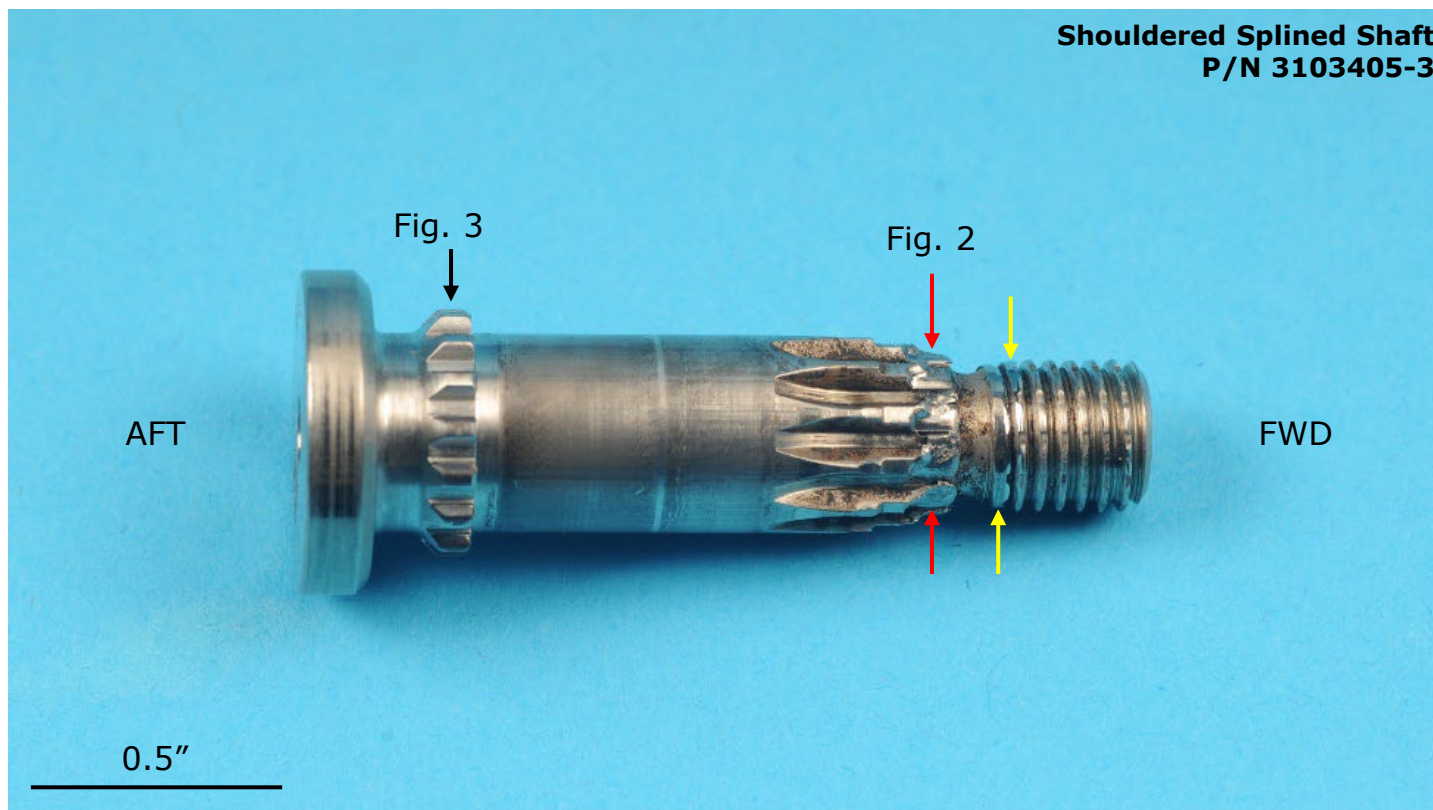
**Figure 1.**

The shouldered splined shaft from TPE331 engine S/N P92122C exhibited damage predominantly on the forward side of the shaft (Figures 1-2). The forward splines were worn and deformed approximately 2/3 of the axial length from contact with the mating 2<sup>nd</sup> idler forward spur gear. Damage was observed on the aft side of the shaft threads from contact with the nut.

Image showing the shouldered splined shaft (P/N 3103405-3) from TPE331 engine S/N P92122C after cleaning with acetone. Damage was observed on the forward splines (red arrows) and threads (yellow arrows). Close-up images of the areas identified are shown in Figures 2-3.

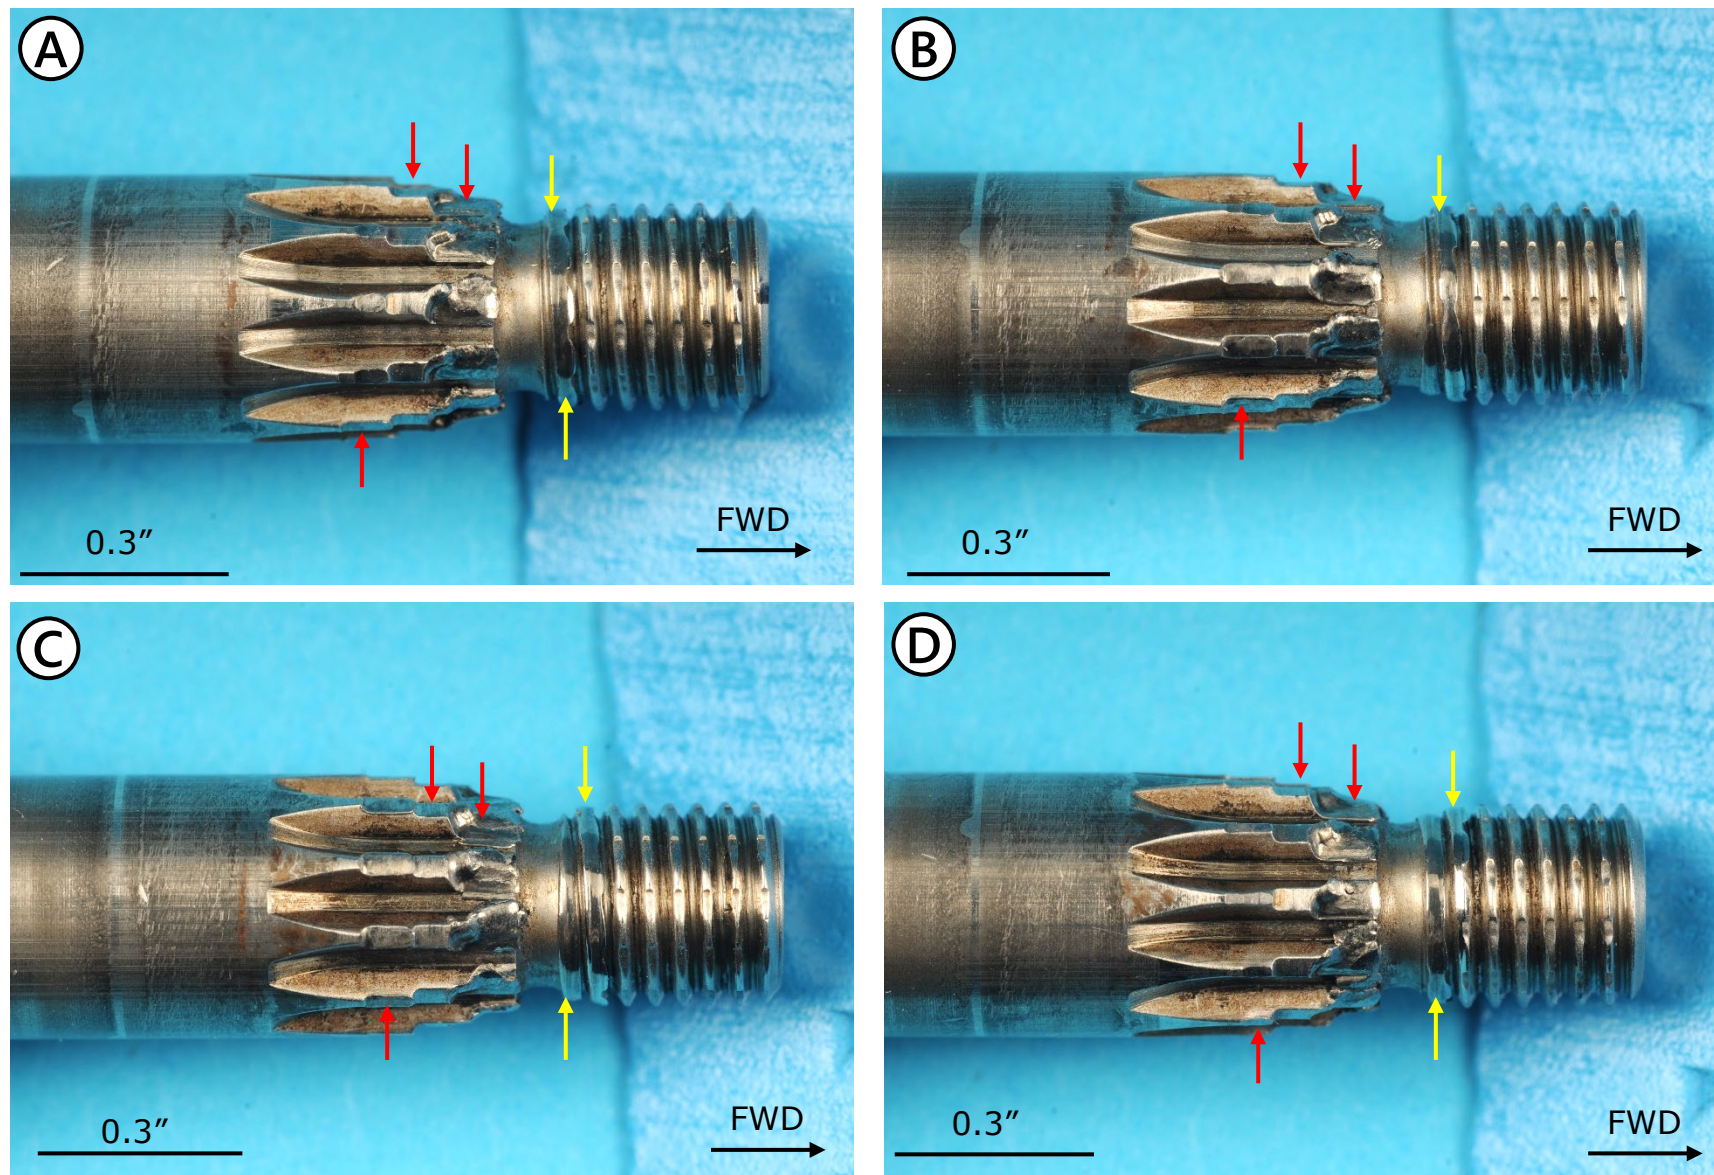
**Figure 2.**

(A-D) Digital microscope images showing the condition of the forward end of the shouldered spline shaft at 90° intervals. Wear and deformation were observed on the threads (yellow arrows) and splines (red arrows).

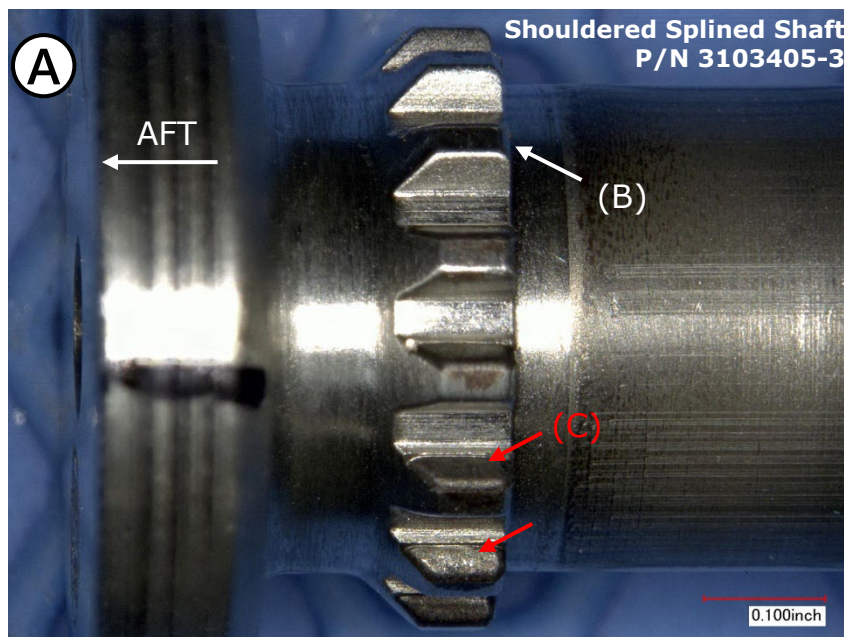
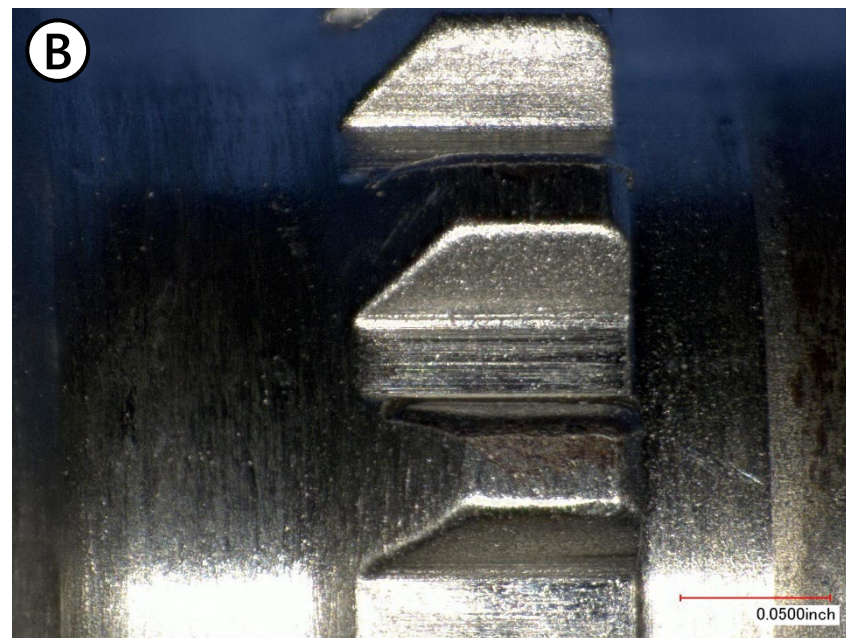
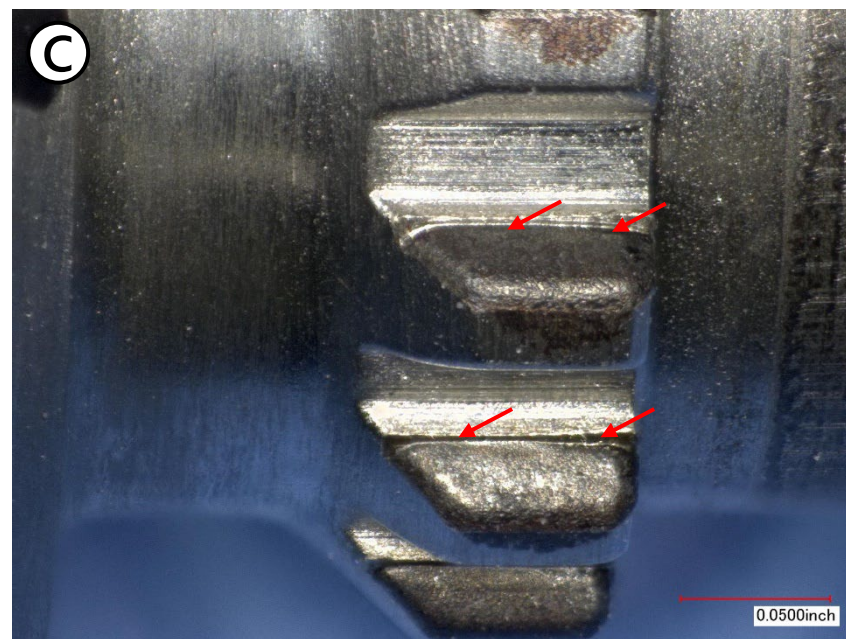
Wear was observed on the loaded side of the aft splines of the shaft (Figure 3). The wear step on the aft splines ranged from ~0.007"-0.011" in depth. The forward side of the shaft head exhibited fret wear from contact with the mating 2<sup>nd</sup> idler aft spur gear (Figure 4C).

**Figure 3.**  
(A-C) Digital microscope images showing the condition of the aft spline of the shouldered splined shaft (reference Figure 1). Wear was observed predominantly on the loaded side of the spline teeth (red arrows in (A) and (C)).

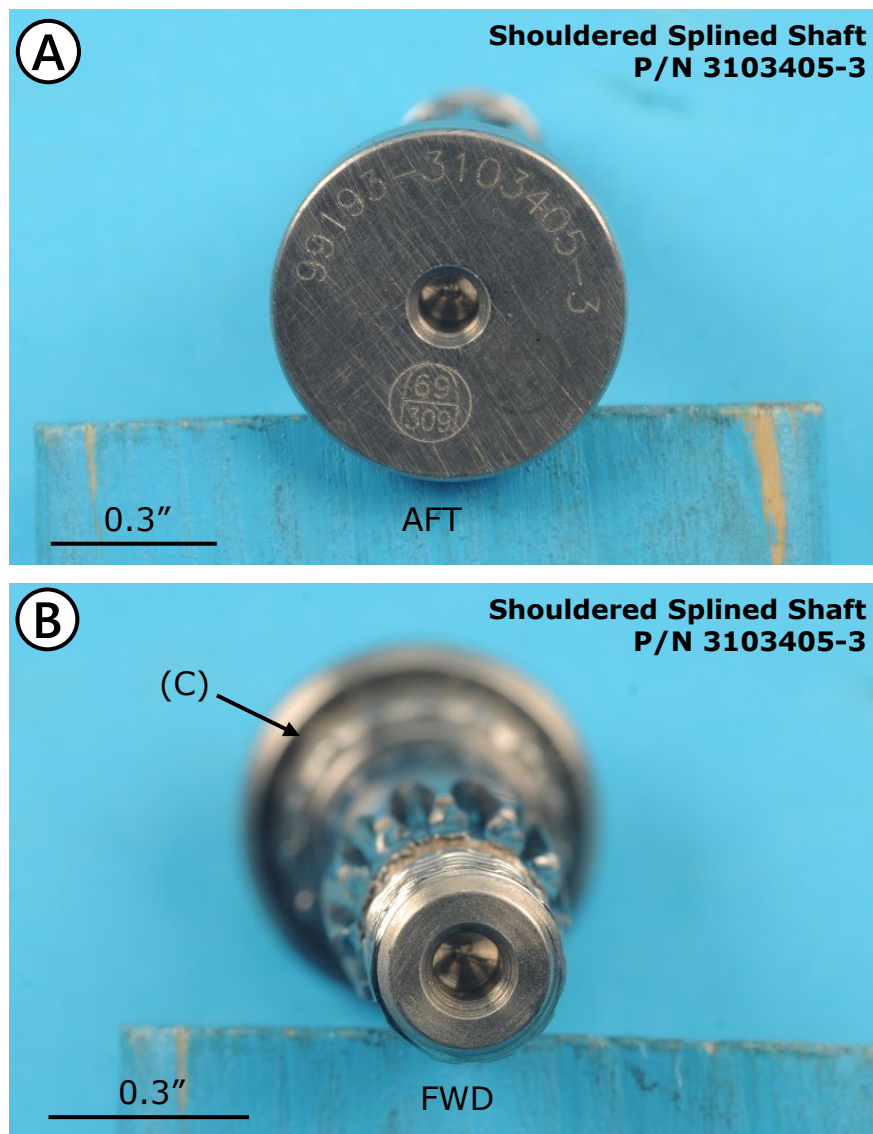
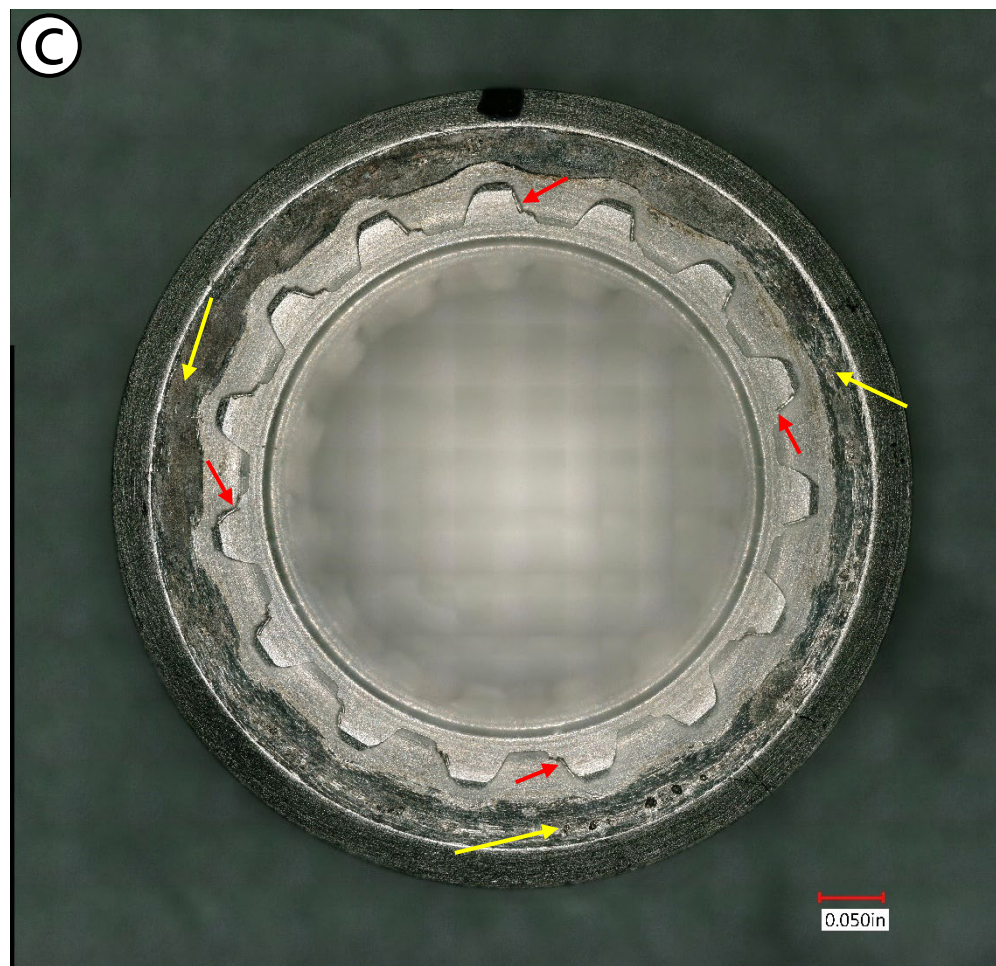
**Figure 4.**

(A-B) Close-up images showing the aft and forward ends, respectively, of the splined shaft. (C) Digital microscope image showing fret wear on the shaft head (yellow arrows) and on the aft splines (red arrows) from contact with the mating 2<sup>nd</sup> idler aft spur gear (P/N 3103406-2). The wear step on the aft splines ranged from ~0.007"-0.011" in depth.

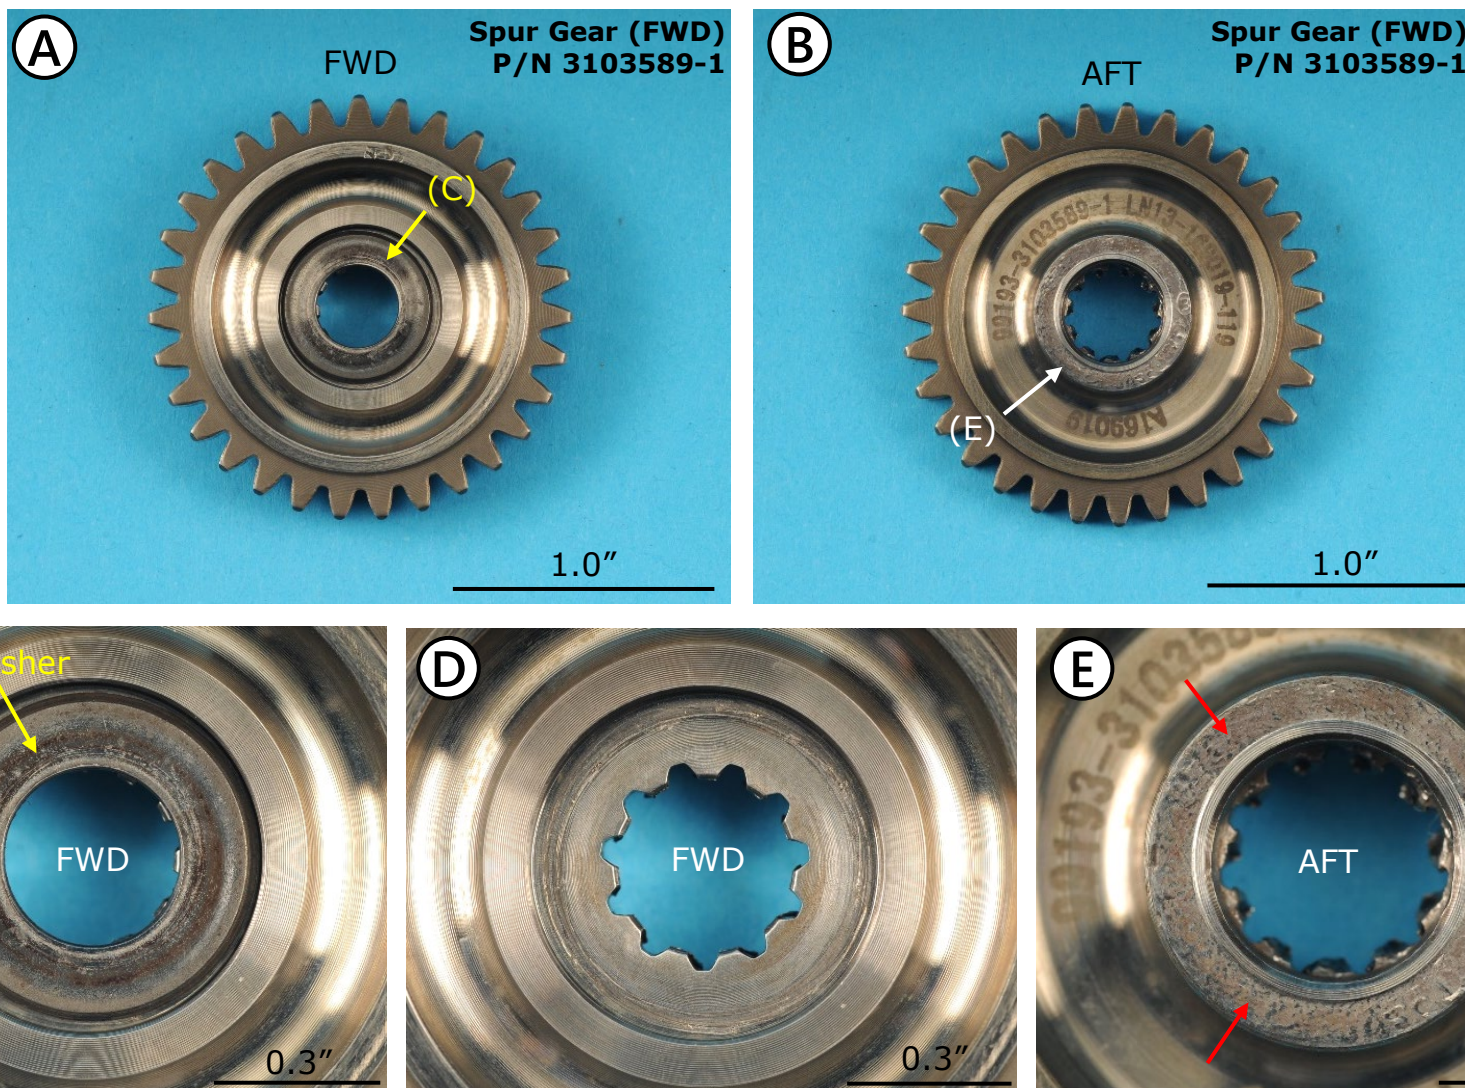
**Figure 5.**

The as-received condition of the 2<sup>nd</sup> idler forward spur gear from TPE331 engine S/N P92122C is shown in Figure 5. Fret wear was observed on the aft face of the spur gear from contact with the mating duplex ball bearing (Figure 5E). Note that some of the

(A-E) Image showing the as-received condition of the 2<sup>nd</sup> idler forward spur gear (P/N 3103589-1) from TPE331 engine S/N P92122C. The yellow arrows in (A) and (C) identify the washer between the spur gear and the nut. View (D) shows the forward spur gear with the washer removed. Fret wear (red arrows in (E)) was observed on the aft side of the spur gear from contact with the duplex ball bearing. Note that some of the bearing markings were transposed to the spur gear surface.

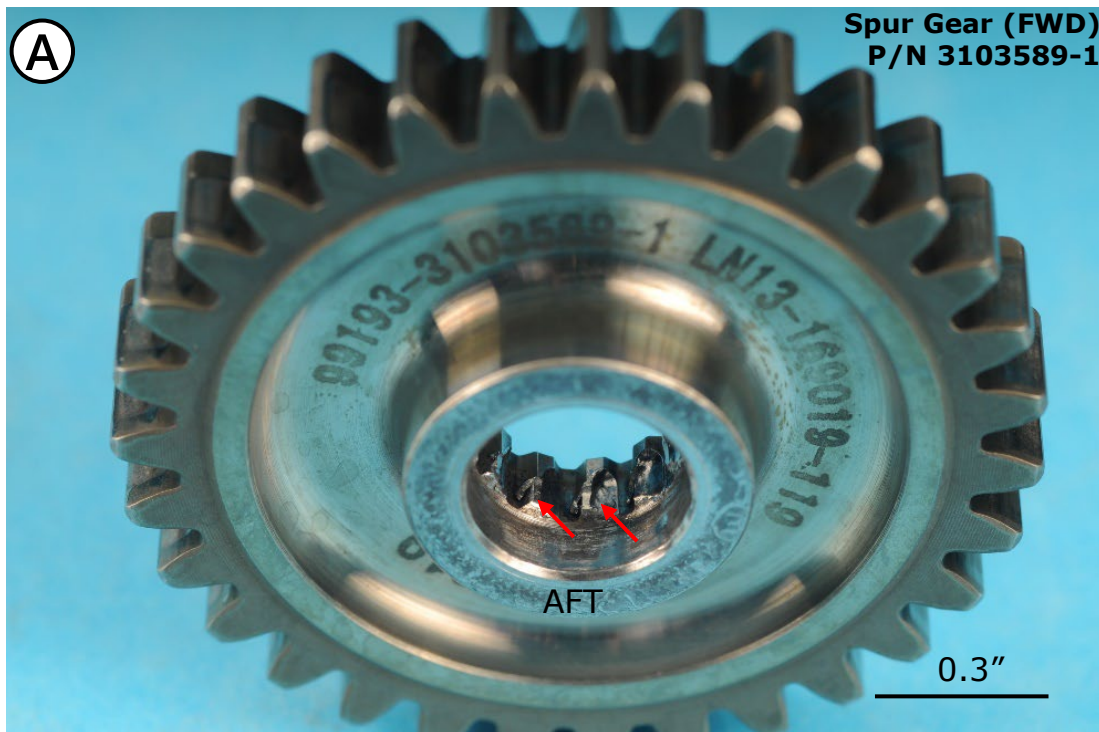
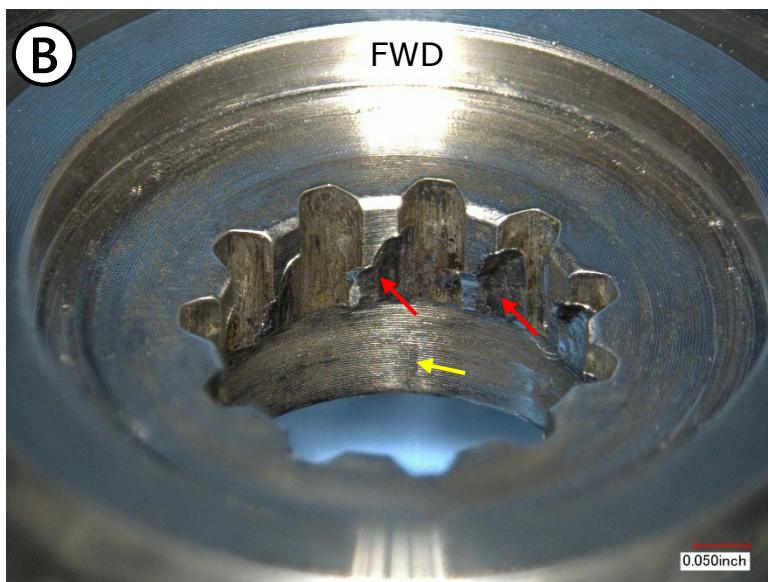
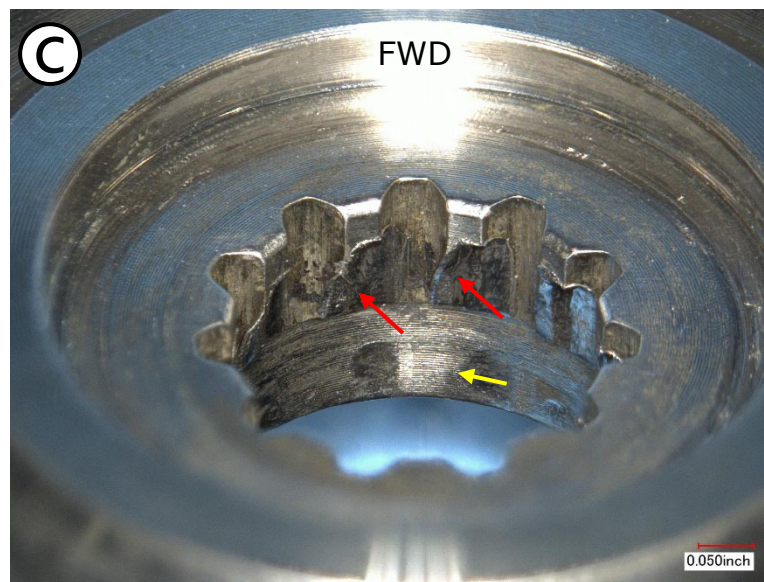
**Figure 6.**

bearing markings were transposed to the spur gear surface. The internal splines of the spur gear exhibited wear and deformation spanning approximately 2/3 of the spline length near the aft end (Figure 6).

(A-C) Images showing the condition of internal splines of the 2<sup>nd</sup> idler forward spur gear. Wear and deformation was observed on the loaded side of the splines (red arrows) from contact with the mating shouldered splined shaft. Yellow arrows in (B-C) identify wear from contact with the shaft OD.

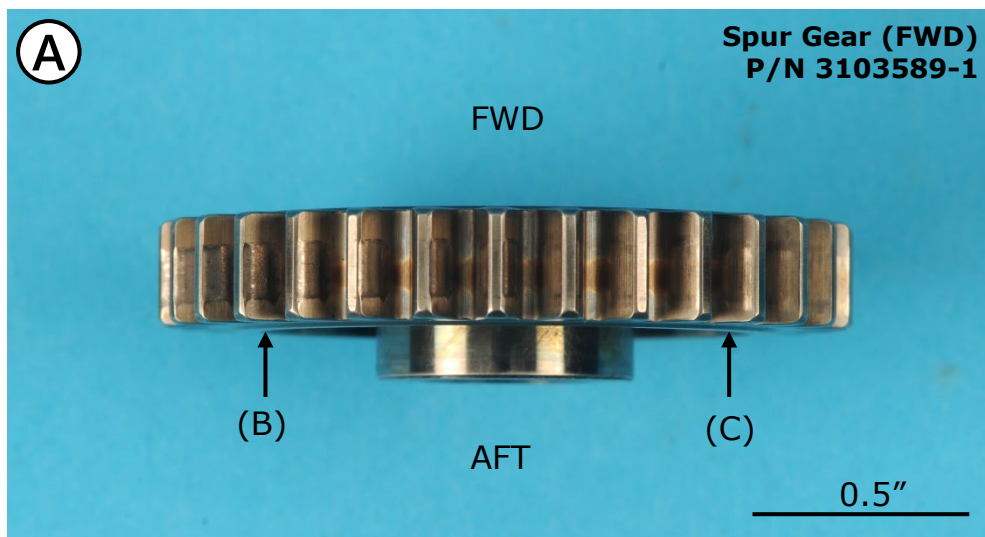
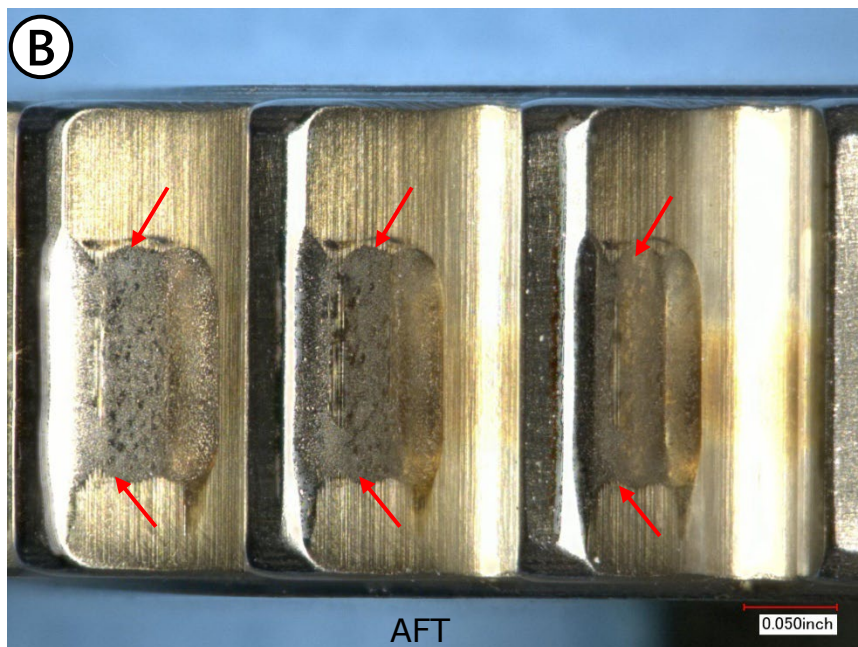
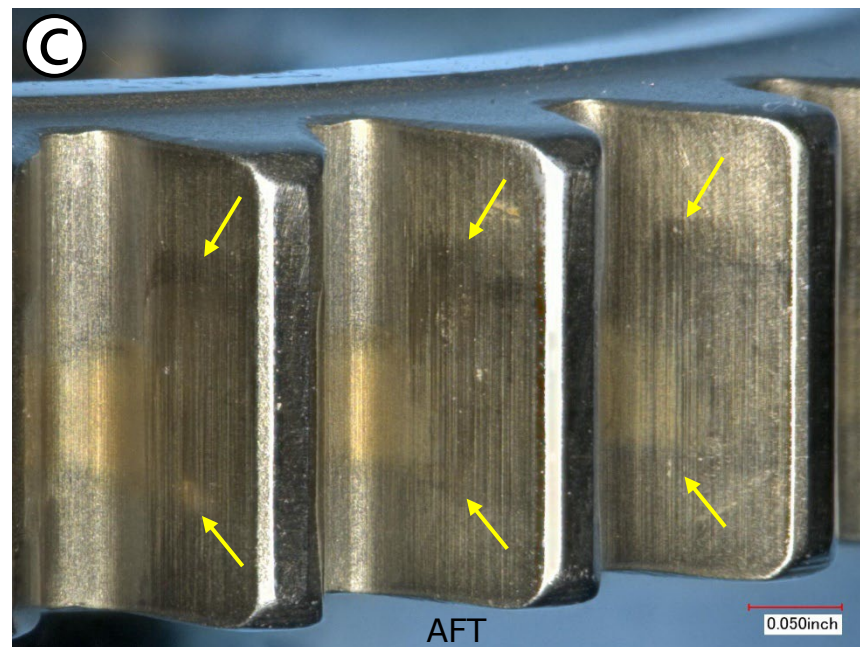
**Figure 7.**

The forward spur gear exhibited wear and deformation on the loaded side of the gear teeth (Figure 7). Witness marks were observed on the unloaded side of the gear teeth.

(A-C) Images showing the condition of gear teeth of the 2<sup>nd</sup> idler forward spur gear. Wear and deformation was observed on the loaded side of the gear teeth (red arrows) from contact with the mating 3<sup>rd</sup> idler spur gear (P/N 3103590-2). Witness marks (yellow arrows in (C)) were observed on the unloaded side of the gear teeth.

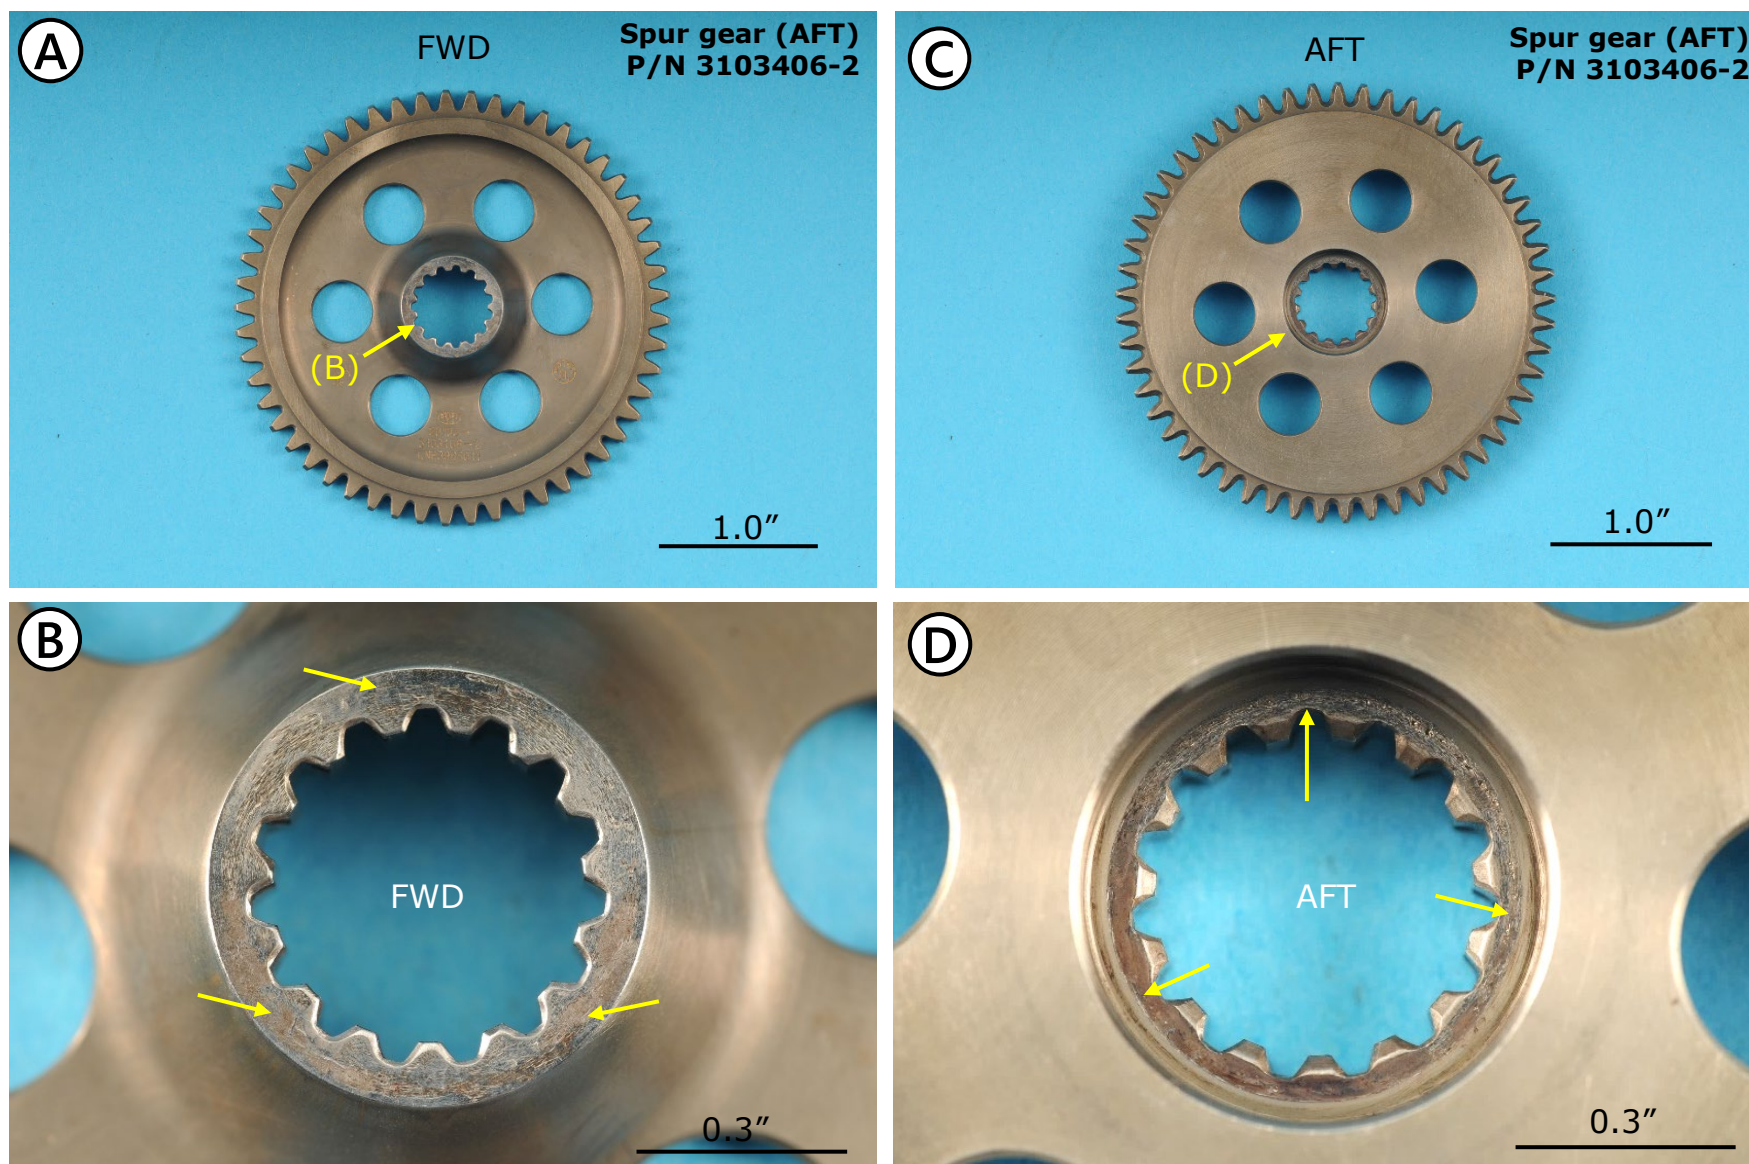
**Figure 8.**

The as-received condition of the 2<sup>nd</sup> idler aft spur gear from TPE331 engine S/N P92122C is shown in Figure 8. Fret wear was observed on the forward and aft sides of the spur gear from contact with the duplex ball bearing and the shouldered splined shaft head, respectively.

(A-D) Images showing the as-received condition of the 2<sup>nd</sup> idler aft spur gear (P/N 3103406-2) from TPE331 engine S/N P92122C. Wear (yellow arrows) was observed on the forward and aft sides of the spur gear from contact with the duplex ball bearing and shouldered splined shaft head, respectively.

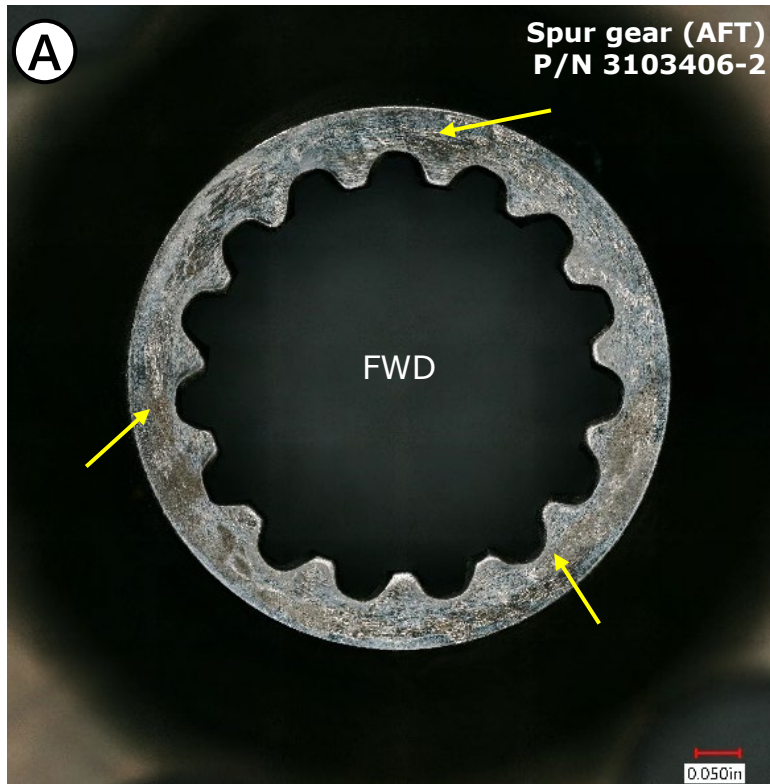
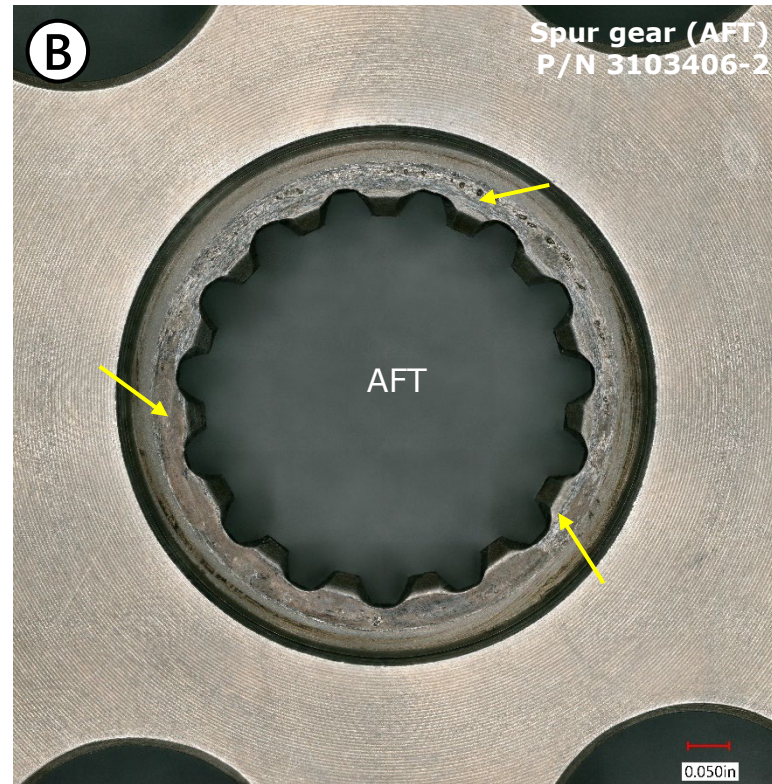
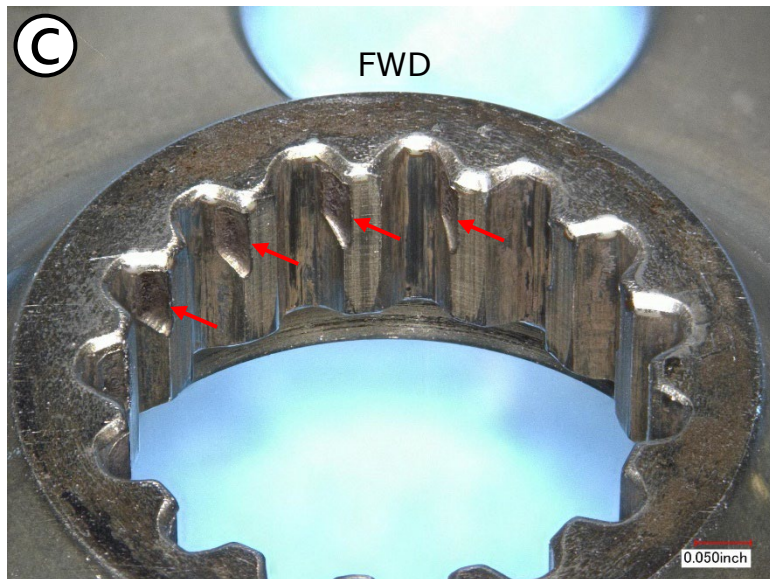
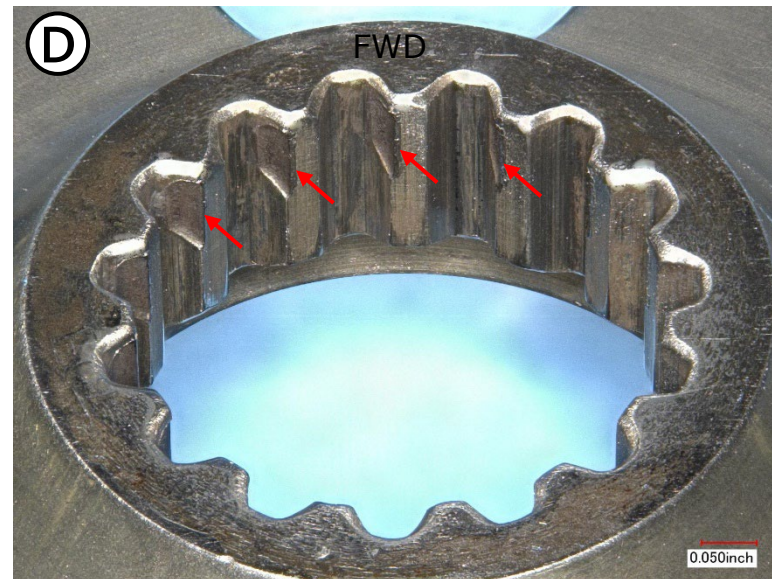
**Figure 9.**

Wear was observed on the loaded side of the internal splines from contact with the mating splines from the shouldered splined shaft (Figure 9). The wear markings spanned approximately half of the spline length near the forward end.

(A-B) Digital microscope images showing the forward and aft ID surfaces of the 2<sup>nd</sup> idler aft spur gear. Fret wear (yellow arrows) was observed on the forward and aft sides of the spur gear from contact with the duplex ball bearing and shouldered splined shaft head, respectively. (C-D) Digital microscope images showing the internal spline of the 2<sup>nd</sup> idler aft spur gear. Wear (red arrows) was observed on the loaded side of the spline teeth from contact with the mating splines from the shouldered splined shaft.

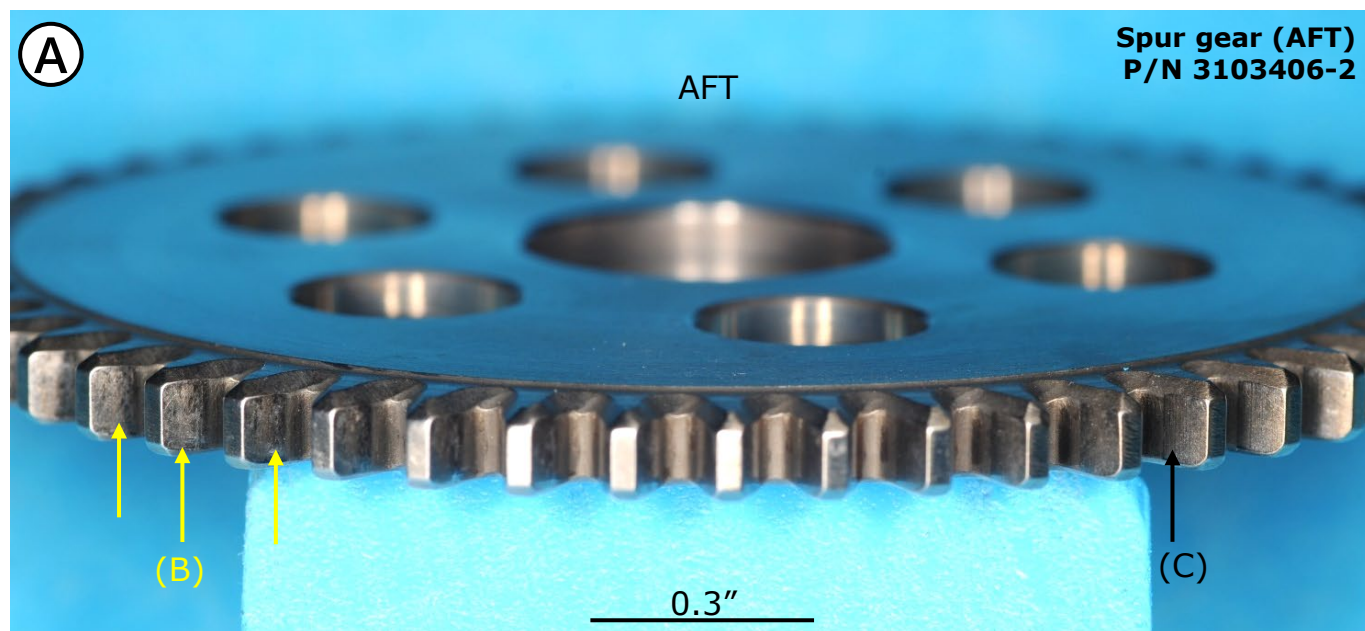
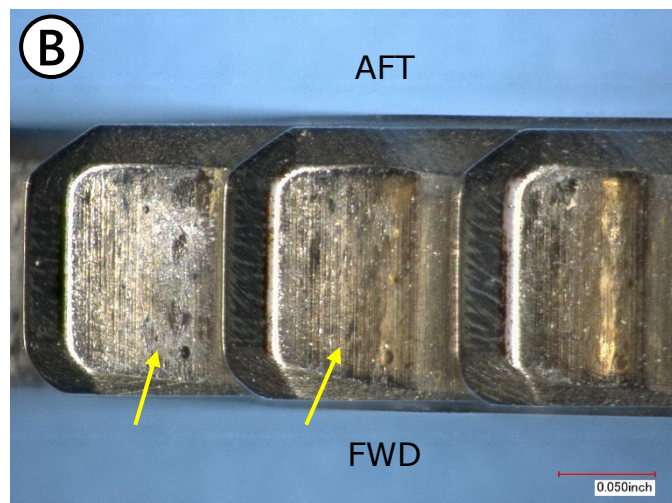
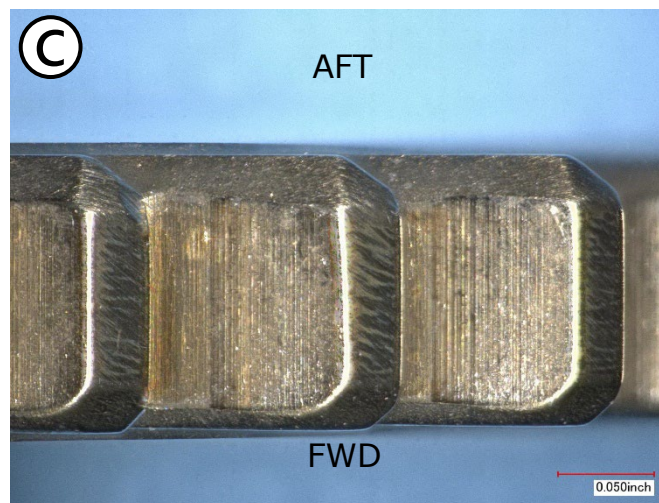
Contact marks were observed on the loaded side of the spur gear; however, no notable wear depth was observed (Figure 10).

**Figure 10.** (A-C) Digital microscope images showing the gear teeth of the 2<sup>nd</sup> idler aft spur gear. Contact marks (yellow arrows in (A-B)) were observed on the loaded side of the gear teeth; however, no notable wear depth was observed.

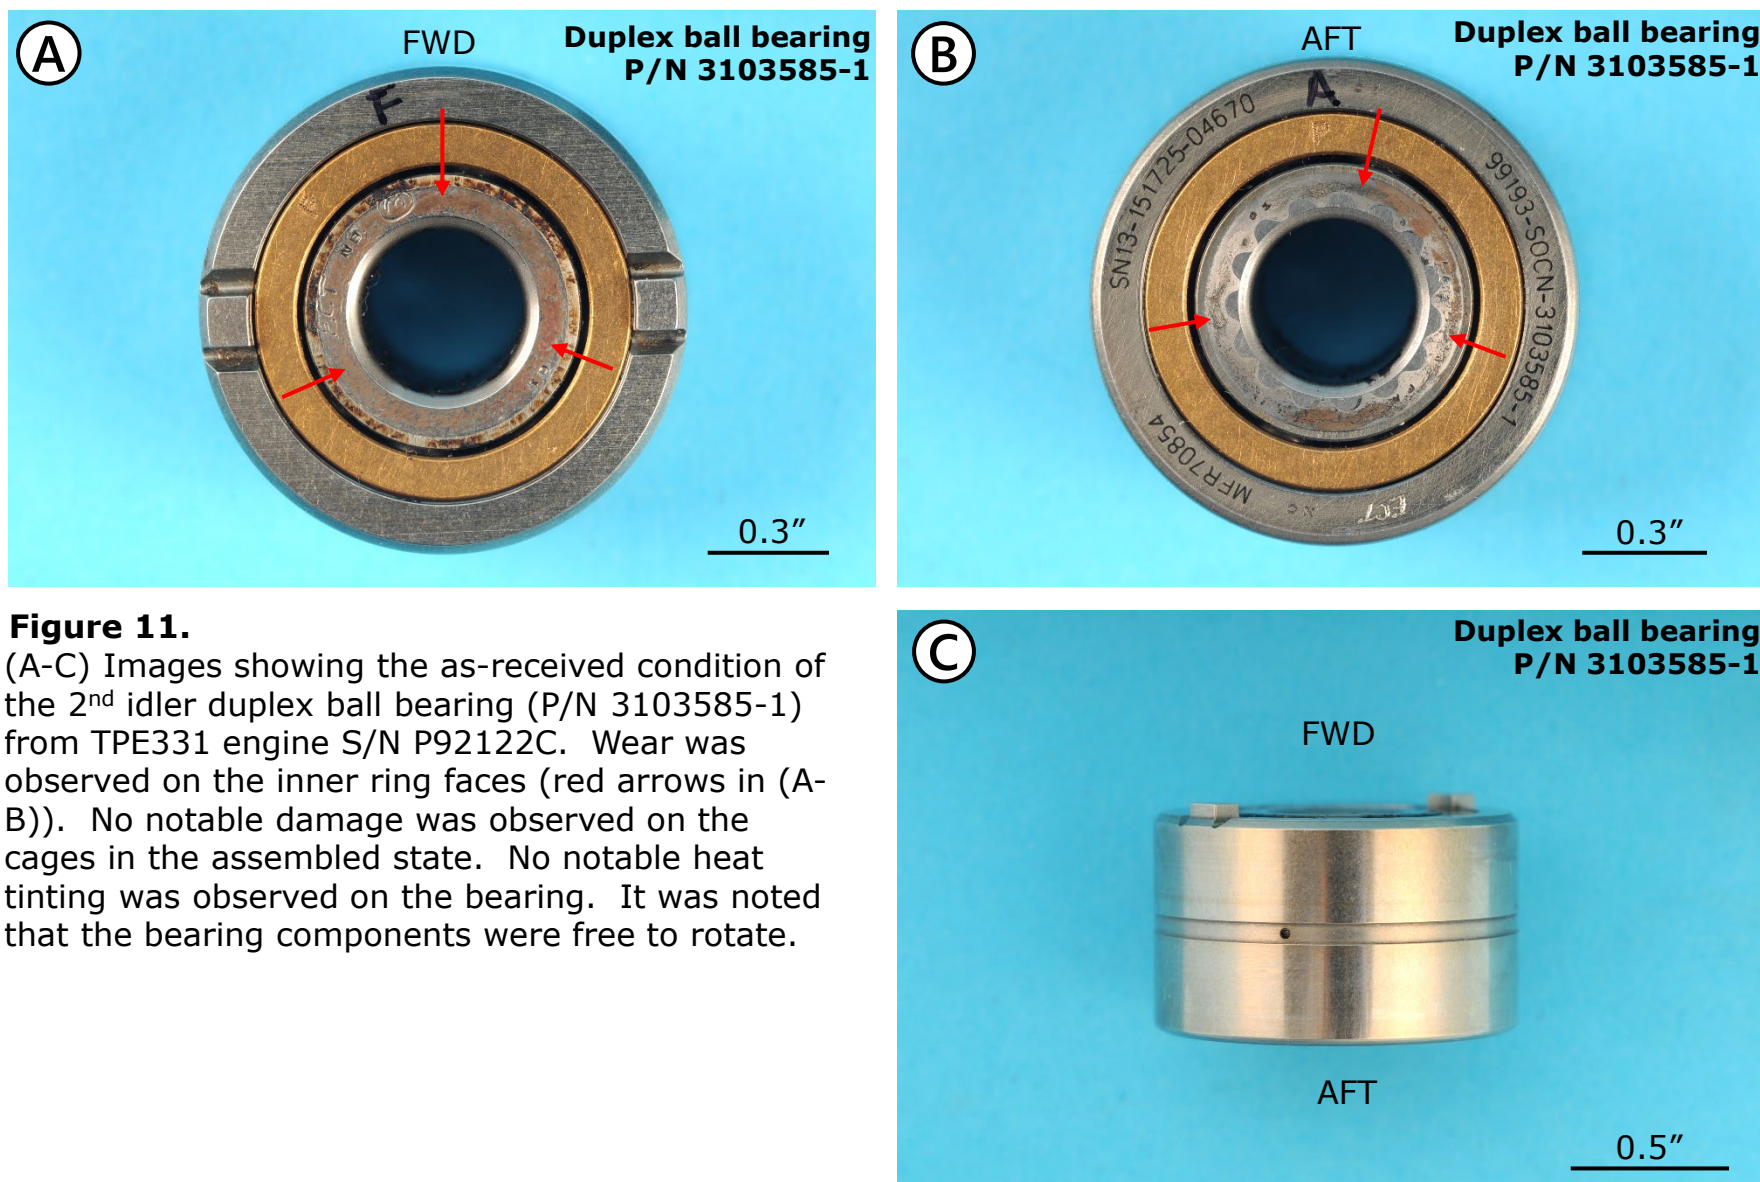
**Figure 11.**

The as-received condition of the 2<sup>nd</sup> idler duplex ball bearing from TPE331 engine S/N P92122C is shown in Figures 11-12. Wear was observed on the inner ring faces from contact with the mating spur gears. No notable damage was observed on the cages in the assembled state. It was noted that the bearing components were free to rotate.

(A-C) Images showing the as-received condition of the 2<sup>nd</sup> idler duplex ball bearing (P/N 3103585-1) from TPE331 engine S/N P92122C. Wear was observed on the inner ring faces (red arrows in (A-B)). No notable damage was observed on the cages in the assembled state. No notable heat tinting was observed on the bearing. It was noted that the bearing components were free to rotate.

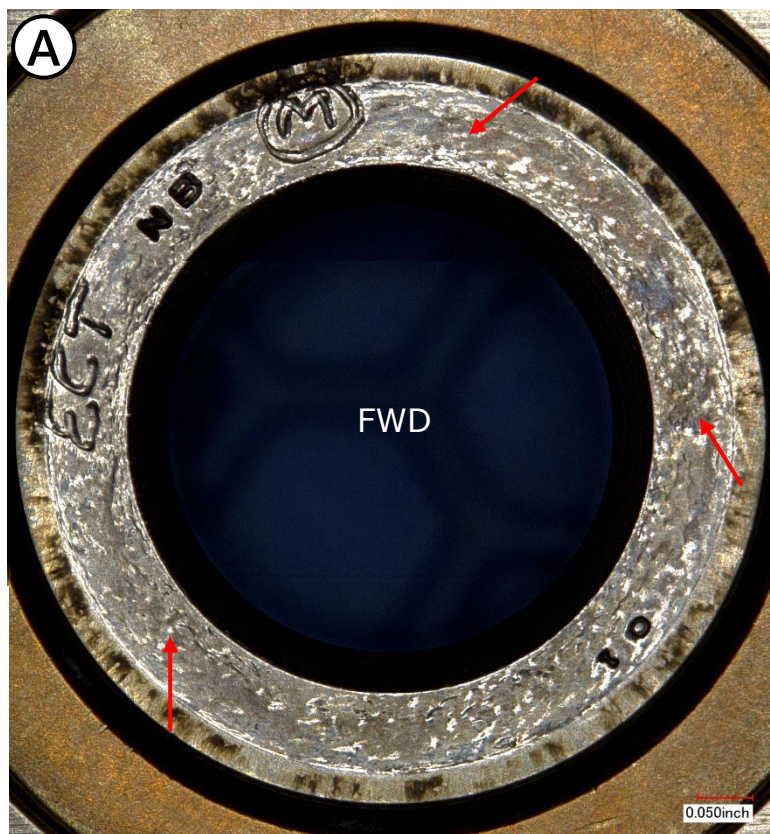
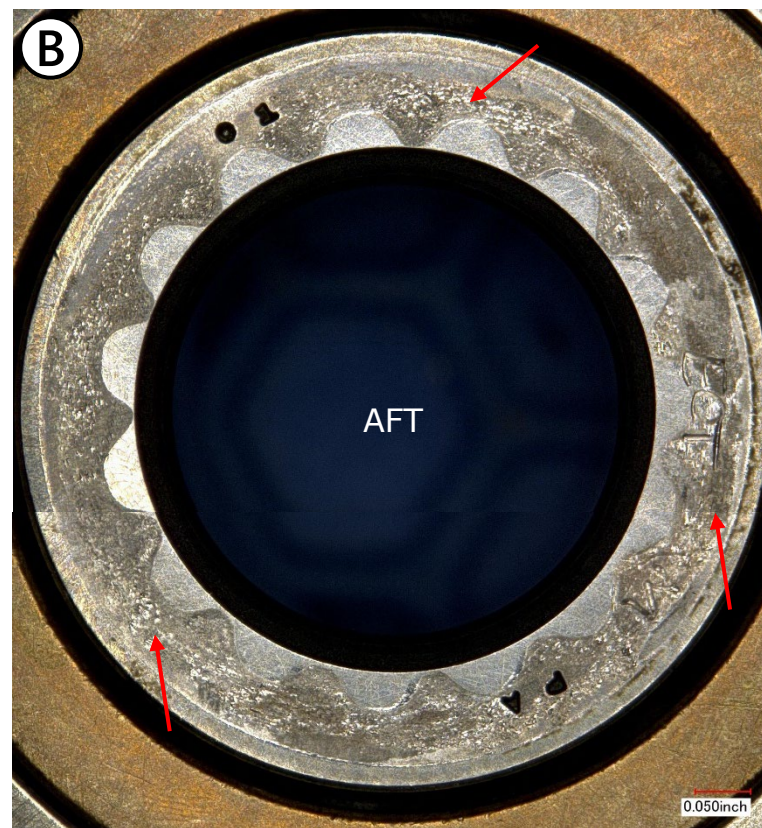
**Figure 12.**

(A-B) Digital microscope images showing the forward and aft sides, respectively, of the duplex ball bearing inner ring faces. Fret wear (red arrows) was observed on the forward and aft faces from contact with the mating 2<sup>nd</sup> idler forward and aft spur gears, respectively.
